# Provision of Cremators at Wo Hop Shek Crematorium

Tree Survey Report

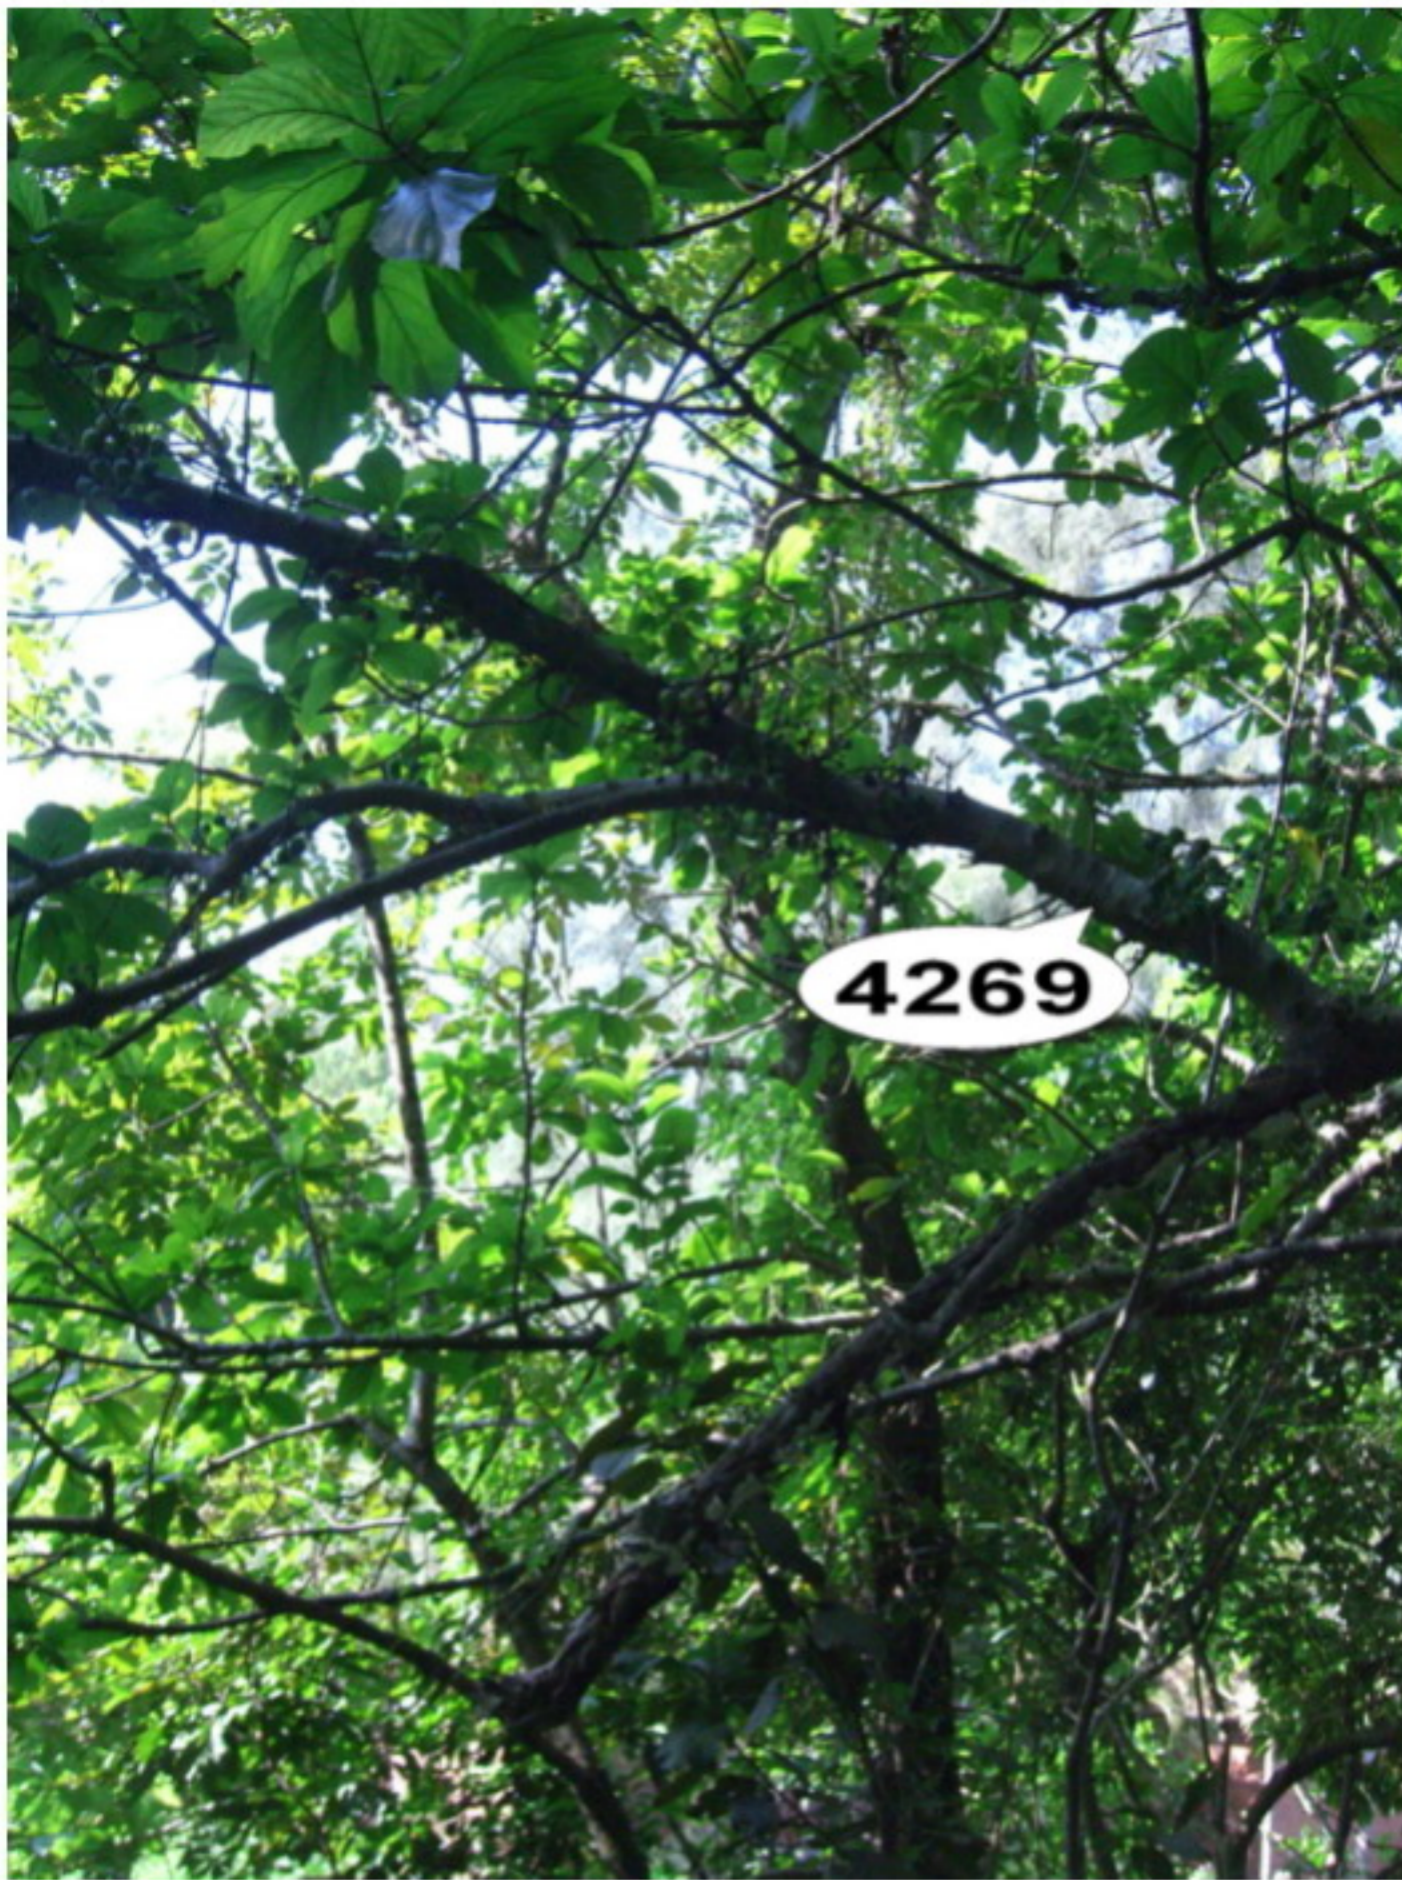
Tree 4269

Poor form which lead to low amenity value. Besides, the tree is unbalance. It may need heavy pruning after transplantation that will affect its transplantation survival rate. Moreover, the operation of the transplantation for poor form tree is also difficult.

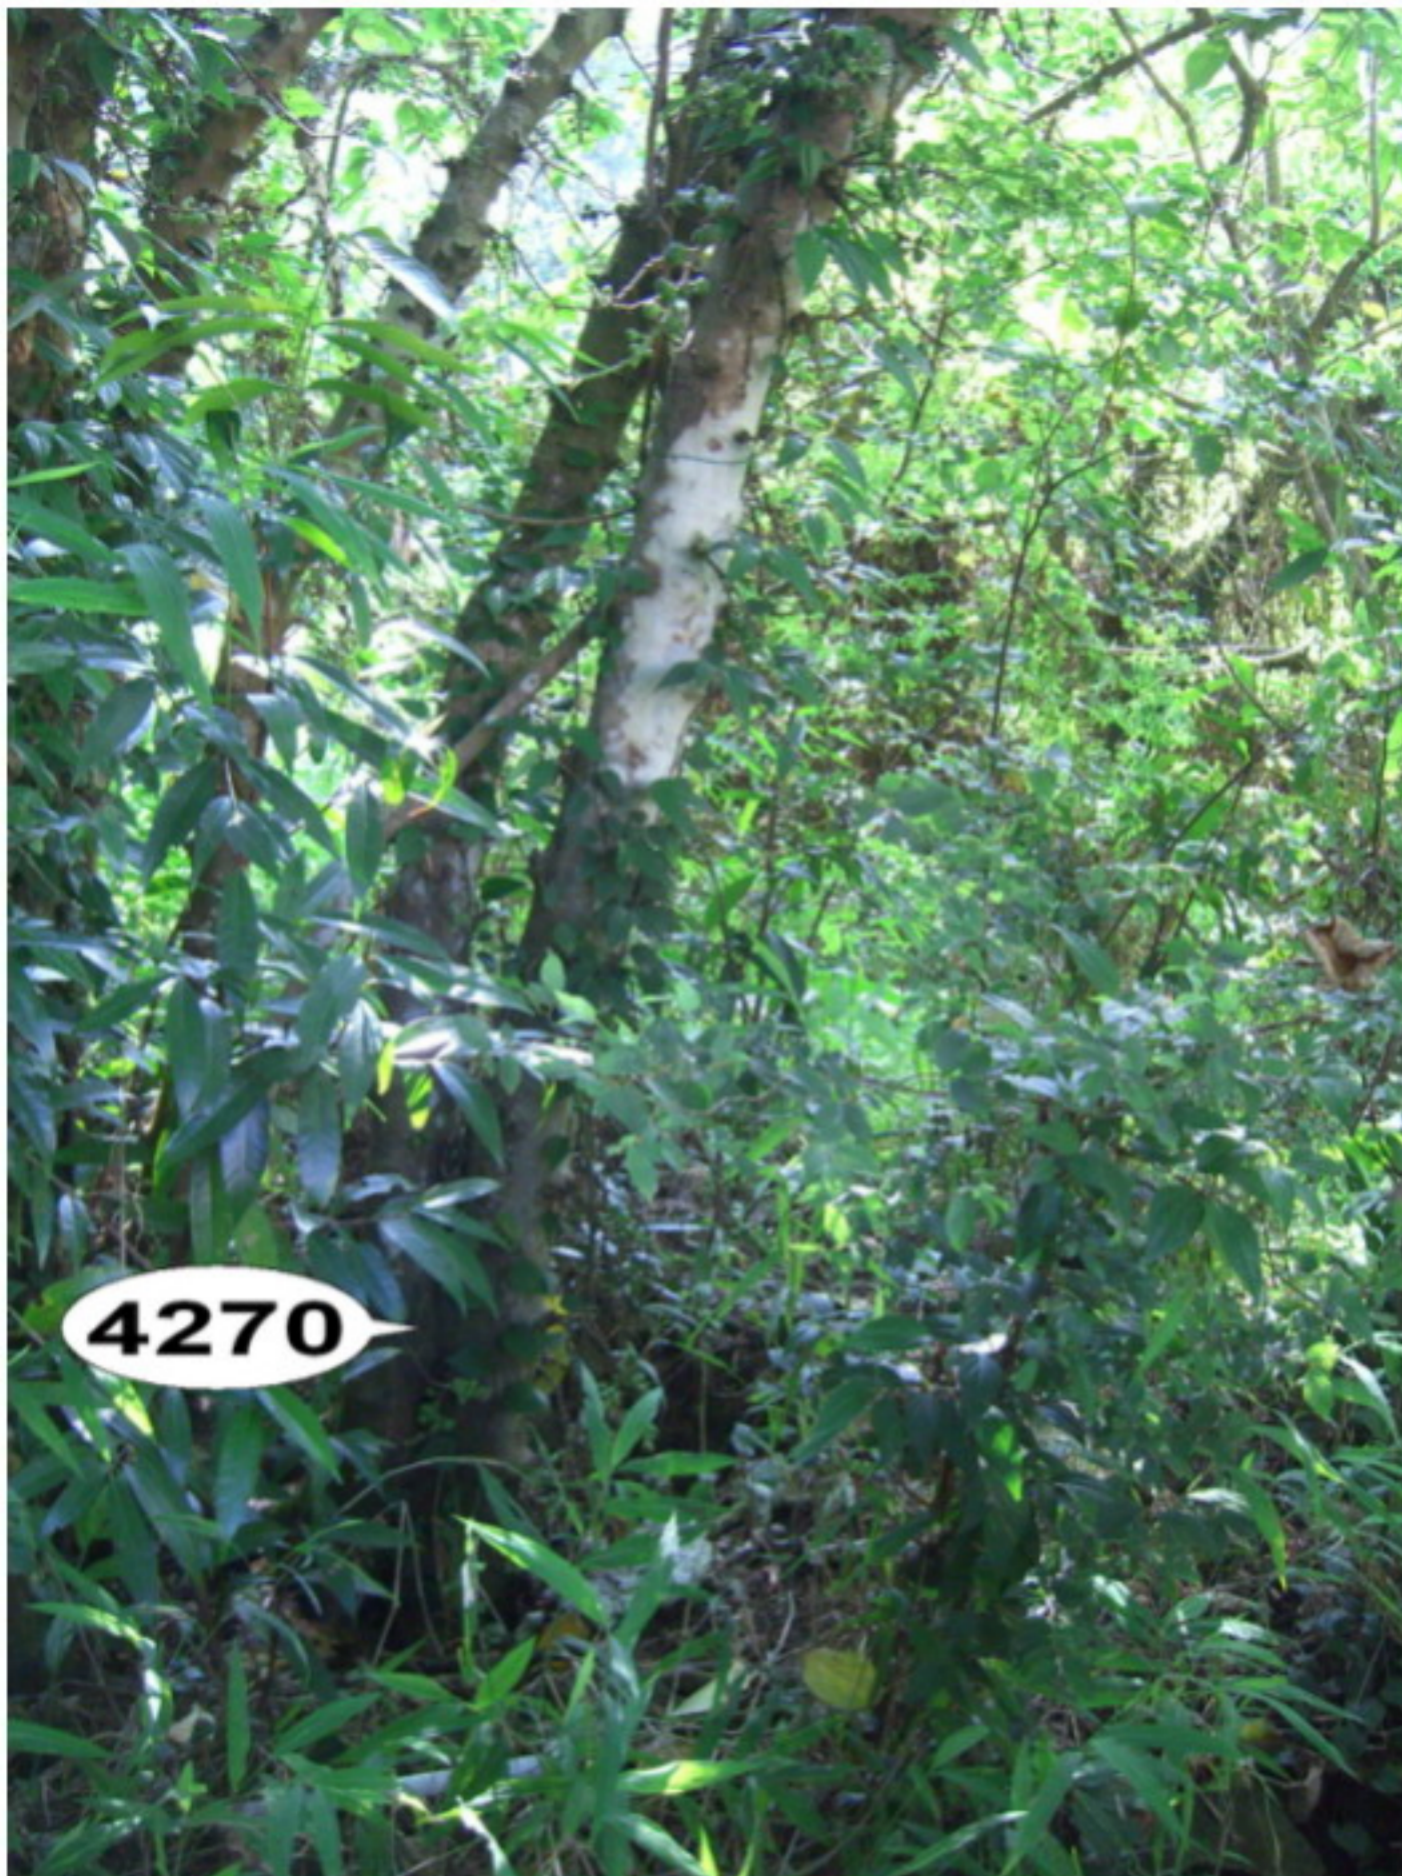
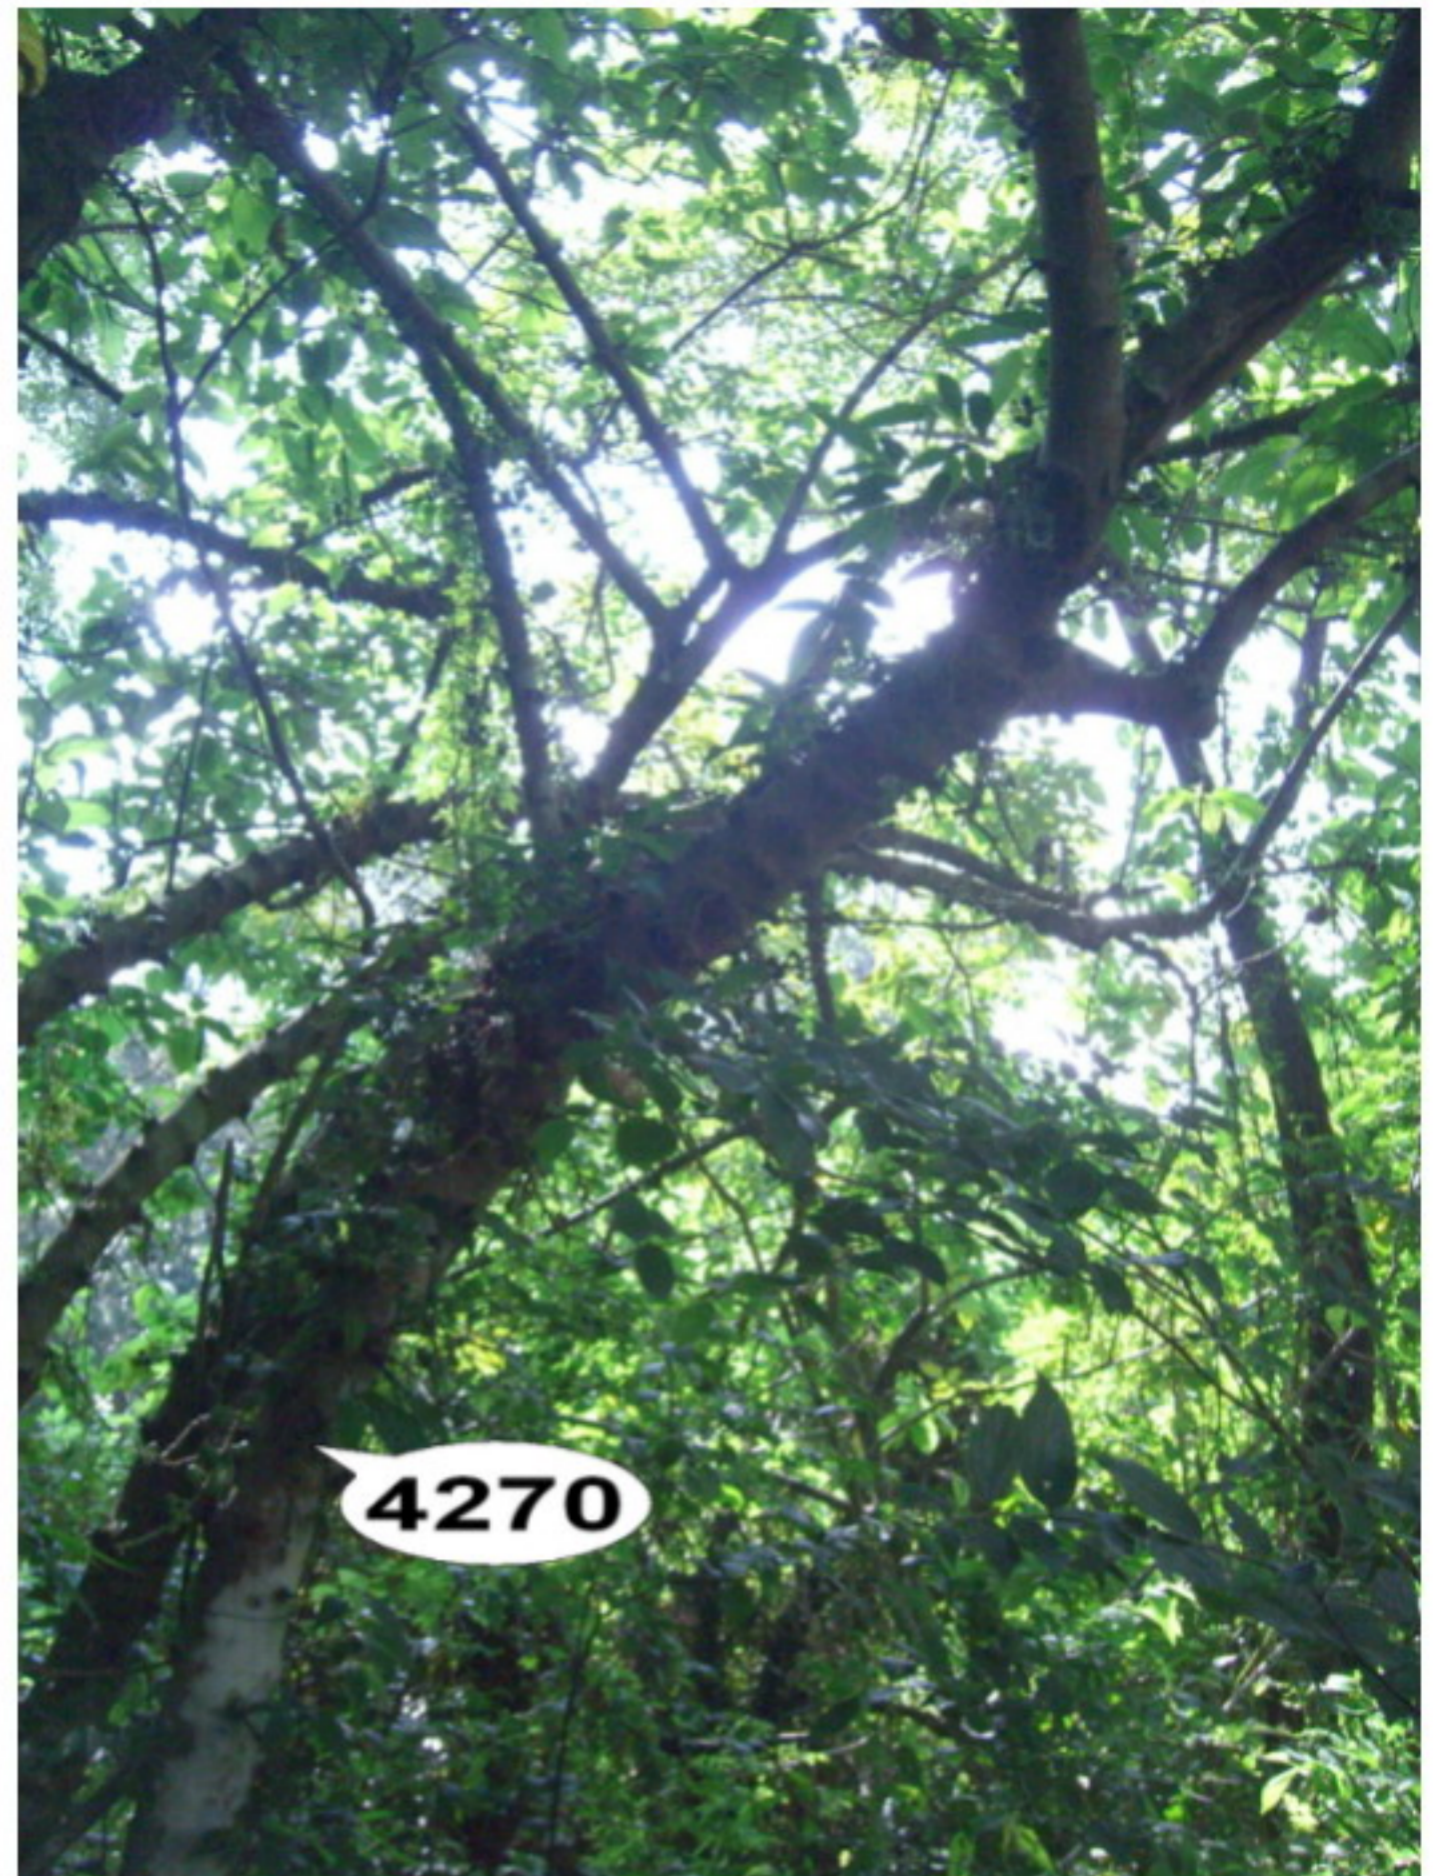
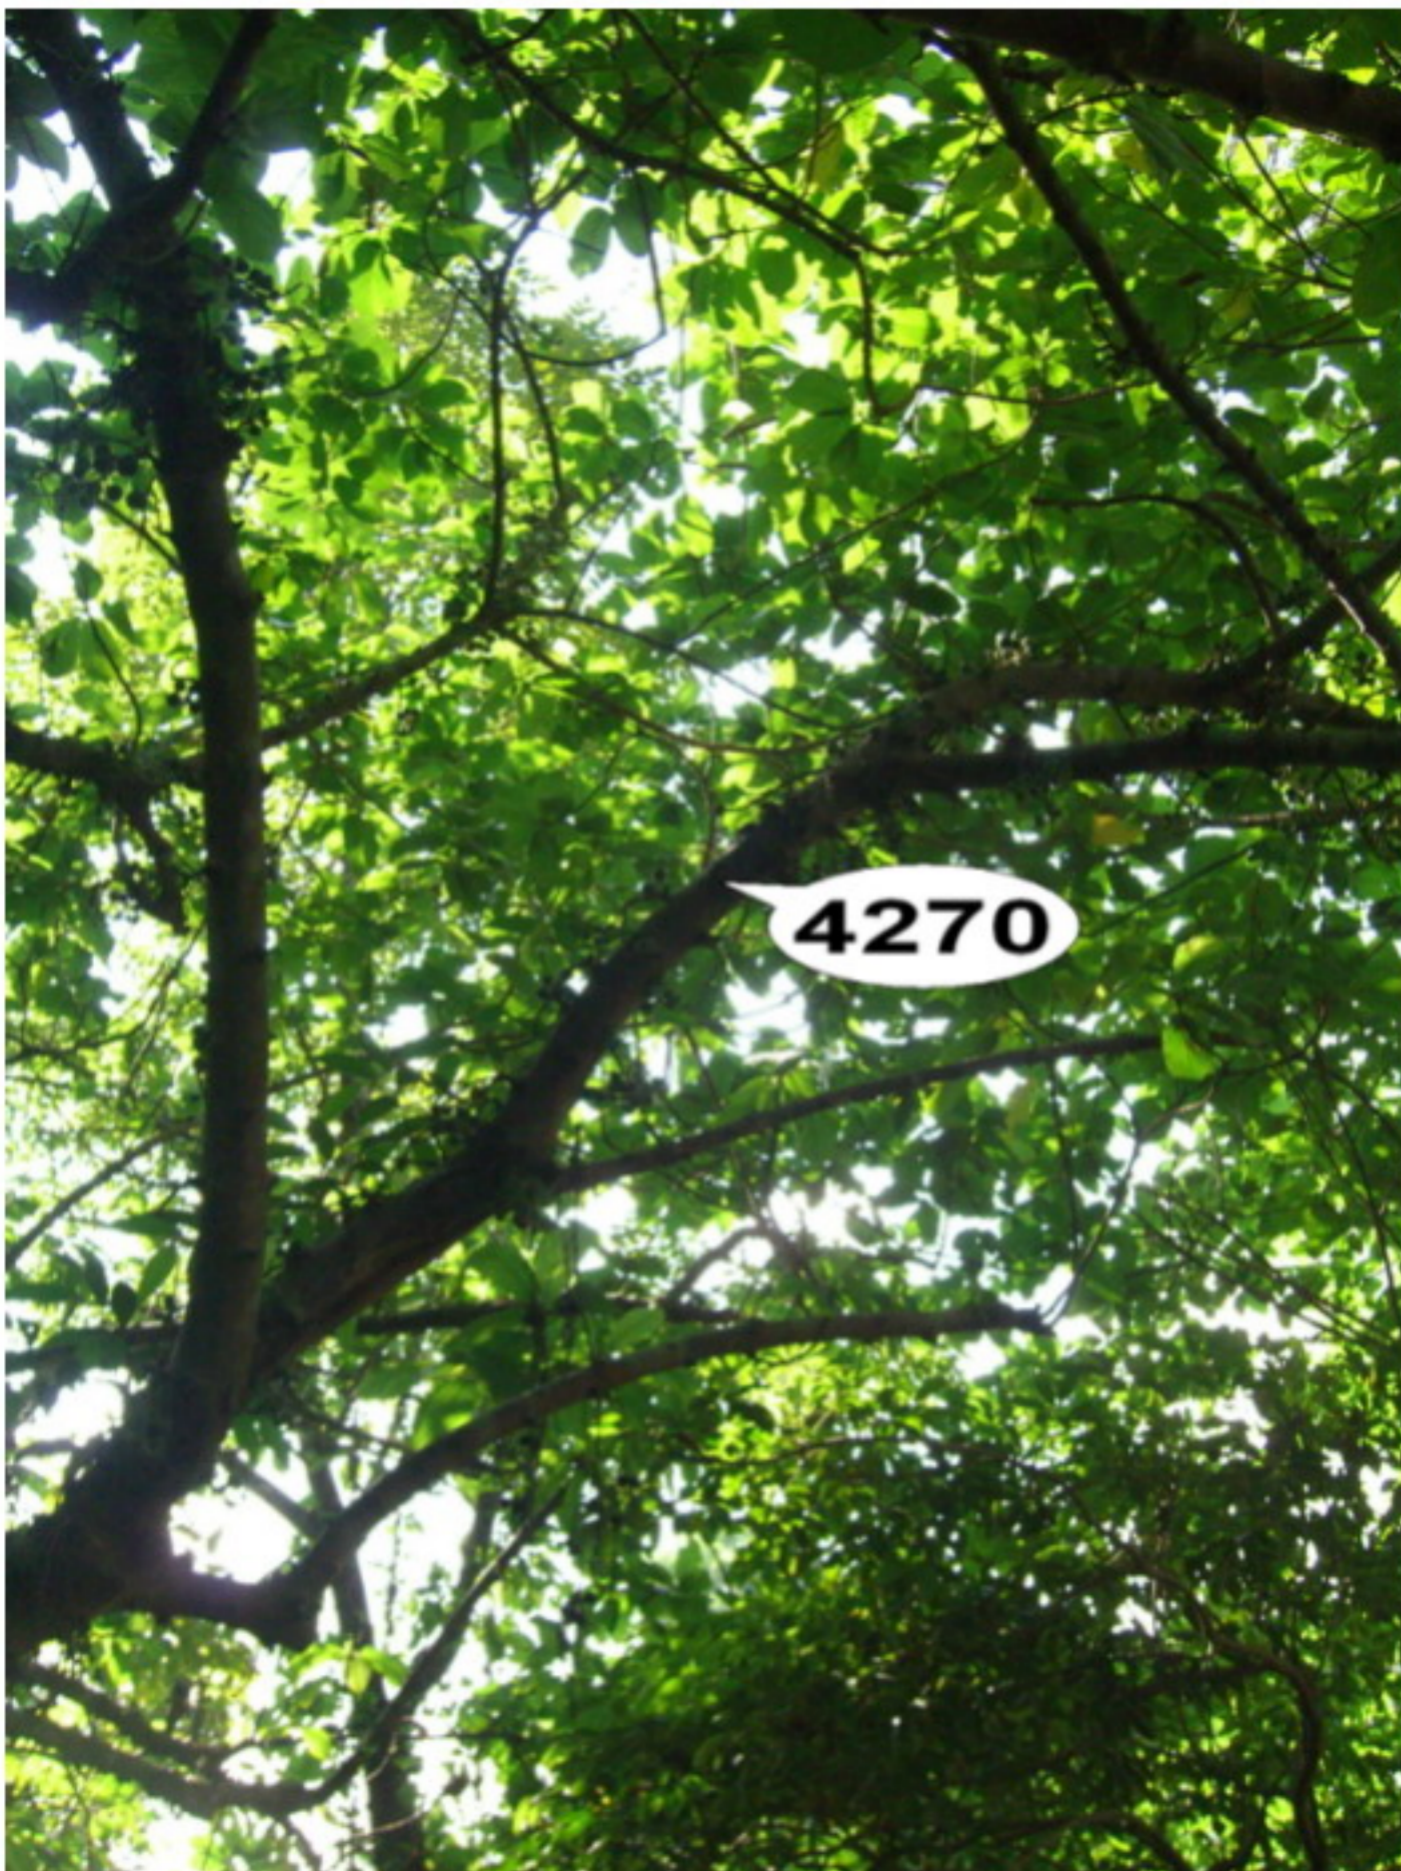
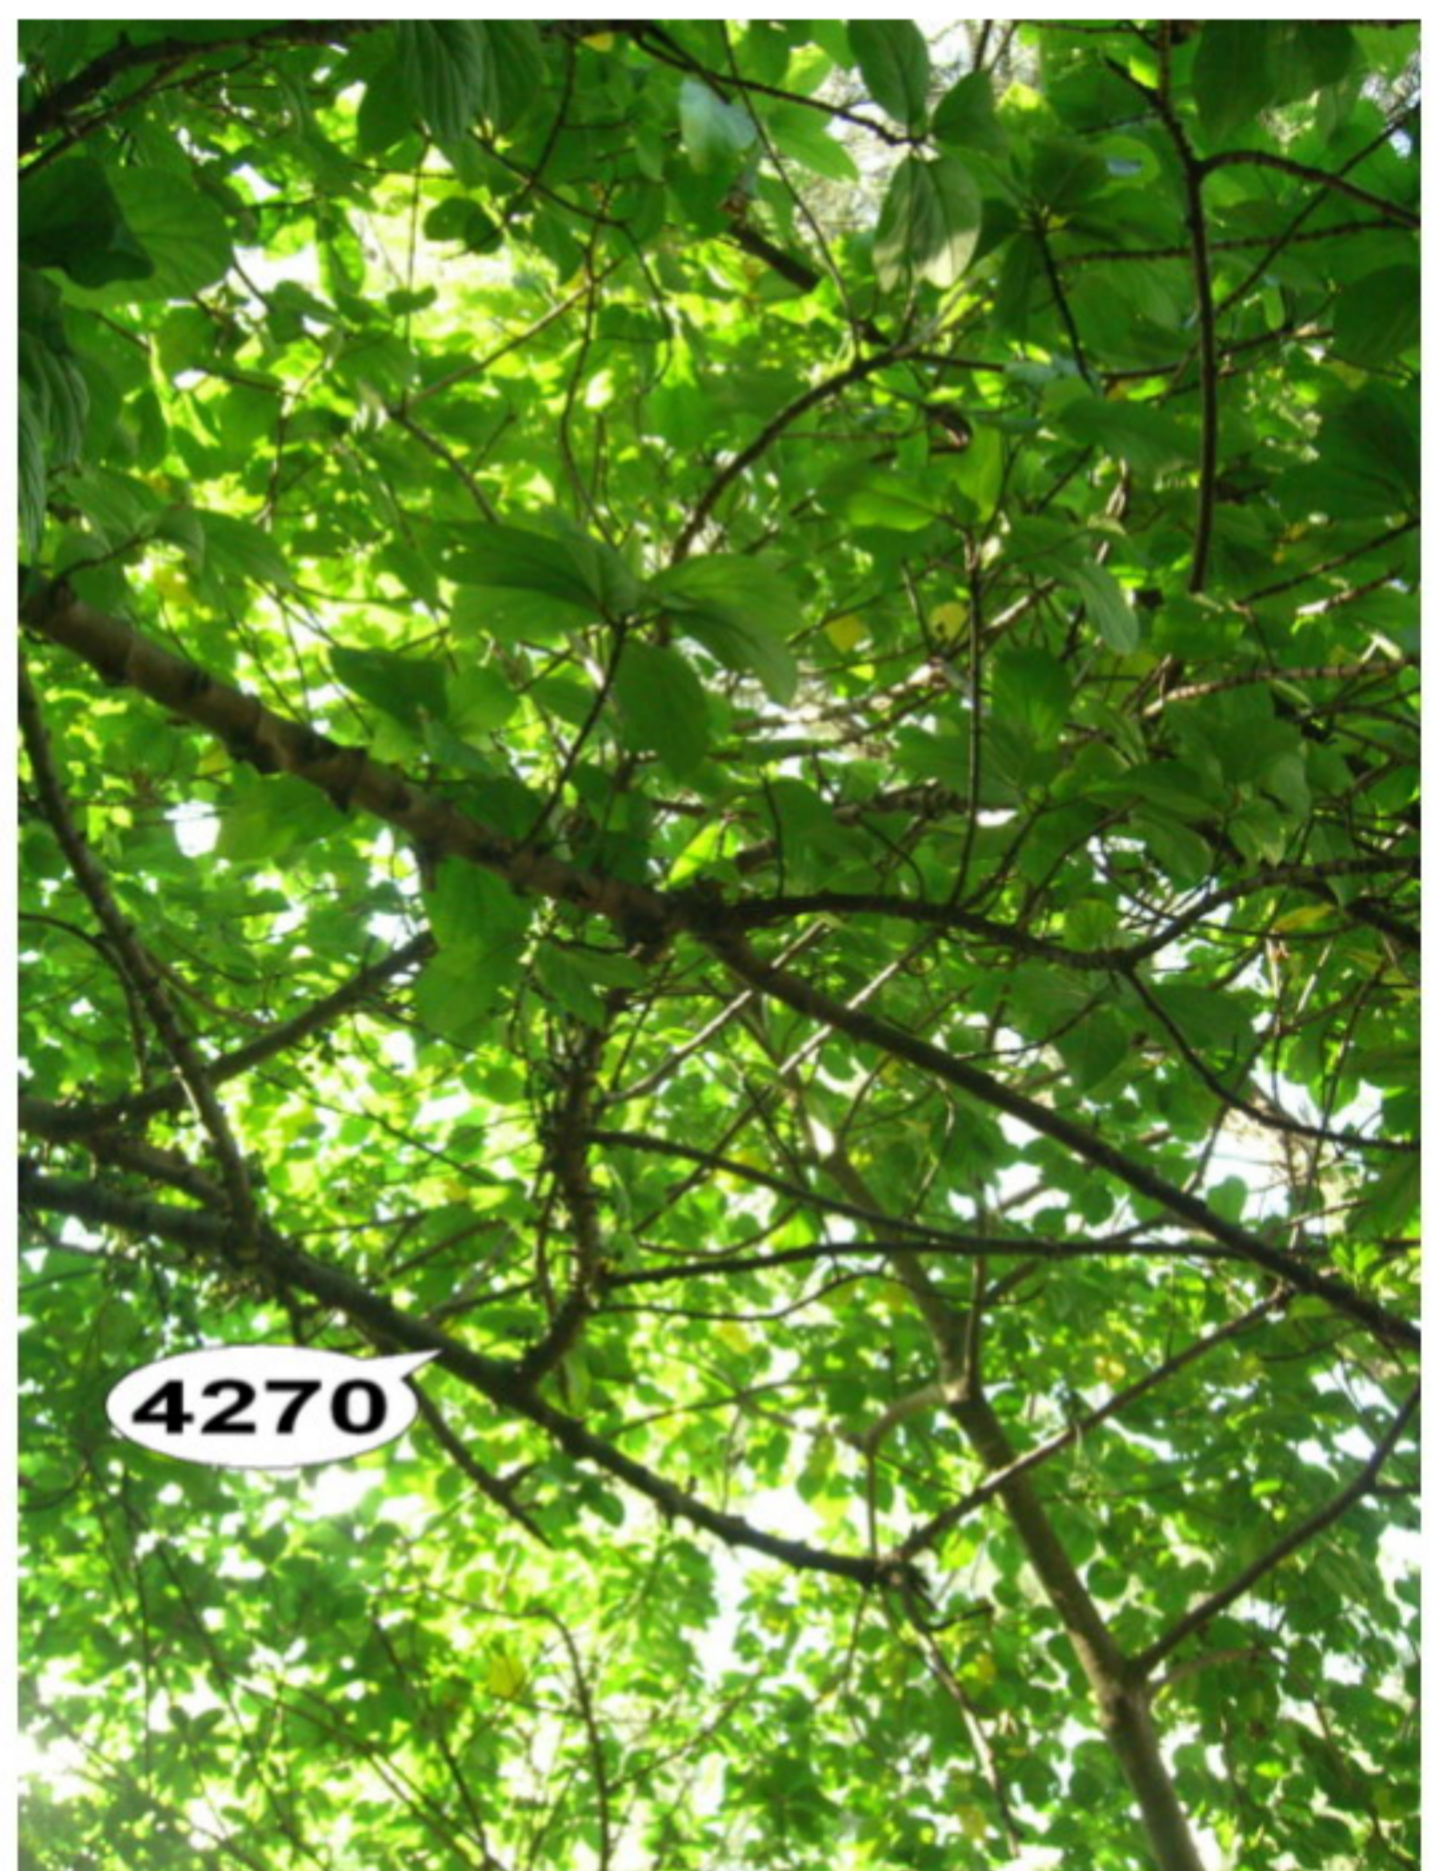
Tree 4269

Poor form which lead to low amenity value. Besides, the tree is unbalance. It may need heavy pruning after transplantation that will affect its transplantation survival rate. Moreover, the operation of the transplantation for poor form tree is also difficult.

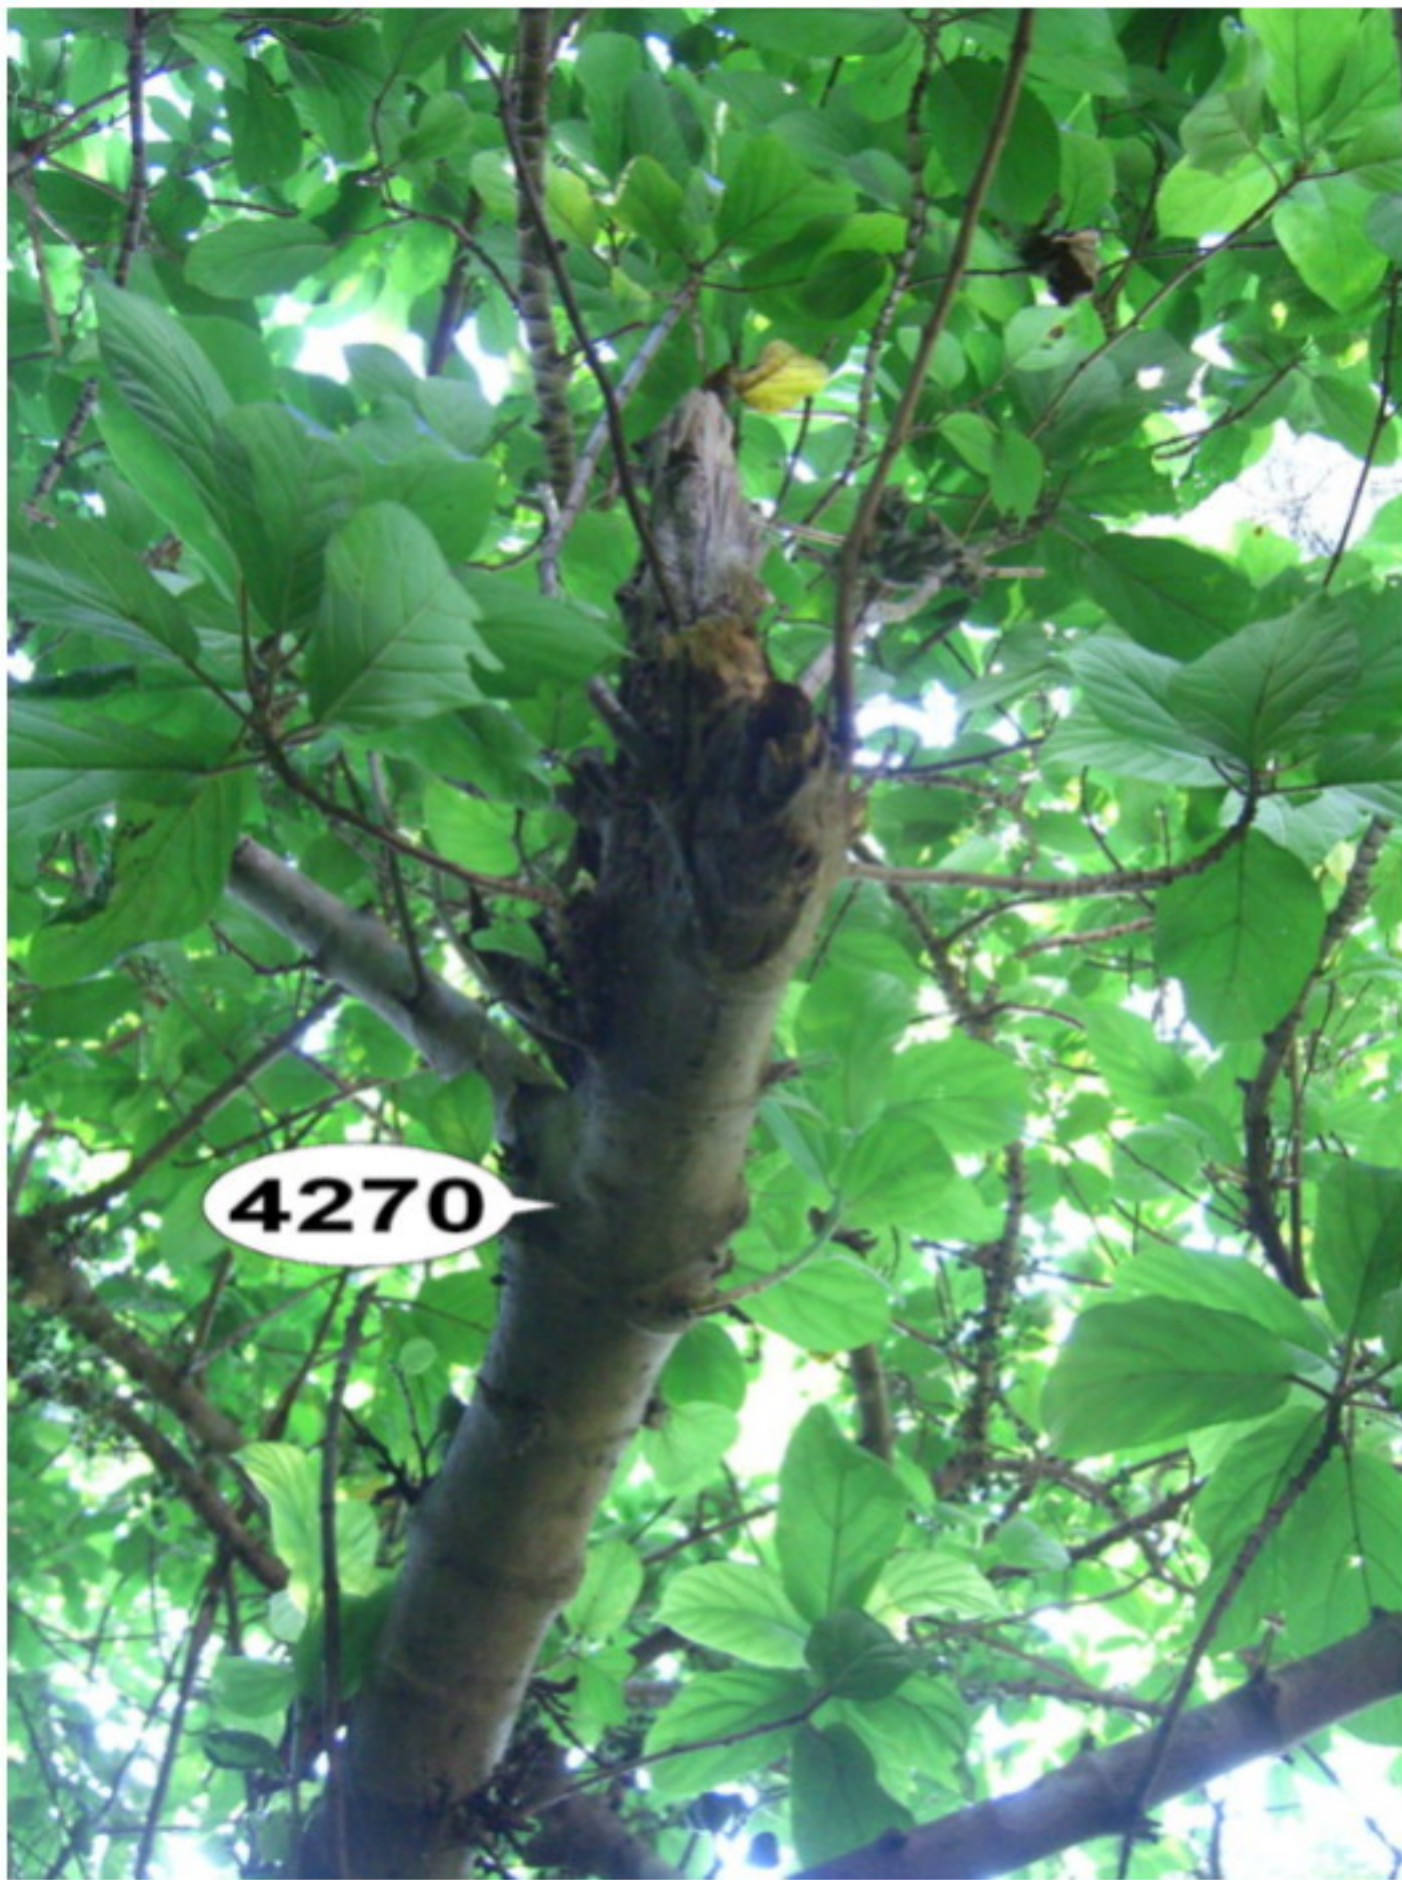
Tree 4270

Poor form which lead to low amenity value. Besides, the tree is unbalance. It may need heavy pruning after transplantation that will affect its transplantation survival rate. Moreover, the operation of the transplantation for poor form tree is also difficult.

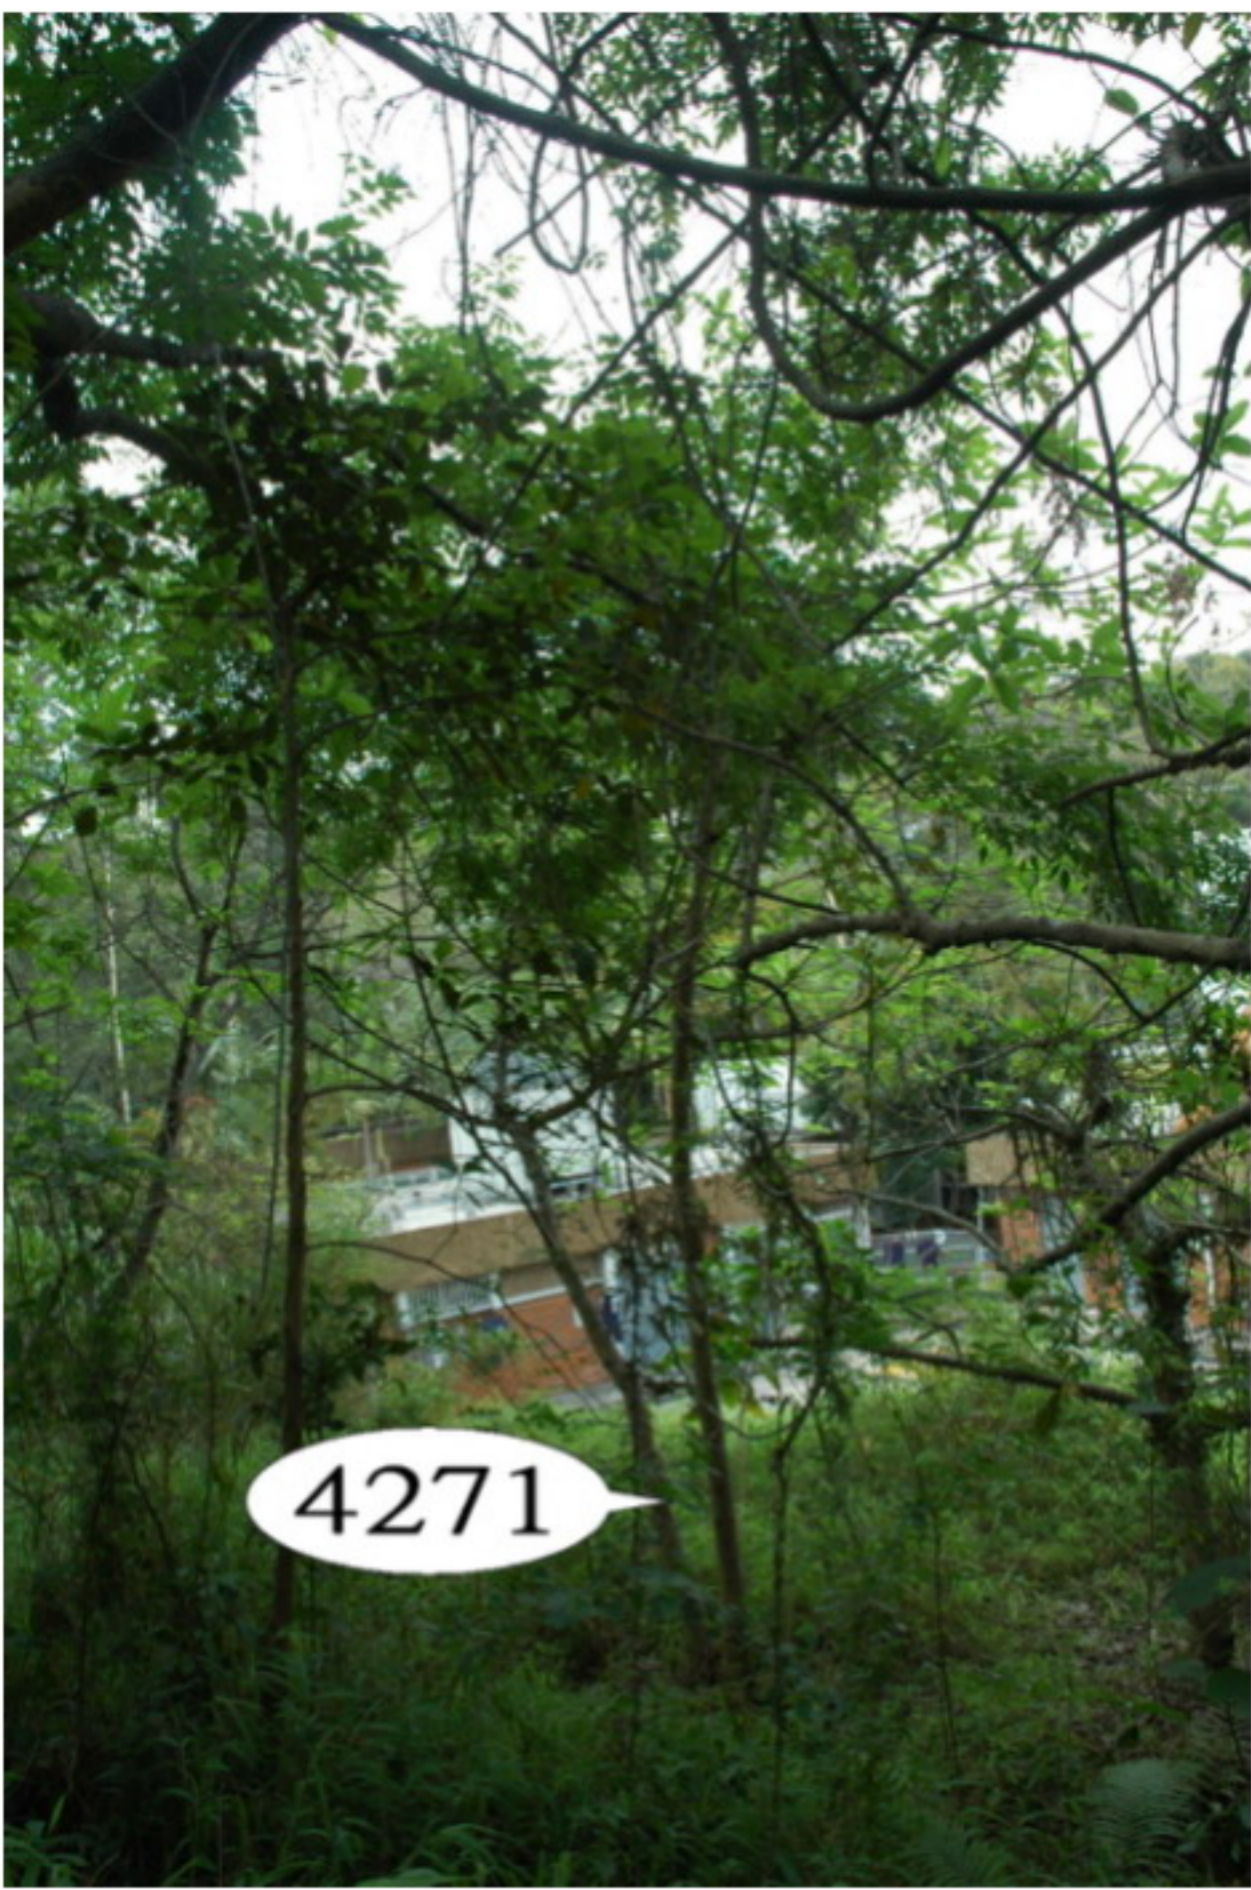
Tree 4270

Poor form which lead to low amenity value. Besides, the tree is unbalance. It may need heavy pruning after transplantation that will affect its transplantation survival rate. Moreover, the operation of the transplantation for poor form tree is also difficult.
