# Provision of Cremators at Wo Hop Shek Crematorium

Tree Survey Report

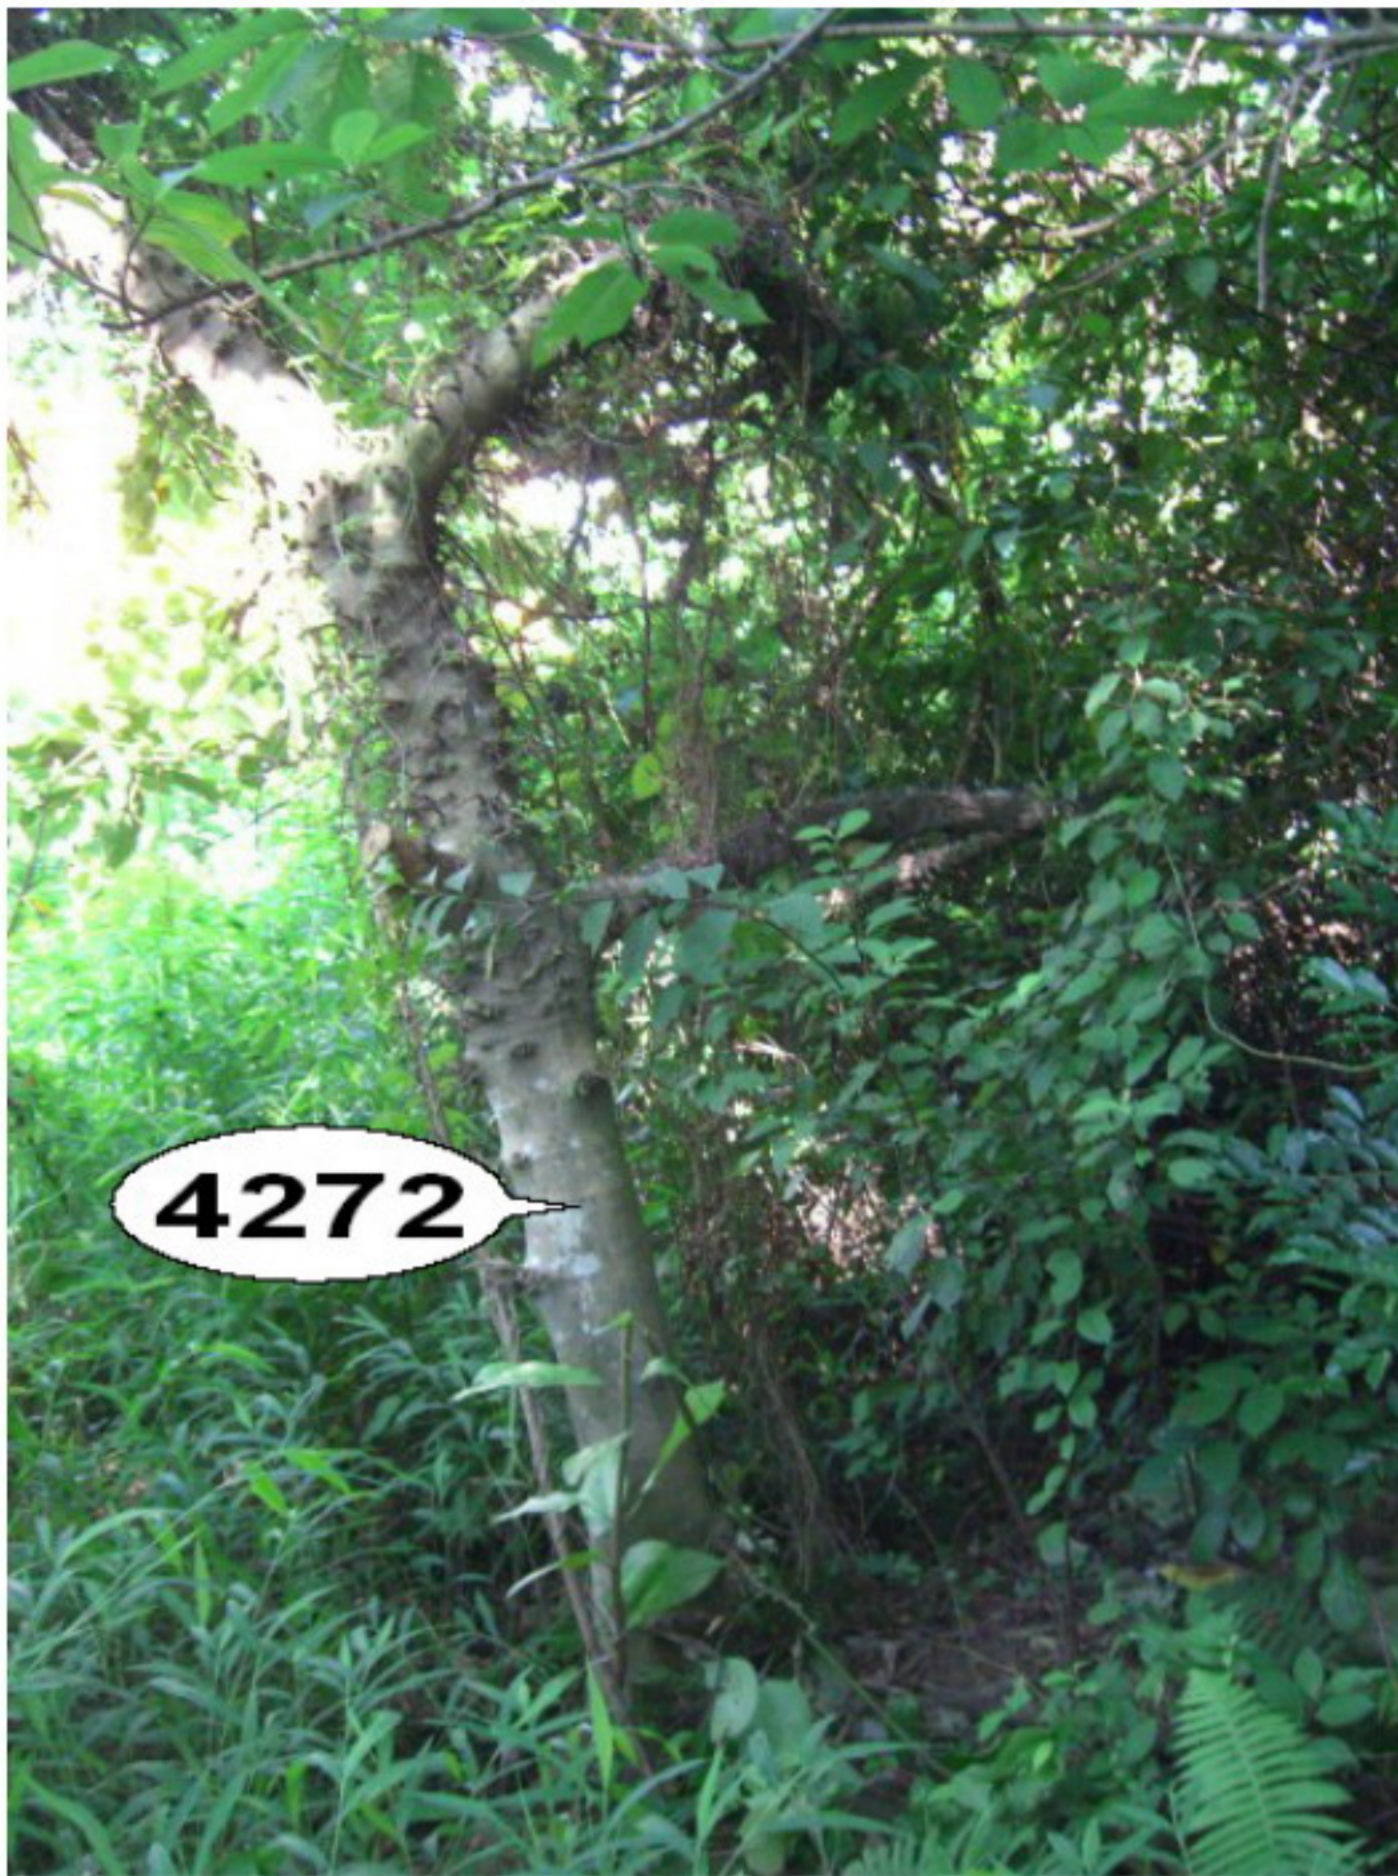
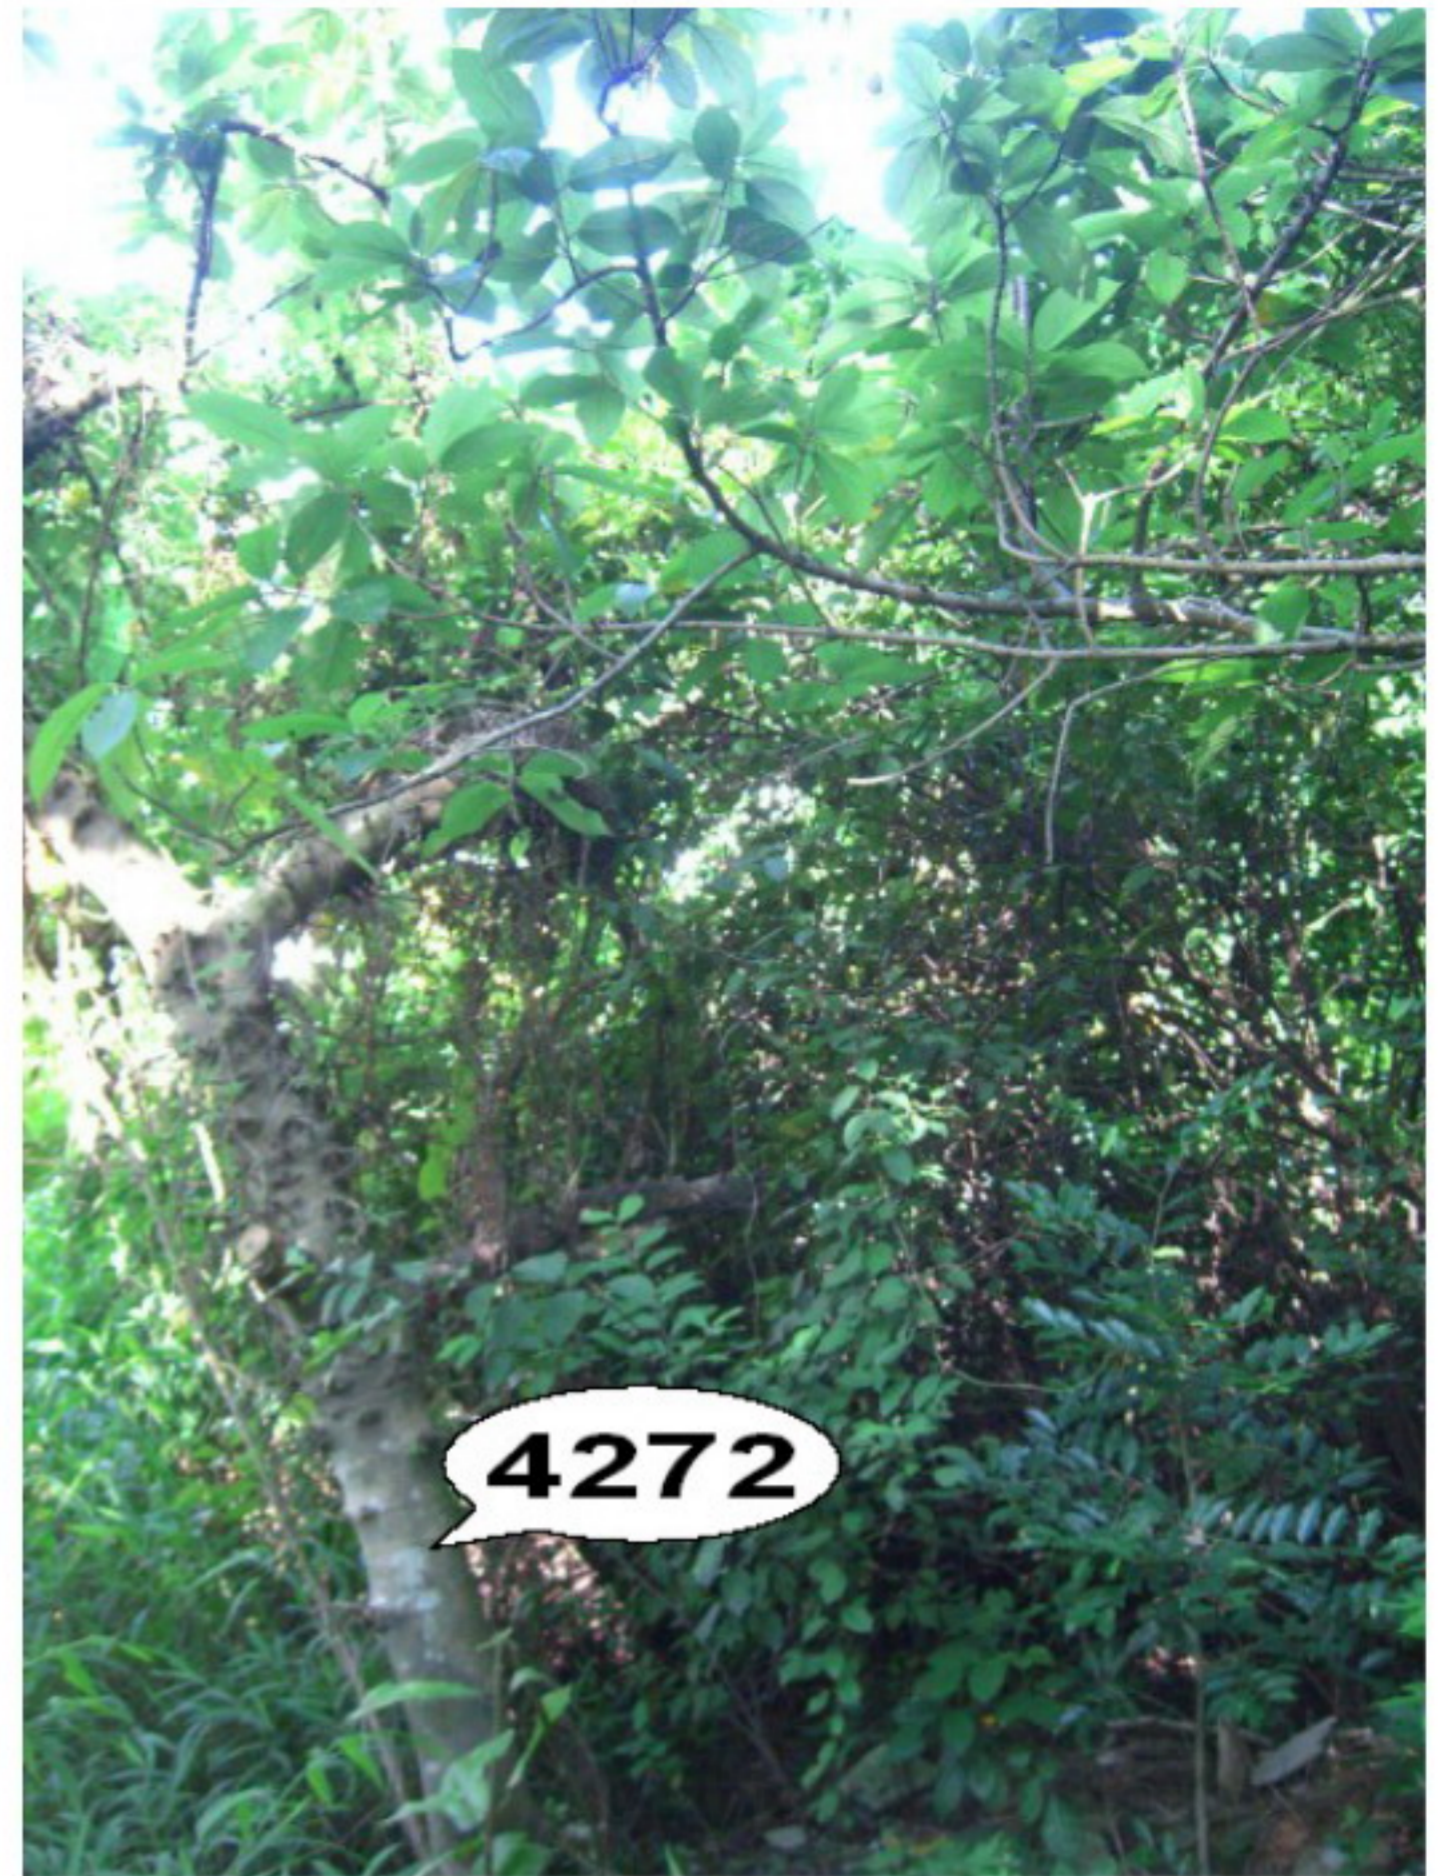
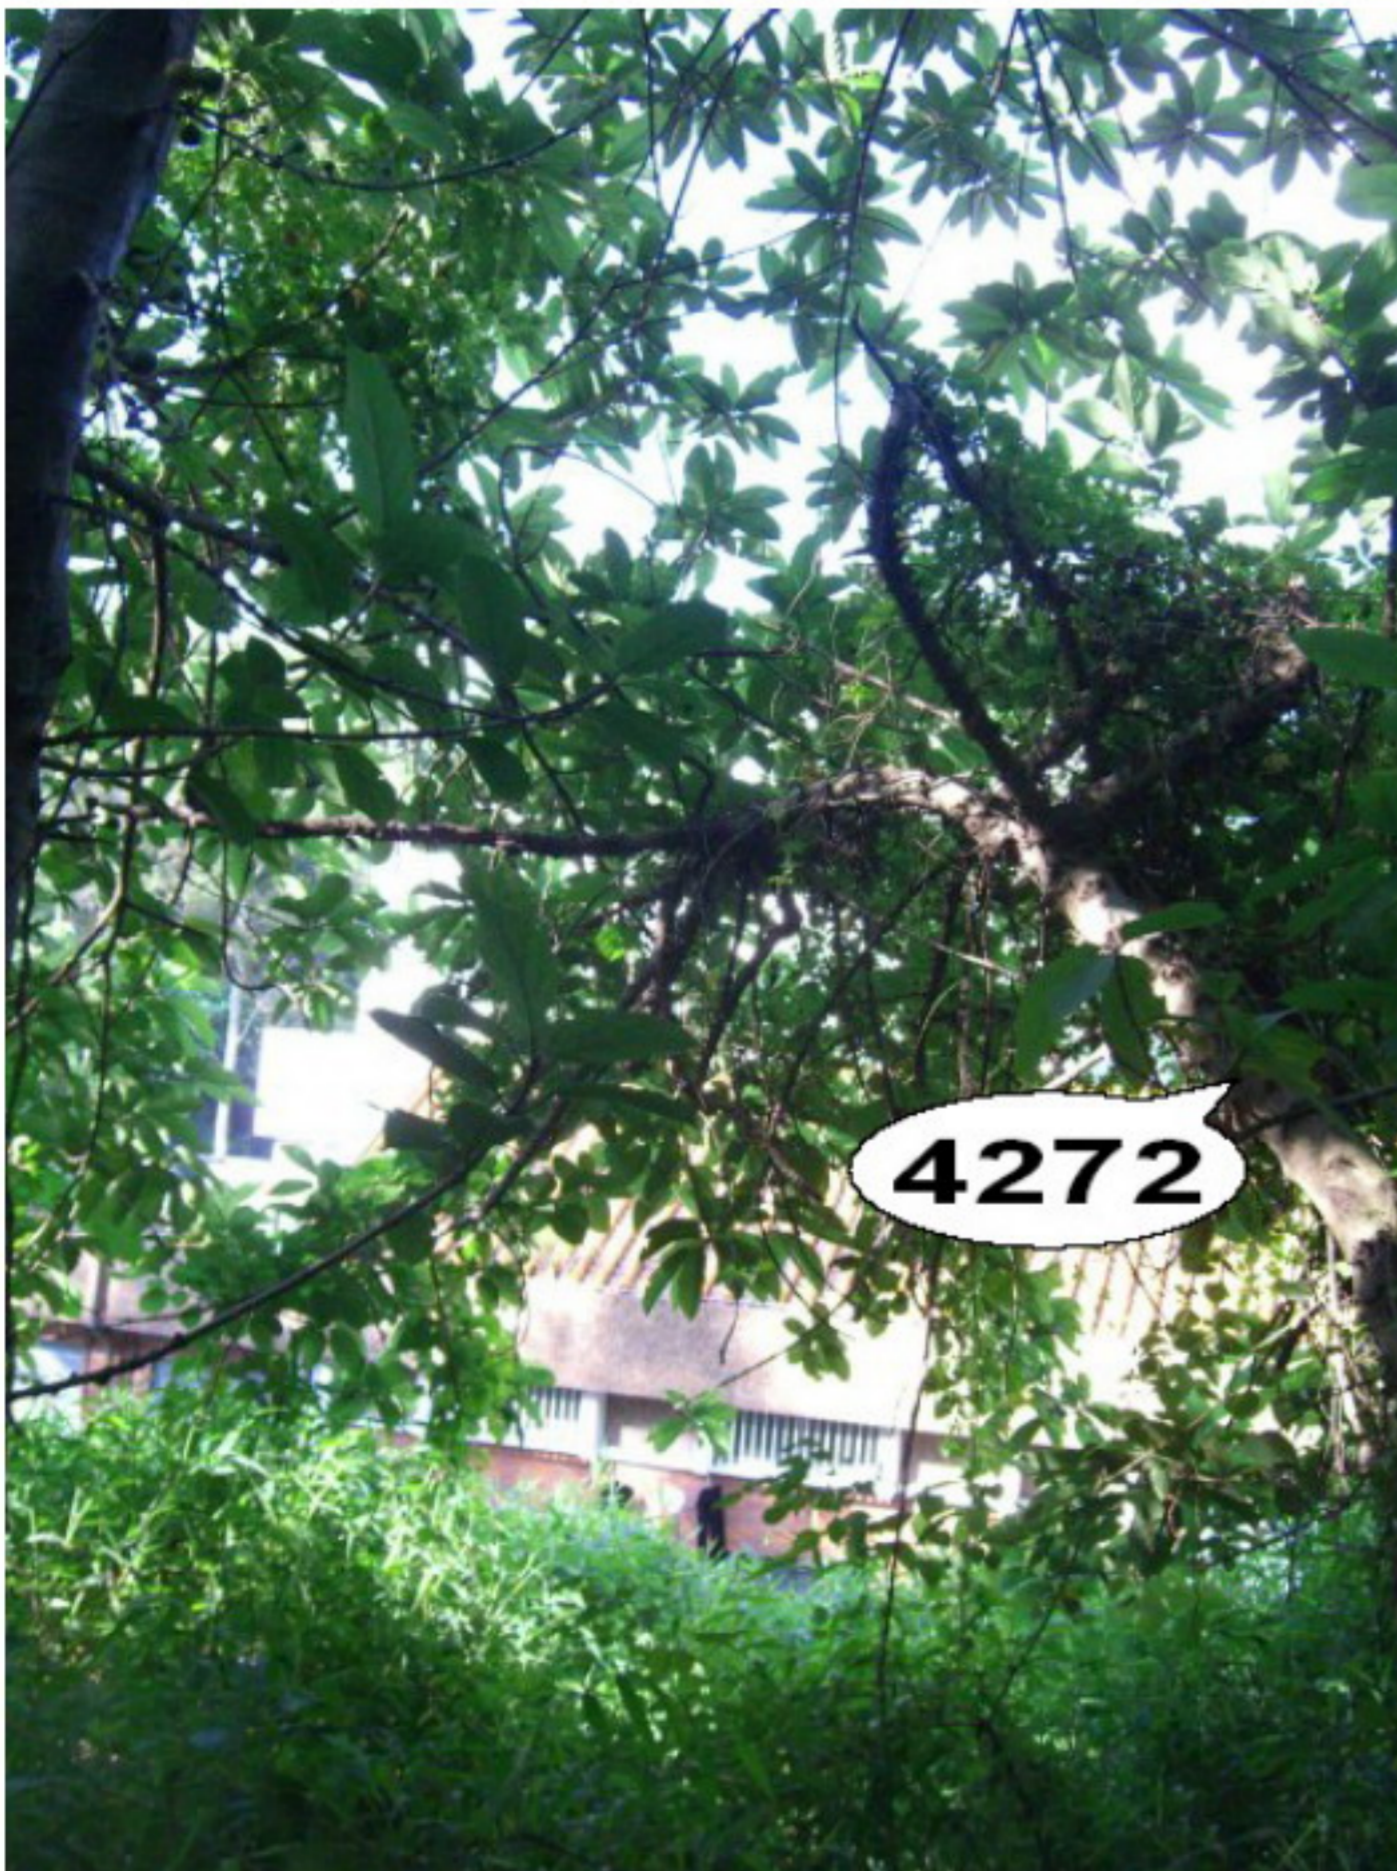
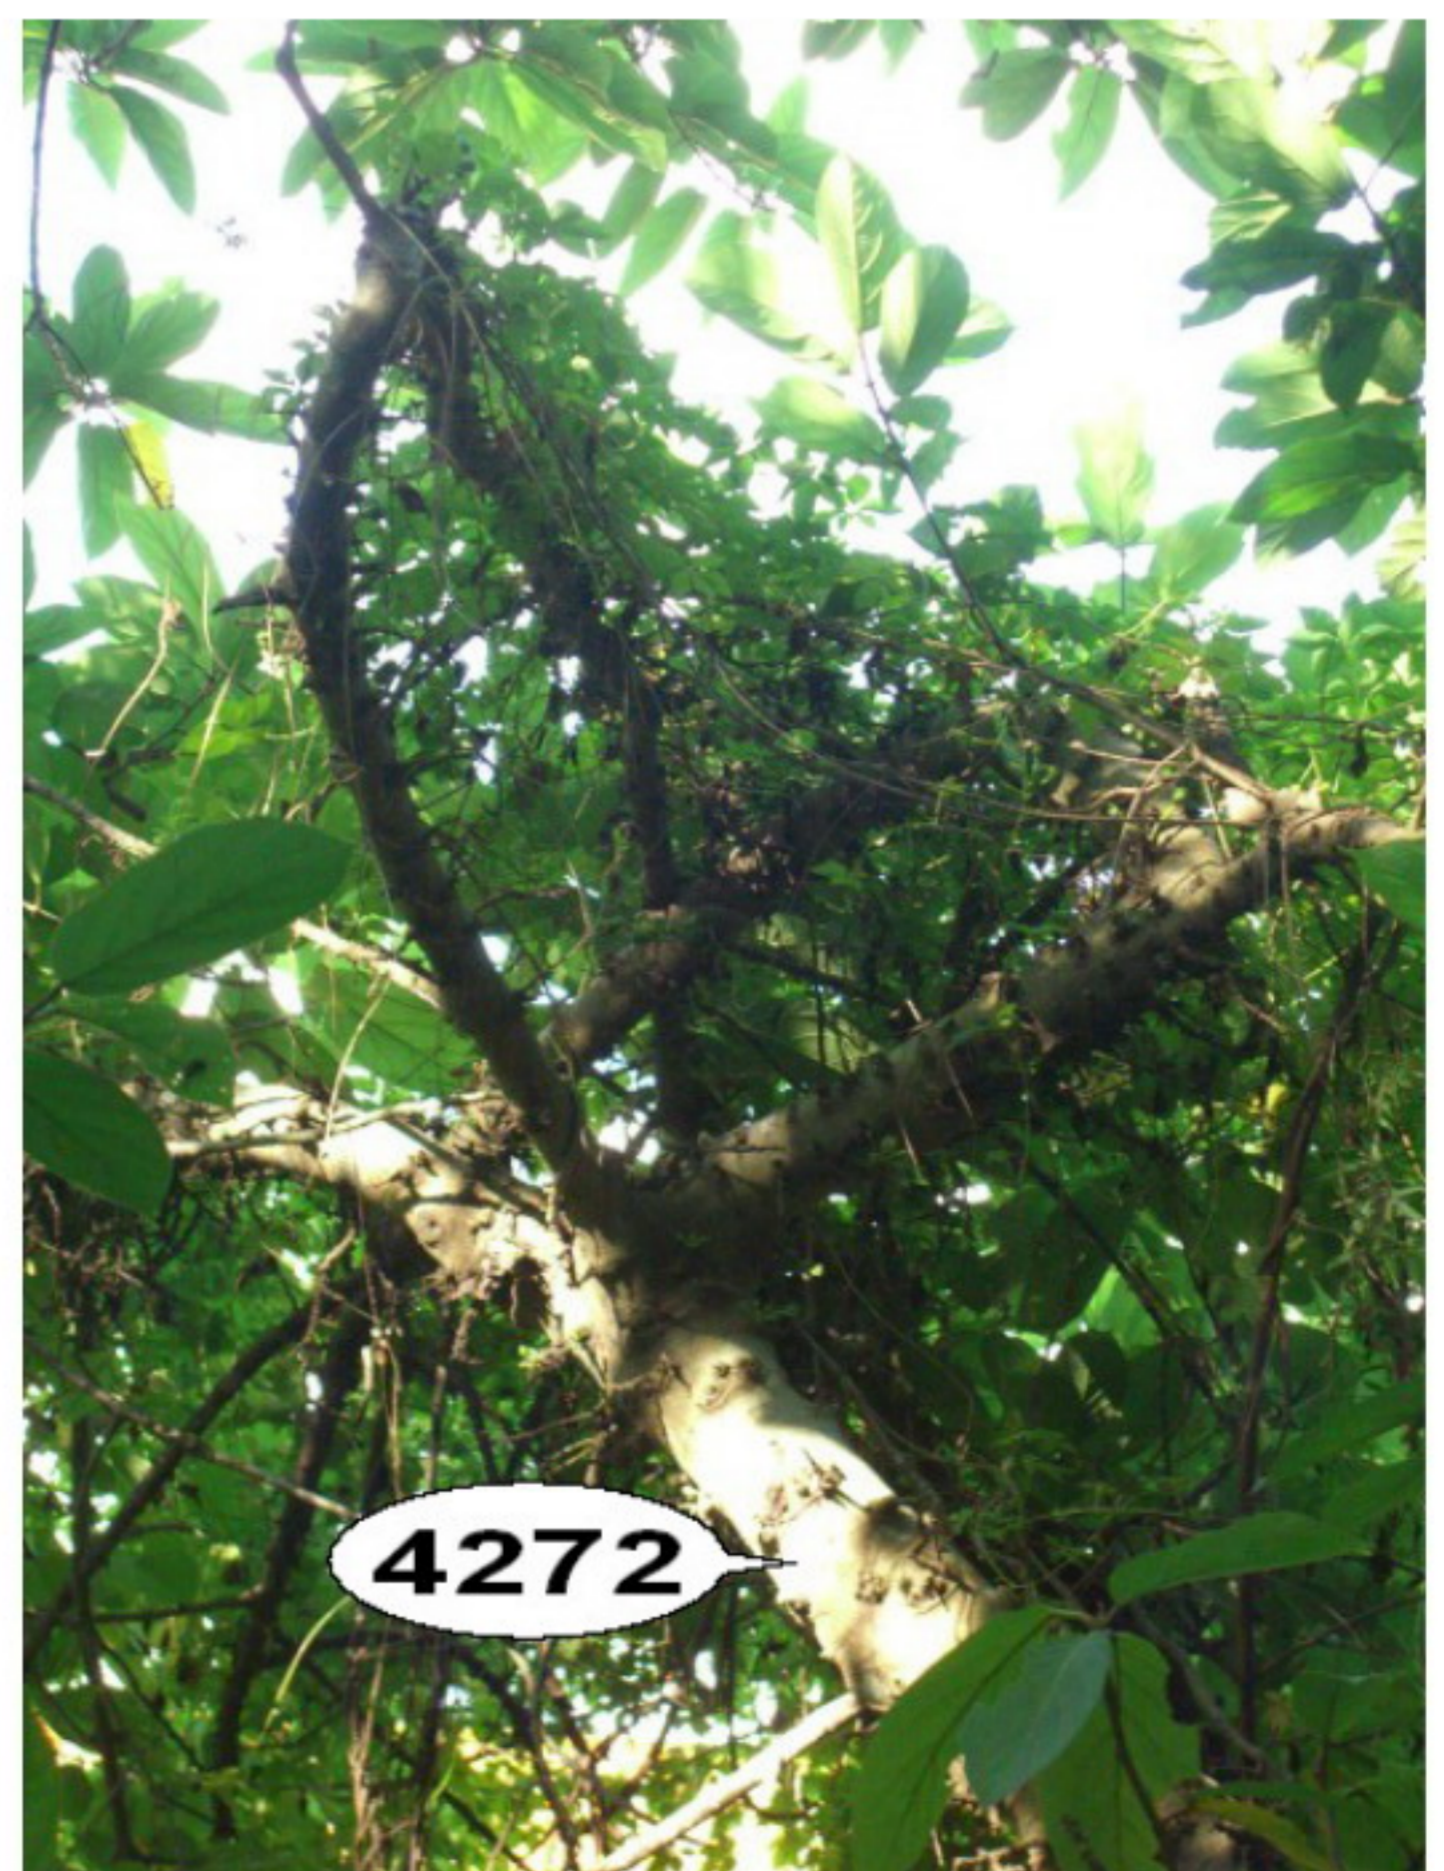
Tree 4271  
Dead Tree

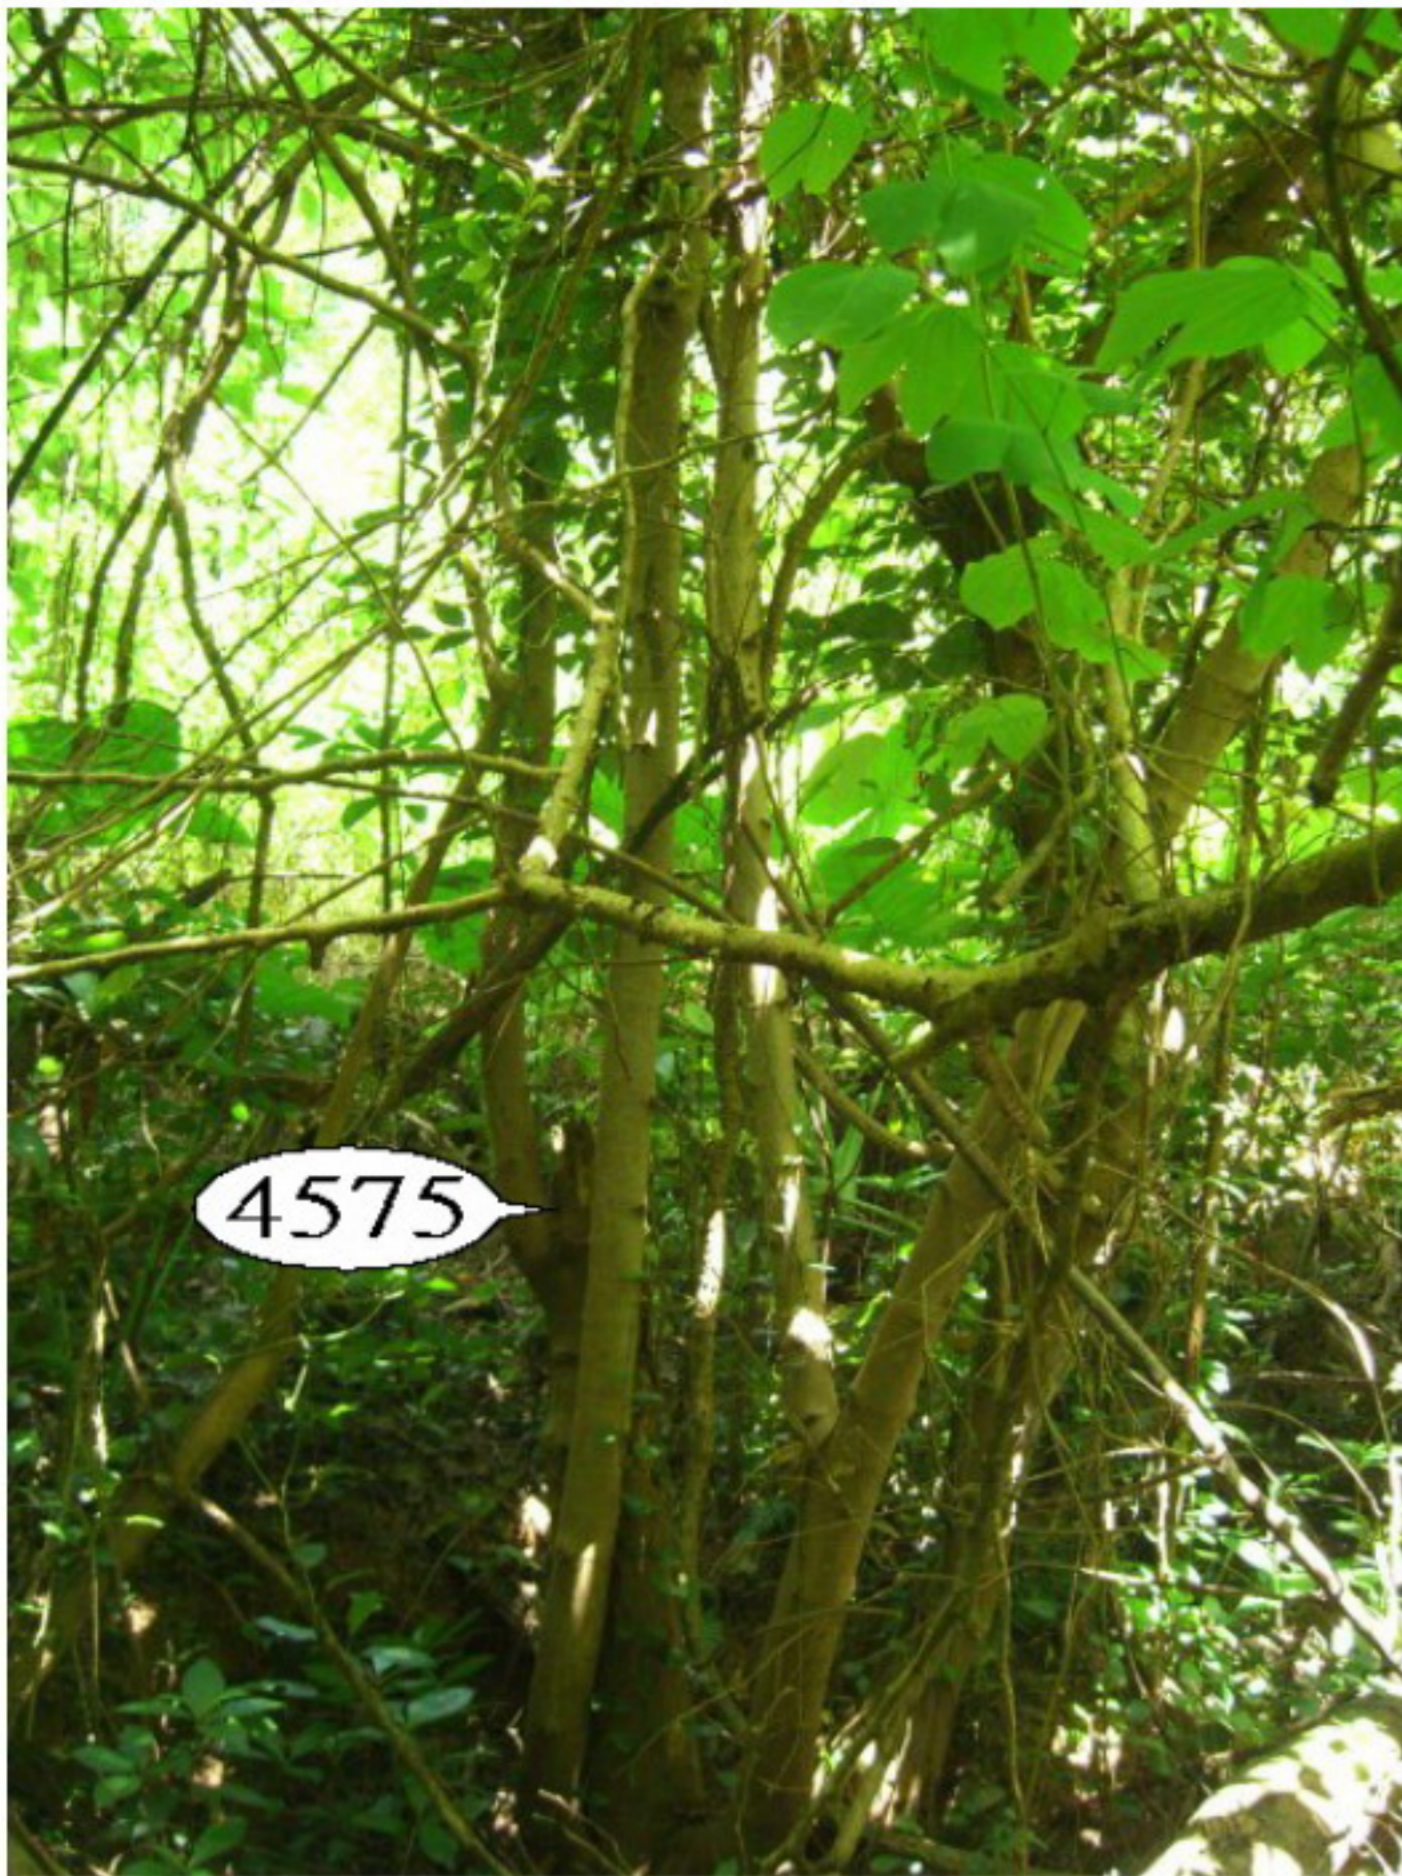
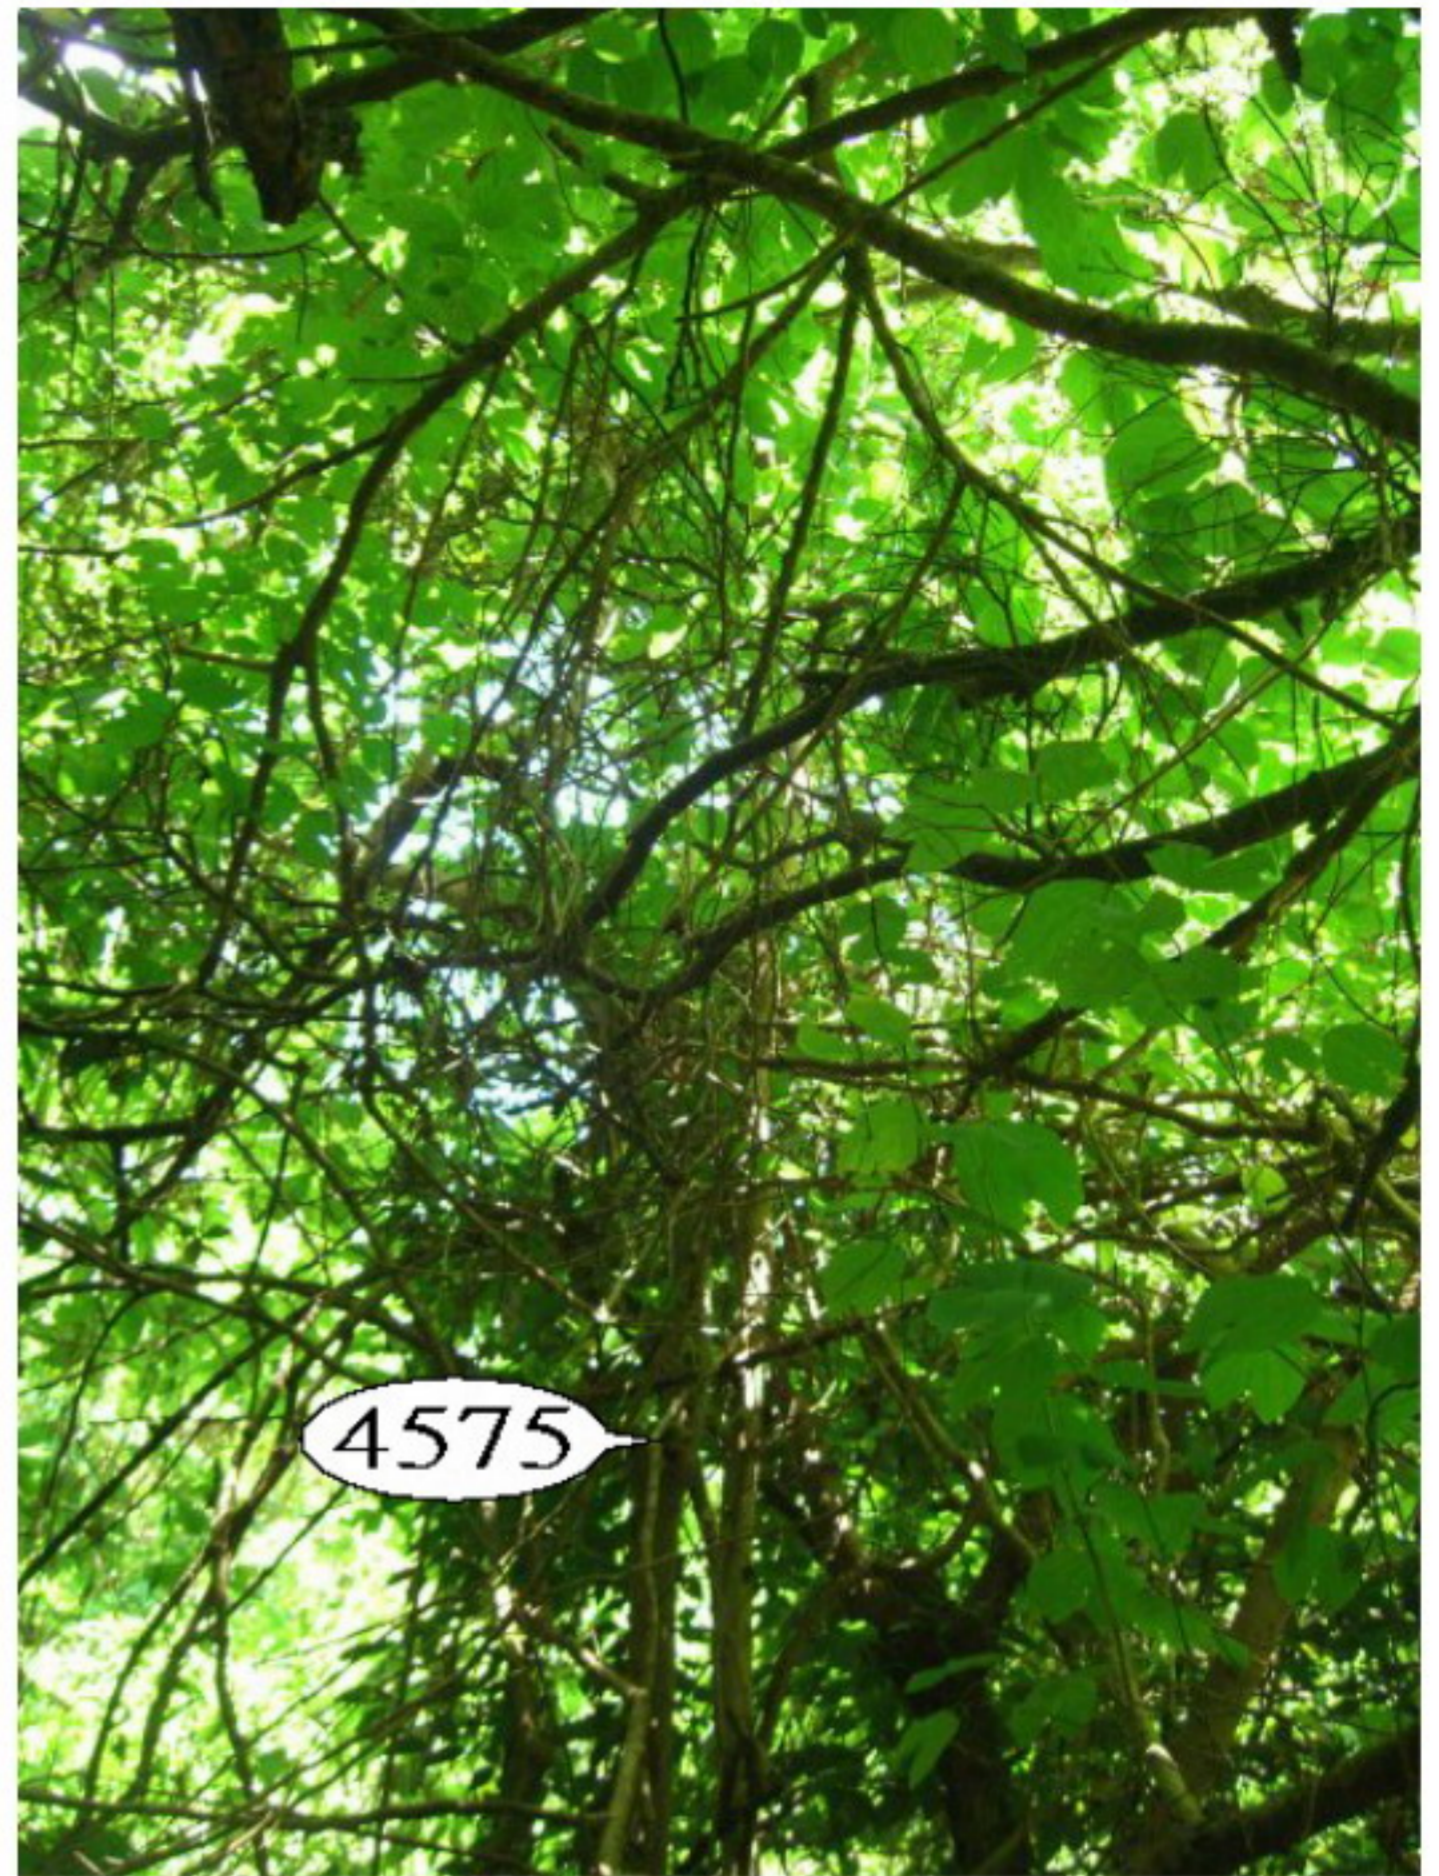
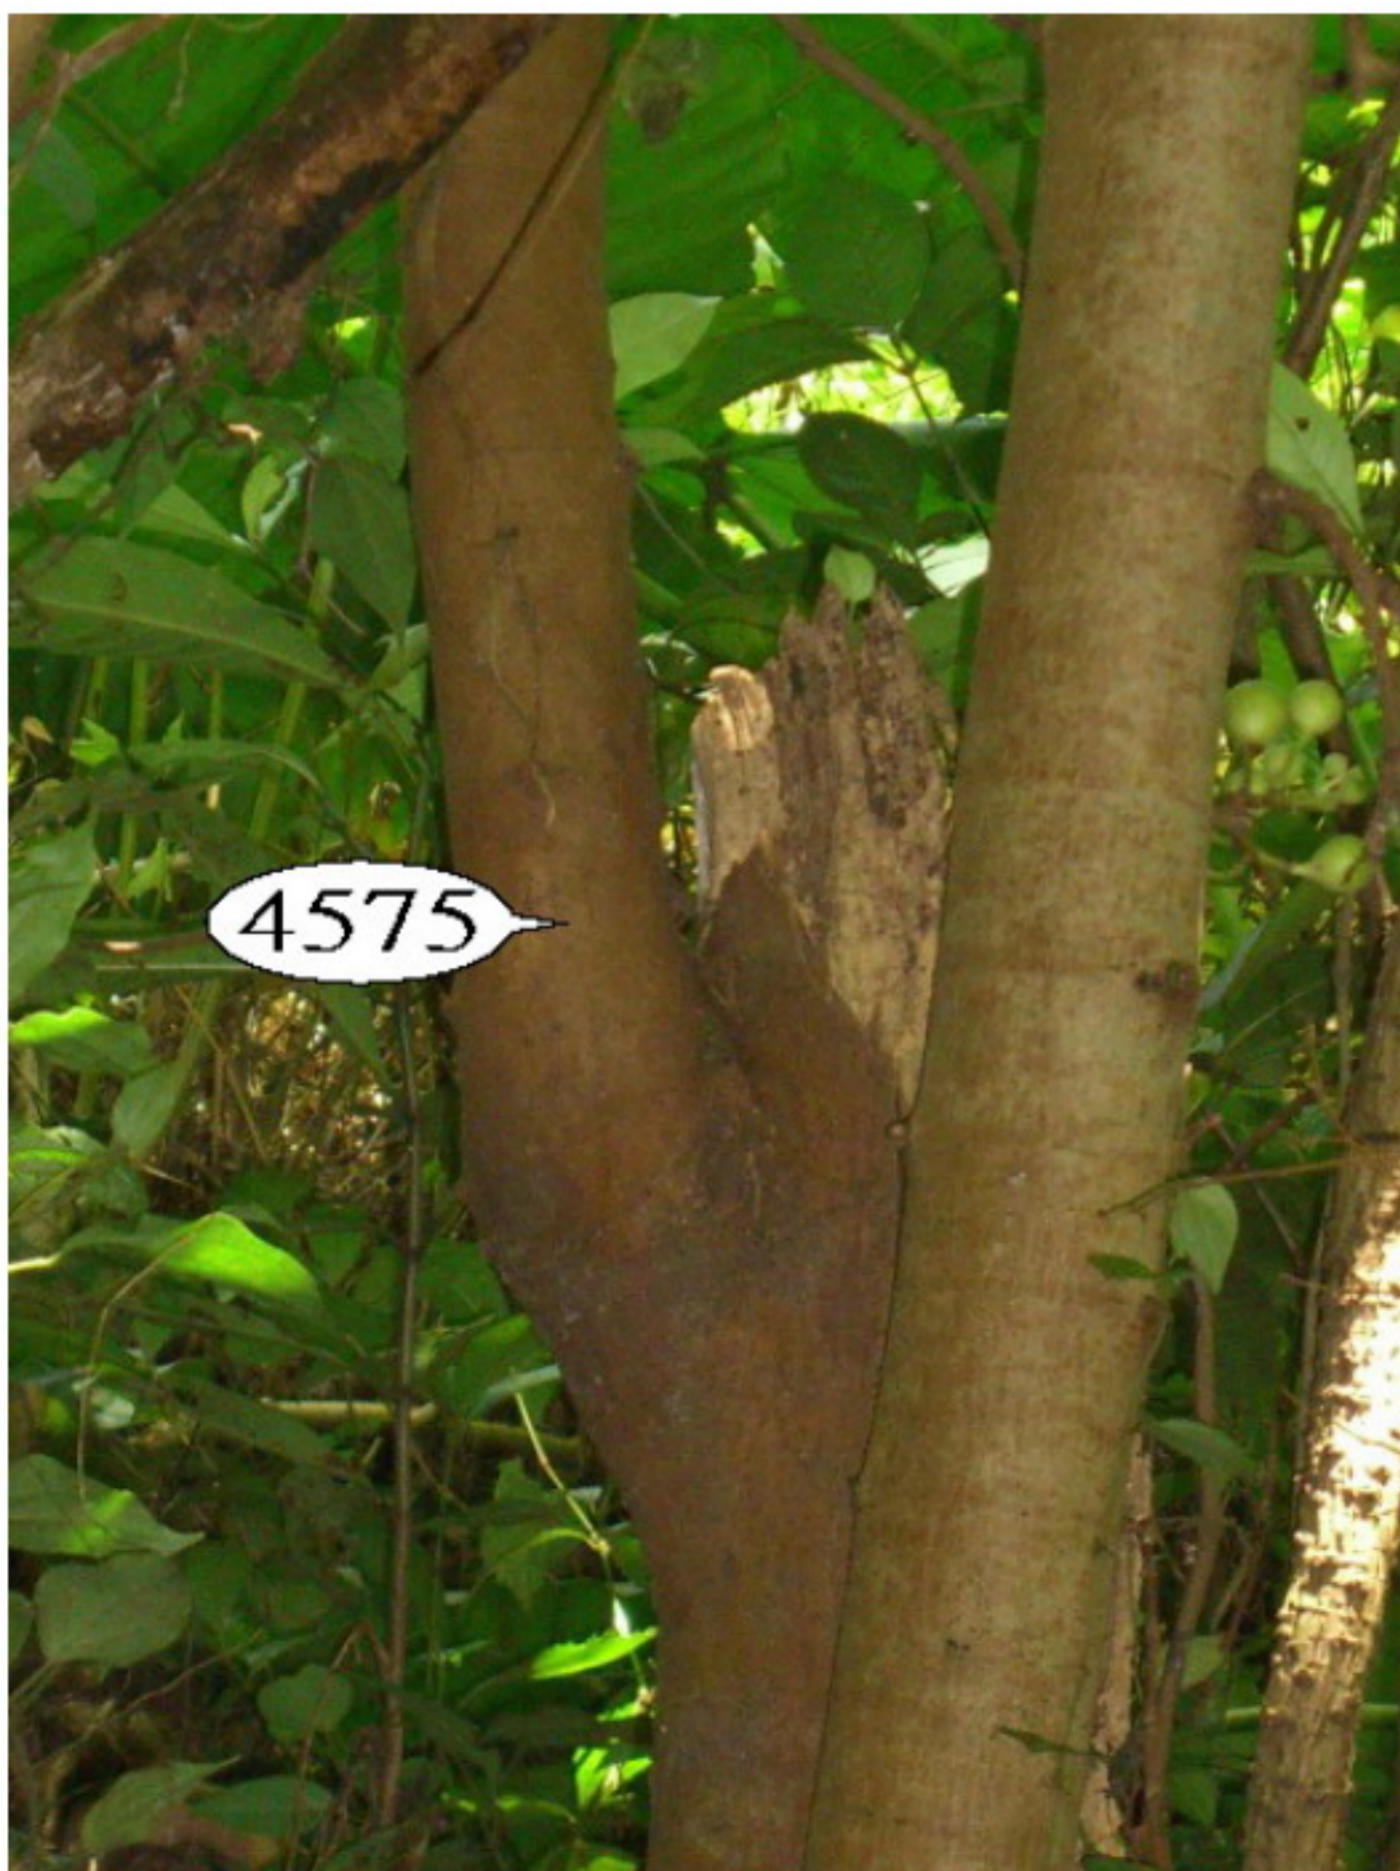
Tree 4289  
Dead Tree
