# Provision of Cremators at Wo Hop Shek Crematorium

Tree Survey Report

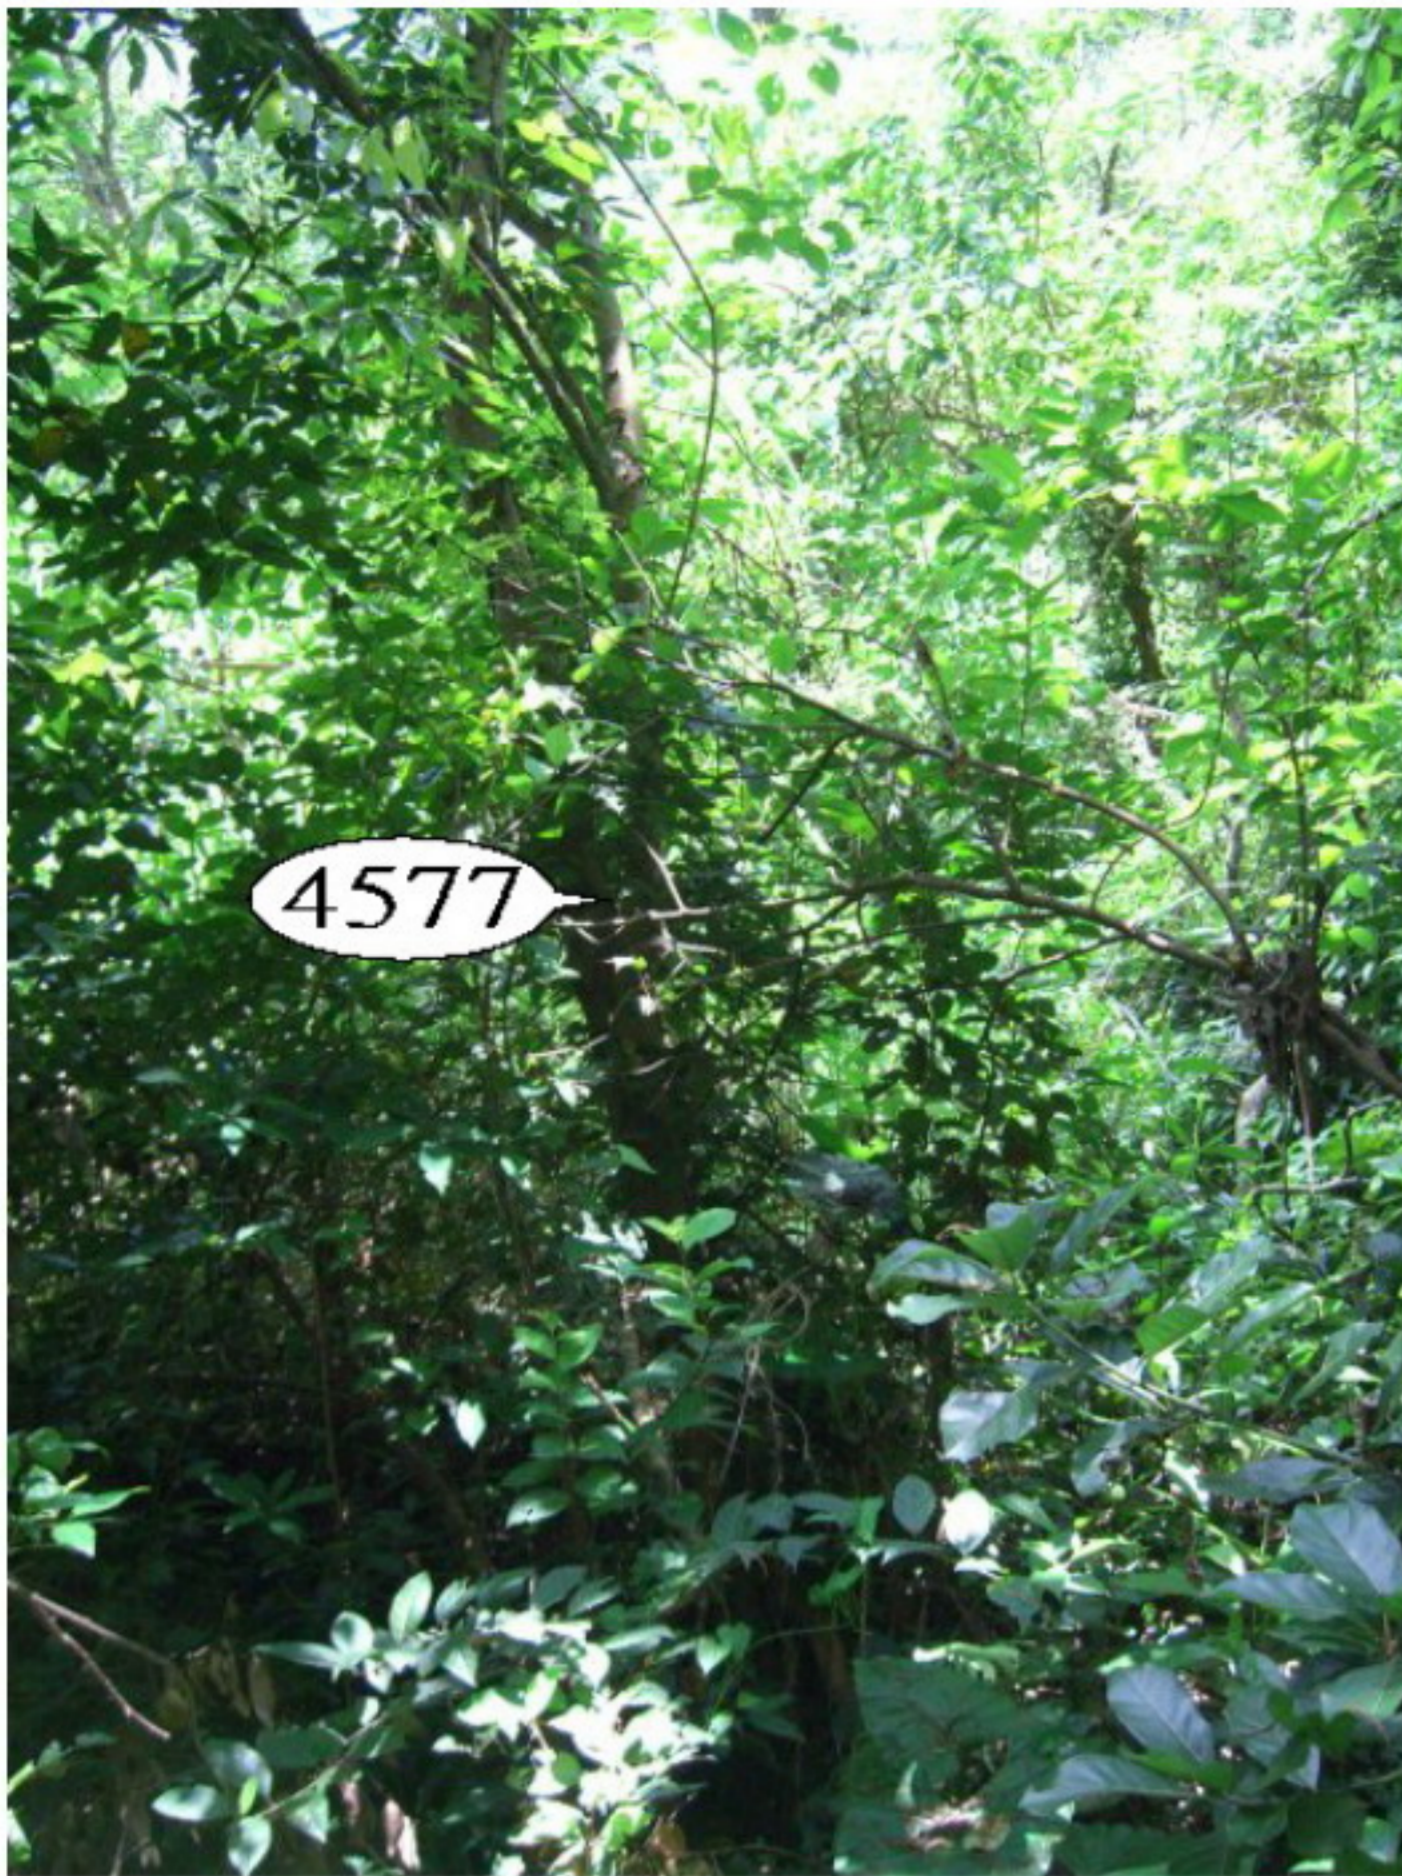
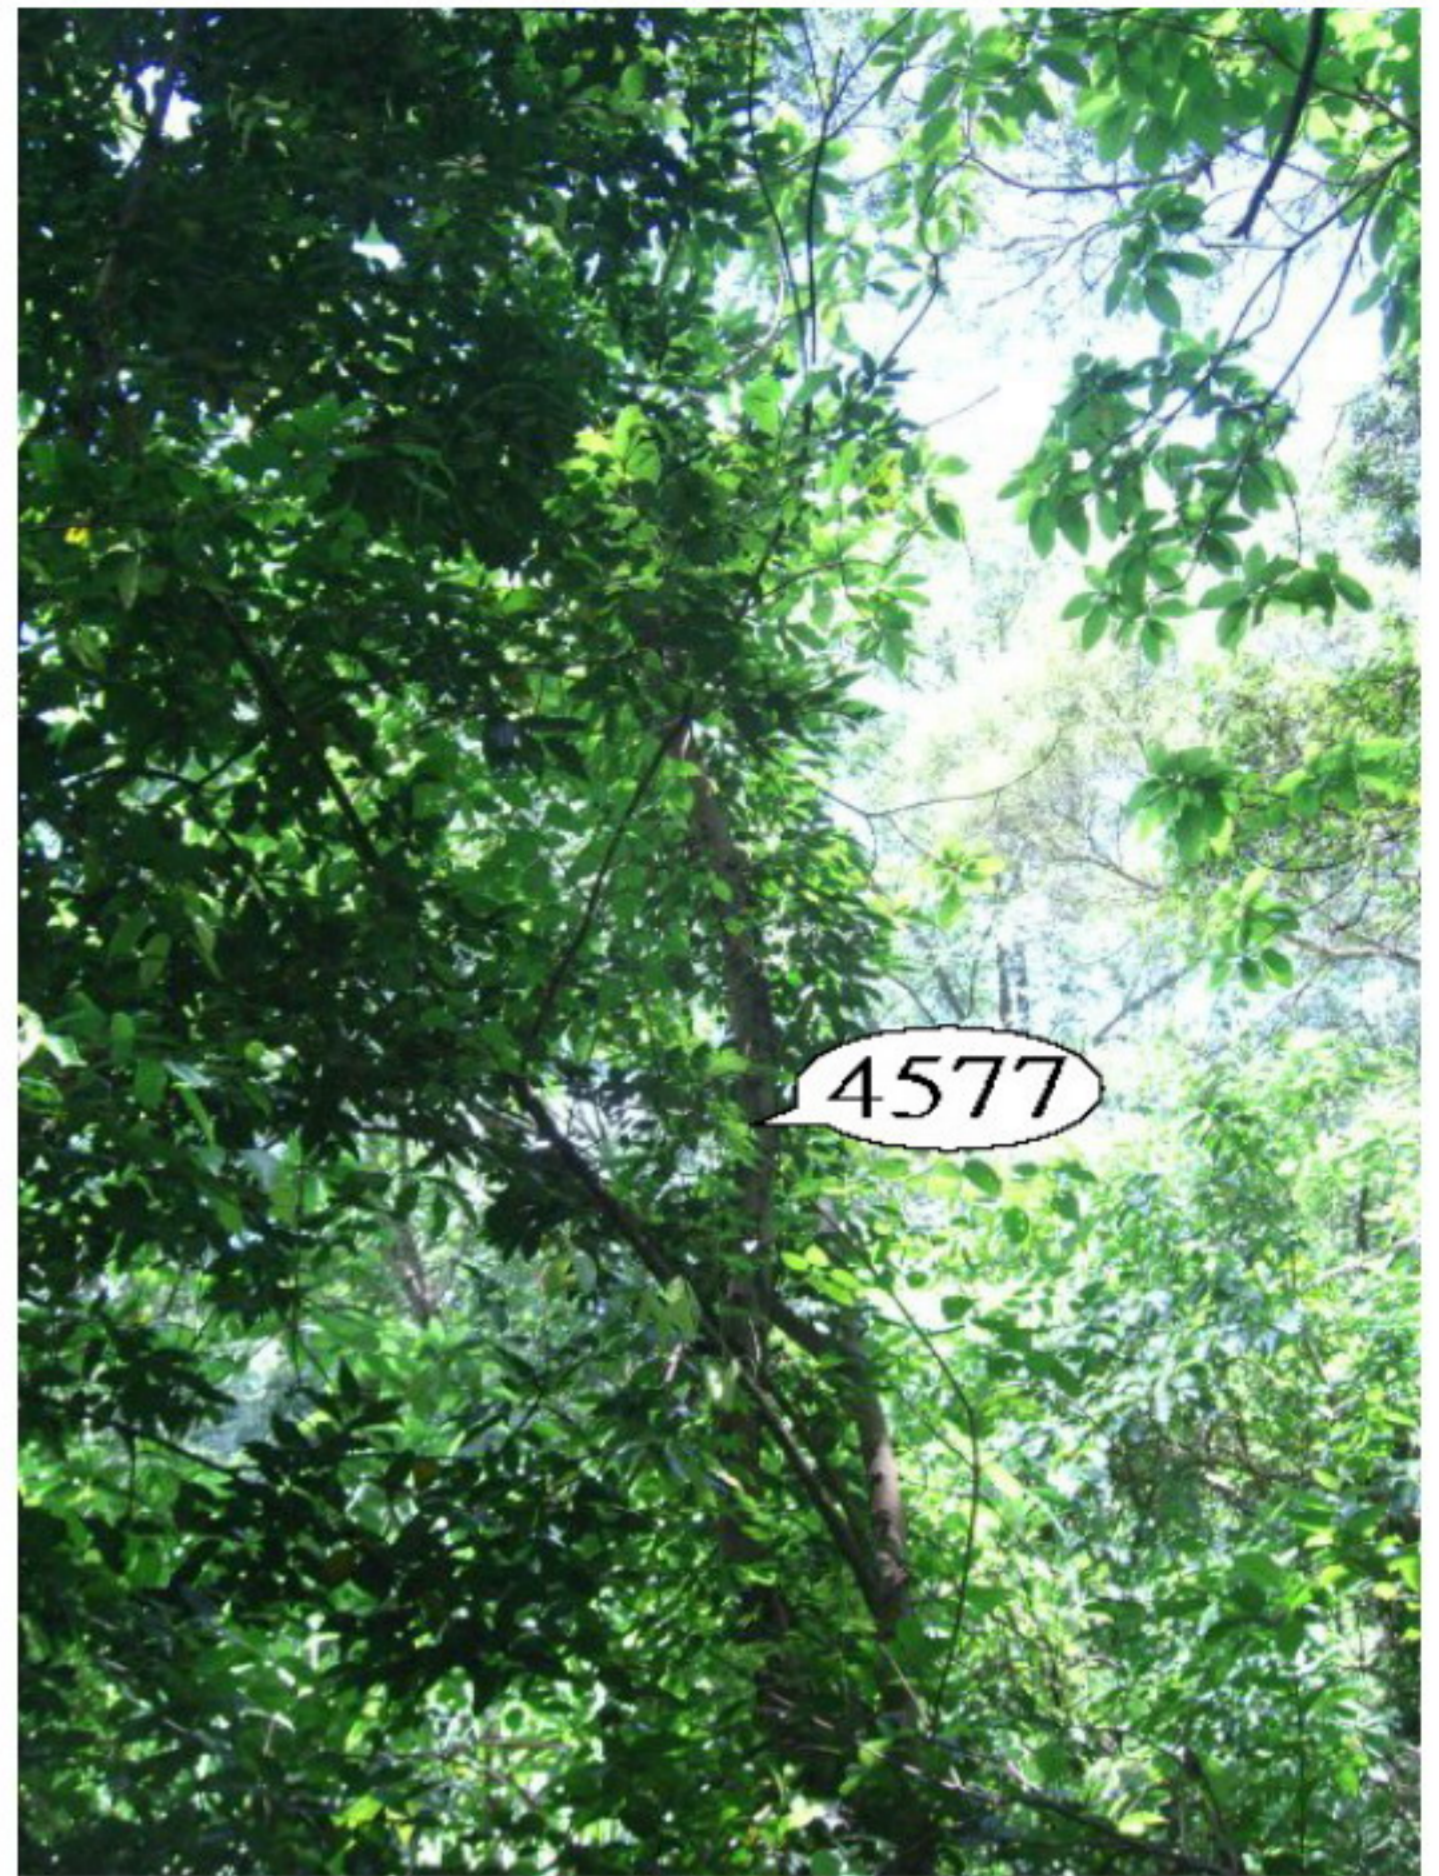
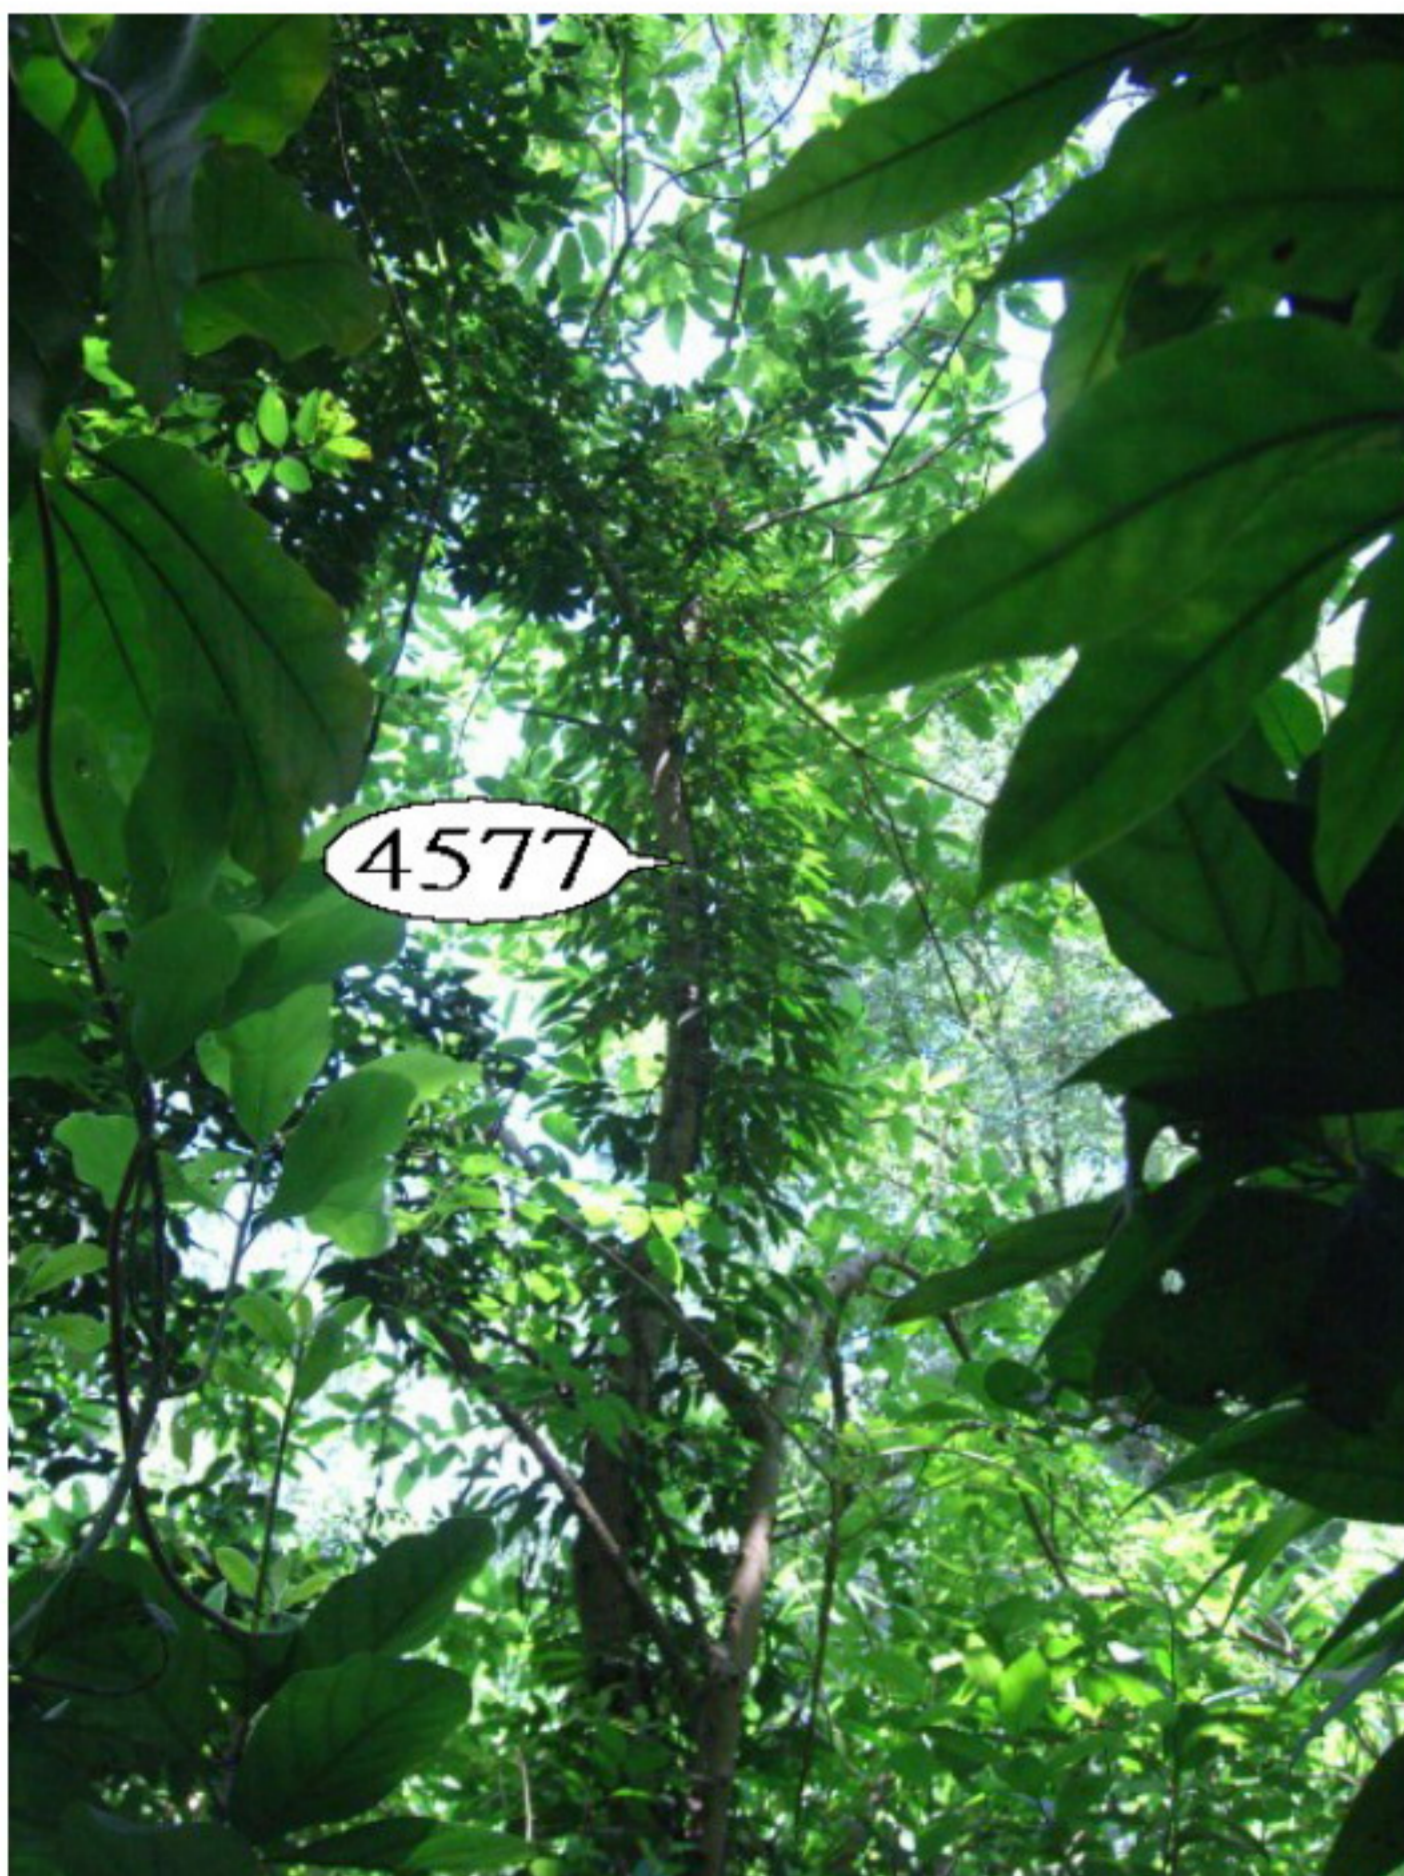
Tree 4575

Poor form which lead to low amenity value. Besides, the tree is unbalance. It may need heavy pruning after transplantation that will affect its transplantation survival rate. Moreover, the operation of the transplantation for poor form tree is also difficult.

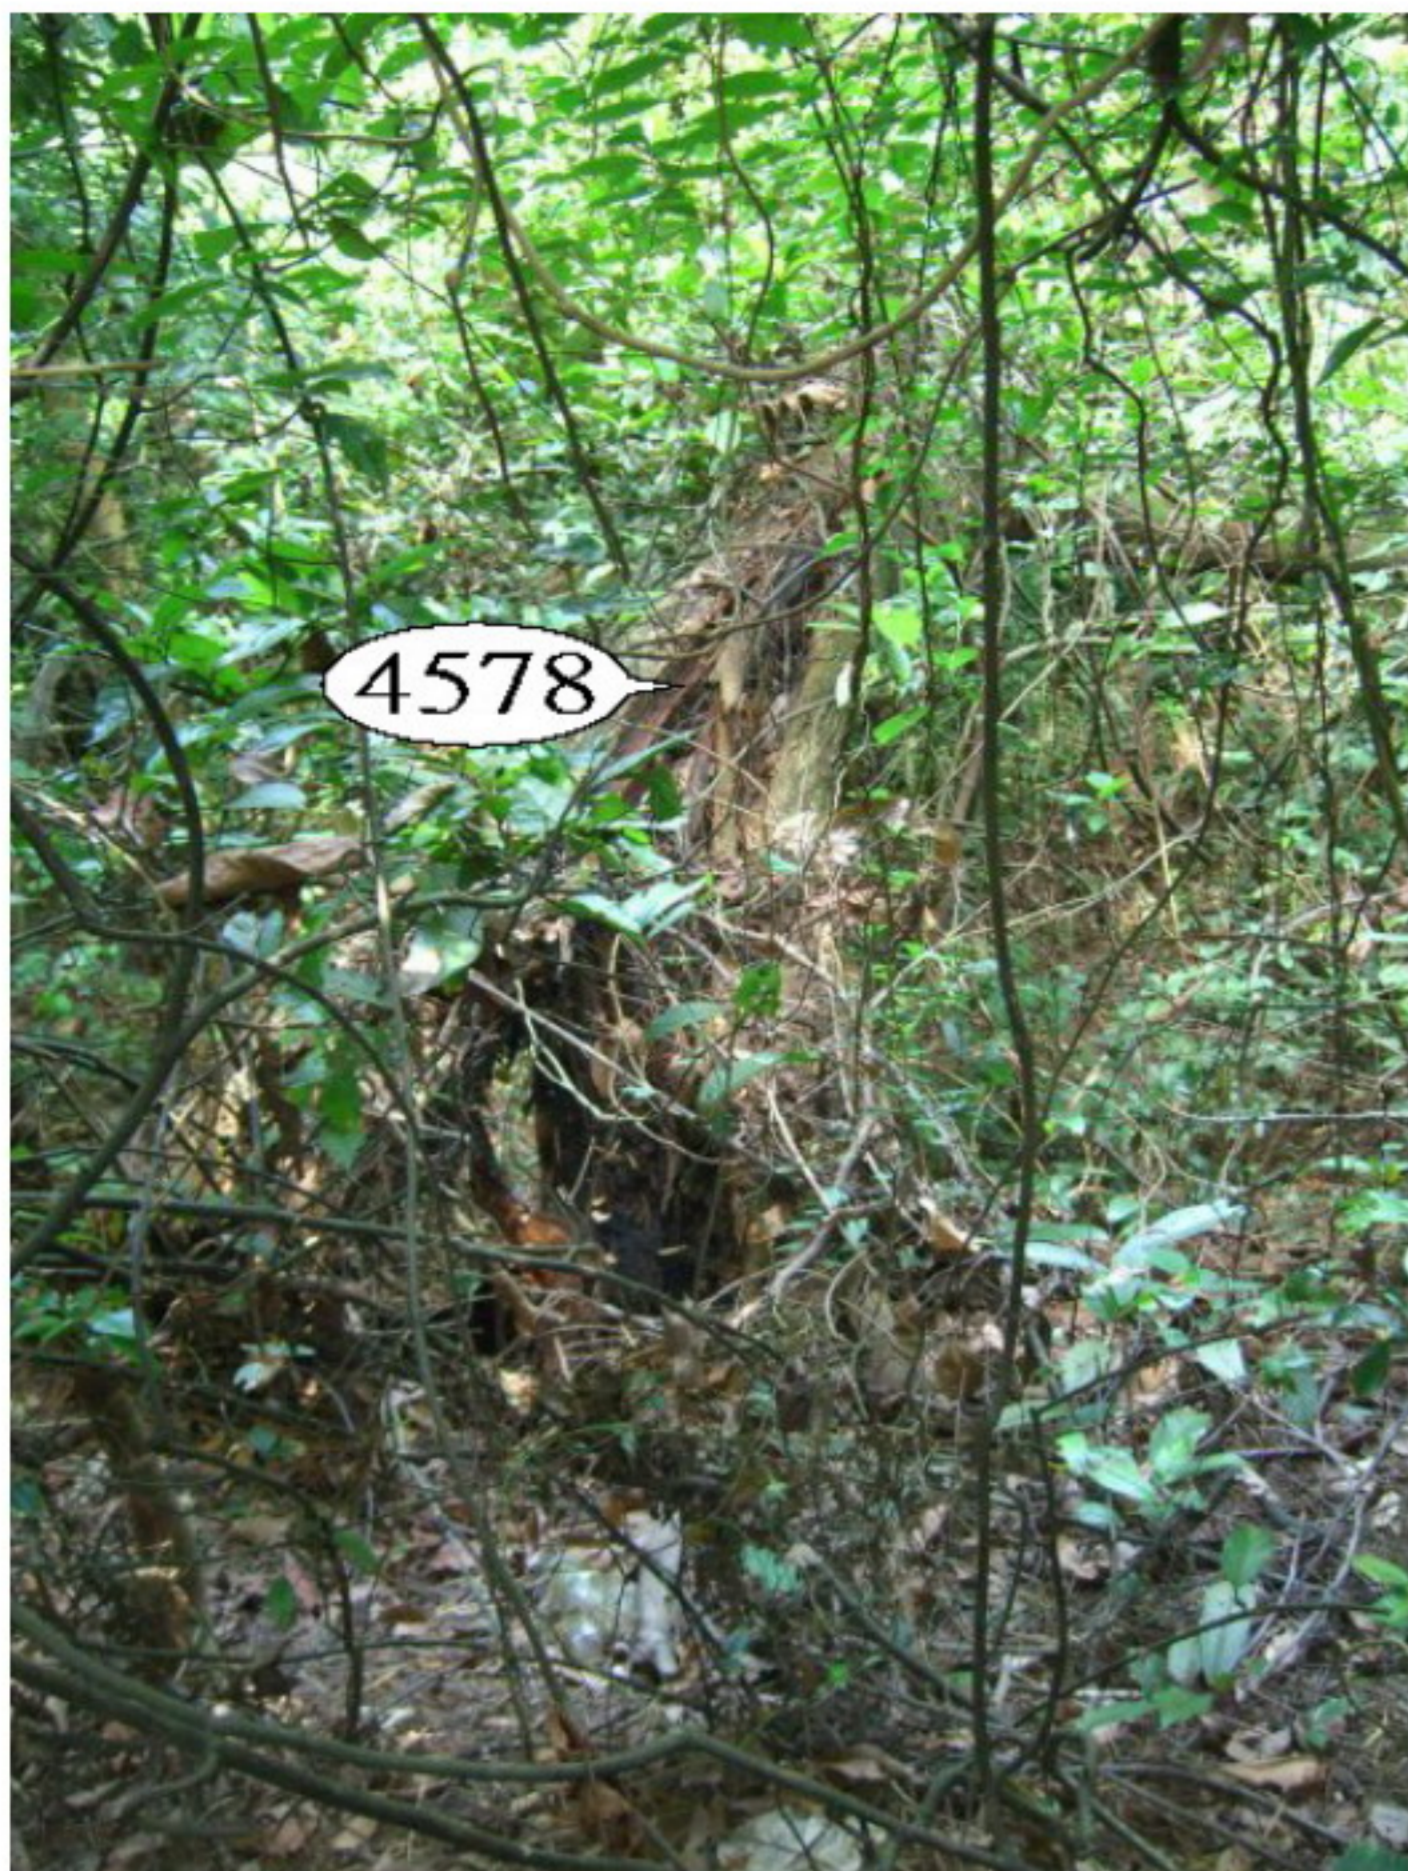
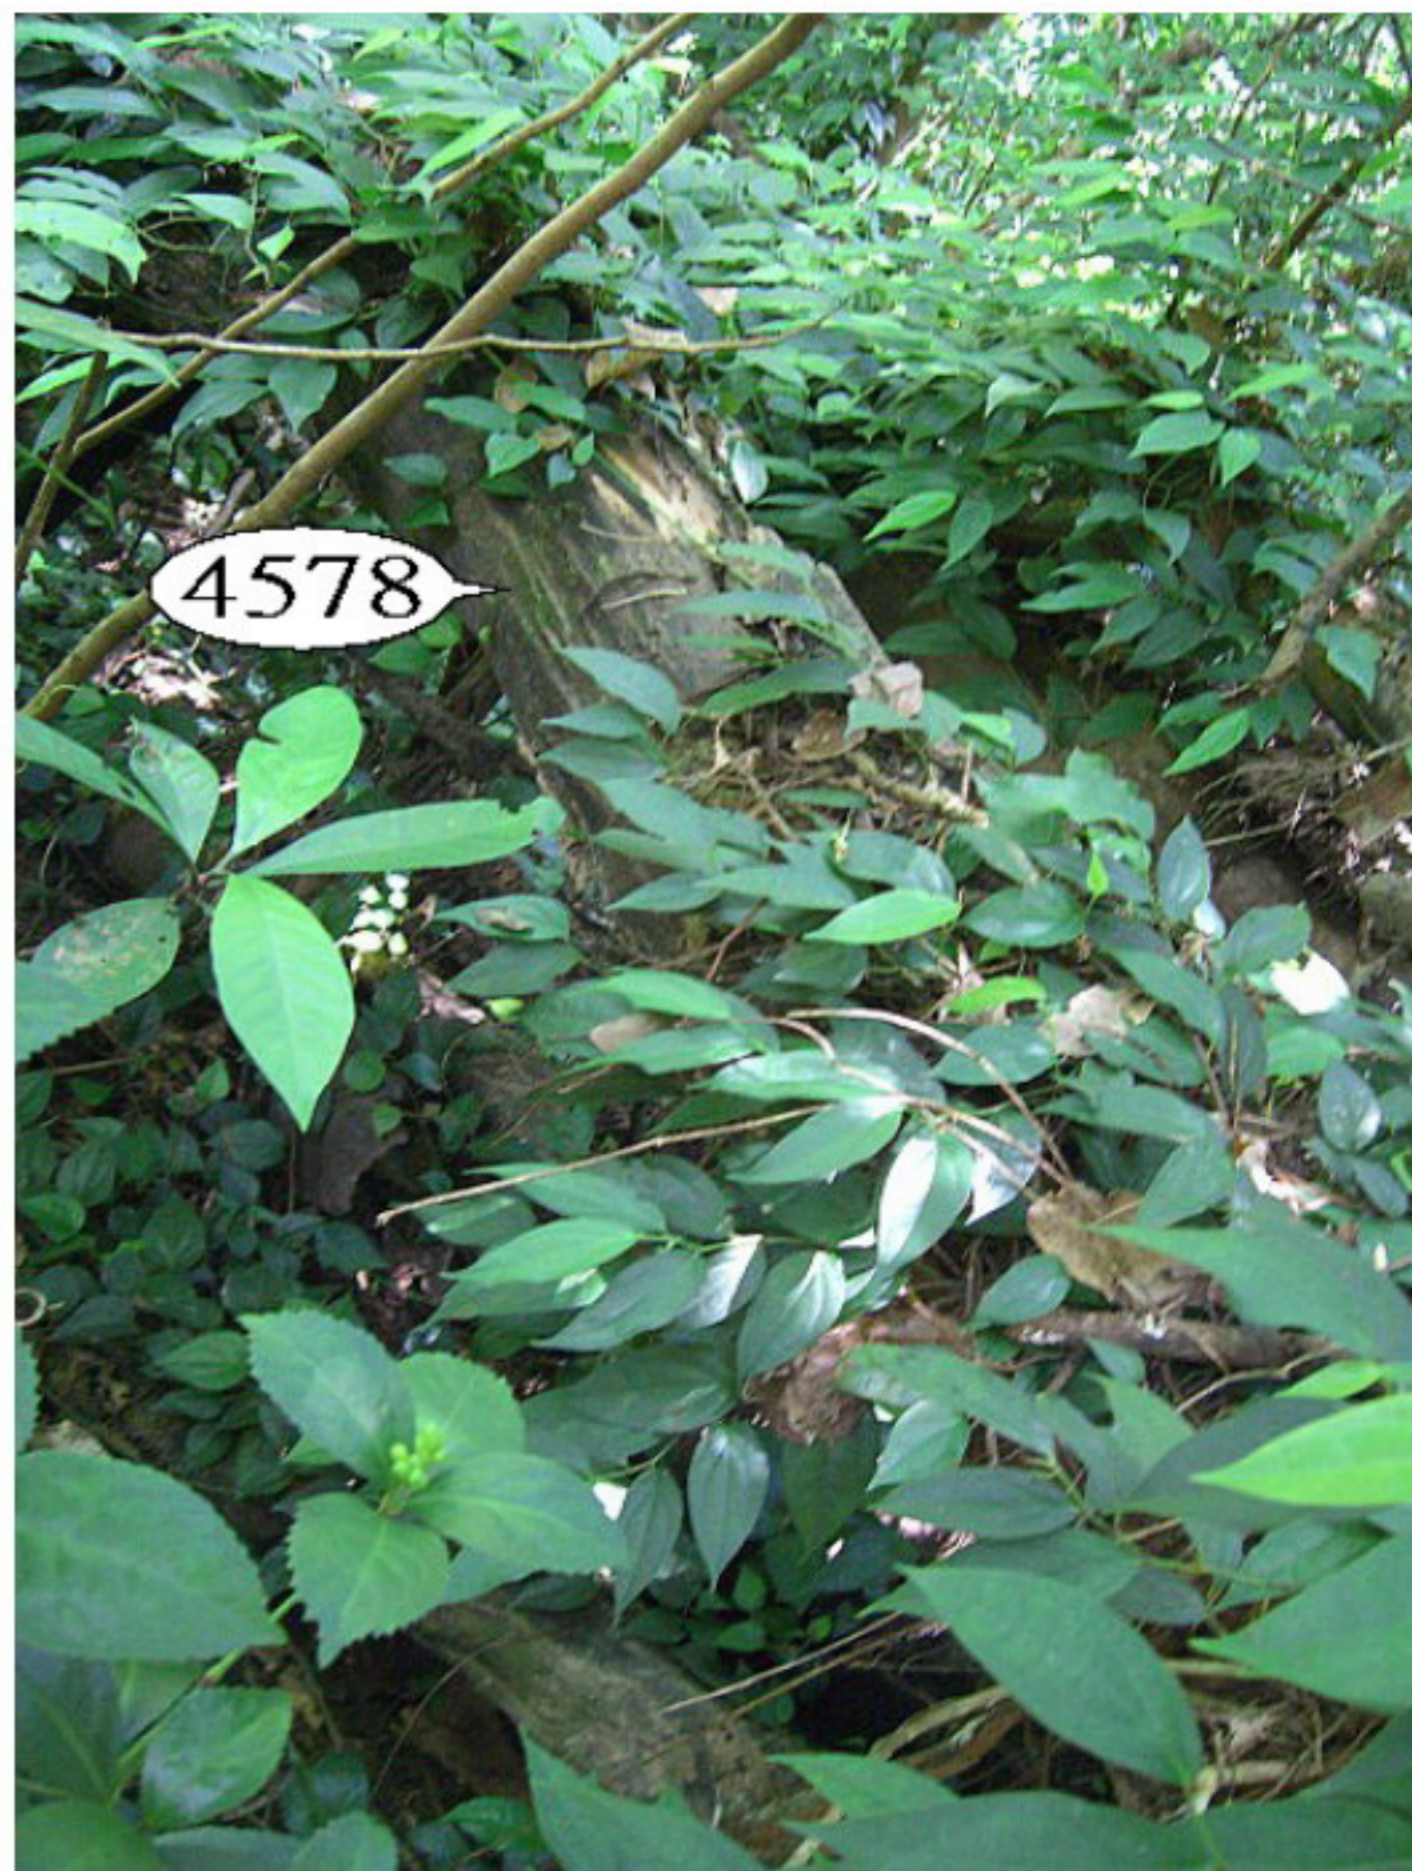
#### Tree 4577

Poor health will lead to low transplantation survival rate. Poor form which also lead to low amenity value. Besides, the tree is unbalance. It may need heavy pruning after transplantation that will affect its transplantation survival rate. Moreover, the operation of the transplantation for poor form tree is also difficult.

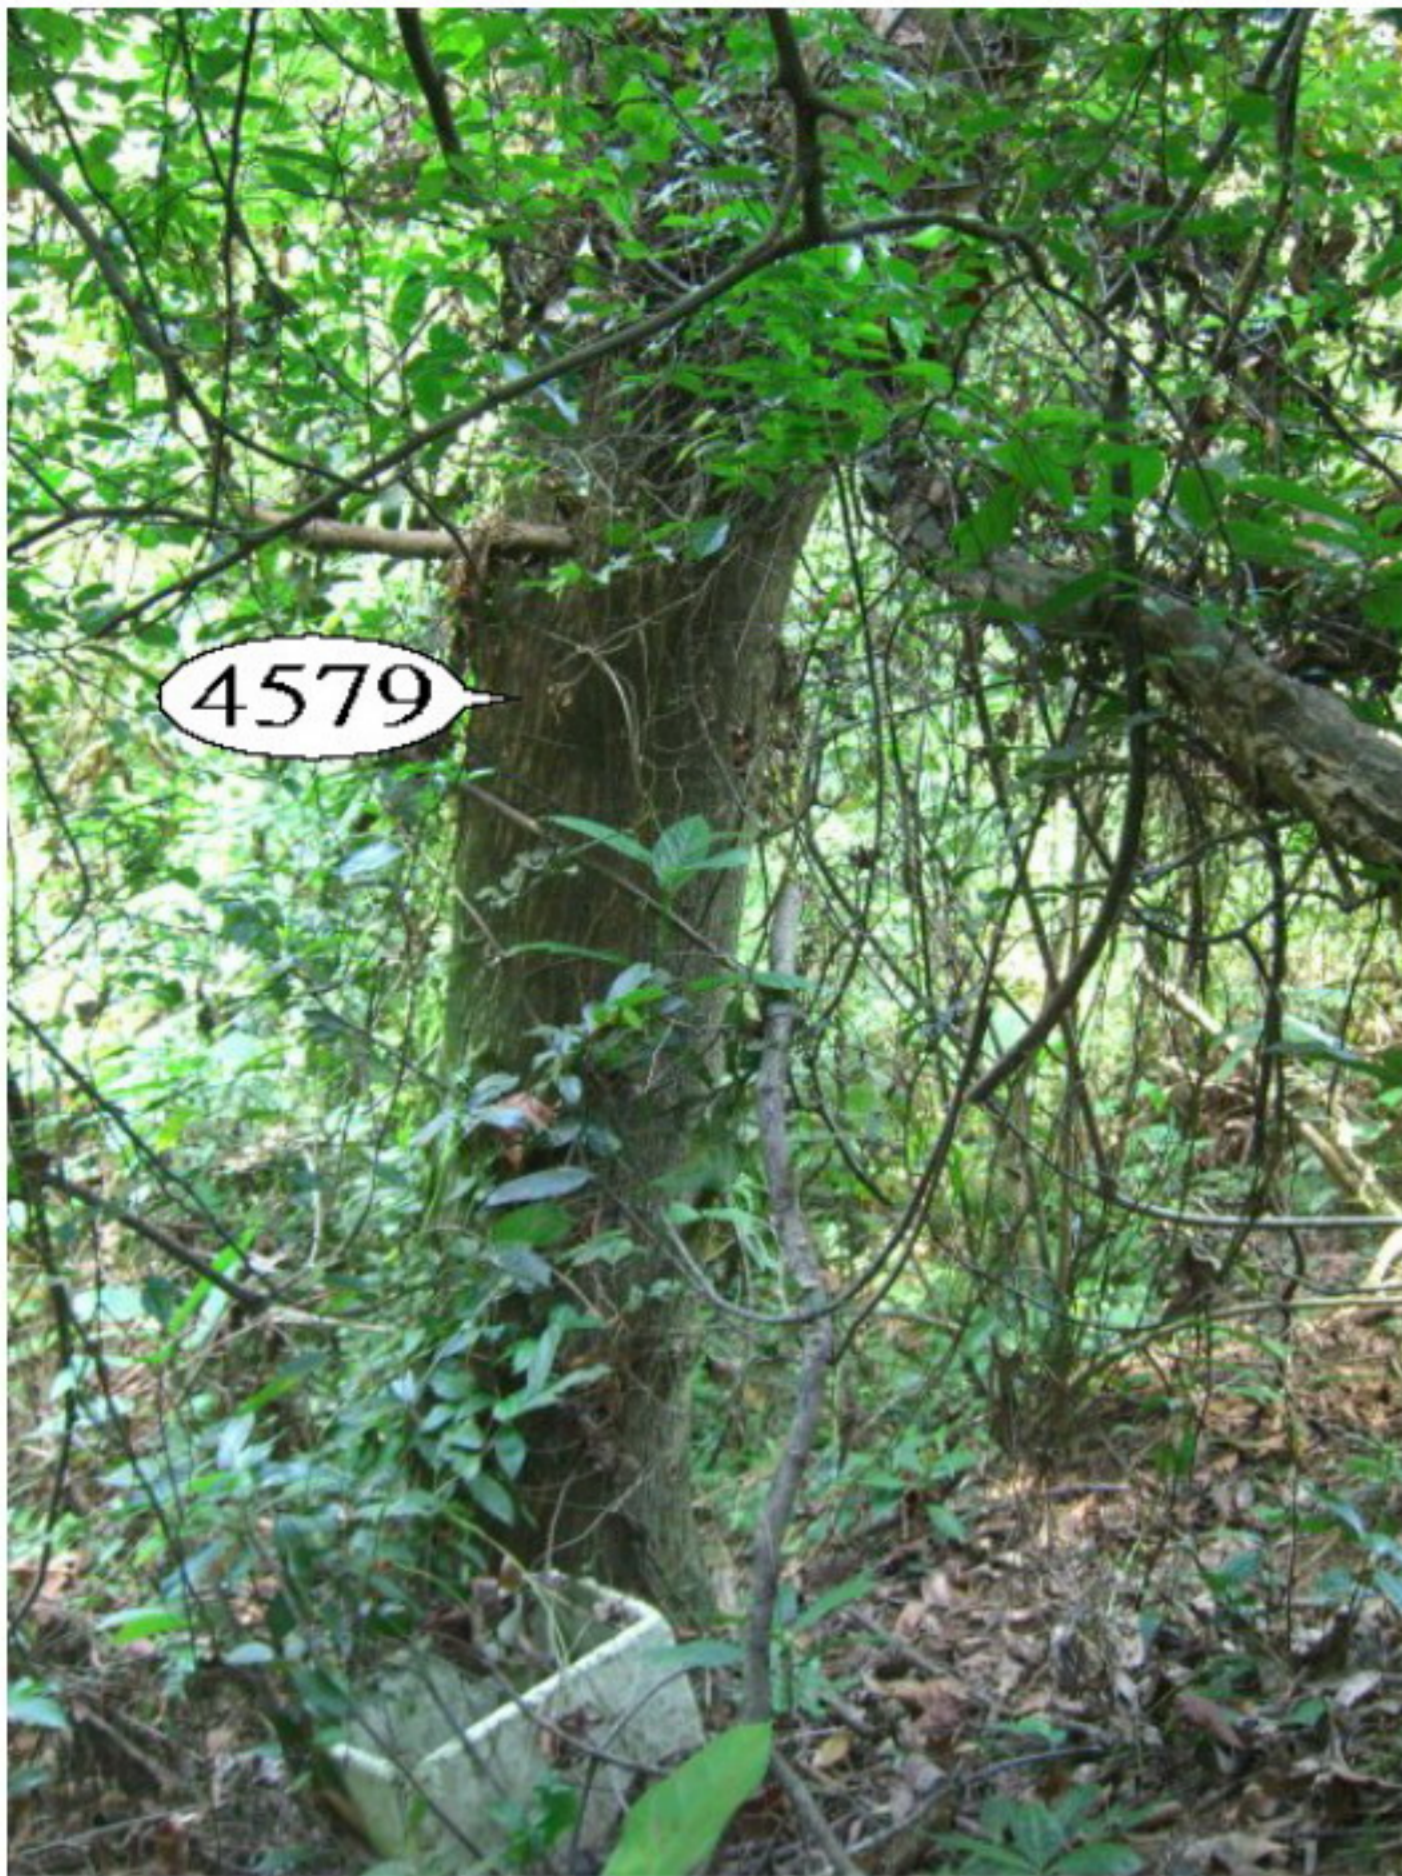
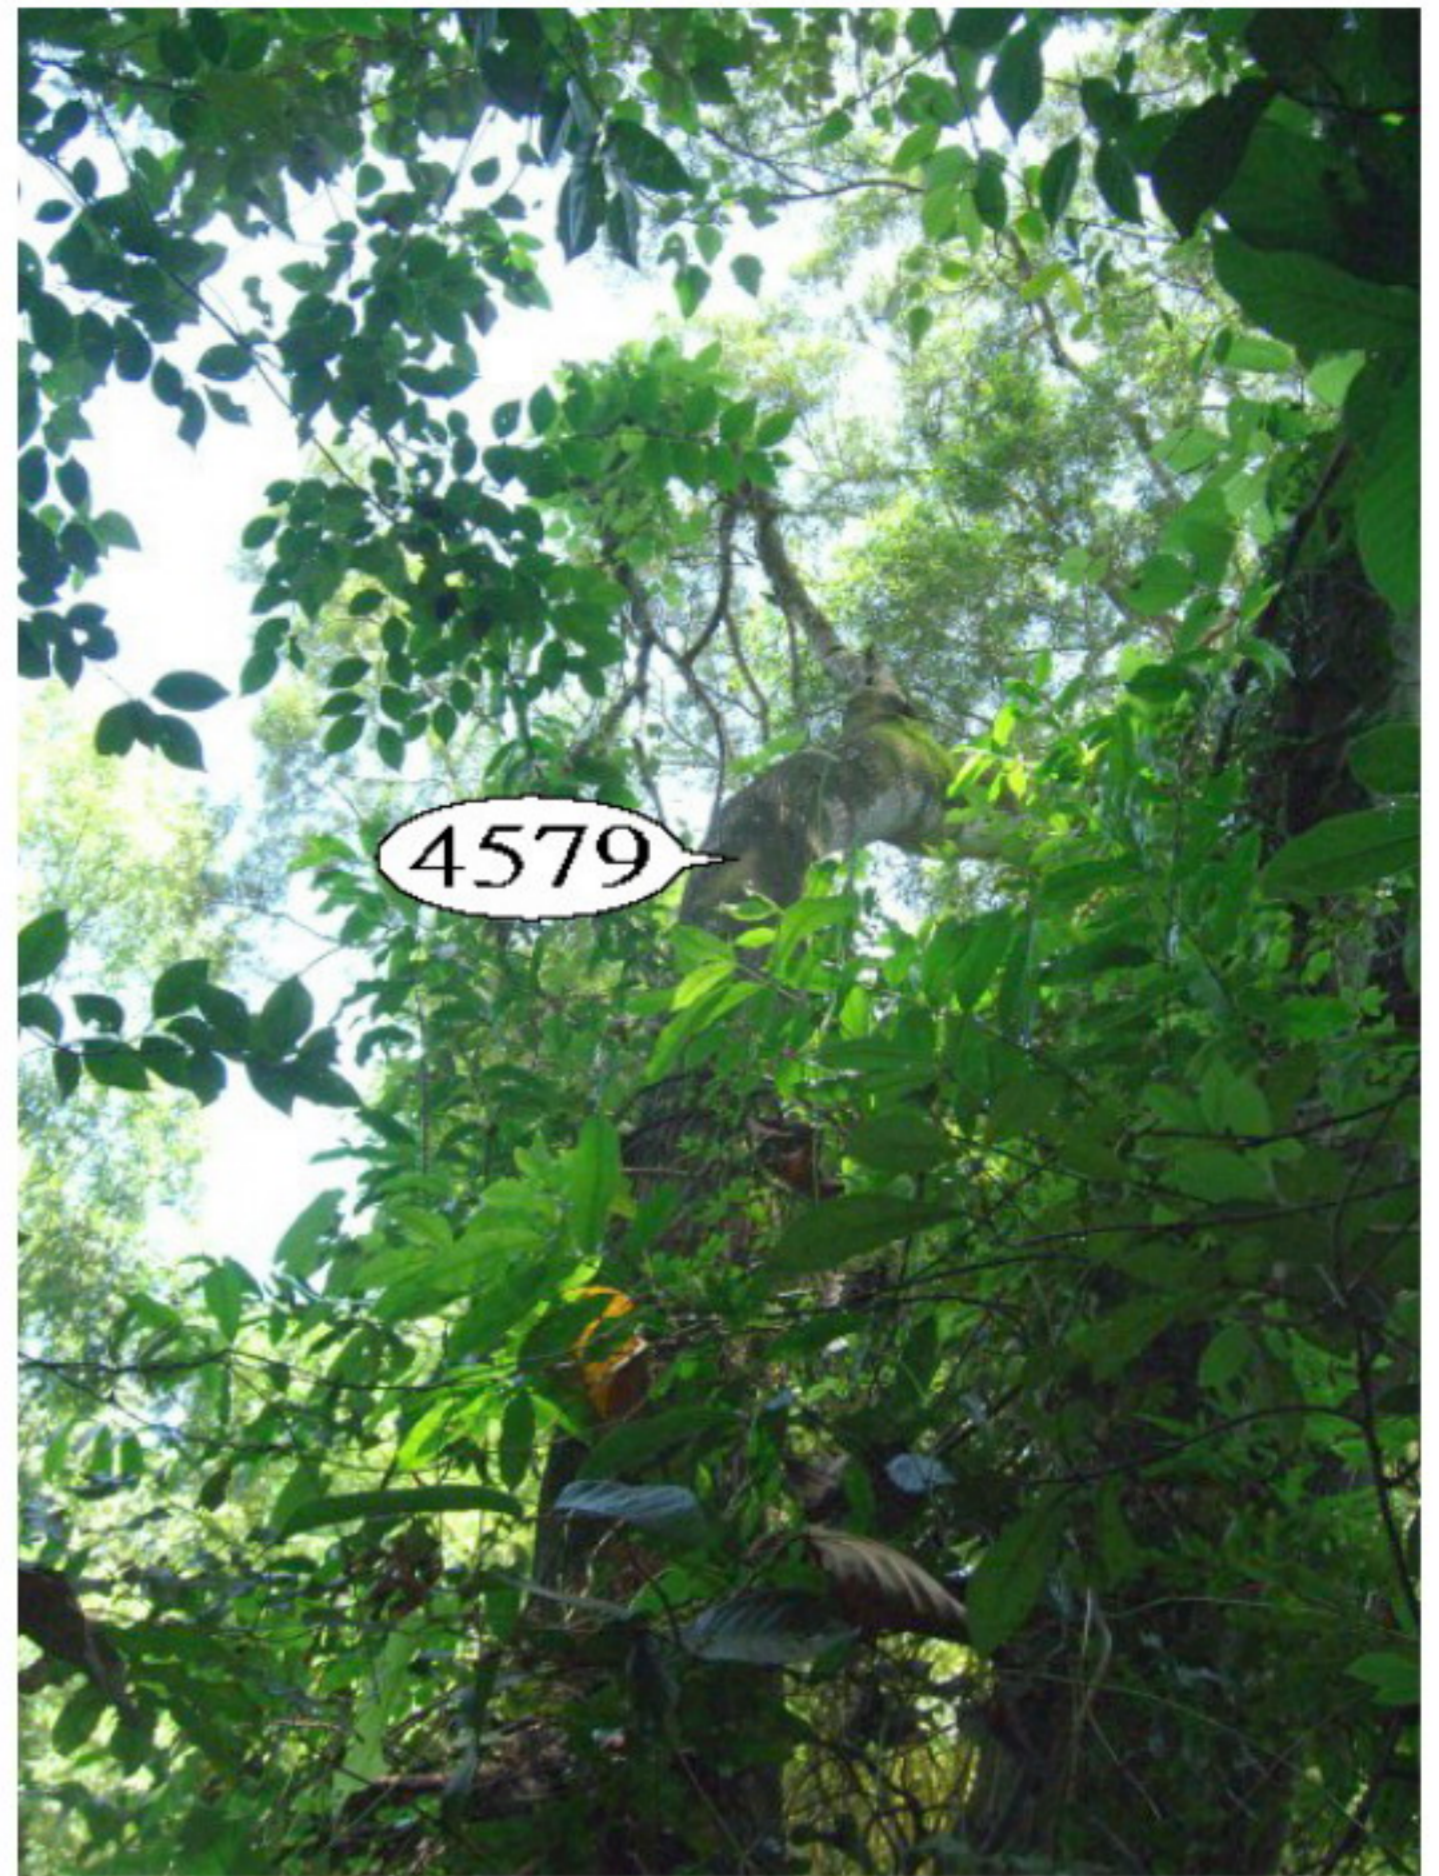
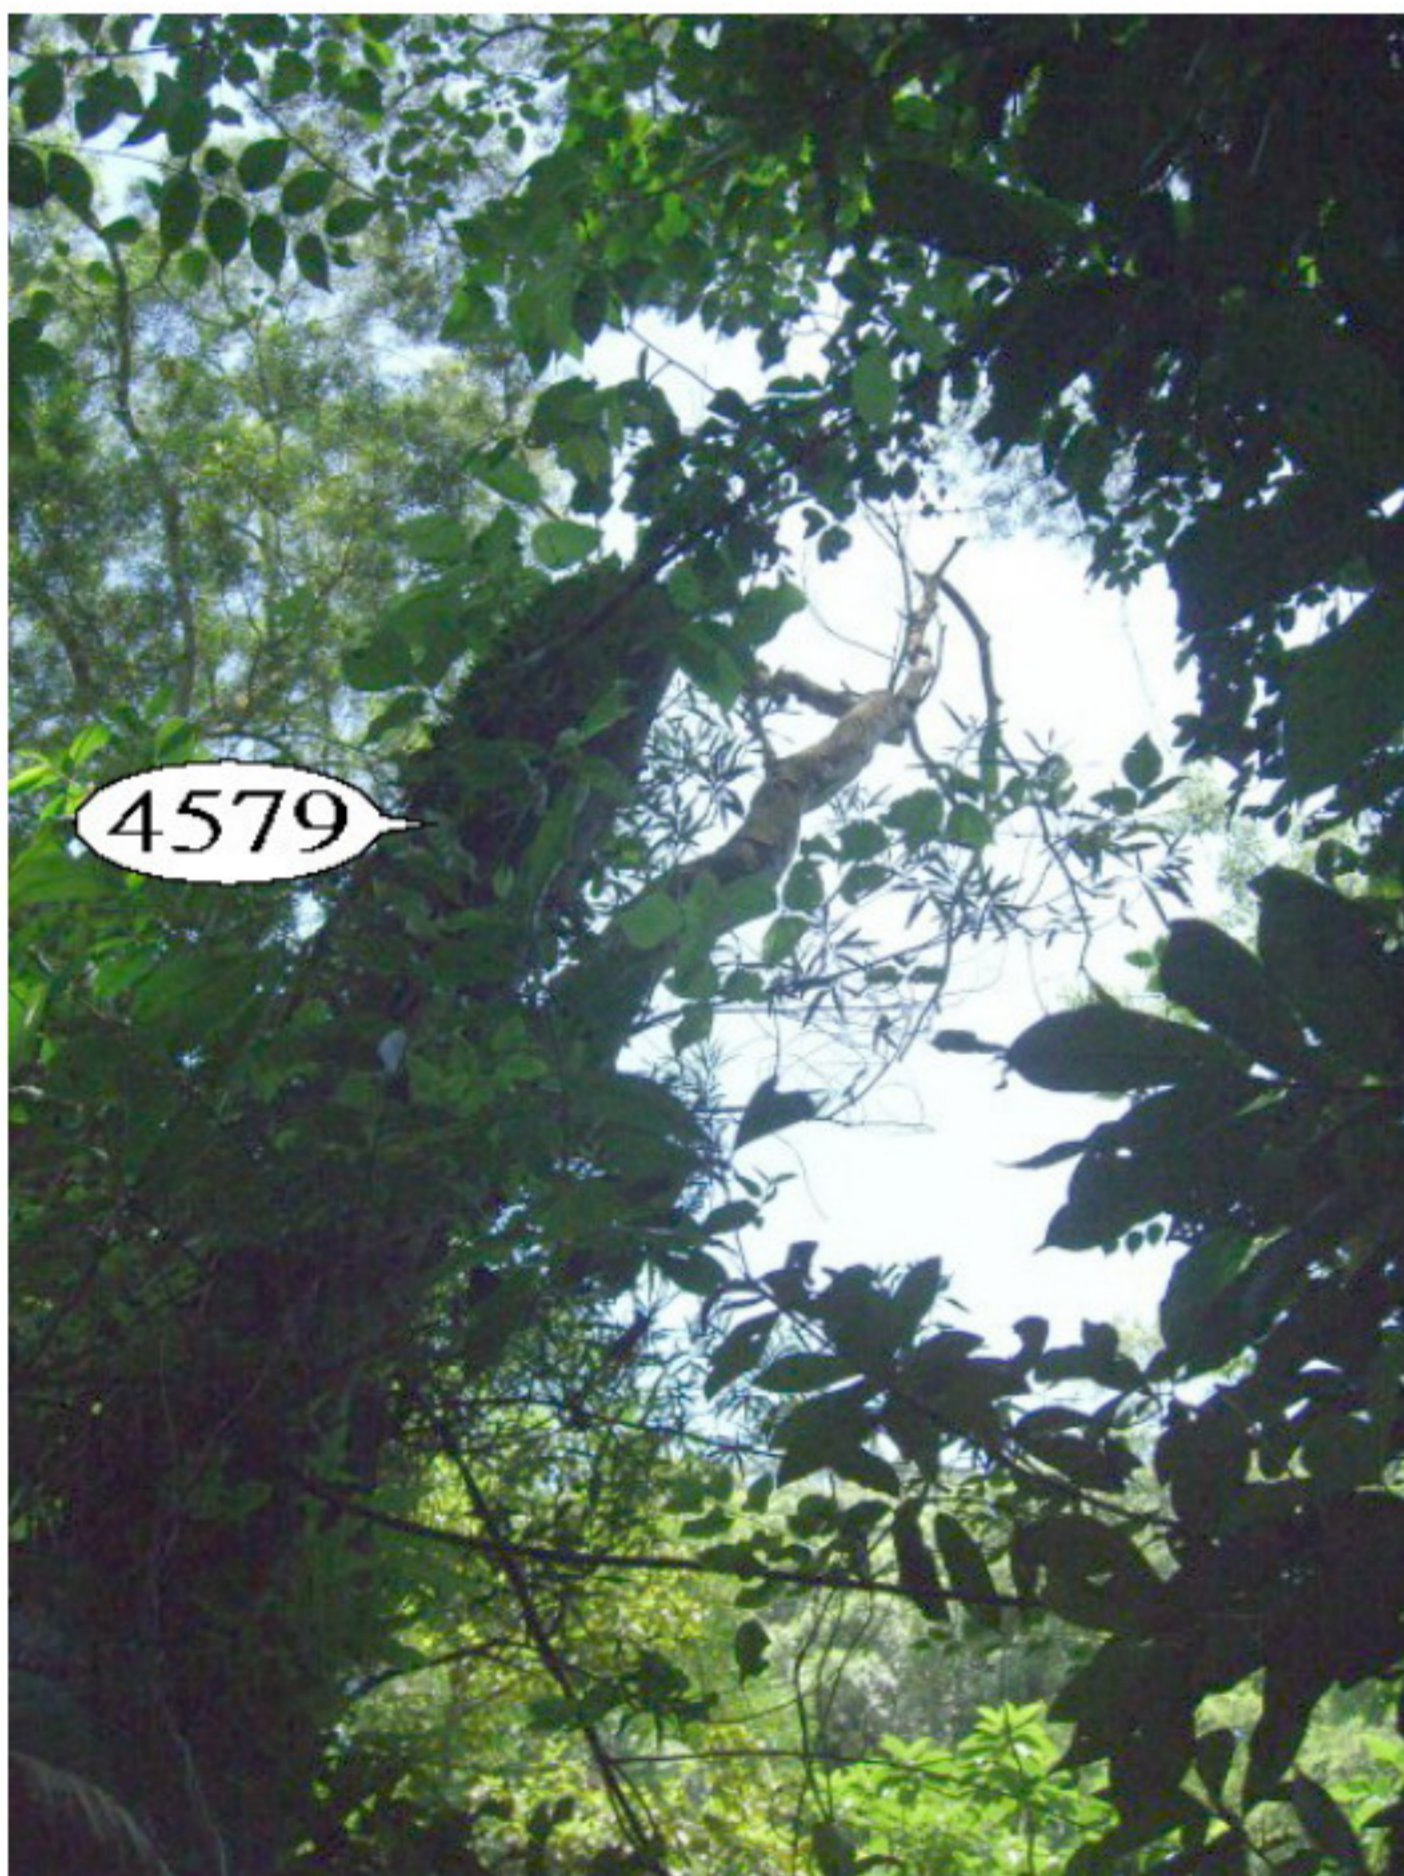
Tree 4578  
Dead Tree
