# Provision of Cremators at Wo Hop Shek Crematorium

Tree Survey Report

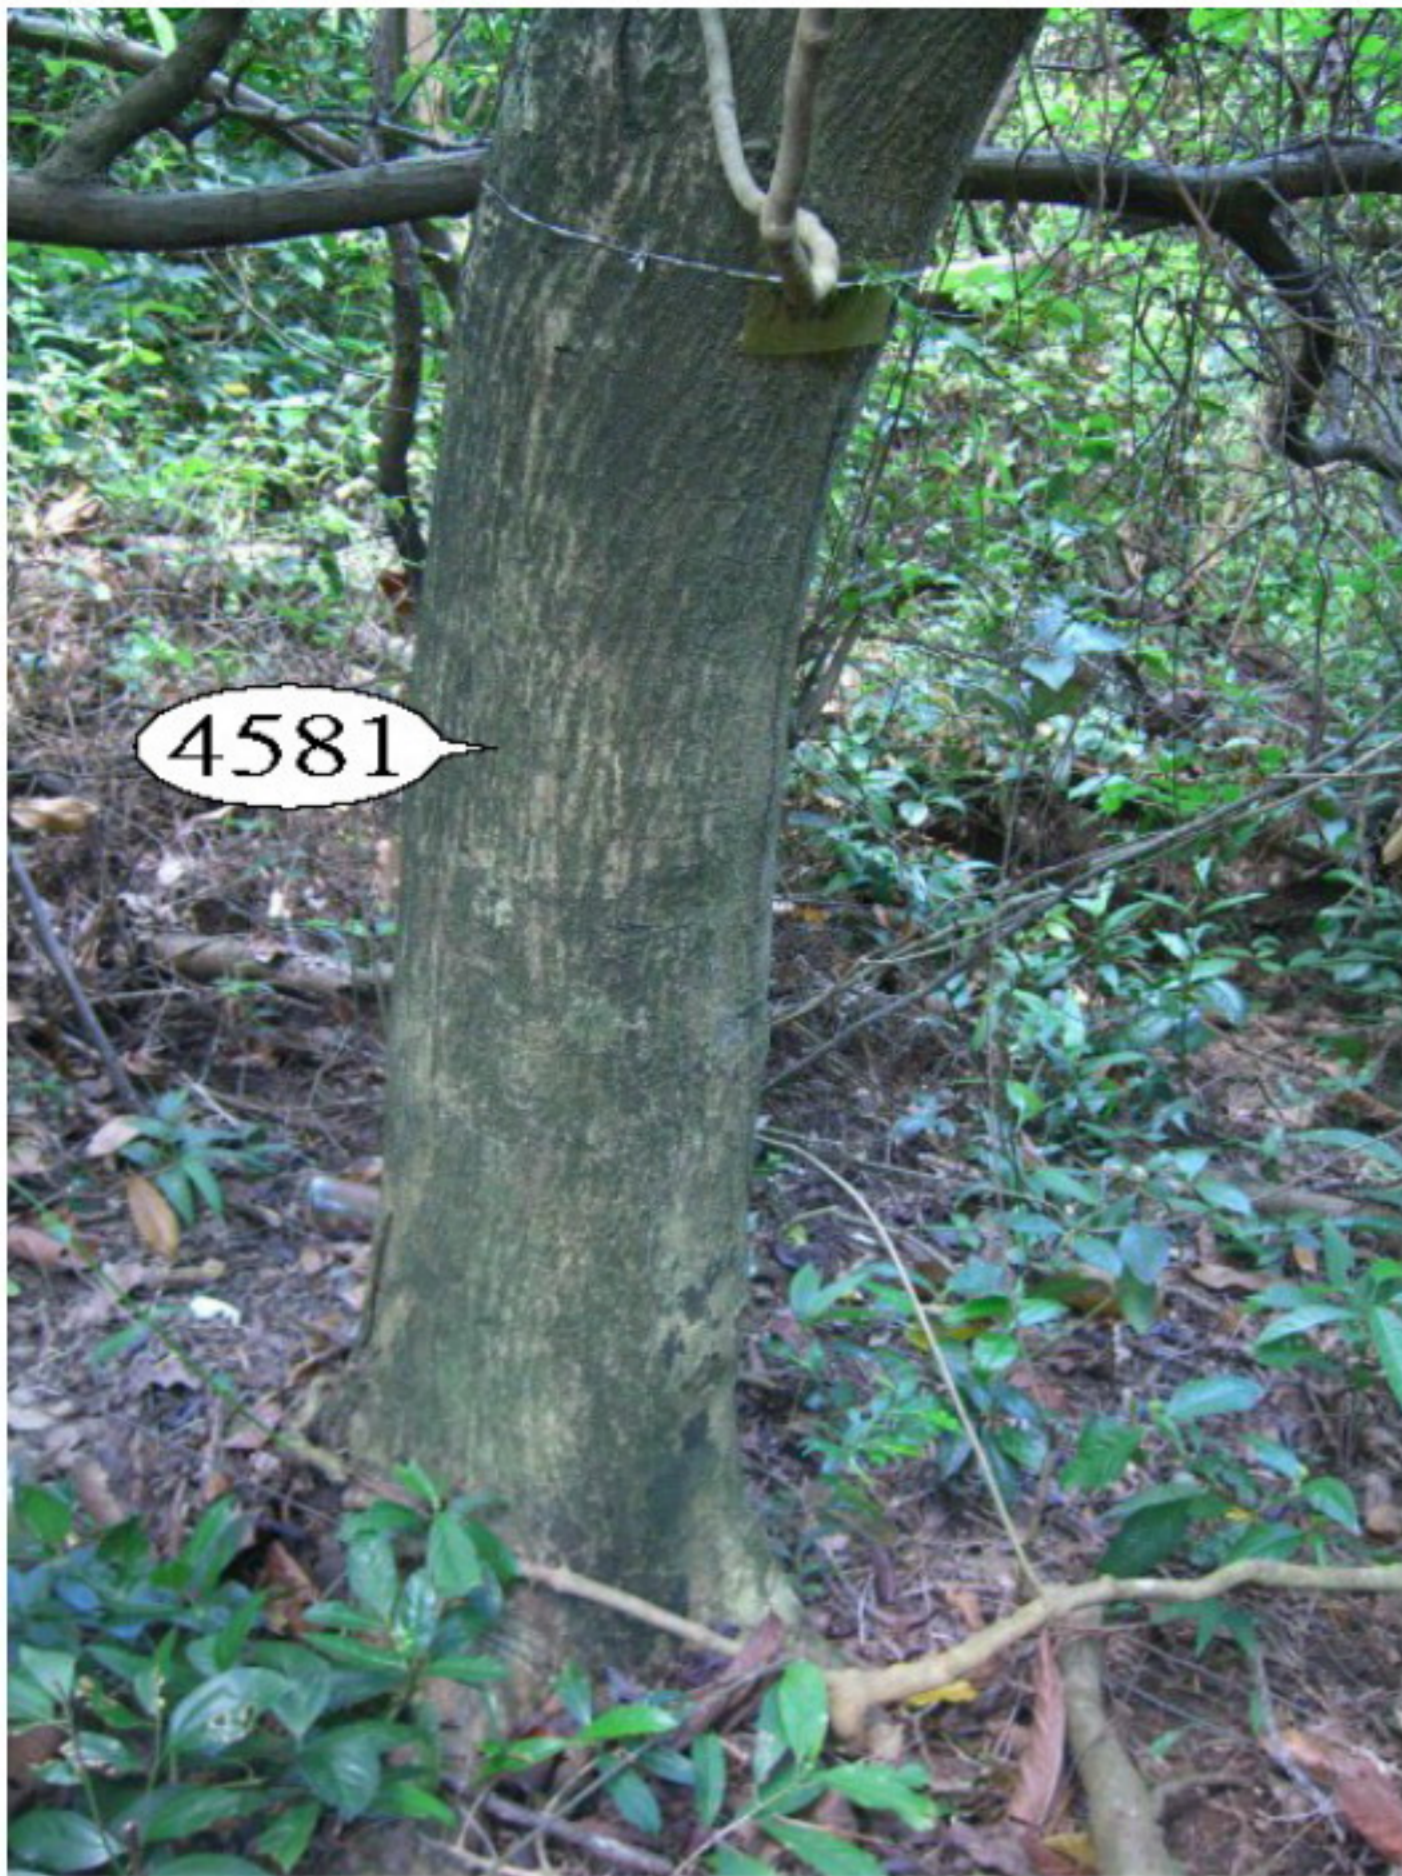
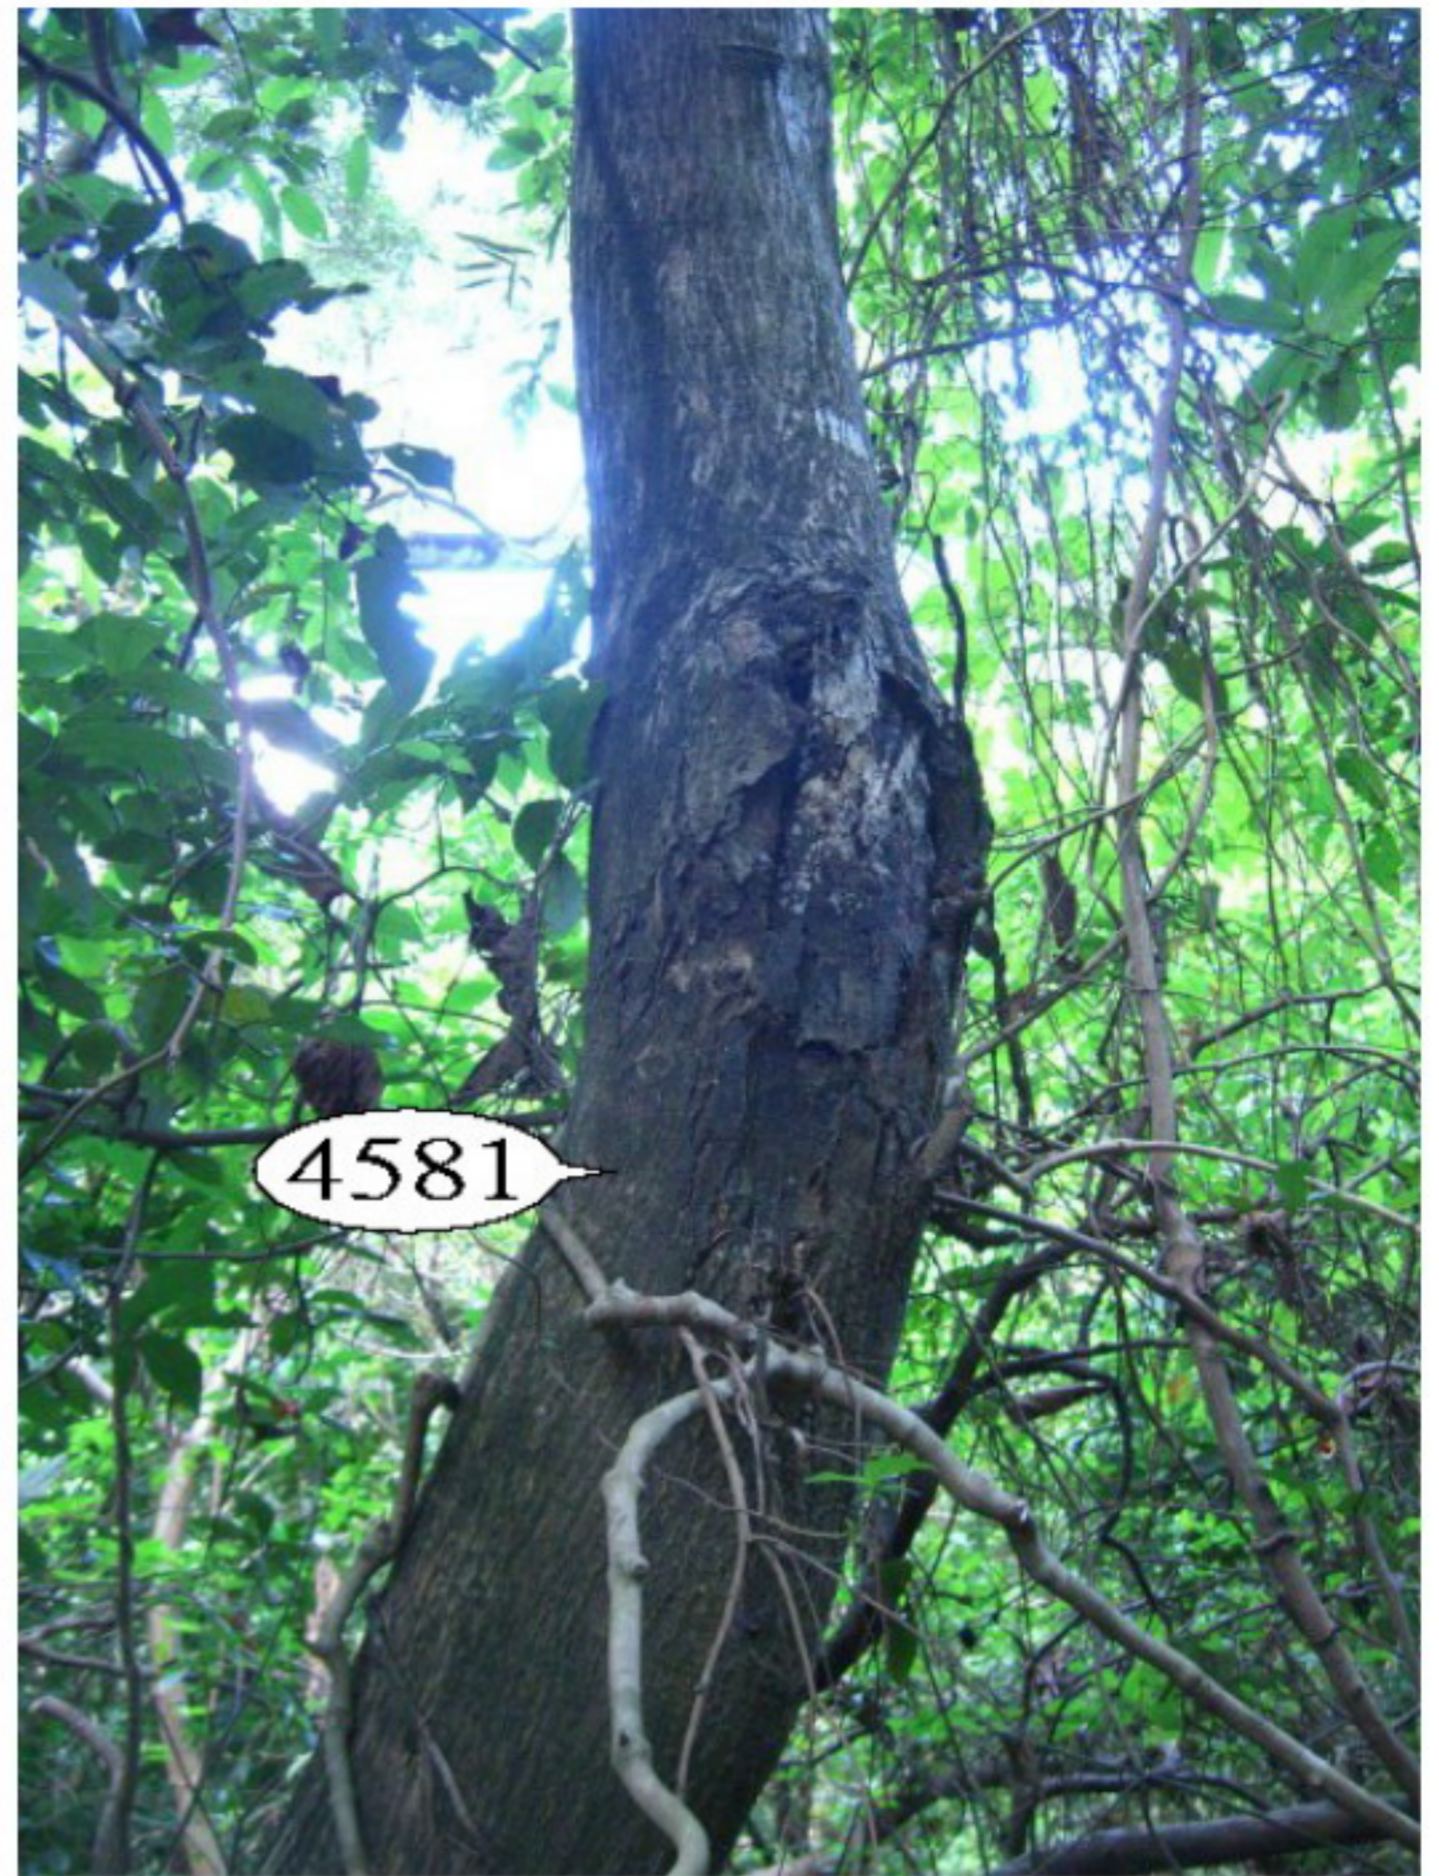
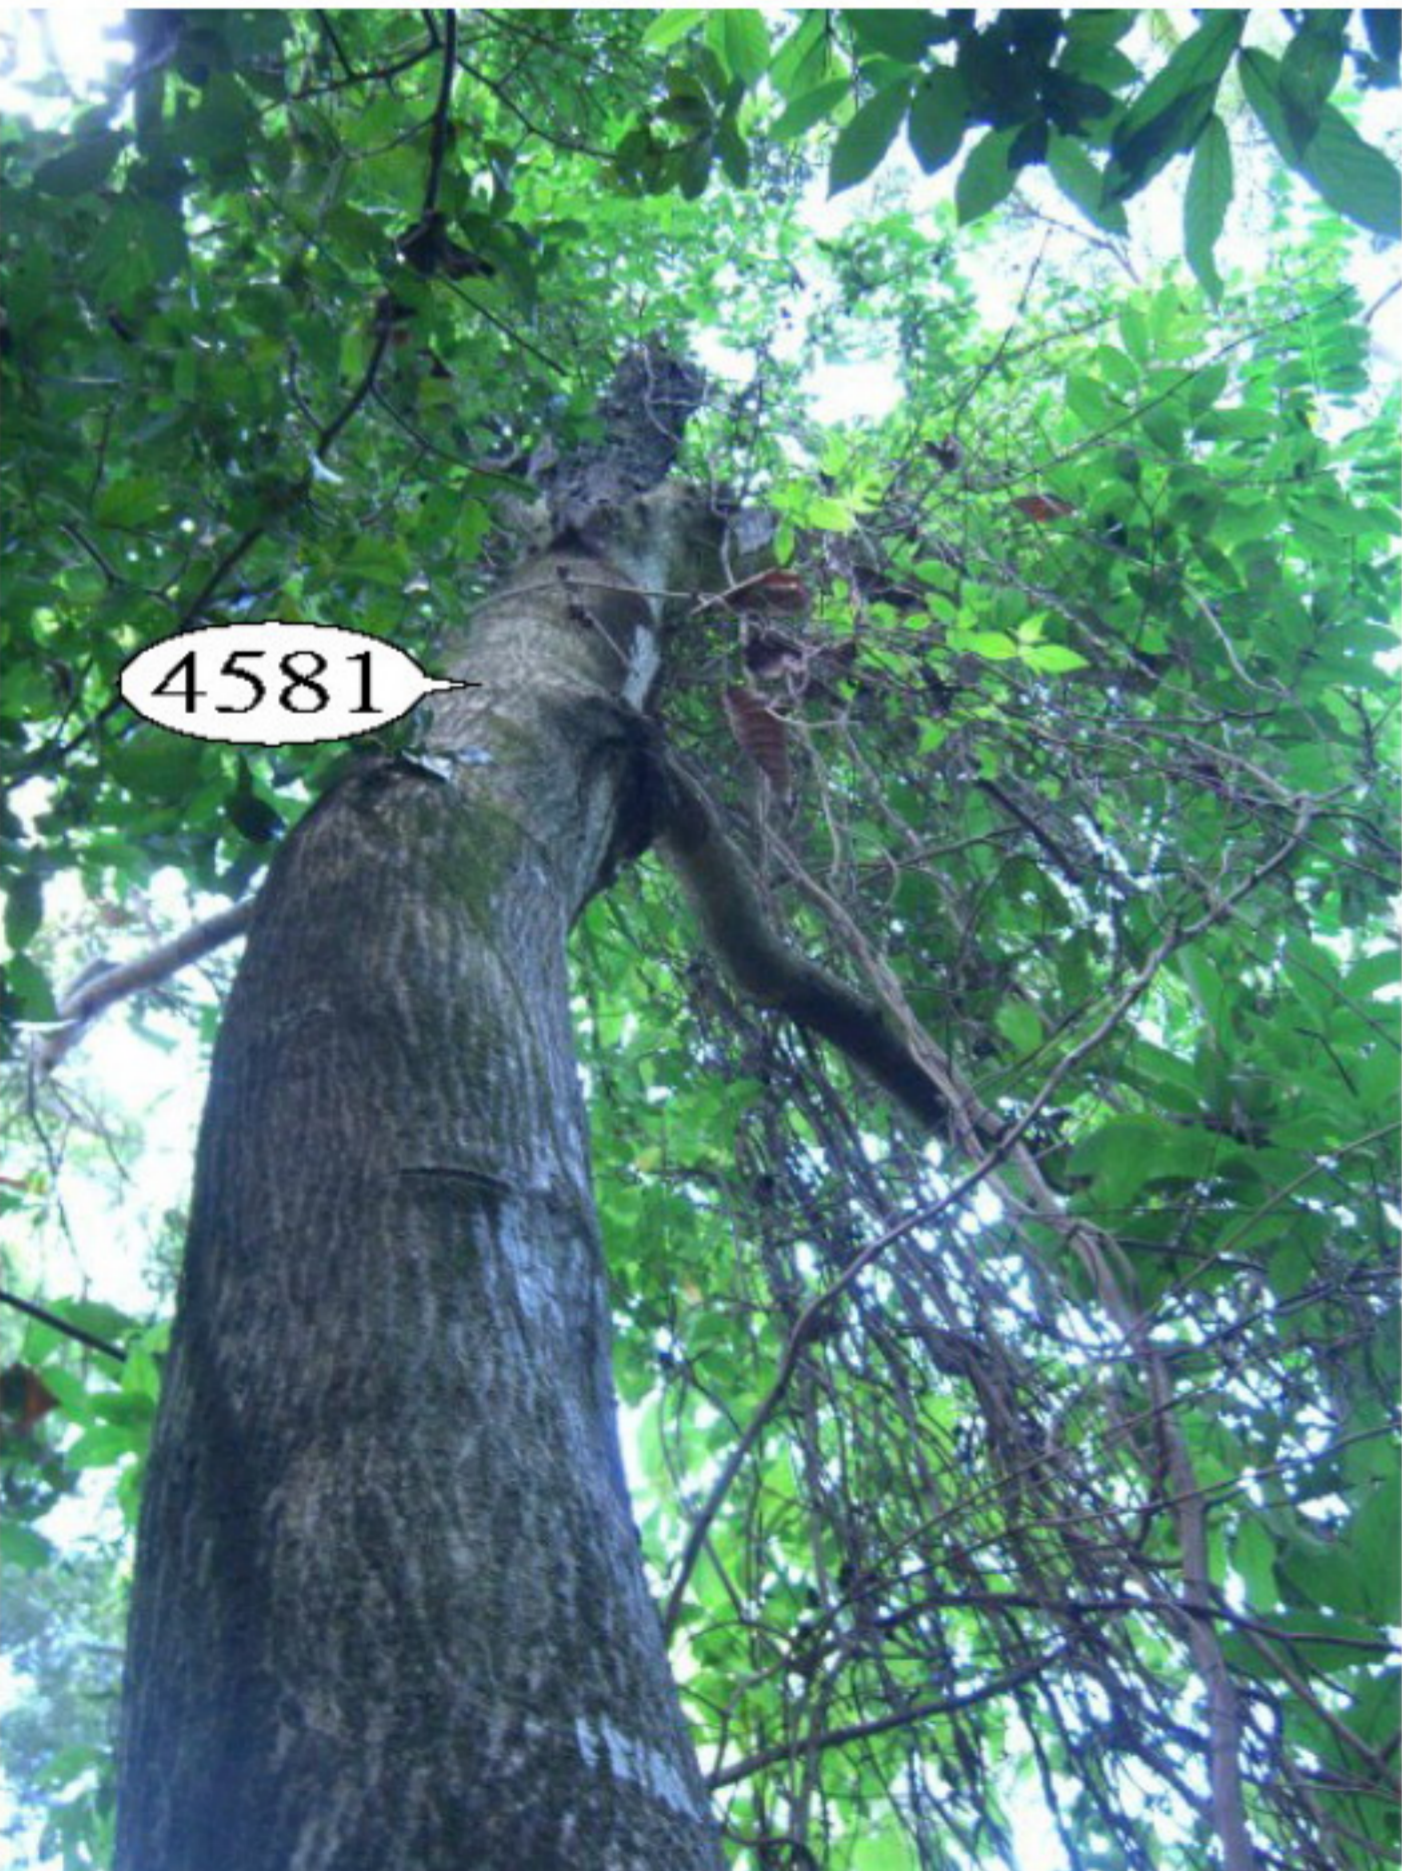
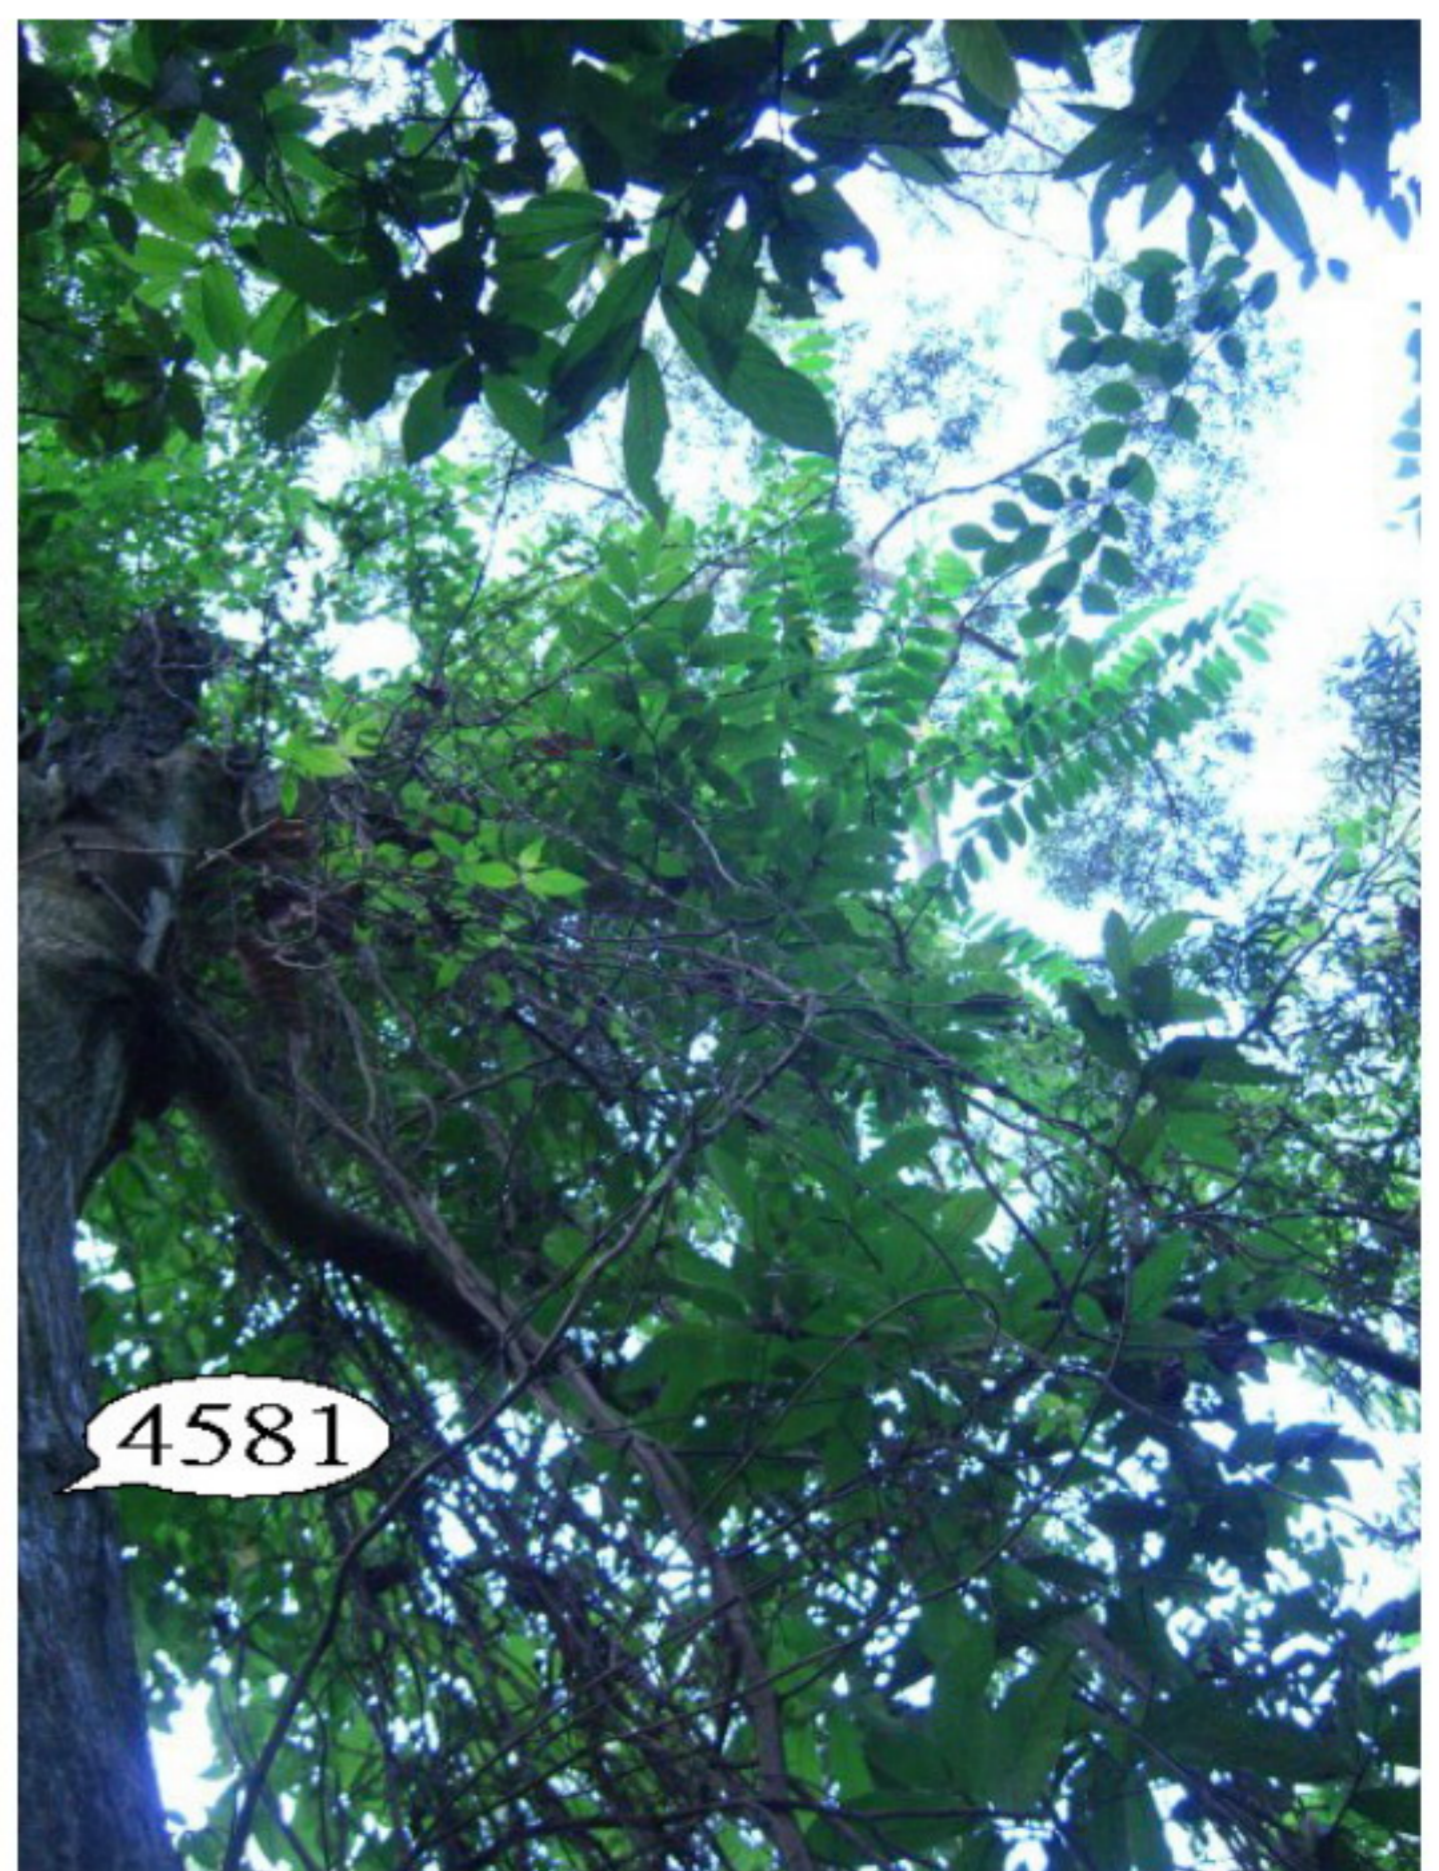
Tree 4579

Poor form which lead to low amenity value. Besides, the tree is unbalance. It may need heavy pruning after transplanted that will affect its transplanted survival rate. Moreover, the operation of the transplanted for poor form tree is also difficult.

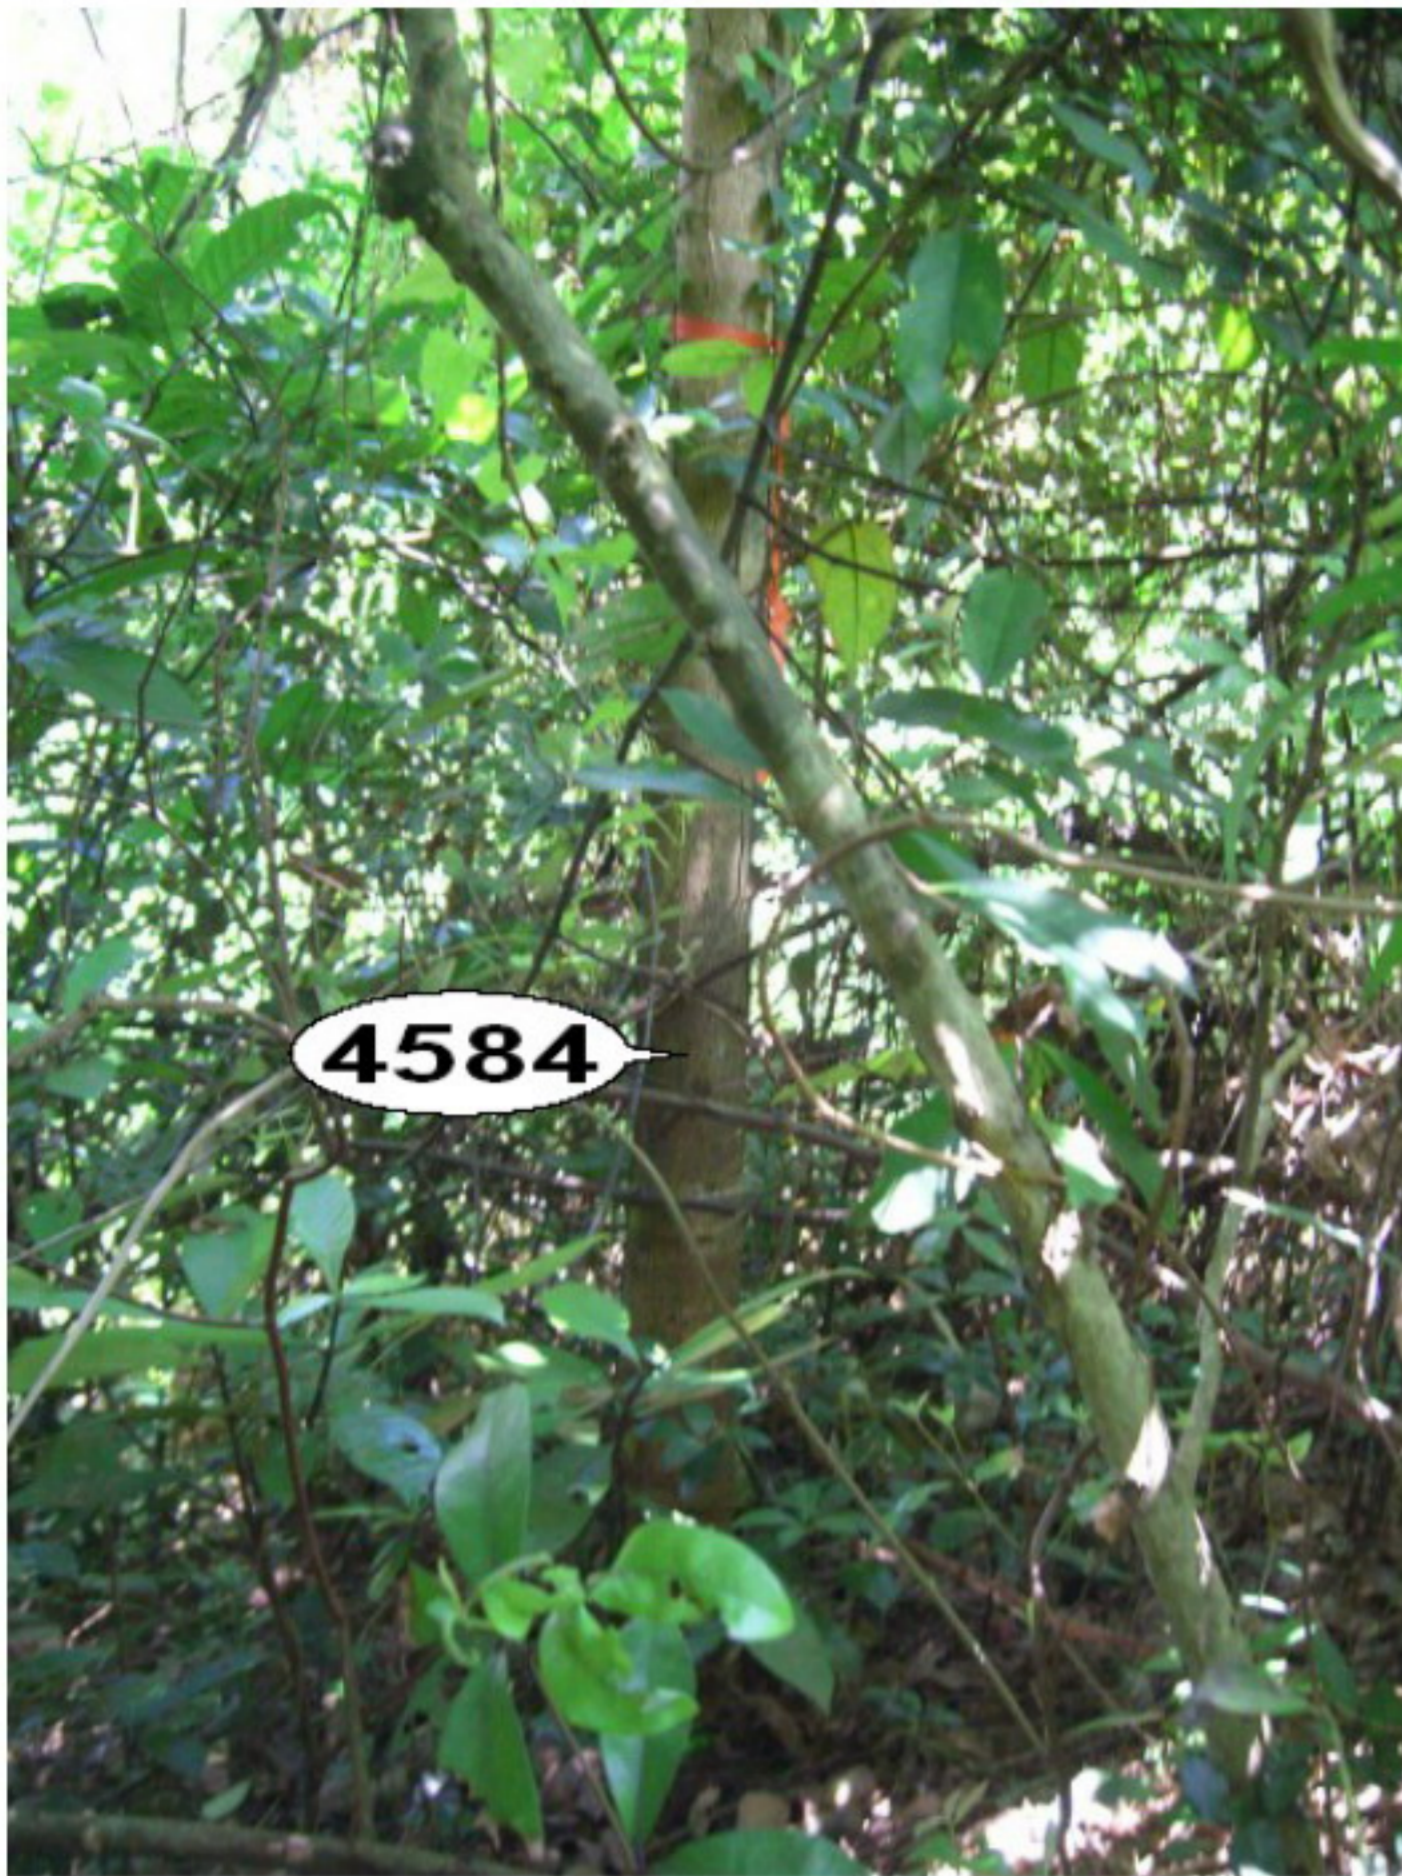
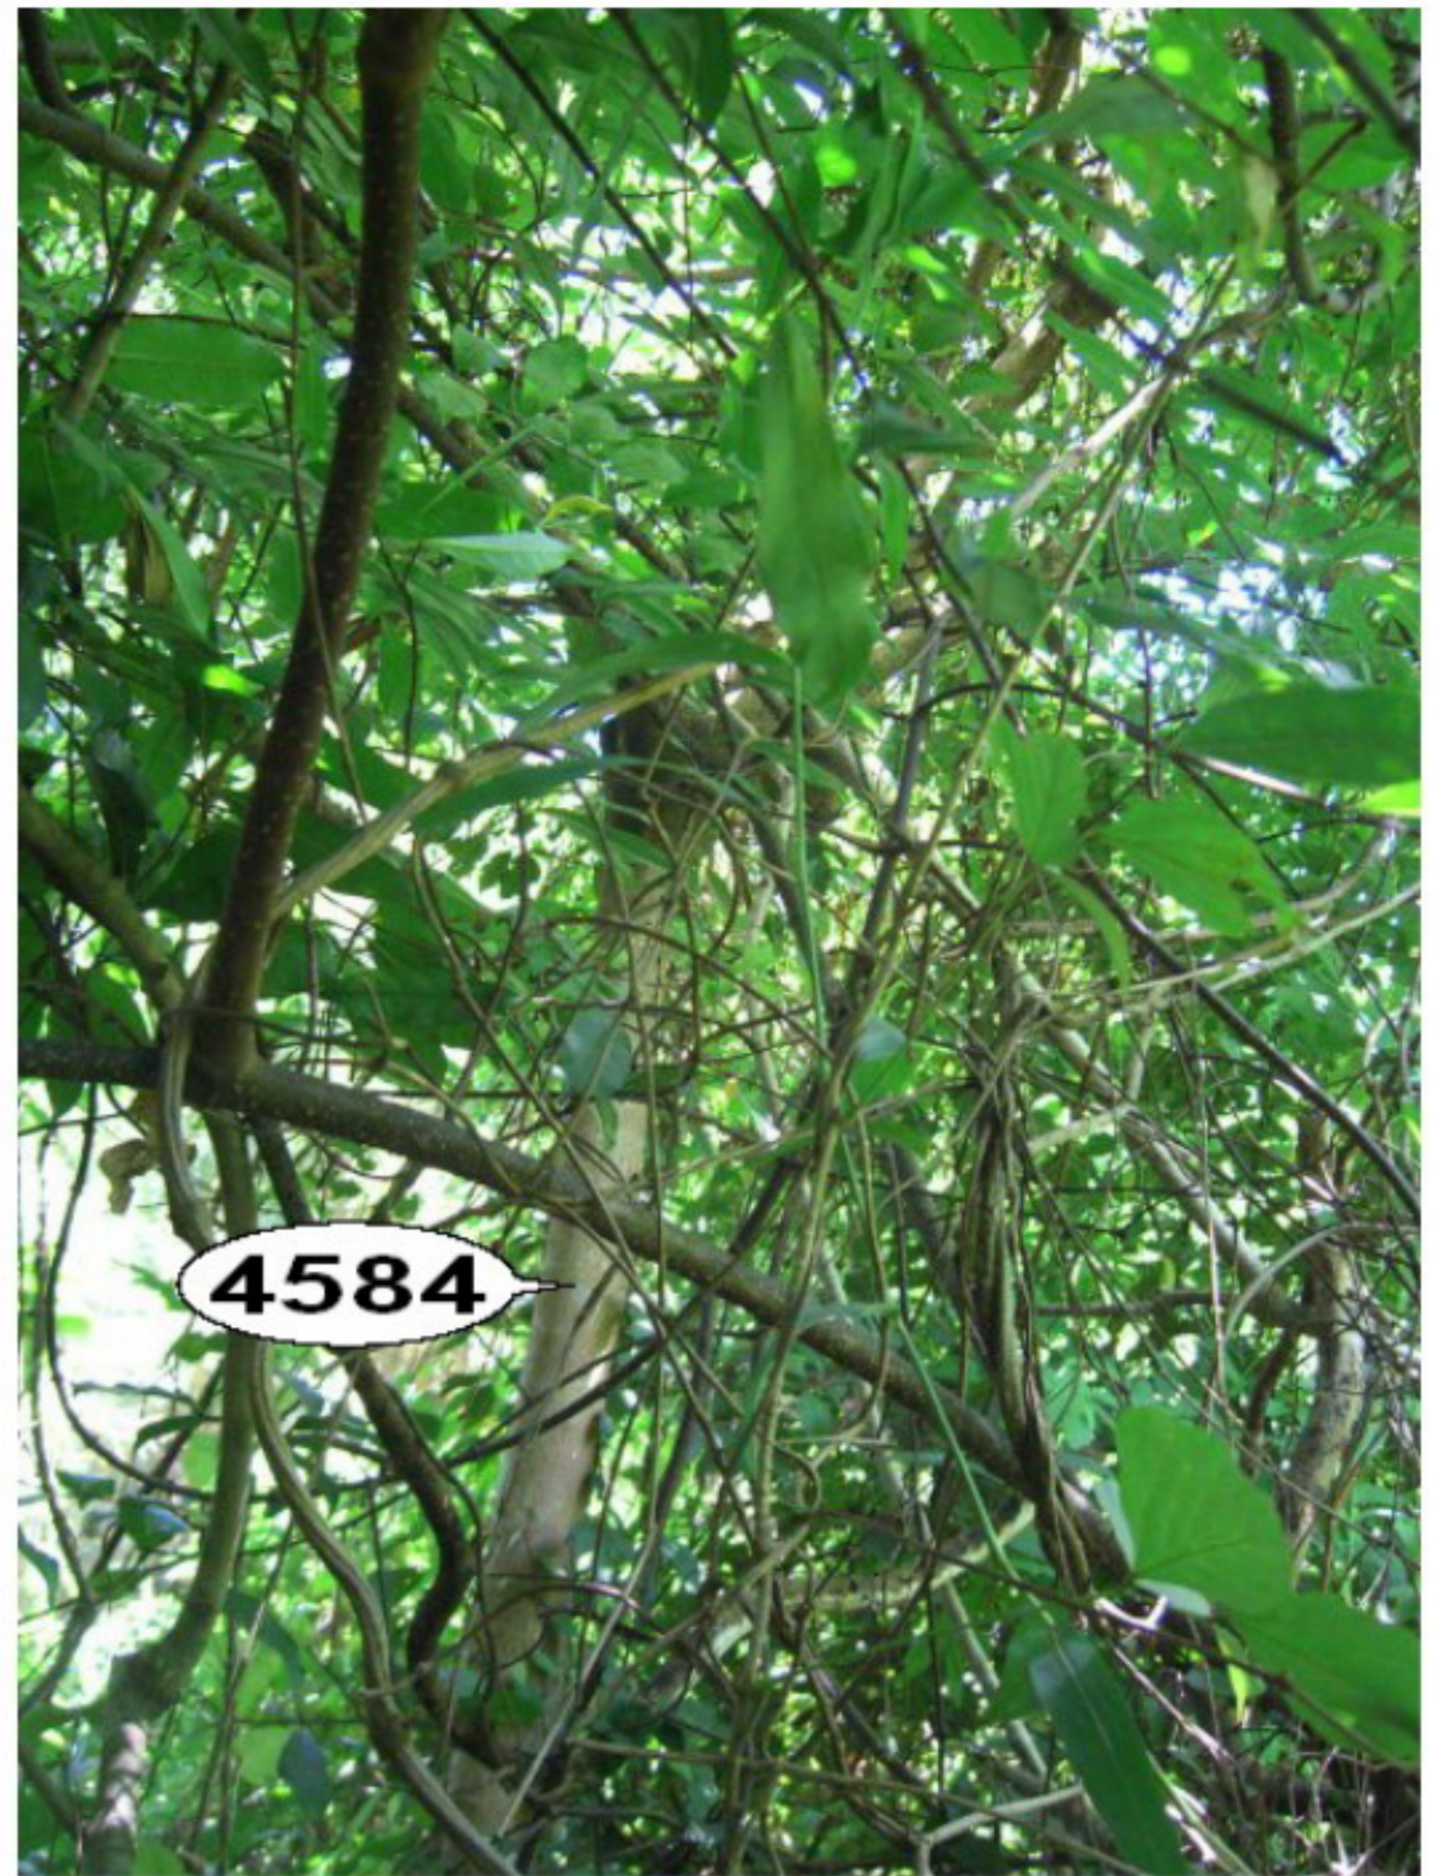
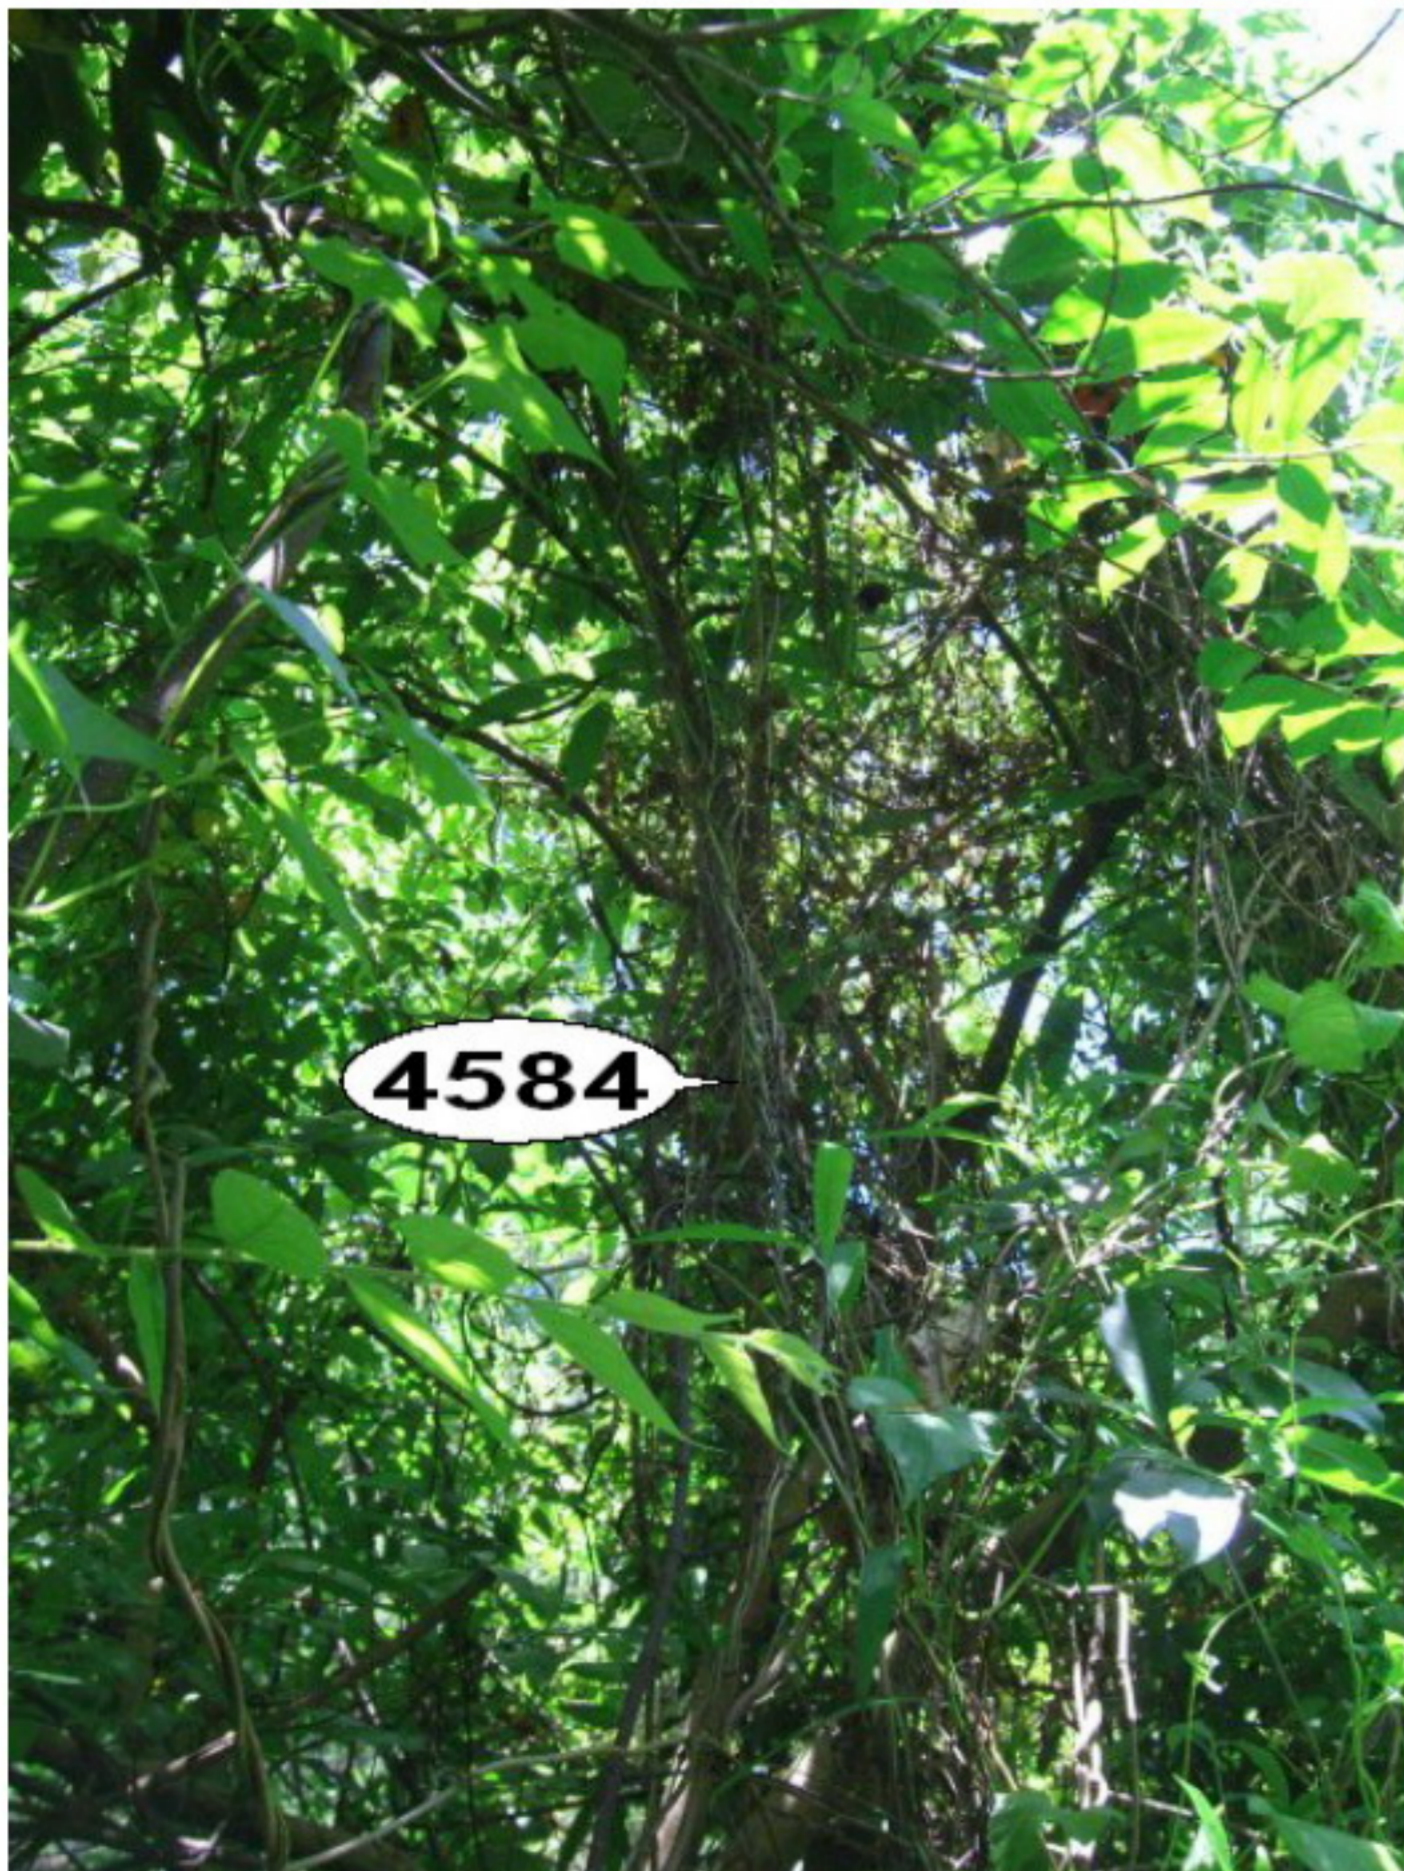
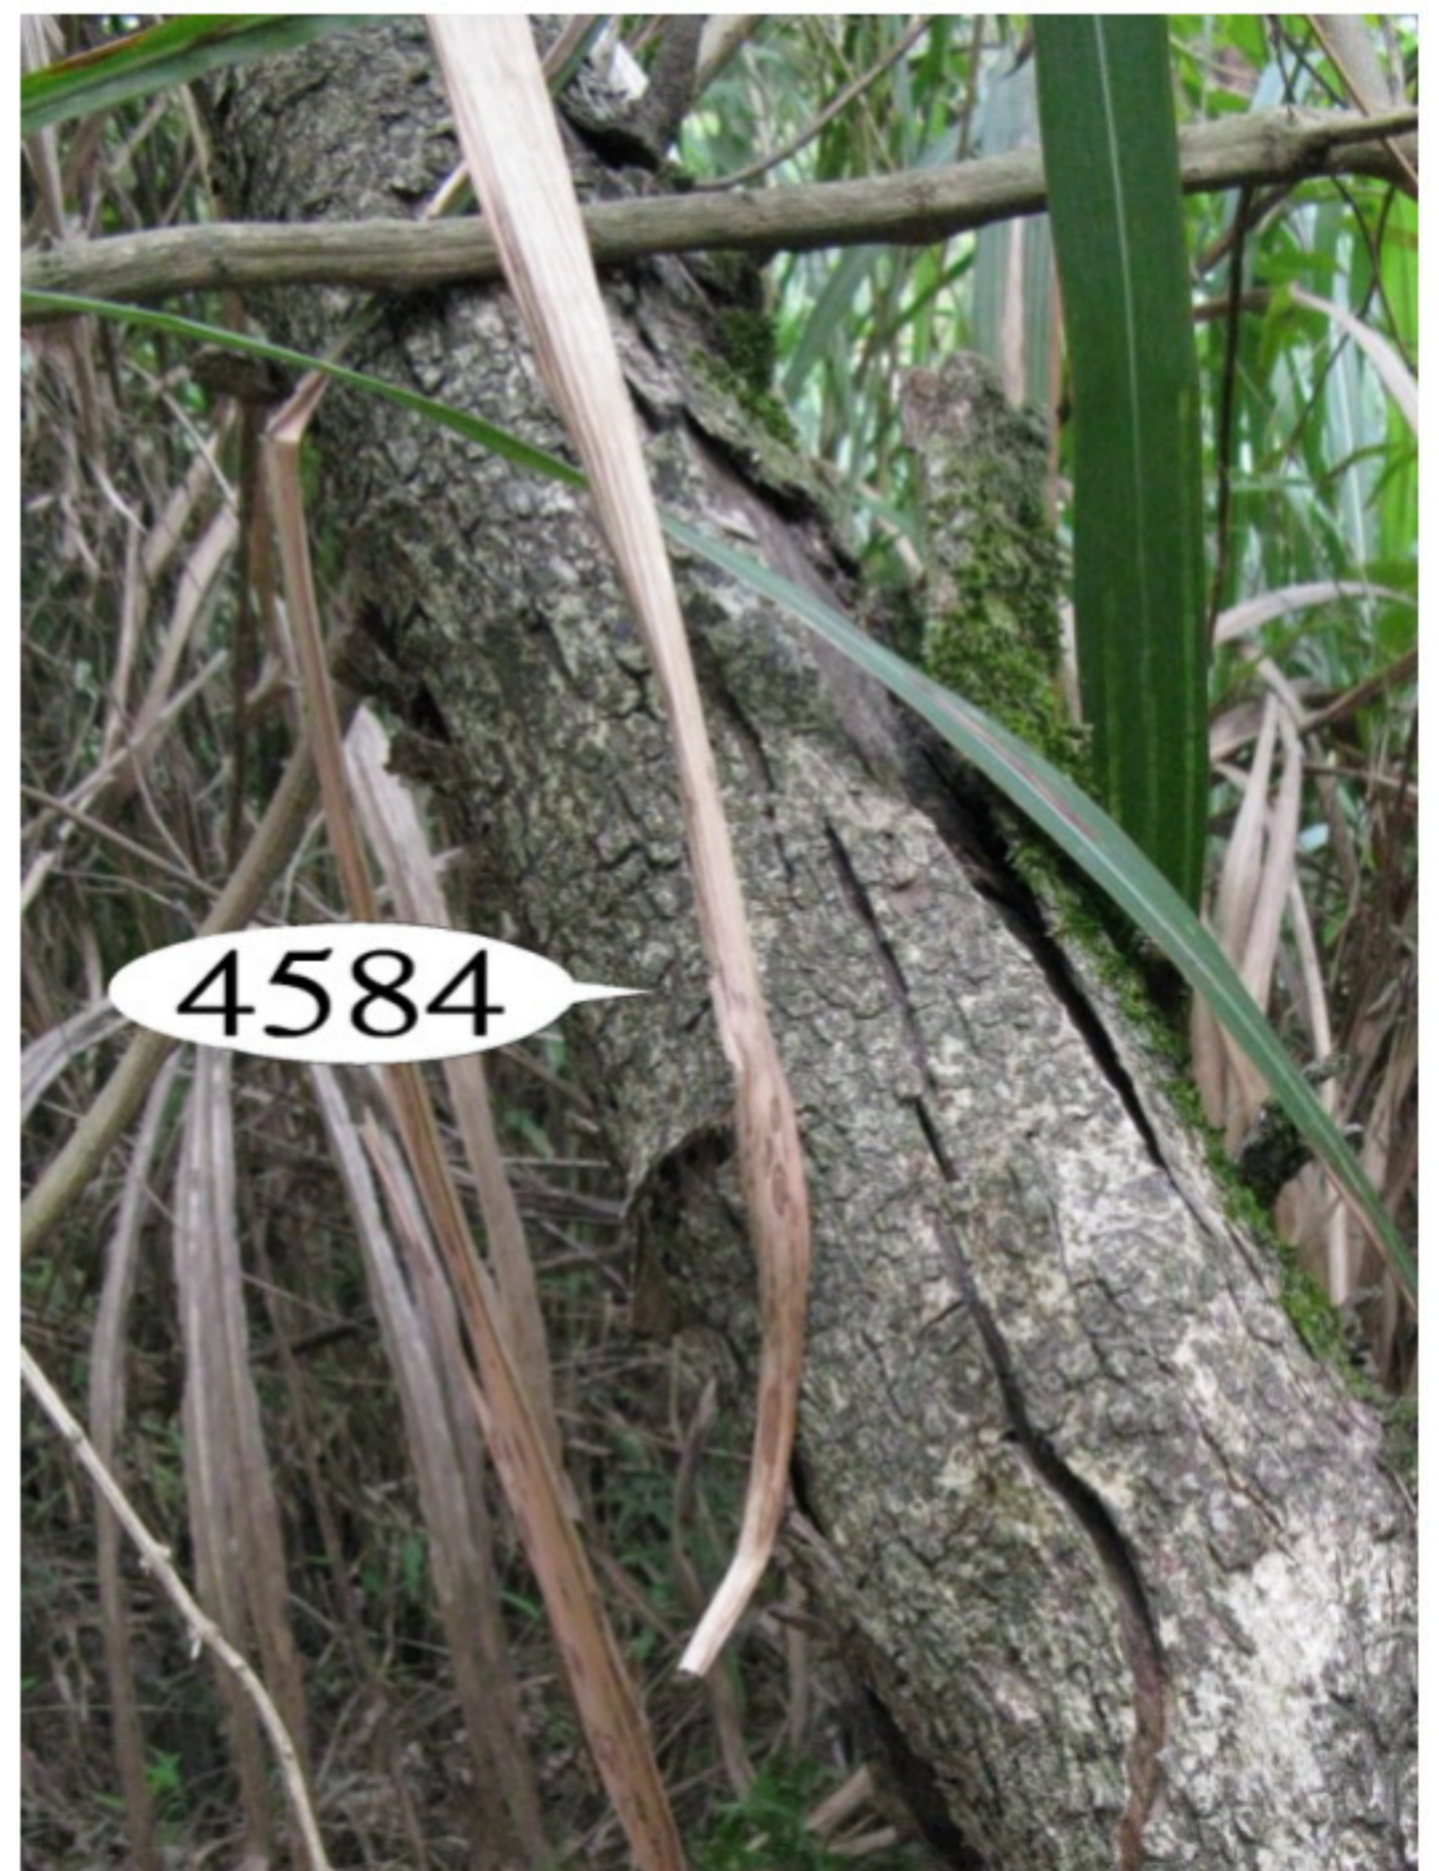
Tree 4581

Poor health will lead to low transplantation survival rate. Poor form which also lead to low amenity value. Besides, the tree is unbalance. It may need heavy pruning after transplantation that will affect its transplantation survival rate. Moreover, the operation of the transplantation for poor form tree is also difficult.
