# Provision of Cremators at Wo Hop Shek Crematorium

Tree Survey Report

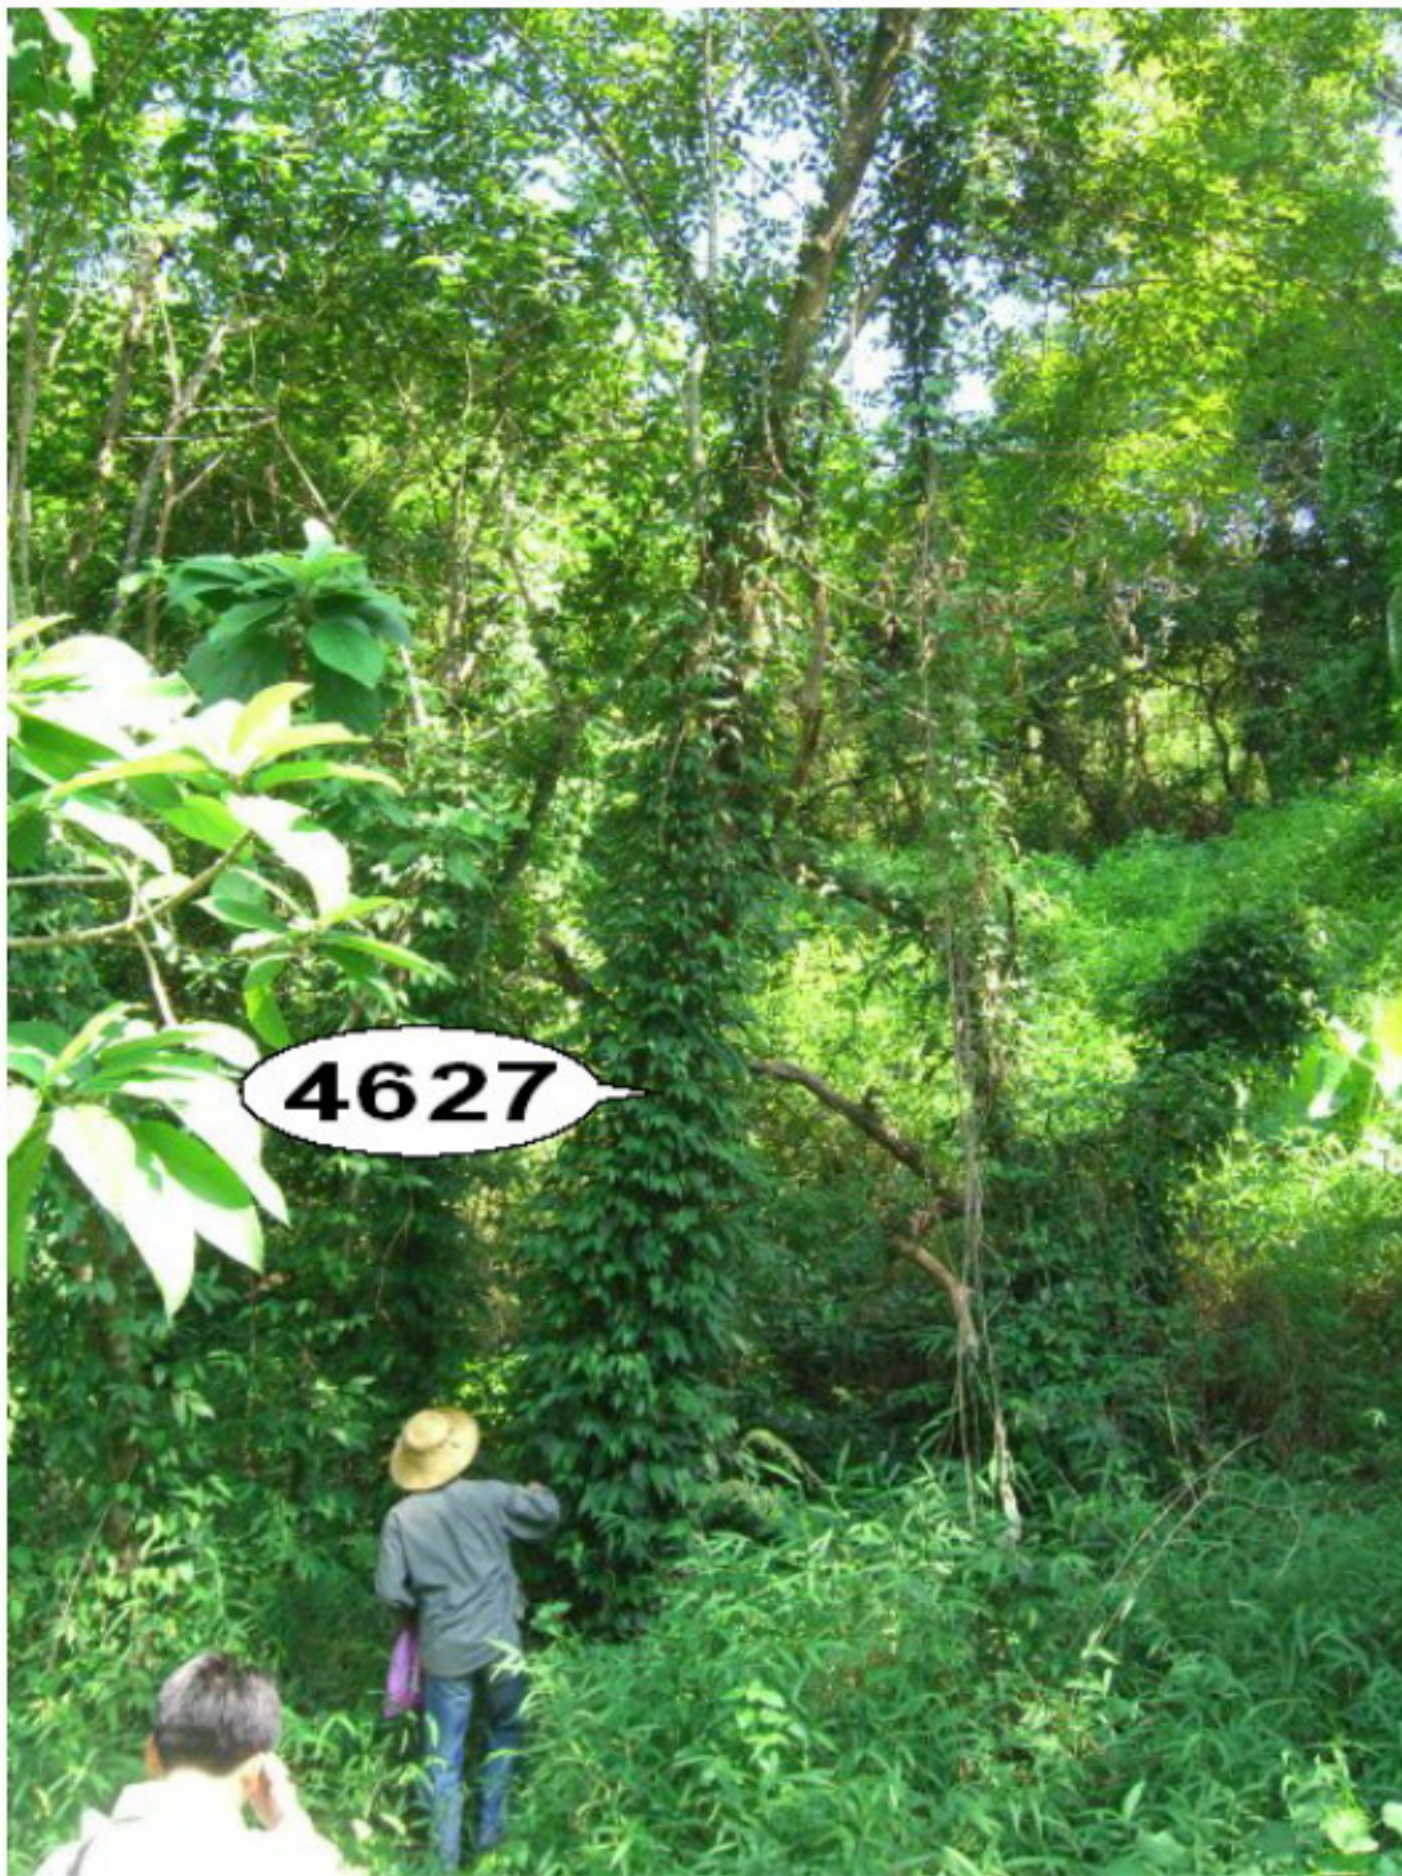
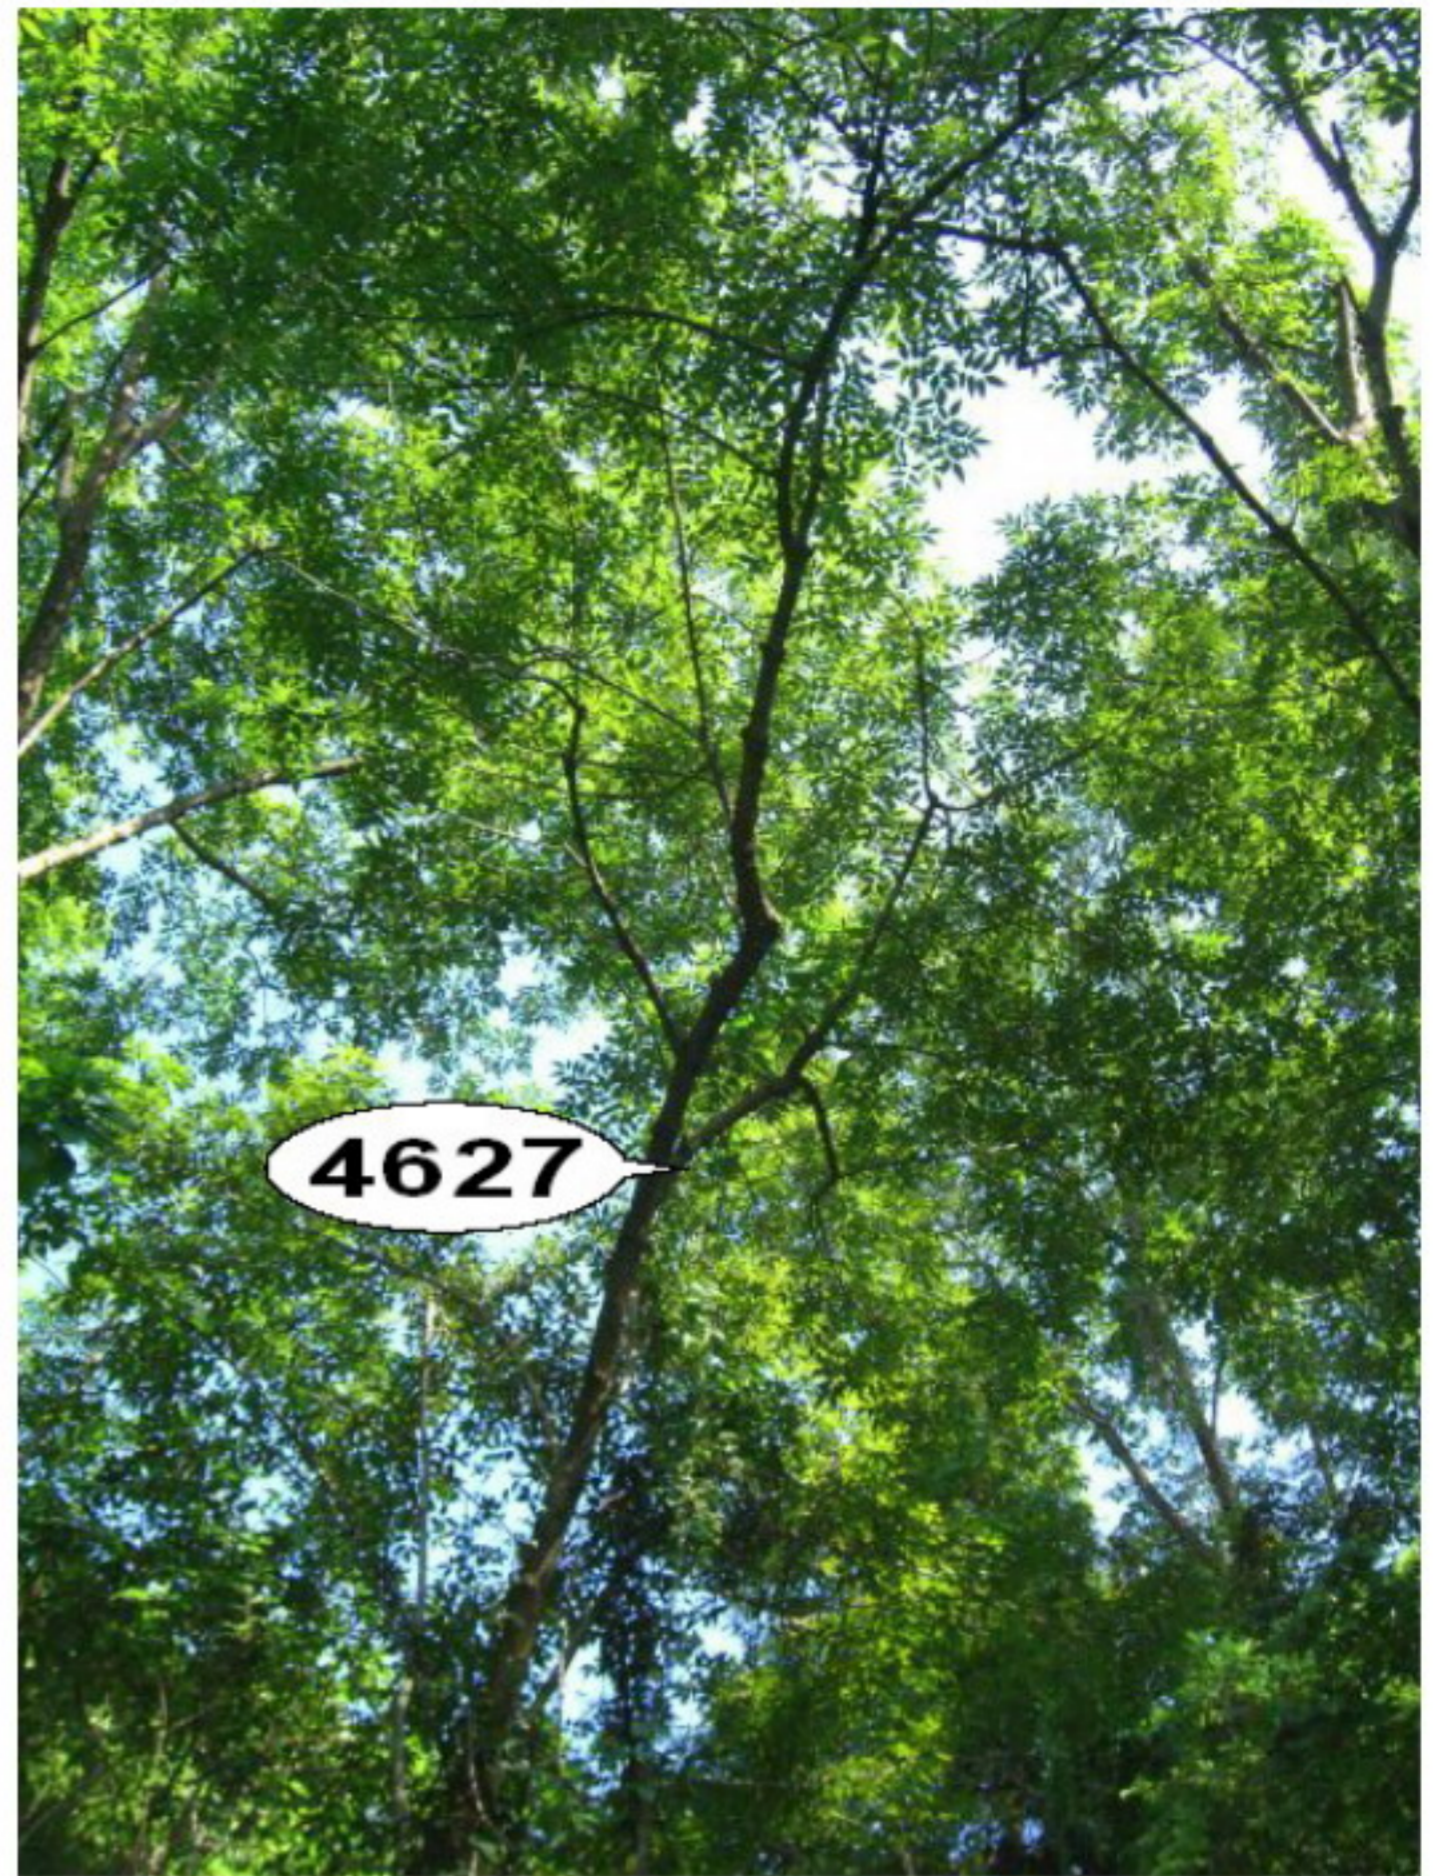
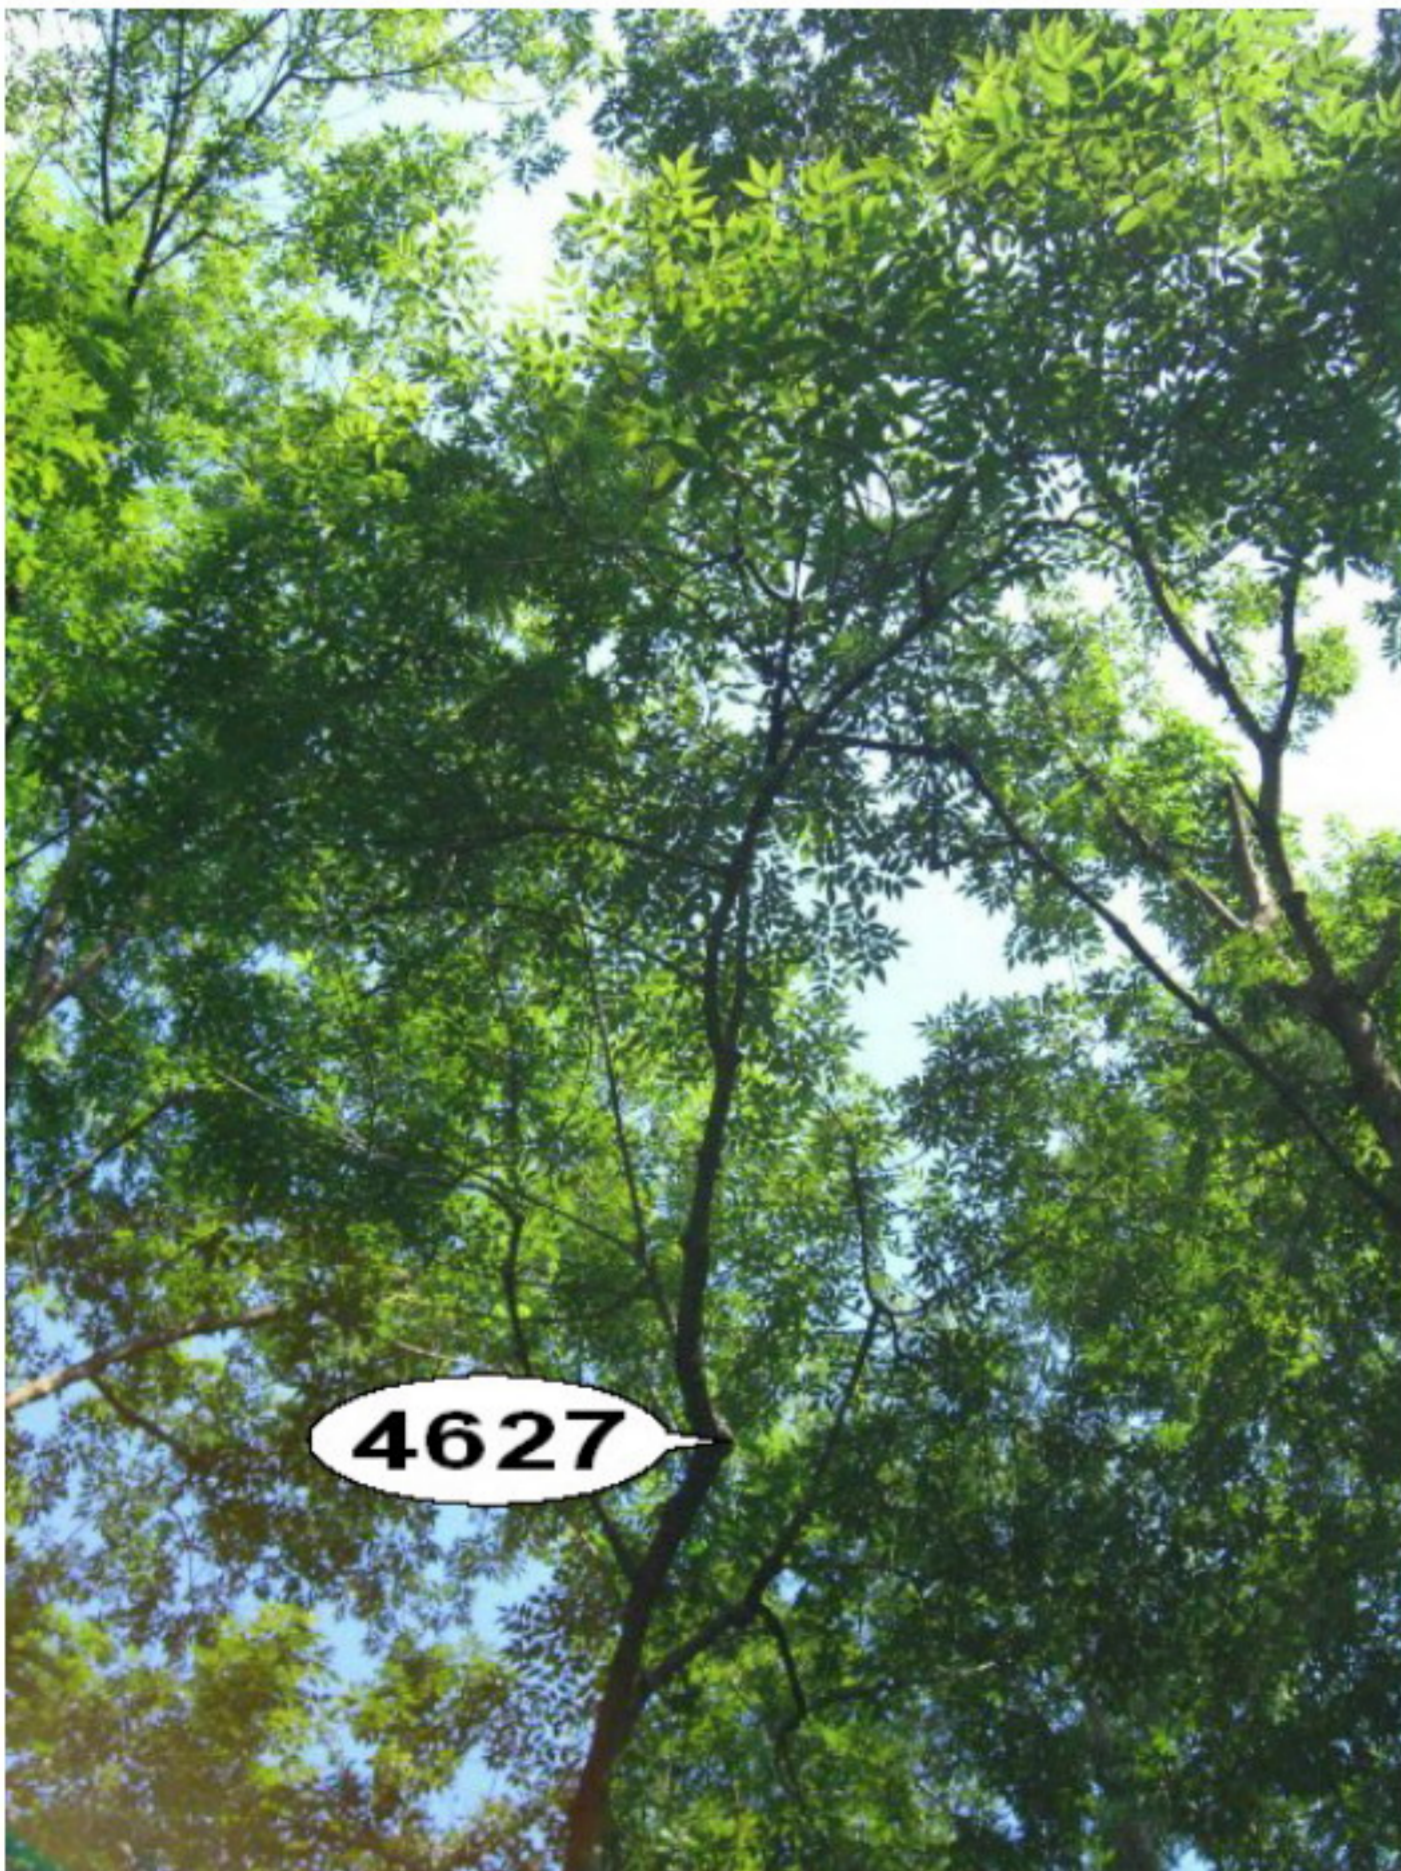
Tree 4584  
Poor health will lead to low transplantation survival rate.

4583	石栗	0.89	0.28	8	4	M	M	M	L	N	Bending truck, Crown fuse with other tree	T	--
4584	假蘋婆	0.34	0.11	4	4	P	M	L	L	T	Heavy vines, Branch decay	F	Poor health indicated by heavy vines and branch decay : poor health will lead to low transplantation survival rate.

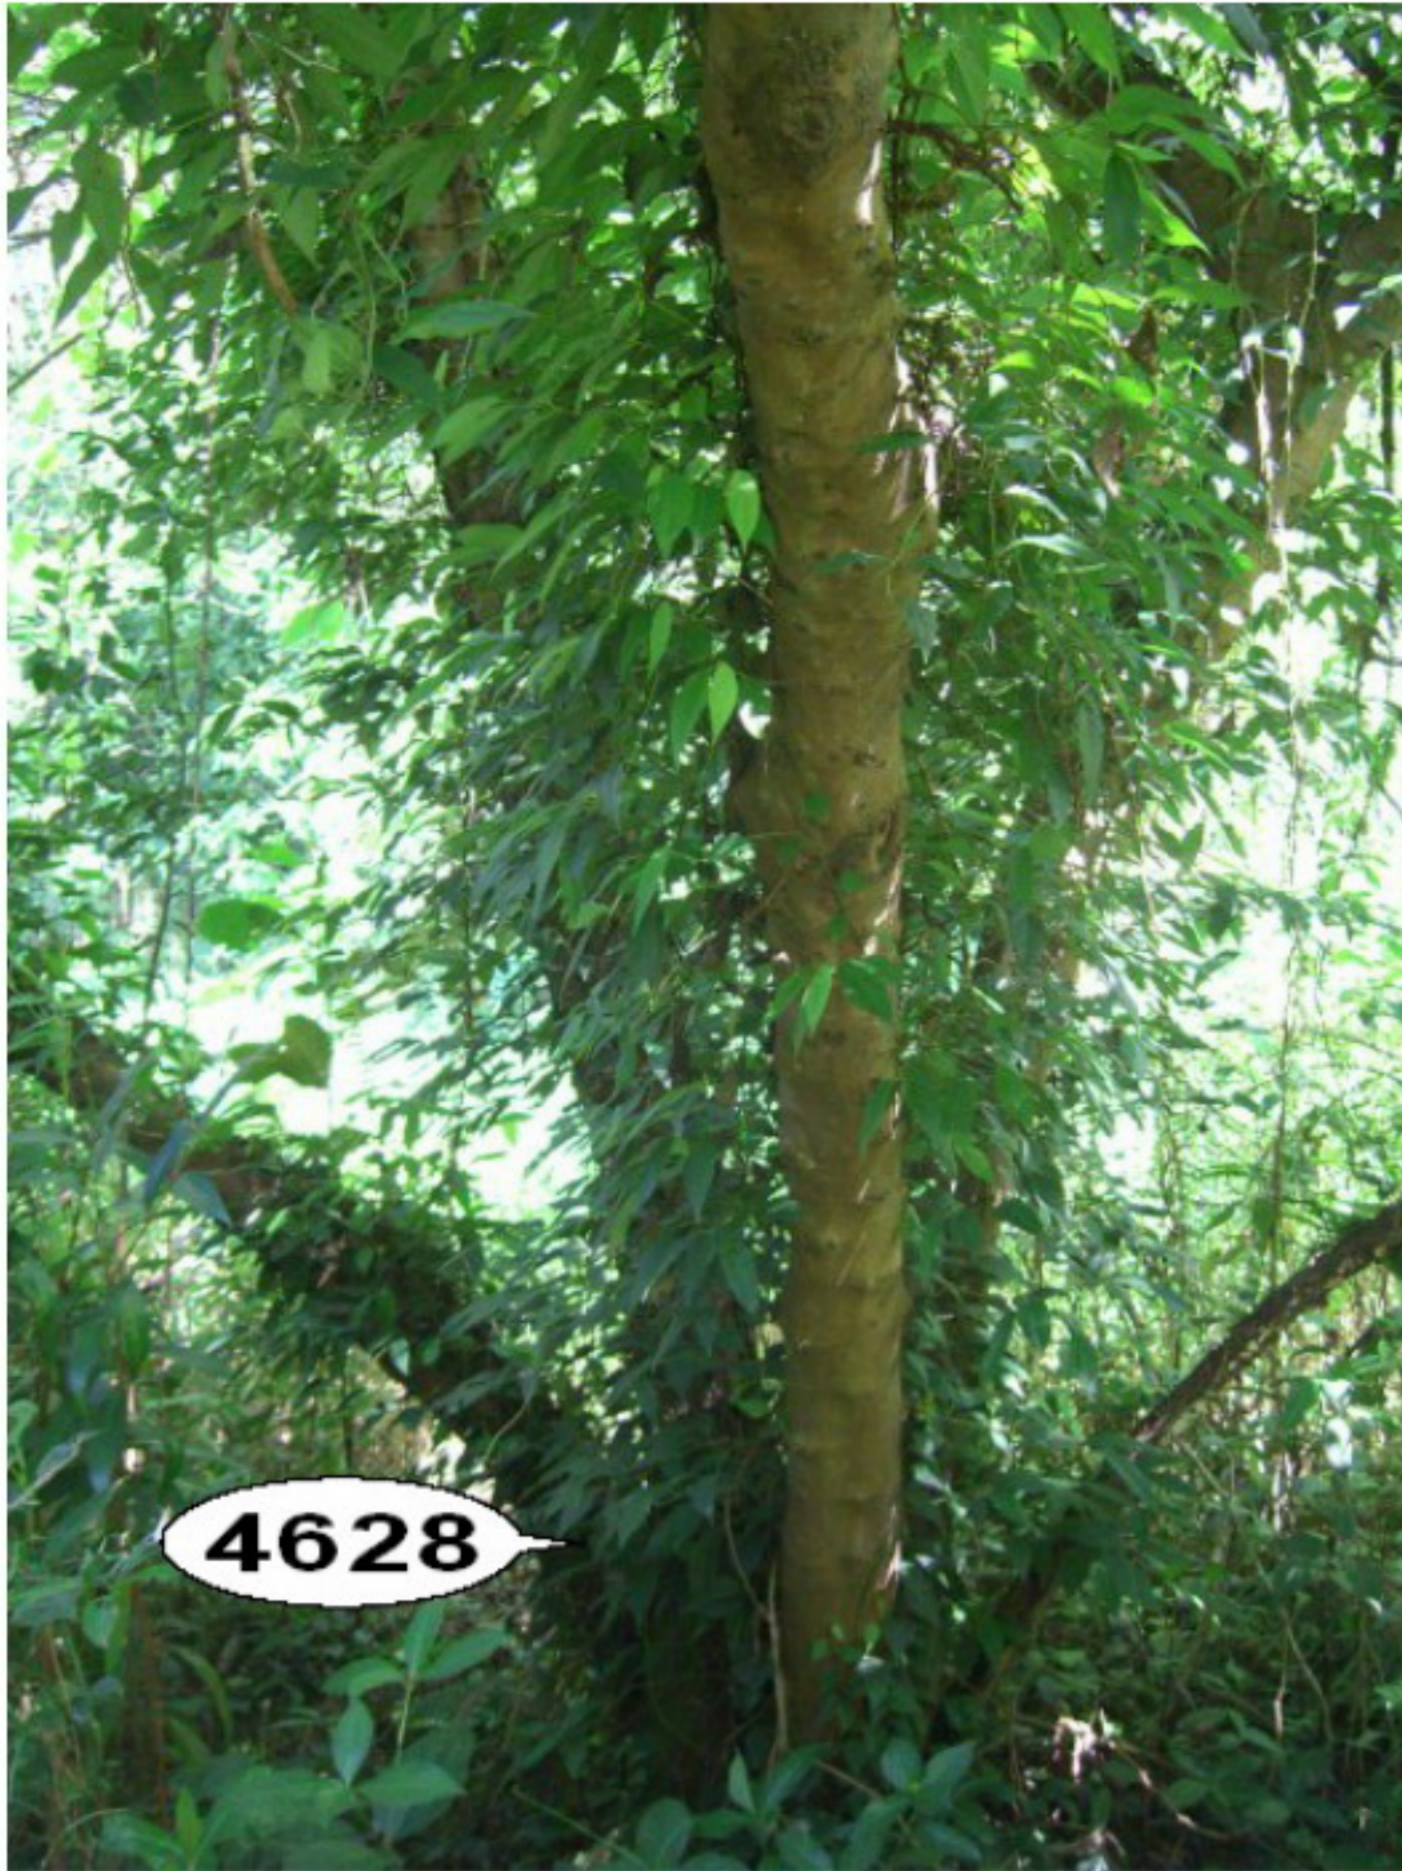
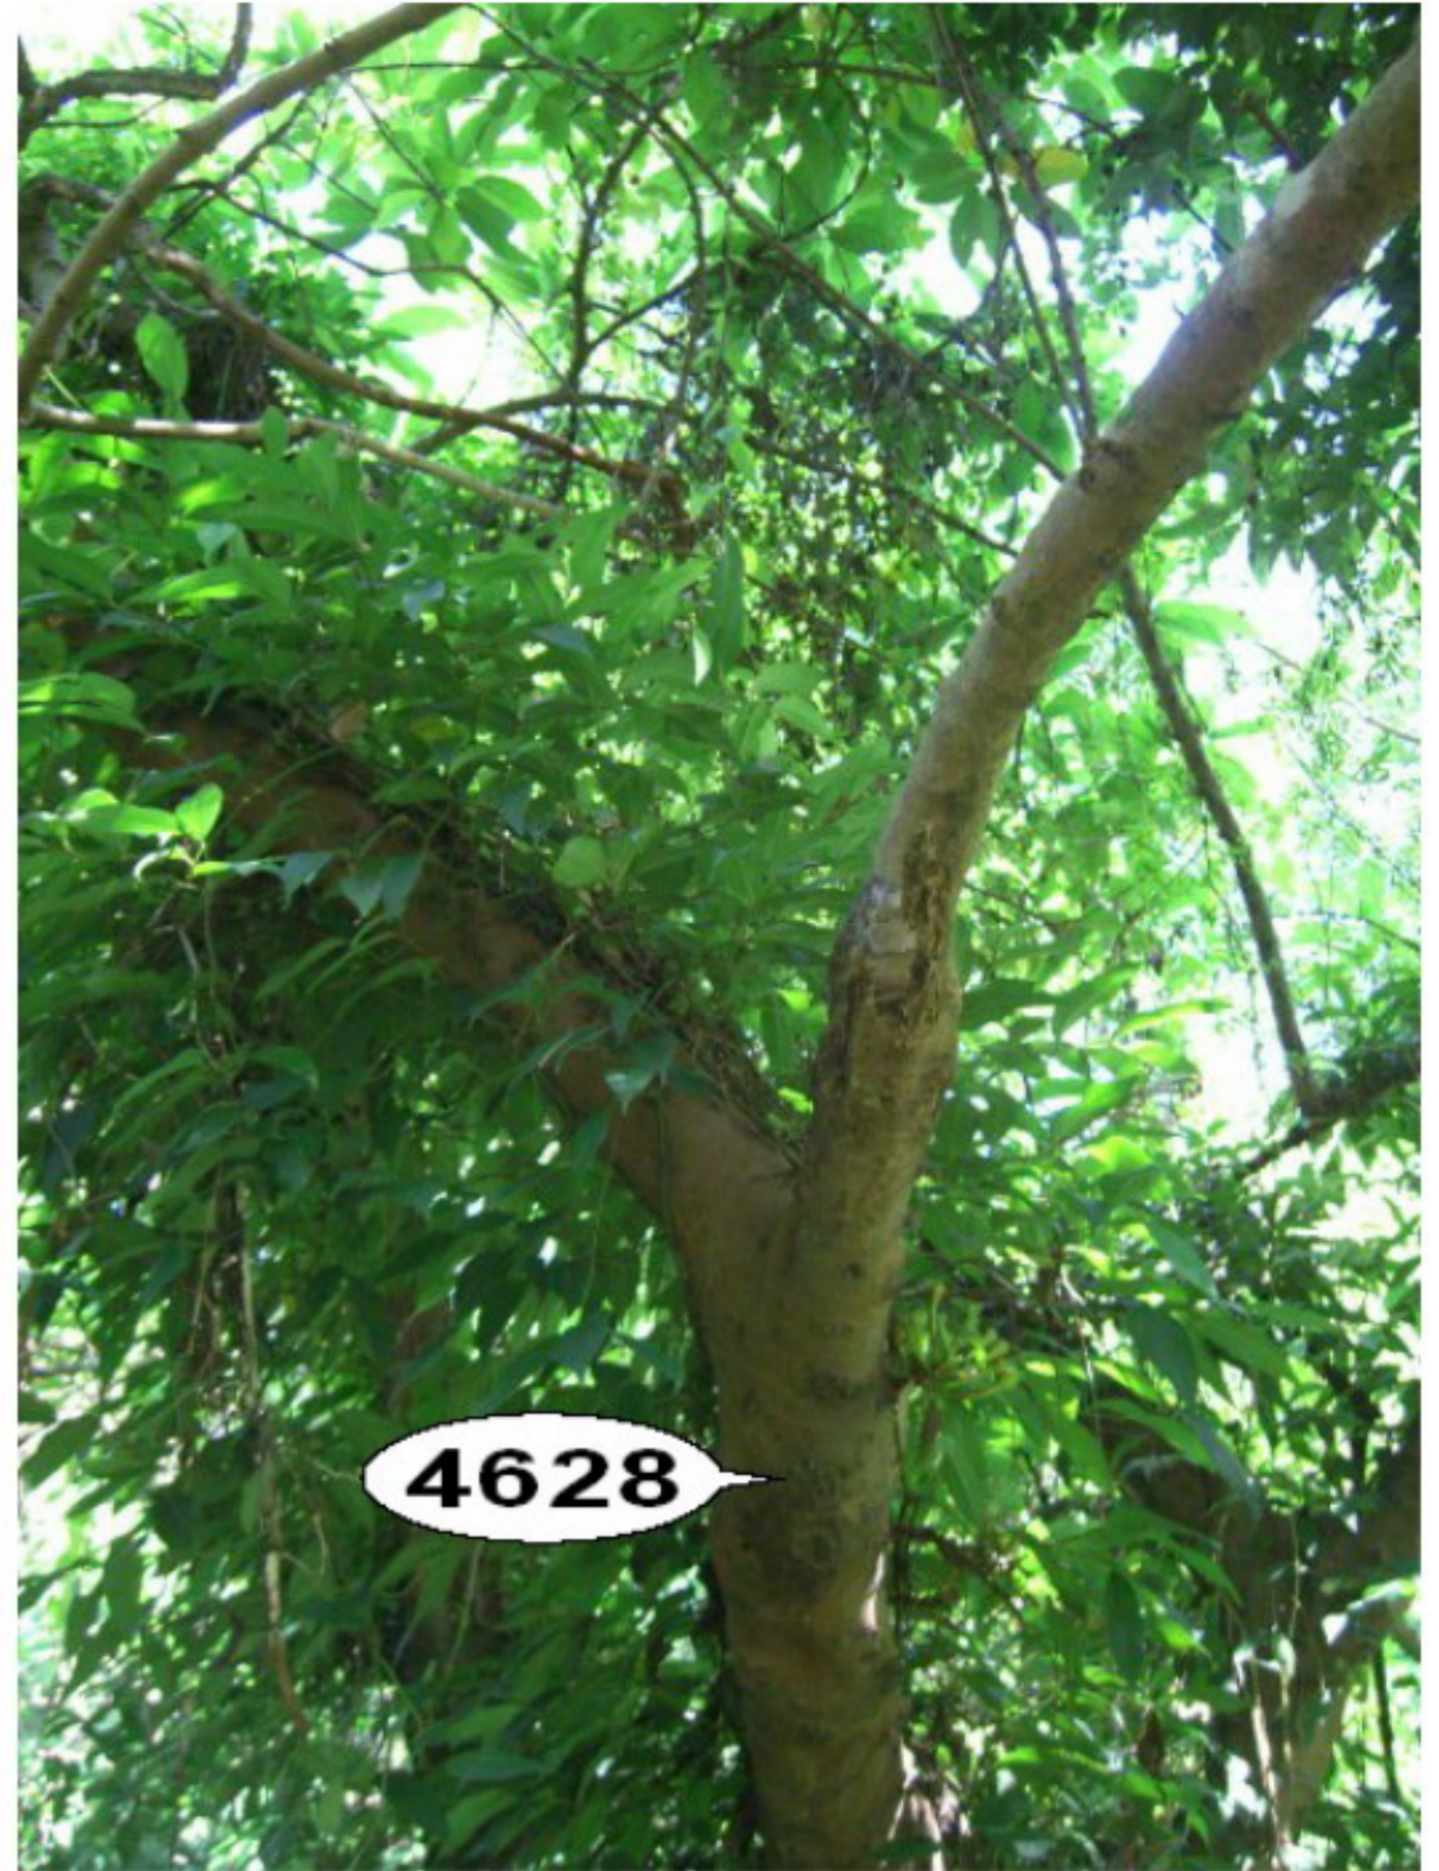
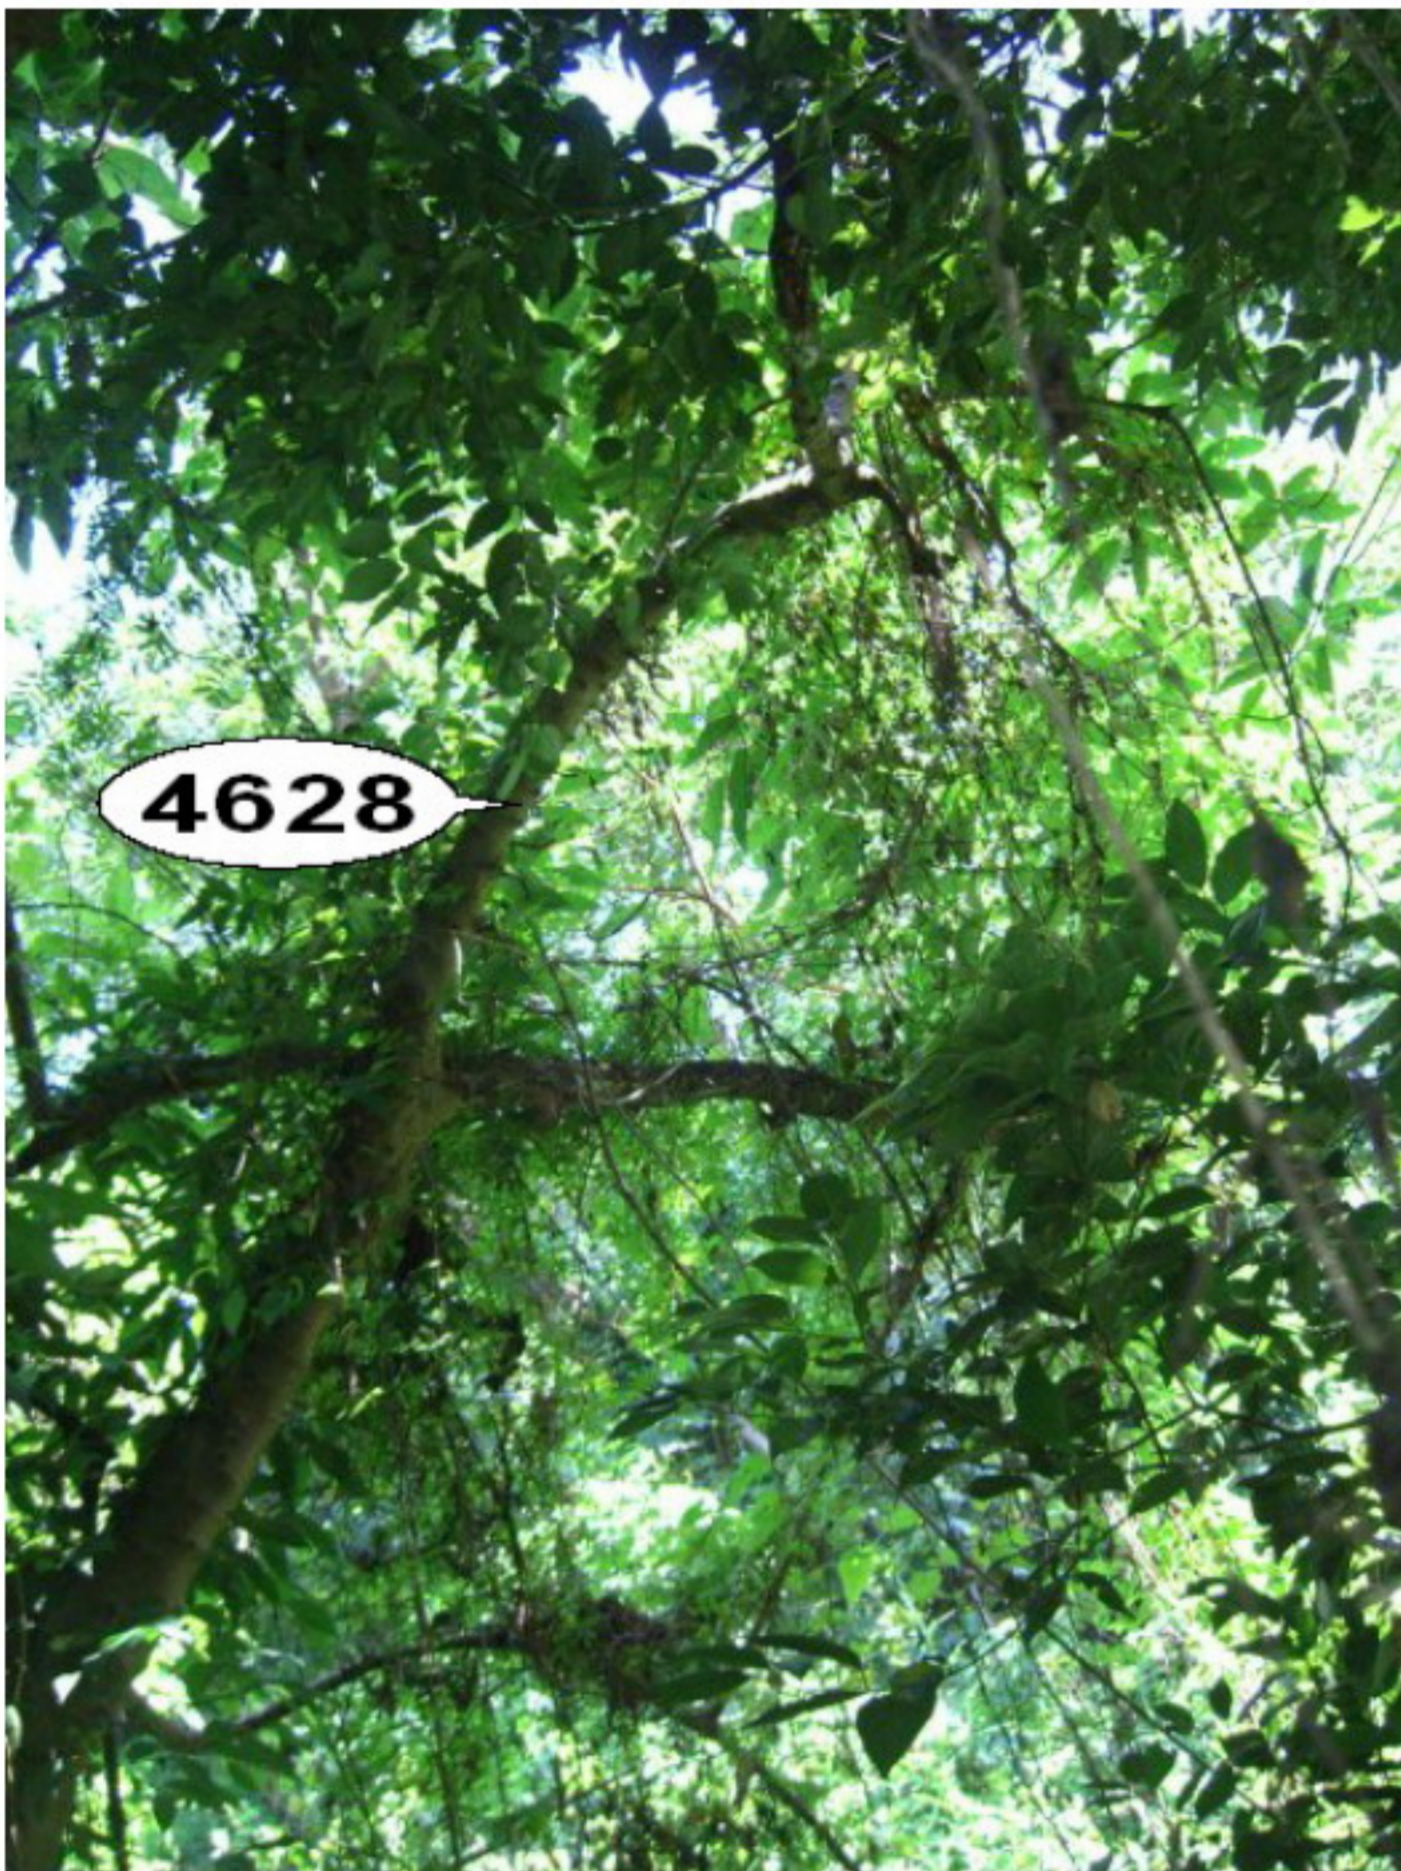
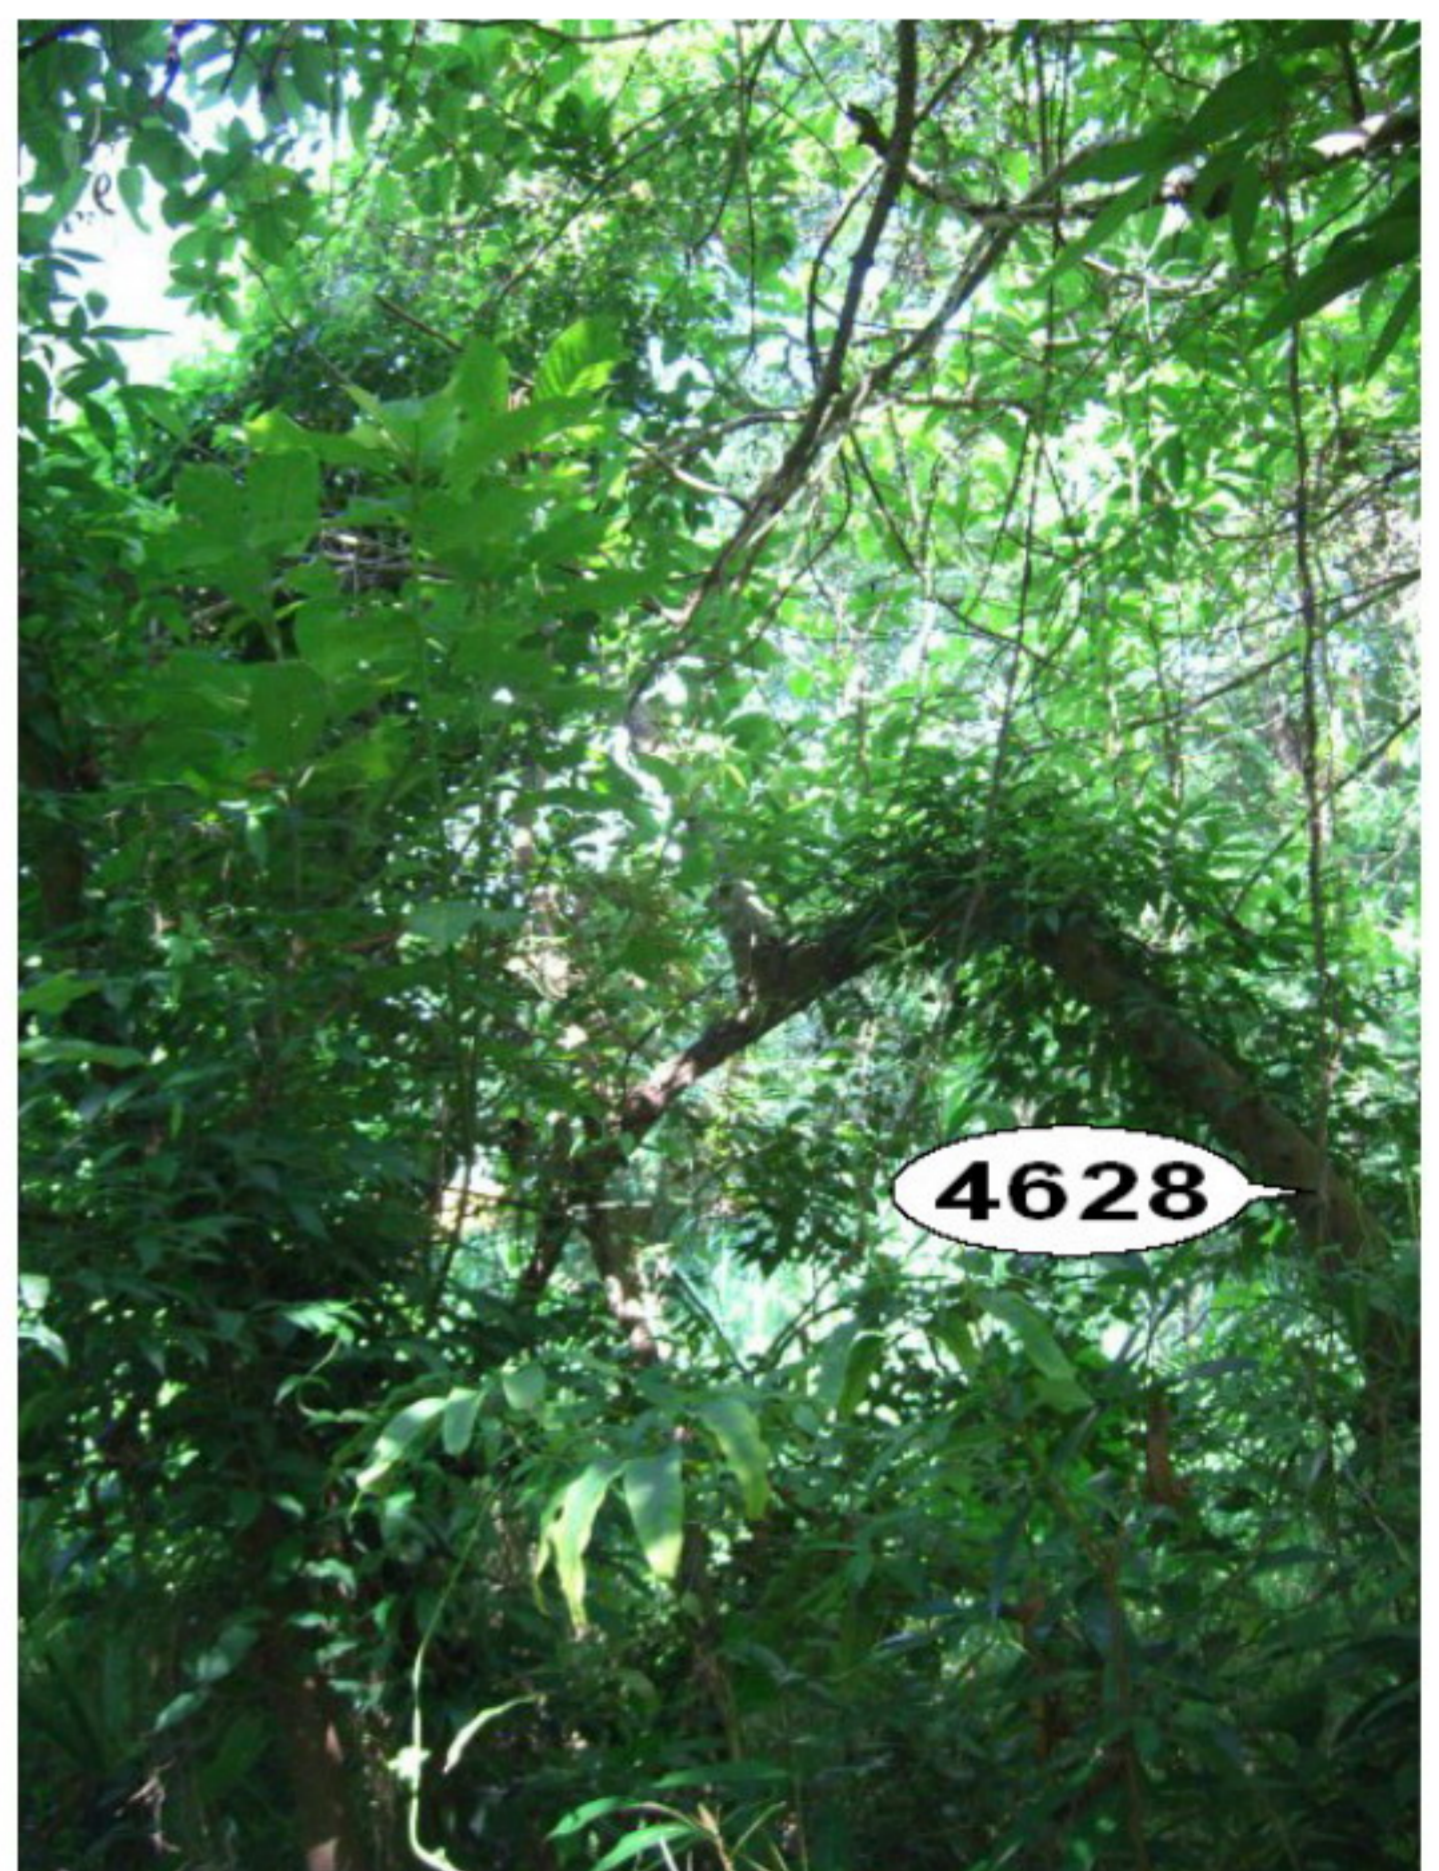
Tree 4627

Poor form which lead to low amenity value. Besides, the tree is unbalance. It may need heavy pruning after transplanted that will affect its transplanted survival rate. Moreover, the operation of the transplanted for poor form tree is also difficult.
