# Provision of Cremators at Wo Hop Shek Crematorium

Tree Survey Report

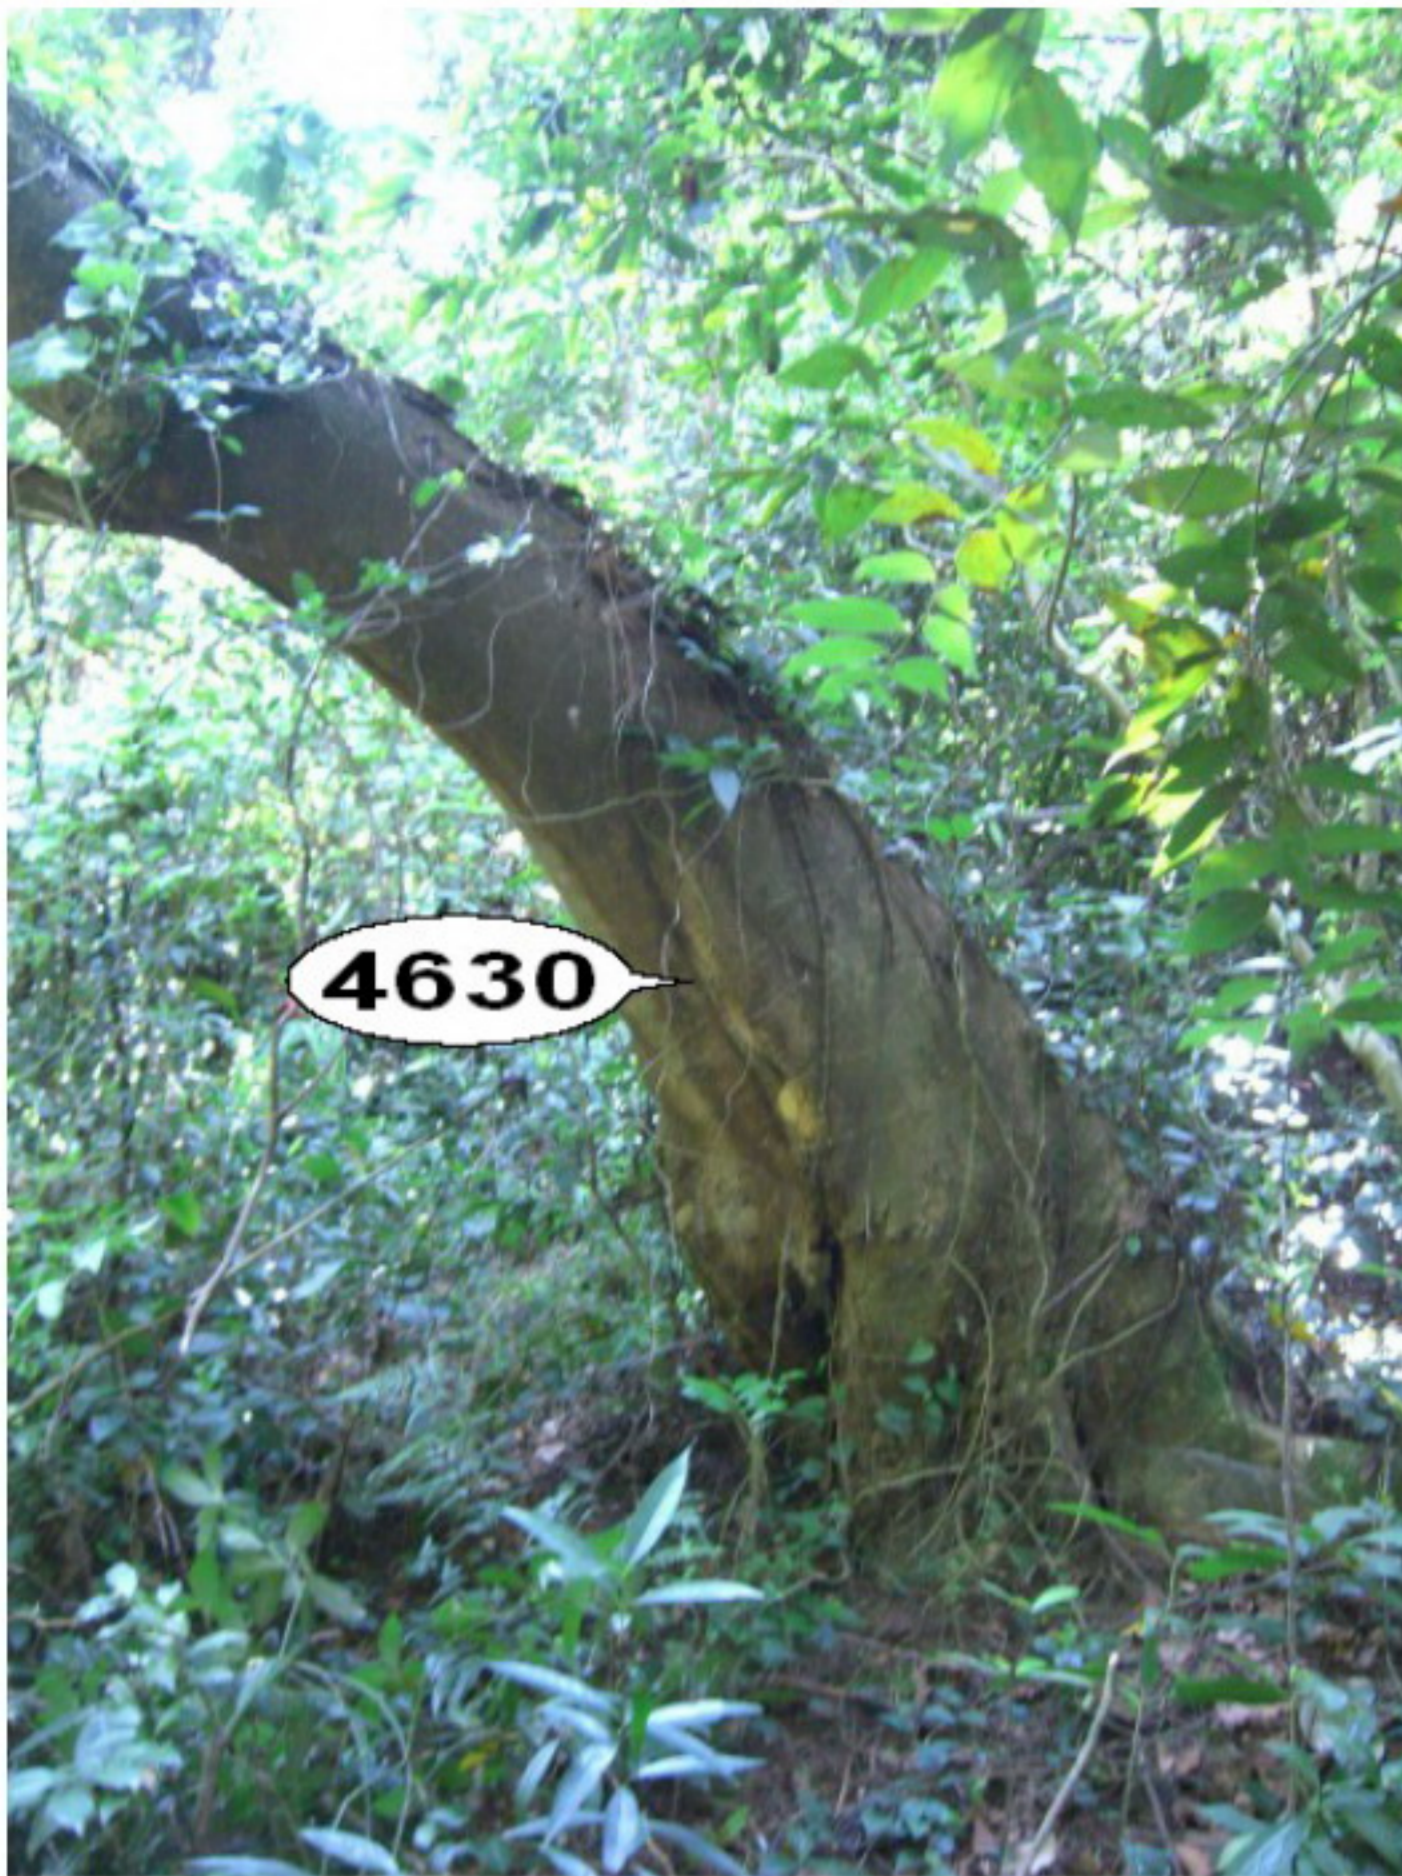
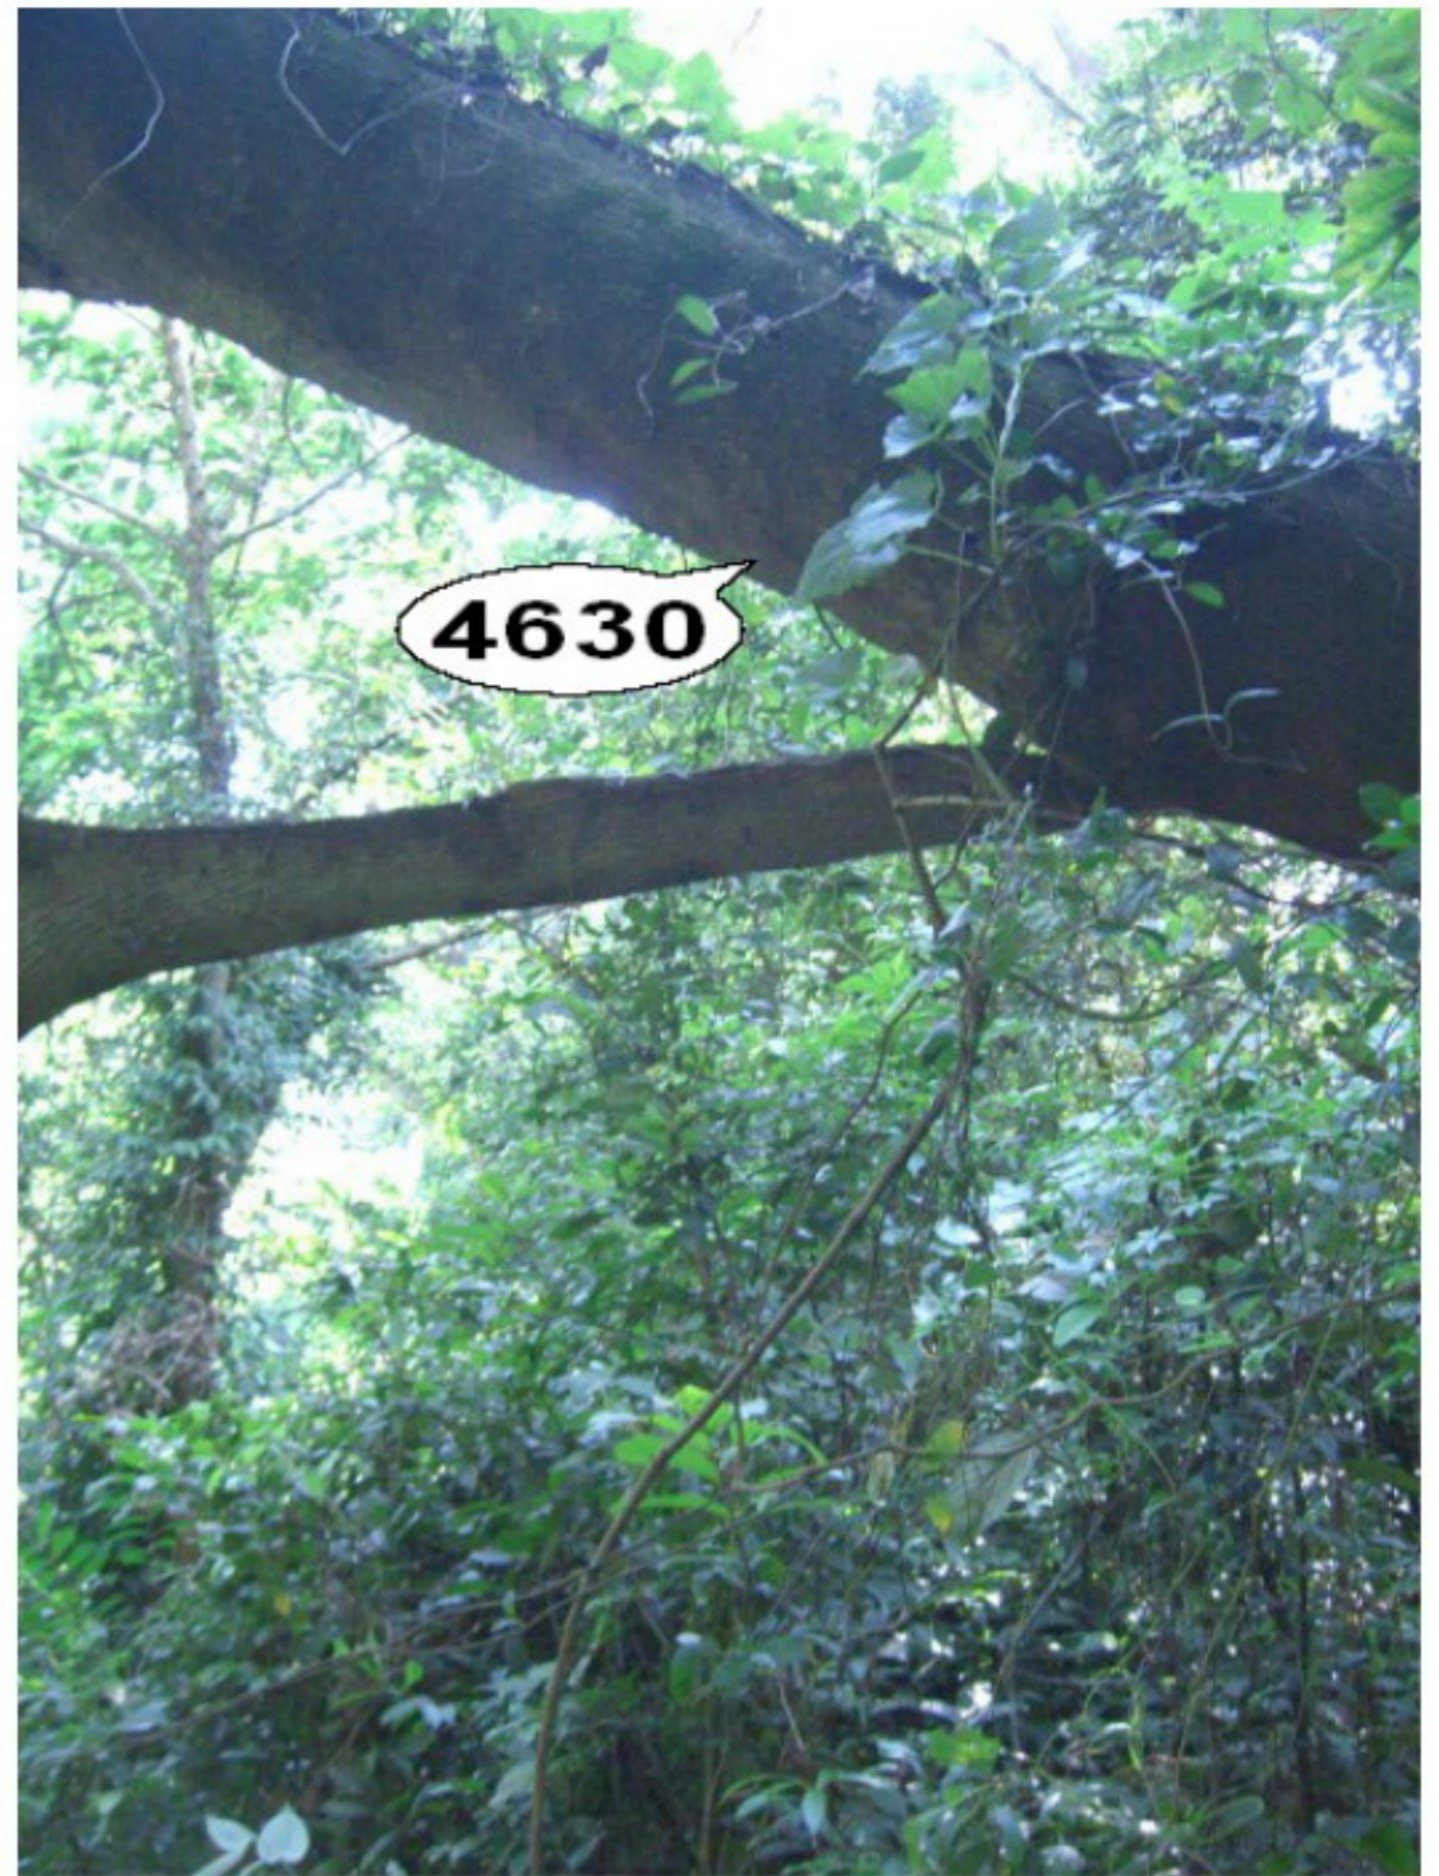
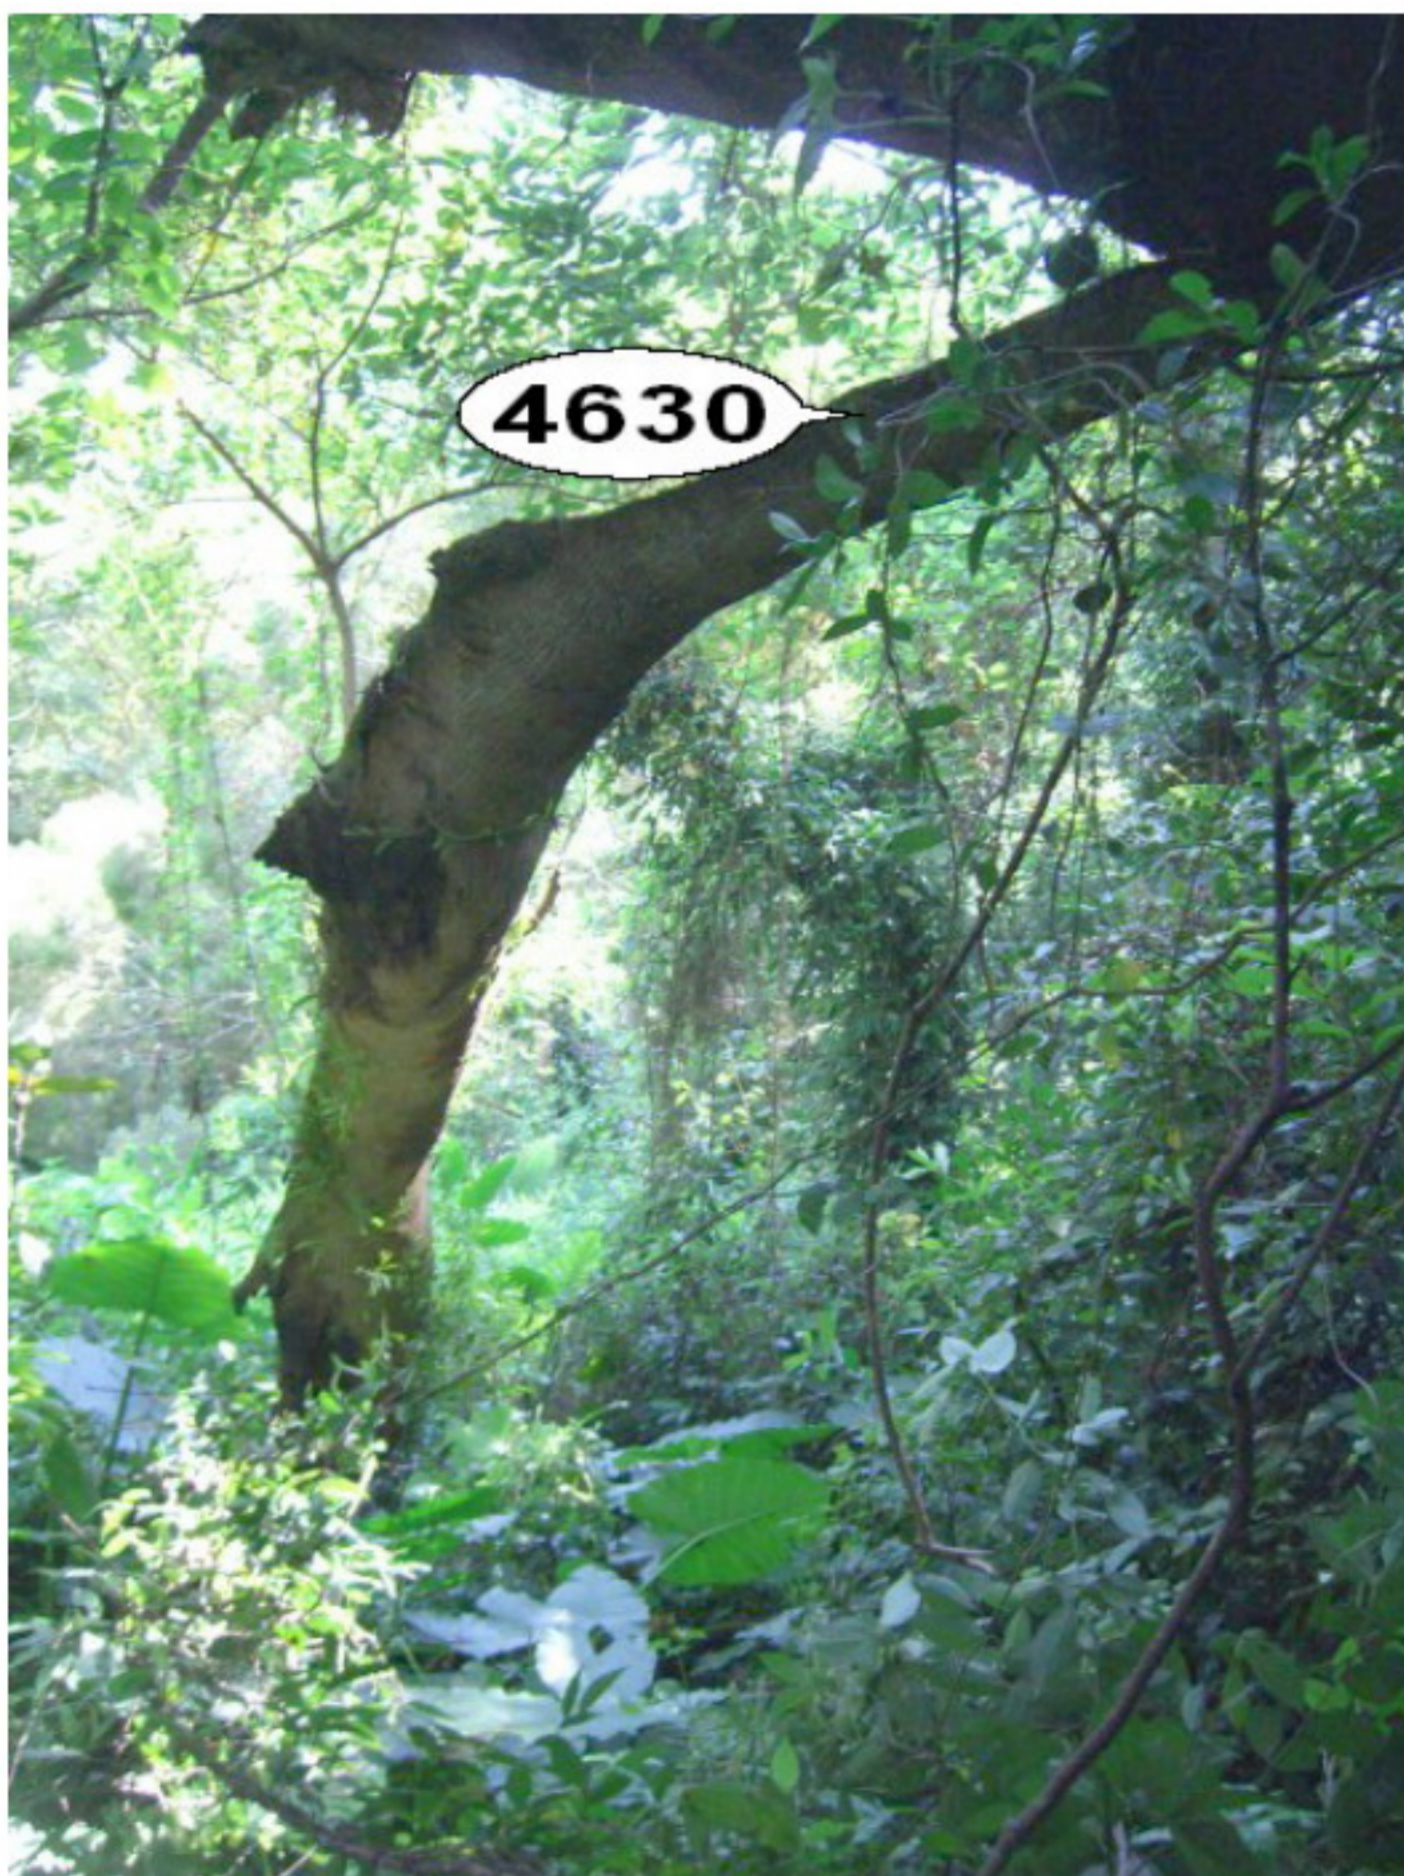
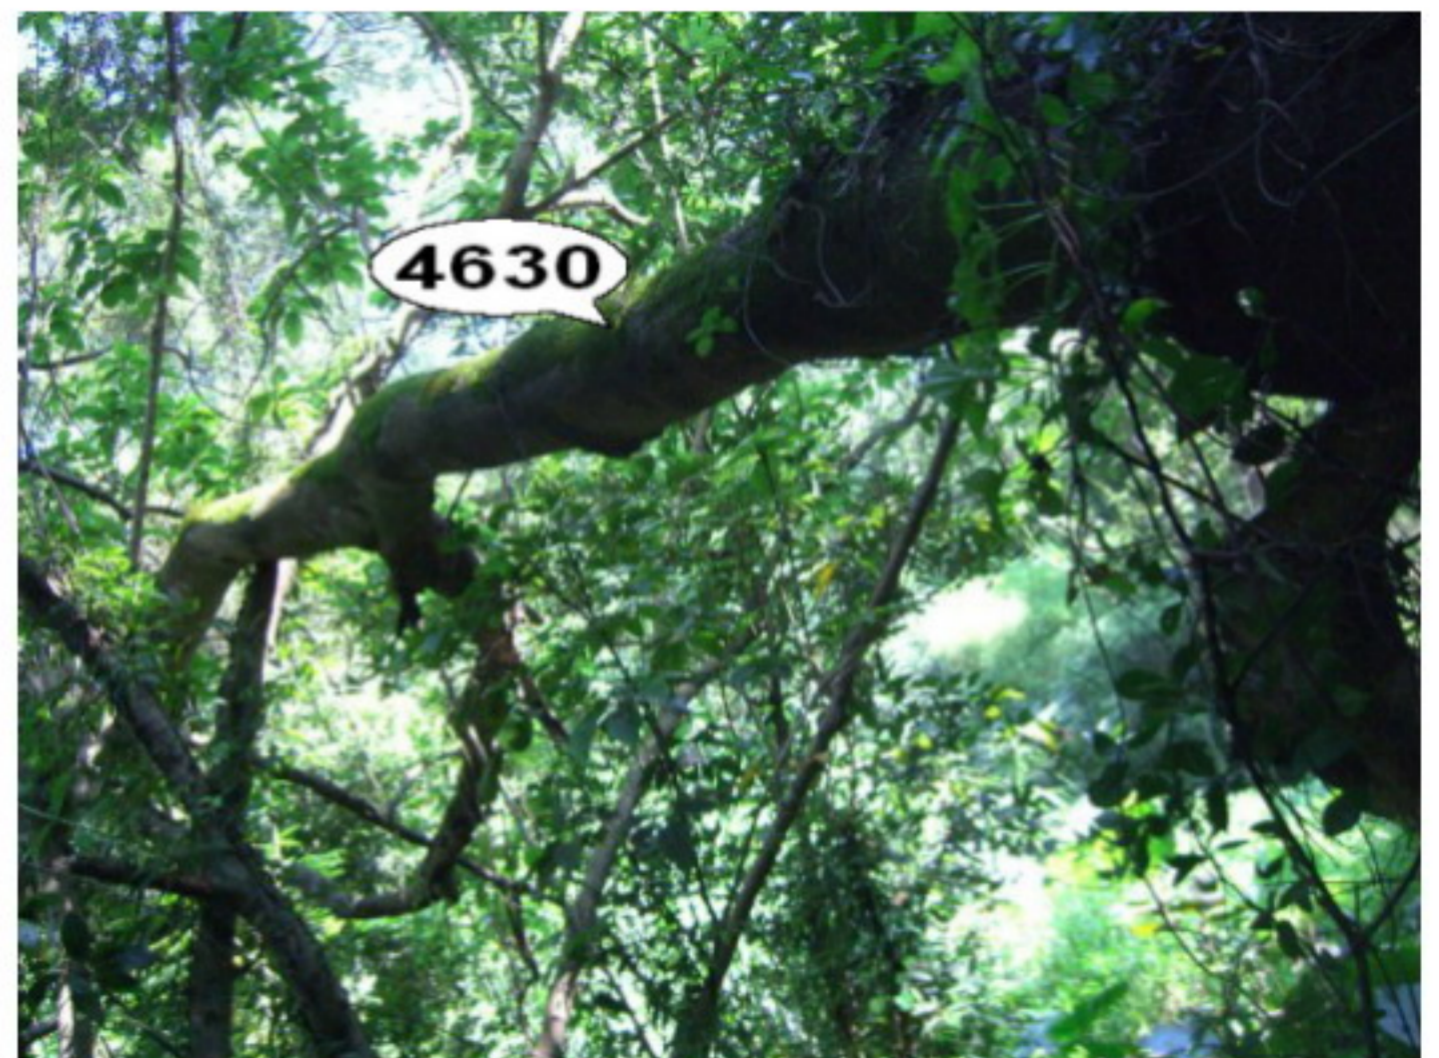
Tree 4628

Poor health will lead to low transplantation survival rate. Poor form which also lead to low amenity value. Besides, the tree is unbalance. It may need heavy pruning after transplantation that will affect its transplantation survival rate. Moreover, the operation of the transplantation for poor form tree is also difficult.

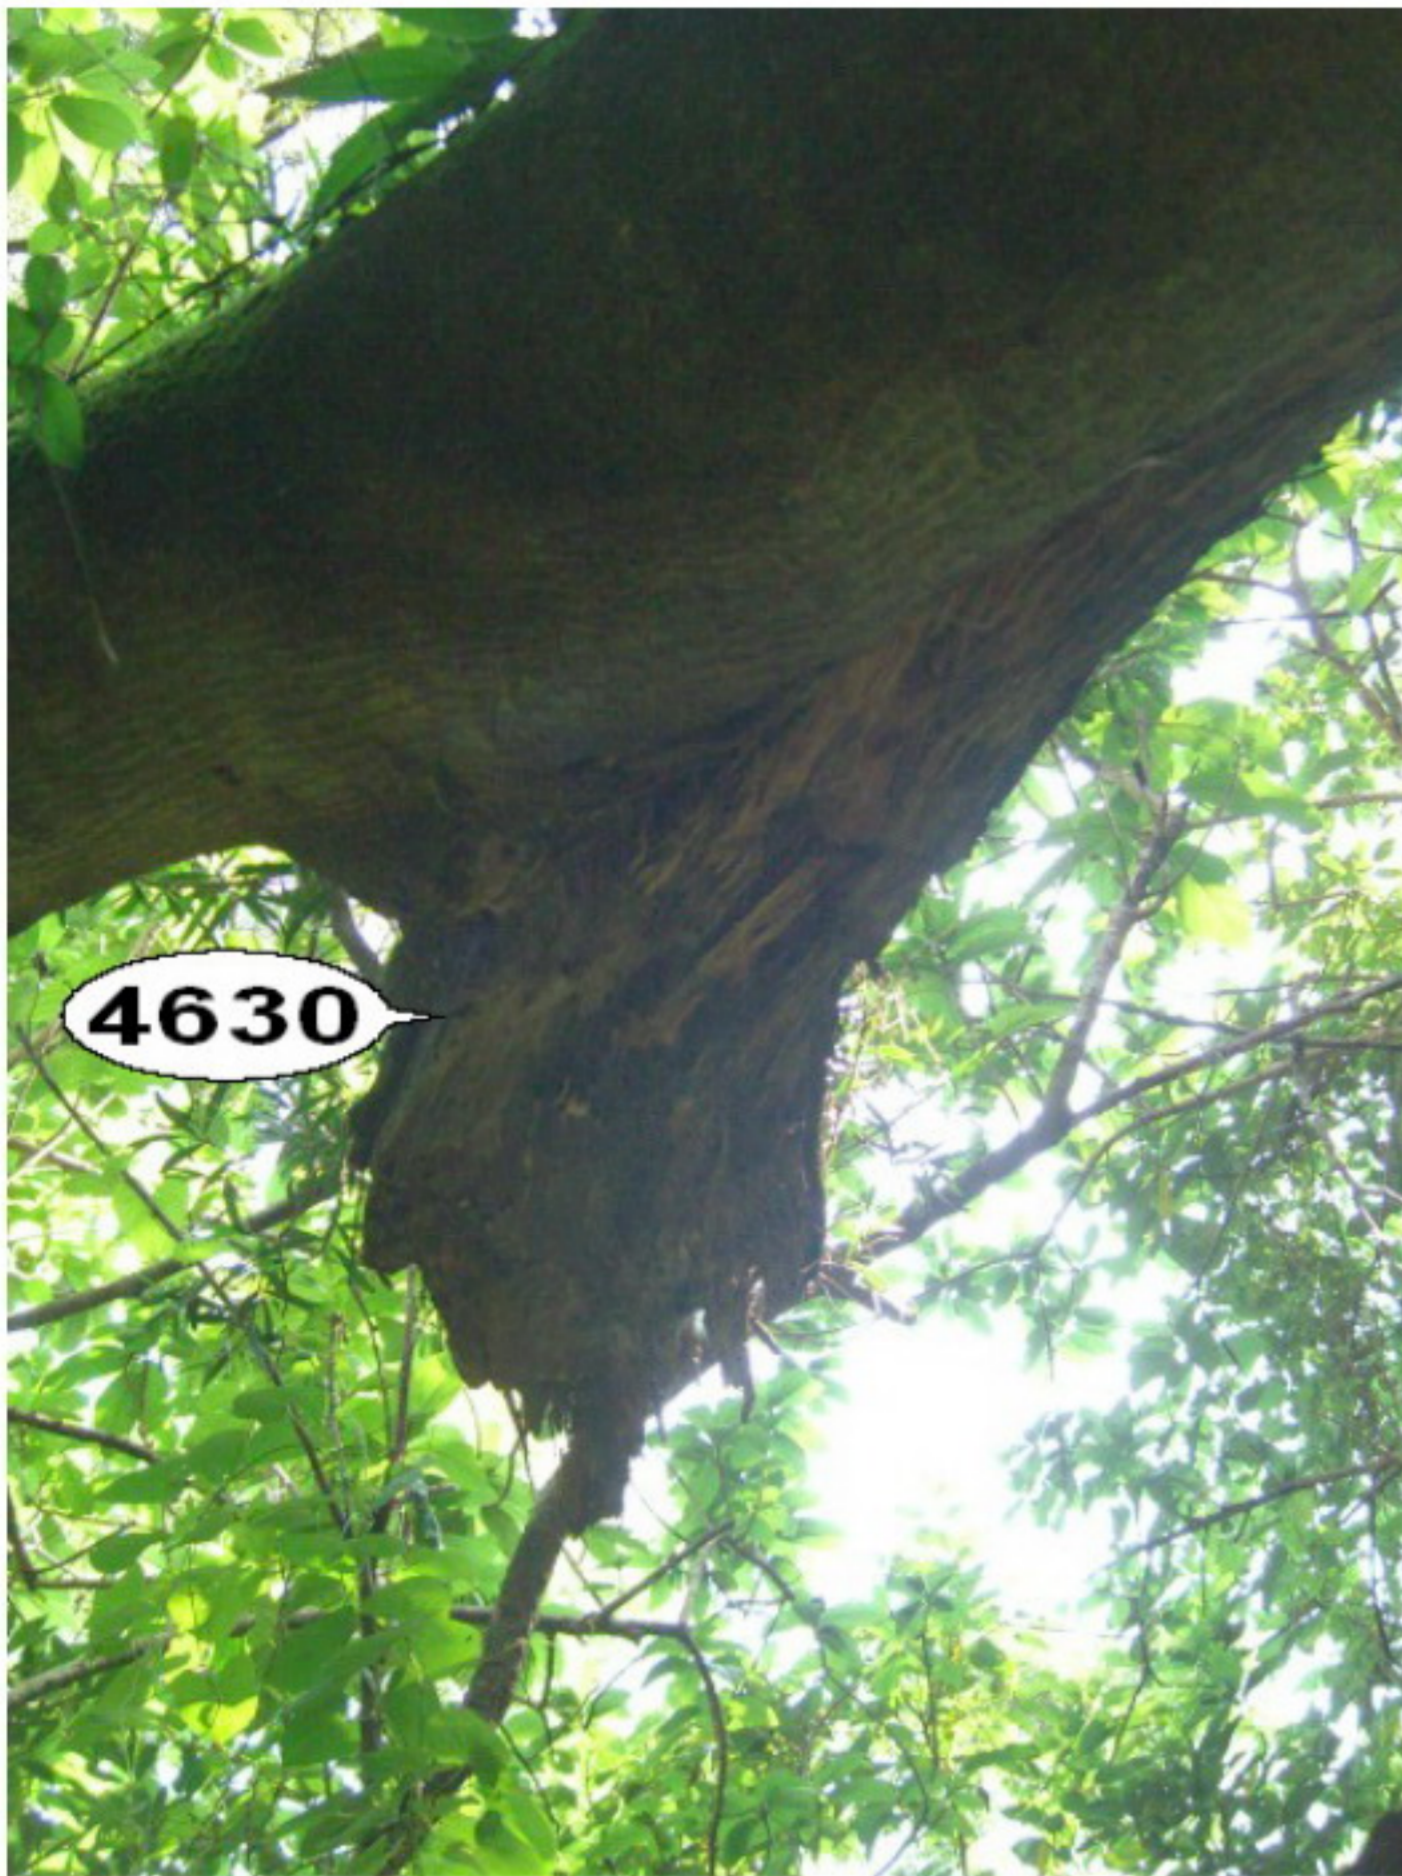
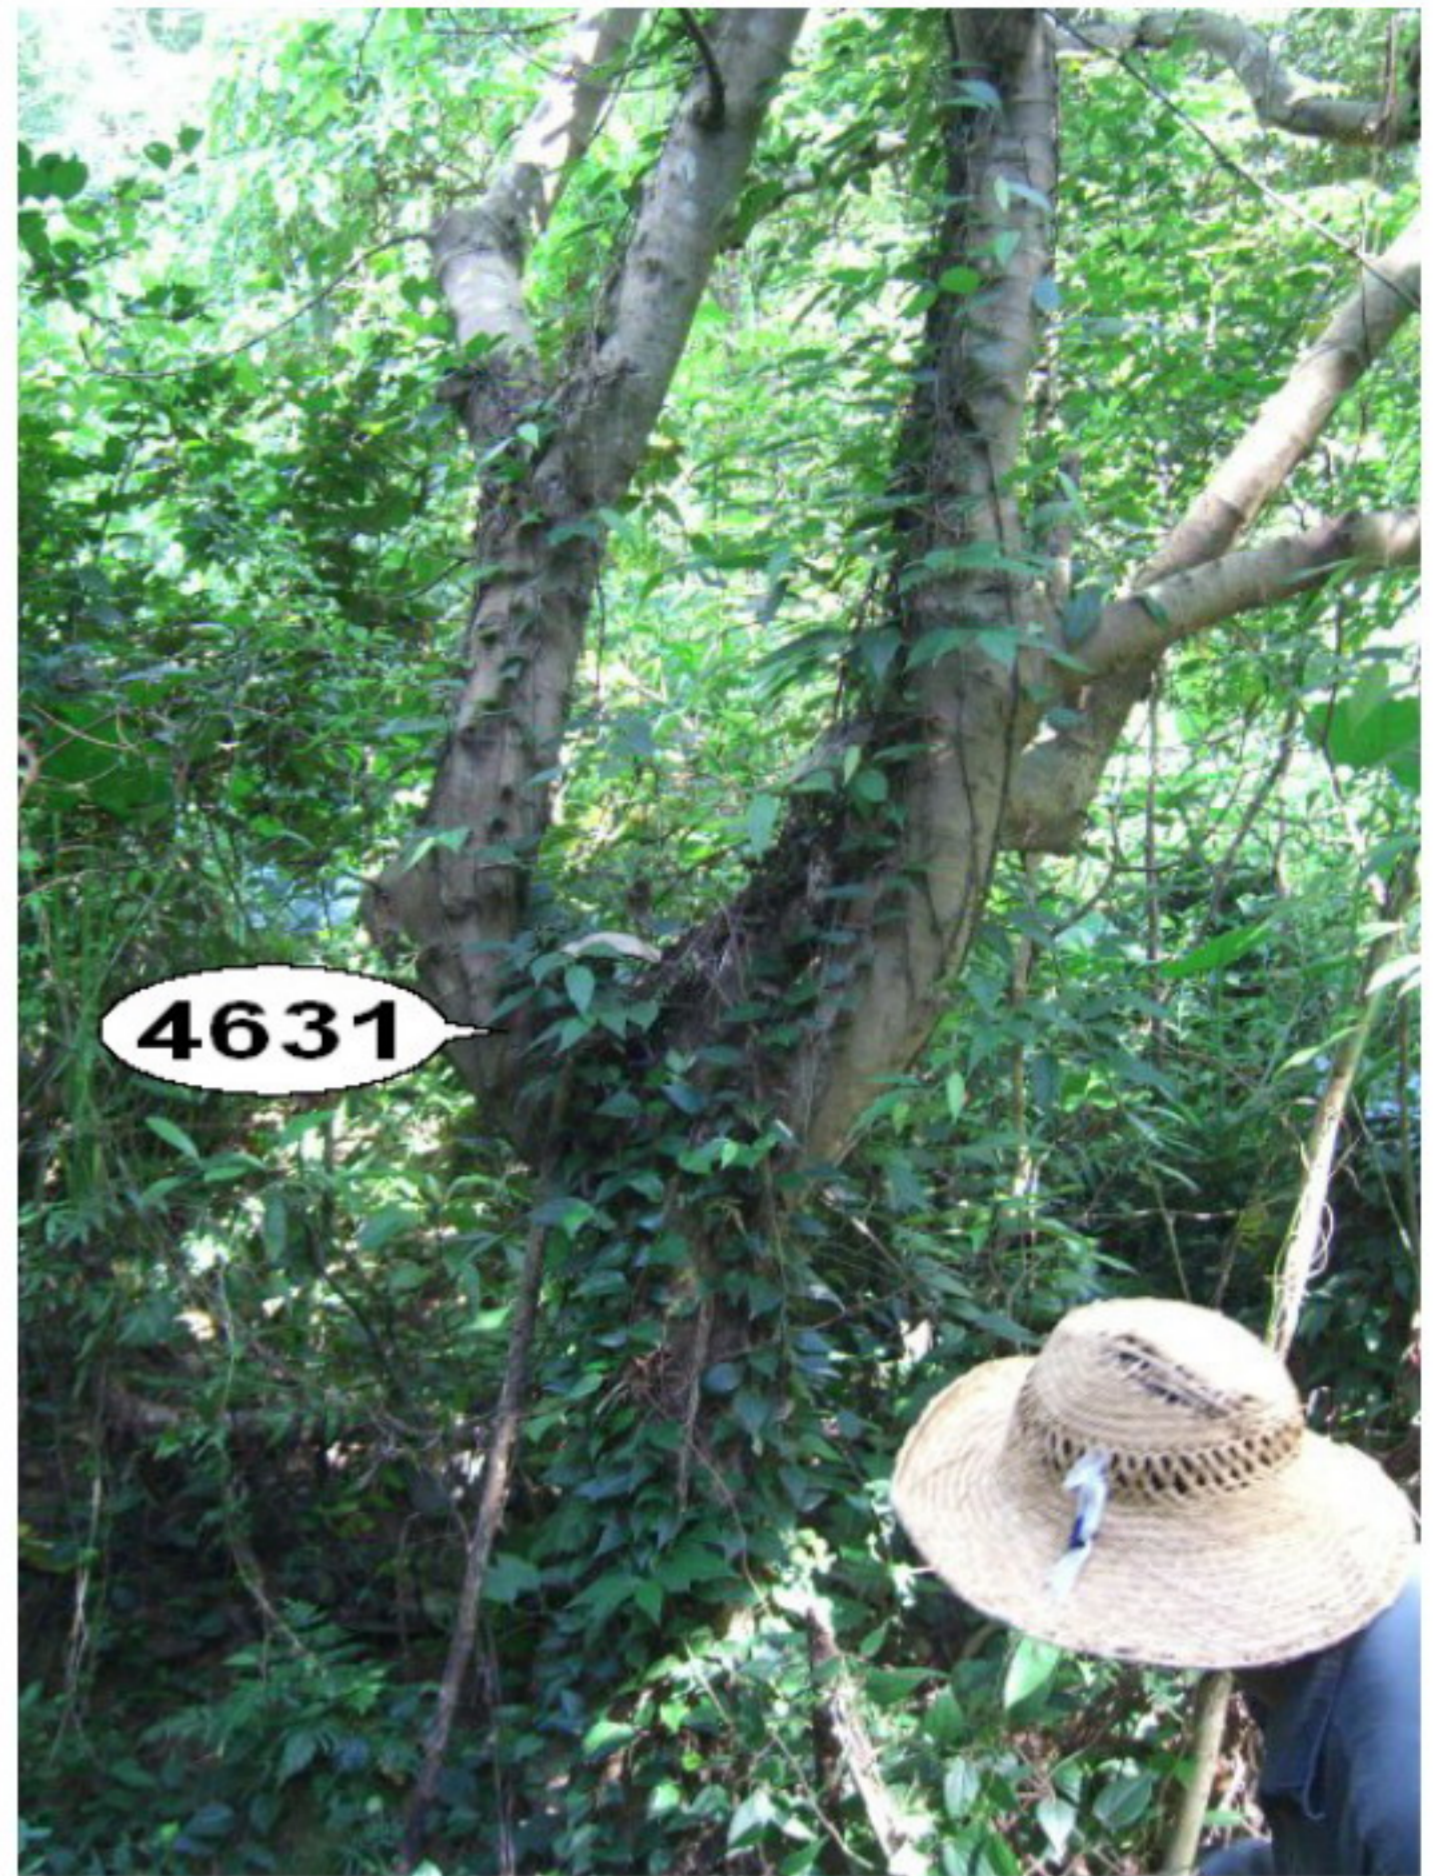
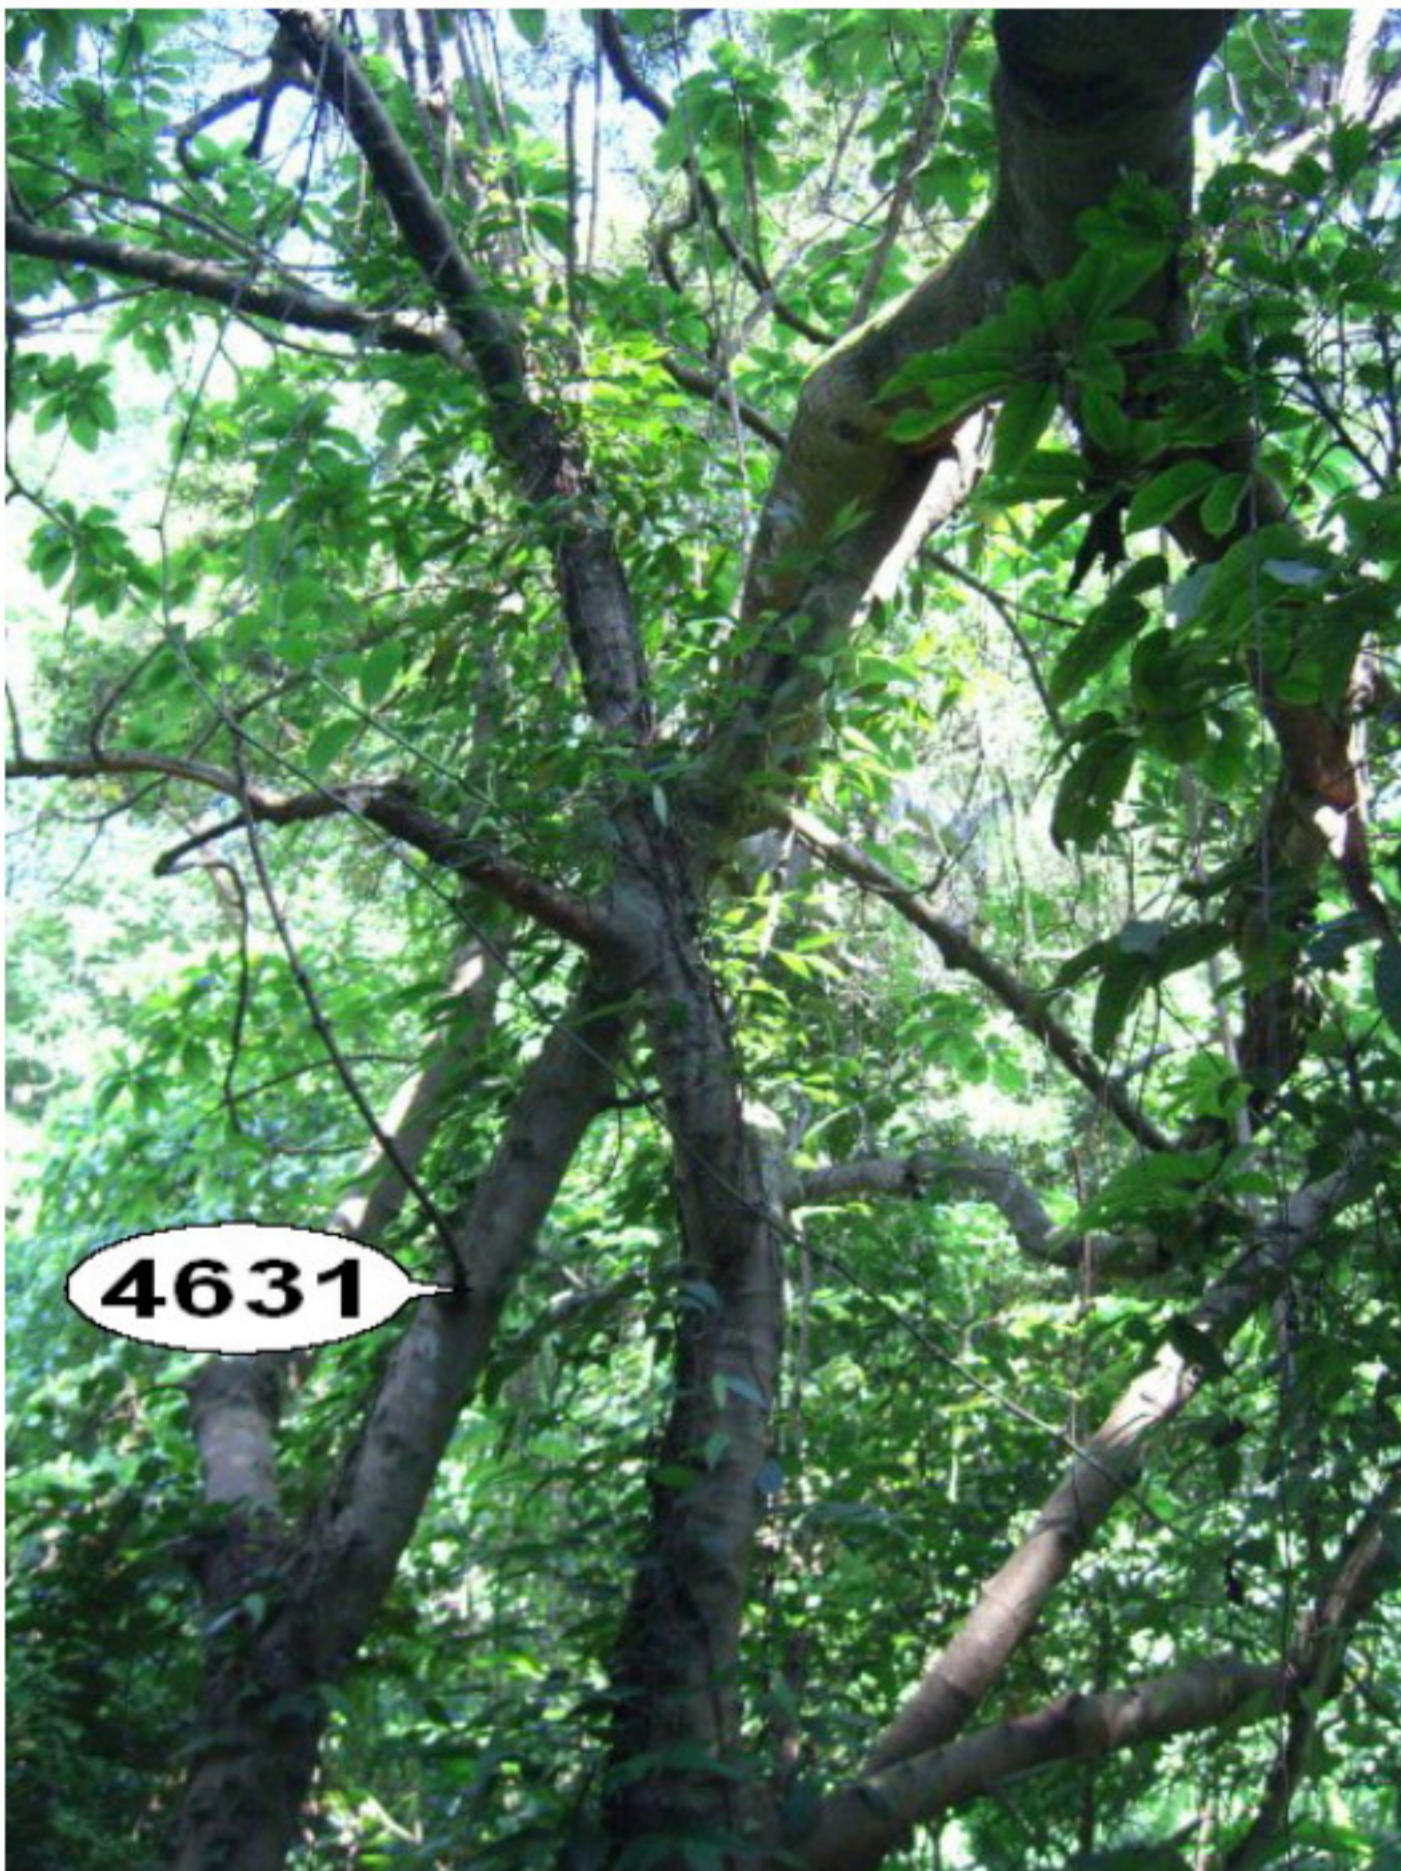
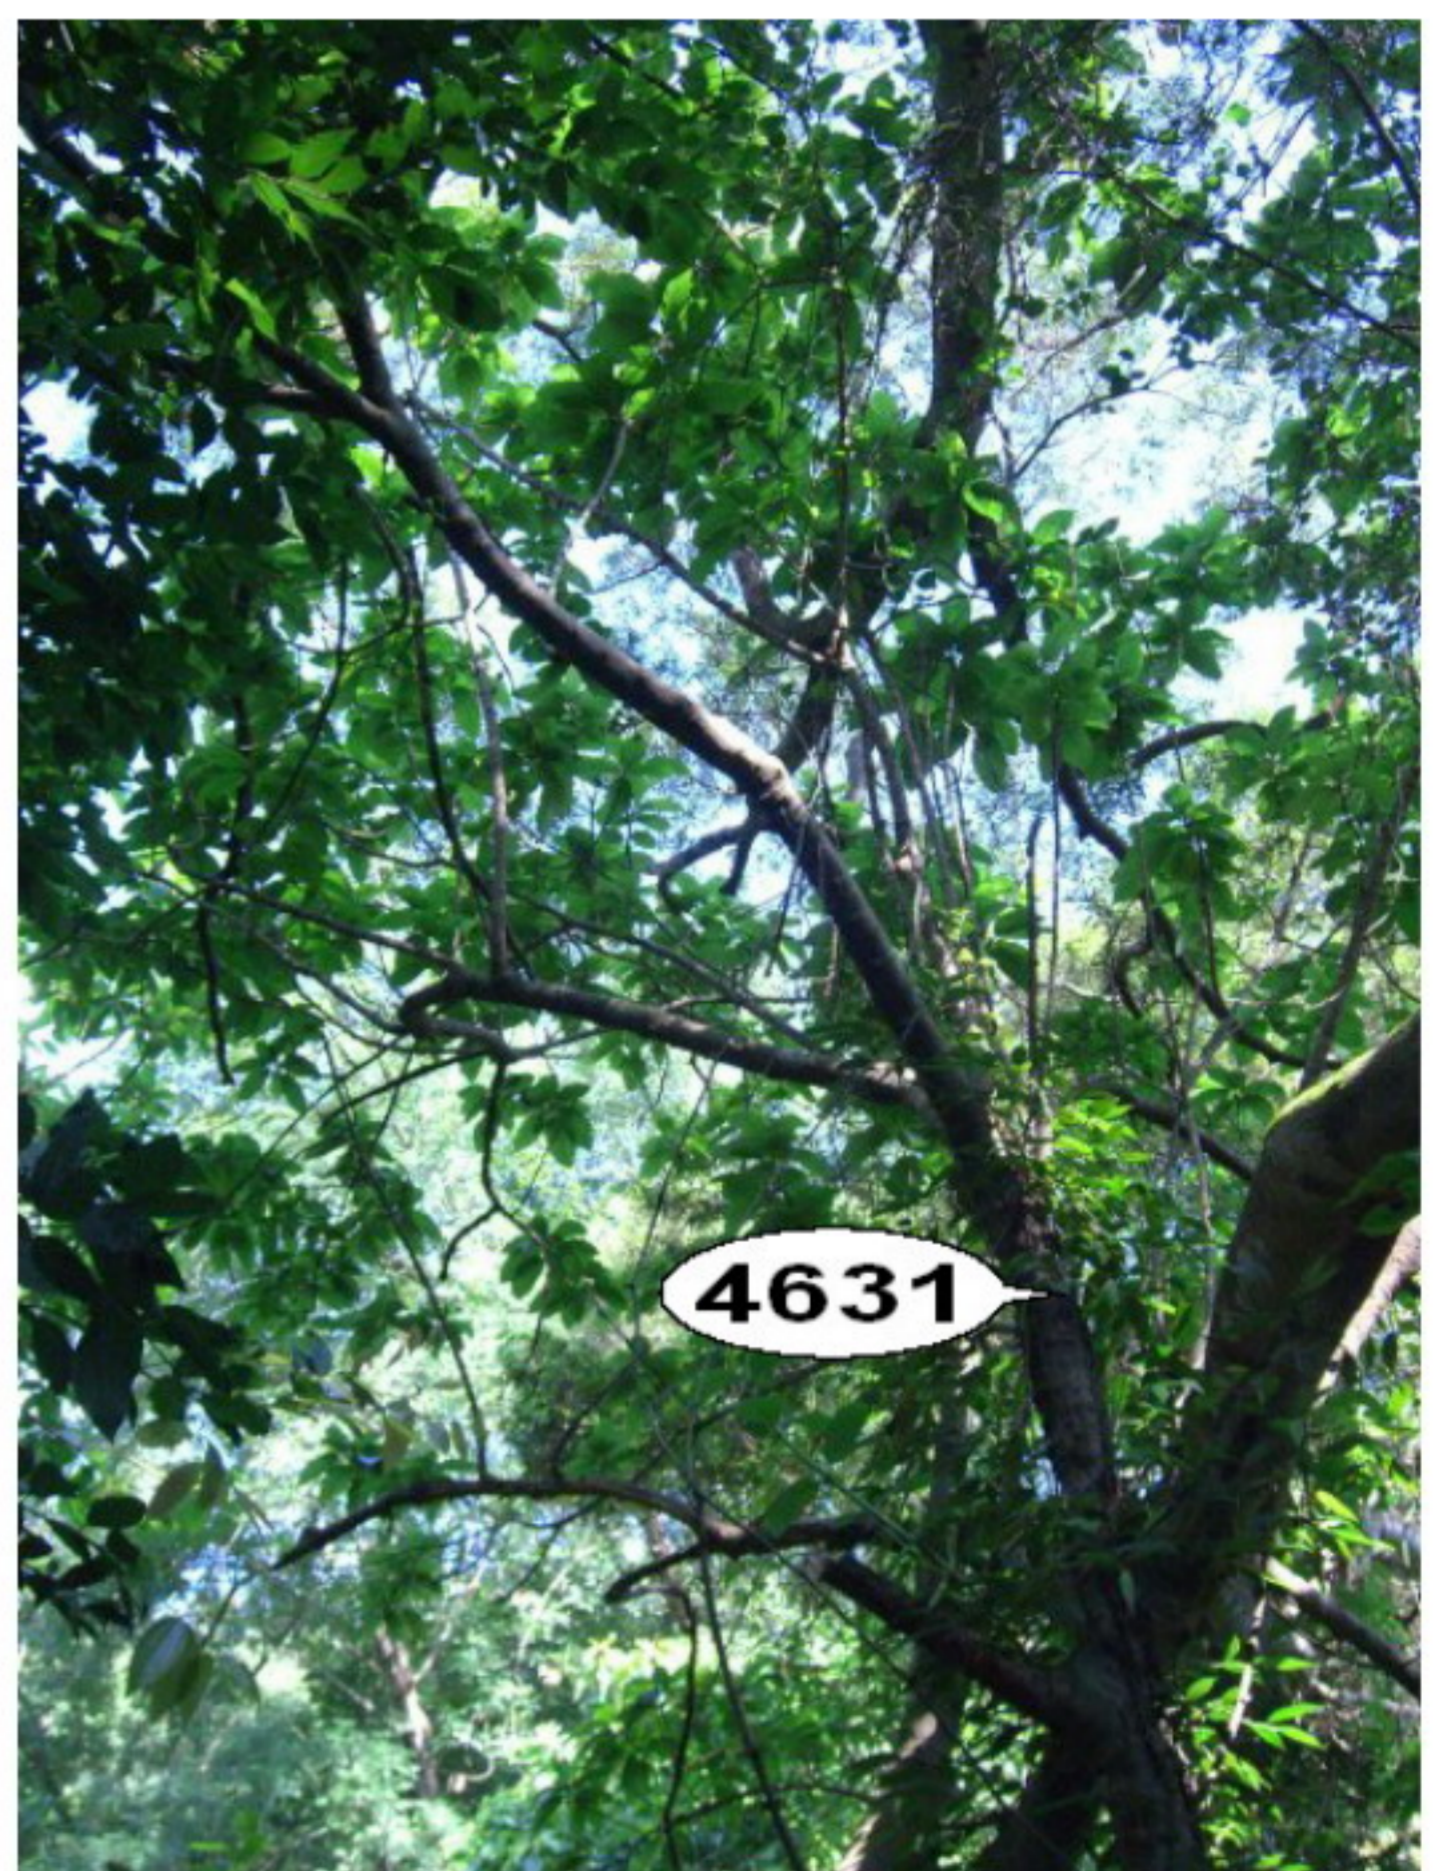
Tree 4630  
Poor health will lead to low transplantation survival rate.
