# Provision of Cremators at Wo Hop Shek Crematorium

Tree Survey Report

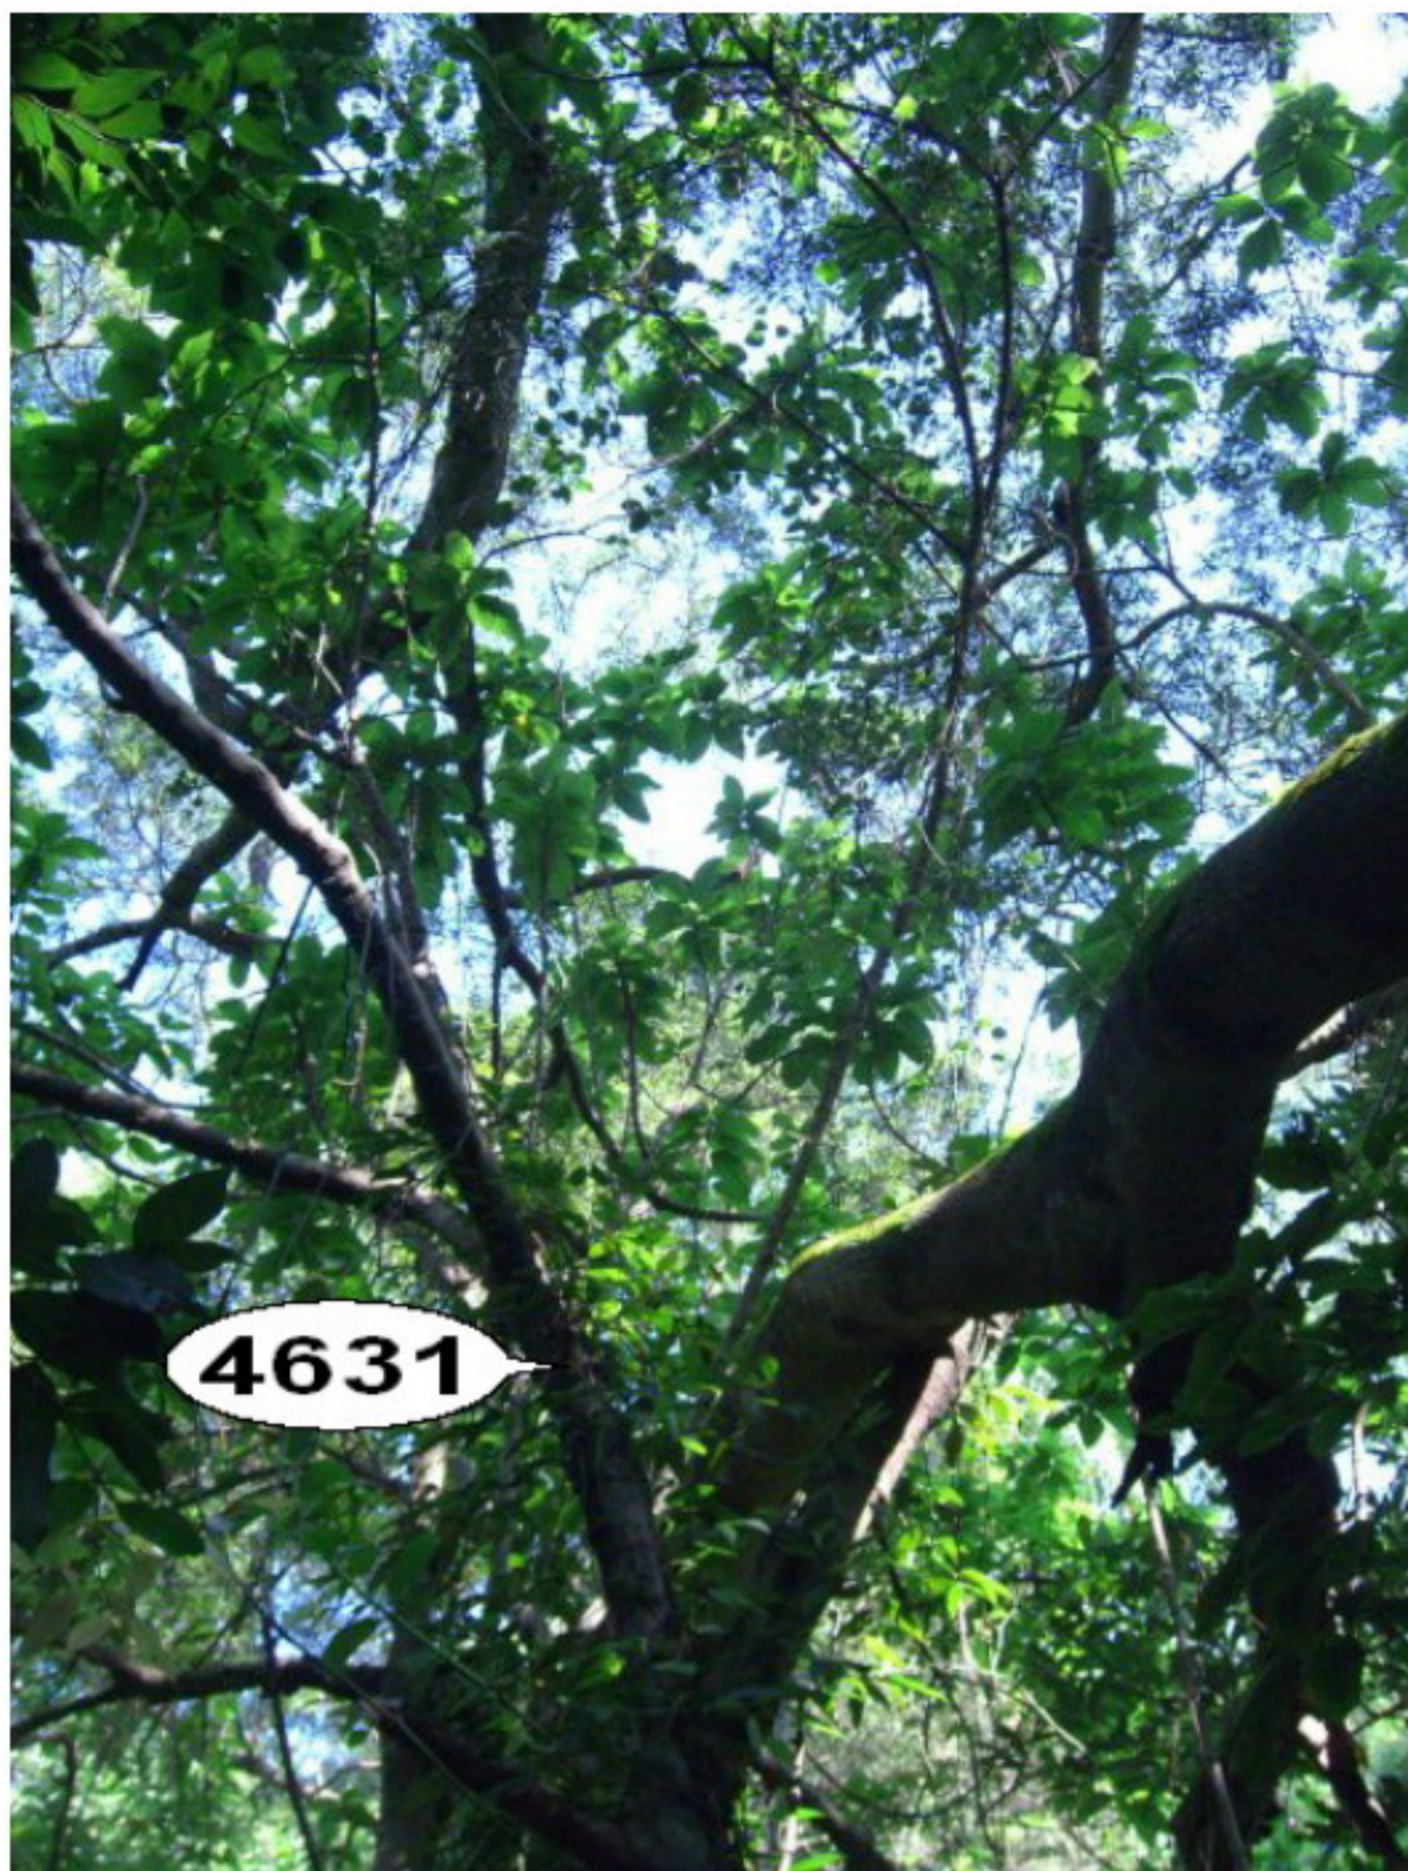
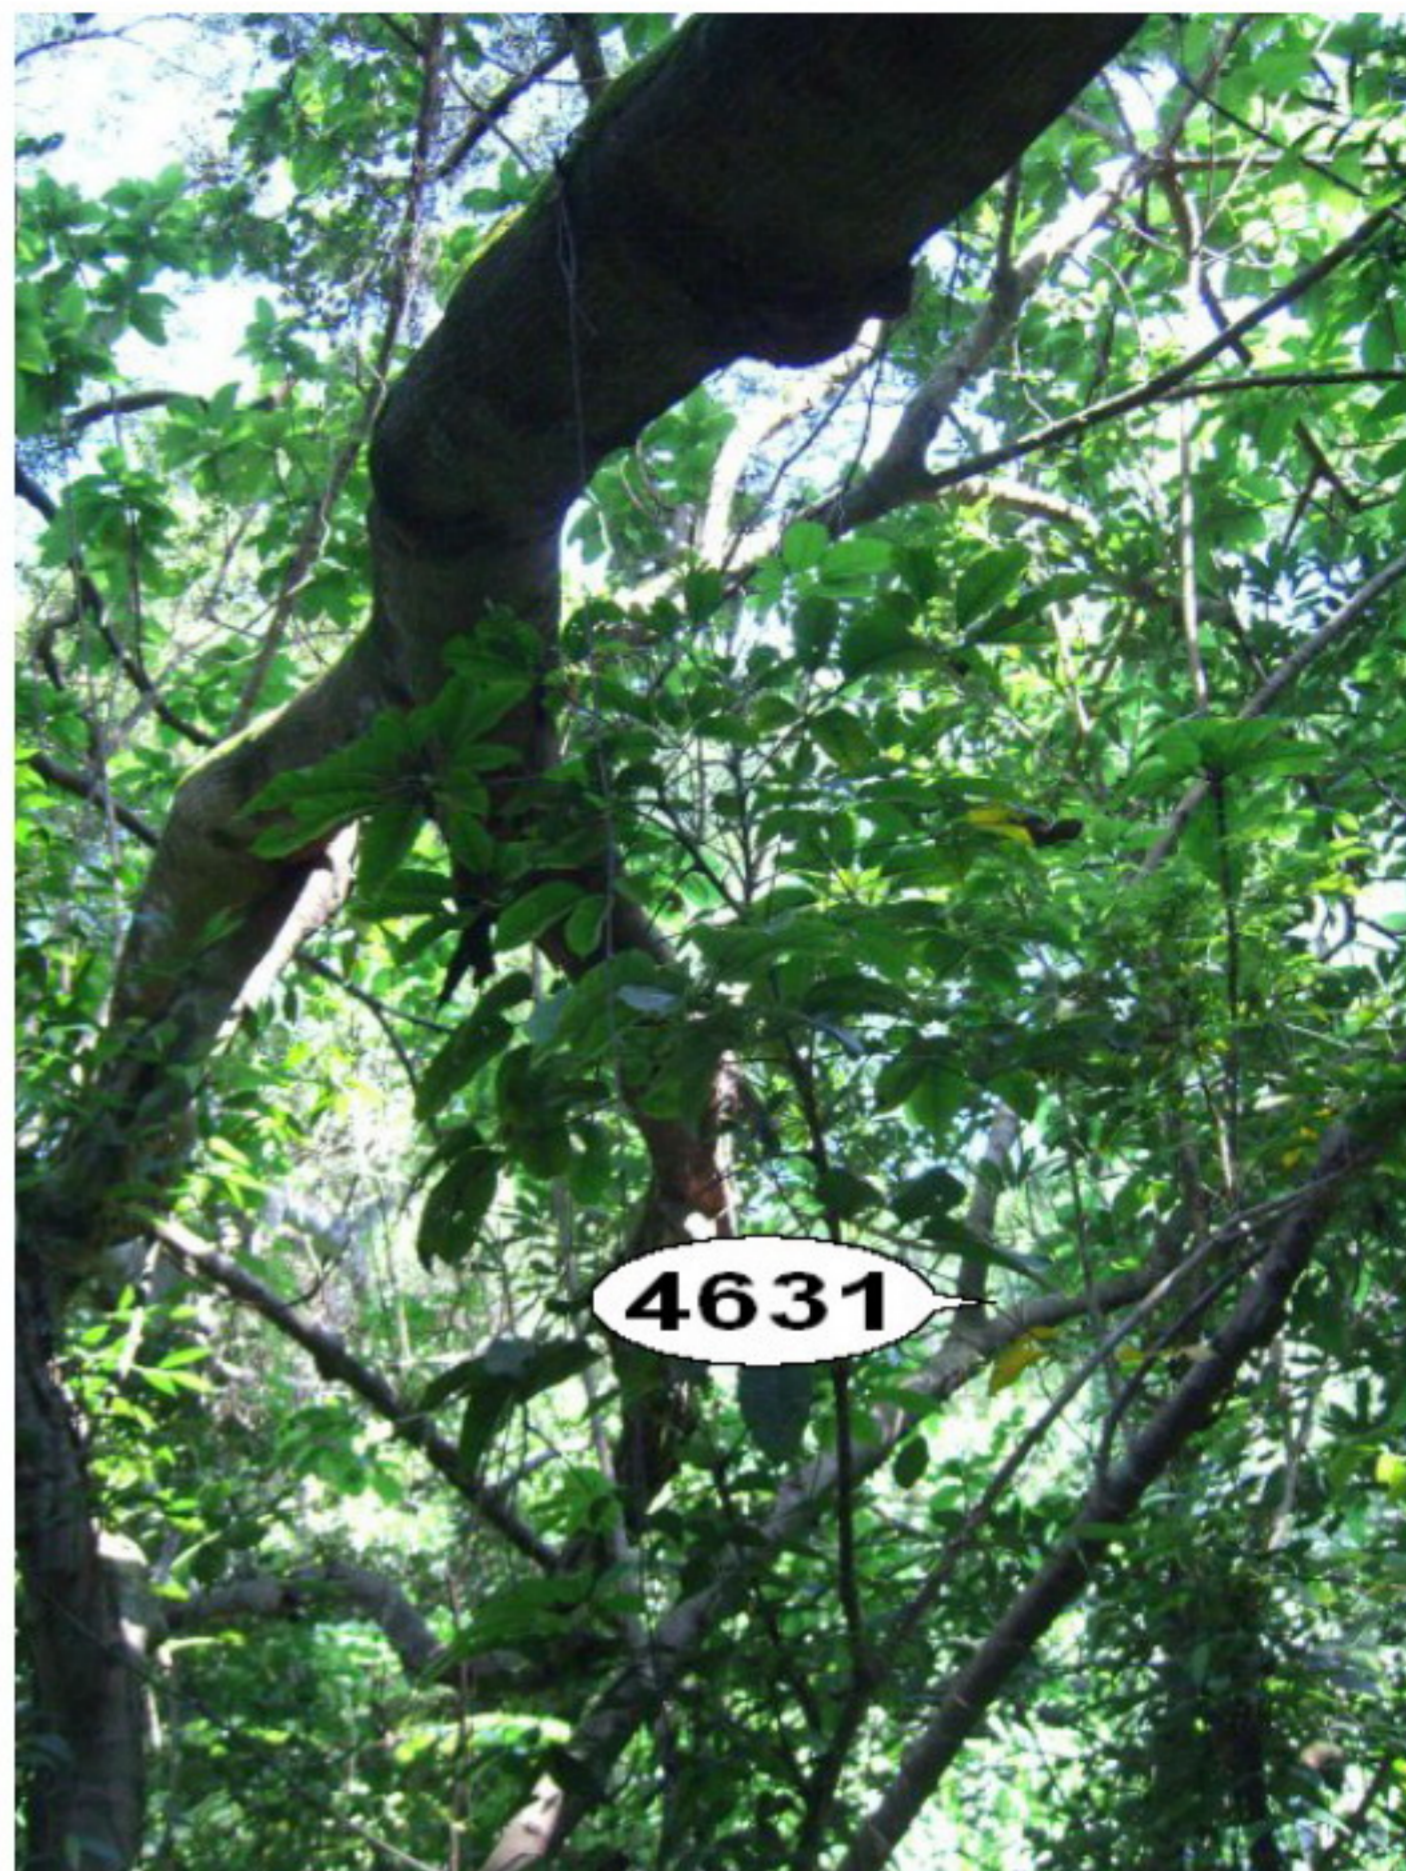
Tree 4630 and 4631  
Poor health will lead to low transplantation survival rate.

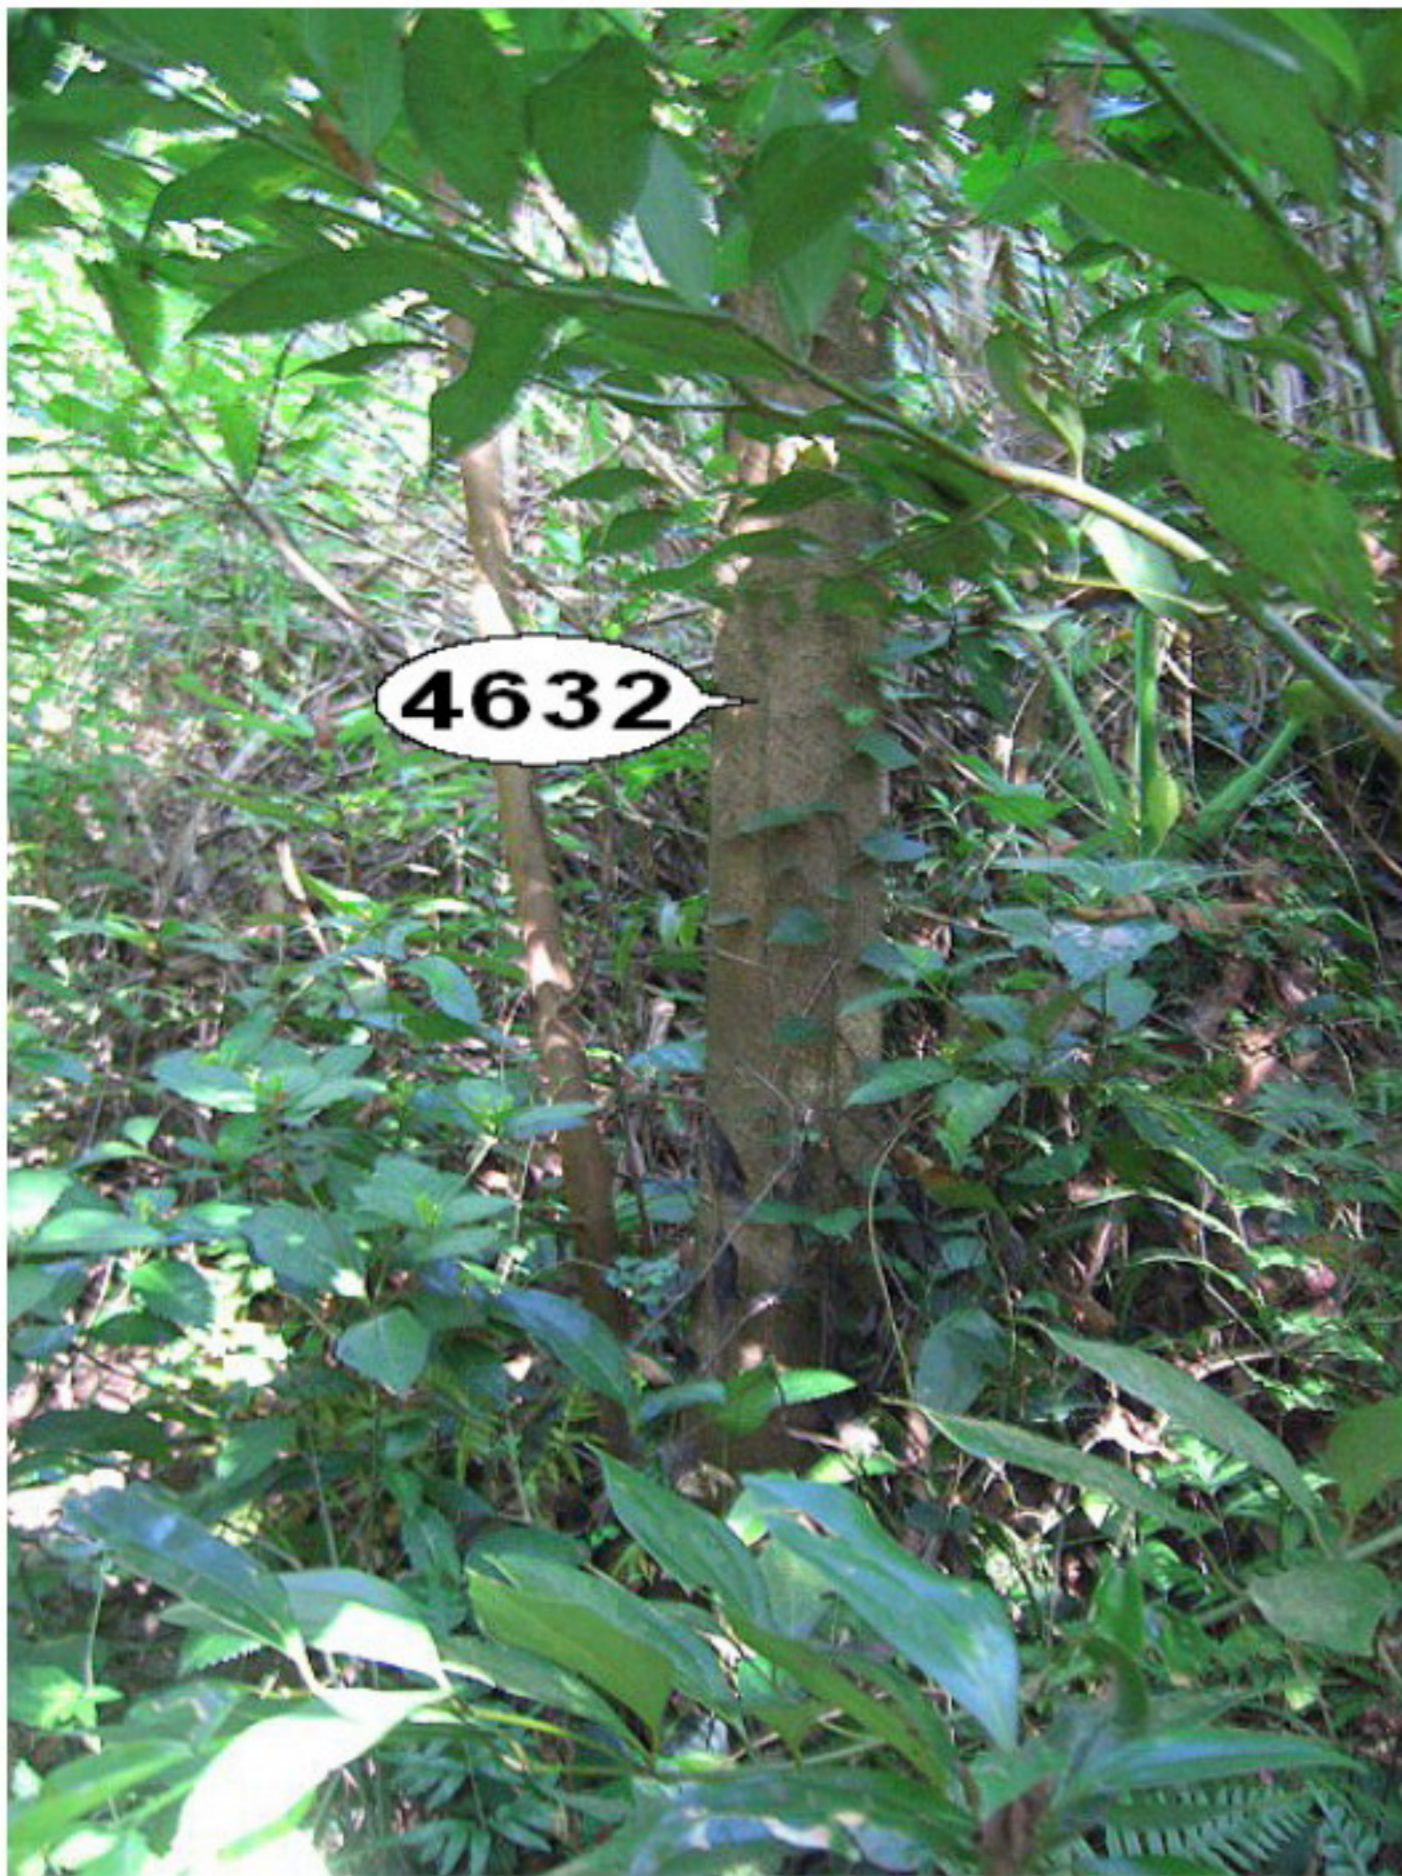
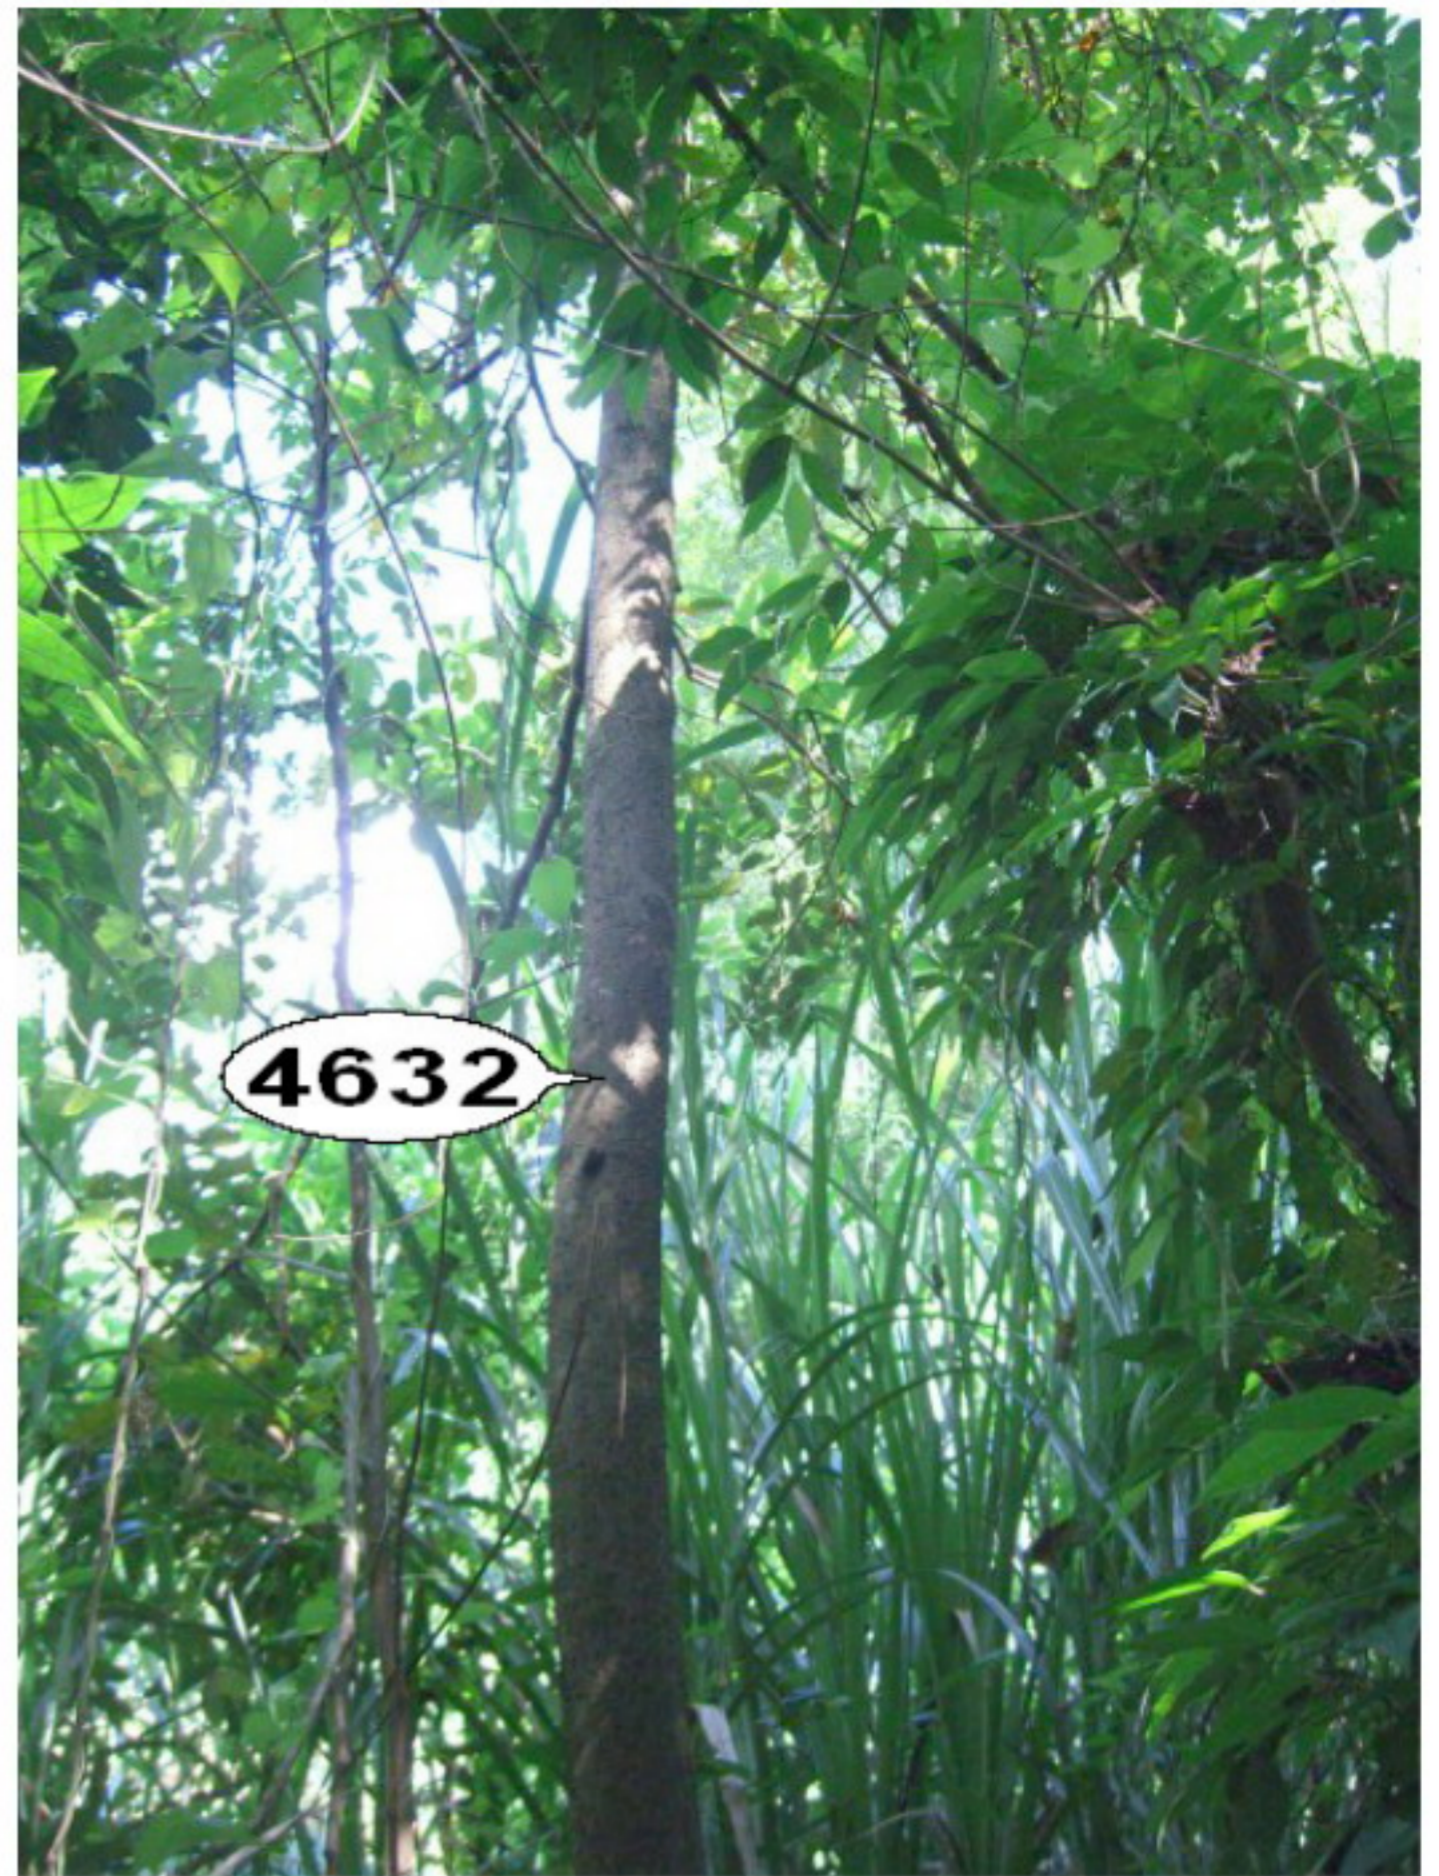
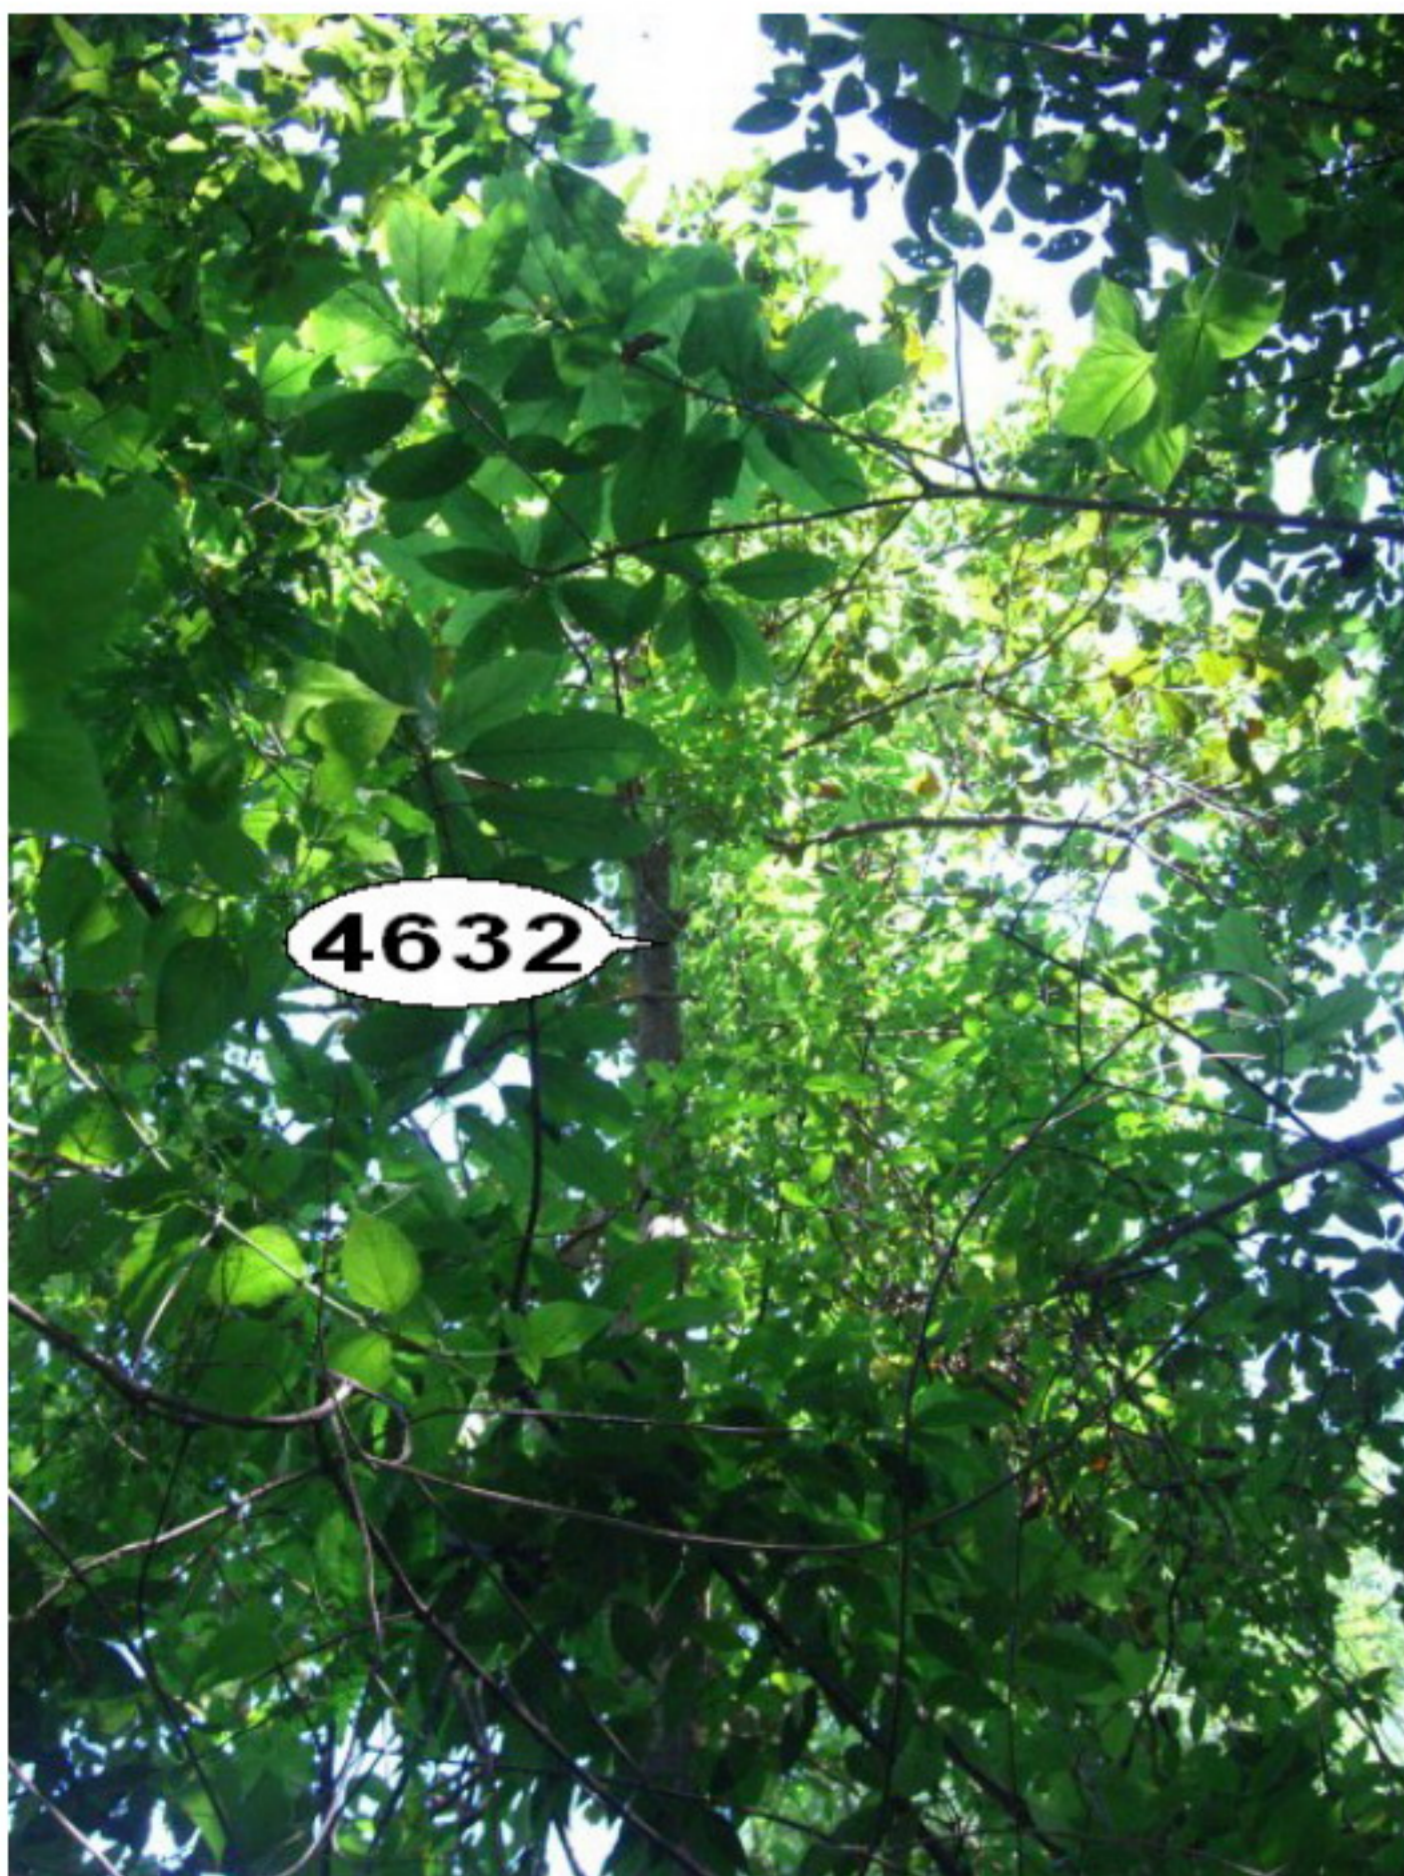
Tree 4631  
Poor health will lead to low transplantation survival rate.

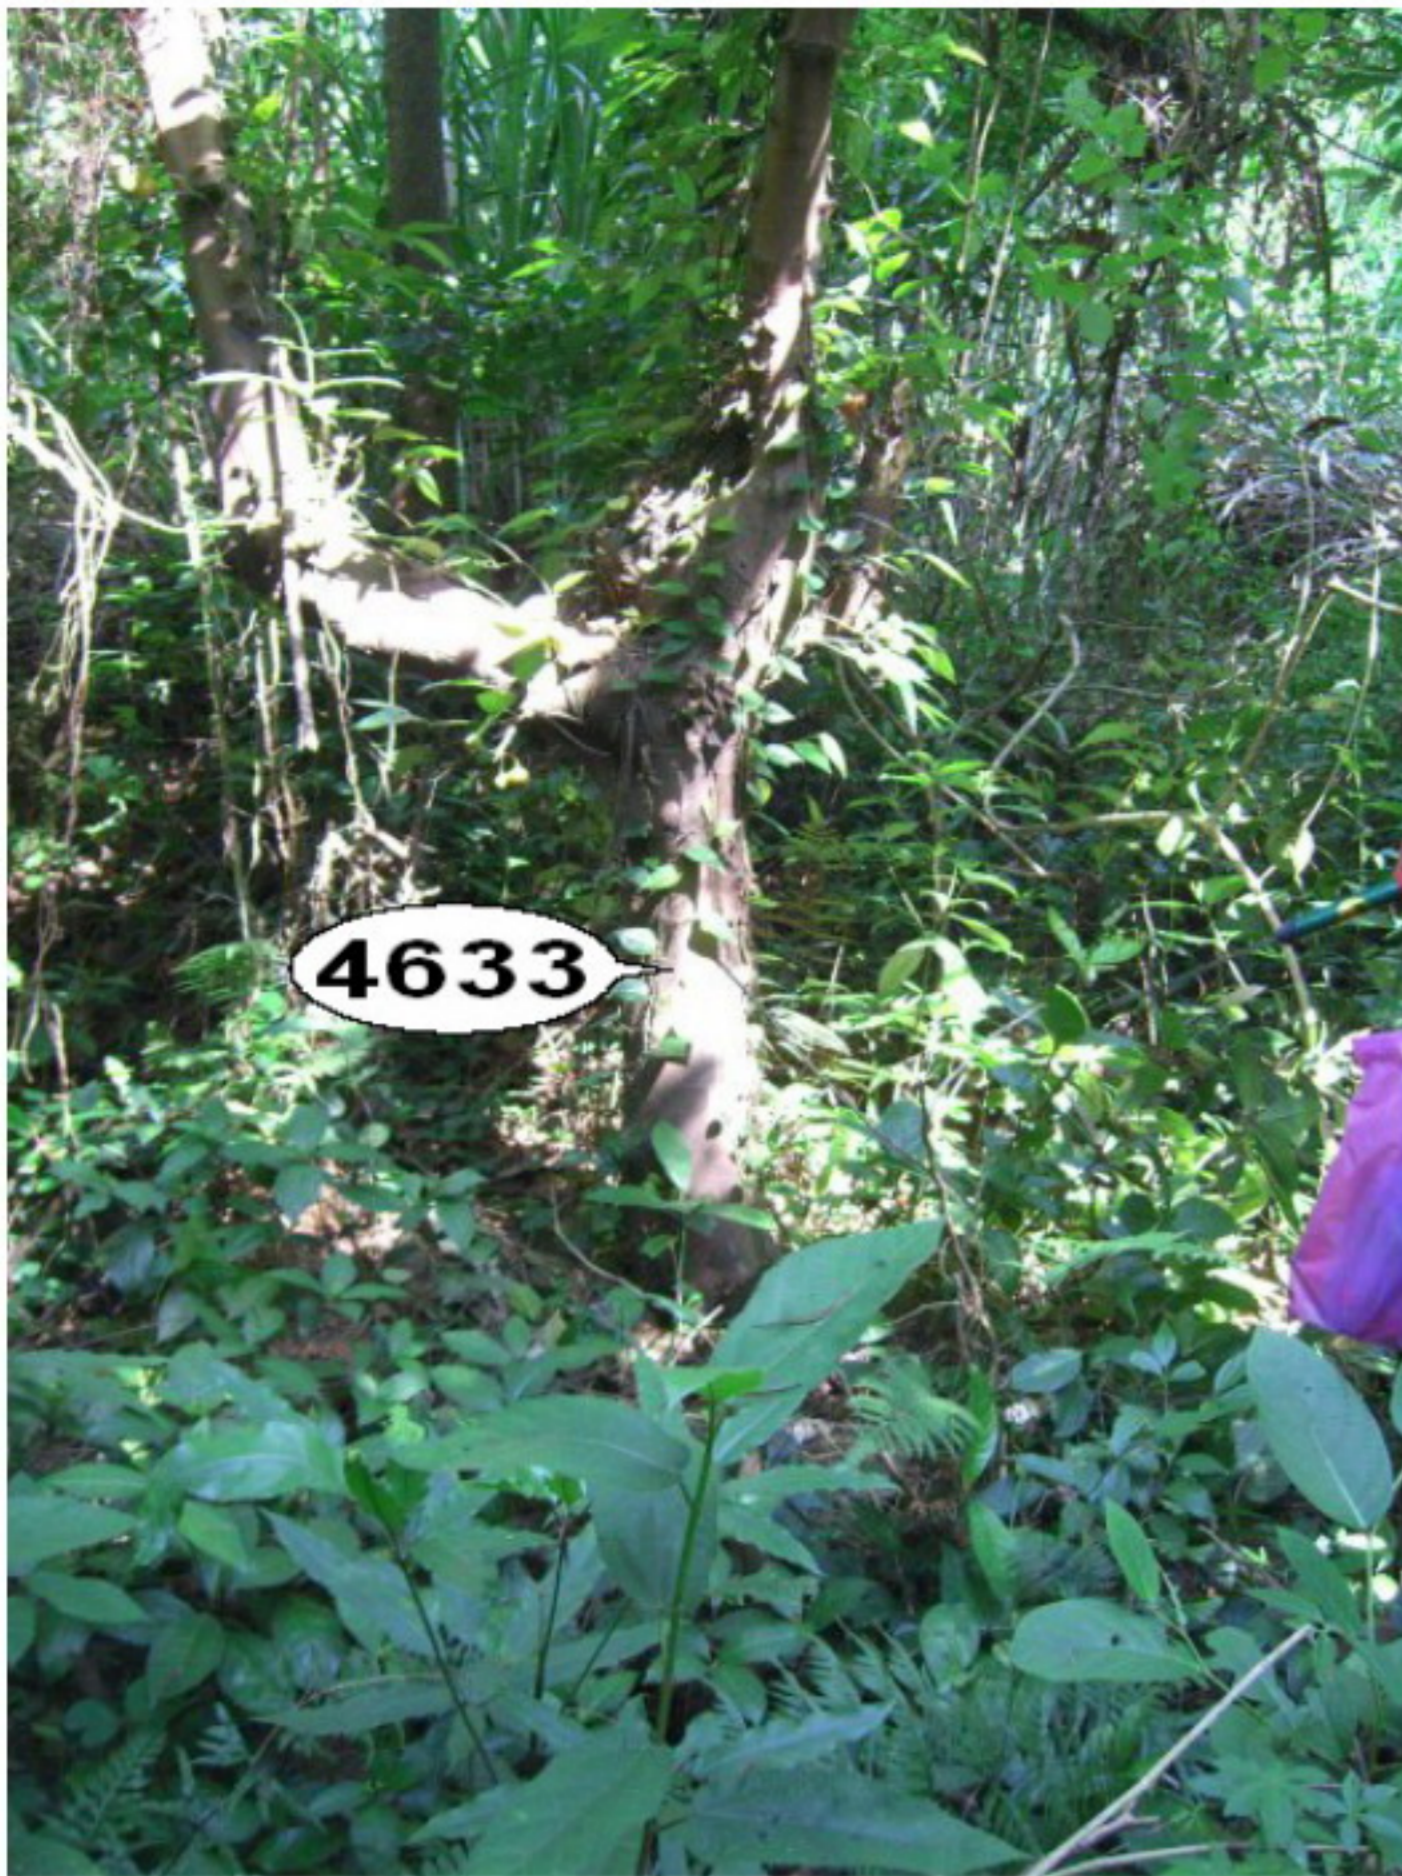
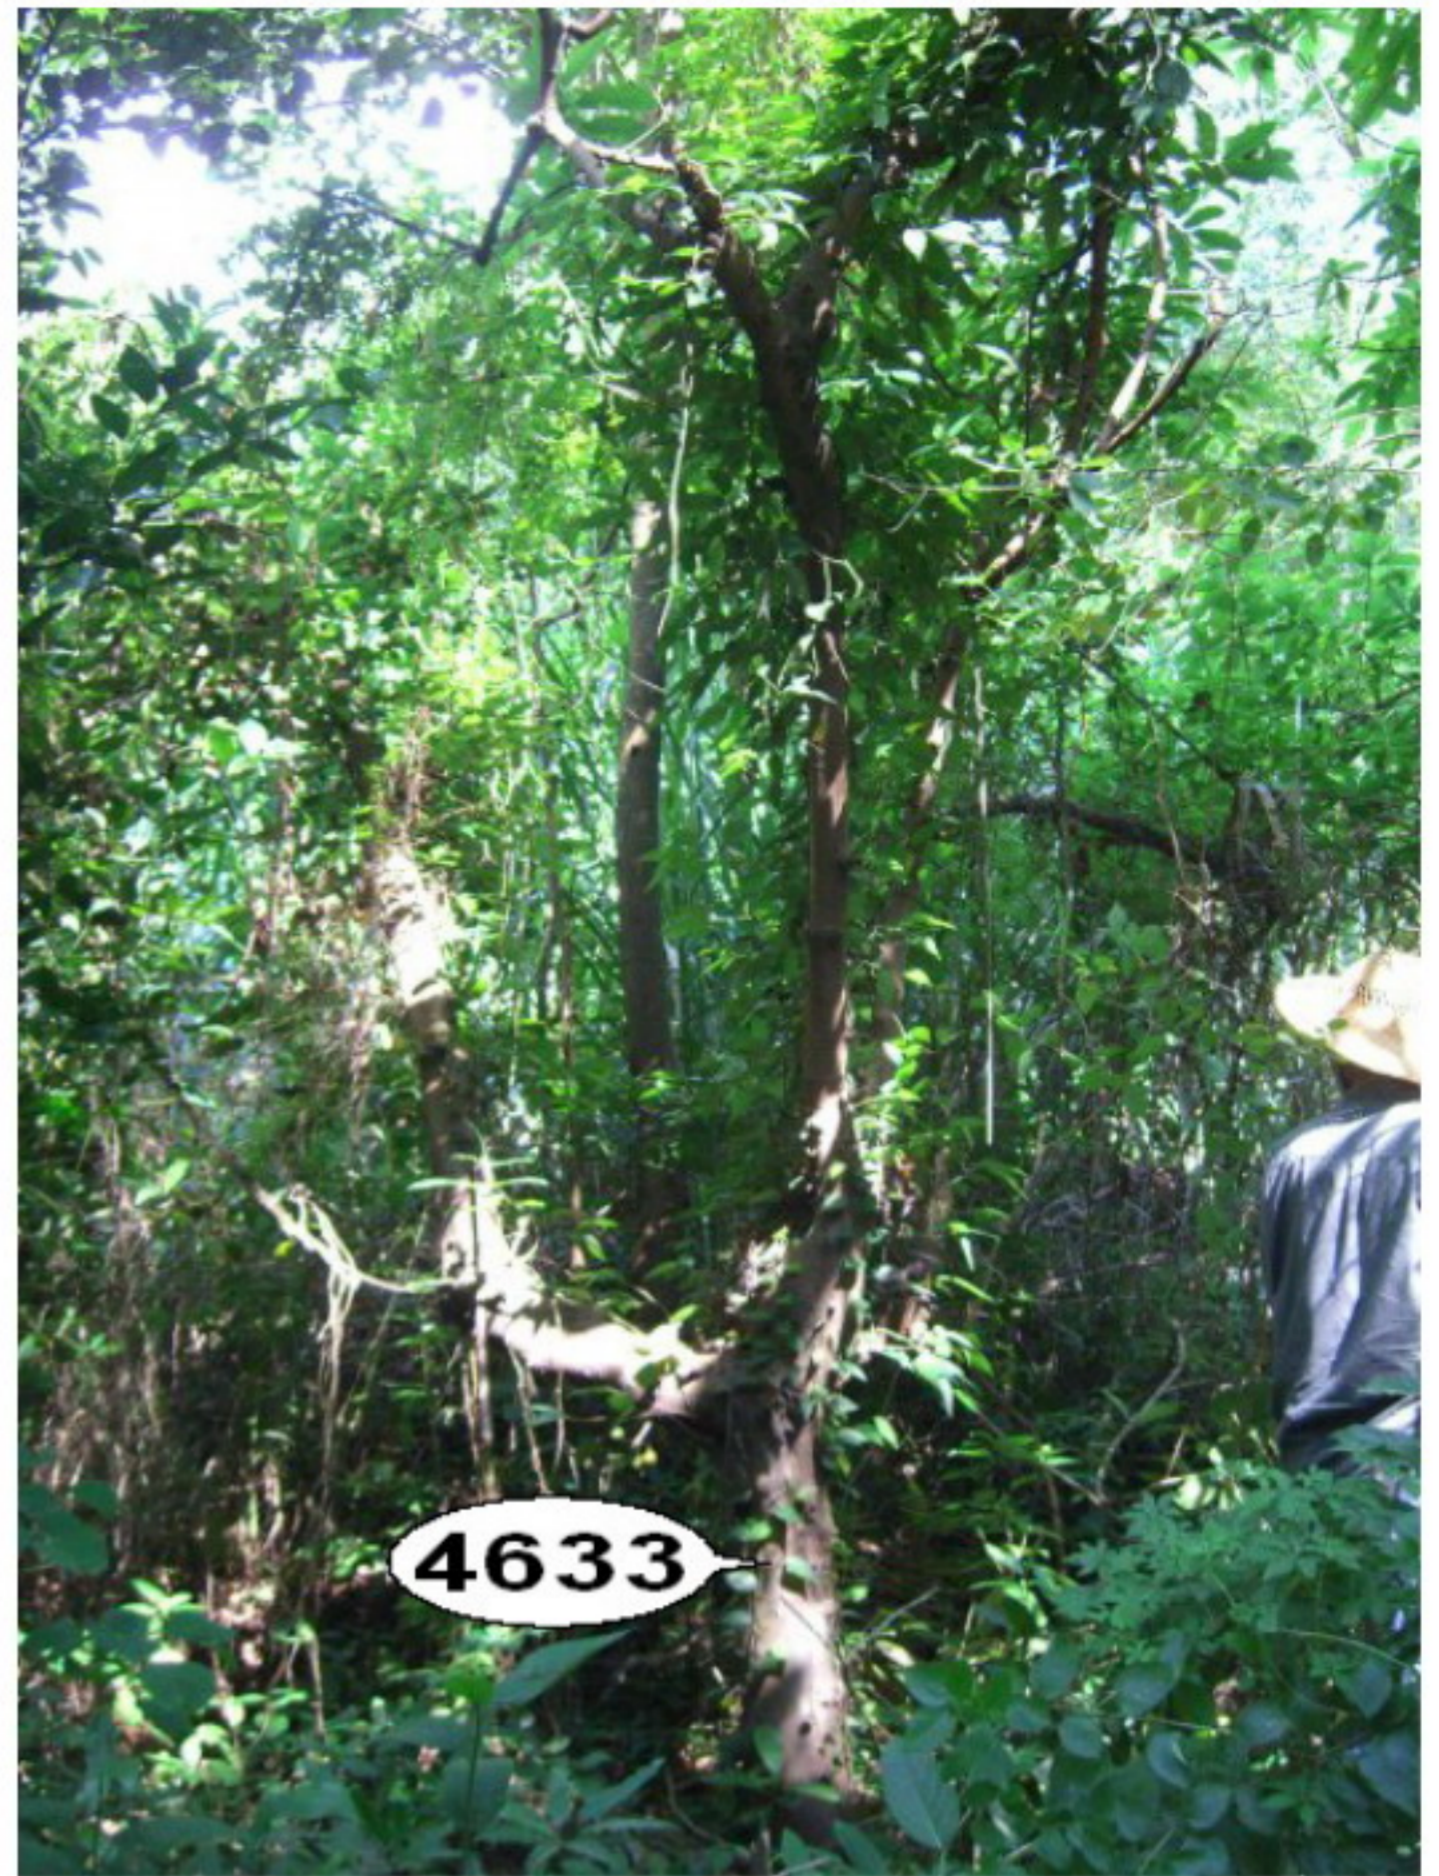
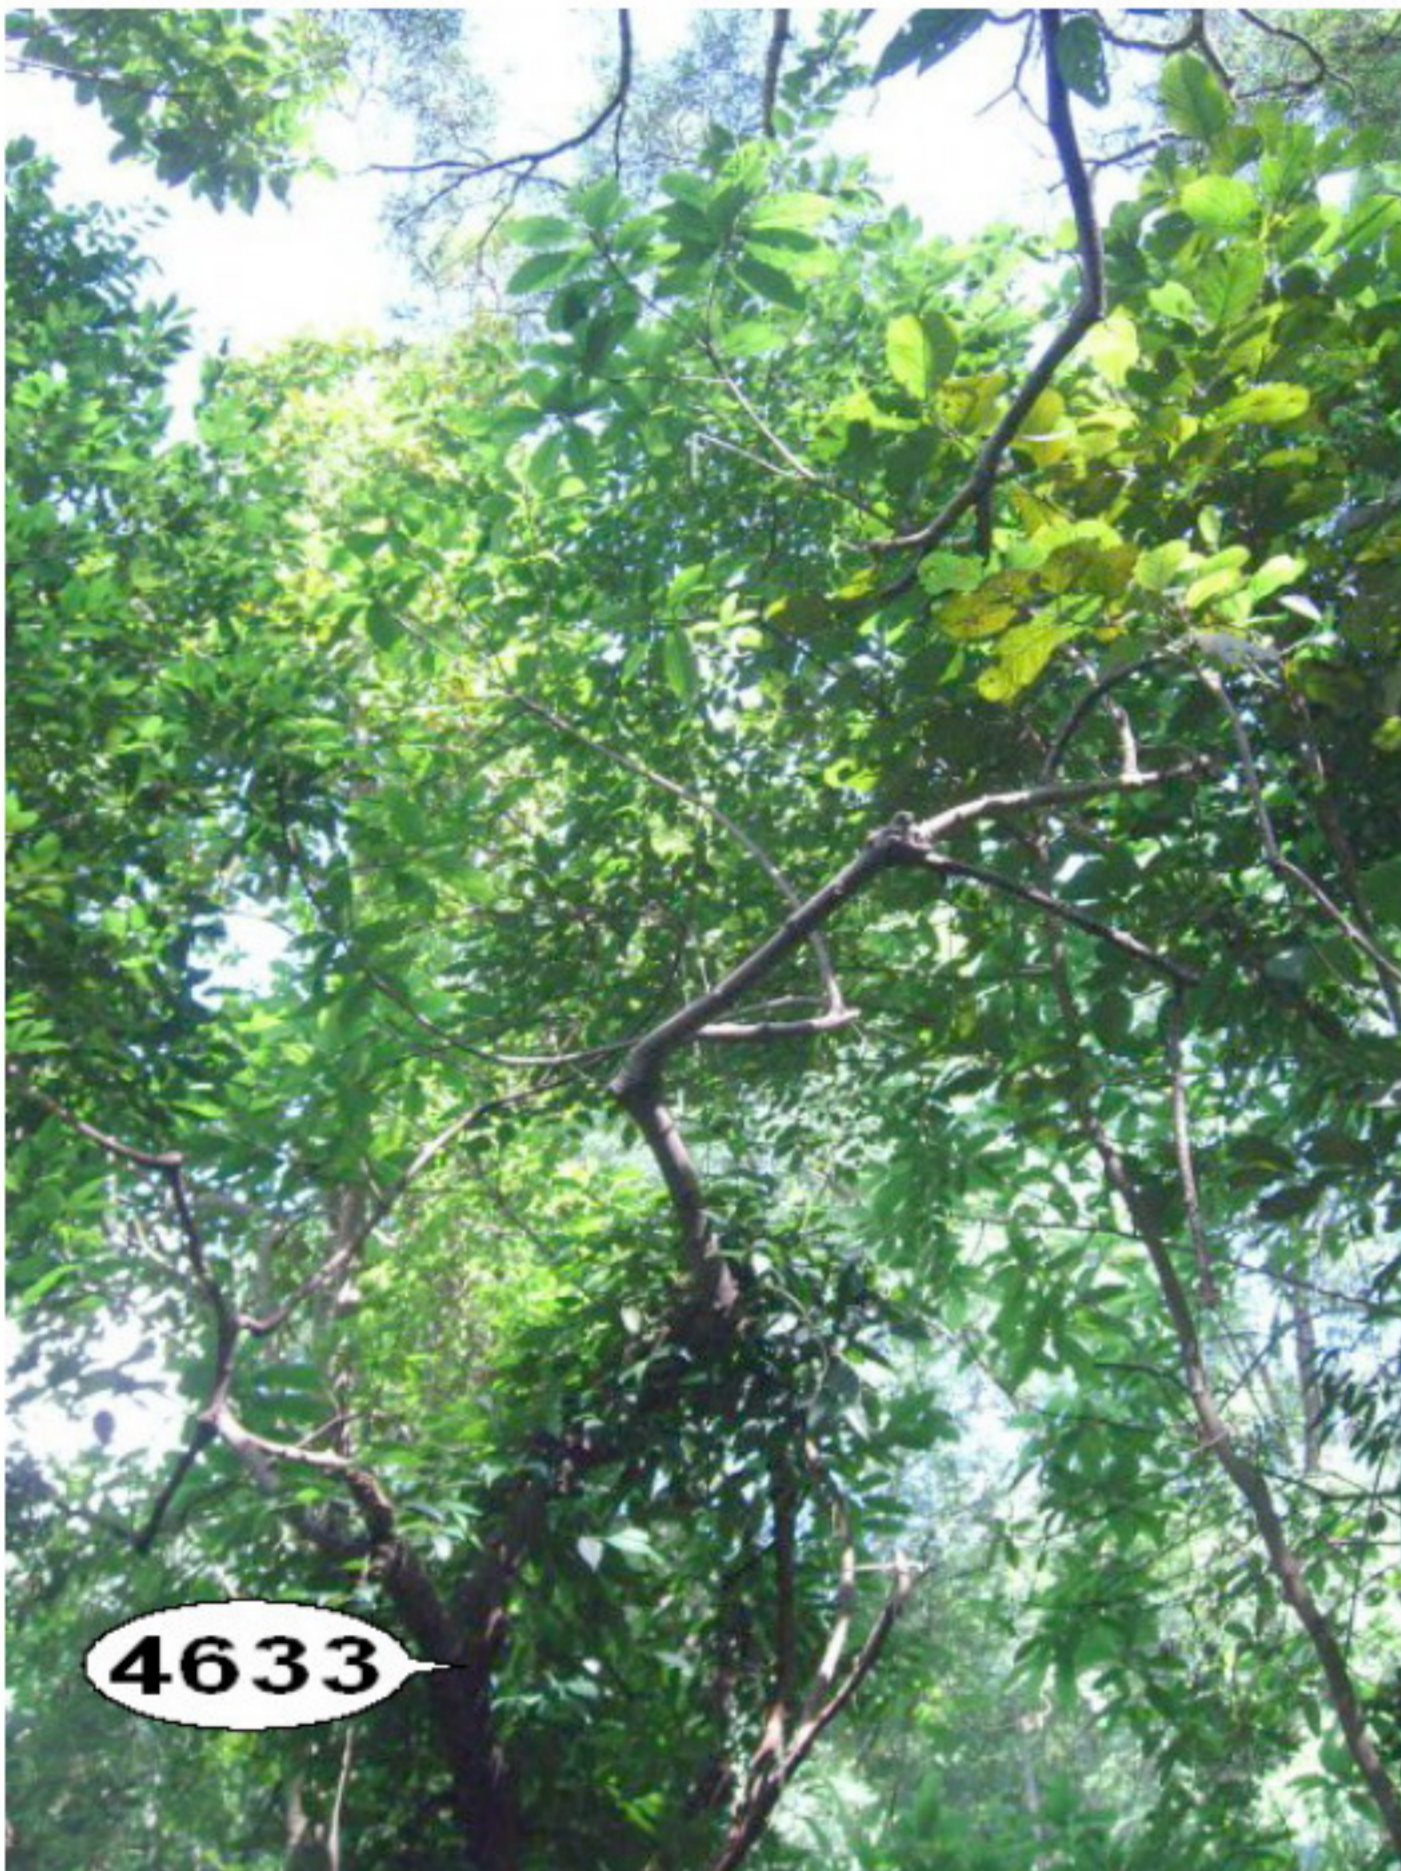
Tree 4632  
This species is generally poor in transplantation survival rate.
