# Provision of Cremators at Wo Hop Shek Crematorium

Tree Survey Report

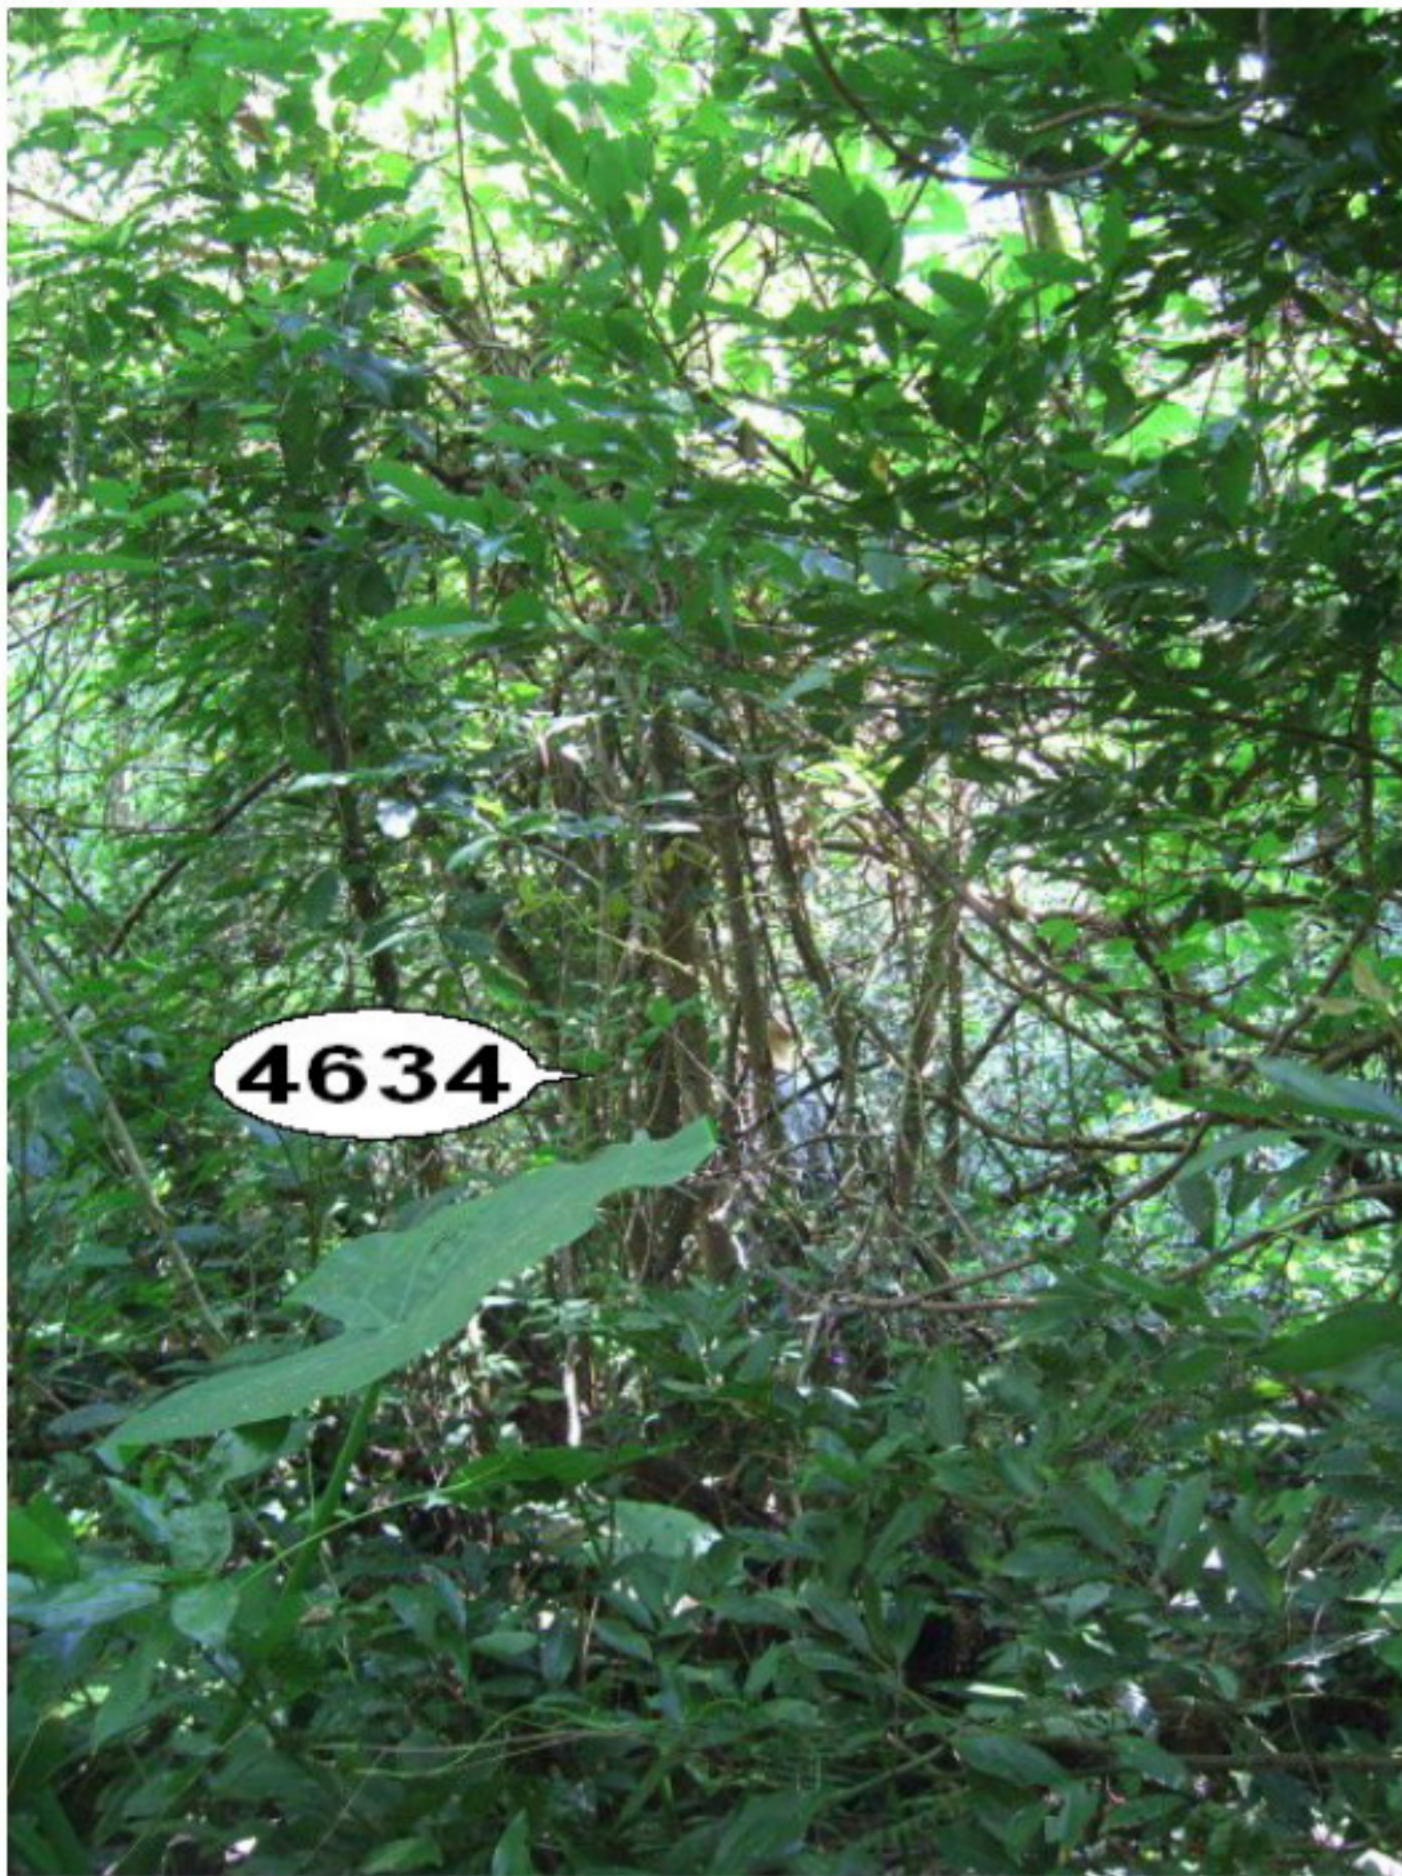
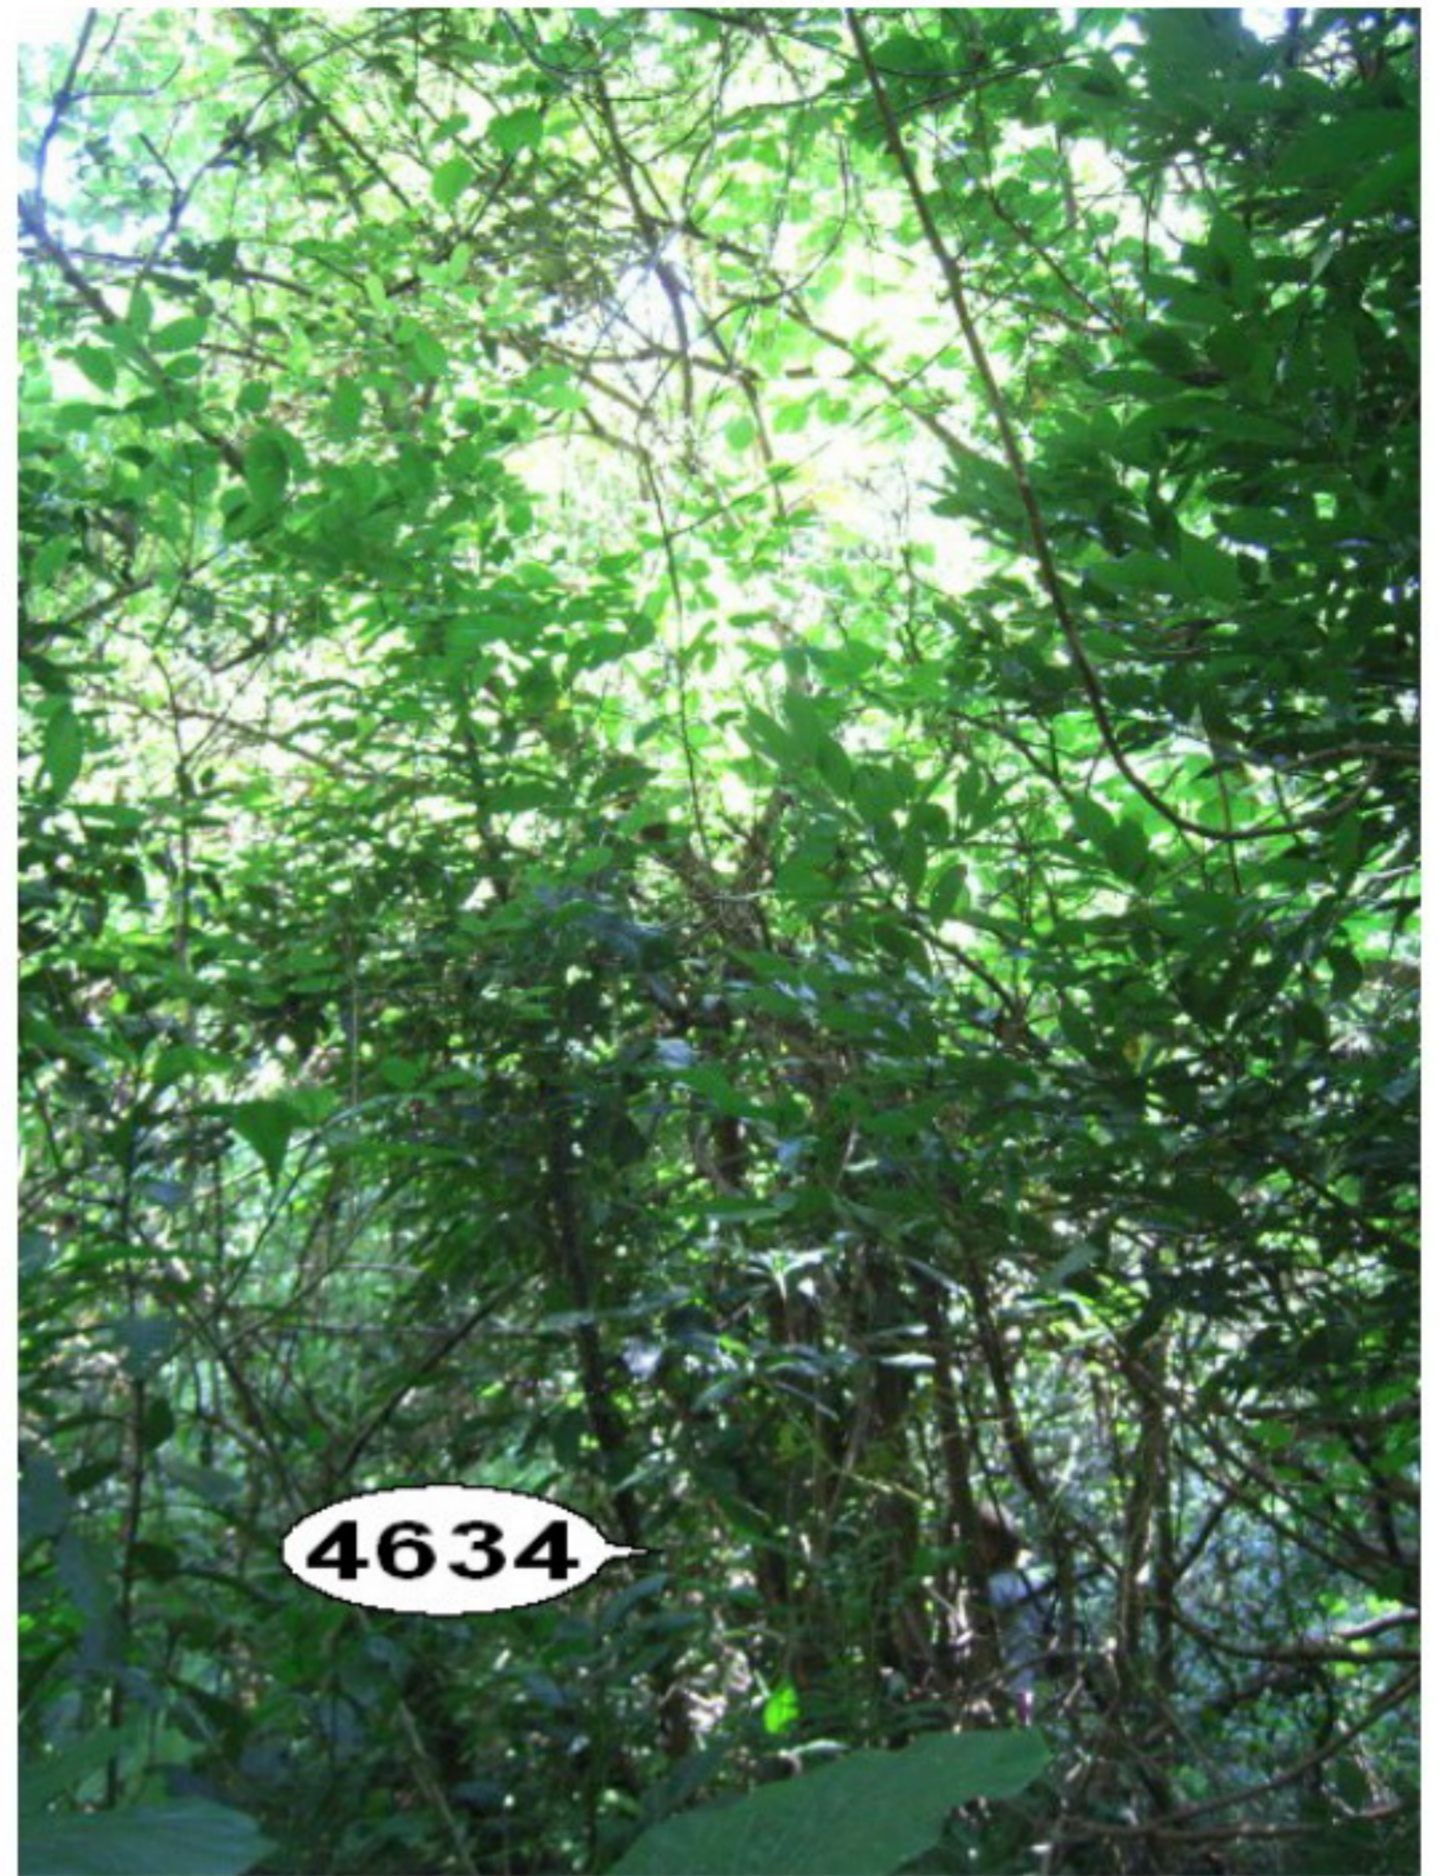
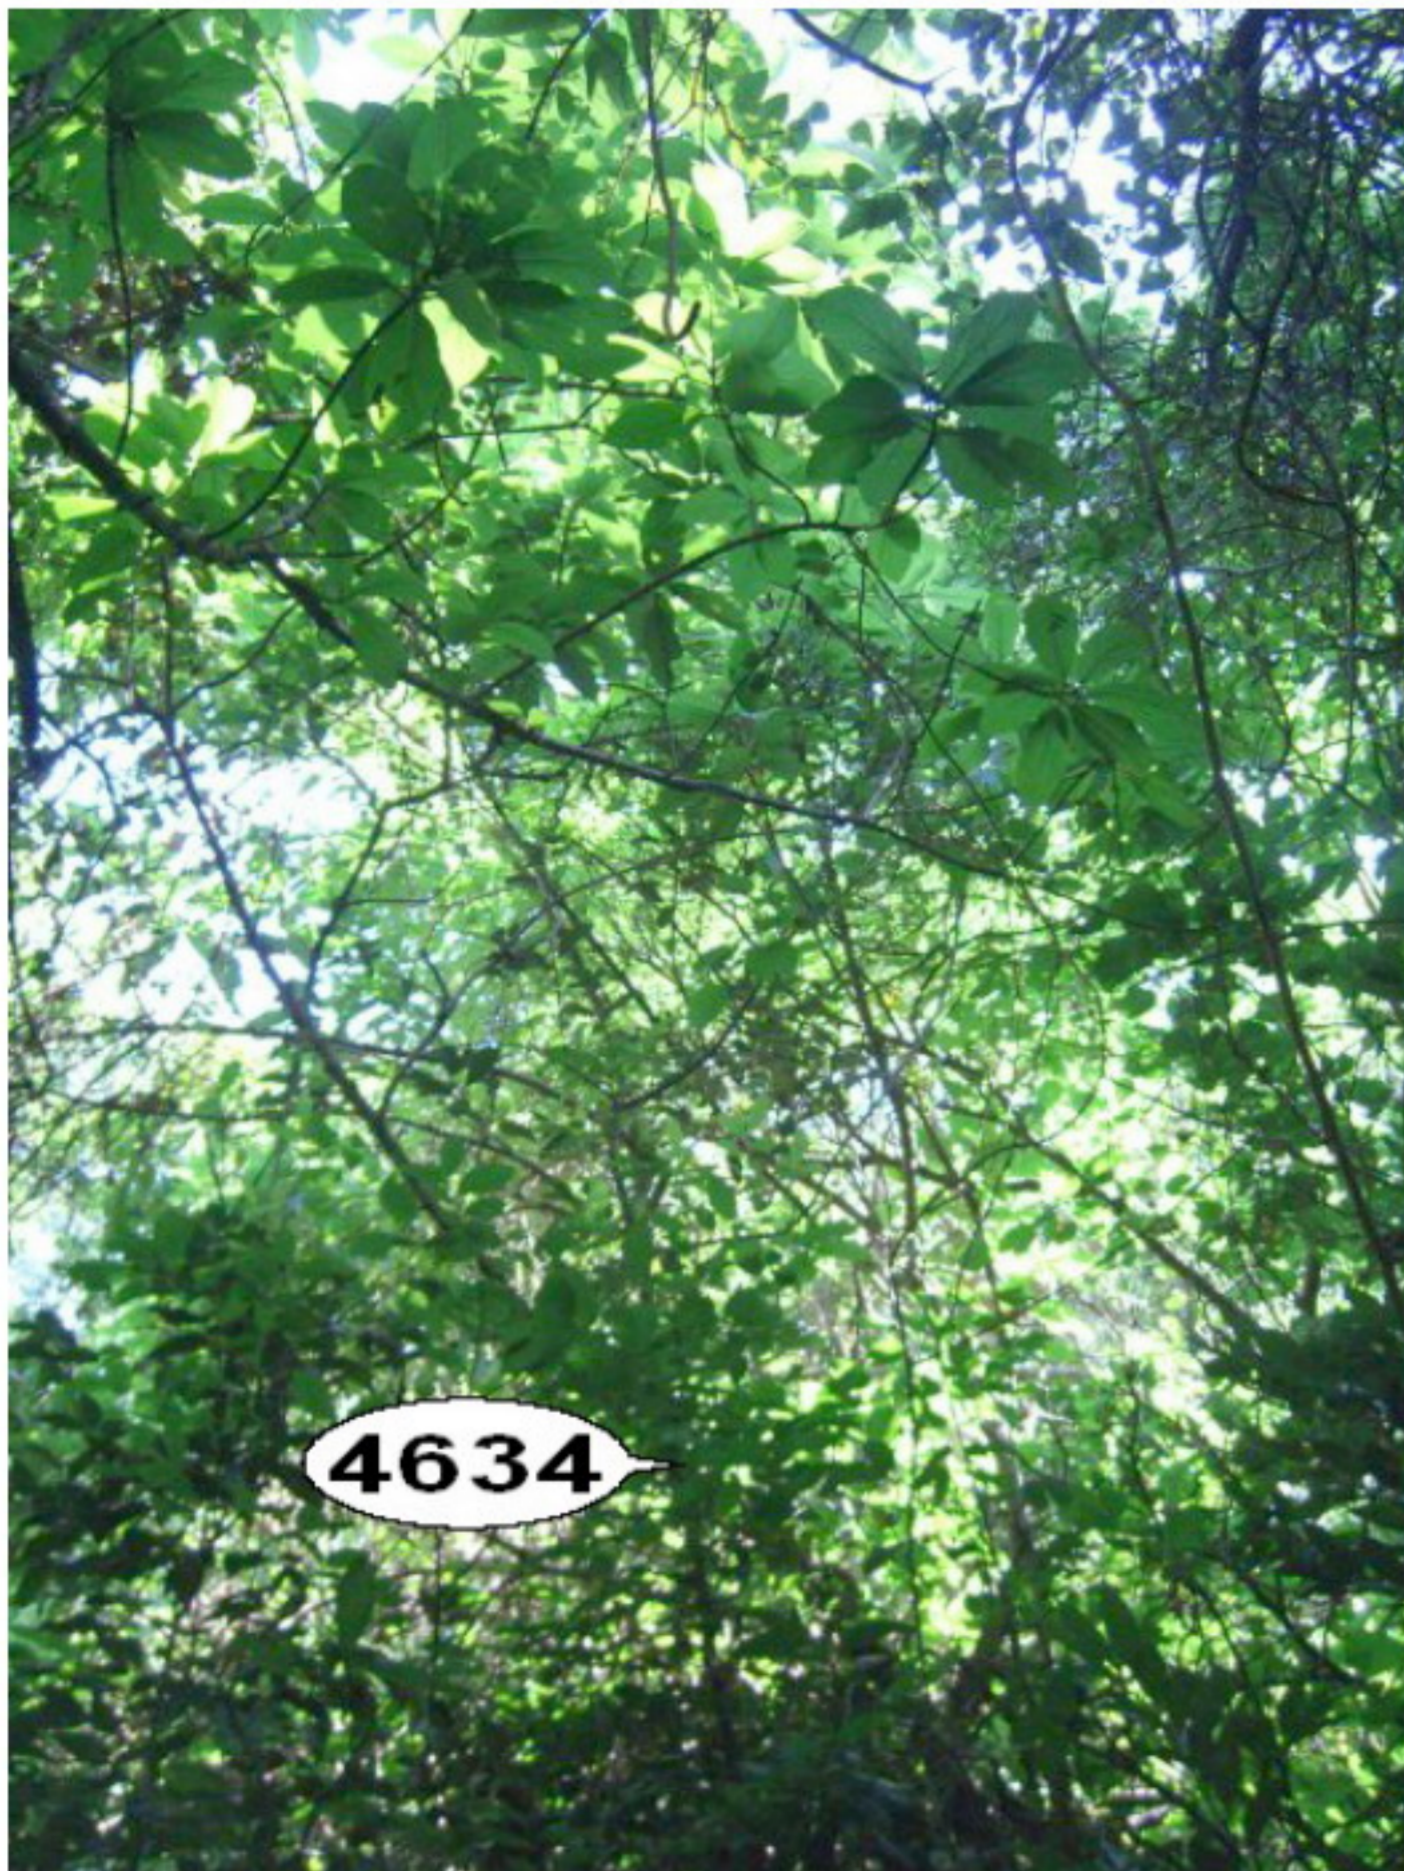
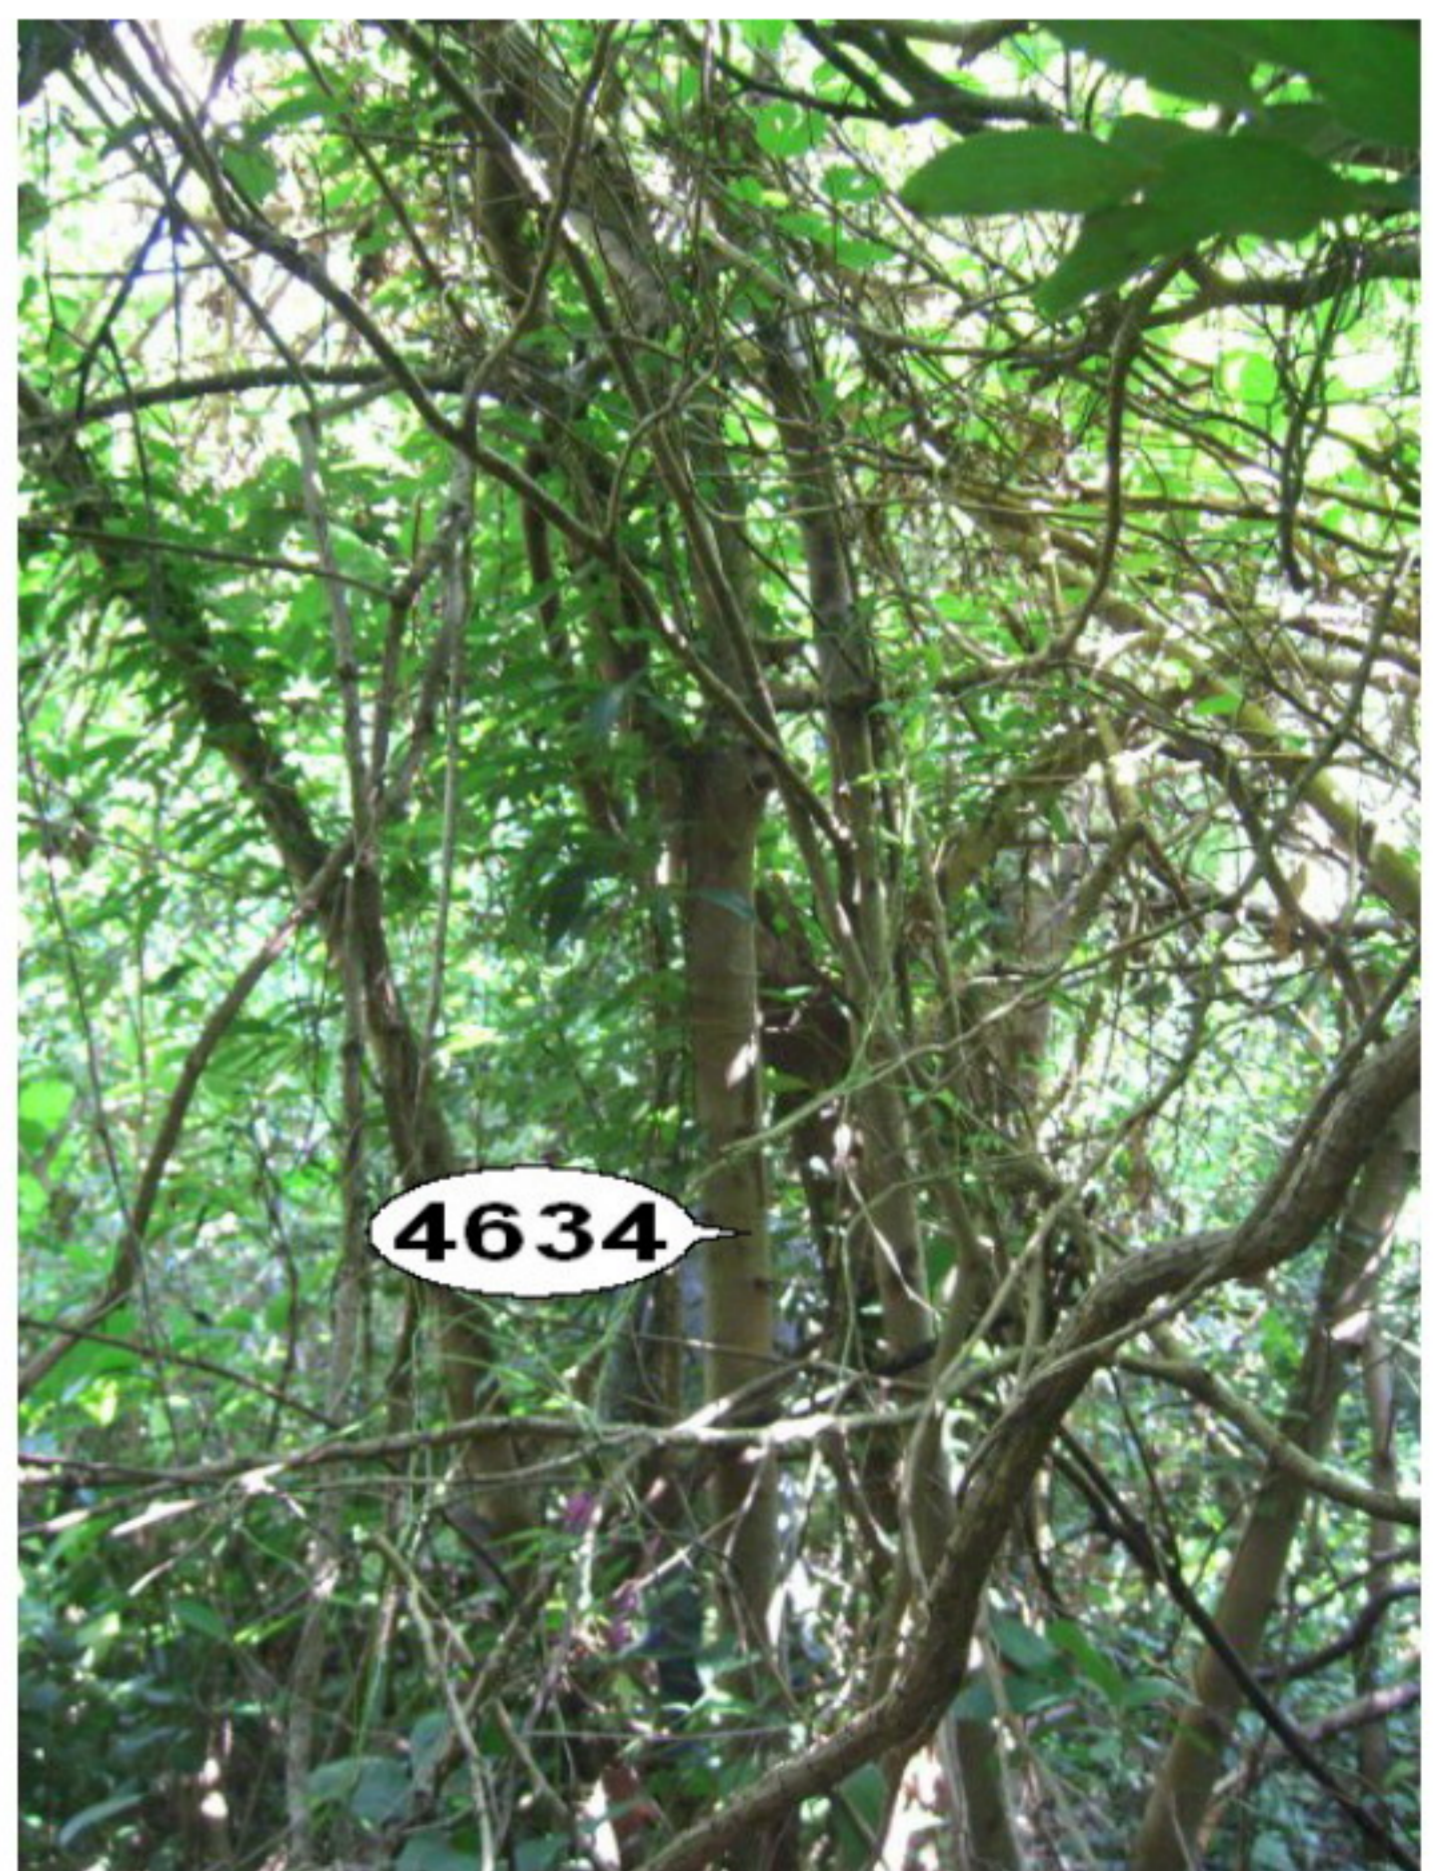
Tree 4633  
Poor health will lead to low transplantation survival rate.

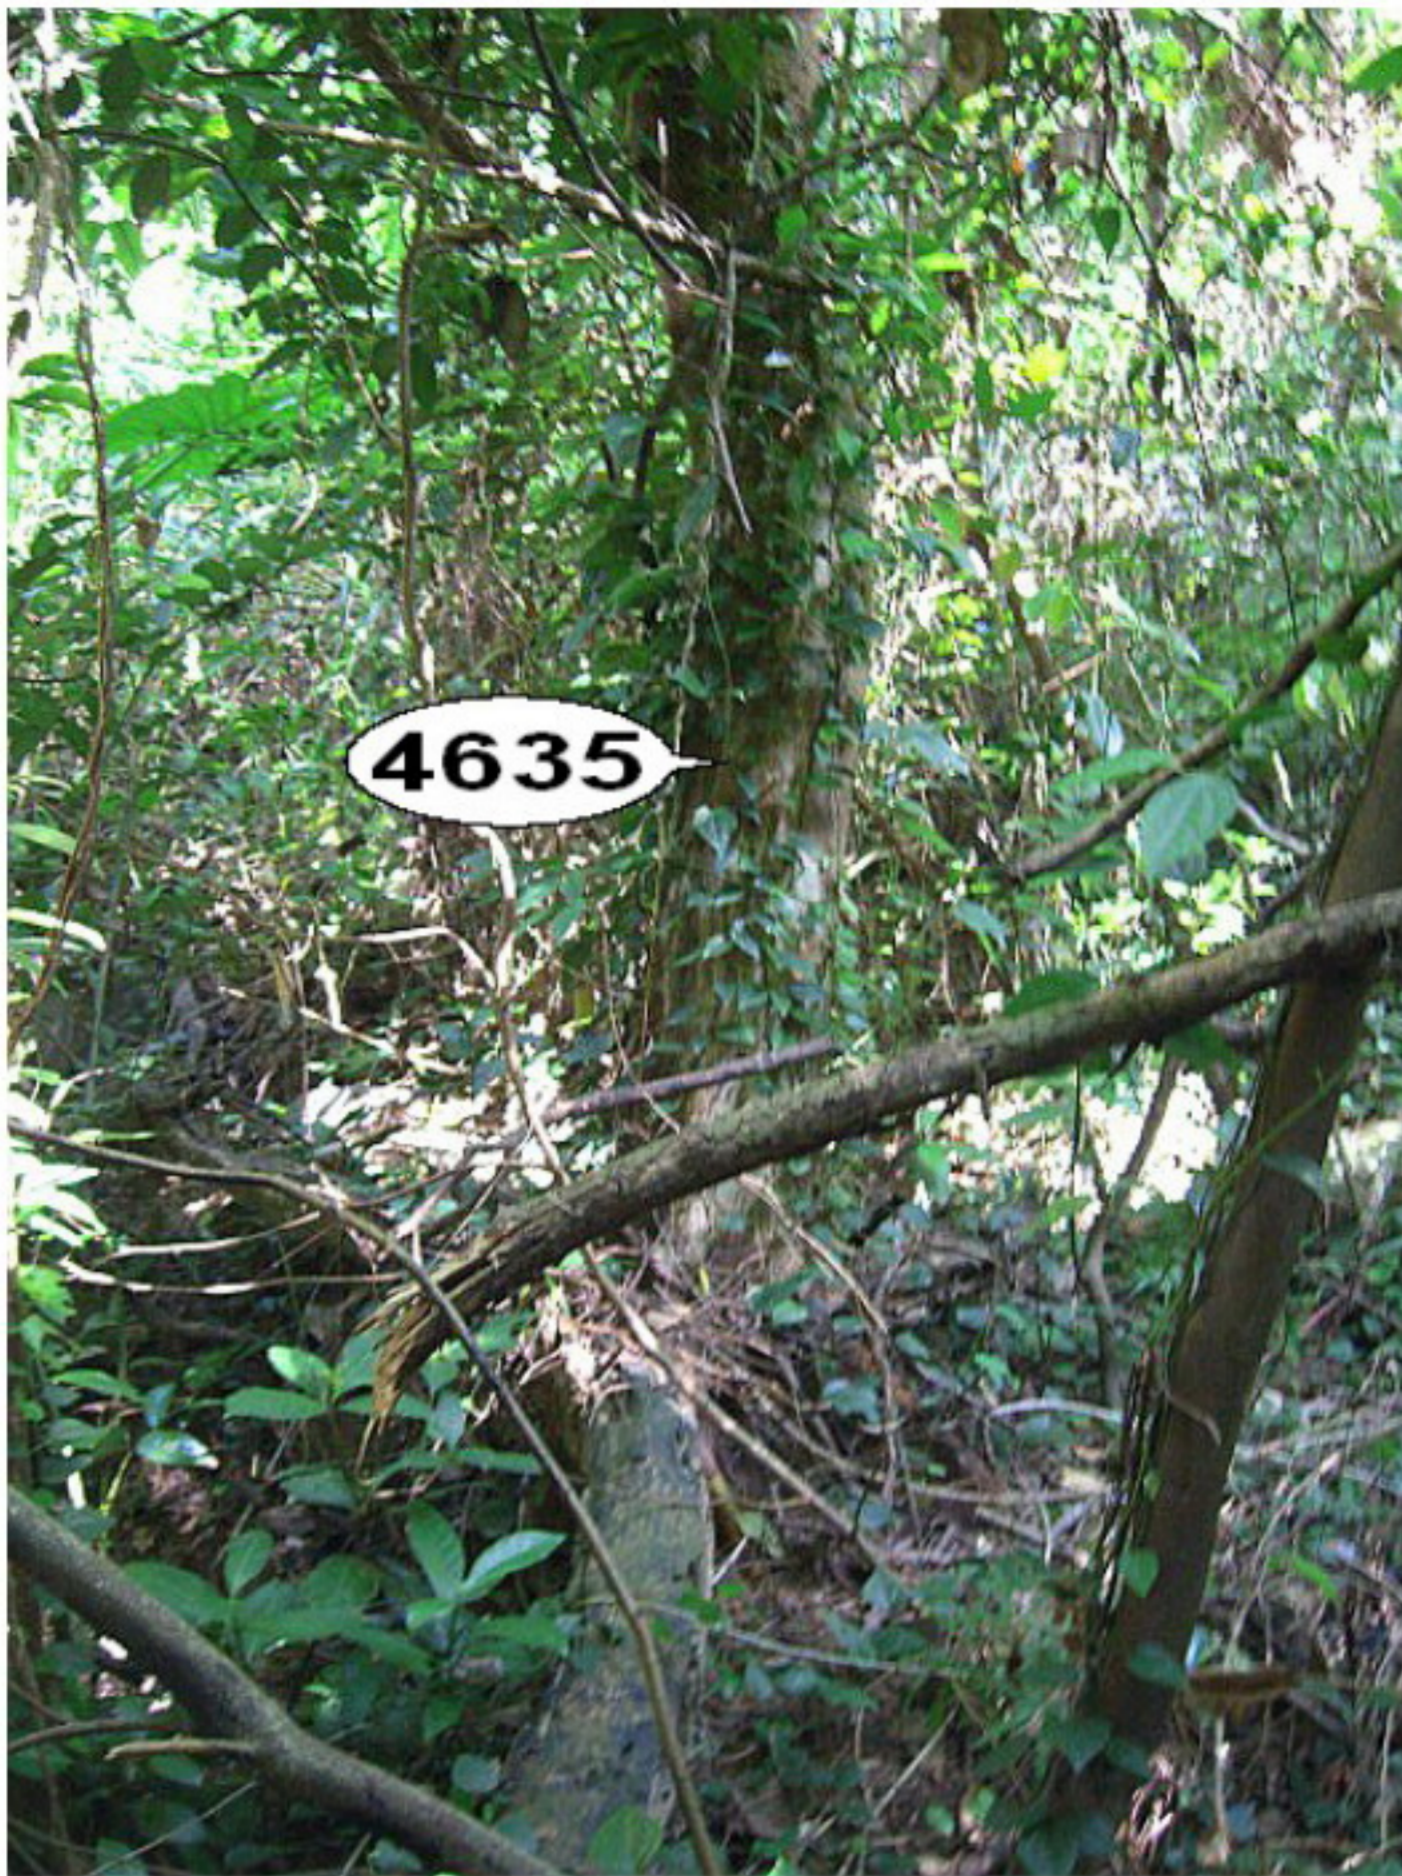
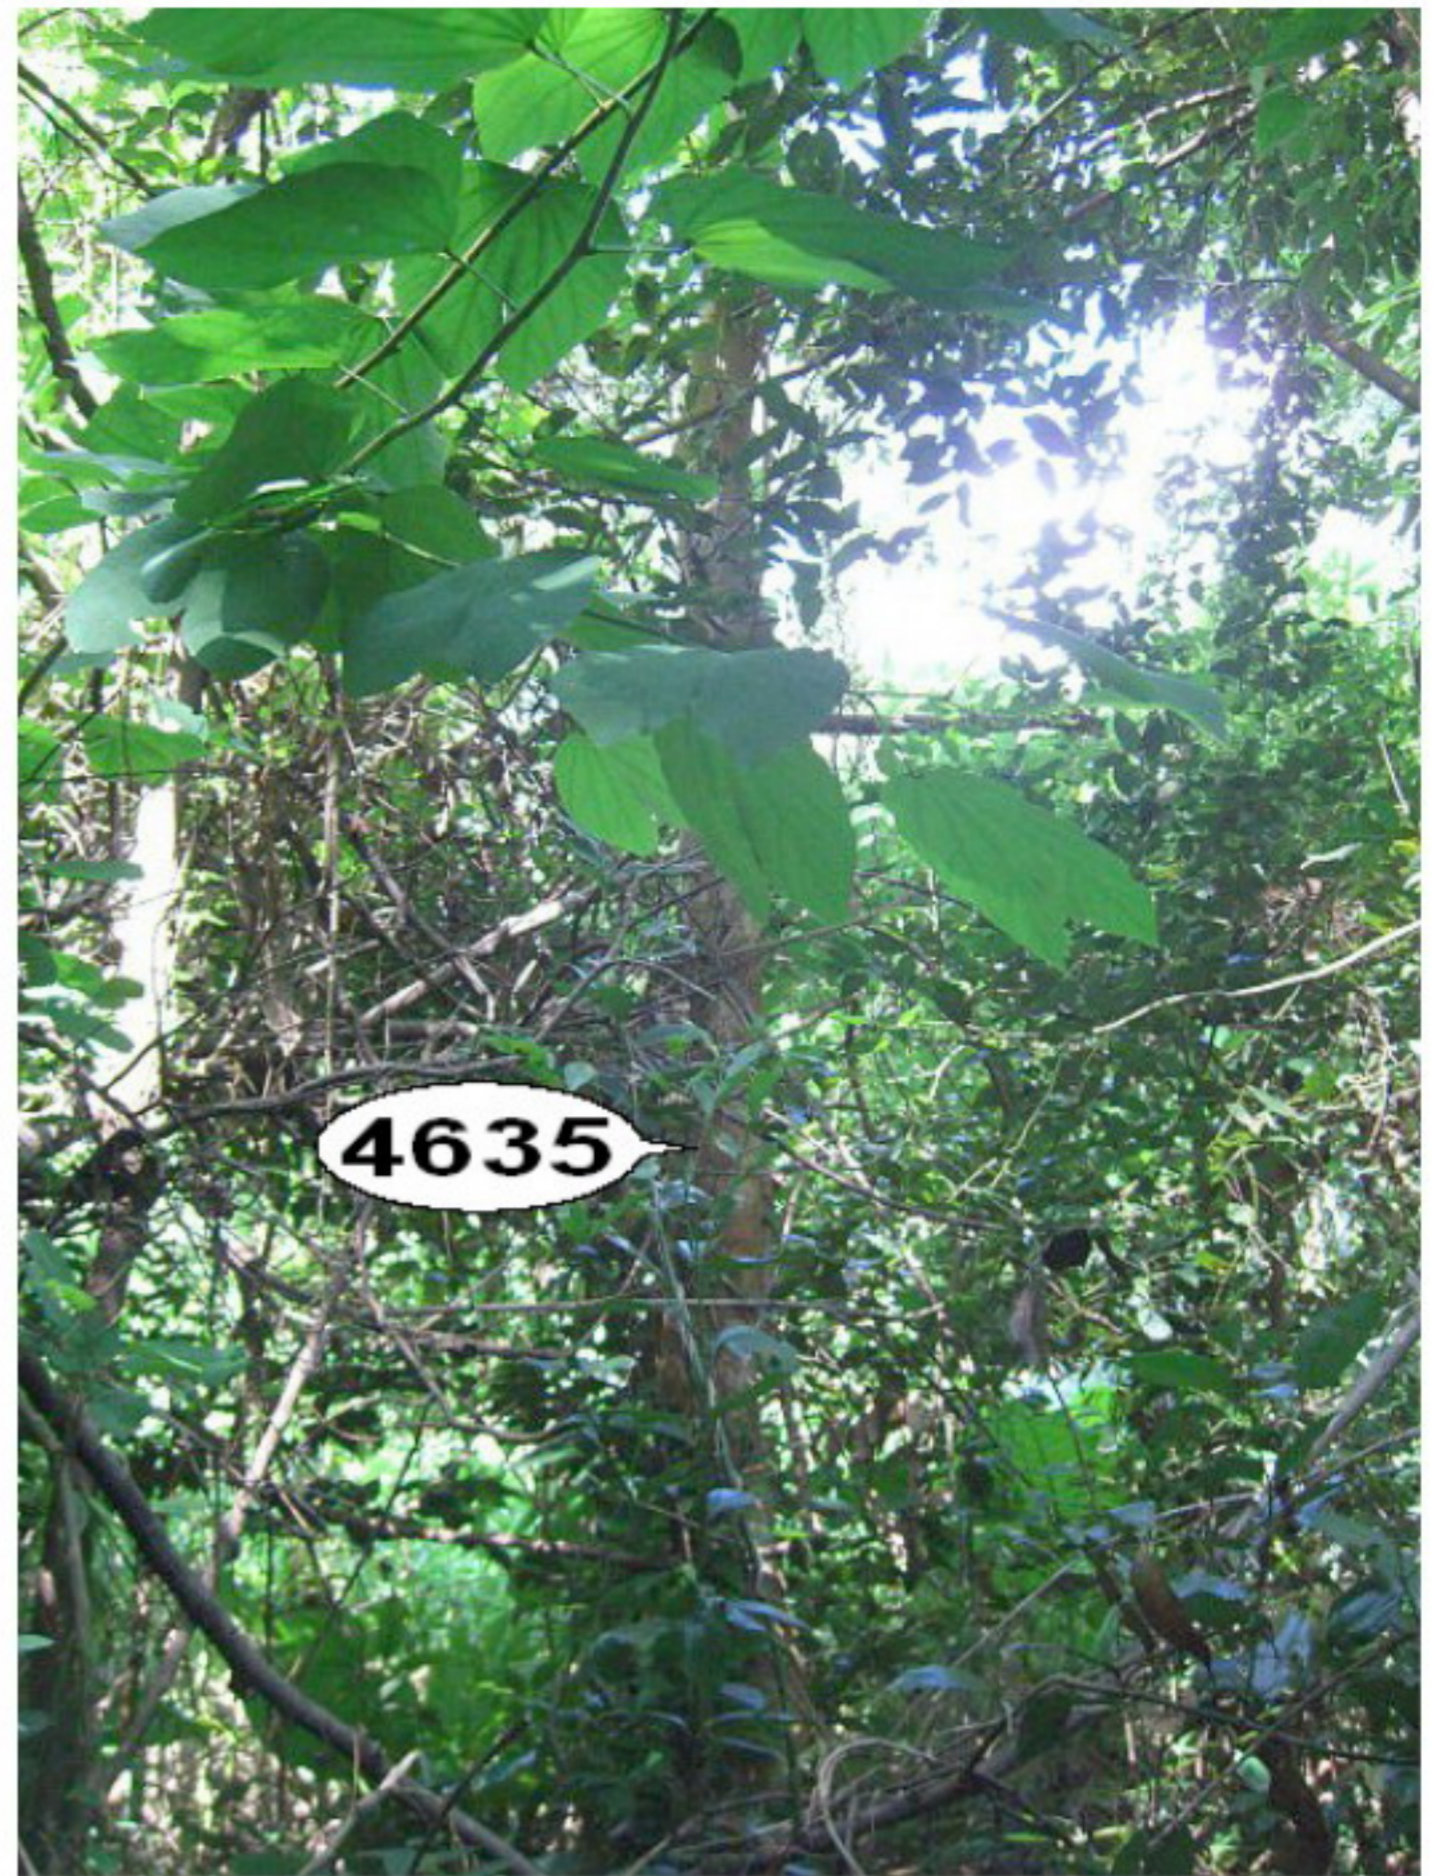
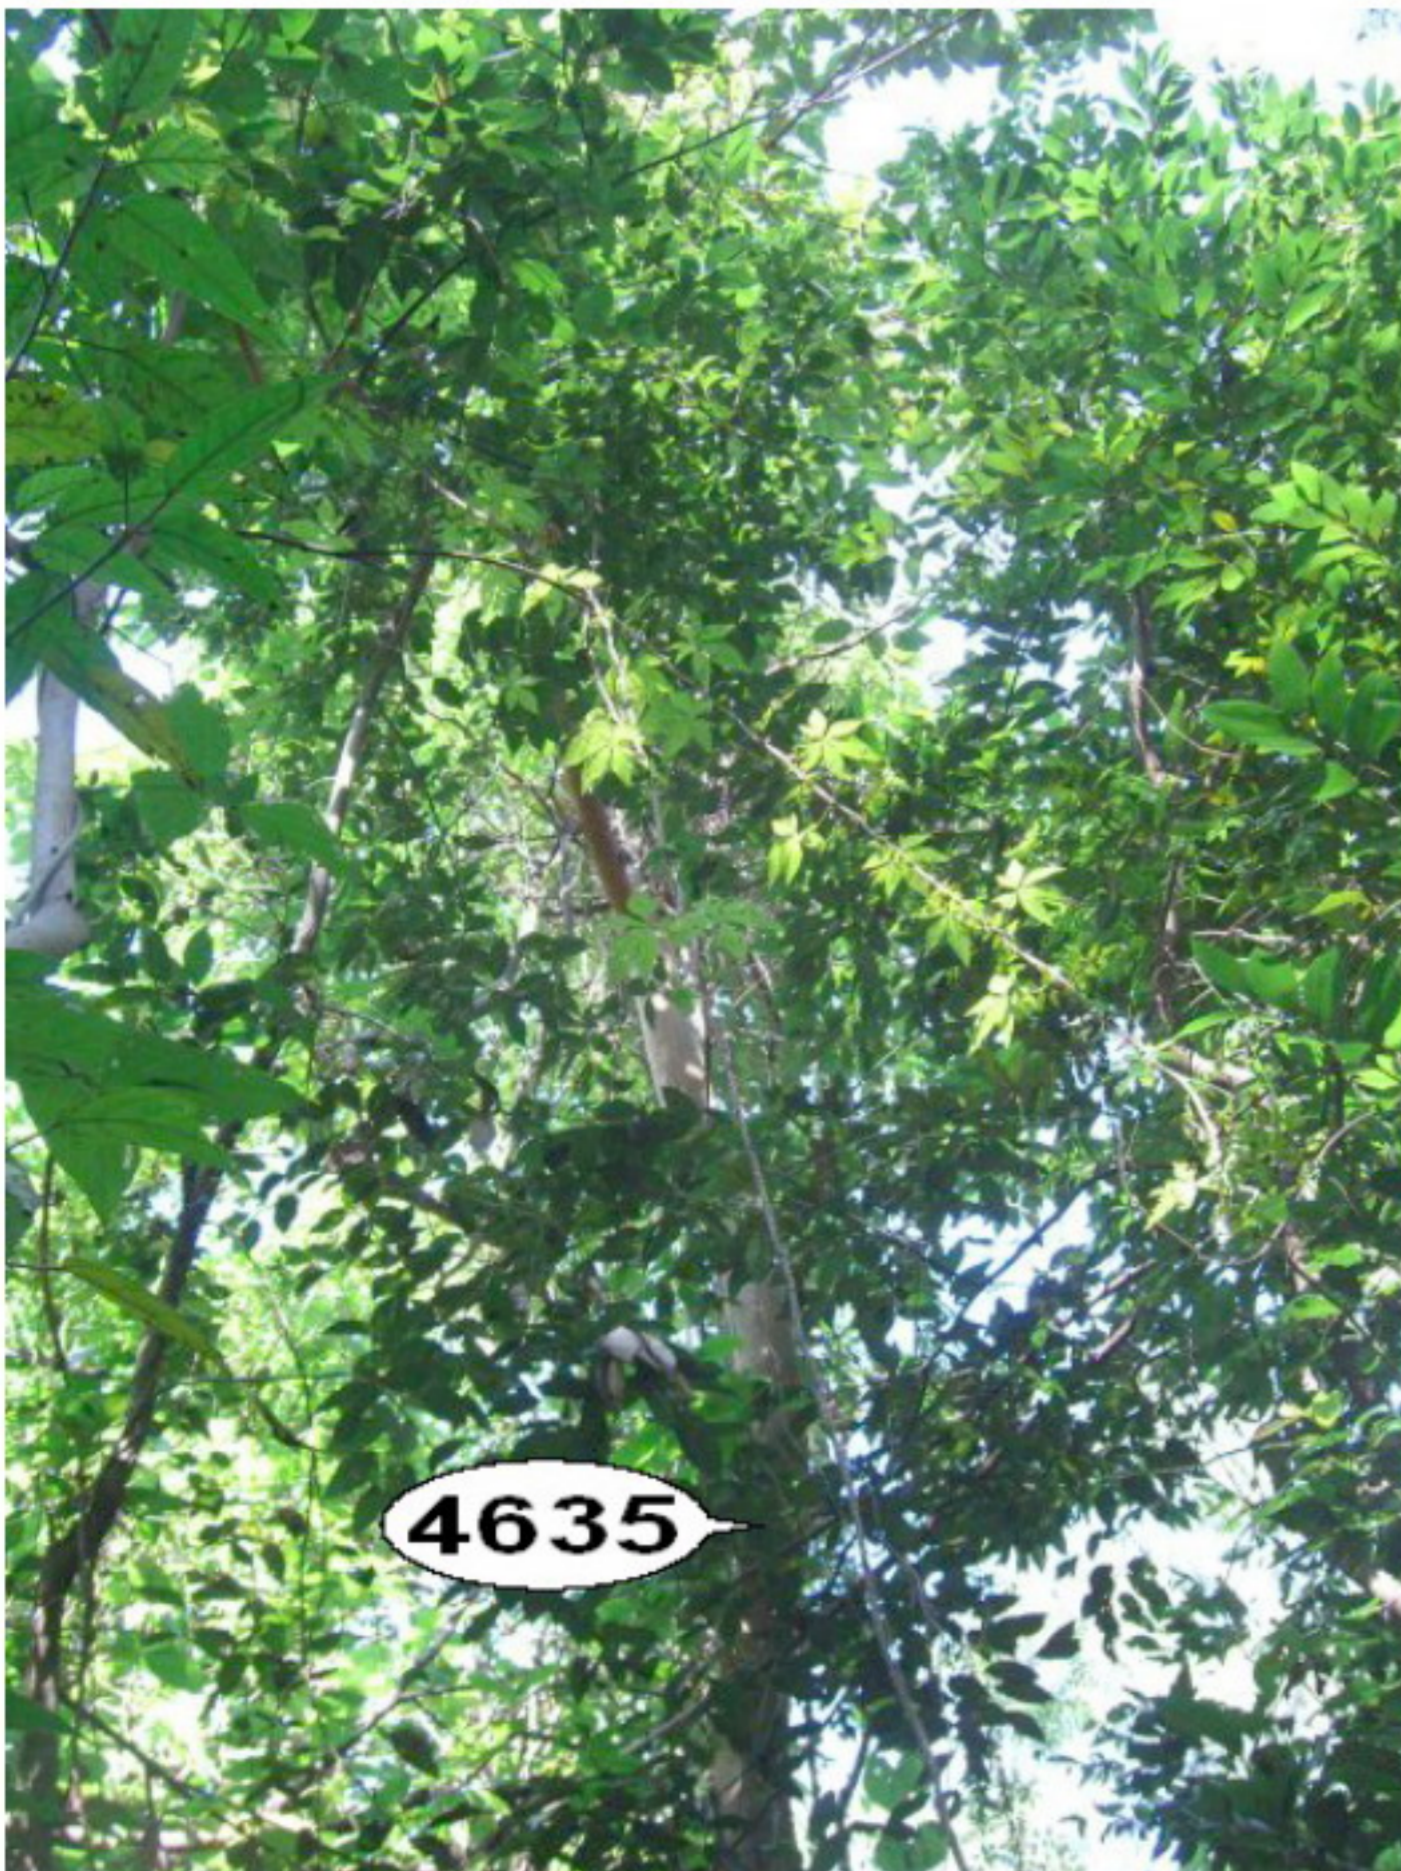
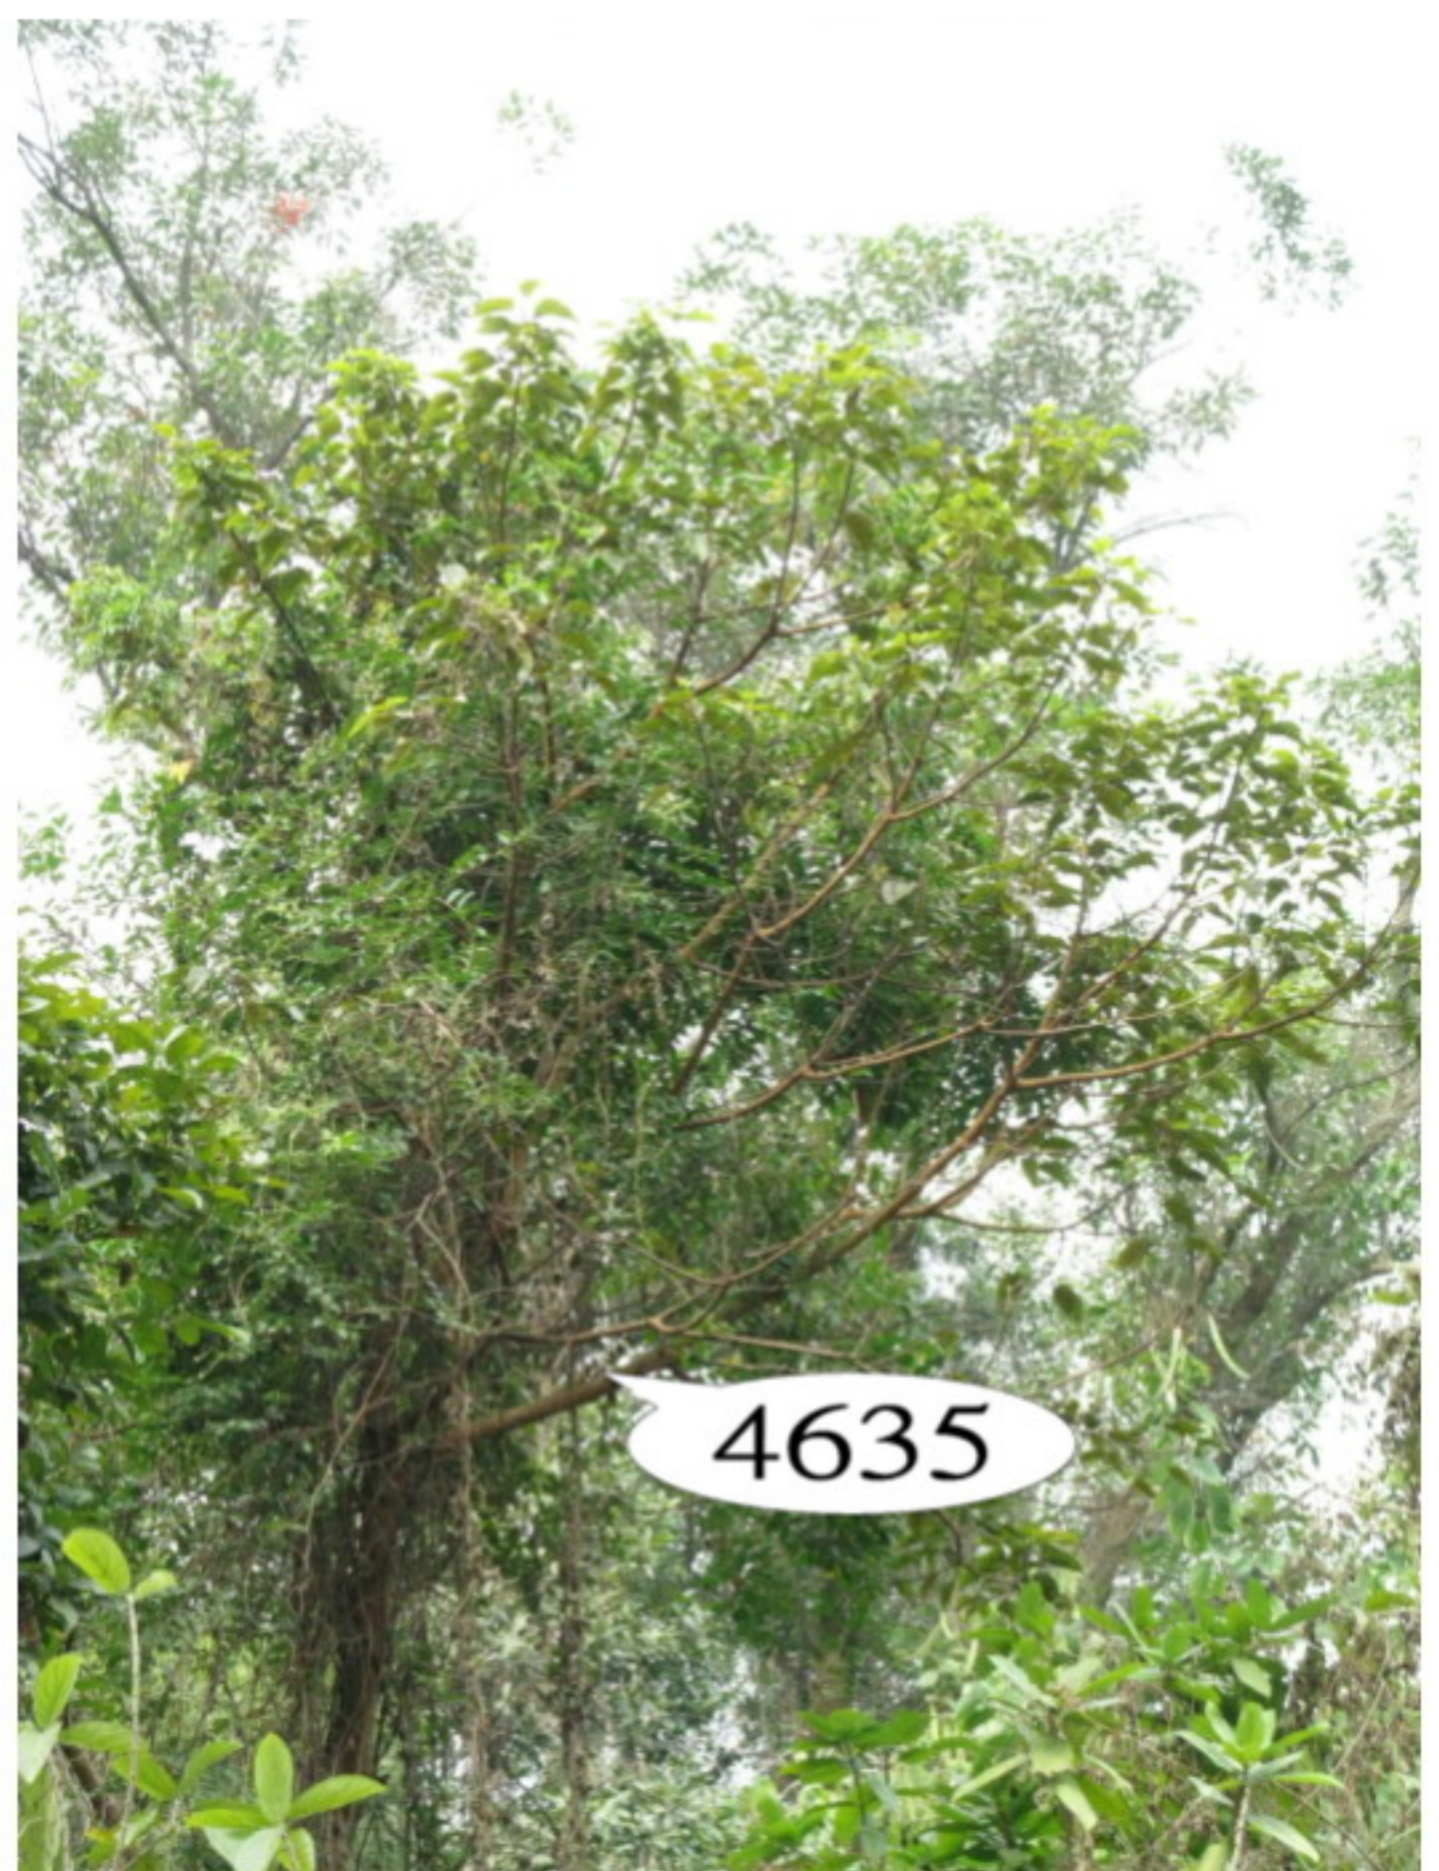
Tree 4634  
Poor health will lead to low transplantation survival rate.
