# Provision of Cremators at Wo Hop Shek Crematorium

Tree Survey Report

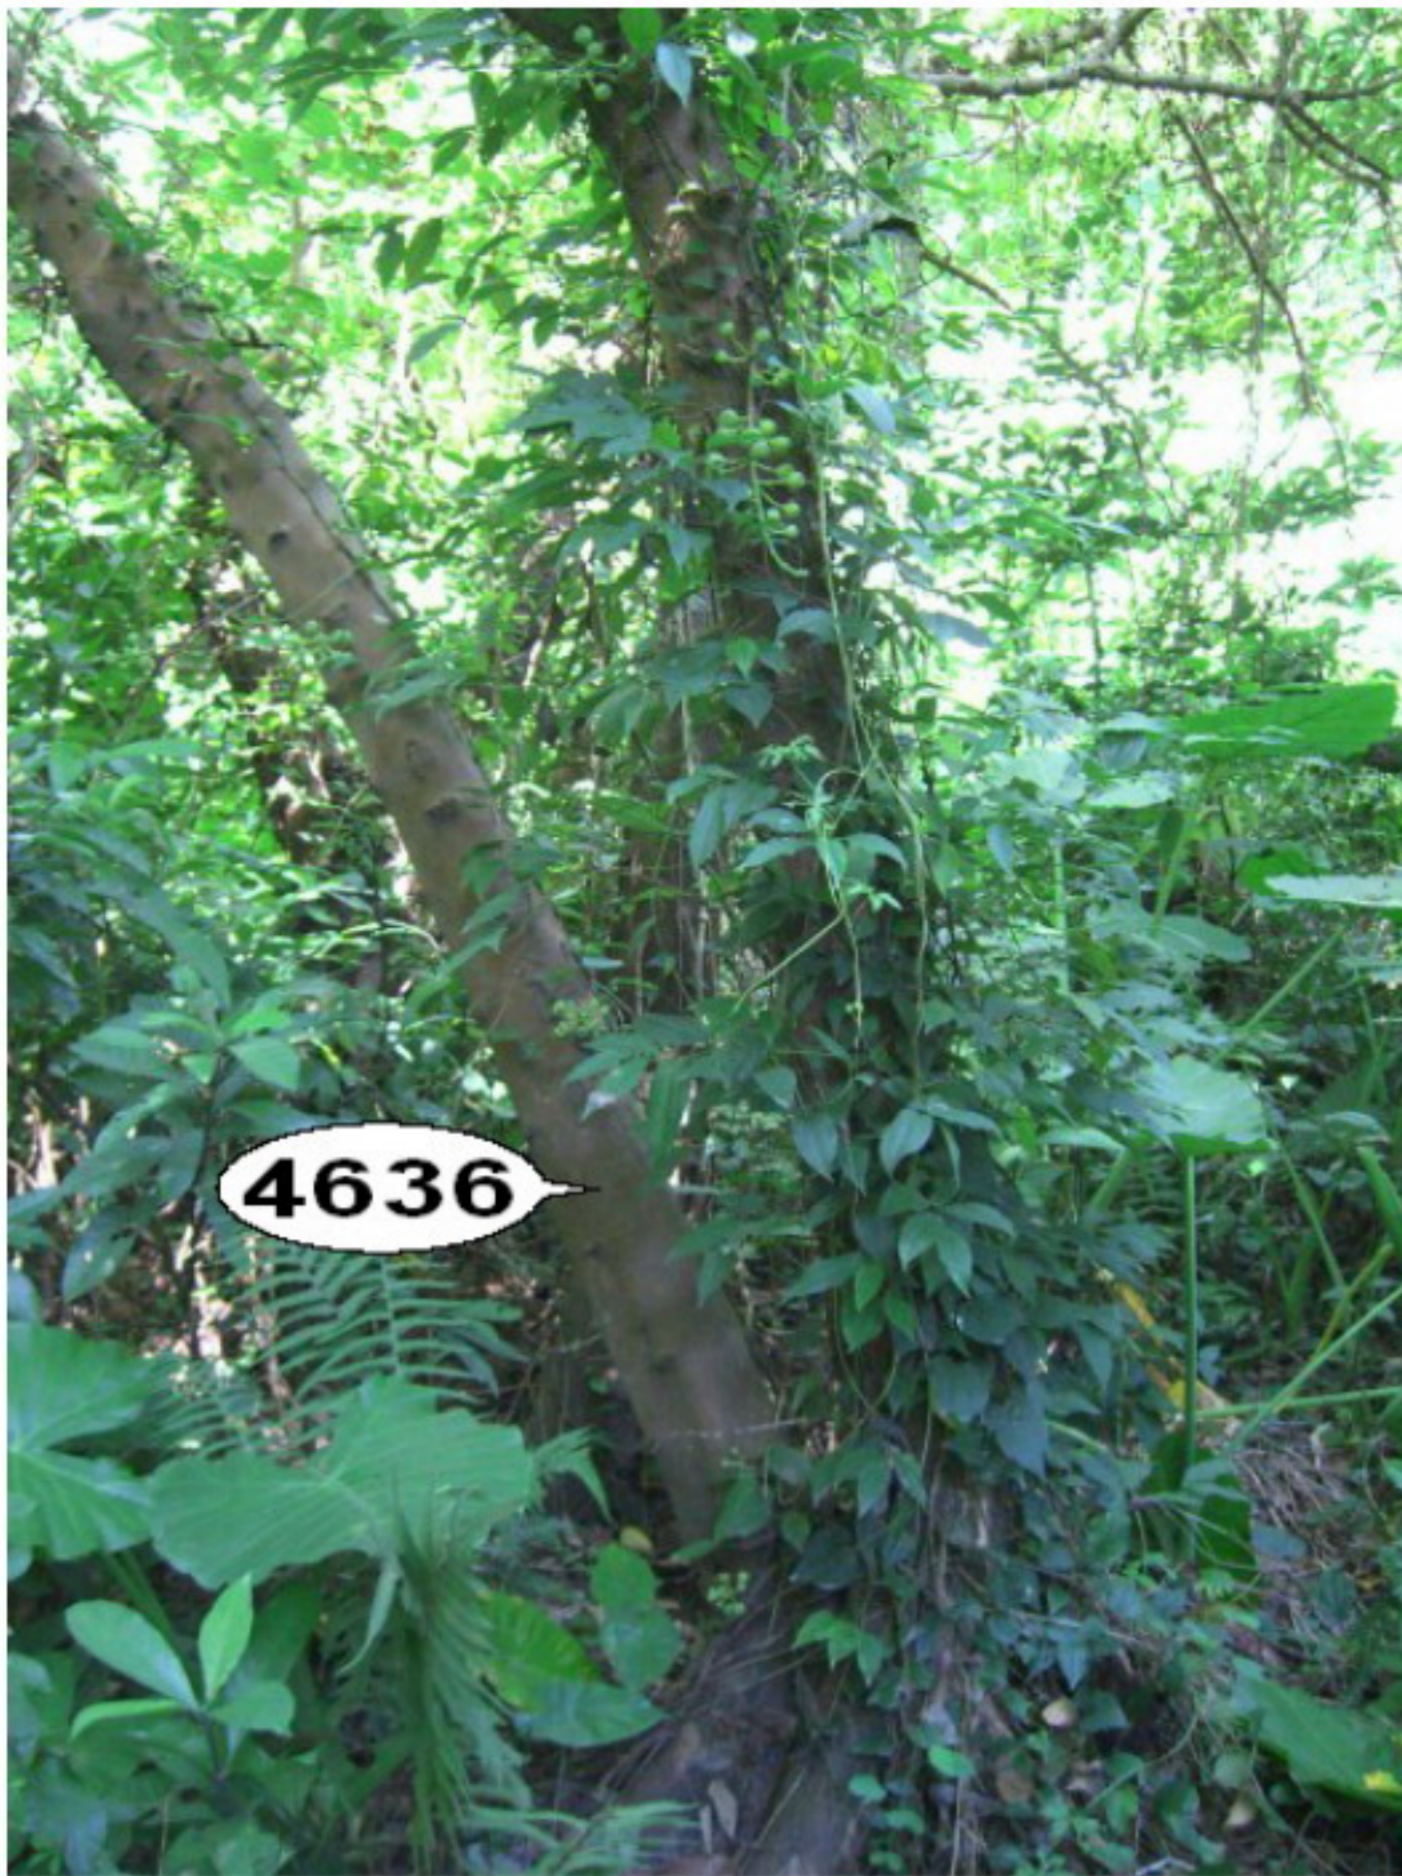
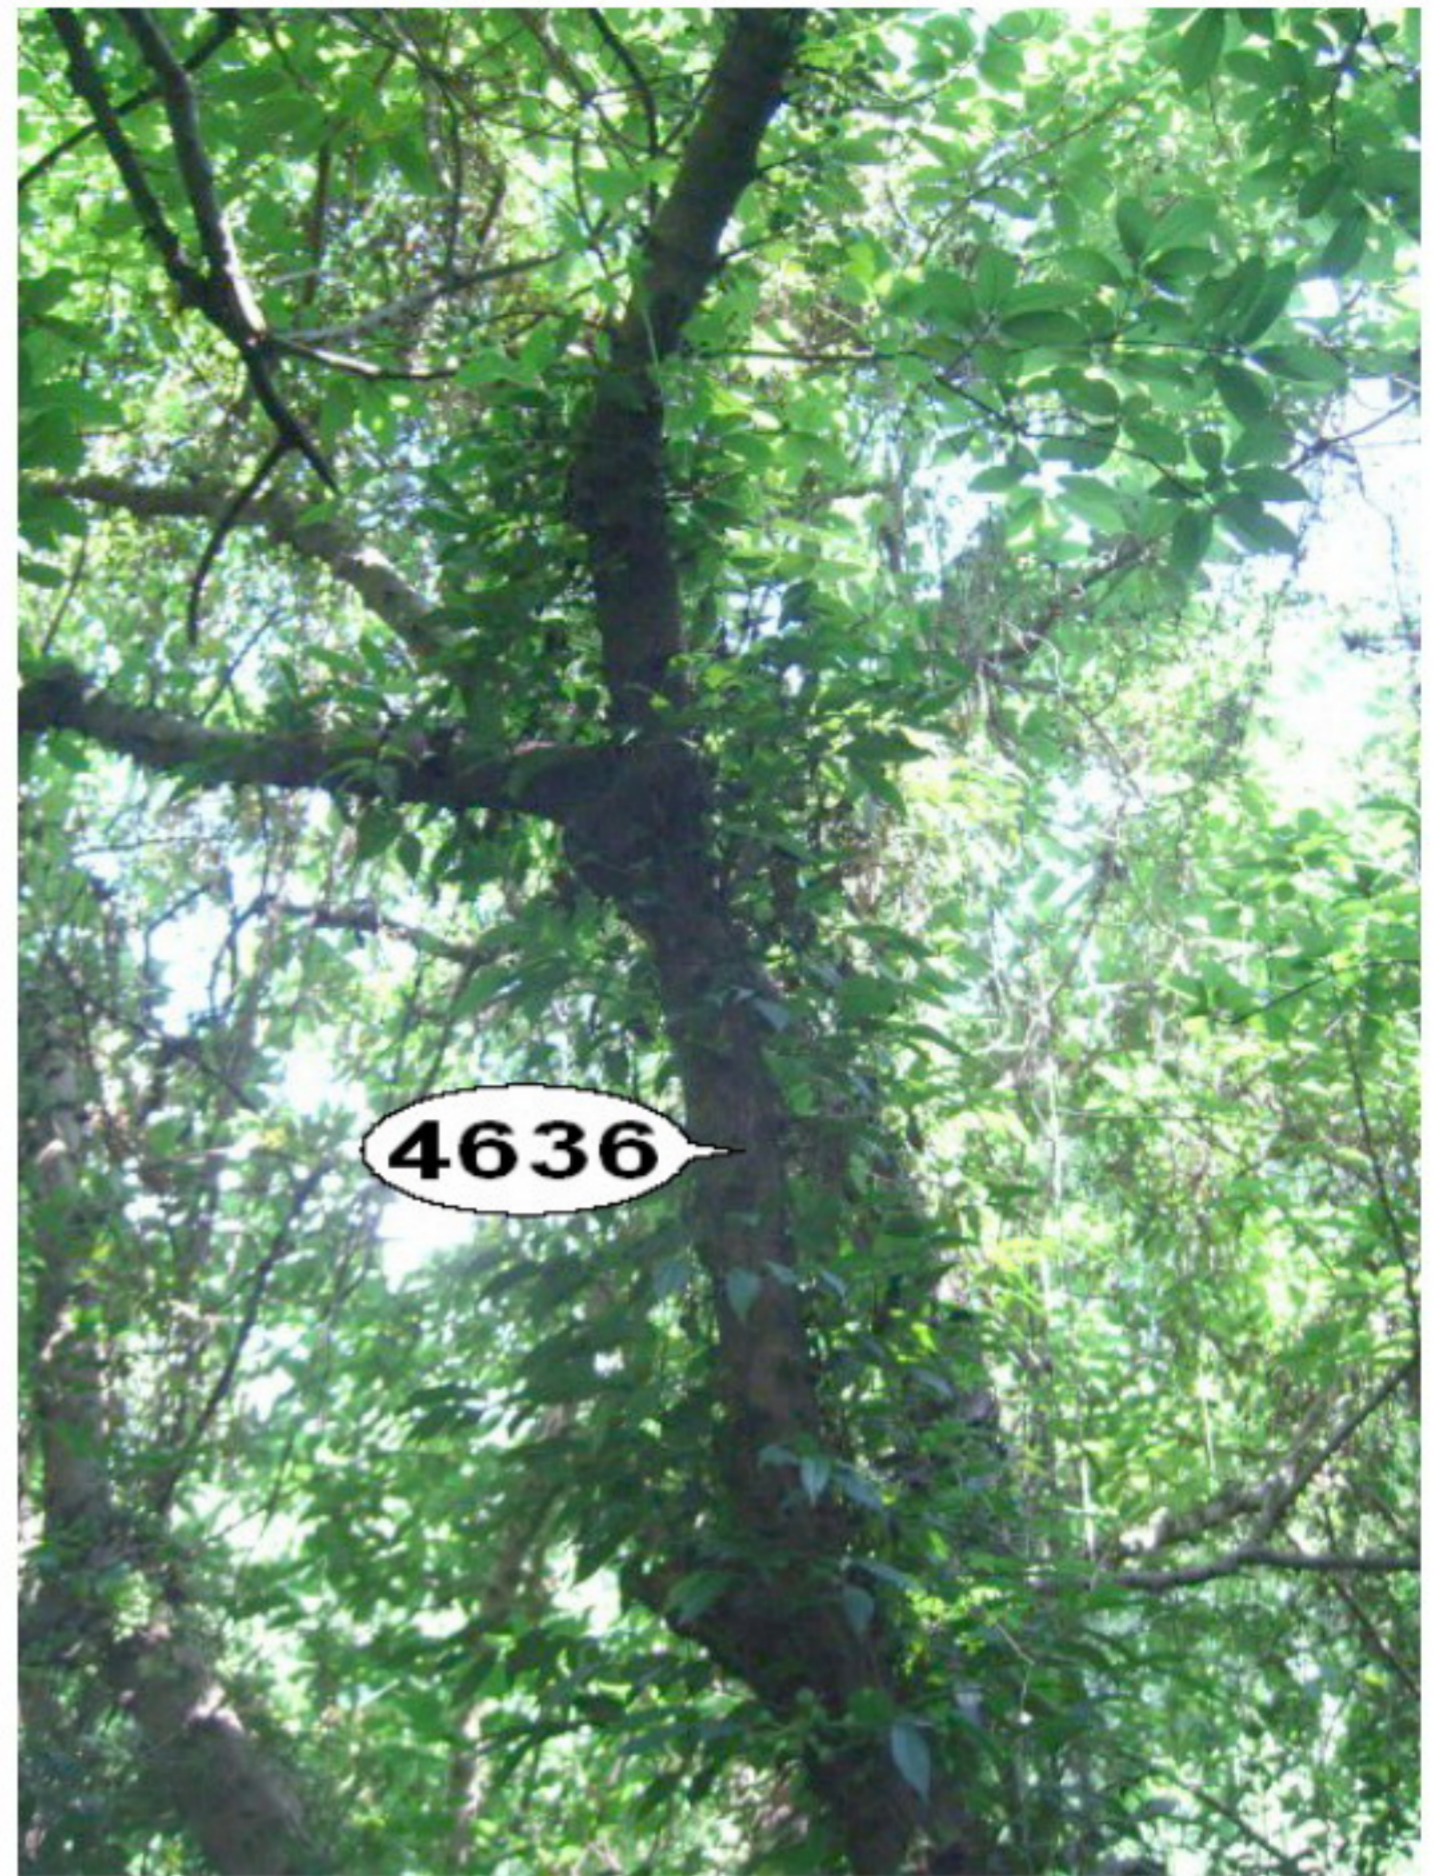
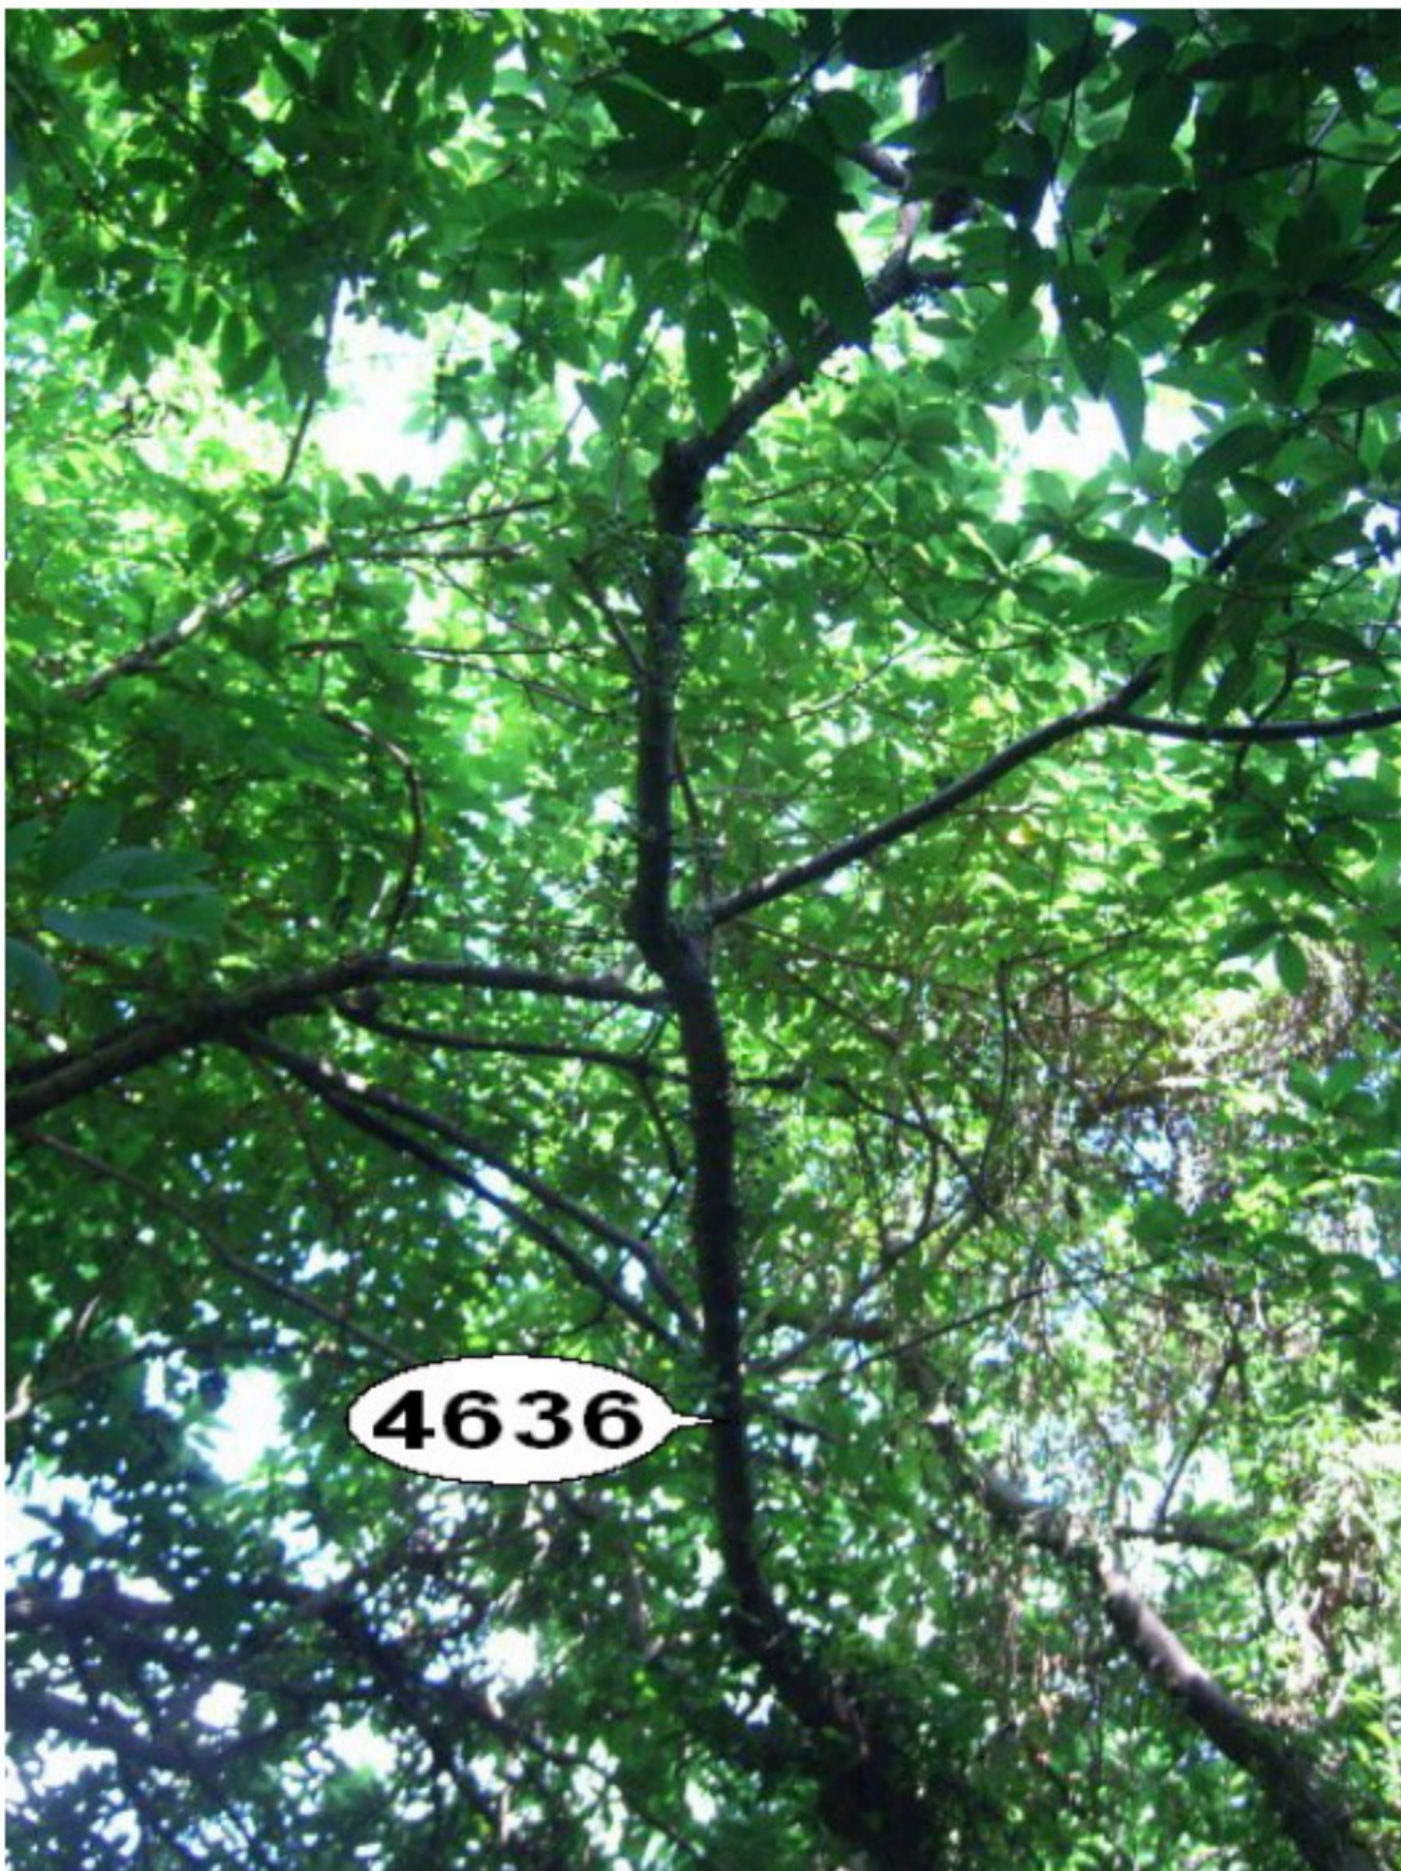
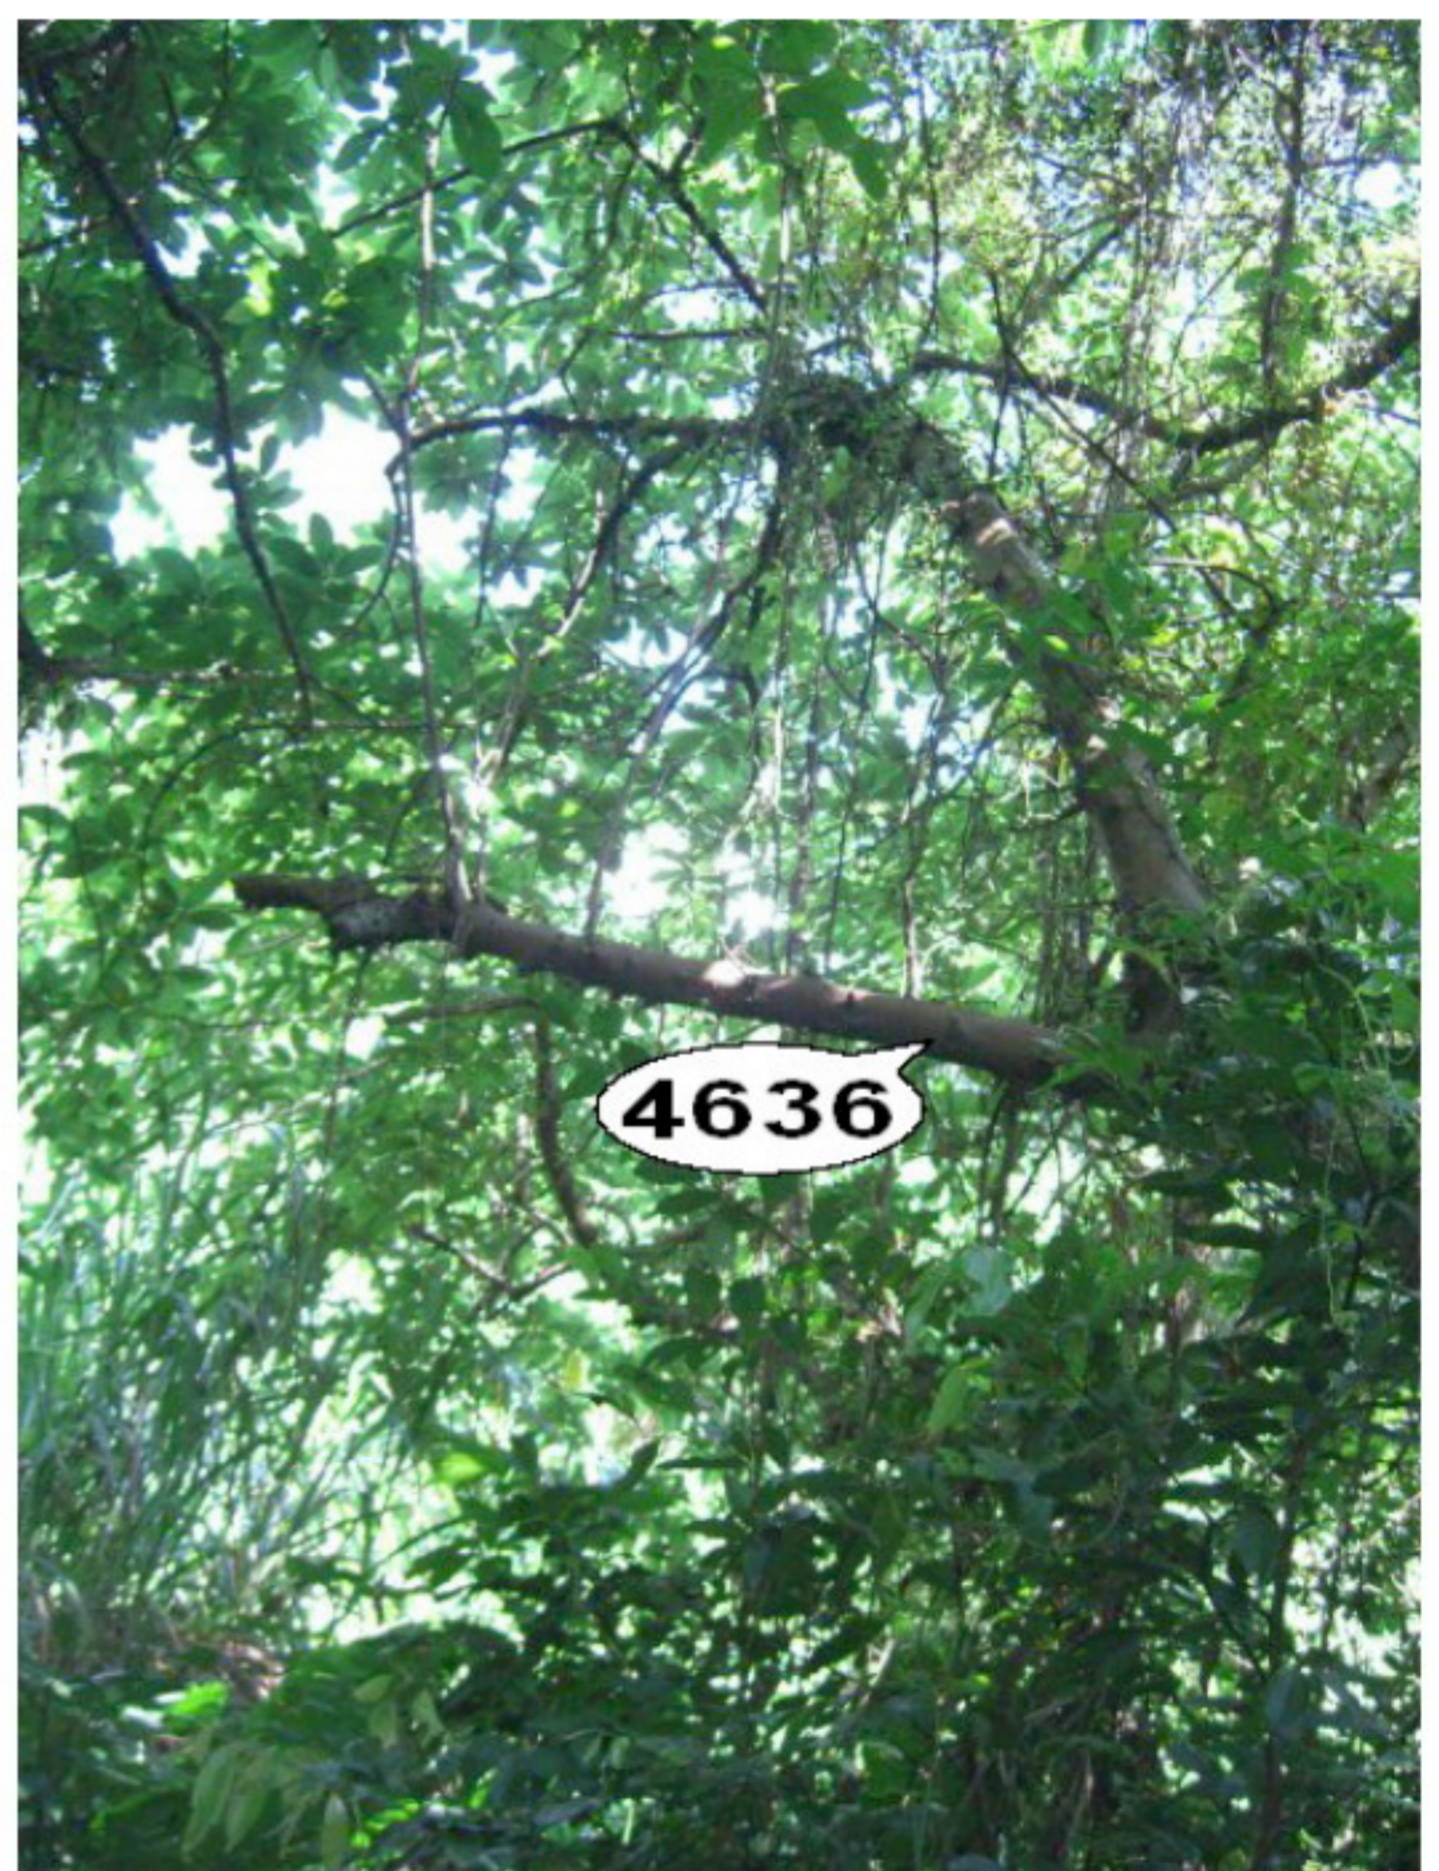
Tree 4635  
Poor health will lead to low transplantation survival rate.

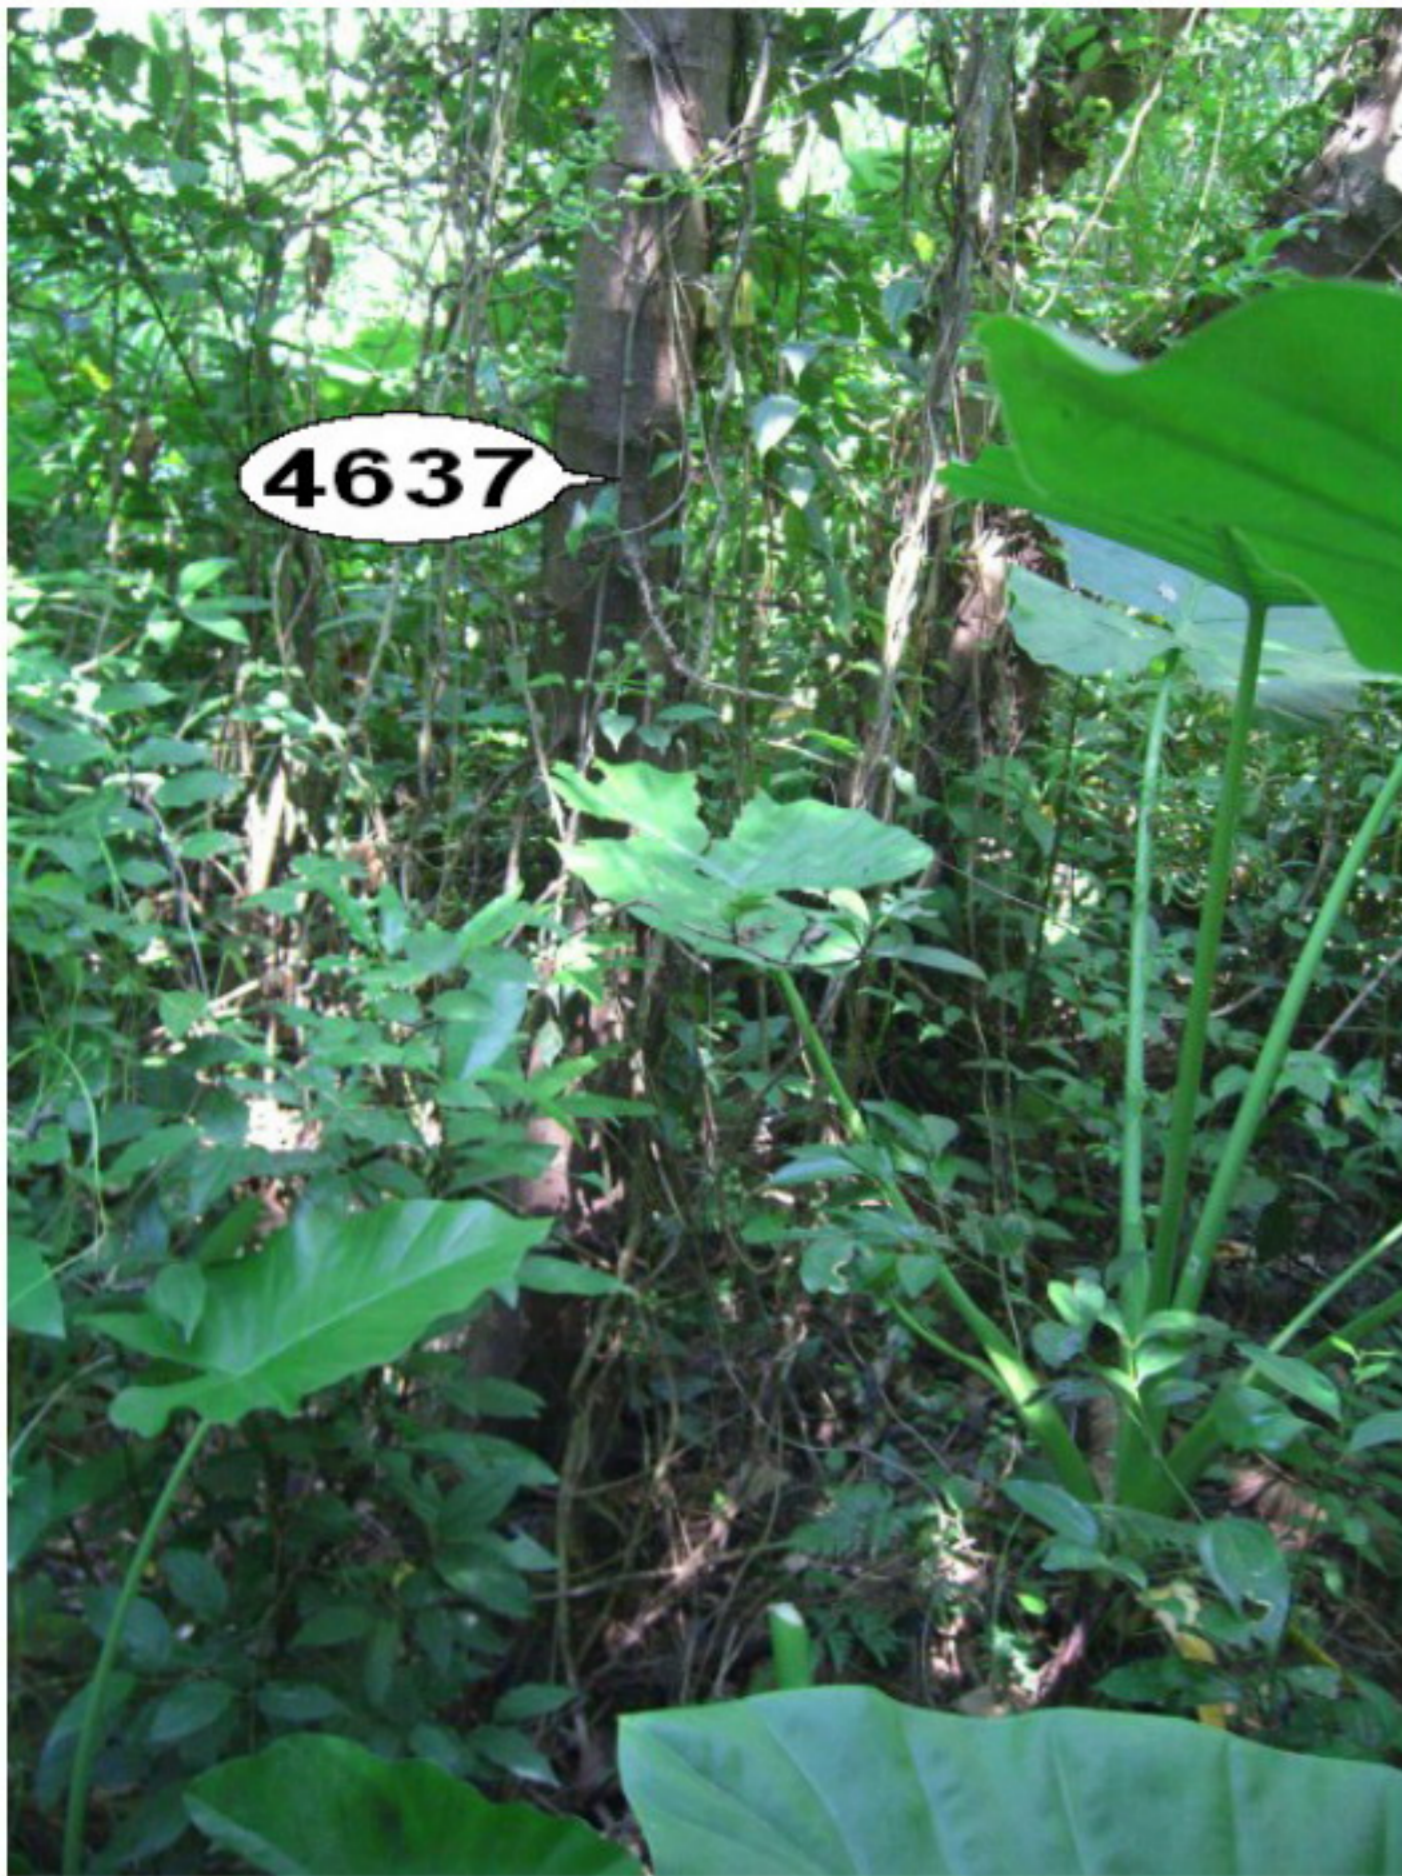
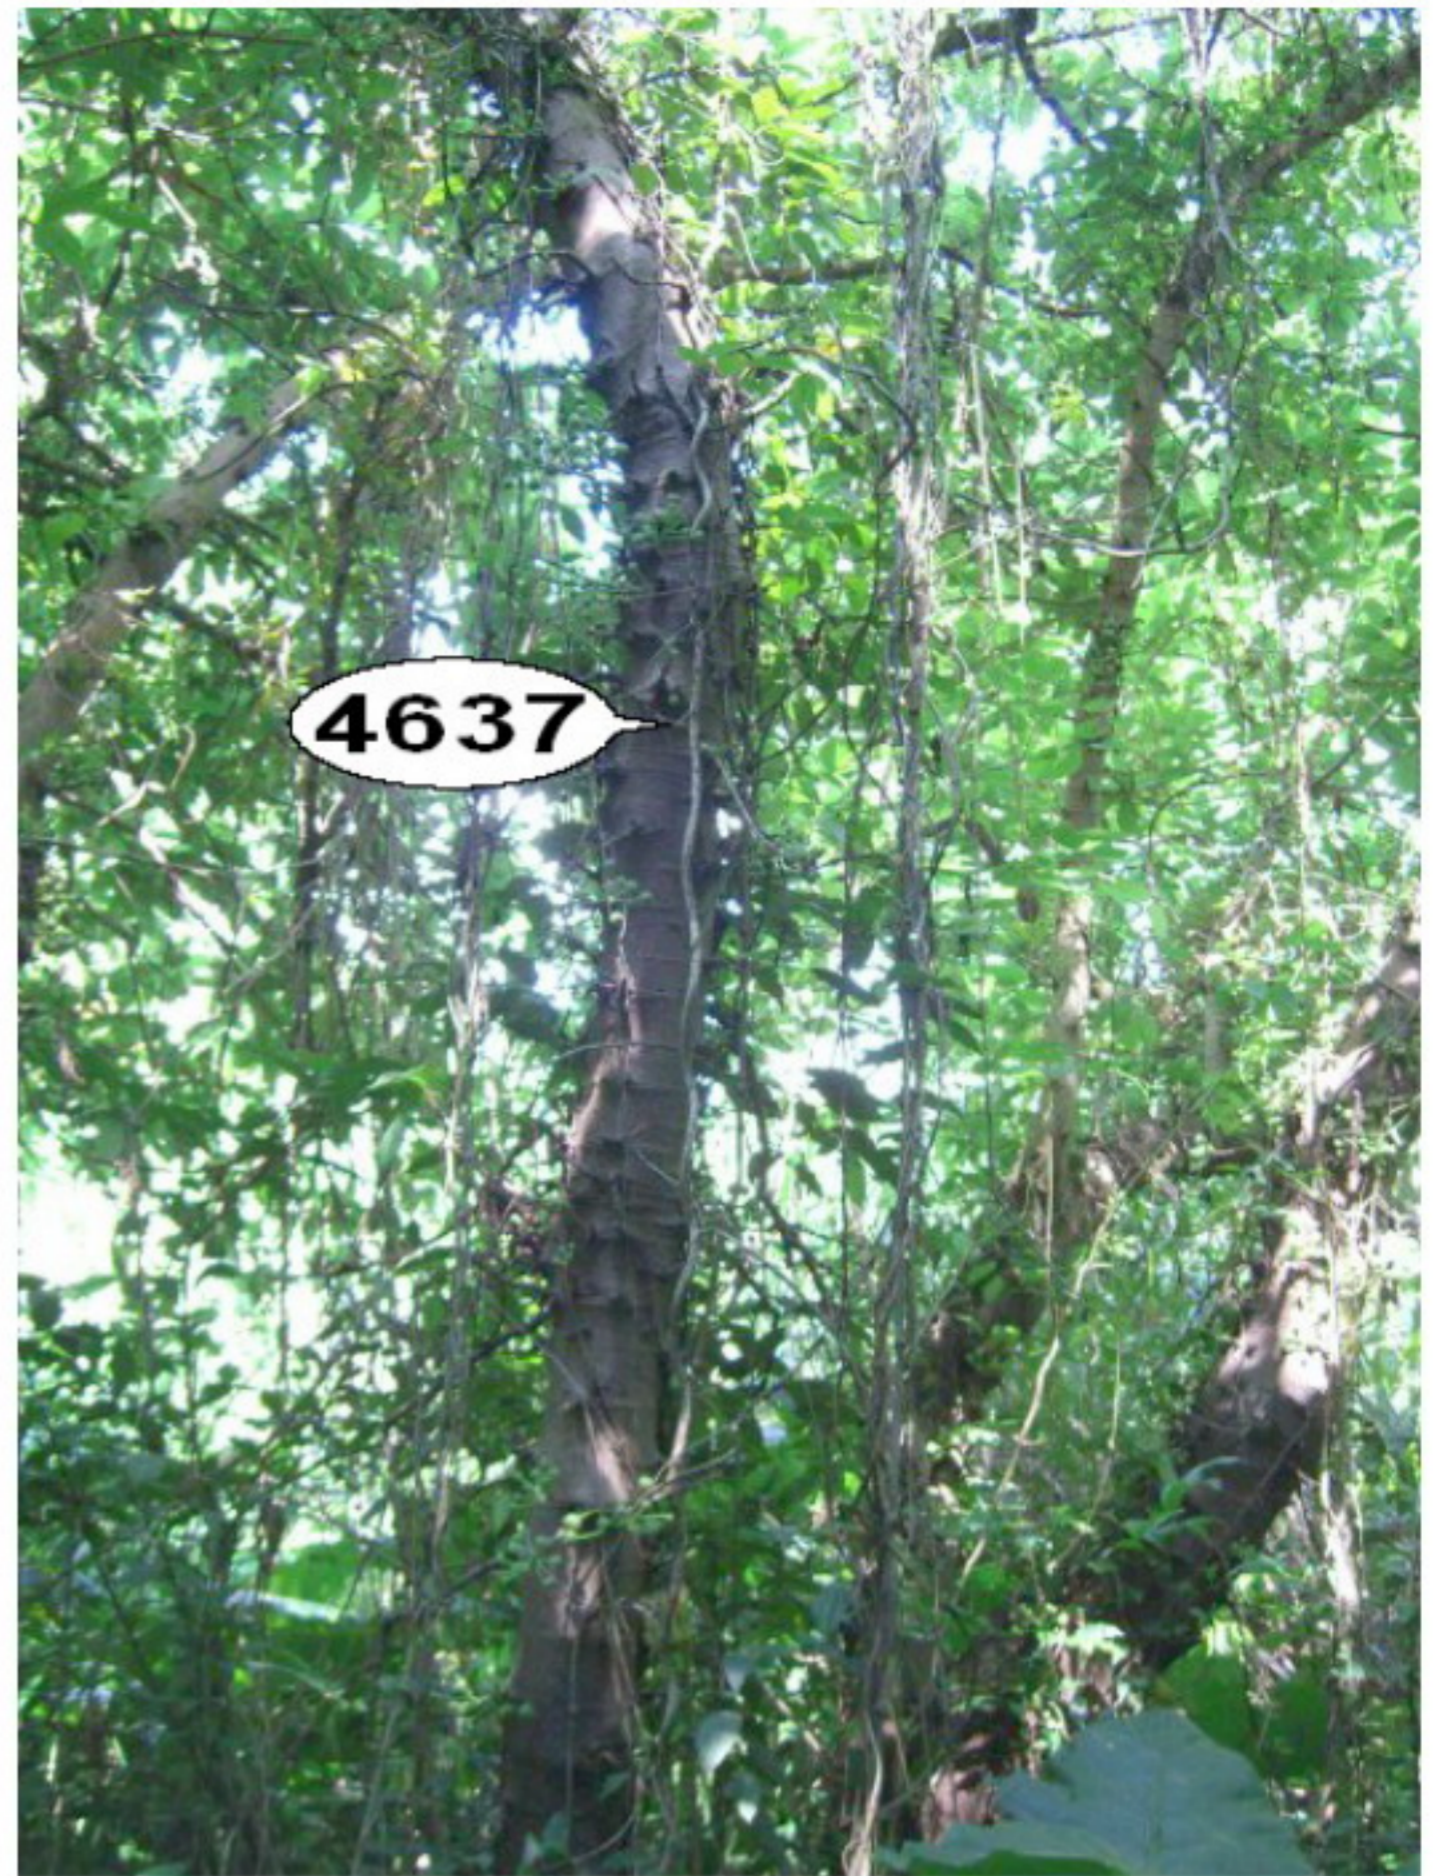
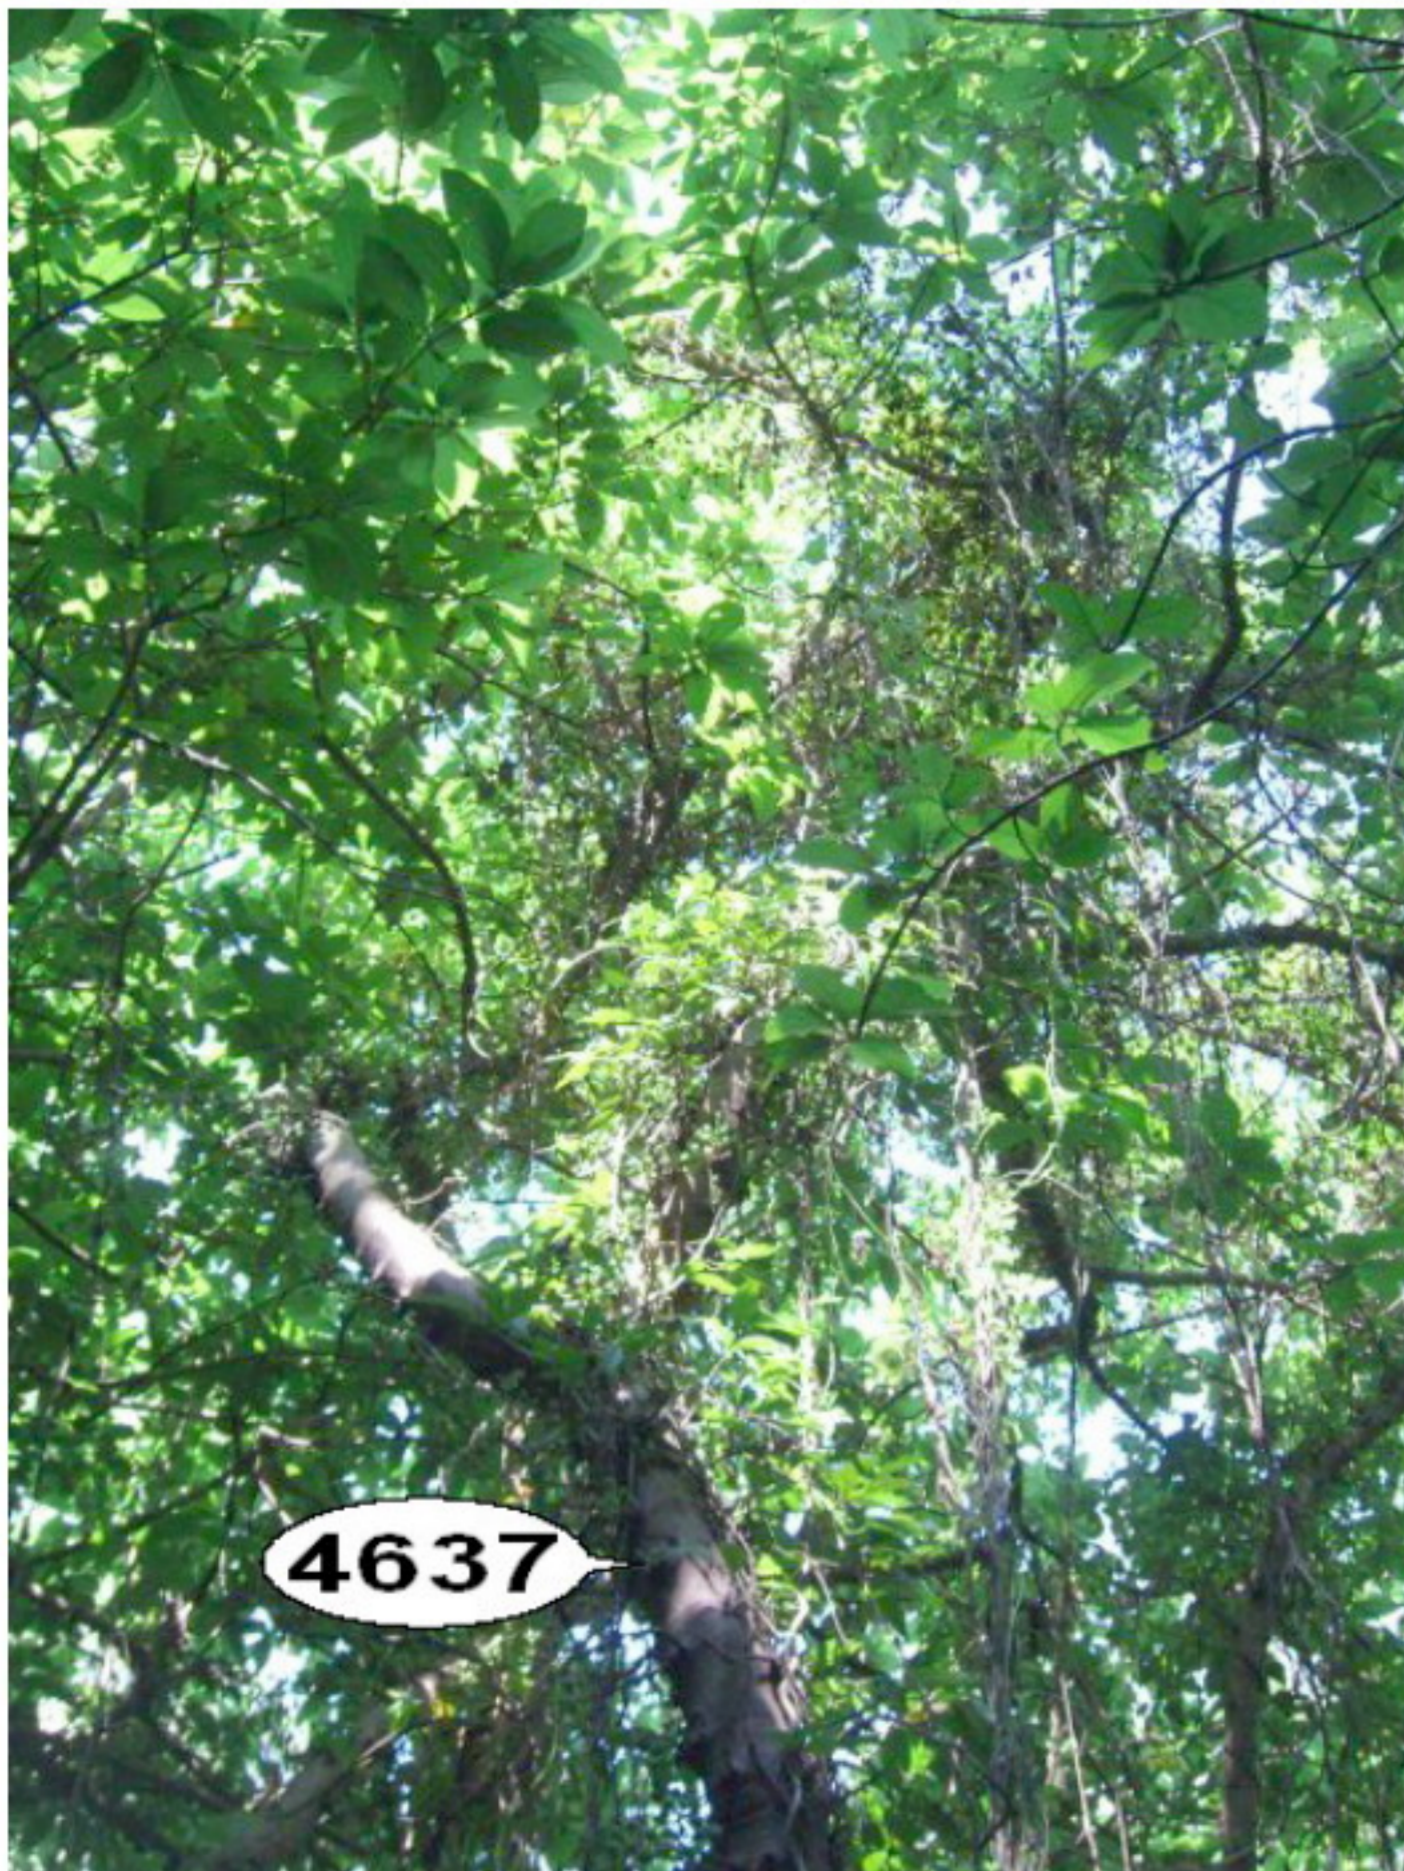
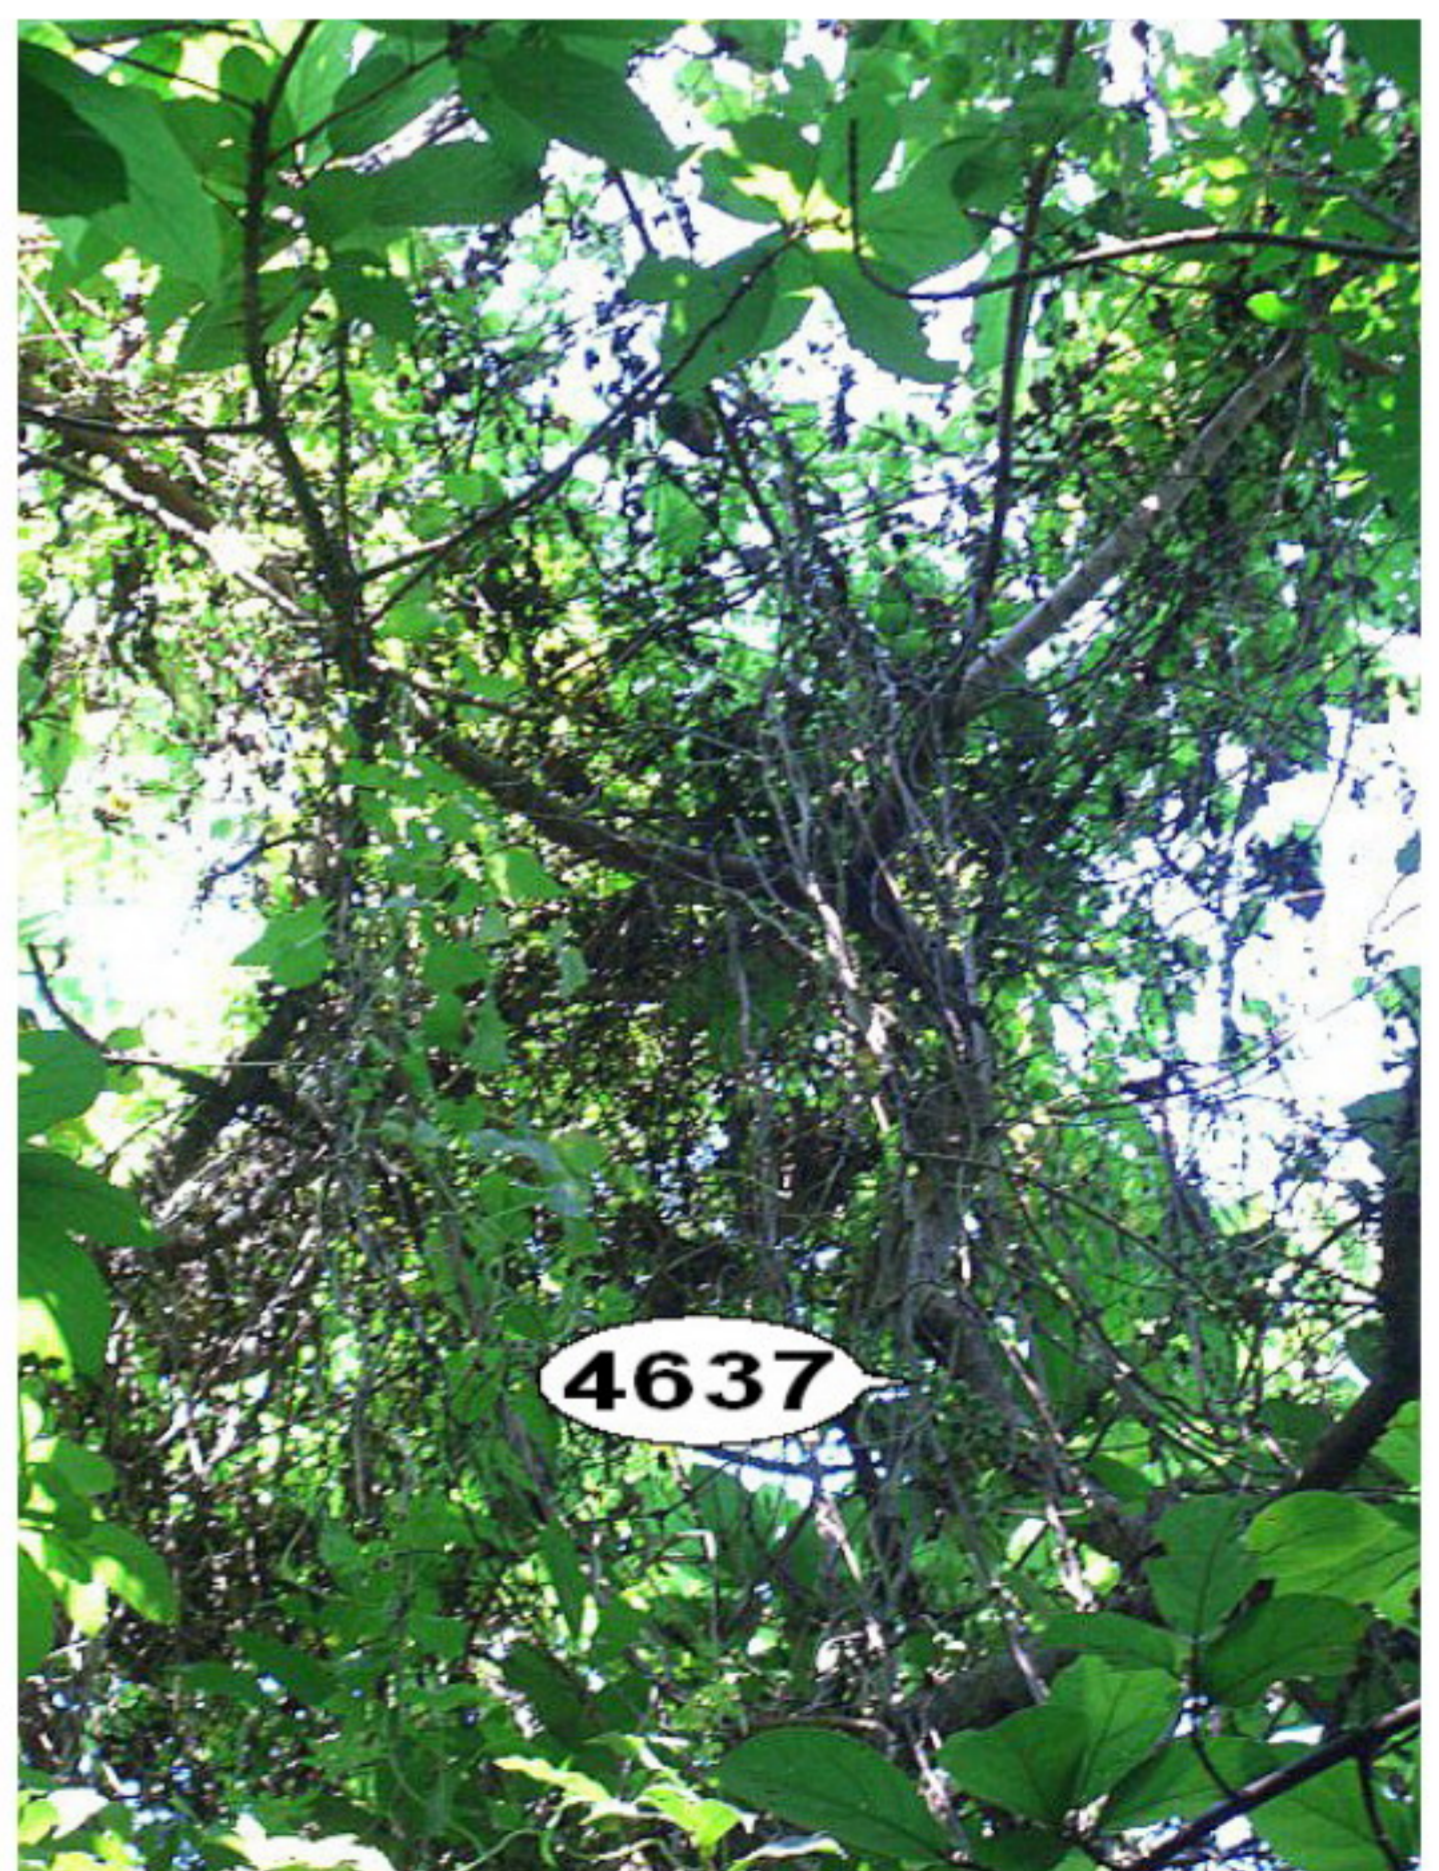
Tree 4636

Poor form which lead to low amenity value. Besides, the tree is unbalance. It may need heavy pruning after transplanted that will affect its transplanted survival rate. Moreover, the operation of the transplanted for poor form tree is also difficult.
