# Provision of Cremators at Wo Hop Shek Crematorium

Tree Survey Report

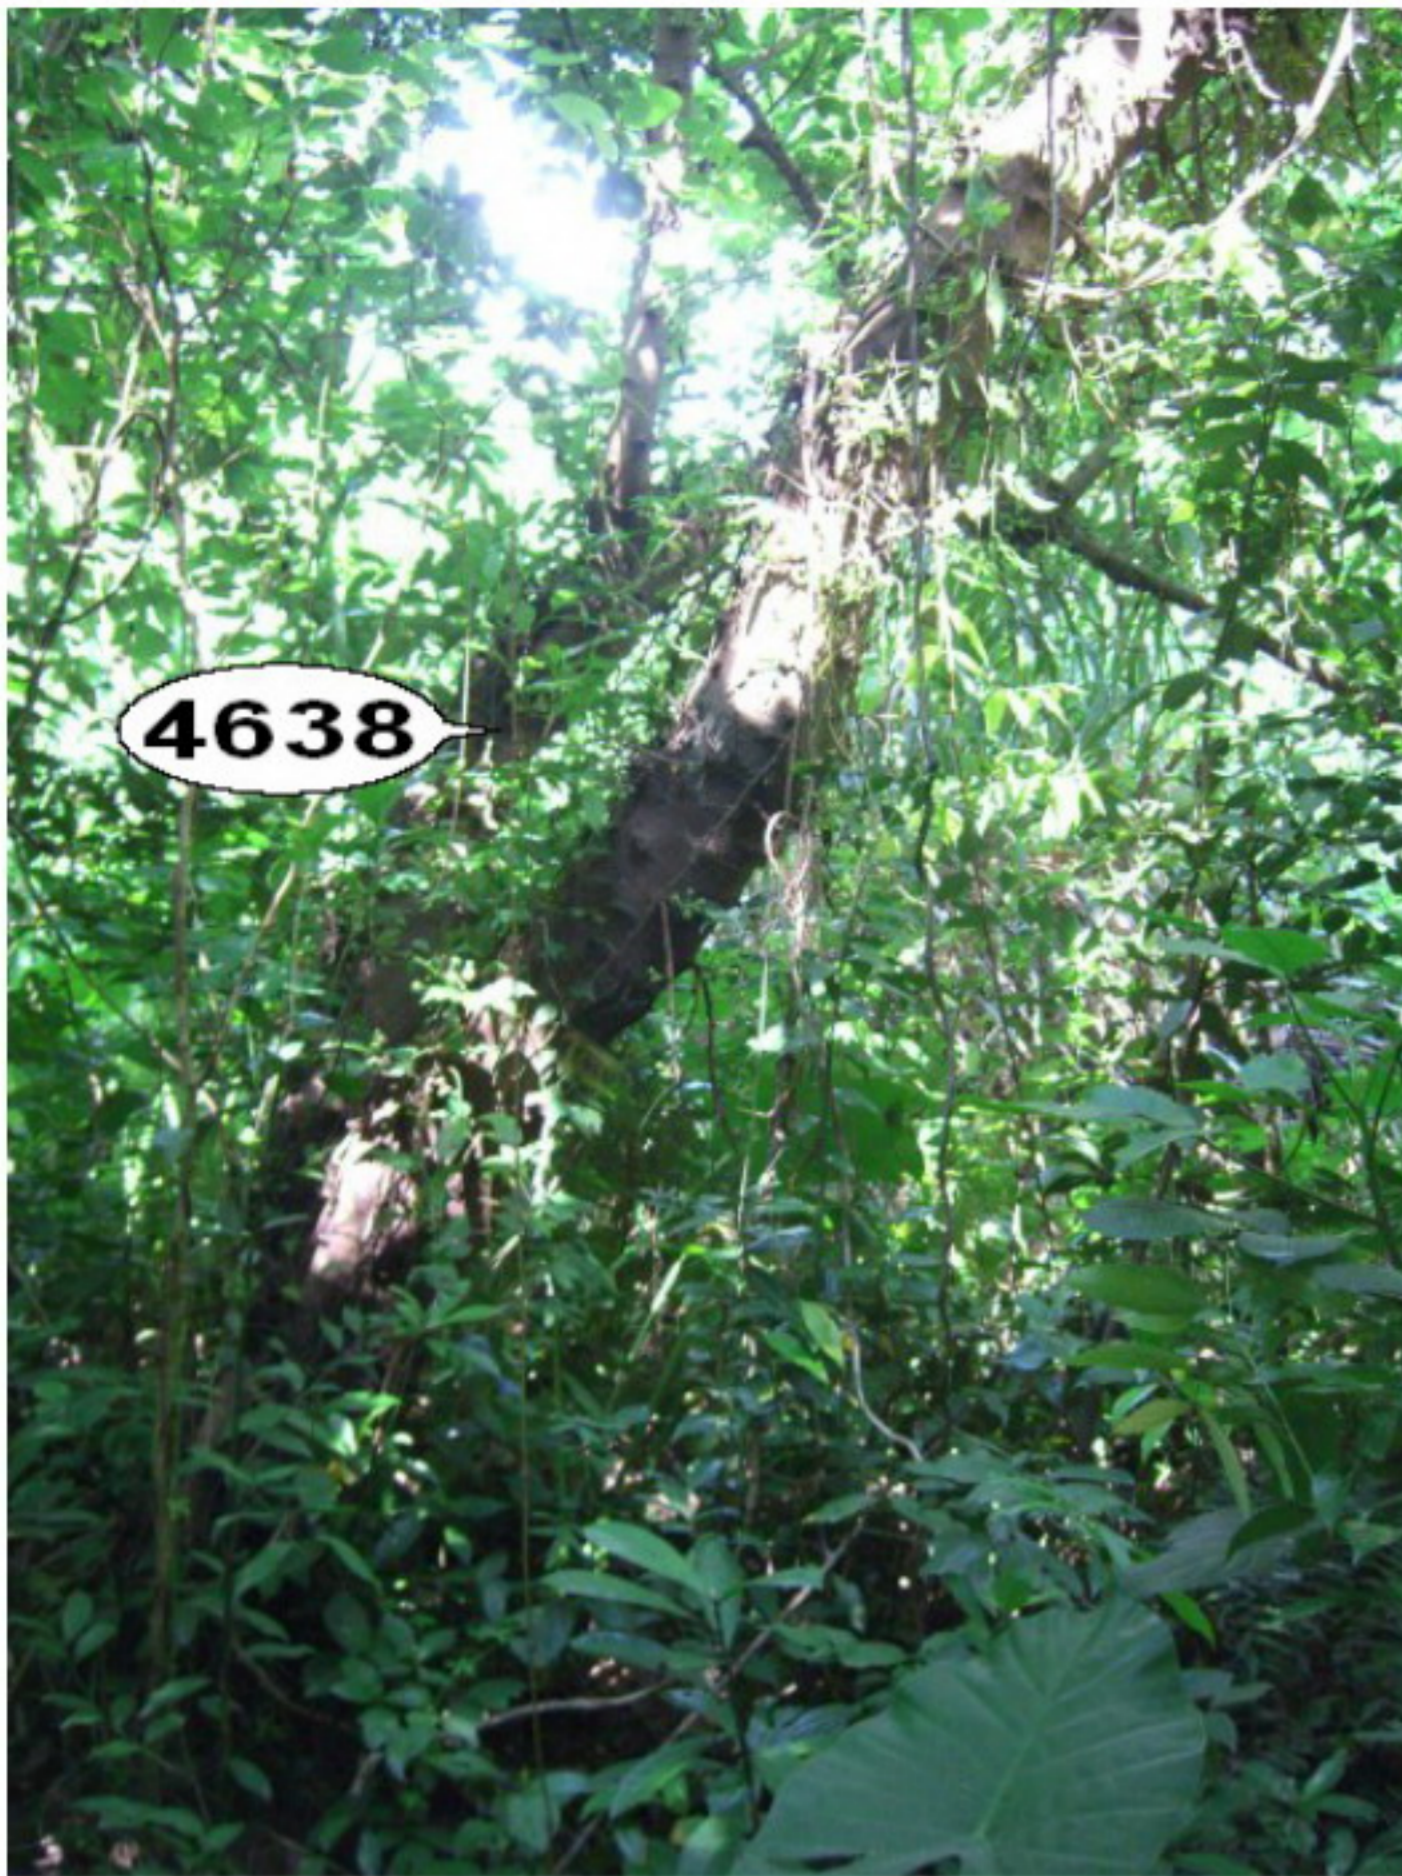
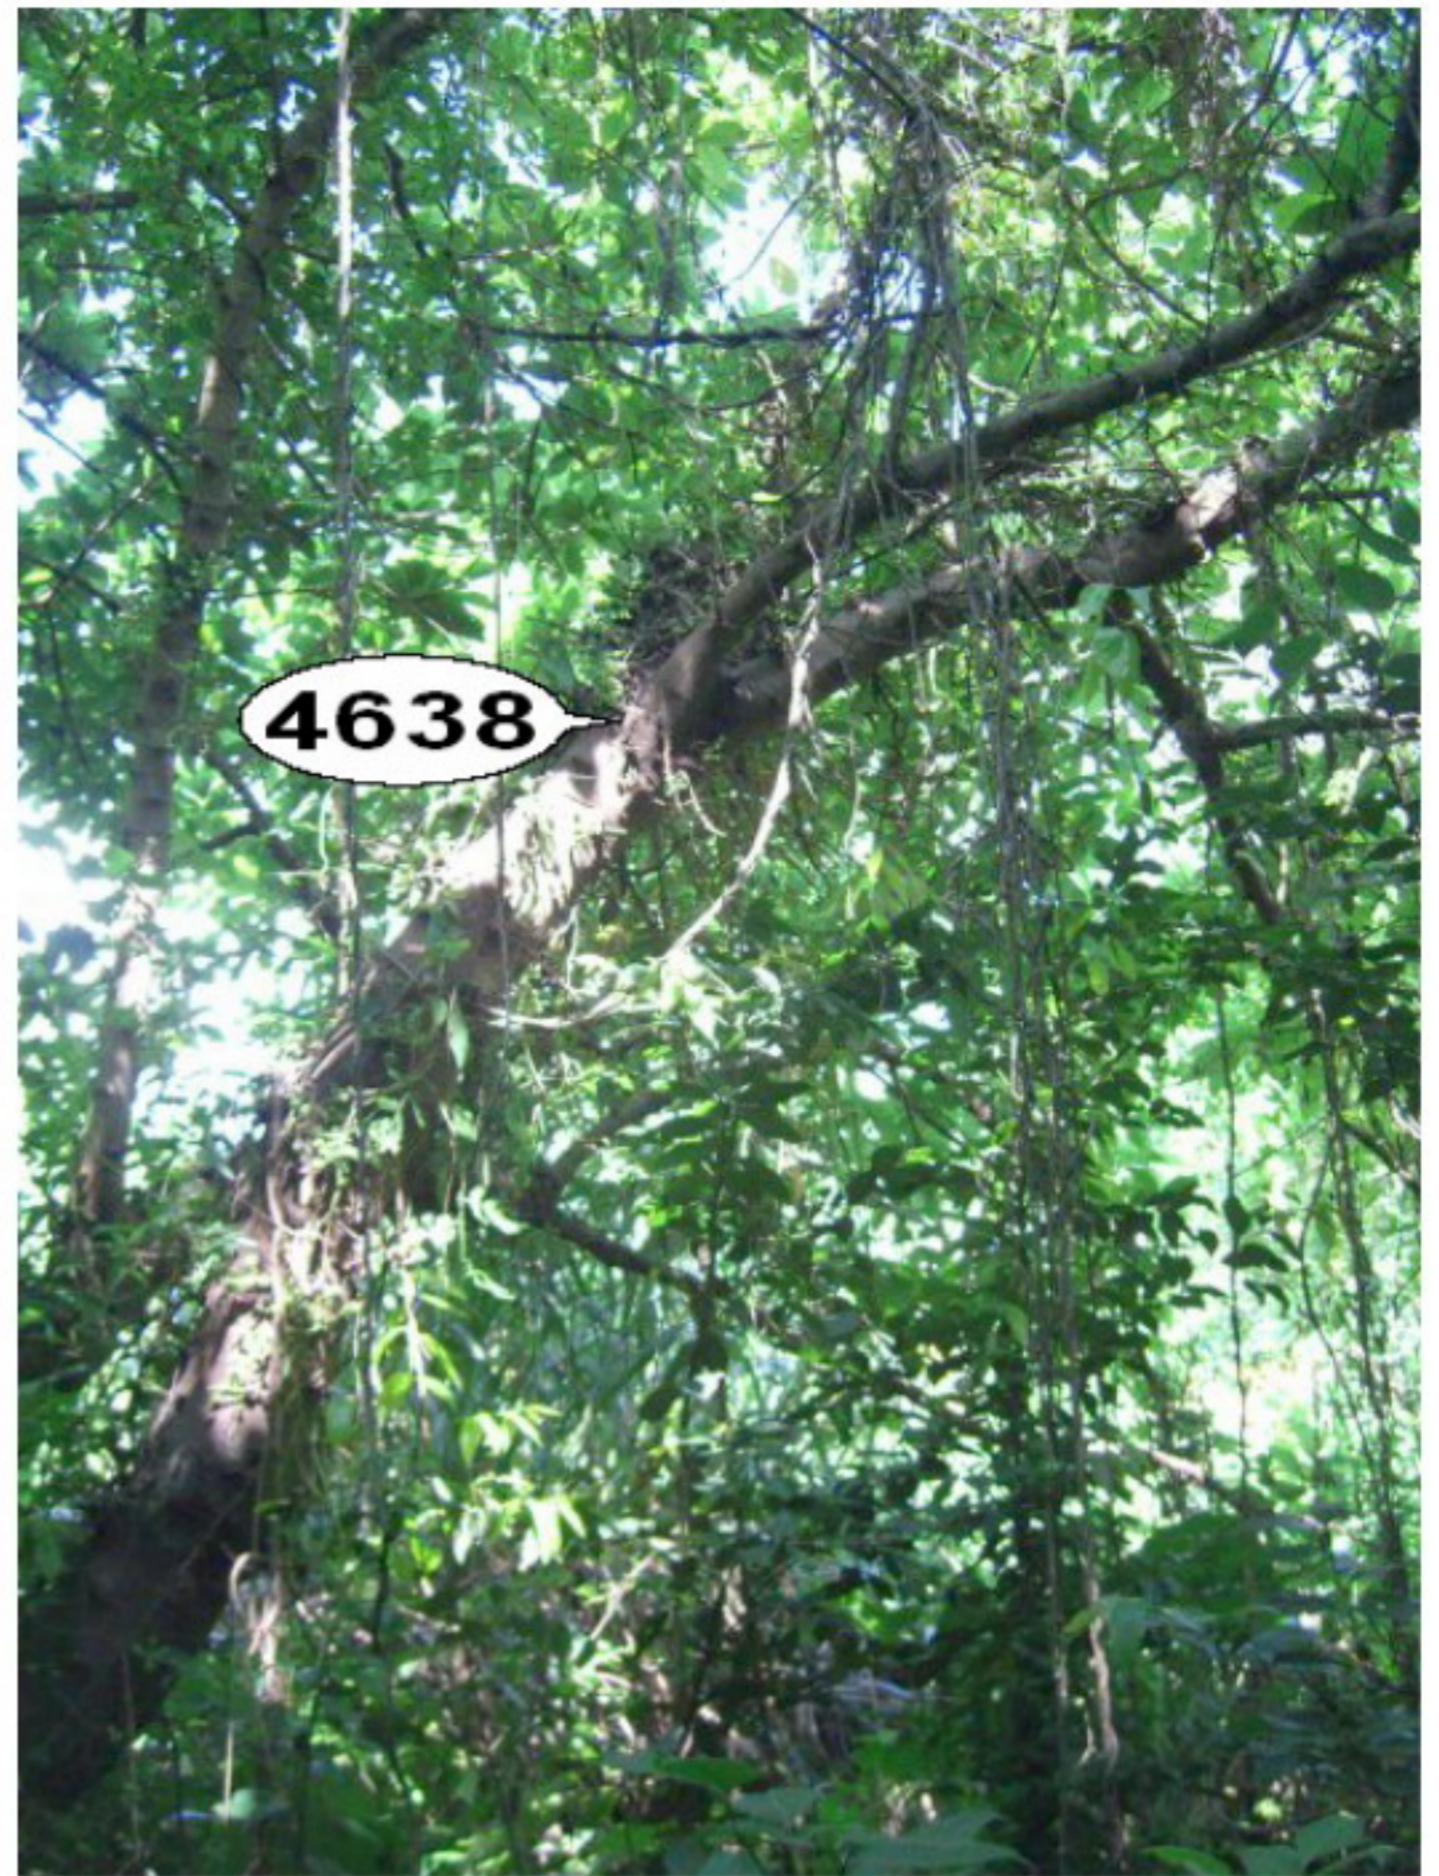
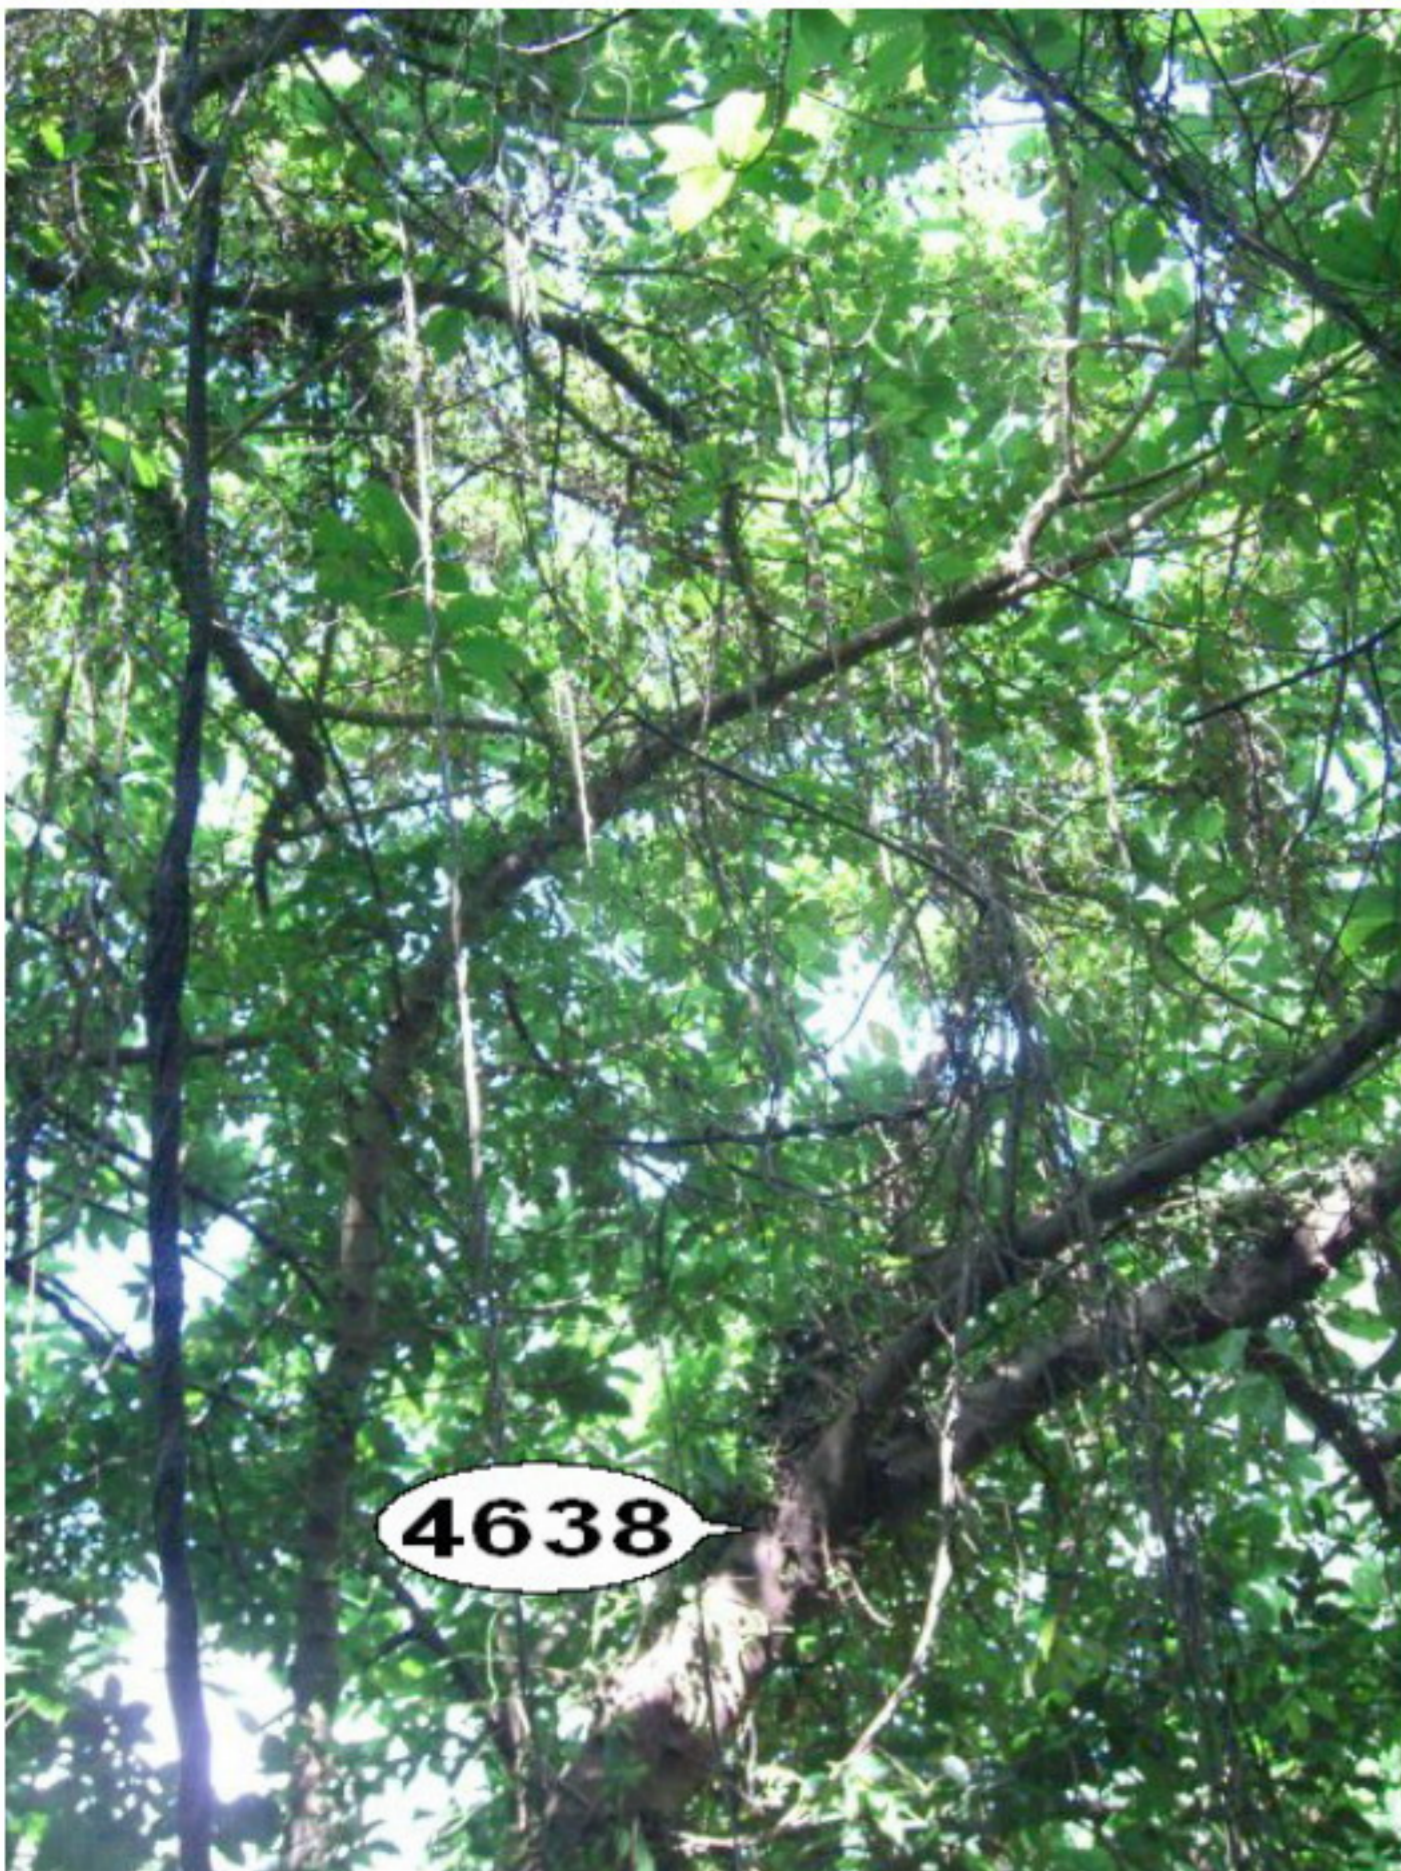
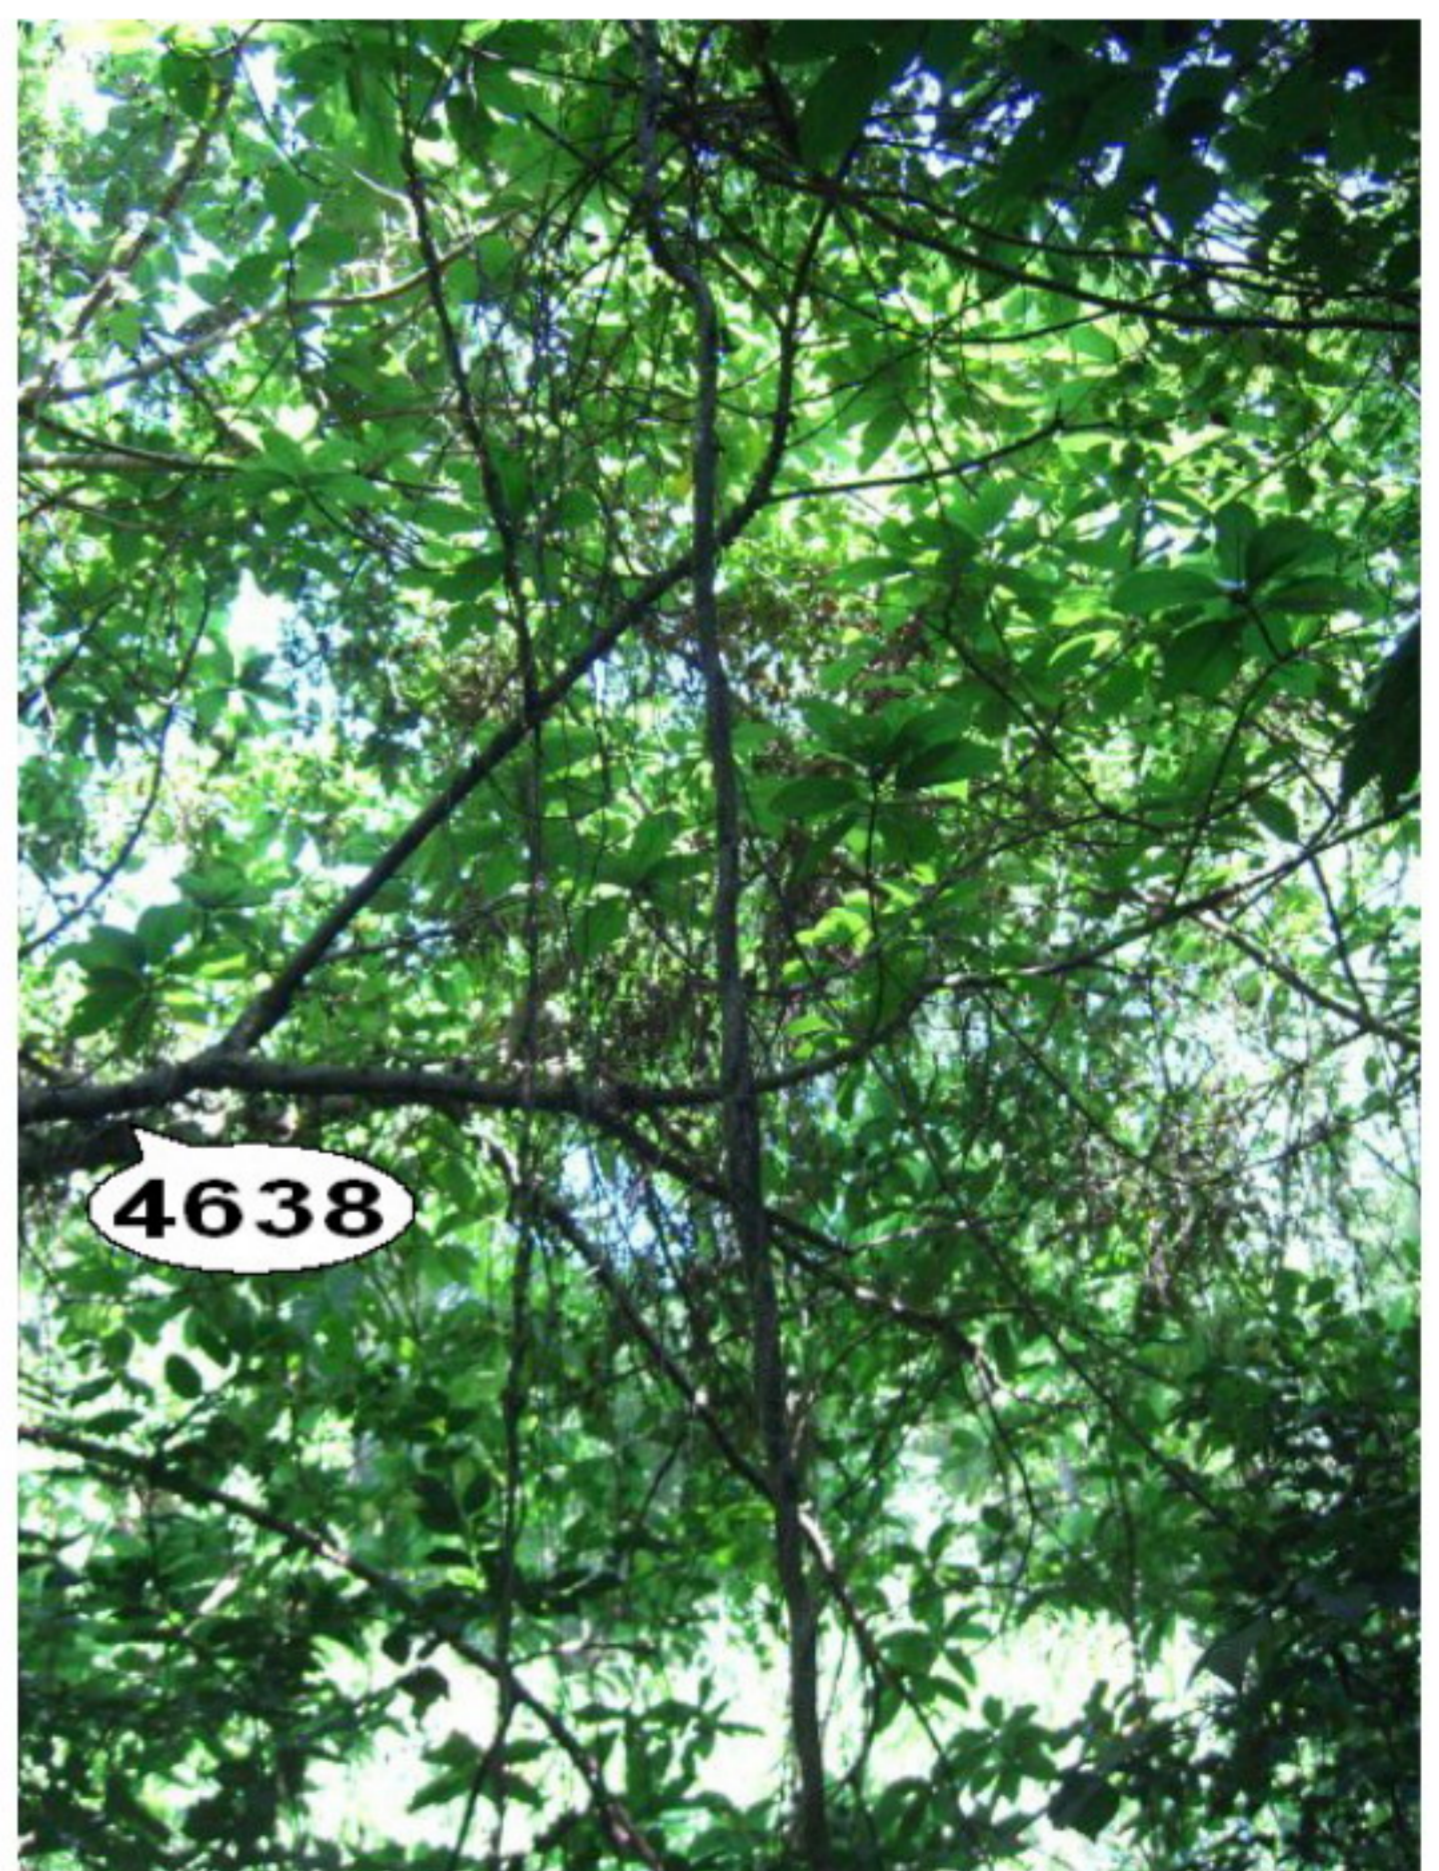
Tree 4637

Poor health will lead to low transplantation survival rate. Poor form which also lead to low amenity value. Besides, the tree is unbalance. It may need heavy pruning after transplantation that will affect its transplantation survival rate. Moreover, the operation of the transplantation for poor form tree is also difficult.

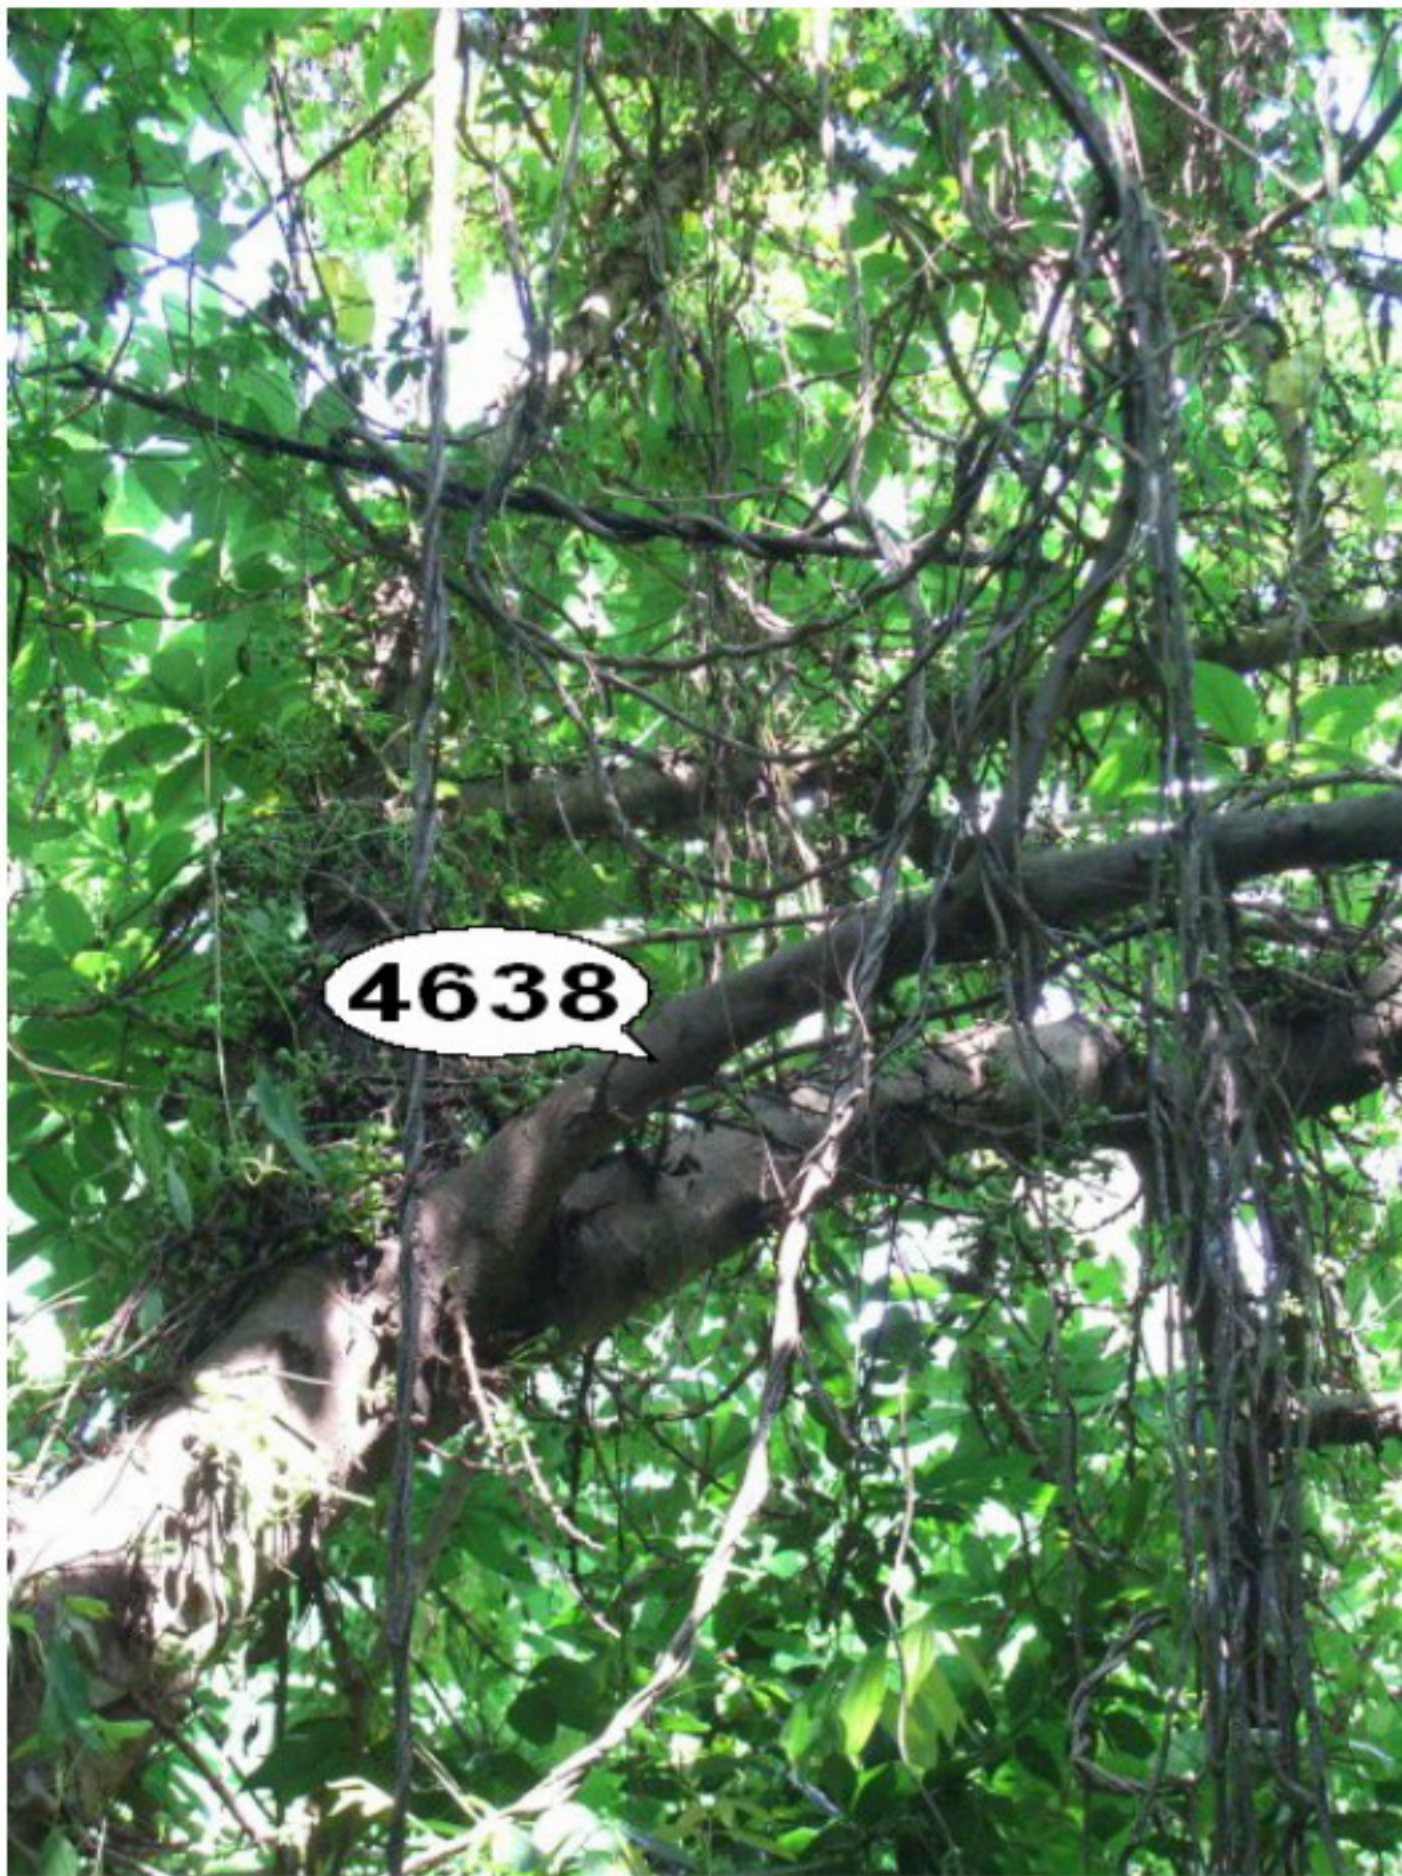
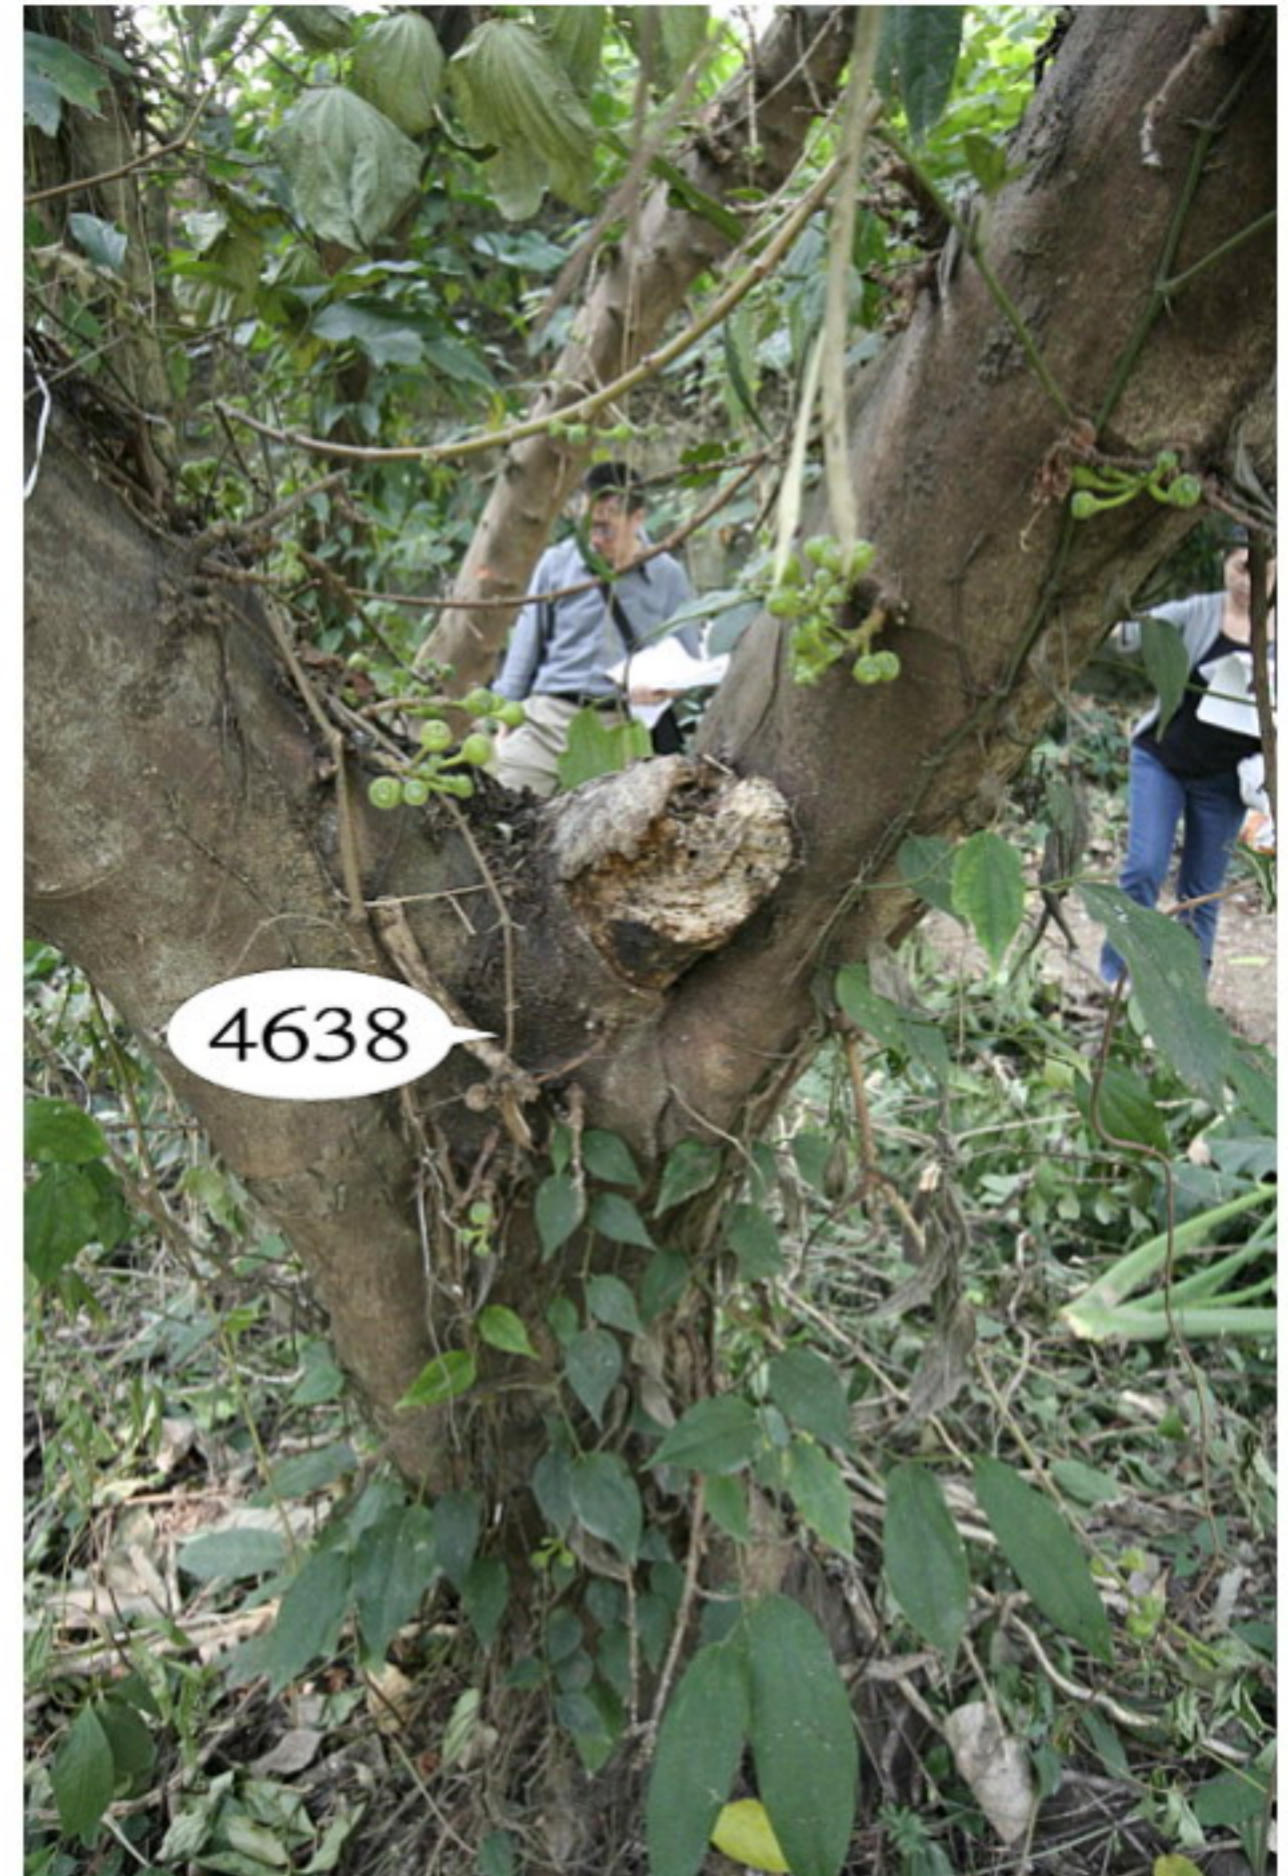
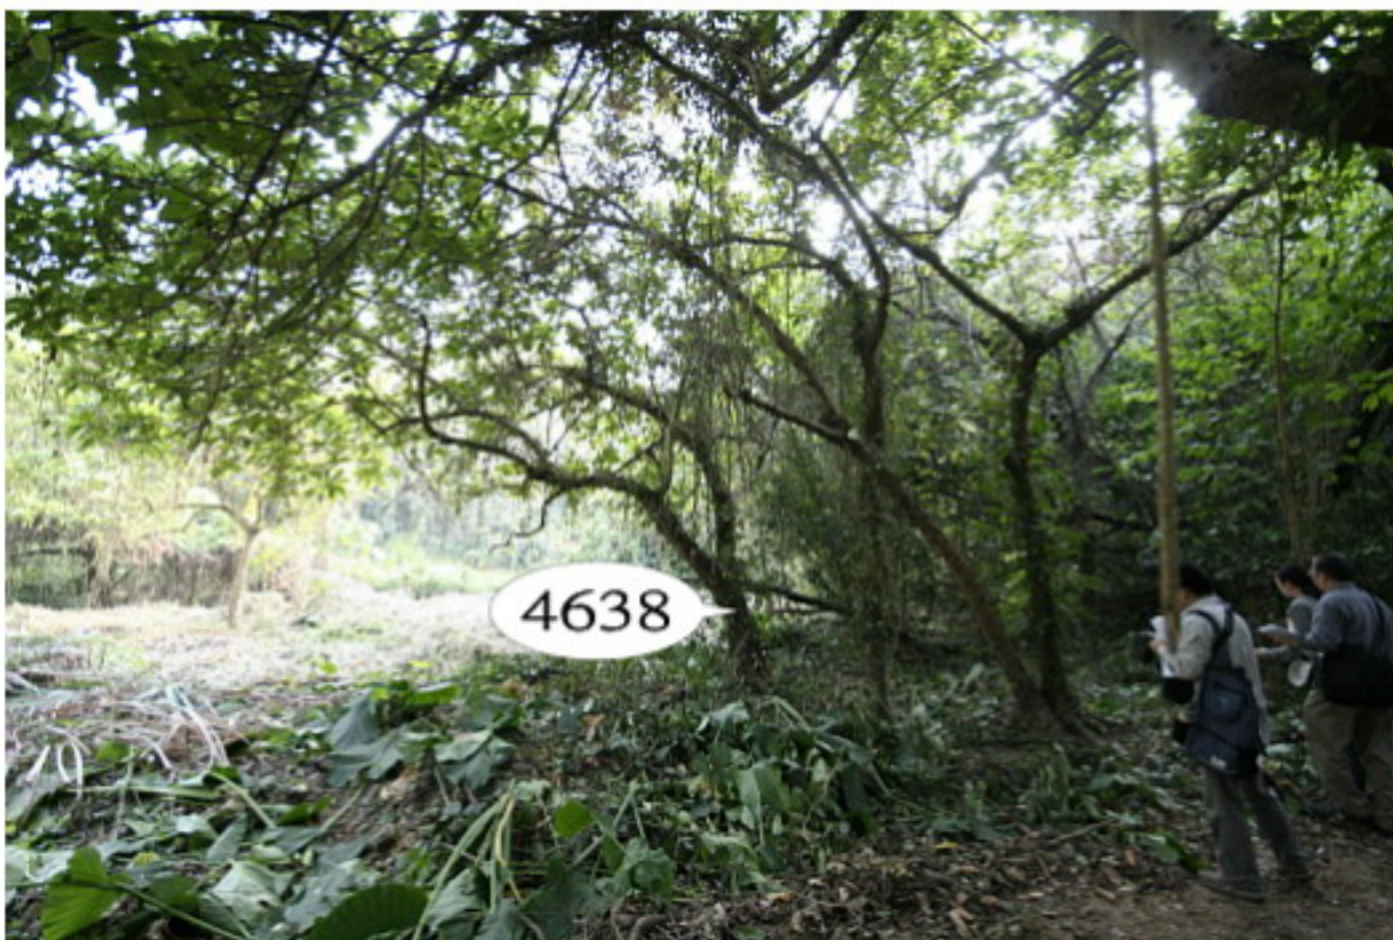
Tree 4638

Poor form which lead to low amenity value. Besides, the tree is unbalance. It may need heavy pruning after transplantation that will affect its transplantation survival rate. Moreover, the operation of the transplantation for poor form tree is also difficult.

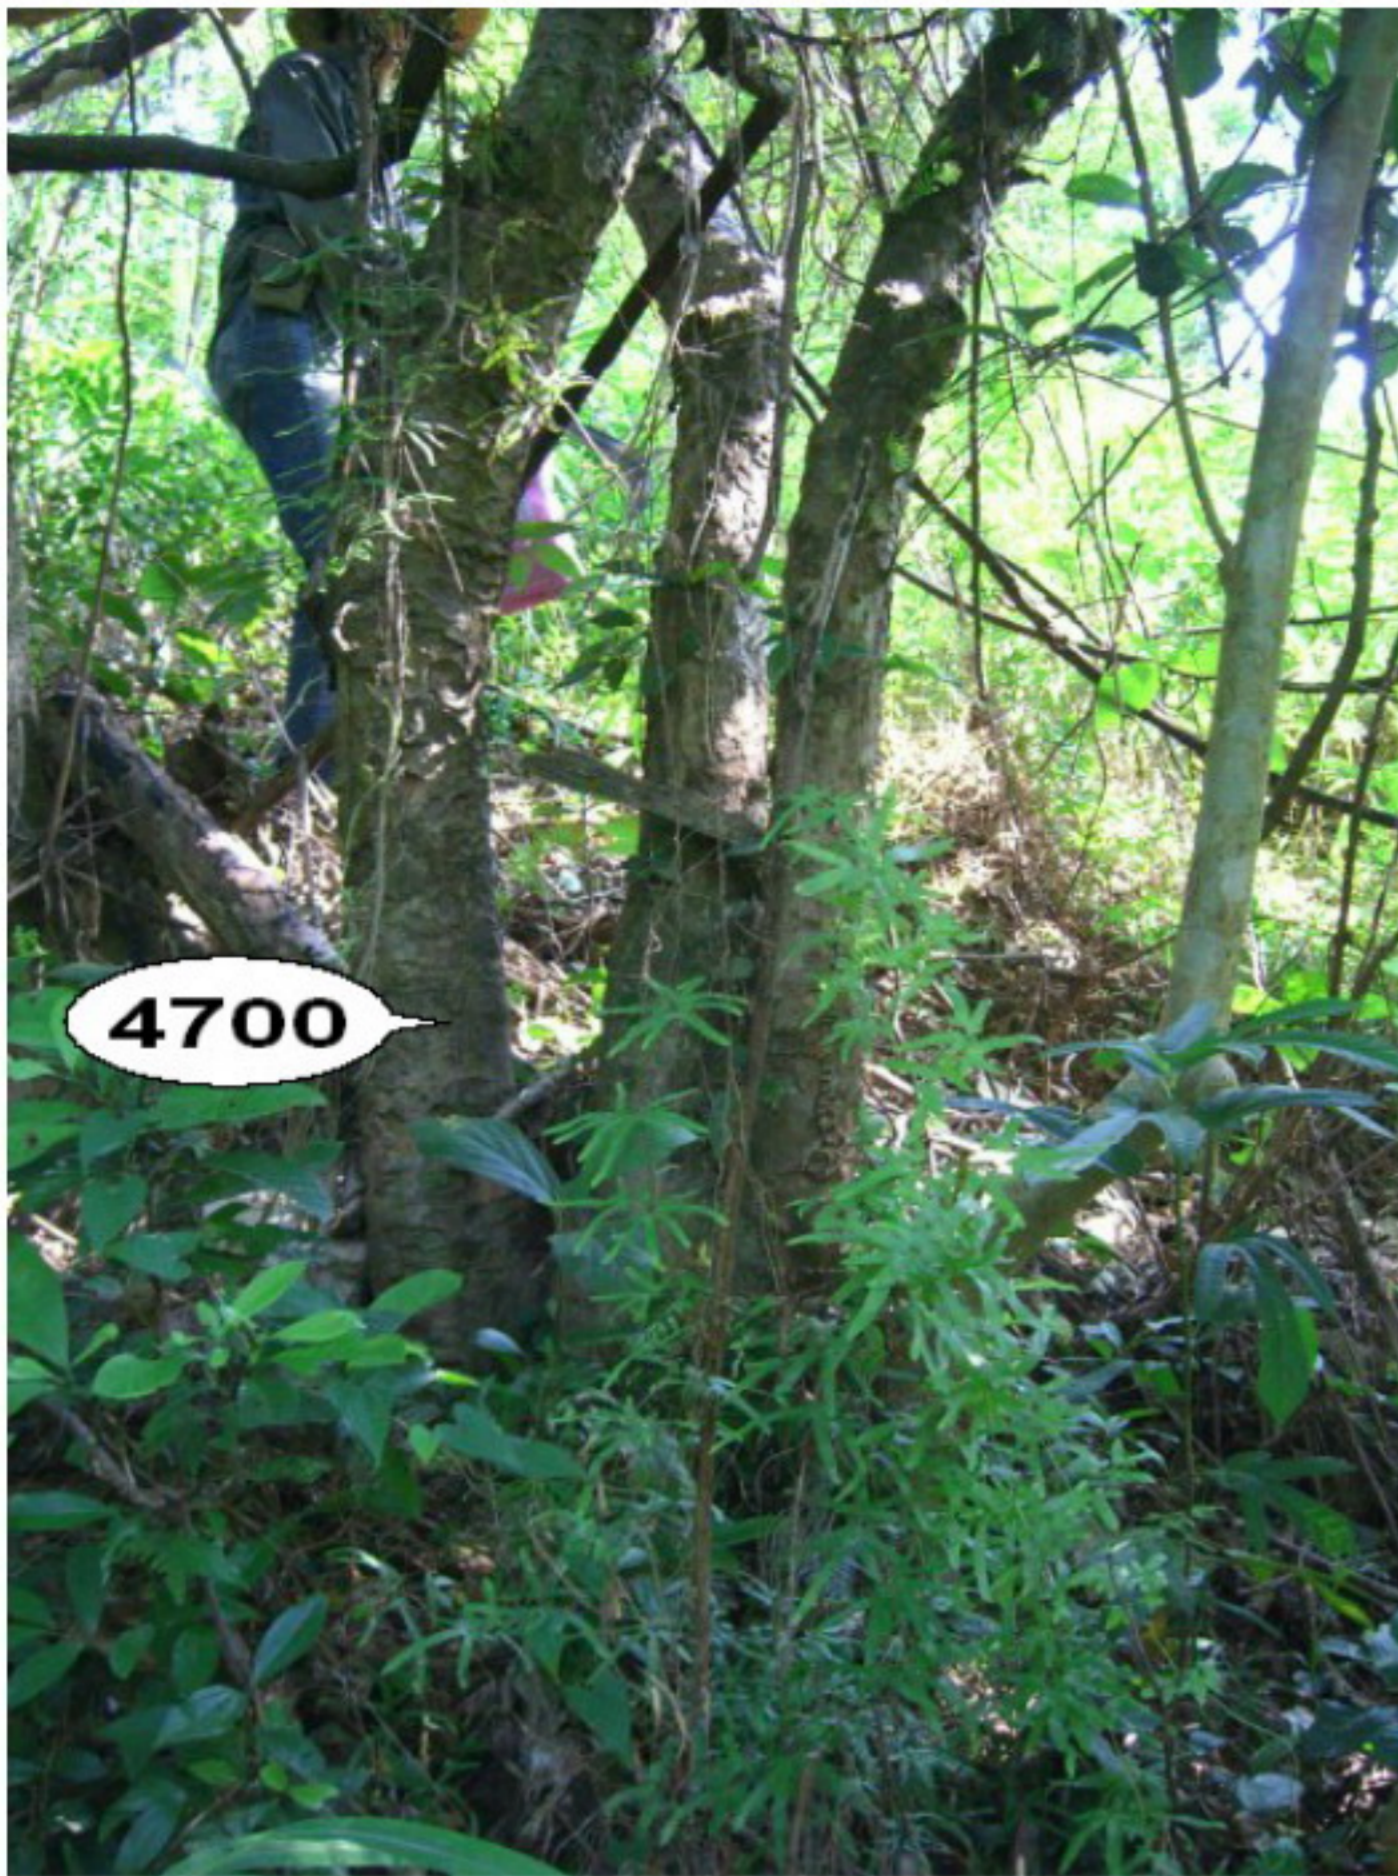
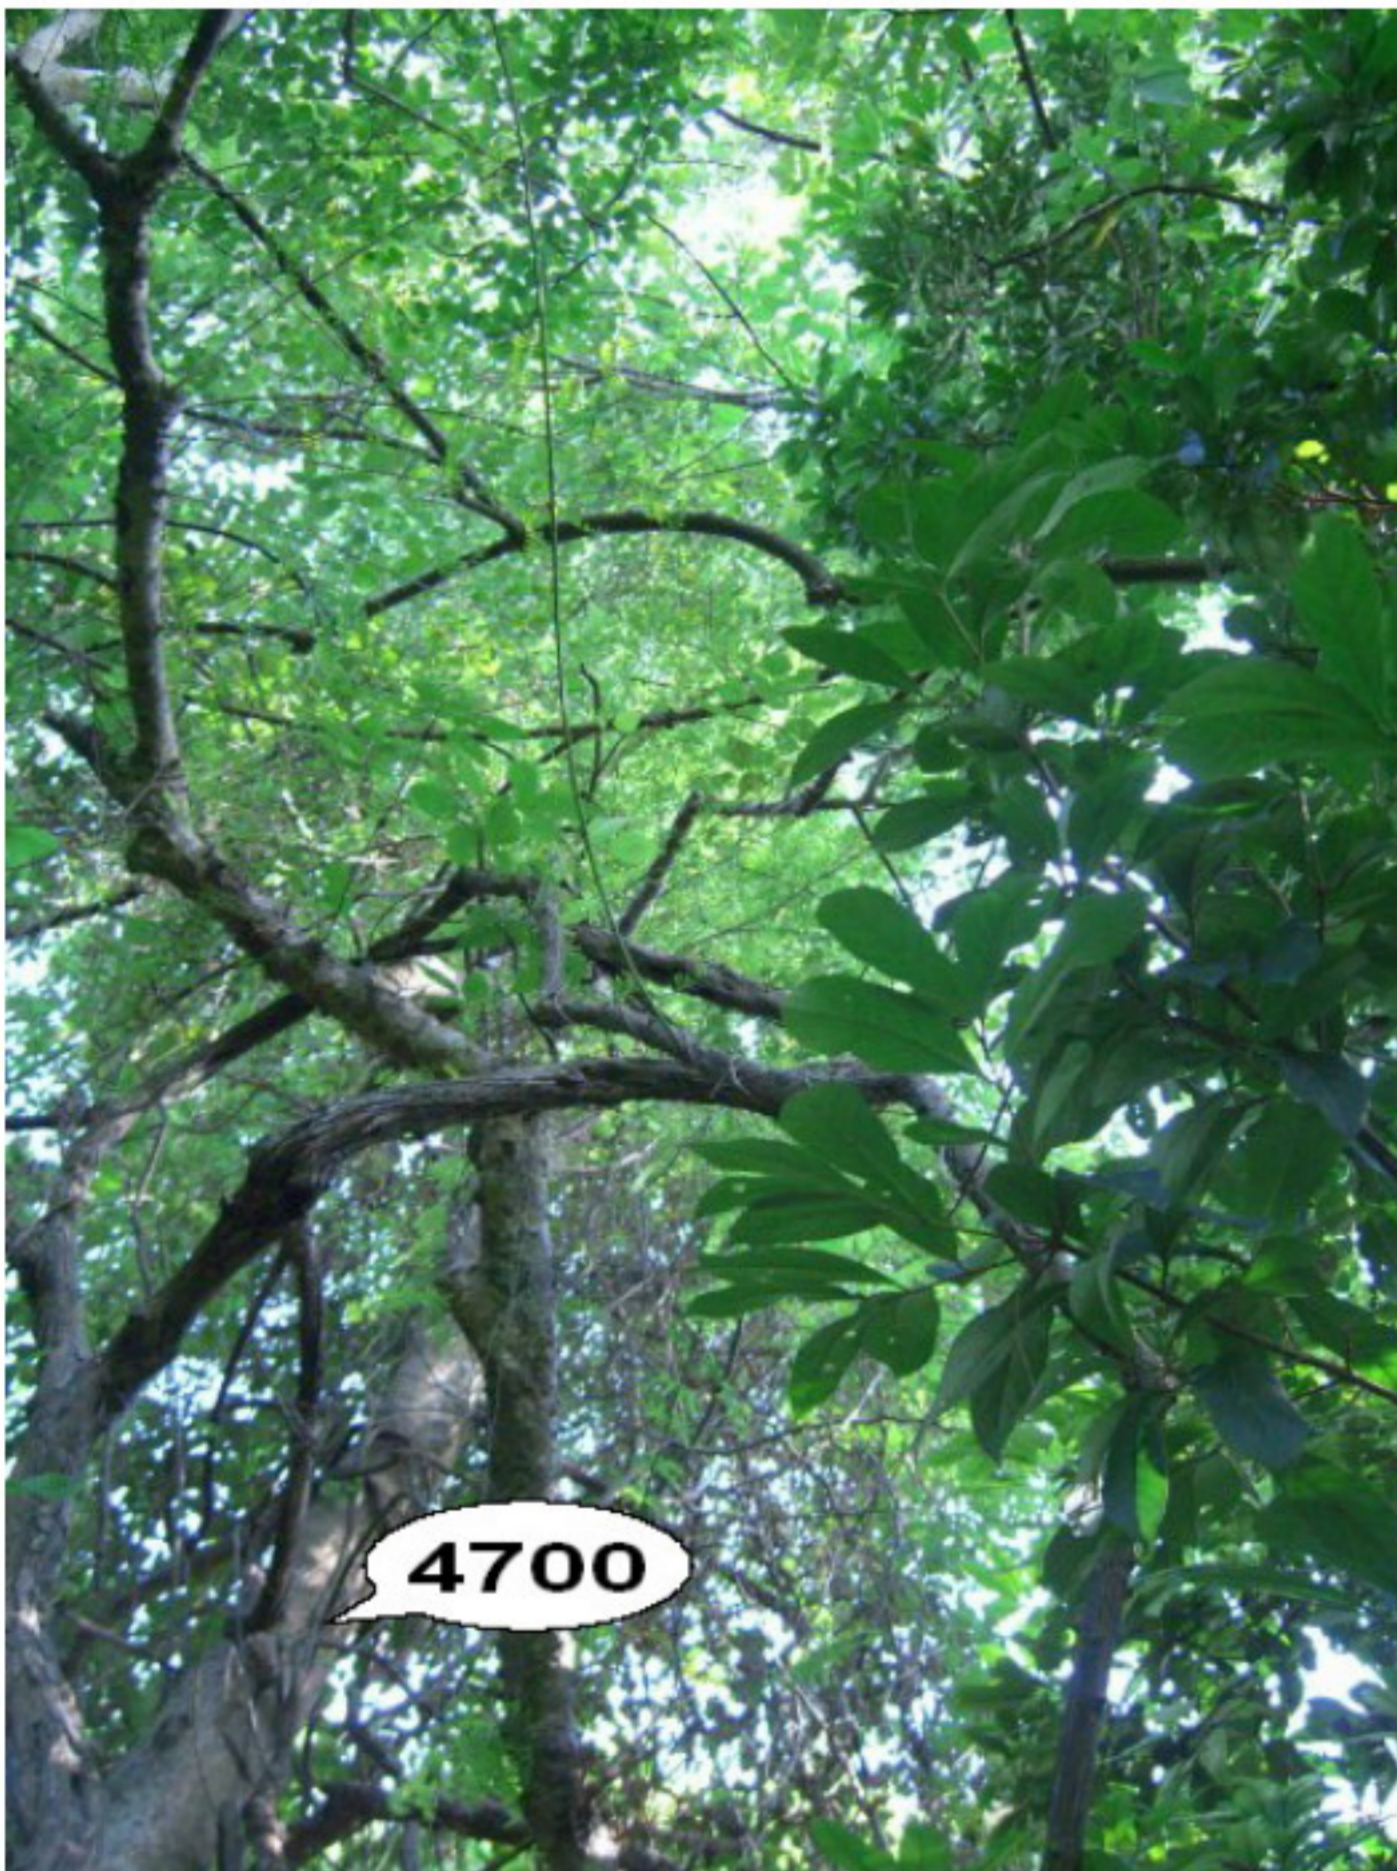
#### Tree 4638

Poor form which lead to low amenity value. Besides, the tree is unbalance. It may need heavy pruning after transplantaion that will affect its transplantaion survival rate. Moreover, the operation of the transplantaion for poor form tree is also difficult.
