Shatin to Central Link Tai Wai to Hung Hom Section

WP CE15 Conditions Survey of
Former Royal Air Force Hangar in Diamond Hill

July 2009

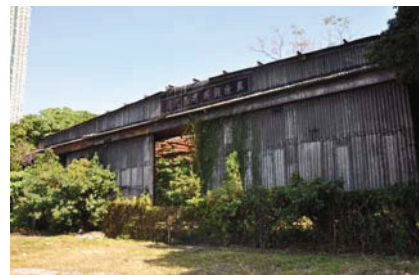
2.2.1 The original aircraft hangar is built of steel members and its roof is formed by the truss with corrugated zinc sheet roof and bitumen sheet waterproofing layer on top (**Photo 2**). The truss roof (**Photo 4**) is supported by a series of steel I-columns and concrete block footings, as shown in below photos. The side walls are also built of steel channels tied with the steel-I-columns along the perimeter of structure and covered with corrugated zinc sheet cladding. Typical defect photos are extracted and shown in **Appendix C**.

Photo 2 – Corrugated zinc sheet roof and bitumen sheet waterproofing layer at the main entrance

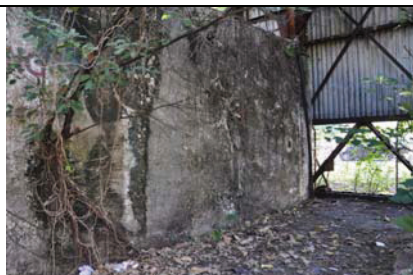
Photo 3 – Mass Concrete side wall with grown vegetation

2.2.3 As the aircraft hangar structure had been exposed to the atmosphere for long period under wet and dry weather, most of the steel members of the frame were corroded with different levels of deterioration. Particular to the small steel members, they are deteriorated with less than 50% of original size left and some even broken and fallen down on the floor. Most of the bolts and nuts at the connection joints of the structure were corroded and deteriorated; this would reduce the whole structural strength of the aircraft hangar, and would also cause impacts to the relocation of the structure. A few steel-I-columns have buckled (**Photo 7**). Most of the concrete footings at each steel-I-column and side walls are grown with vegetation (**Photo 9 & 10**), which would increase the difficulty of relocation of the structure.

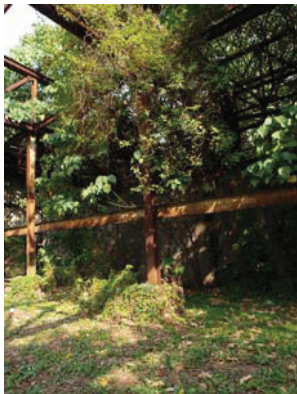
Photo 10 – Vegetation attached on steel frame

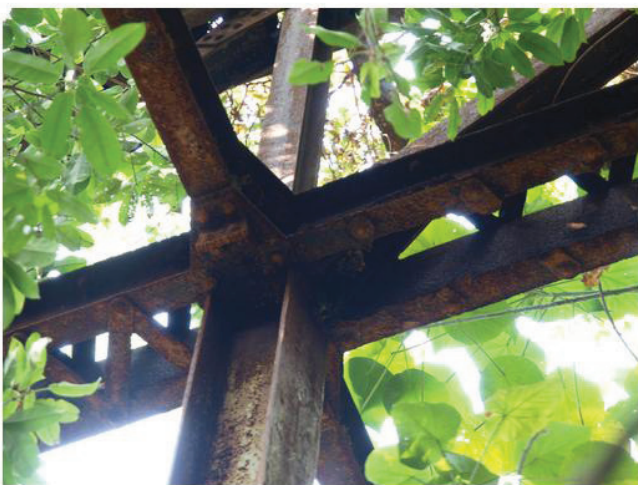
P1070579

E / 9	4	3	3	3	Partially concealed, no visible damage	P1070579, P1070586
E / 10	4	4	4	4	N/A	P1070588
E / 11	4	4	4	4	N/A	
F / 1	4	4	4	4	N/A	
F / 2	4	4	4	4	N/A	P1070592
F / 10	4	4	4	4	N/A	P1070594
F / 11	4	4	4	3	N/A
