Annex H4

Detailed Records of Lei Uk

Overview of Lei Uk

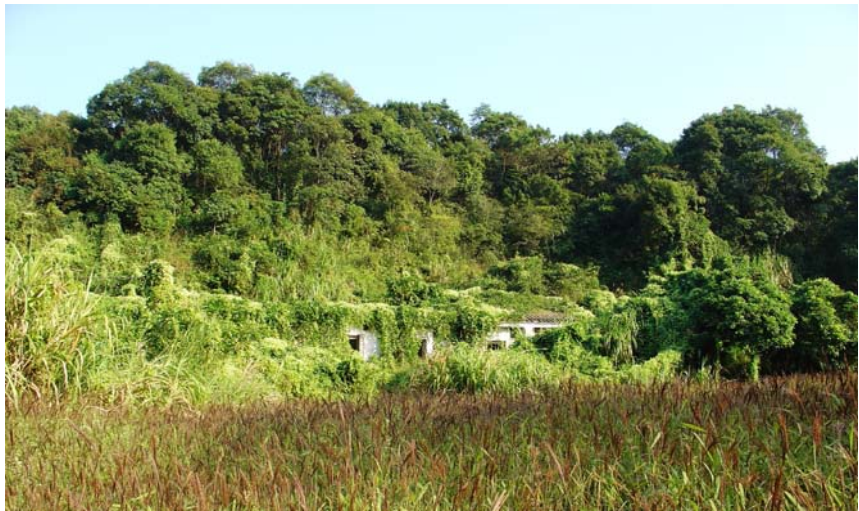
General View

Interior: Not accessible/abandoned	
Details of Architectural Features: See photographic records.	
Past and Present Uses: They were residential houses and are currently ruined.	
Notes on Any Modifications: Some of the buildings were modified by modern material. Such as metal framed glass window.	
Existing Condition: Unroofed, ruined and mostly covered by vegetation and abandoned.	
Photographic Records:

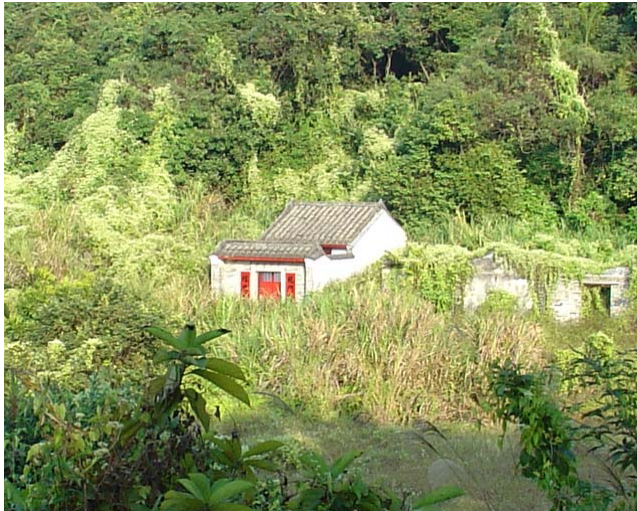
General View

Past and Present Uses: It is used as the Leis ancestral hall.	
Notes on Any Modifications: Nil.	
Existing Condition: Good.	
Photographic Records:

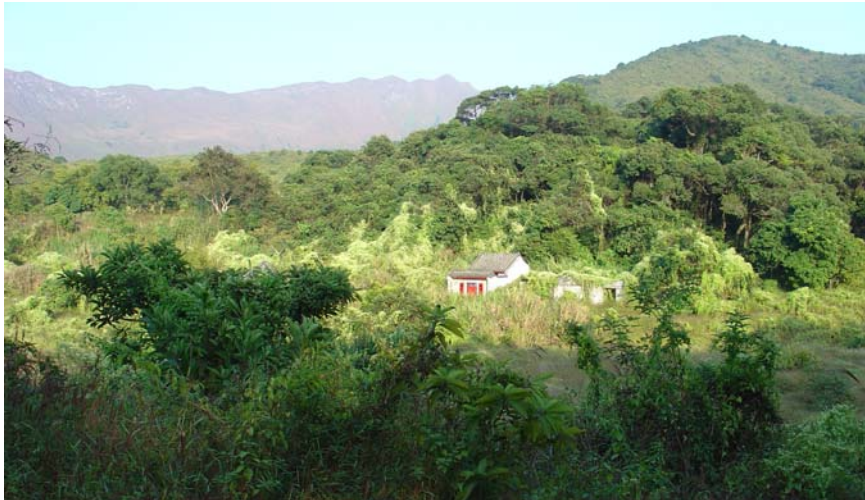
General View

Notes on Any Modifications: Nil.	
Existing Condition: Unroofed, ruined and mostly covered by vegetation and abandoned.	
Photographic Records:
