Appendix 16.9: Diver Survey Results

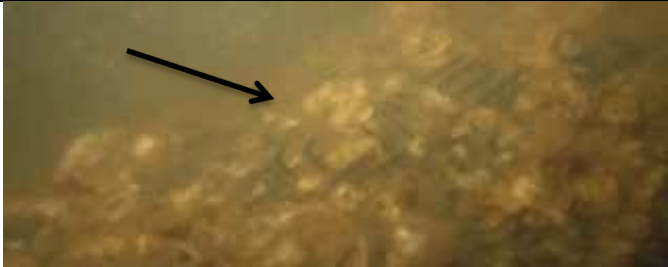
An underwater photograph showing a thin, light-colored metal wire or cable extending diagonally across the frame. The background is a murky, greenish-brown water with some faint, vertical structures visible in the distance.
MC011	807181.2	821042.2	Concrete blocks with marine growth

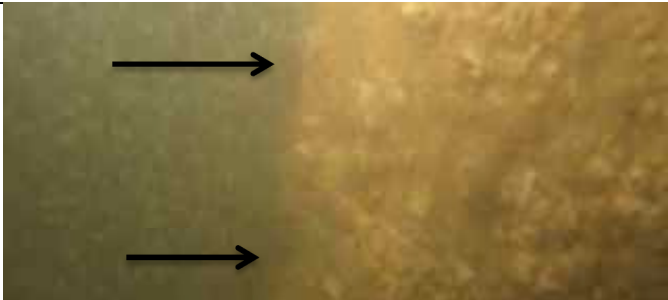
An underwater photograph showing a large, irregular mass of yellowish-brown marine growth, likely algae or coral, covering a surface. A black arrow points from the upper left towards the center of the growth.
MC012	807181.2	821042.2	Concrete blocks with marine growth

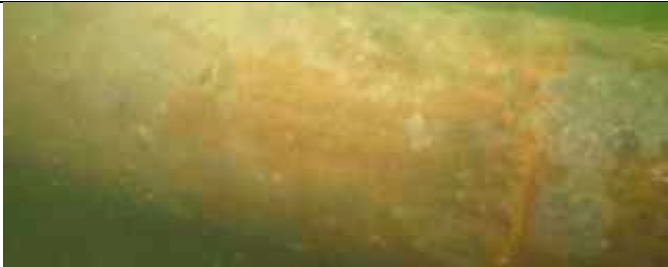
SC020	807432.7	820850.5	Modern bamboo poles with marine growth

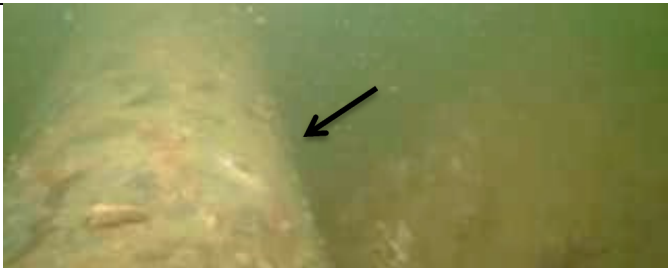
MC038	807450.5	820857.6	Modern bamboo poles with marine growth

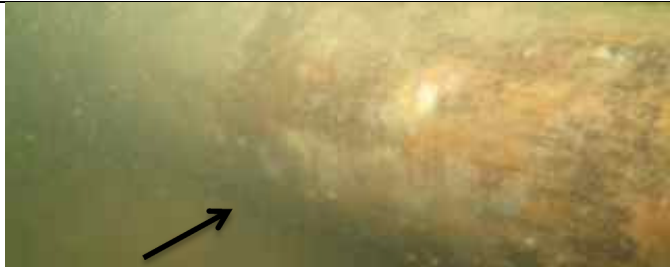
MC041	807448.6	820849.2	Modern bamboo poles with marine growth

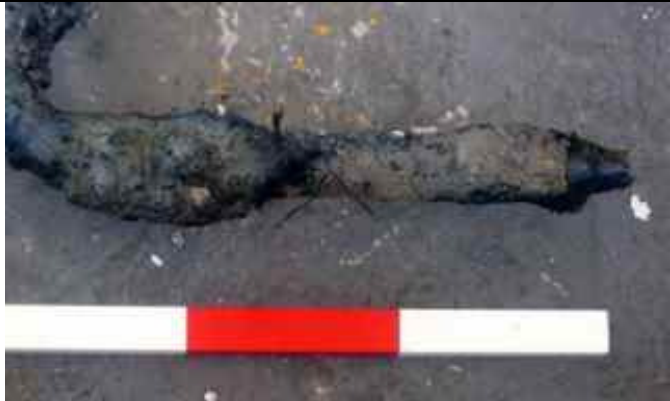
Sonar Contact (SC) Magnetic Contact (MC) Number	Easting	Northing	Description	Underwater Photograph or retrieved object at the surface
MC172	807065.5	820602.7	Modern rebar

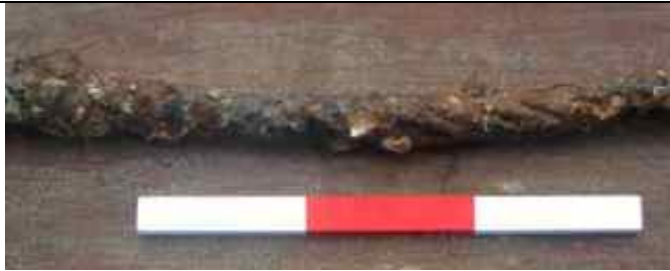
MC173	807088.6	820610.6	Modern metal wire cable

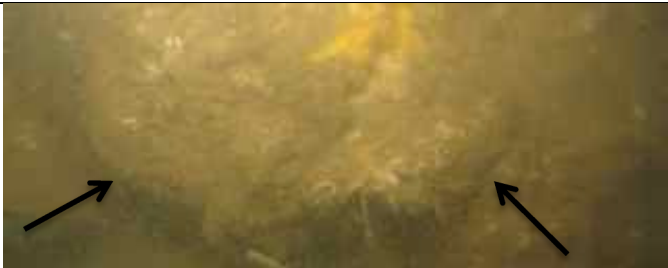
MC094	806647.3	820053.2	Modern concrete block

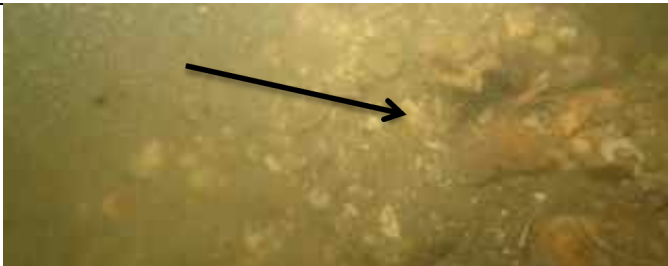
MC101	806646.4	820041.4	Construction waste

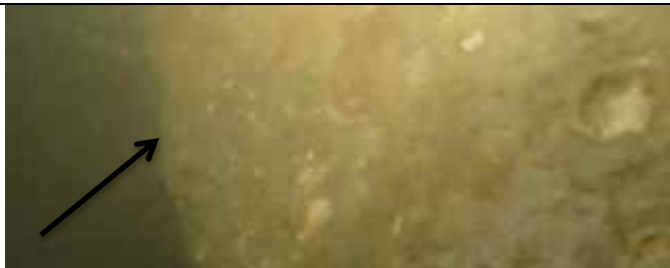
MC118	805347.6	819108.7	Concrete block with marine growth

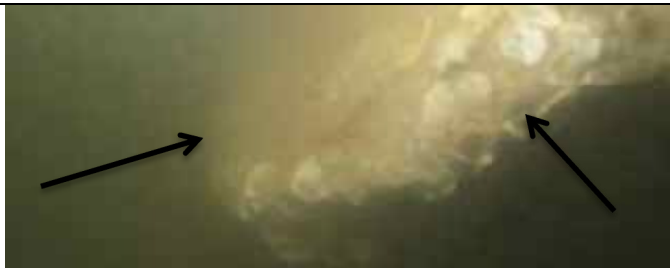
MC126	805313.4	819127.6	Concrete block with marine growth

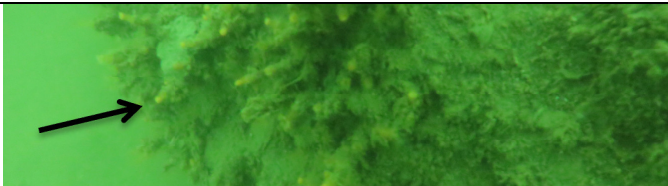
MC147	810704.1	820481.5	Modern rock

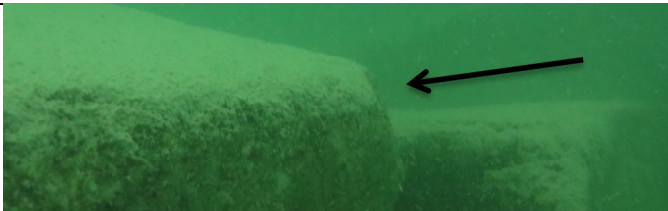
SC040	810301.6	820339.3	Modern rock

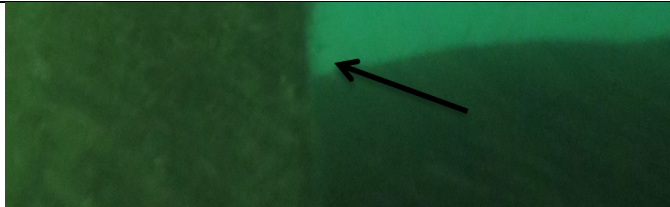
Sonar Contact (SC) Magnetic Contact (MC) Number	Easting	Northing	Description	Underwater Photograph or retrieved object at the surface
MC156	810289.9	820334.2	Modern rock
