路政署

Agreement No. CE 48/2018 (HY)

Improvement of Lion Rock Tunnel – Investigation

Contamination Assessment Plan (Final)

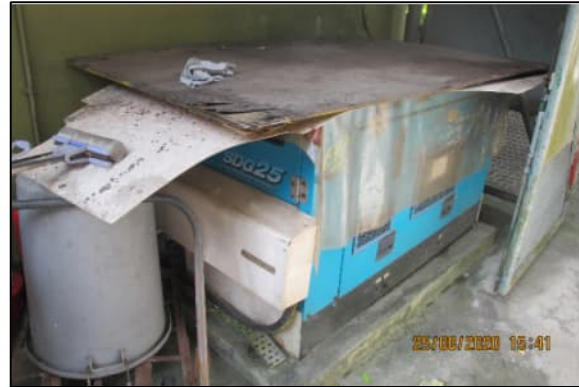
PHOTO 4378: GENERATOR
 (DATE TAKEN: 25 AUGUST 2020)

| Concerned Facility / Area (approx. area) | Hotspot (approx. area) | Site Observation / Current Potentially Contaminating Activities | Corresponding Photographic Record Reference in Appendix C | Other Past Potential Contaminating Land Use / Activities | Potential COCs | Future Land Uses | RBRGs Land Use Scenario |
|--|--|---|---|--|---|---|---|
| | Generator (1 m ²) | A generator with a 70 L diesel fuel tank was installed on a thick concrete slab in the southeast of the E&M building. No stains were observed in the vicinity of the generator. The concrete paved floor and the concrete slab were in good condition. | Photo 4378 in 60604728/CAPb/PR2 | N/A | Metals, PCRs, VOCs and SVOCs | Roads / Car Park | Lower of Industrial or Public Park |

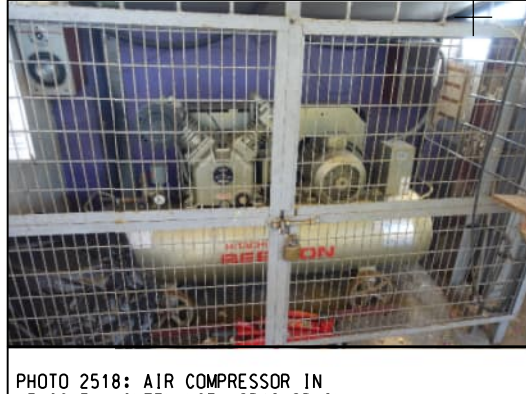
PHOTO 2518: AIR COMPRESSOR IN VEHICLE MAINTENANCE WORKSHOP IN ADMINISTRATION BUILDING (DATE TAKEN: 25 AUGUST 2020)

| Concerned Facility / Area (approx. area) | Hotspot (approx. area) | Site Observation / Current Potentially Contaminating Activities | Corresponding Photographic Record Reference in Appendix C | Other Past Potential Contaminating Land Use / Activities | Potential COCs | Future Land Uses | RBRGs Land Use Scenario |
|---|---|--|---|--|---|---|---|
| | Air Compressor (approx. 3 m ²) | An oil-lubricated mobile air compressor was observed on a metal tray within a metal storage cage in the west of the vehicle maintenance workshop in Administration Building. The metal tray was in good conditions with no spillage observed in the vicinity. | Photo 2518 in 60604728/CAPb/PR3 | N/A | Metals, VOCs, SVOCs and PCRs | Roads | Lower of Industrial or Public Park |

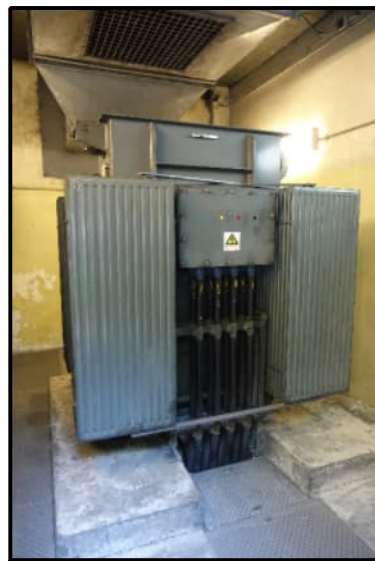
PHOTO 2752: TRANSFORMER S1-2 IN S1-2 BUILDING (DATE TAKEN: 25 AUGUST 2020)

| Concerned Facility / Area (approx. area) | Hotspot (approx. area) | Site Observation / Current Potentially Contaminating Activities | Corresponding Photographic Record Reference in Appendix C | Other Past Potential Contaminating Land Use / Activities | Potential COCs | Future Land Uses | RBRGs Land Use Scenario |
|--|---|--|---|--|---|---|---|
| | Transformer S1-2 (5 m ²) | A transformer was observed on thick concrete slab in the transformer room of S1-2 building. No stains were observed in the vicinity of the transformers. The concrete paved floors and the concrete slabs were in good condition. | Photo 2752 in 60604728/CAPb/PR4 | N/A | Metals, VOCs, SVOCs, PCRs and PCBs | Roads | Lower of Industrial or Public Park |

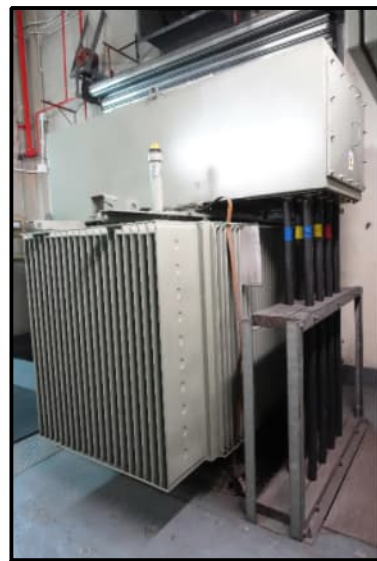
PHOTO 2783: TRANSFORMER S1 IN VENTILATION BUILDING S1 (DATE TAKEN: 25 AUGUST 2020)

| Concerned Facility / Area (approx. area) | Hotspot (approx. area) | Site Observation / Current Potentially Contaminating Activities | Corresponding Photographic Record Reference in Appendix C | Other Past Potential Contaminating Land Use / Activities | Potential COCs | Future Land Uses | RBRGs Land Use Scenario |
|--|---|--|---|--|---|---|---|
| | Transformer S1 (5 m ²) | A transformer was installed on concrete paved ground in the transformer room (substation D) of ventilation building S1. No stains were observed in the vicinity of the transformers. The concrete paved floors and the concrete slabs were in good condition. | Photo 2783 in 60604728/CAPb/PR4 | N/A | Metals, VOCs, SVOCs, PCRs and PCBs | Roads | Lower of Industrial or Public Park |

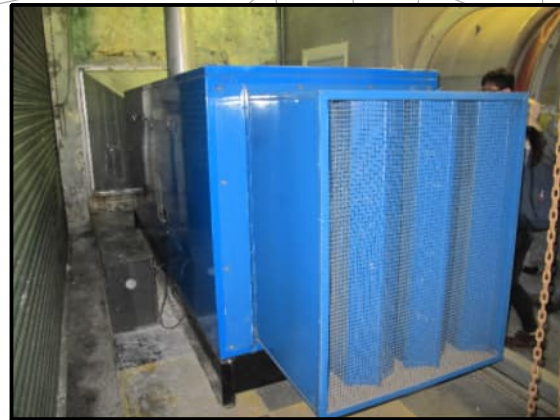
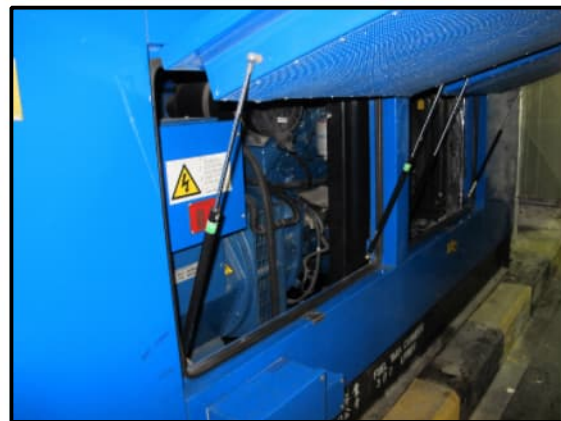
| Concerned Facility / Area (approx. area) | Hotspot (approx. area) | Site Observation / Current Potentially Contaminating Activities | Corresponding Photographic Record Reference in Appendix C | Other Past Potential Contaminating Land Use / Activities | Potential COCs | Future Land Uses | RBRGs Land Use Scenario |
|--|--|---|---|--|---|---|---|
| Ventilation Building S1 | Generator S1 (15 m ²) | A generator with a 300 L diesel fuel tank was installed on thick concrete slab in the ventilation building S1 in the south of the Sha Tin Portal of LRT. | Photo 9838 & 9840 in 60604728/CAPb/PR4 | N/A | Metals, PCRs, VOCs and SVOCs | Roads | Lower of Industrial or Public Park |

PHOTO 9838: GENERATOR S1 IN VENTILATION BUILDING S1 (DATE TAKEN: 25 AUGUST 2020)

PHOTO 9840: GENERATOR S1 IN VENTILATION BUILDING S1 (DATE TAKEN: 25 AUGUST 2020)

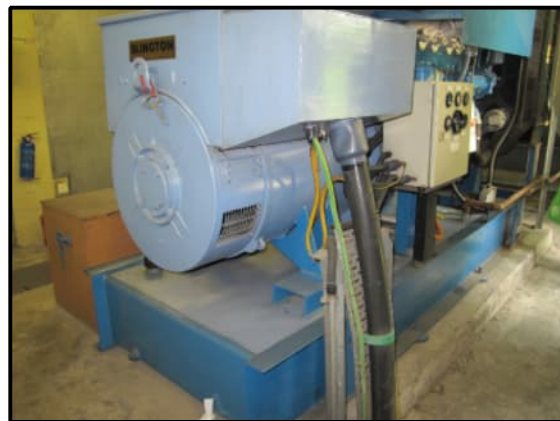
| Concerned Facility / Area (approx. area) | Hotspot (approx. area) | Site Observation / Current Potentially Contaminating Activities | Corresponding Photographic Record Reference in Appendix C | Other Past Potential Contaminating Land Use / Activities | Potential COCs | Future Land Uses | RBRGs Land Use Scenario |
|--|---|--|---|--|---|---|---|
| S1-2 Building | Generator S1-2 (15 m ²) | A generator with a 480 L diesel fuel tank was observed on thick concrete slab in the emergency generator room of S1-2 building located in the south of the Sha Tin Portal of LRT. No stains were observed in the vicinity of the generator. The concrete paved floors and the concrete slabs were in good condition. | Photo 9827 in 60604728/CAPb/PR4 | N/A | Metals, PCRs, VOCs and SVOCs | Roads | Lower of Industrial or Public Park |

PHOTO 9827: GENERATOR S1-2 IN S1-2 BUILDING (DATE TAKEN: 25 AUGUST 2020)

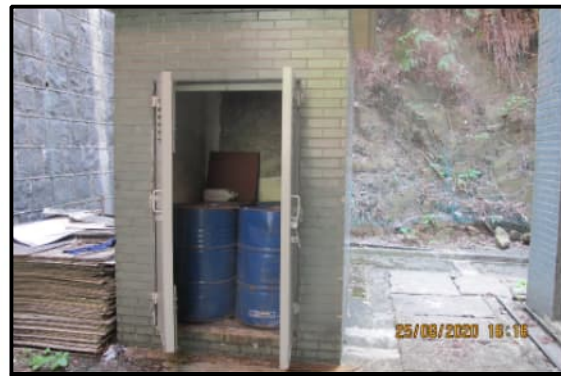
| Concerned Facility / Area (approx. area) | Hotspot (approx. area) | Site Observation / Current Potentially Contaminating Activities | Corresponding Photographic Record Reference in Appendix C | Other Past Potential Contaminating Land Use / Activities | Potential COCs | Future Land Uses | RBRGs Land Use Scenario |
|--|---|--|---|--|---|---|---|
| | Chemical Waste Storage Area (5 m ²) | A chemical waste storage area for the storage of spent diesel oil after filling the generators (S1 and S1-2) was observed at the south of Ventilation Building S1. 4 spent diesel oil drums were observed on raised concrete platform within the area. No stains were observed in the chemical waste storage area. The raised concrete platform was in good condition. | Photo 4430 in 60604728/CAPb/PR4 | N/A | Metals, PCRs, VOCs and SVOCs | Roads | Lower of Industrial or Public Park |

PHOTO 4430: CHEMICAL WASTE STORAGE AREA OF VENTILATION BUILDING S1 (DATE TAKEN: 25 AUGUST 2020)

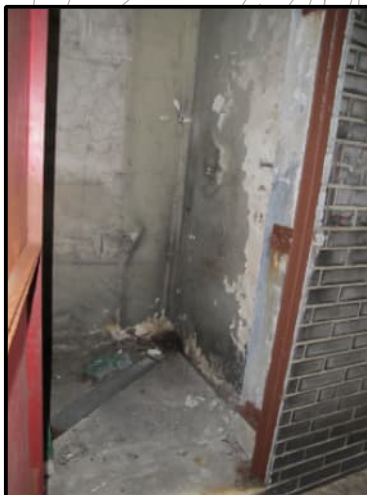
| Concerned Facility / Area (approx. area) | Hotspot (approx. area) | Site Observation / Current Potentially Contaminating Activities | Corresponding Photographic Record Reference in Appendix C | Other Past Potential Contaminating Land Use / Activities | Potential COCs | Future Land Uses | RBRGs Land Use Scenario |
|--|---|---|---|--|---|---|---|
| | Chemical Waste Storage Area (2 m ²) | A chemical waste storage area was observed in the north of the ventilation building K2, which was a vacant concrete paved room. According to the site representative, the area reportedly store any spent diesel oil drums after filling the 2 mobile gensets. No stains were observed in the chemical waste storage area. All the concrete paved floors were in good condition. | Photo 9872 in 60604728/CAPb/PR6 | N/A | Metals, PCRs, VOCs and SVOCs | Roads | Lower of Industrial or Public Park |

PHOTO 9872: CHEMICAL WASTE STORAGE AREA IN VENTILATION BUILDING K2 (DATE TAKEN: 25 AUGUST 2020)

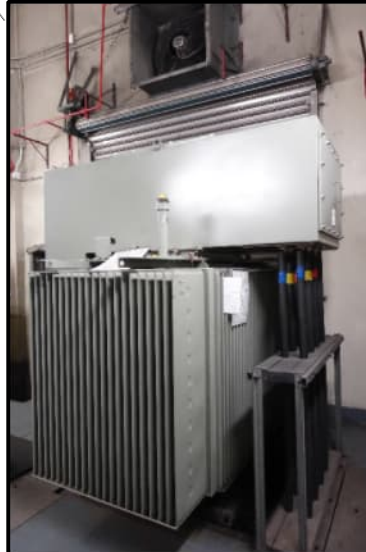
| Concerned Facility / Area (approx. area) | Hotspot (approx. area) | Site Observation / Current Potentially Contaminating Activities | Corresponding Photographic Record Reference in Appendix C | Other Past Potential Contaminating Land Use / Activities | Potential COCs | Future Land Uses | RBRGs Land Use Scenario |
|--|---|--|---|--|---|---|---|
| Ventilation Building K1* | 2 Transformers (K1 and K1-2) (5 m ² each) | The Ventilation Building K1 is located in the north of the Kowloon Portal of LRT. Two transformers (K1 and K1-2) were observed on concrete paved floor in the transformer rooms (substation C and substation K1-2) within the Ventilation Building K1. No stains were observed inside the building and the concrete paved floor was in good condition. | Photo 2881, 4462 & 9882 in 60604728/CAPb/PR6 | N/A | Metals, VOCs, SVOCs, PCRs and PCBs | To be confirmed* | To be confirmed * |

PHOTO 2881: TRANSFORMER K1 IN VENTILATION BUILDING K1 (DATE TAKEN: 25 AUGUST 2020)

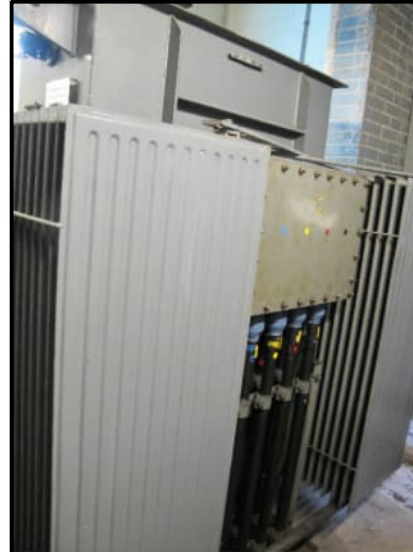
PHOTO 9882: TRANSFORMER K1-2 IN VENTILATION BUILDING K1 (DATE TAKEN: 25 AUGUST 2020)

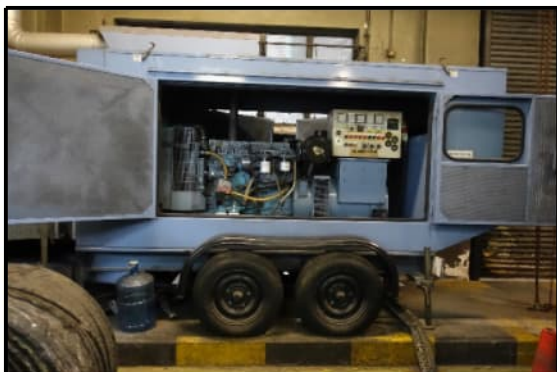
| Concerned Facility / Area (approx. area) | Hotspot (approx. area) | Site Observation / Current Potentially Contaminating Activities | Corresponding Photographic Record Reference in Appendix C | Other Past Potential Contaminating Land Use / Activities | Potential COCs | Future Land Uses | RBRGs Land Use Scenario |
|--|---|--|---|--|---|---|---|
| Ventilation Building K2 | 2 Generators (Mobile Genset 1 and 2) (10 m ² each) | The Ventilation Building K2 located in the northeast of the Kowloon Portal of LRT. Two mobile diesel generators (Mobile Genset 1 and 2) were observed in the northwest and adjacent to the southeast of Ventilation Building K2 respectively. The generators were observed on raised concrete plinth / concrete paved ground. No stains were observed in the vicinity of the generators. All the concrete paved floors were in good condition. | Photo 2835 & 9854 in 60604728/CAPb/PR6 | N/A | Metals, PCRs, VOCs and SVOCs | Roads | Lower of Industrial or Public Park |

PHOTO 2835: MOBILE GENSET 1 IN VENTILATION BUILDING K2 (DATE TAKEN: 25 AUGUST 2020)

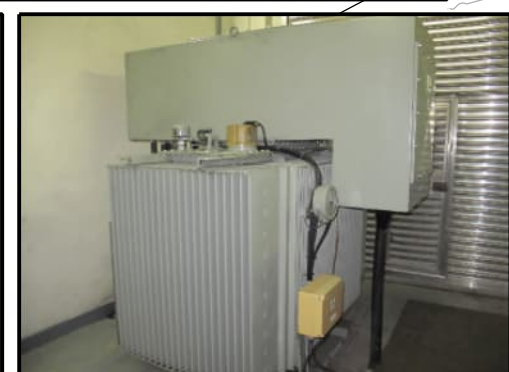
| Concerned Facility / Area (approx. area) | Hotspot (approx. area) | Site Observation / Current Potentially Contaminating Activities | Corresponding Photographic Record Reference in Appendix C | Other Past Potential Contaminating Land Use / Activities | Potential COCs | Future Land Uses | RBRGs Land Use Scenario |
|--|---|---|---|--|---|---|---|
| | Transformer K2 (5 m ²) | A transformer was installed on concrete paved floor in the transformer room (substation A) of Ventilation Building K2. No stains were observed in the vicinity of the transformer. All the concrete paved floors and the concrete slabs were in good condition. | Photo 9867 in 60604728/CAPb/PR6 | N/A | Metals, VOCs, SVOCs, PCRs and PCBs | Roads | Lower of Industrial or Public Park |

PHOTO 9867: TRANSFORMER K2 IN VENTILATION BUILDING K2 (DATE TAKEN: 25 AUGUST 2020)

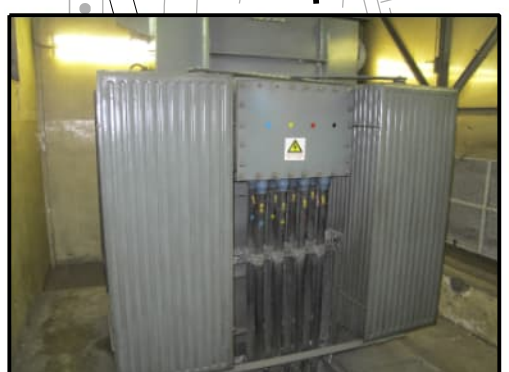
| Concerned Facility / Area (approx. area) | Hotspot (approx. area) | Site Observation / Current Potentially Contaminating Activities | Corresponding Photographic Record Reference in Appendix C | Other Past Potential Contaminating Land Use / Activities | Potential COCs | Future Land Uses | RBRGs Land Use Scenario |
|--|---|---|---|--|---|---|---|
| K2-2 Building | Transformer K2-2 (5 m ²) | A transformer was installed on a thick concrete slab in the transformer room of K2-2 building located in the south of Kowloon Portal. No stains were observed in the vicinity of the transformer. All the concrete paved floors and the concrete slabs were in good condition. | Photo 9857 in 60604728/CAPb/PR6 | N/A | Metals, VOCs, SVOCs, PCRs and PCBs | Roads | Lower of Industrial or Public Park |

PHOTO 9857: TRANSFORMER K2-2 IN K2-2 BUILDING (DATE TAKEN: 25 AUGUST 2020)

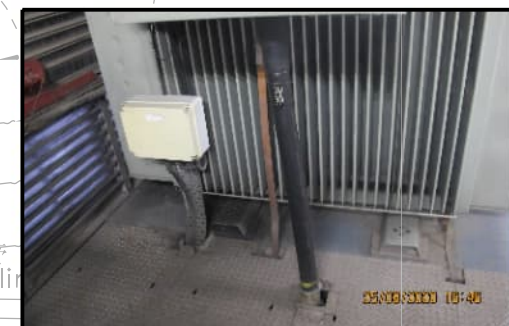
PHOTO 4462: TRANSFORMER K1-2 IN VENTILATION BUILDING K1 (DATE TAKEN: 25 AUGUST 2020)

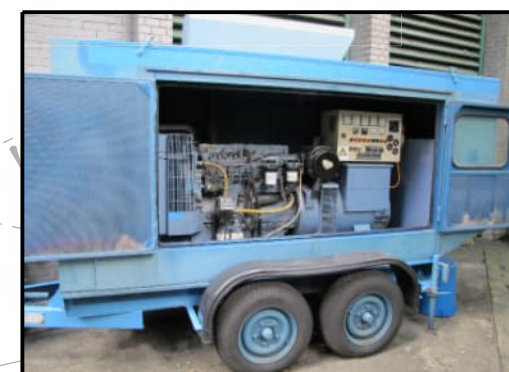
PHOTO 9854: MOBILE GENSET 2 AT VENTILATION BUILDING K2 (DATE TAKEN: 25 AUGUST 2020)

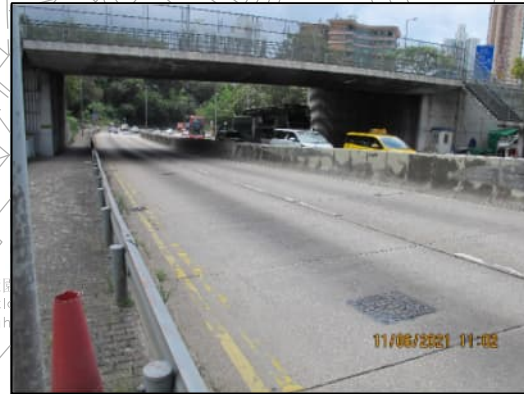
PHOTO 7797: LUNG CHEUNG ROAD AND EXISTING VEHICULAR BRIDGE (DATE TAKEN: 11 JUNE 2021)

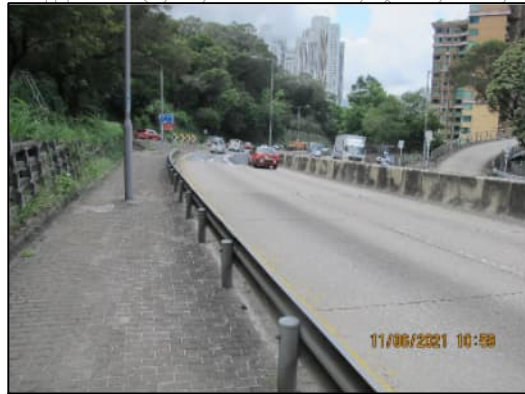
PHOTO 7766: LUNG CHEUNG ROAD AND FOOTPATH NEAR LAMP POST E6986 (DATE TAKEN: 11 JUNE 2021)
