Contract No. : DC/2007/06
**River Improvement Works in Upper Lam Tsuen, She
Shan River and Upper Tai Po River**

ENVIRONMENTAL MONITORING AND AUDIT

MONTHLY EM&A REPORT of

UPPER TAI PO RIVER

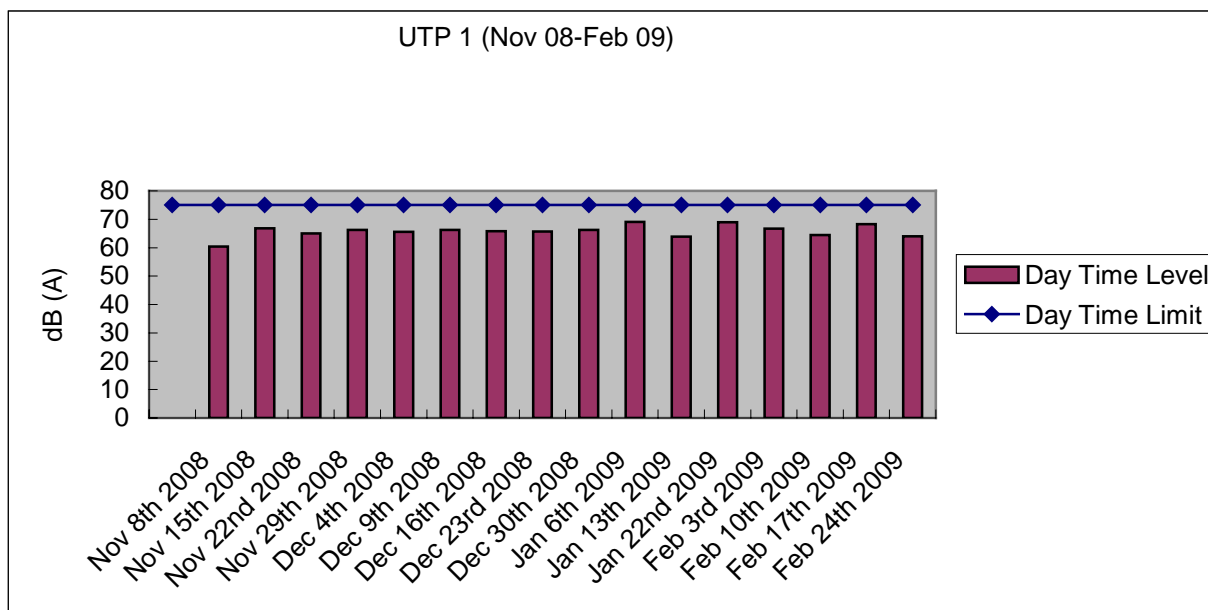
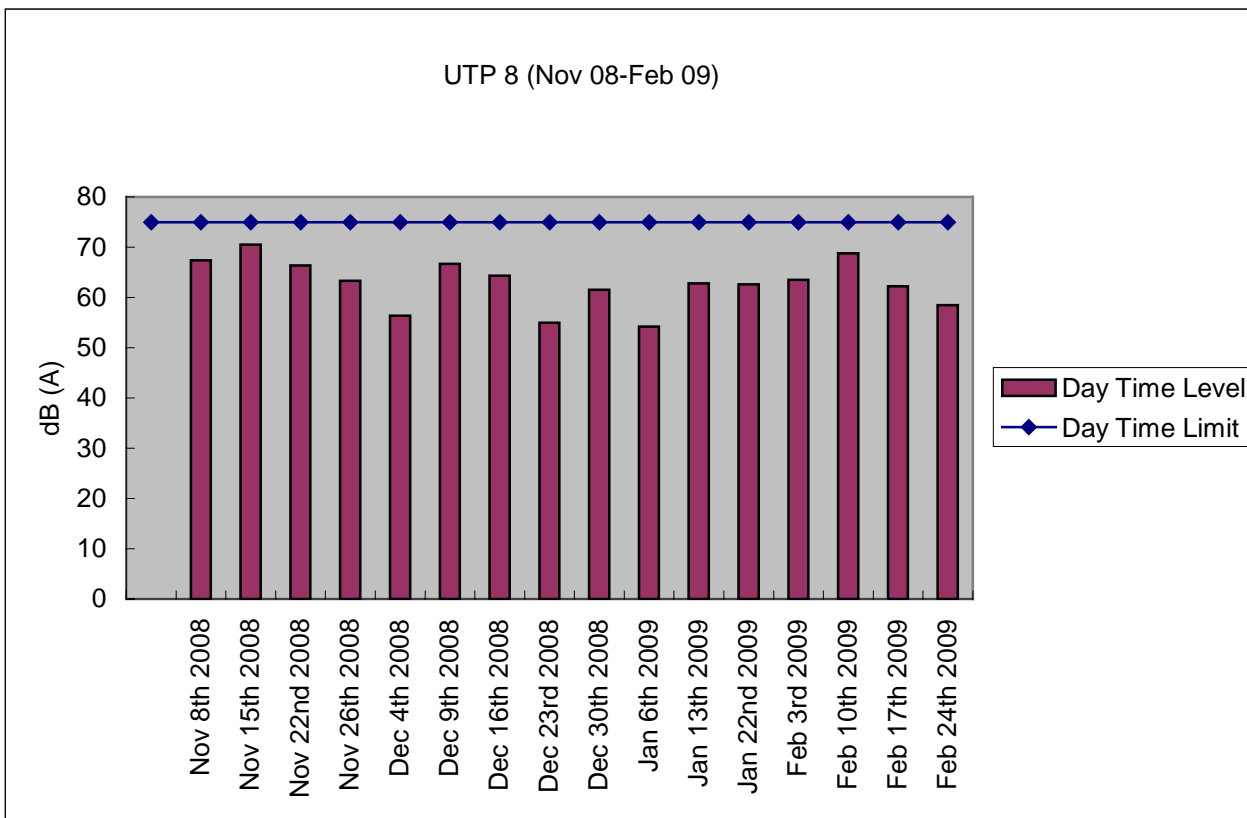
Graphical plot for noise measurements

The following plots were the graphical plots for the 11 monitoring locations. Each plot showed the day time limit 75 dB(A), daytime level, date and the measured dB (A) results as in Leq 30min for each location. The graph contains the data recorded from Nov 2008 to Feb 2009
