Ocean Park Master Redevelopment Project

Monthly Environmental Monitoring & Audit Report – April 2007

EP-249/2006/A – Condition 3.4

Monthly EM&A Report – April 2007

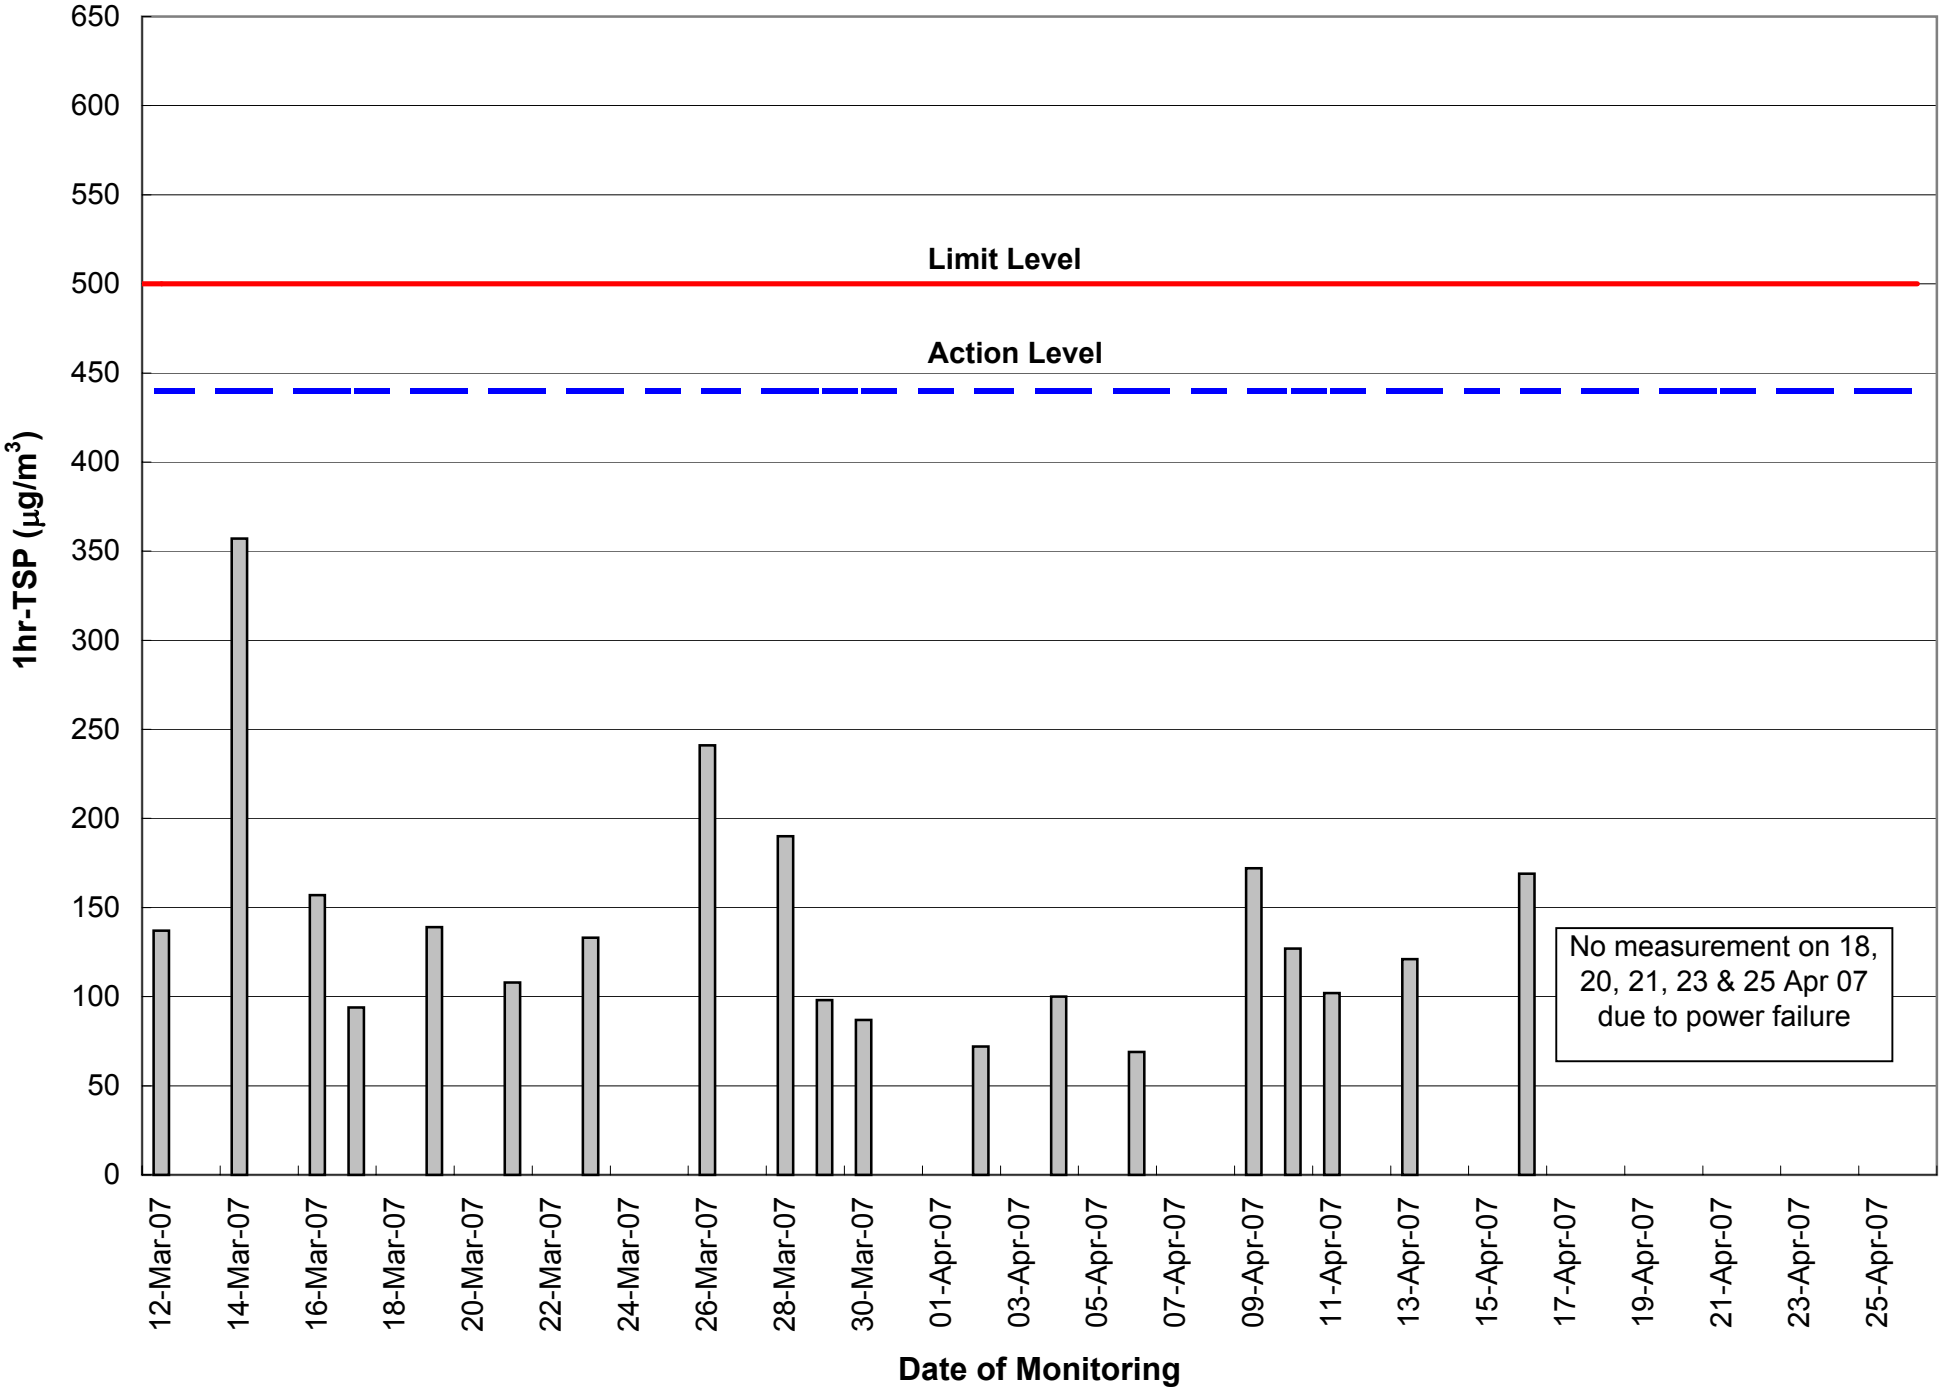
Figure C.1 1-hr TSP monitoring results of Monitoring Station AM1

Note: Please note that no measurement on 1-hr TSP was taken on 18, 20, 21, 23 and 25 April 2007 due to power failure.

X – denotes no measurement due to power failure

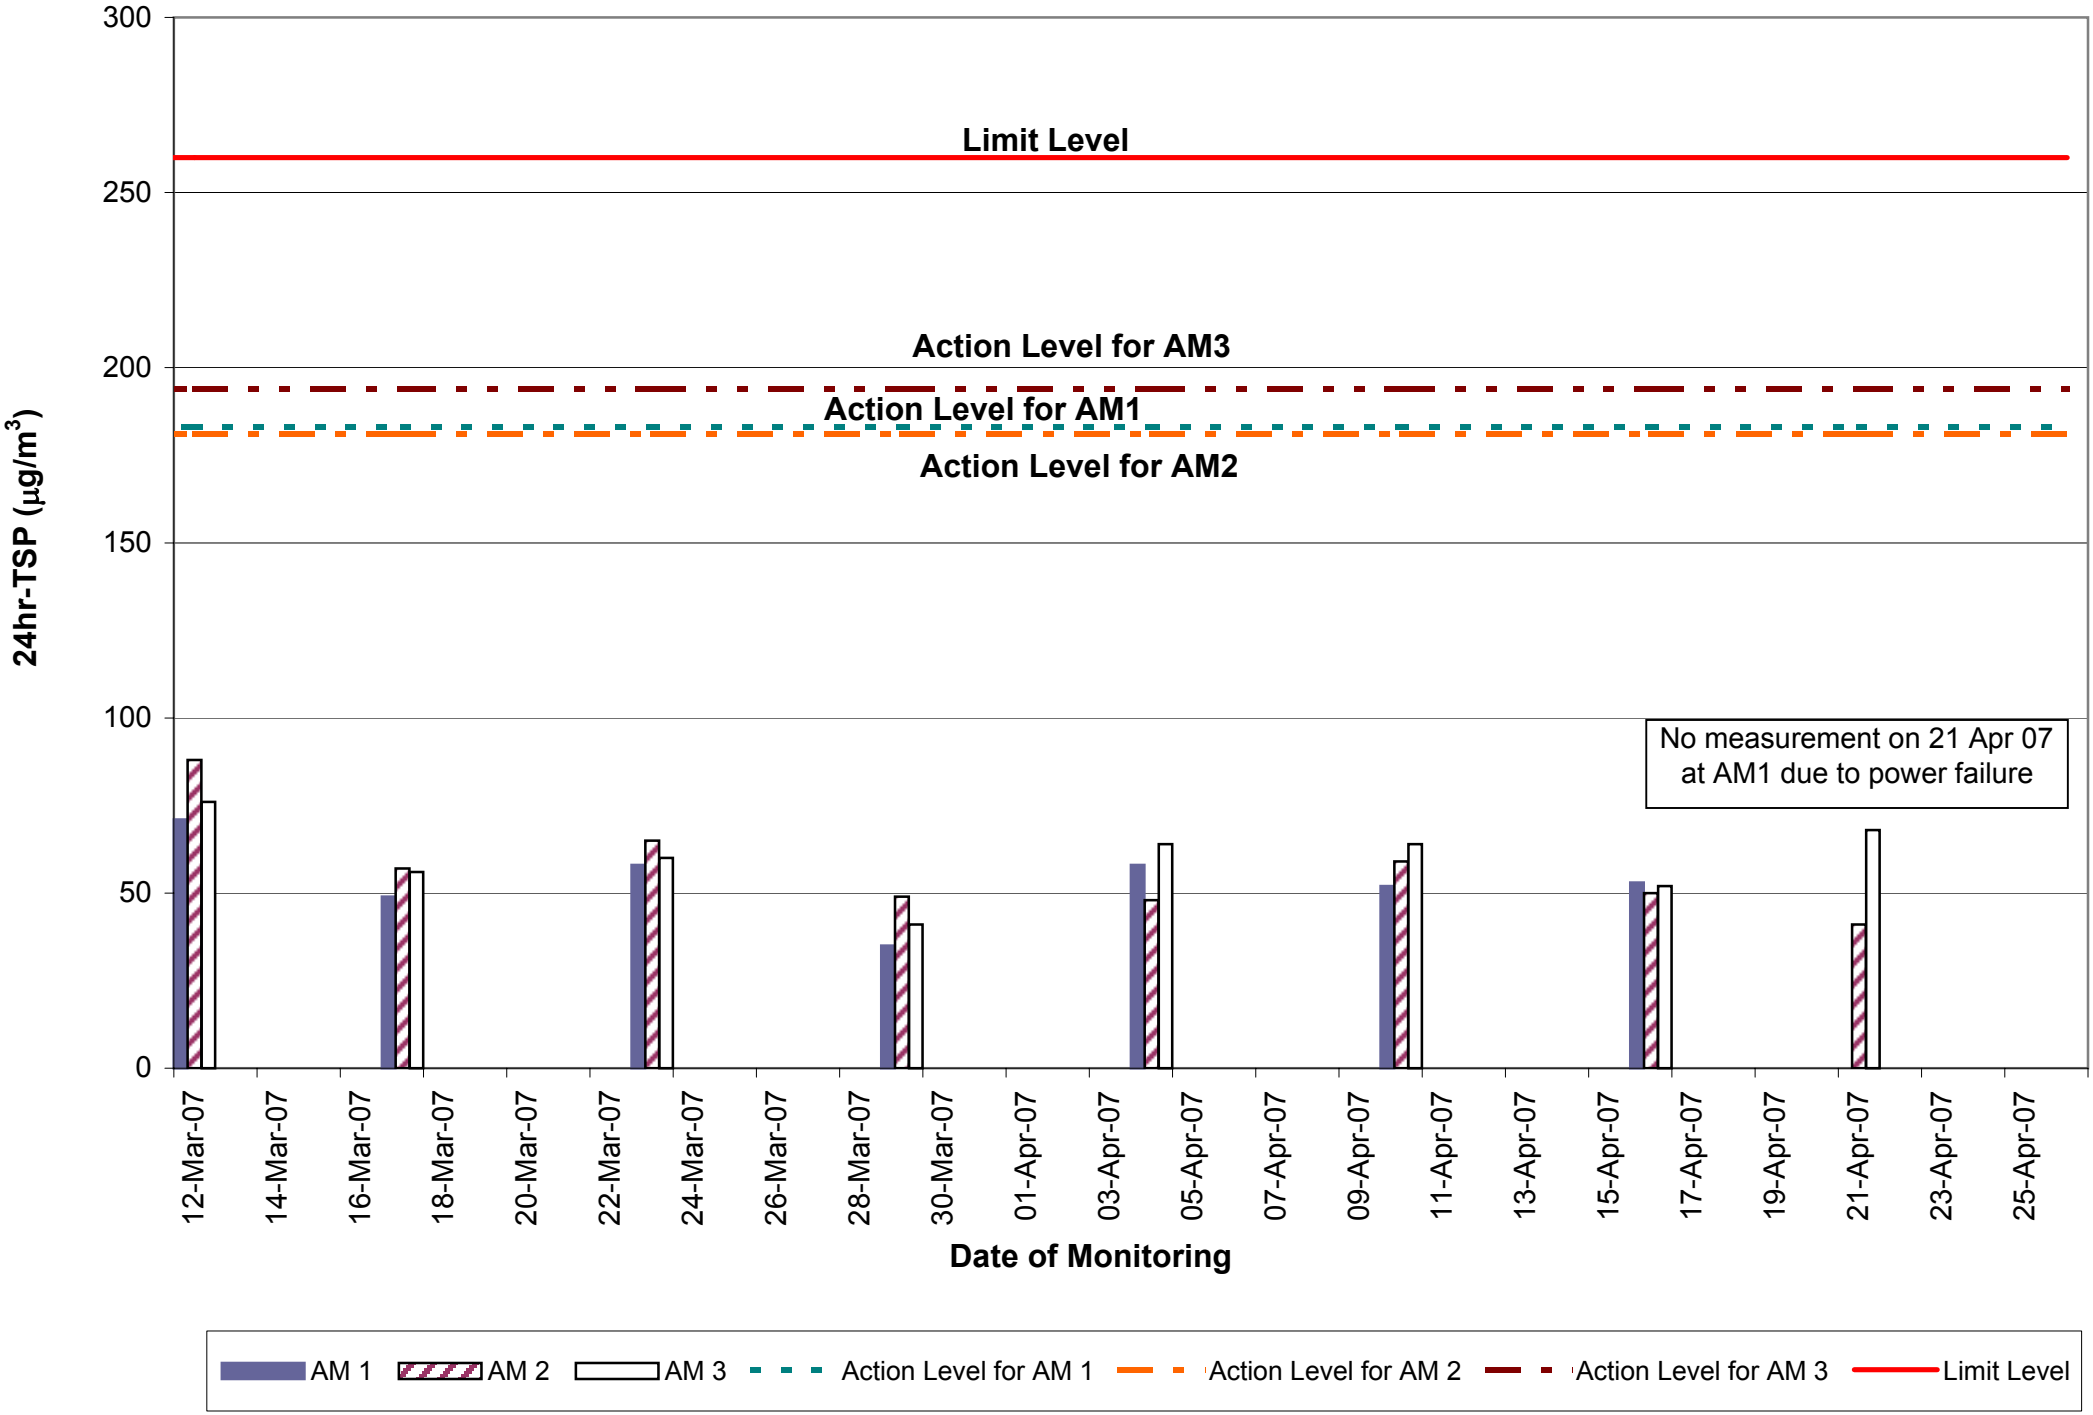
Figure C.4 24-hr TSP monitoring results of Monitoring Station AM1, AM2 & AM3

Note: Please note that no measurement on 24-hr TSP was taken on 21 April 2007 due to power failure.

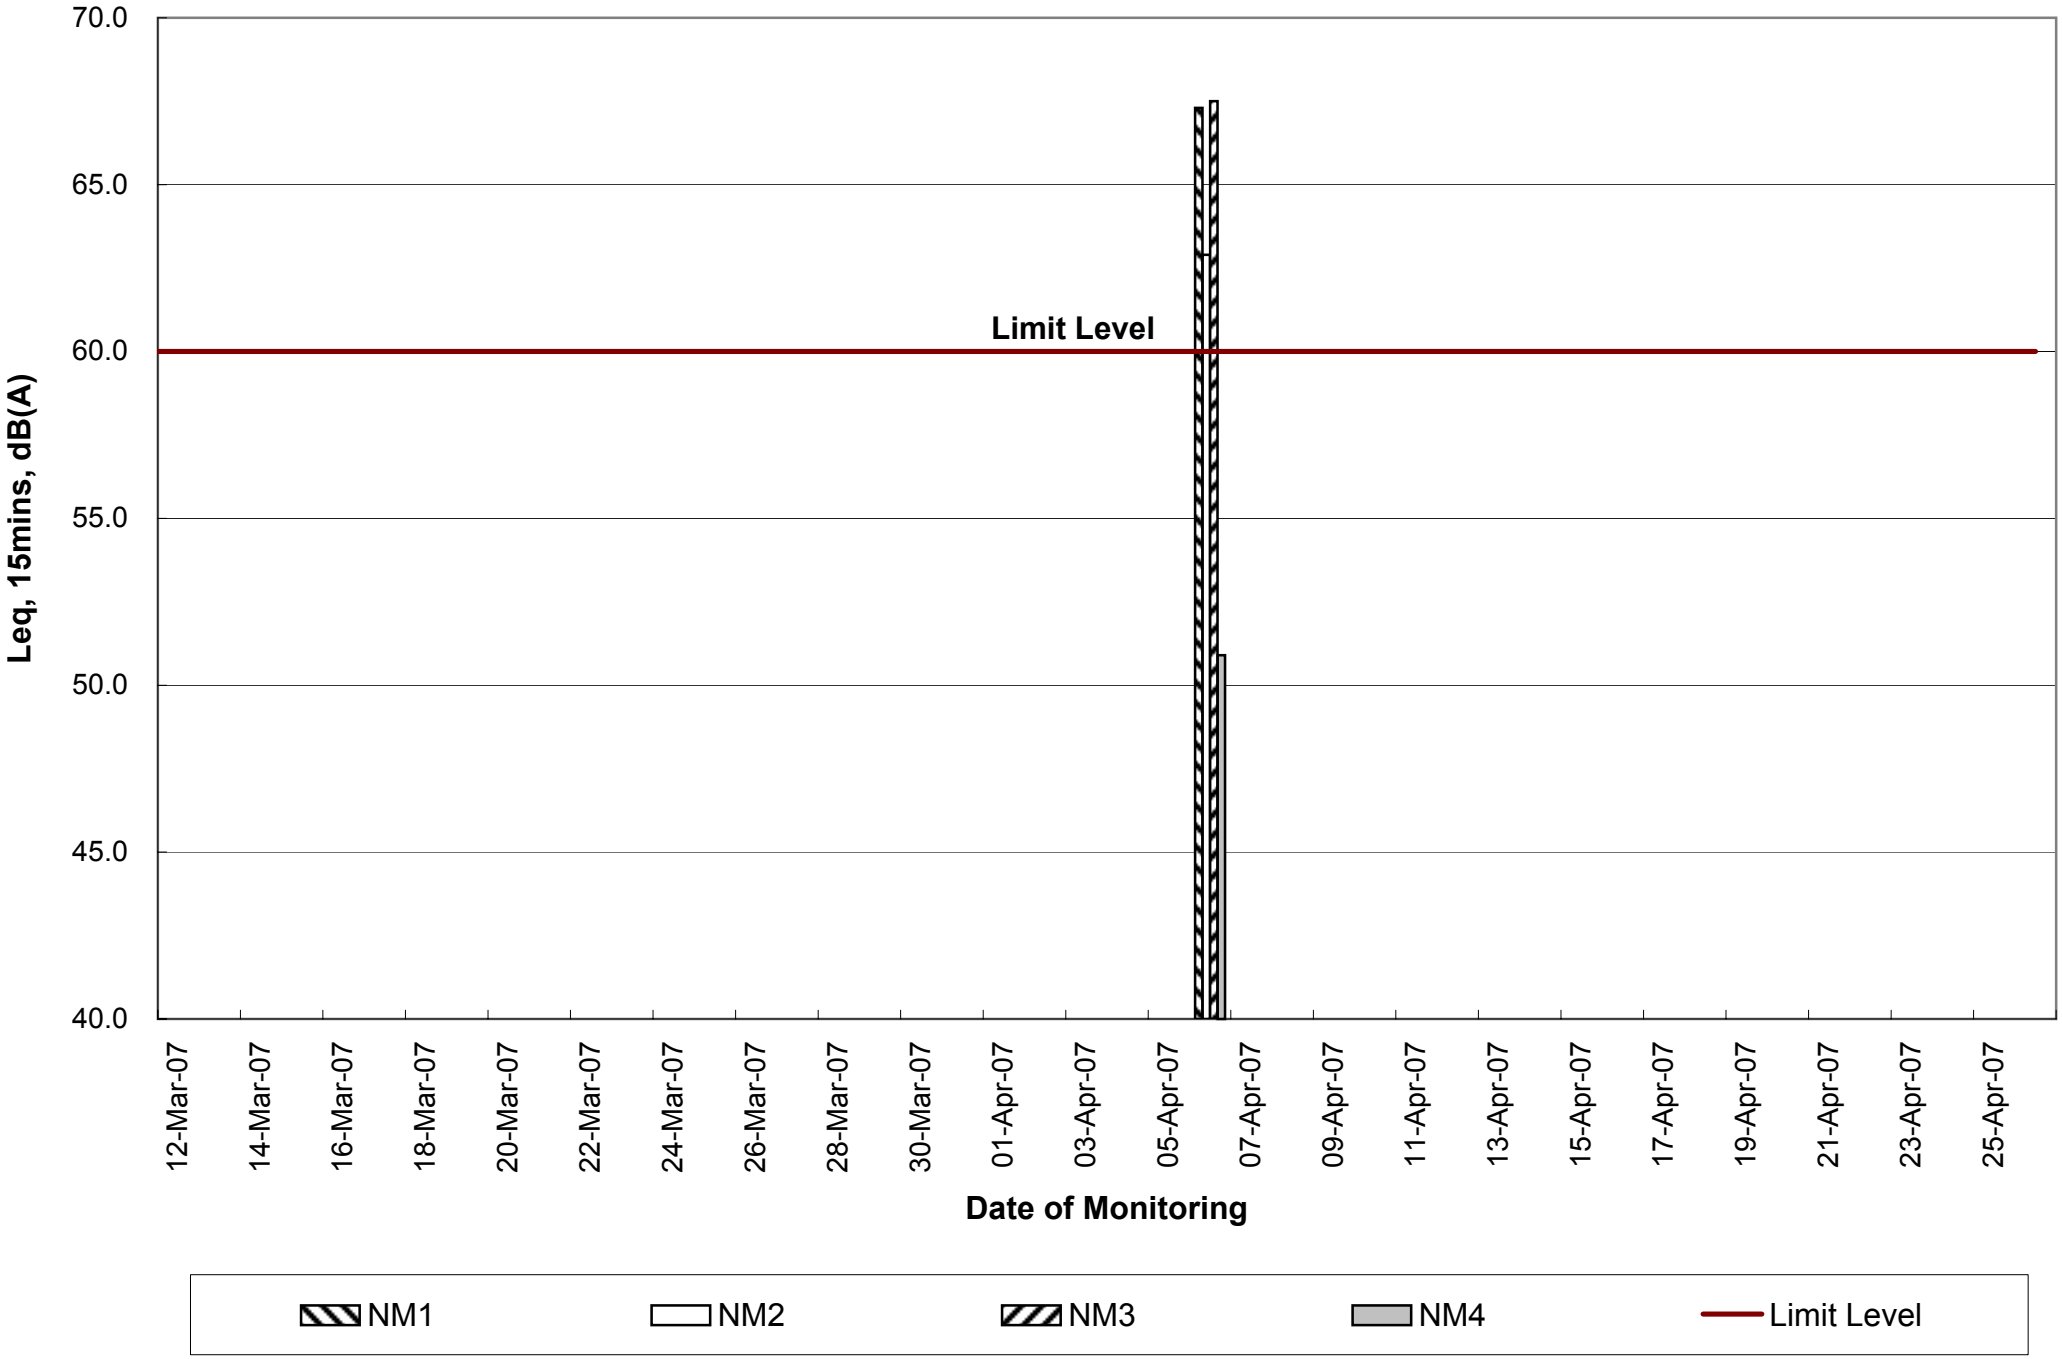
Figure D.3 - Holiday Noise Monitoring Results of Monitoring Stations NM1, NM2, NM3 & NM4

Three exceedances of Limit Level for holiday noise monitoring on 6 April 2007 at CN1, CN2 and CN3, however, the cause of exceedance was the community noise from the visitors at Park, not related to the construction works within the site of Ocean Park.
