Ocean Park Master Redevelopment Project

Monthly EM&A Report – July 2011

Monthly Environmental Monitoring & Audit Report – July 2011

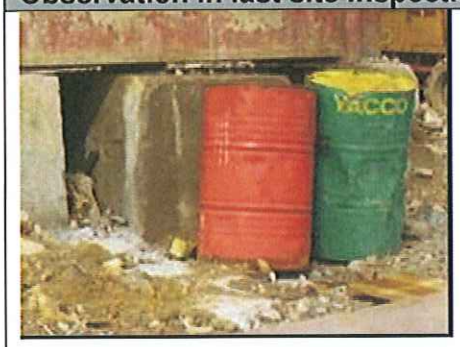
P1130315: Two empty oil drums were placed on bare ground. The Contractor was reminded to place them in chemical waste storage area and dispose them properly.	P1130459 & P1130452: Oil drums were placed on bare ground. The Contractor was reminded either to provide drip trays to the oil drums or store them in the chemical storage area.

P1130314: An idled stockpile of dusty construction material was not covered by any means. The Contractor was reminded to cover it with tarpaulin sheets or other means to suppress dust.	Closed - P1130416: The idled stockpile of dusty construction material had been covered with tarpaulin sheets to suppress dust.

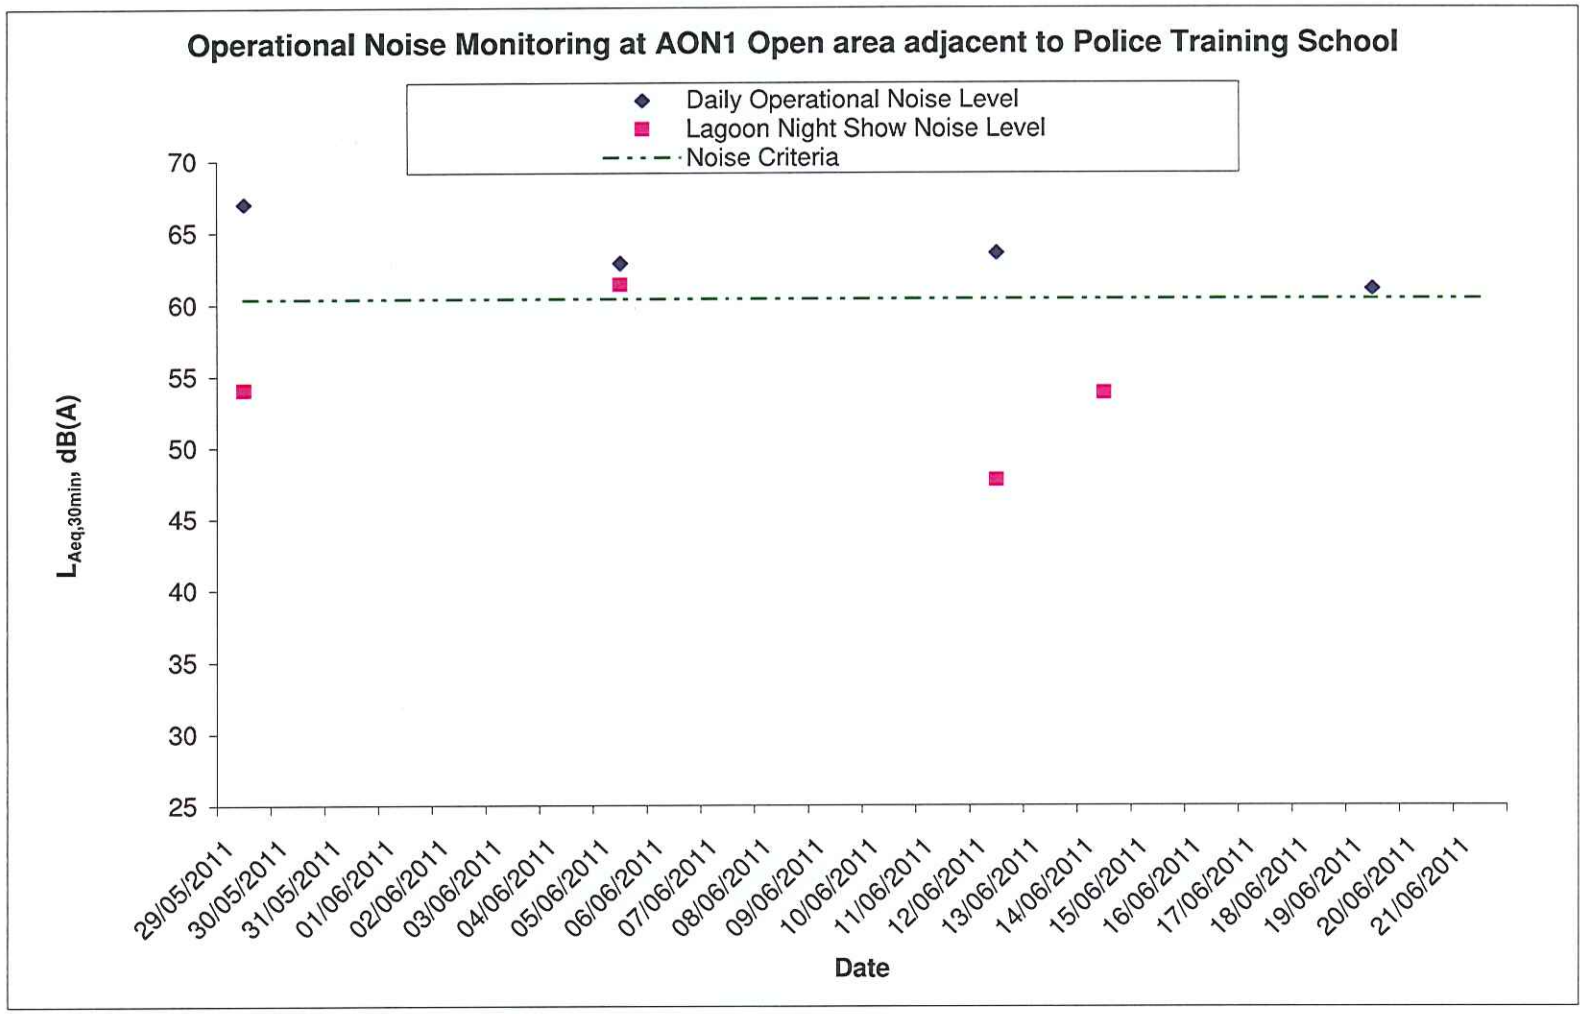
Annex B3-1

Note: The exceedances were due to the high level of background noise from visitors and traffic on public holidays, especially on 29 May, 5 , 12 and 19 June 2011, which were public holidays.

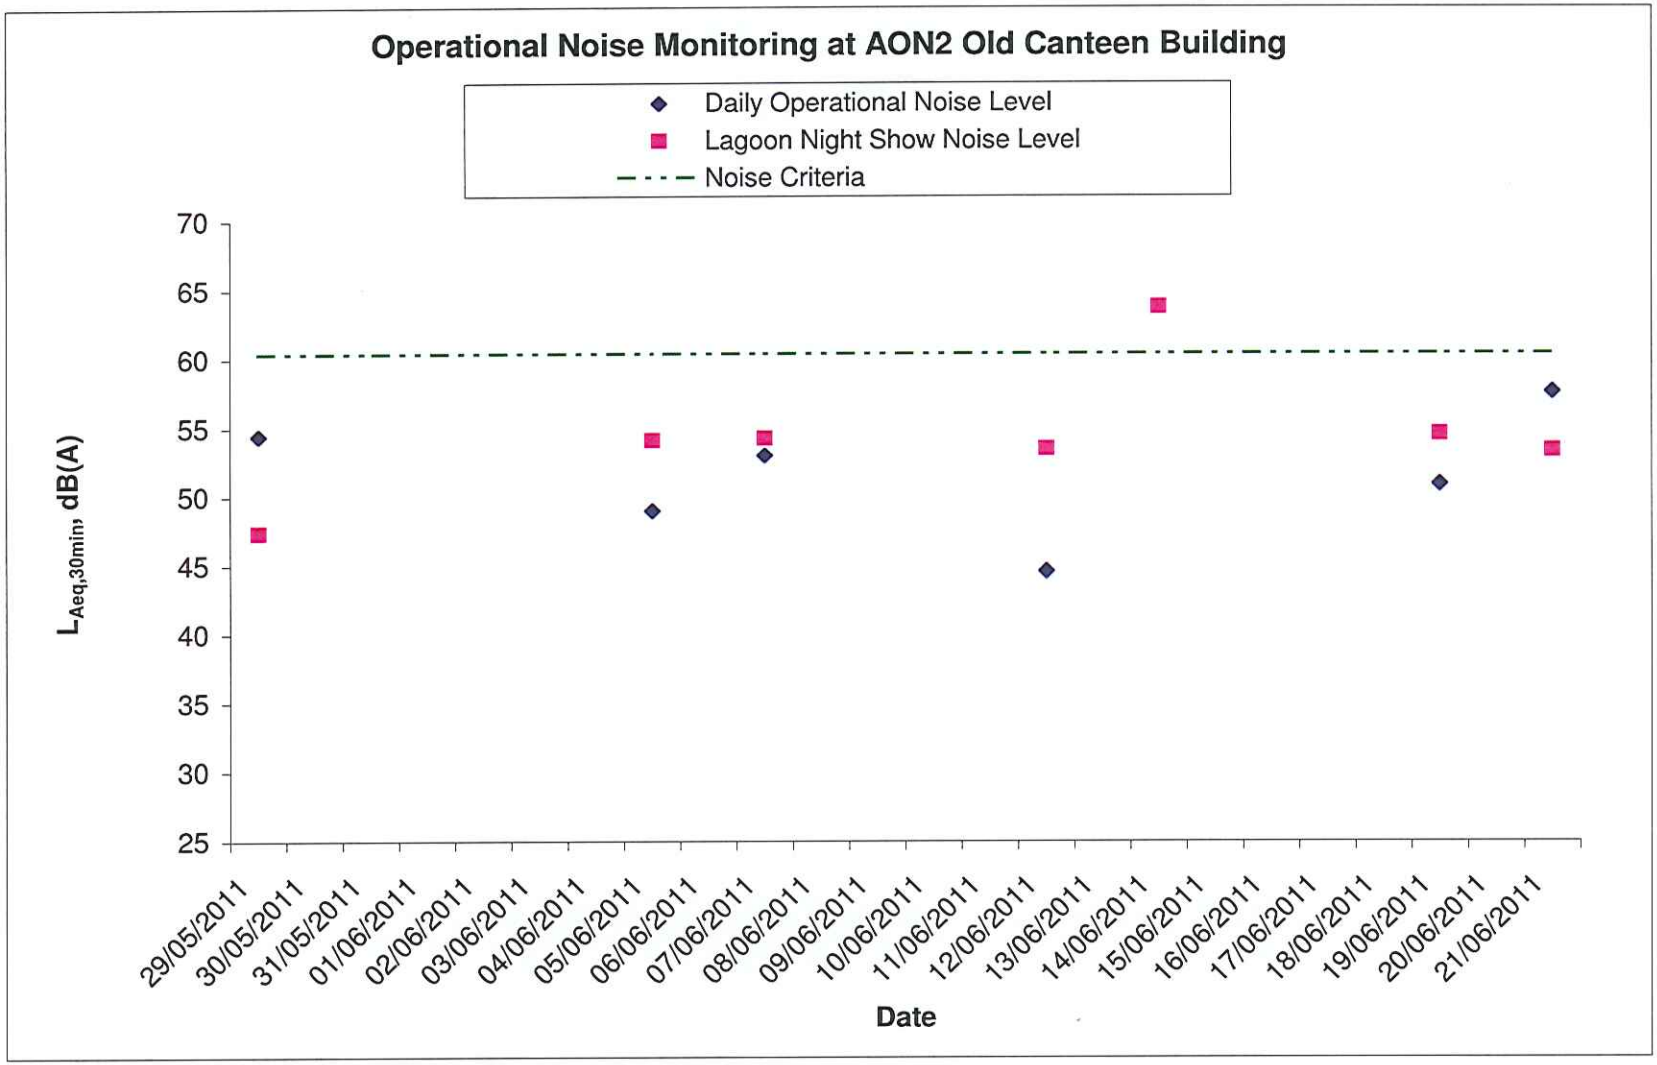
Annex B3-2

Note: The exceedance was due to the noise from construction works near the Cable Car Terminal on 14 June 2011, CNP No. GW-RS0314-11.

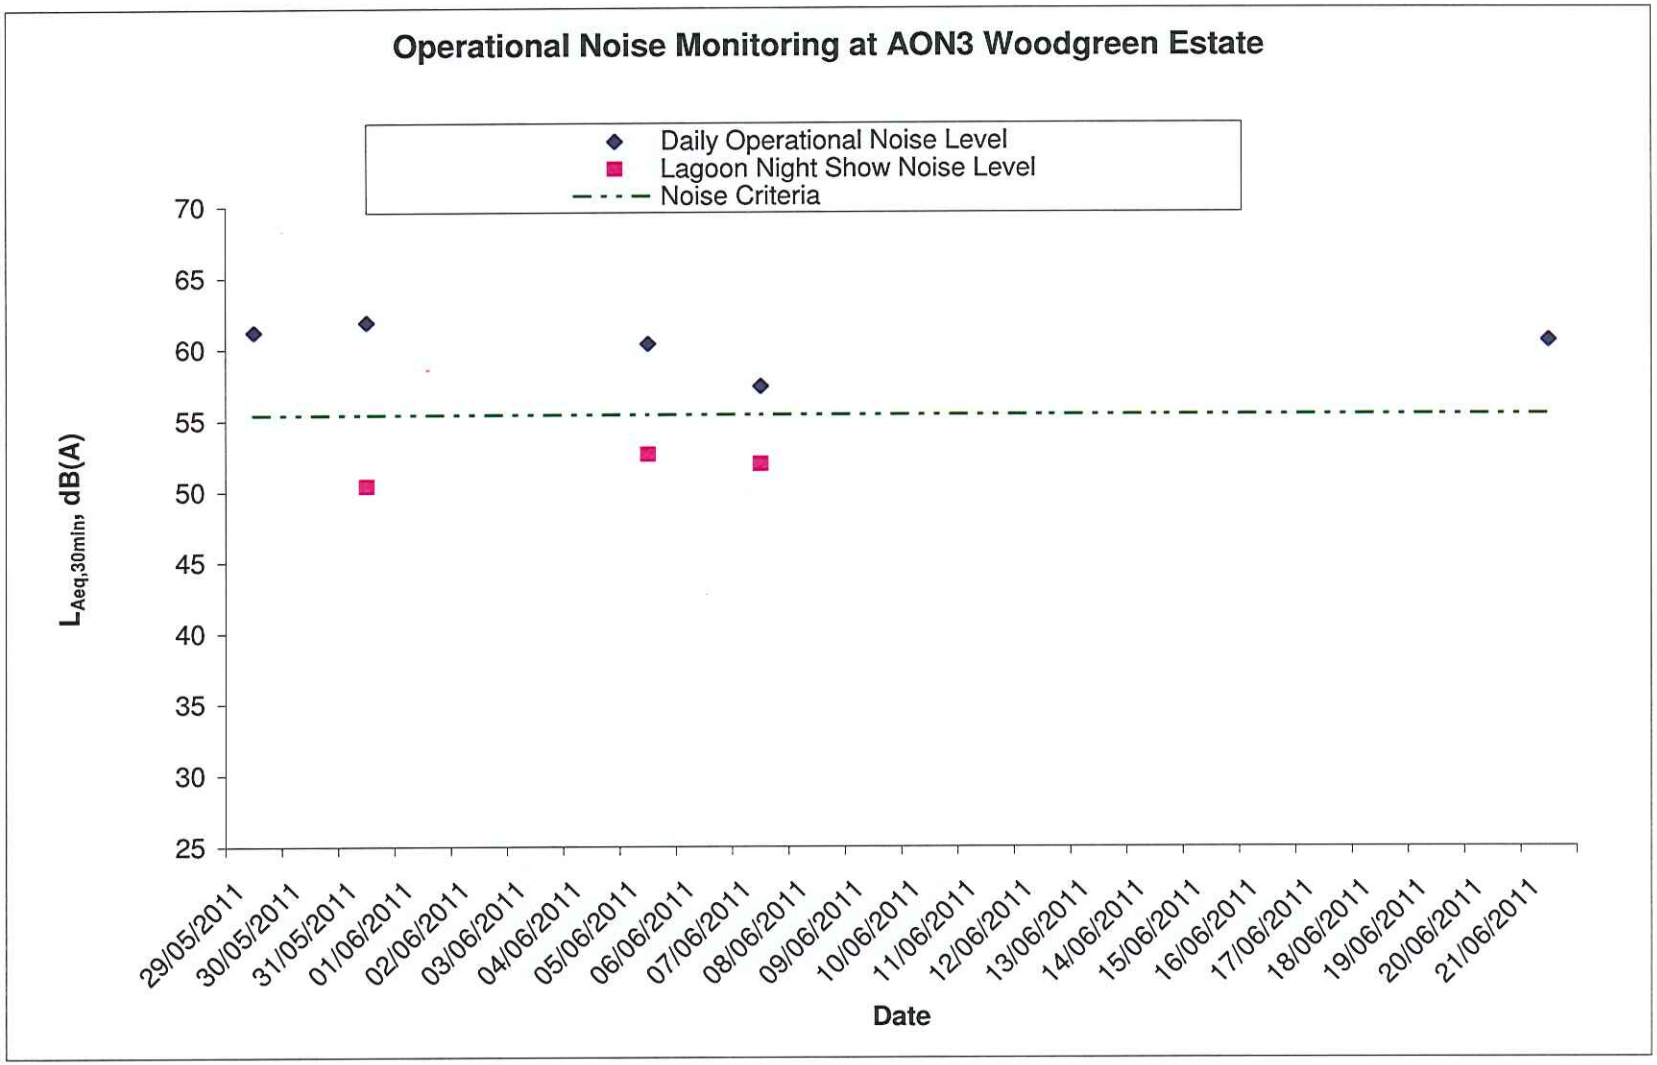
Annex B3-3

Note: The exceedances were due to the traffic noise from Shouson Hill Road

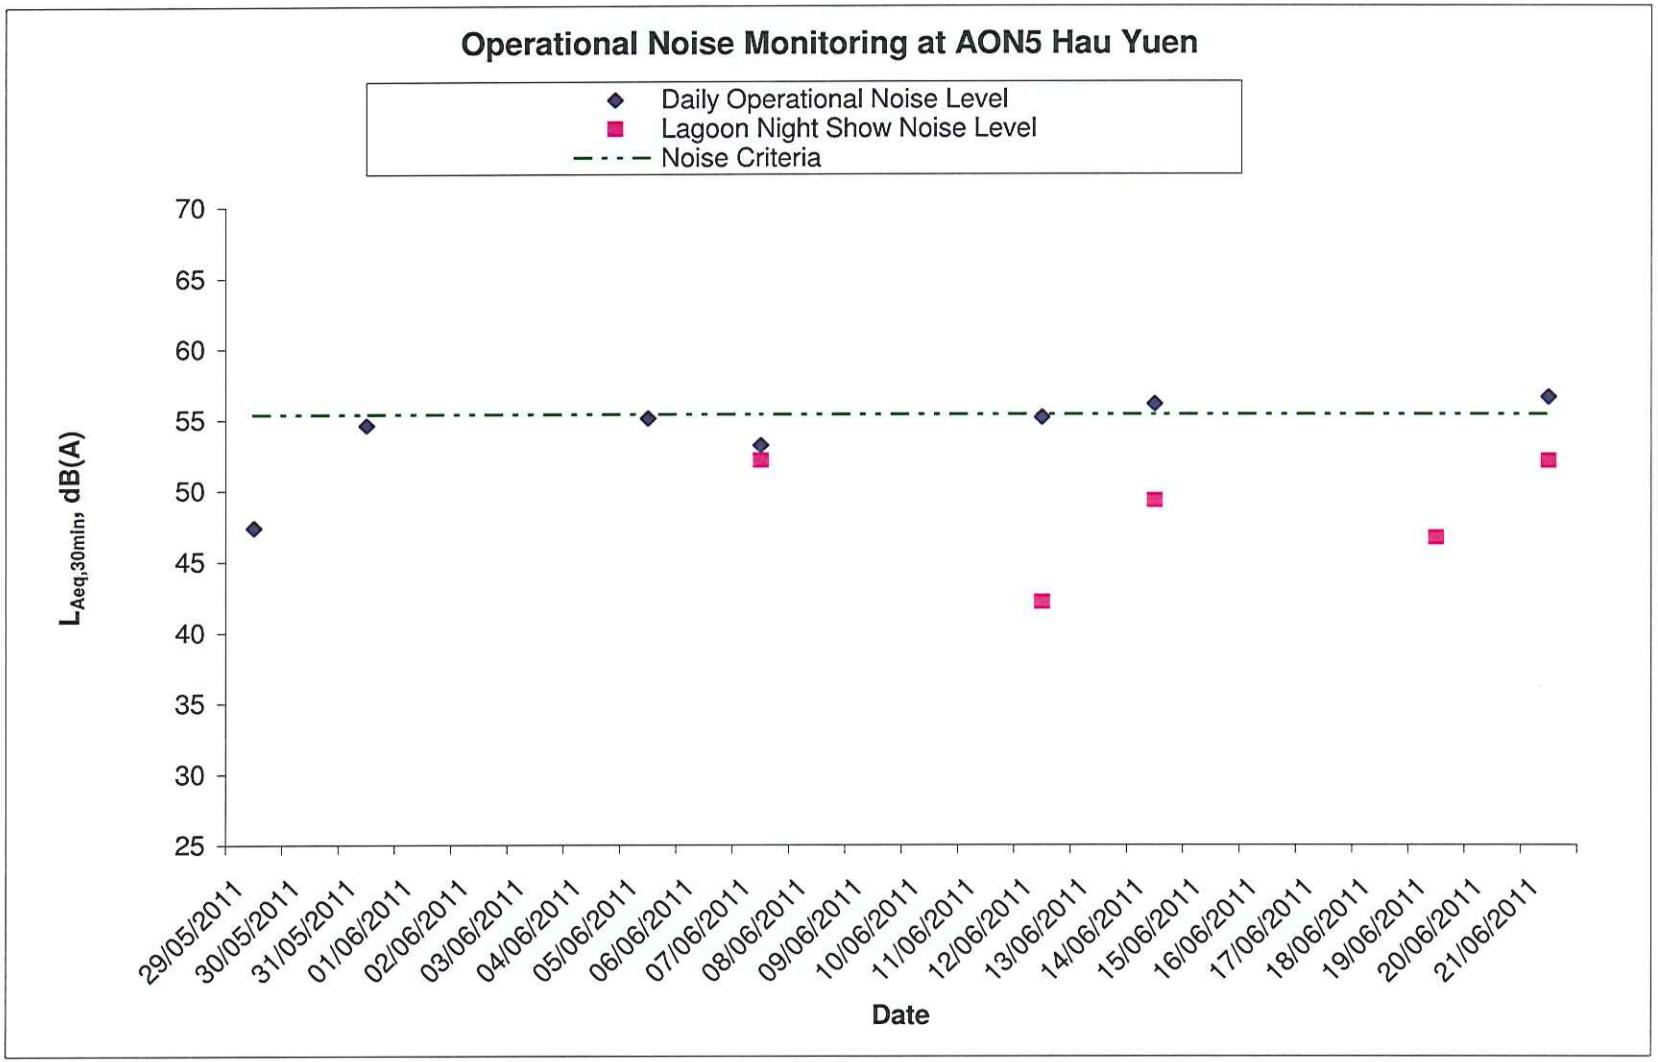
Annex B3-5

Note: The exceedances were due to traffic noise from Shouson Hill Road
