Contract No. HY/2003/19

Improvement to Tung Chung Road between Lung Tseng Tau and Cheung Sha

Monthly EM&A Report (Version 1.1)

October 2008

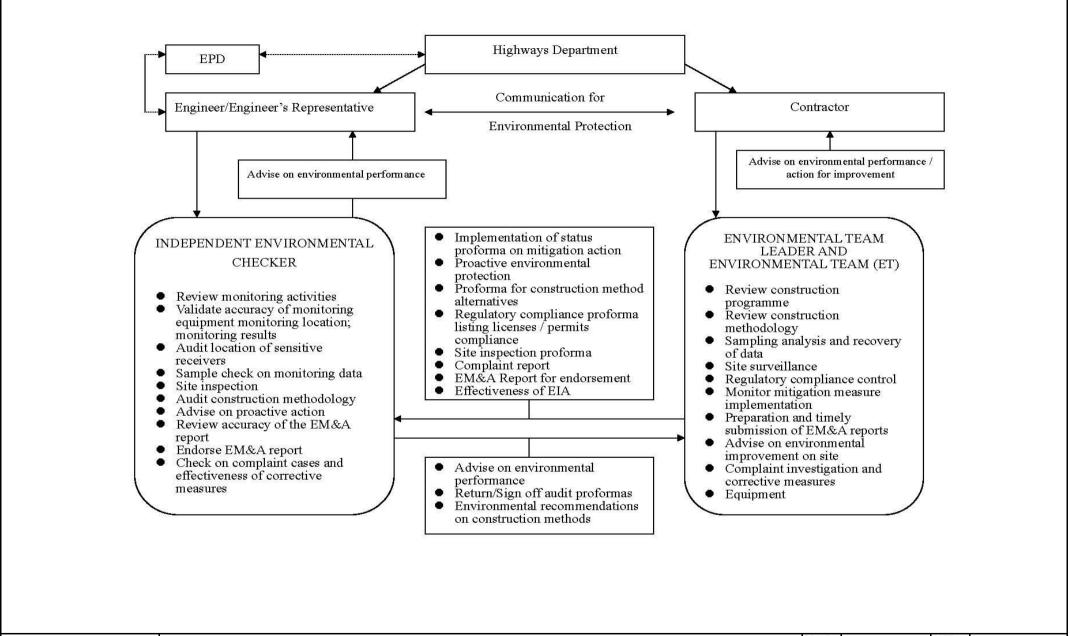
Organization Chart

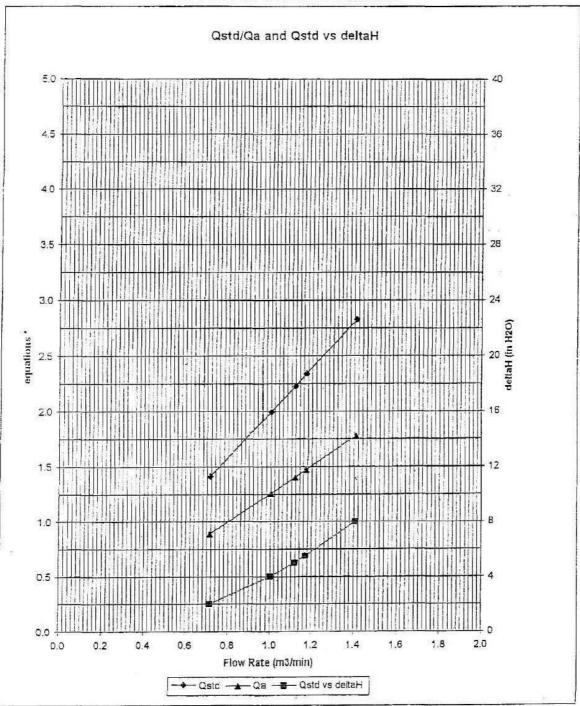
* y-axis equations:

Qstd series:

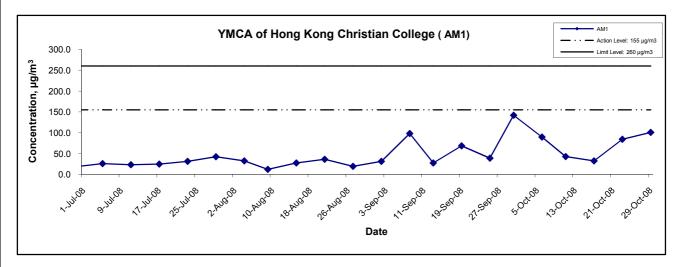
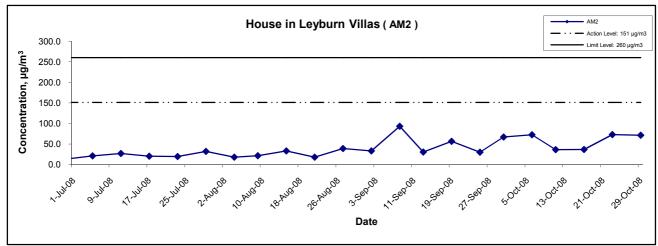
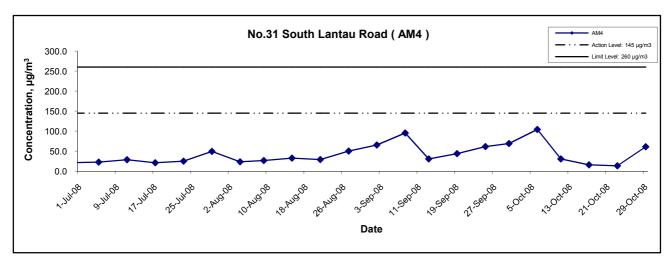
24-hour TSP Levels

Title	Improvement to Tung Chung Road between Lung Tseng Tau and	Scale		Project		
	Cheung Sha	Date		No. Appen	MA6030 dix	CINOTECH
	Graphical Presentation of 24-hour TSP Monitoring Results		Oct 08		D

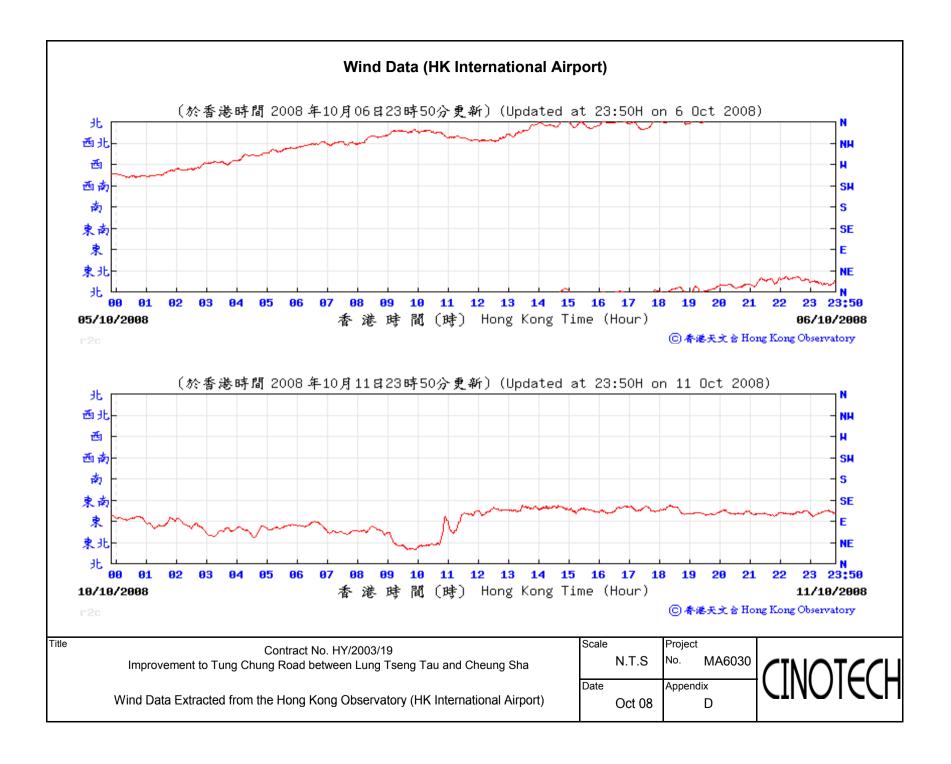
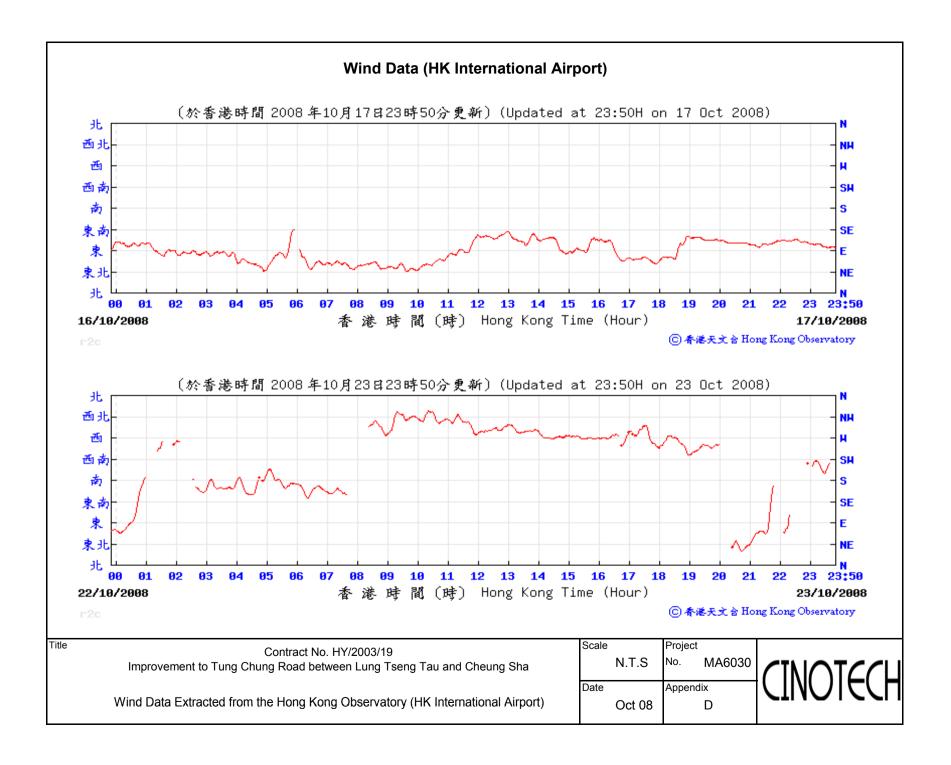
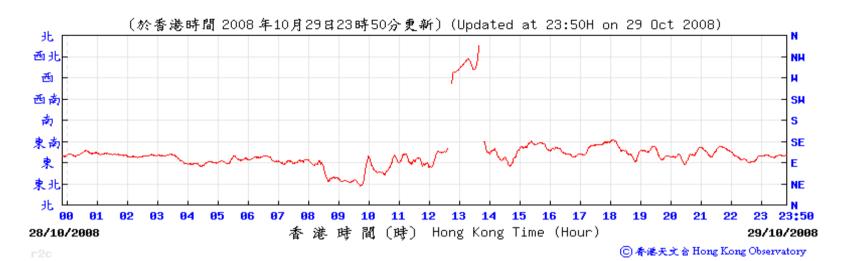
Wind Data (HK International Airport)

Scale		Project	
	N.T.S	No.	MA6030
Date		Append	ix
	Oct 08		D
		1

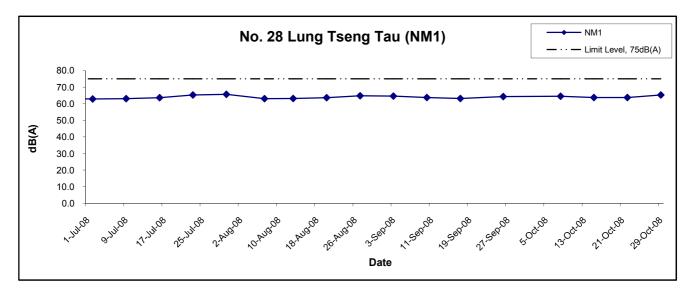
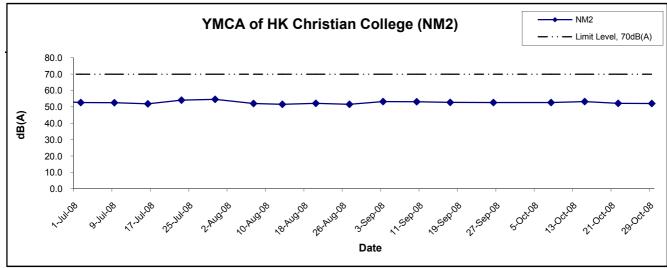
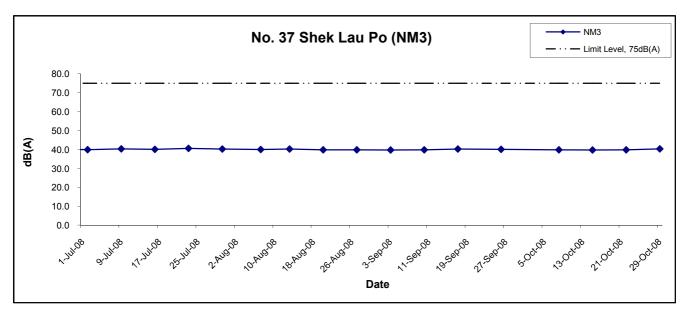
Noise Levels

Title	Contract No. HY/2003/19 Improvement to Tung Chung Road between Lung Tseng Tau and Cheung Sha
	Graphical Presentation of Construction Noise Manitoring

Results

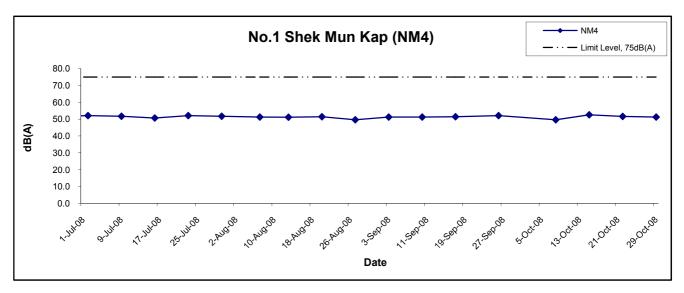
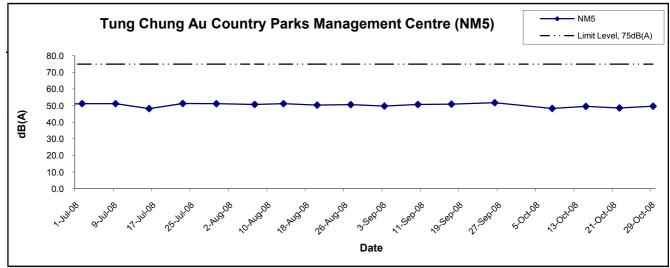
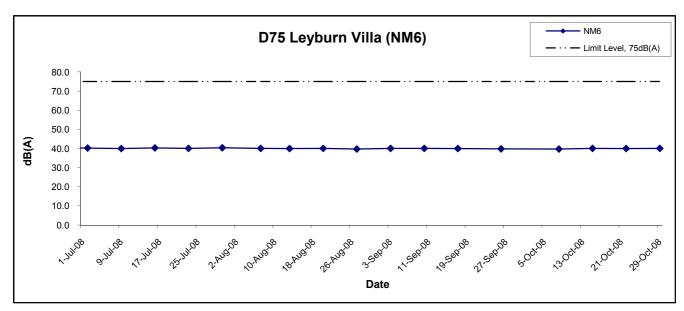
Noise Levels

Title	Contract No. HY/2003/19 Improvement to Tung Chung Road between Lung Tseng Tau and Cheung Sha
	Graphical Presentation of Construction Noise Monitoring

Results

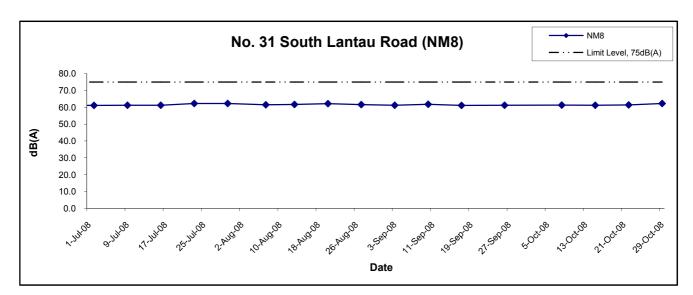
Noise Levels

Title Contract No. HY/2003/19

Improvement to Tung Chung Road between Lung Tseng Tau and Cheung Sha

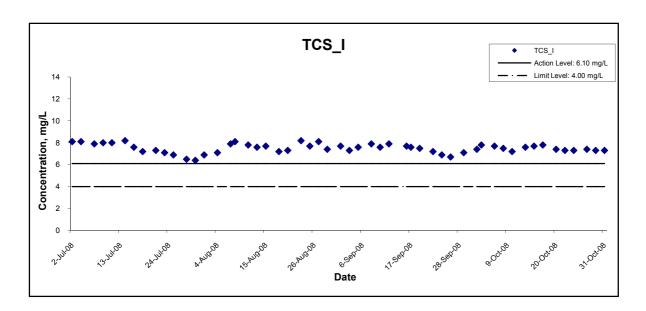
Dissolved Oxygen

Contract No. HY/2003/19
Improvement to Tung Chung Road between Lung Tseng Tau and Cheung Sha
Graphical Presentation of Water Quality
Monitoring Results

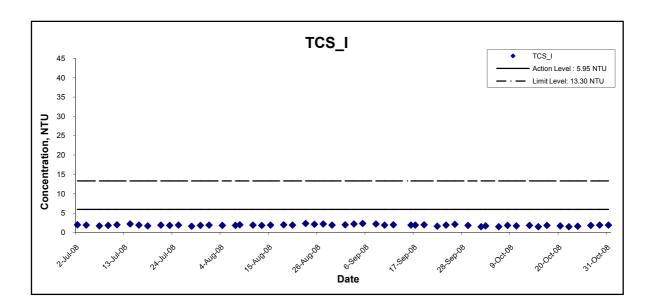
Turbidity

Title Contract No. HY/2003/19
Improvement to Tung Chung Road between Lung Tseng Tau and Cheung Sha

Graphical Presentation of Water Quality

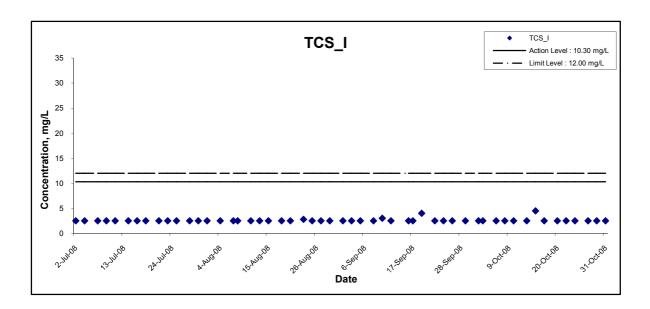
Suspended Solids

Contract No. HY/2003/19
Improvement to Tung Chung Road between Lung Tseng Tau and Cheung
Sha
Graphical Presentation of Water Quality
Monitoring Results

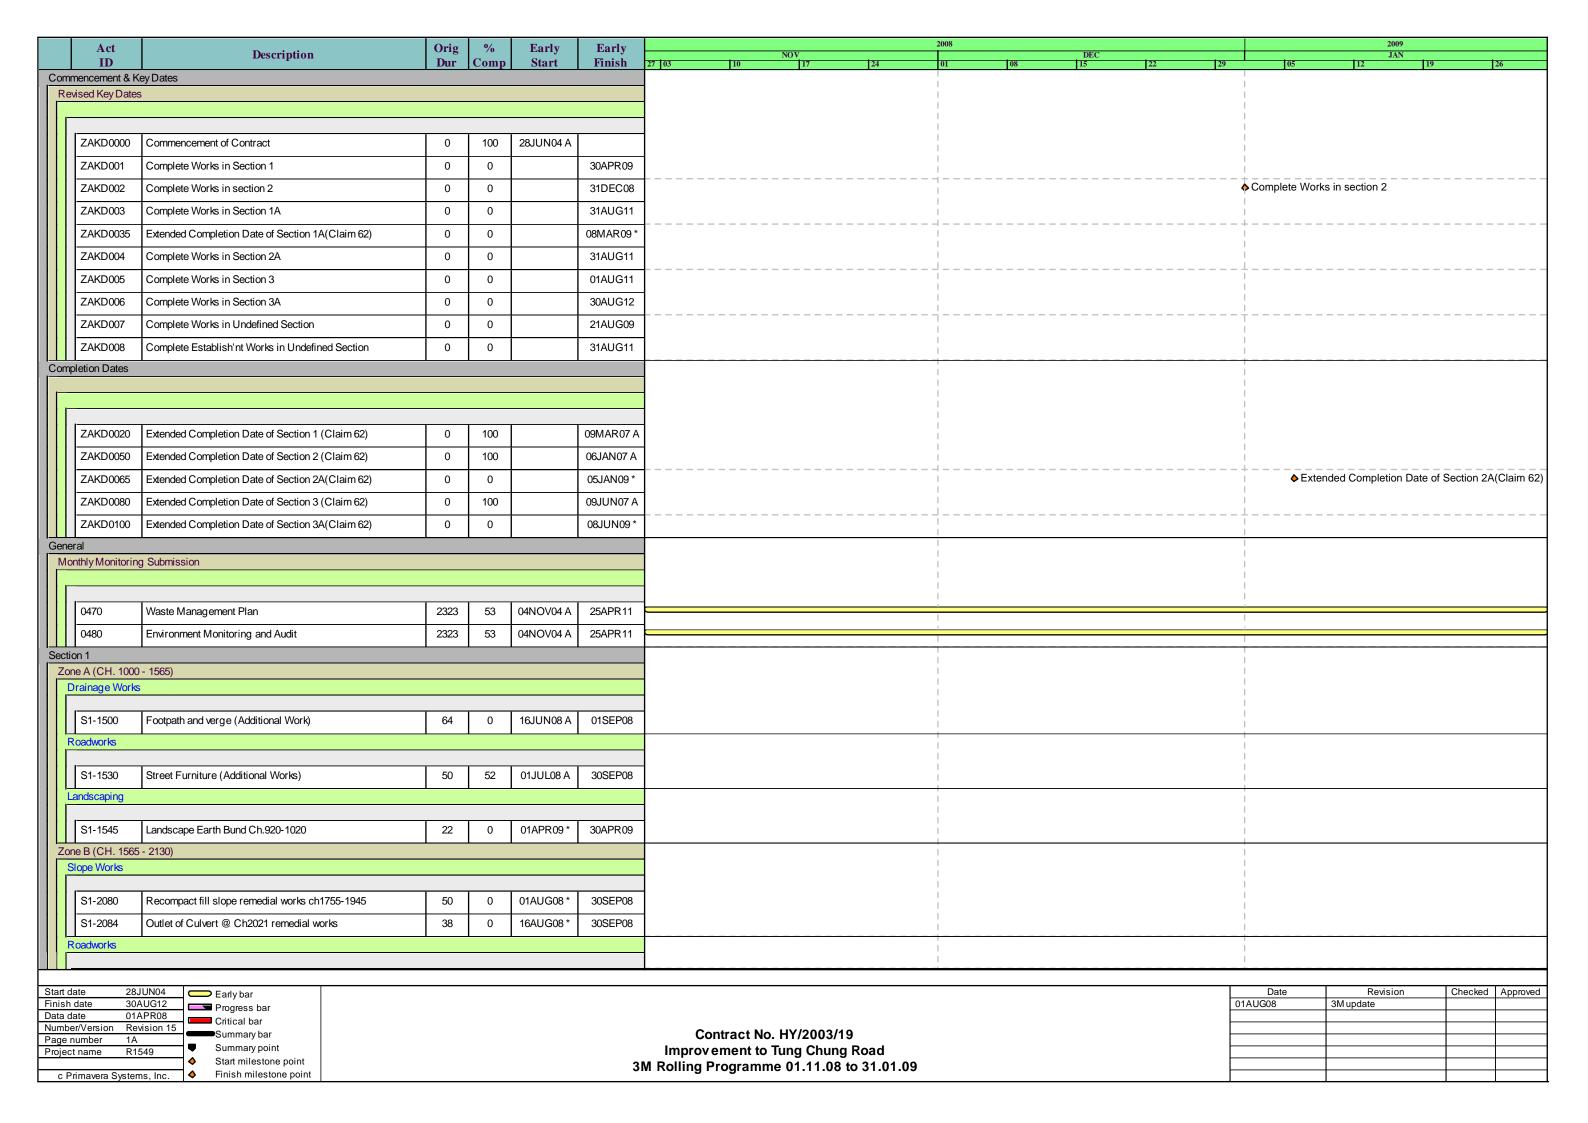
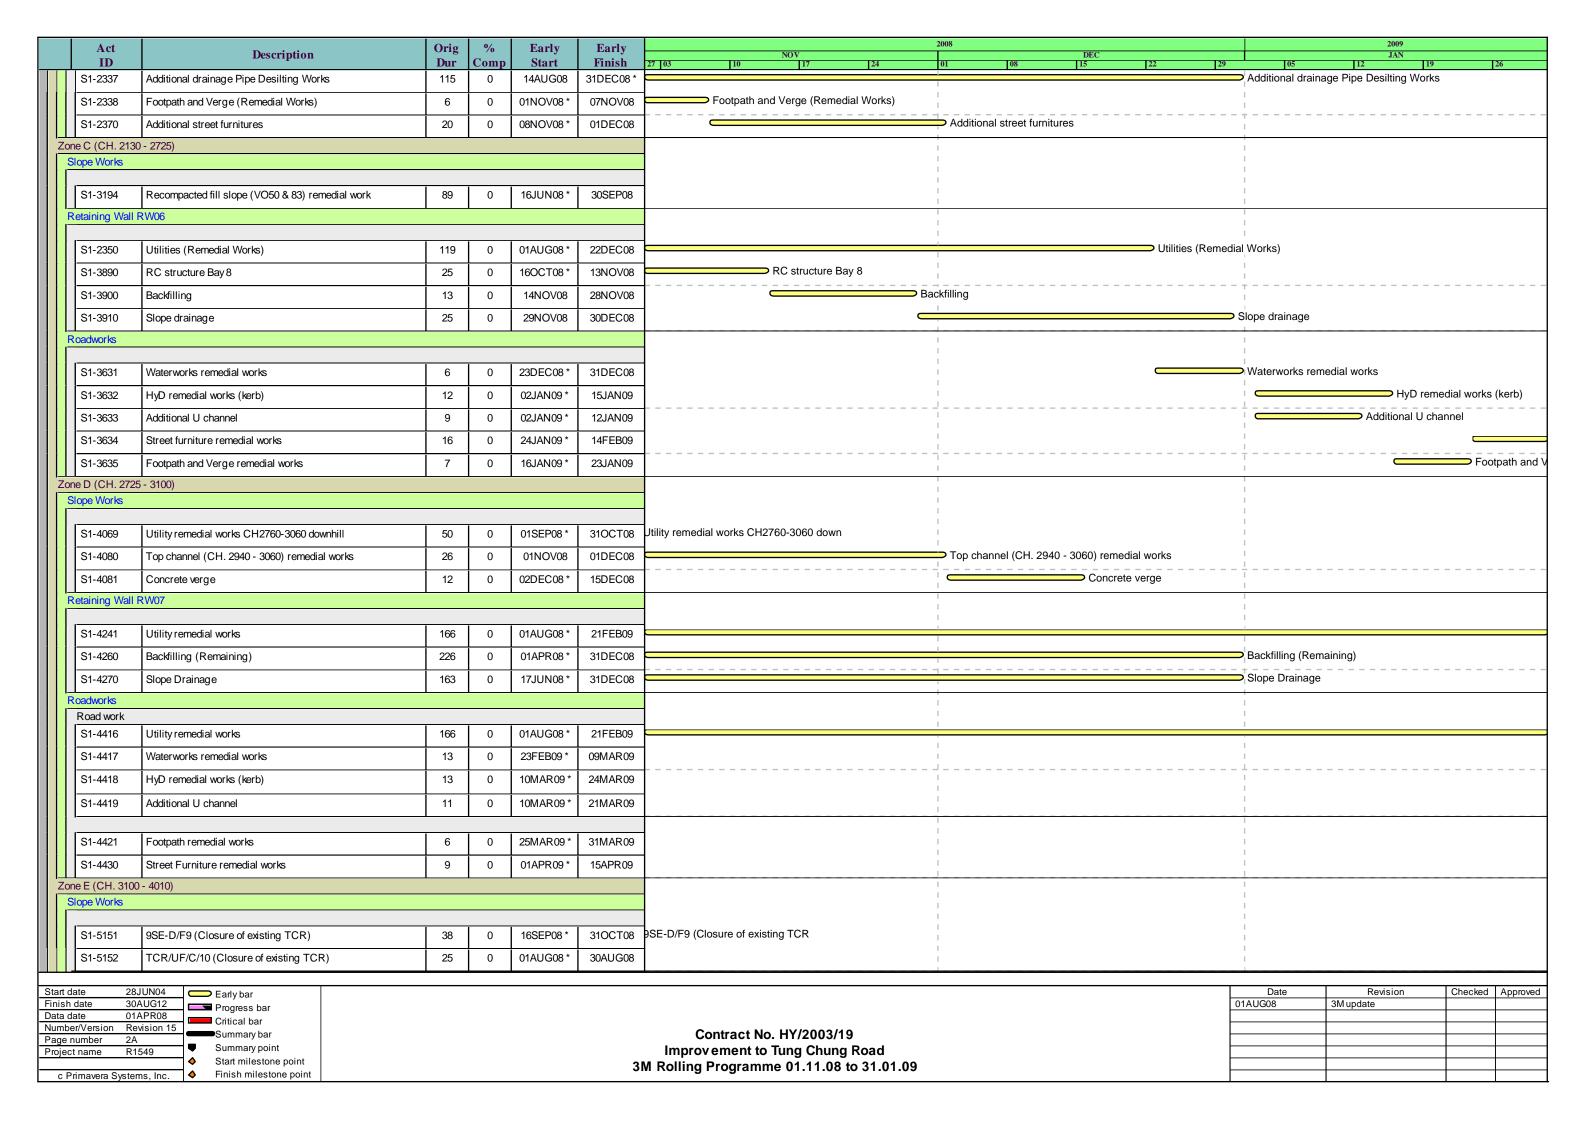
APPENDIX N CONSTRUCTION PROGRAMME

Act	Description	Orig	%	Early	Early	<u> </u>	NOV		2008		DEC					2009 JAN	
ID		Dur	Comp	Start	Finish	27 03 10	17	24	01	08	15	22	29	05	12	19	26
Retaining Wall F	RW10								I I					l I			
S1-5390	Backfilling	176	0	01APR08 *	31OCT08	Backfilling			I I								
Retaining Wall F	RW11								 					 			
1				•	1				I								
	Backfilling	48	0	01DEC08 *	31JAN09												
S1-5463	U channel	24	0	02FEB09 *	28FEB09				i i								
Retaining Wall F	RW12								i								
S1-5500	Backfilling & Reinstatement of Carriageway	37	0	01AUG08 *	16SEP08												
Roadworks									I I								
Road work S1-5843	HyD remedial works (kerb)	23	l 0	02JAN09 *	31JAN09				i								
	Waterworks remedial works	20	0	02JAN09 *	24JAN09				i i								Waterwor
					ļ				<u>!</u>								
	Additional drainage works	223	0	02JUN08 *	28FEB09				I I								
S1-5847	Footpath and verge additional works	26	0	02MAR09 *	31MAR09									!			
S1-5836	Utilities remedial works	113	0	16AUG08 *	31DEC08				:					Utilities remedial	works

S1-5838	Additional street furniture	22	0	01APR09 *	30APR09				1					 			
Zone F (CH. 4010) - 4686)		<u> </u>						!					<u> </u>			
Slope Works									1								
S1-6111	9SE-D/C20 (Closure of existing TCR)	126	0	01APR08 *	30AUG08				1								
S1-6113	TCR/UF/C/12 (Closure of existing TCR)	25	0	01AUG08 *	30AUG08				1								
					ļ				!								
	9SE-D/C35 (Closure of existing TCR)	40	0	02JAN09	20FEB09				1								
Retaining Wall F	RW14								 								
S1-6231	Additional drainage works	35	0	21JUL08 *	30AUG08				1								
S1-6232	Backfillling	25	0	01SEP08 *	30SEP08				1					 			
Retaining Wall F	RW15								! !					<u> </u> 			
S1-6285	Additional base slab & wall (V.O.115)	22	Ι ο	02JAN09	30JAN09				I I								
Retaining Wall F	· · ·		0	UZJANUS	SOJANOS				I I								
Relating Wall P	KWIO								I I					l I			
S1-6365	Proposed utilities installation	60	0	02JAN09	16MAR09				I I								
Retaining Wall R	RW39								I I

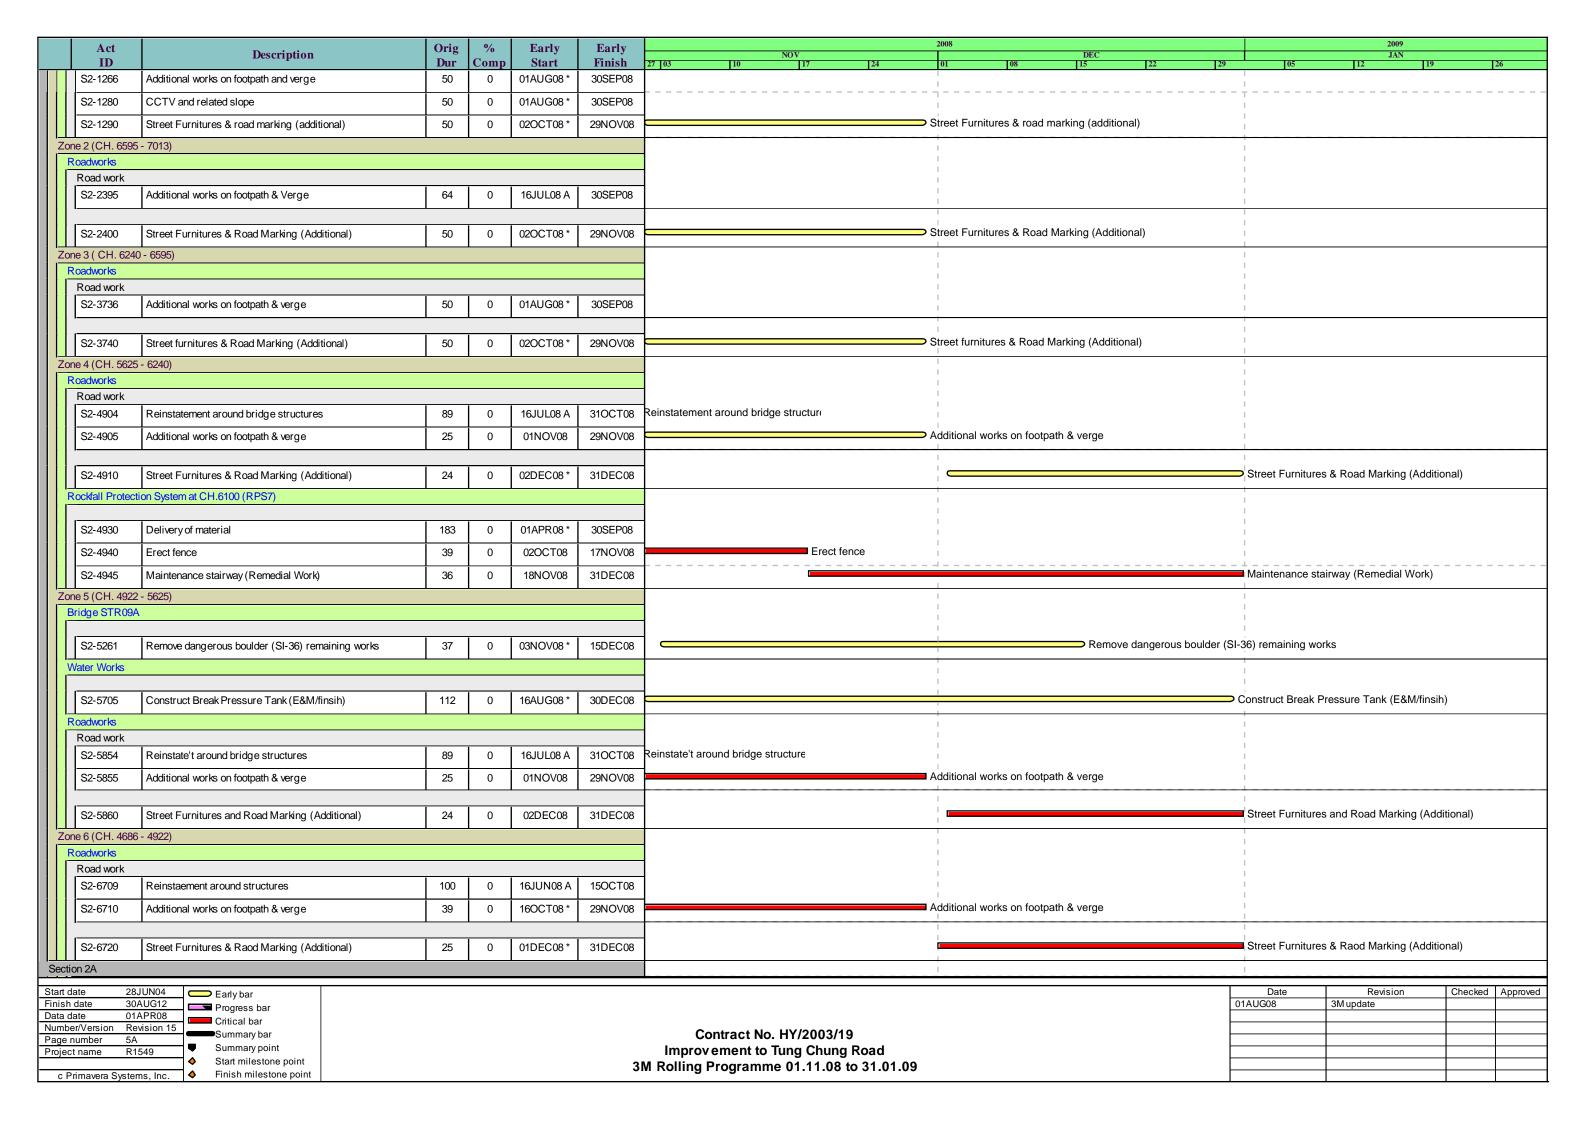
Act ID	Description	Orig	% Comp	Early Start	Early Finish	27 03 10	NOV	24	2008	DE 15		29	05	2009 JAN	19 26
Zone 1-6		Dui	Comp	Start	Tillisii	2/ 03	17	24		13	22	29		12	19 26
Landscaping									I I				I I		
S2-6730	Landscape Softworks	196	0	01APR08 A	31AUG09				l .				I		
S2-6735	Haul road reinstatement	73	0	01APR08 A	31MAR09				I				I		
Establishment w									l l				I I		
		1							 				 		
S2-6740	Establishment Works for Section 2A(claim no.084)	710	0	01SEP09 *	31AUG11				 				1		
Section 3									! 				 		
Feature No. TC	R/UF/C/15								I I				I I		
S3-3000	Cut and Trim Slope Surface	7	0	02JAN09 *	12JAN09				I I					Cut and Tri	m Slope Surface
S3-3010	300mm u channel at crest	10	0	14JAN09	31JAN09				 				 		·
S3-3020	Slope Surface Protection	14	0	31JAN09	17FEB09				, , – – – – –				+		
Feature No. 13N									 						
			1						I I				I I		
S3-3030	Install soil nail (199 nos.)	28	0	31JAN09	05MAR09				I I				I I		٩

S3-3040	Slope surface protection	14	0	05MAR09	21MAR09				 				<u> </u>		
Feature No. 13N	NE-B/U04								I I				I I		
S3-3050	Install soil nail (127 nos.)	20	0	05MAR09	28MAR09				 						
S3-3060	Pull out tests (4 nos.)	8	0	28MAR09	08APR09				I I						
S3-3065	300mm u-channel at crest & toe	20	0	08APR09	07MAY09				i				ī		
S3-3070	Slope surface protection	14	0	07MAY09	23MAY09				I I				I I		
Feature No. 13N	NE-B/C63								I I				I I		
S3-3080	Install soil nail (111 nos.)	19	0	07MAY09	30MAY09				 						
	Pull out test (5 nos.)	8	0	30MAY09					I						
S3-3100	300mm stepped & u-channel	20	0	09JUN09	03JUL09								÷ ·		
S3-3110	Slope surface protection	14	0	03JUL09	20JUL09				I I				I I		
Feature No. 13N	NE-B/C62								l				1		
S3-3120	Install soil nail (144 nos.)	Loo	Ι ο	03JUL09	29JUL09				I I						
S3-3120 S3-3130	Pull out tests (5 nos.)	22 8	0	29JUL09	07AUG09				! 				 		
S3-3140	300mm stepped & u channel	20	0	07AUG09	31AUG09				!				1
