MTR Corporation Limited

West Island Line Project

Environmental Monitoring and Audit Report No.77

(January 2016)

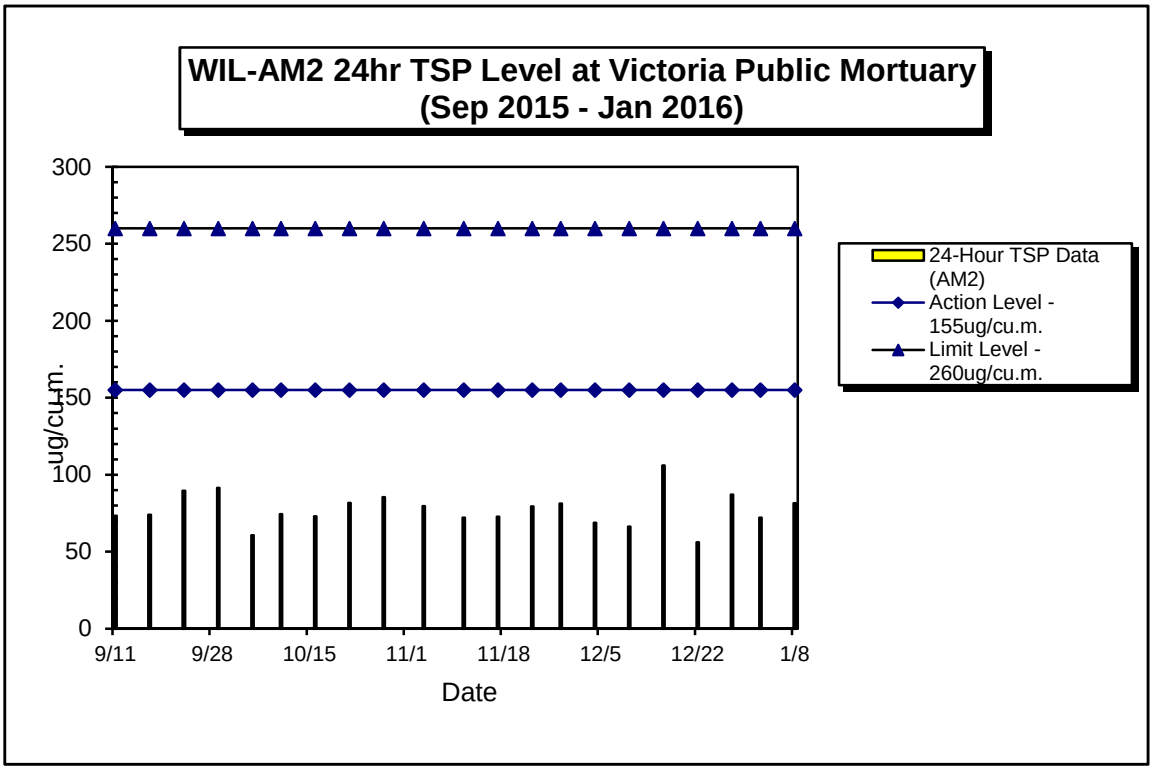
WIL-AM2 24hr TSP Level at Victoria Public Mortuary
(Sep 2015 - Jan 2016)
300
250
200
150
100
50
0
ug/cu.m.
9/11
9/28
10/15
11/1
11/18
12/5
12/22
1/8
Date
24-Hour TSP Data (AM2)
Action Level - 155ug/cu.m.
Limit Level - 260ug/cu.m.

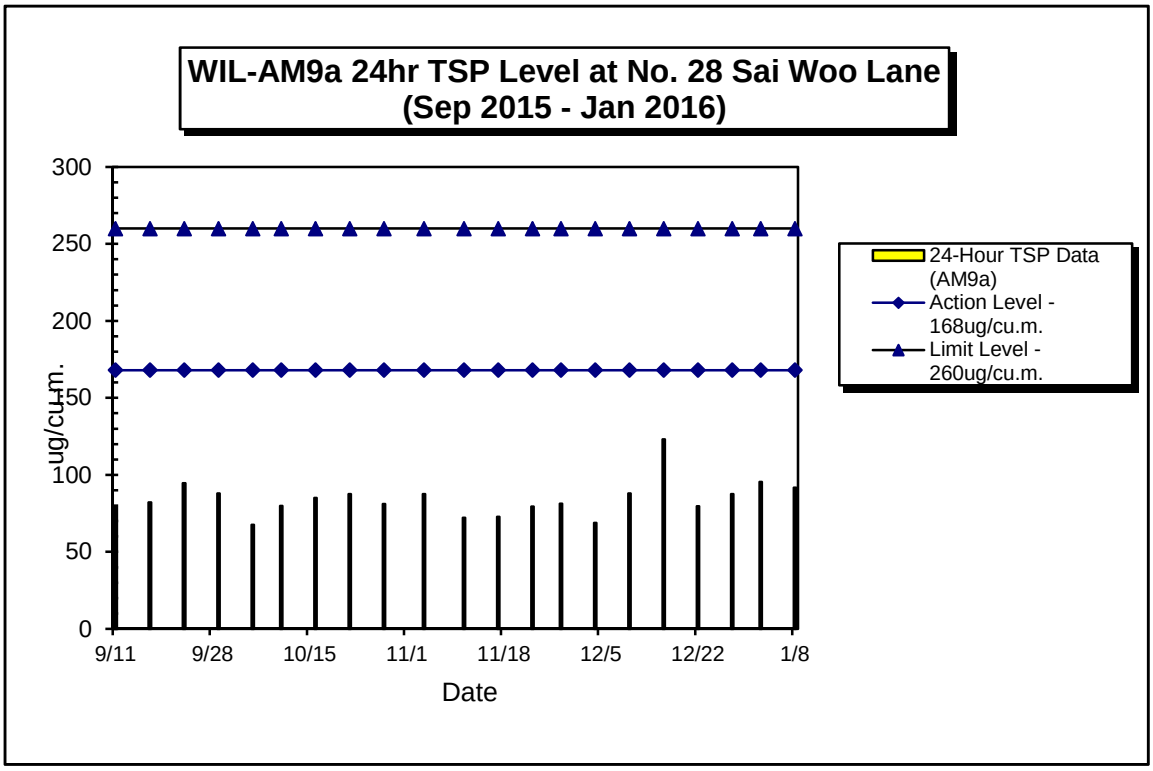
WIL-AM9a 24hr TSP Level at No. 28 Sai Woo Lane
(Sep 2015 - Jan 2016)
300
250
200
150
100
50
0
ug/cu.m.
9/11
9/28
10/15
11/1
11/18
12/5
12/22
1/8
Date
24-Hour TSP Data (AM9a)
Action Level - 168ug/cu.m.
Limit Level - 260ug/cu.m.

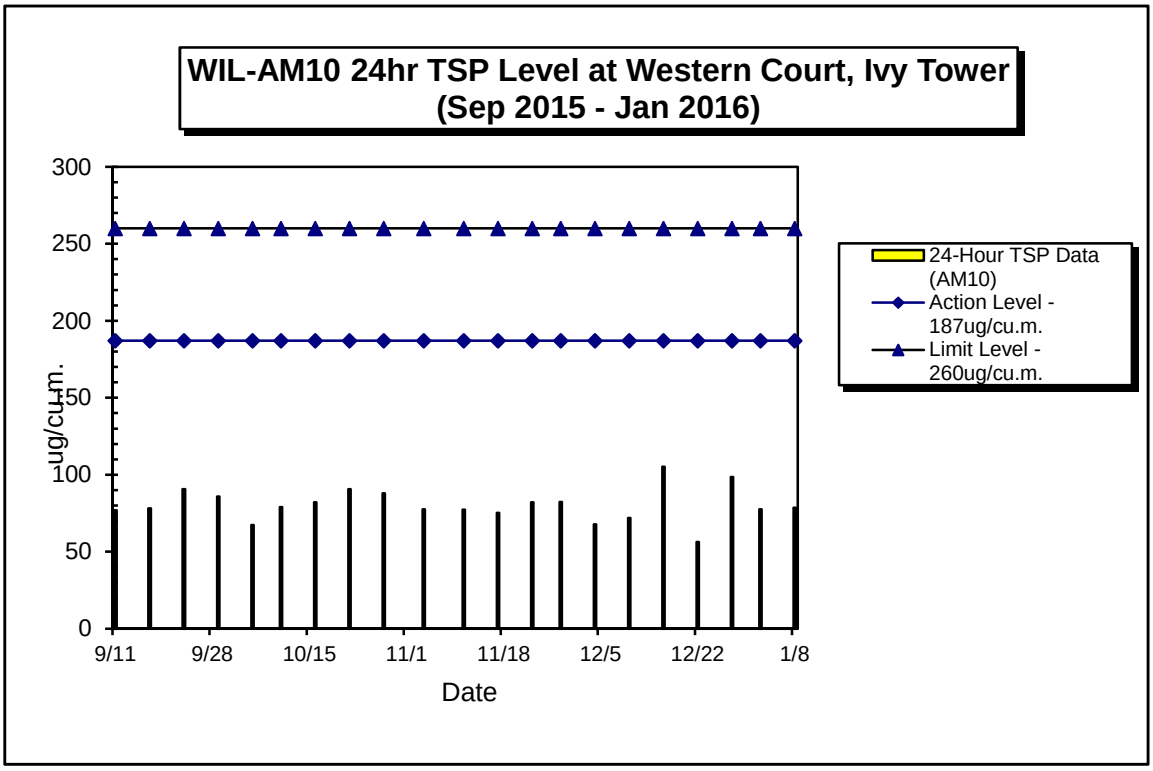
WIL-AM10 24hr TSP Level at Western Court, Ivy Tower
(Sep 2015 - Jan 2016)
300
250
200
150
100
50
0
ug/cu.m.
9/11
9/28
10/15
11/1
11/18
12/5
12/22
1/8
Date
24-Hour TSP Data (AM10)
Action Level - 187ug/cu.m.
Limit Level - 260ug/cu.m.

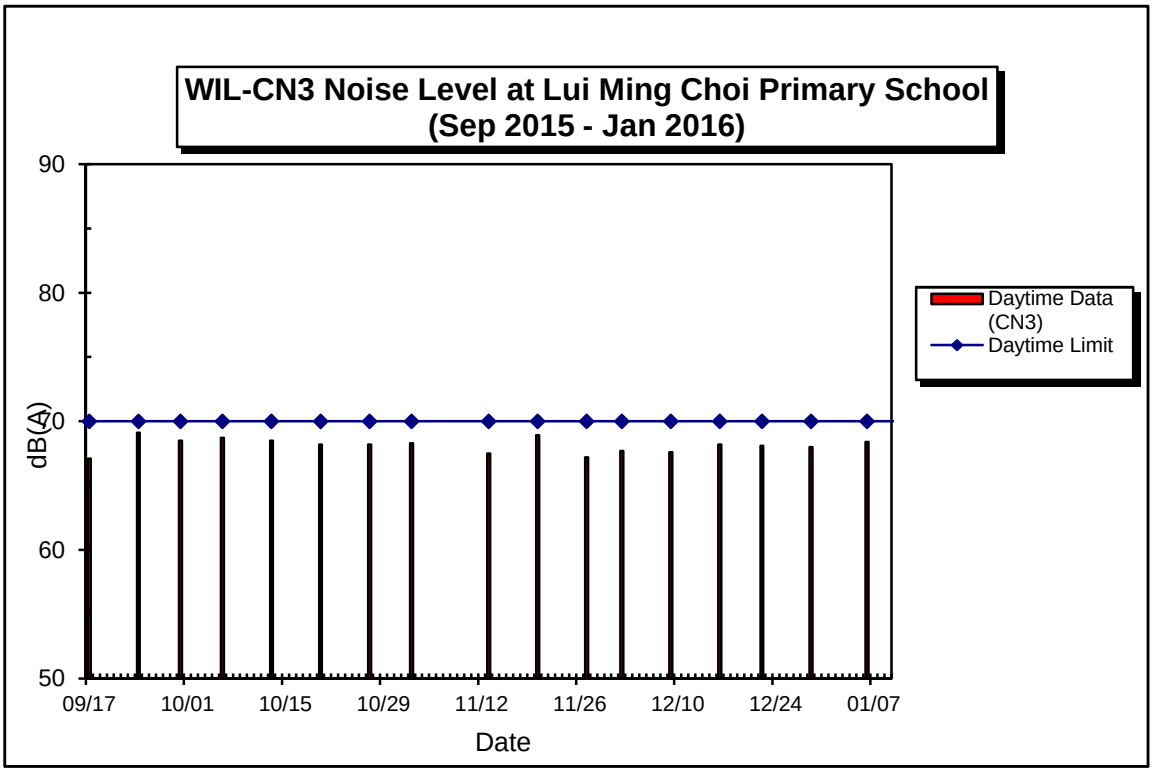
WIL-CN3 Noise Level at Lui Ming Choi Primary School
(Sep 2015 - Jan 2016)
90
80
70
60
50
dB(A)
09/17
10/01
10/15
10/29
11/12
11/26
12/10
12/24
01/07
Date
Daytime Data (CN3)
Daytime Limit

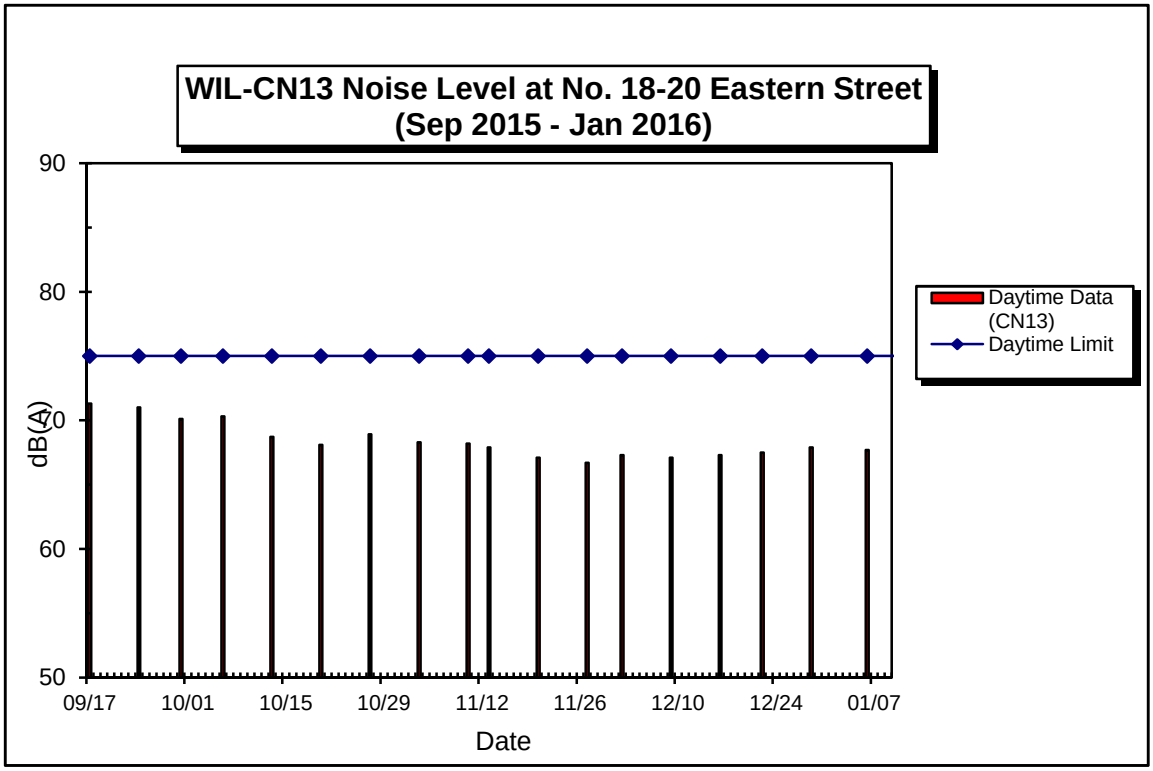
WIL-CN13 Noise Level at No. 18-20 Eastern Street
(Sep 2015 - Jan 2016)
90
80
70
60
50
dB(A)
09/17
10/01
10/15
10/29
11/12
11/26
12/10
12/24
01/07
Date
Daytime Data
(CN13)
Daytime Limit

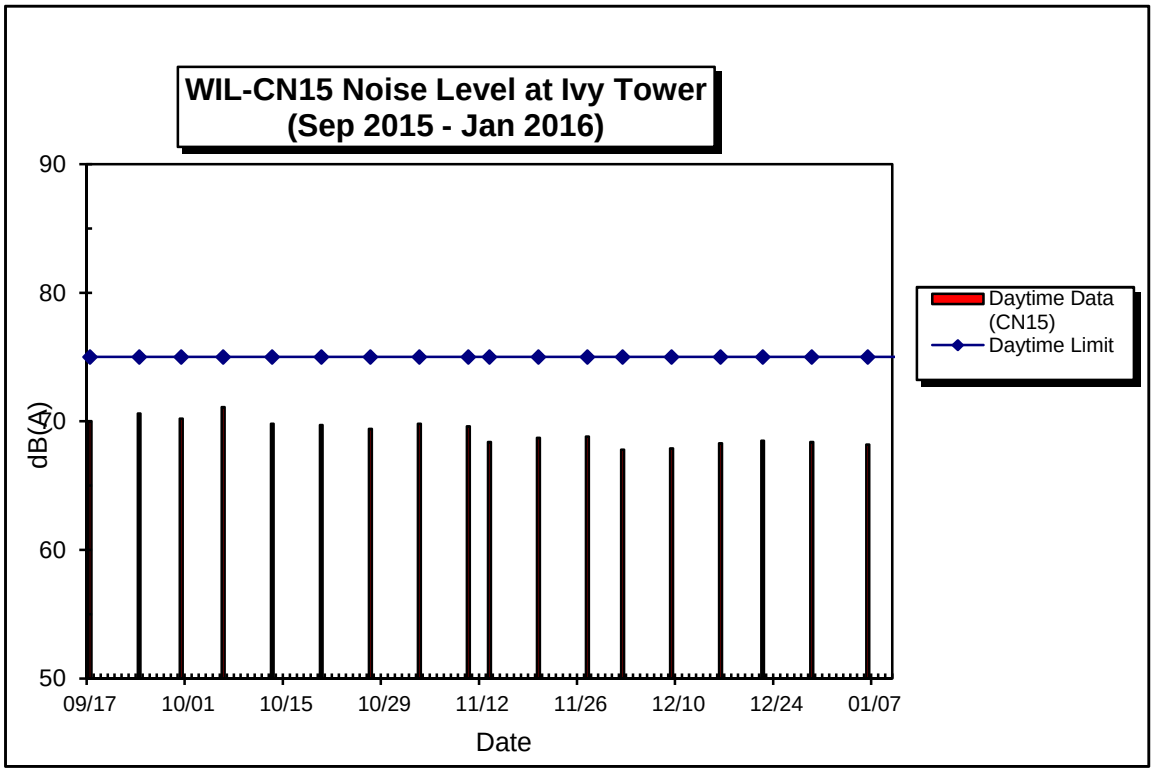
WIL-CN15 Noise Level at Ivy Tower
(Sep 2015 - Jan 2016)
90
80
70
60
50
dB(A)
09/17
10/01
10/15
10/29
11/12
11/26
12/10
12/24
01/07
Date
Daytime Data
(CN15)
Daytime Limit

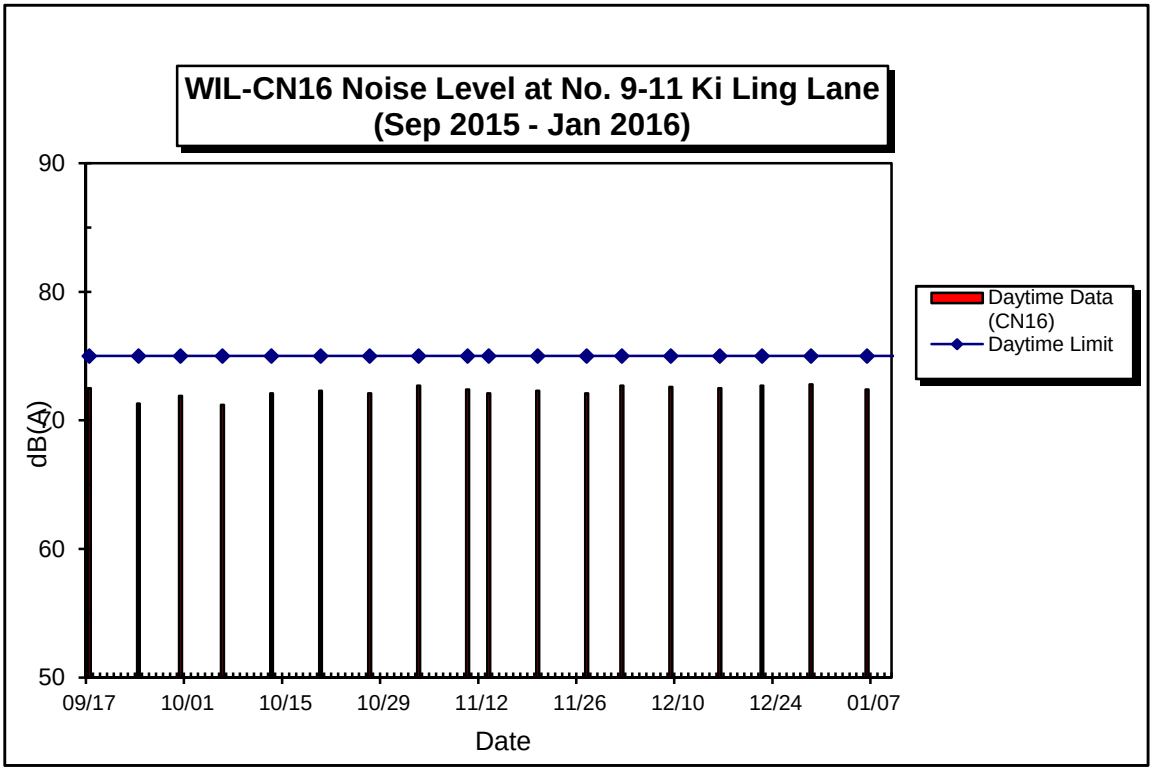
WIL-CN16 Noise Level at No. 9-11 Ki Ling Lane
(Sep 2015 - Jan 2016)
90
80
70
60
50
dB(A)
09/17
10/01
10/15
10/29
11/12
11/26
12/10
12/24
01/07
Date
Daytime Data
(CN16)
Daytime Limit

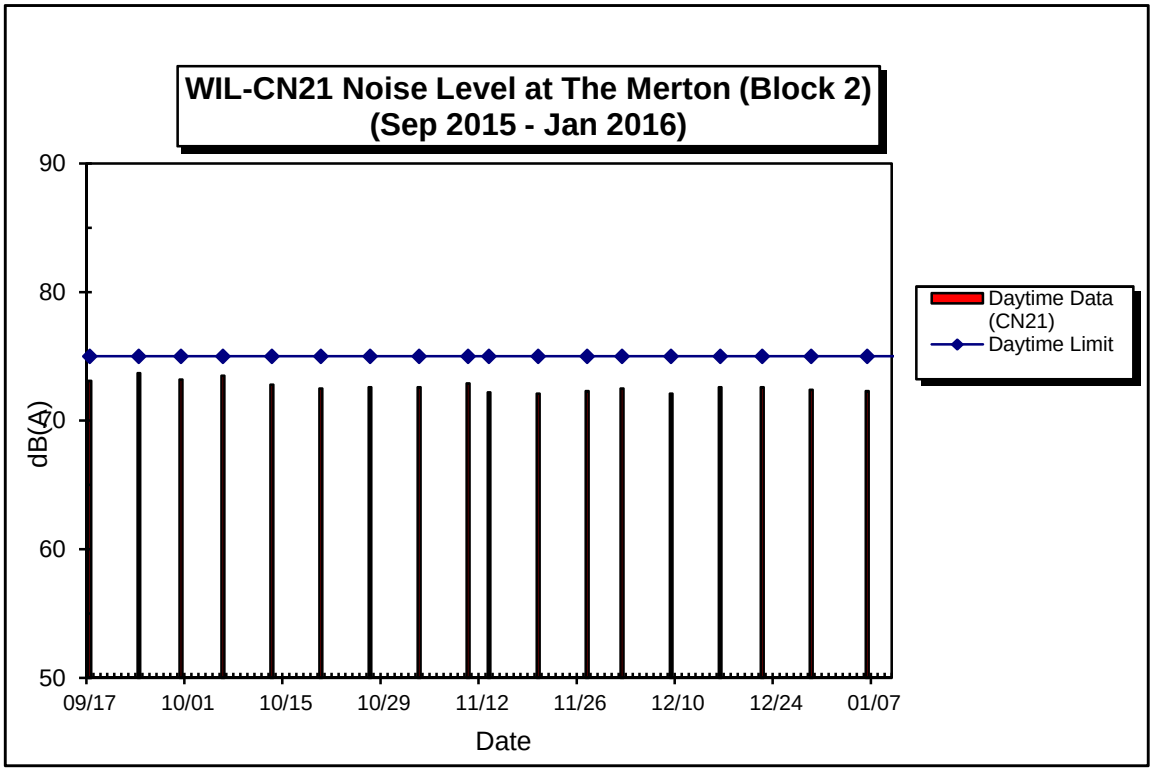
WIL-CN21 Noise Level at The Merton (Block 2)
(Sep 2015 - Jan 2016)
90
80
70
60
50
dB(A)
09/17
10/01
10/15
10/29
11/12
11/26
12/10
12/24
01/07
Date
Daytime Data
(CN21)
Daytime Limit
