Contract No. HY/2003/19

Improvement to Tung Chung Road between Lung Tseng Tau and Cheung Sha

Monthly EM&A Report (Version 2.1)

November 2008

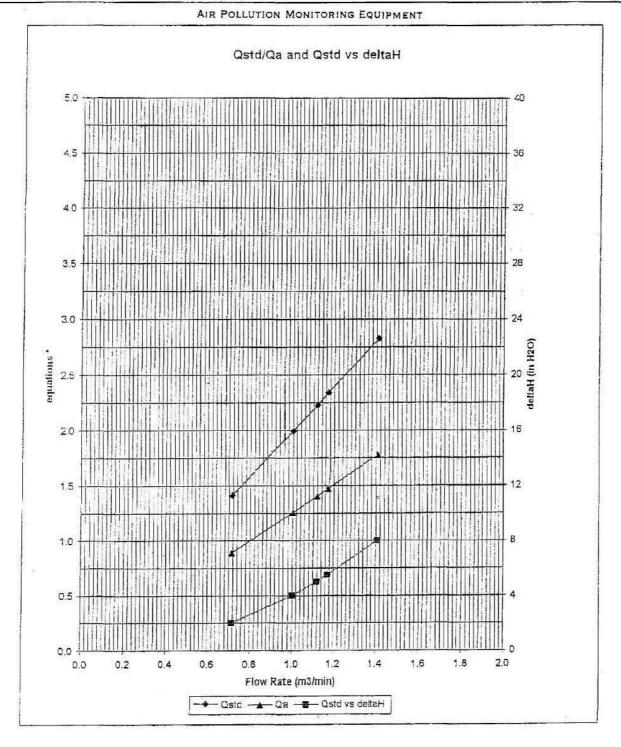
* y-axis equations: Qstd series:

$$\frac{\sqrt{\Delta H} \left(\frac{Pa}{Pstd}\right) \left(\frac{Tstd}{Ta}\right)}{\sqrt{(\Delta H (Ta / Pa))}}$$
