Contract No. HY/2003/19

Improvement to Tung Chung Road between Lung Tseng Tau and Cheung Sha

Monthly EM&A Report (Version2.0)

June 2009

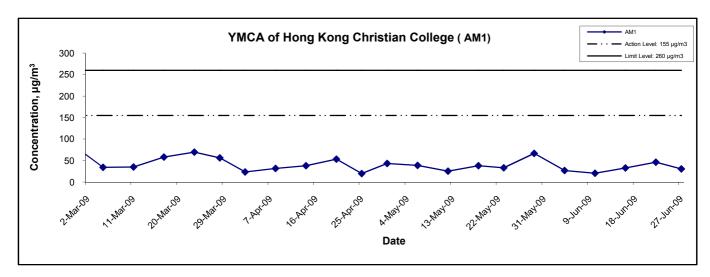
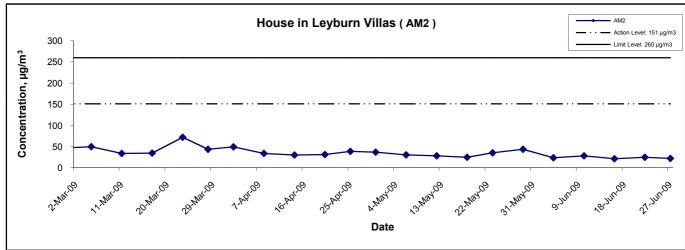
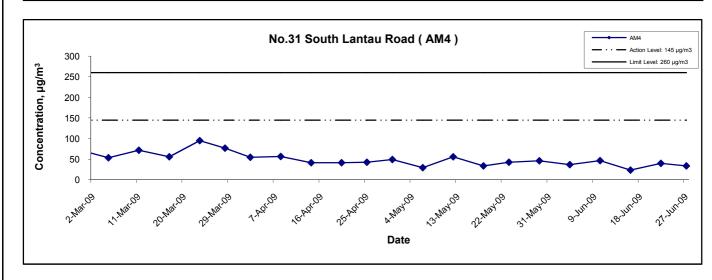
24-hour TSP Levels

Title	Contract No. HY/2003/19
	Improvement to Tung Chung Road between Lung Tseng Tau and
	Cheung Sha
	Graphical Presentation of 24-hour TSP Monitoring Results

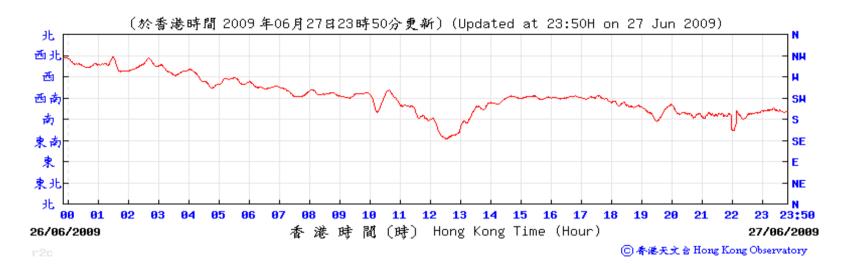
Wind Data (HK International Airport)

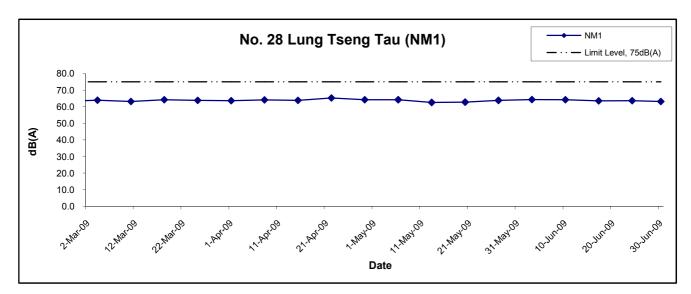
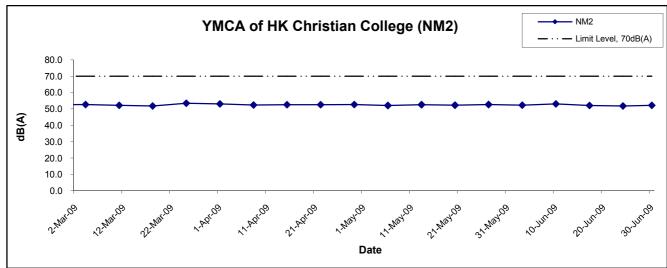
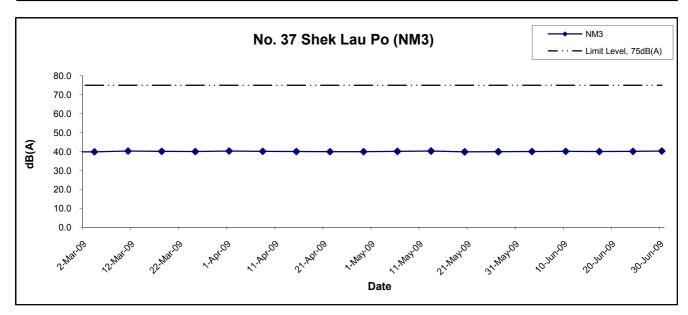
Noise Levels

Title Contract No. HY/2003/19
Improvement to Tung Chung Road between Lung Tseng Tau and Cheung Sha
Graphical Presentation of Construction Noise Monitoring

Results

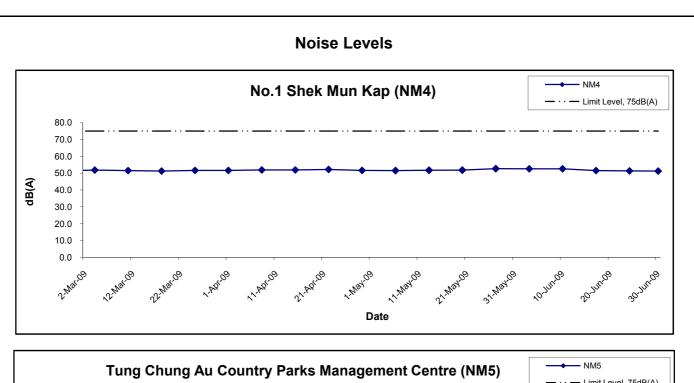
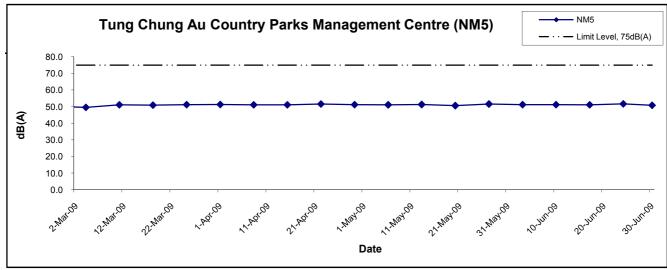
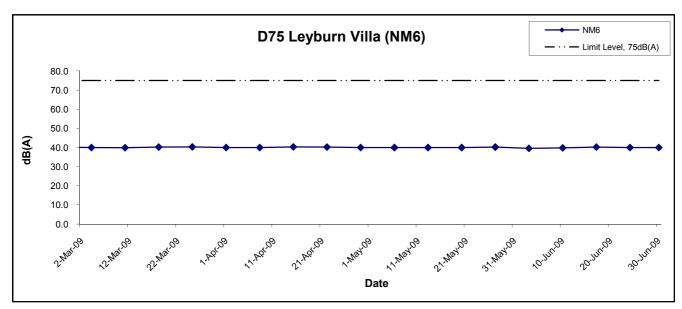
litie	Contract No. HY/2003/19
	Improvement to Tung Chung Road between Lung Tseng Tau and Cheung Sha
	Graphical Presentation of Construction Noise Monitoring

Results

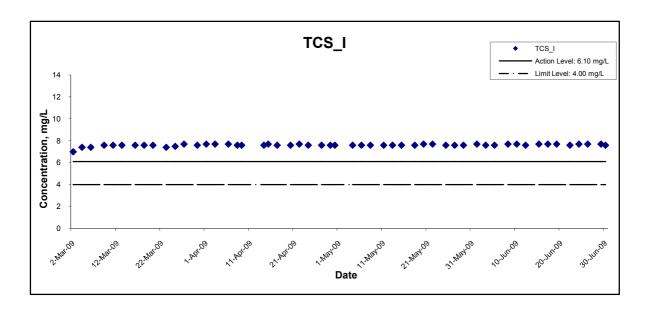
Dissolved Oxygen

Title Contract No. HY/2003/19
Improvement to Tung Chung Road between Lung Tseng Tau and Cheung Sha

Graphical Presentation of Water Quality

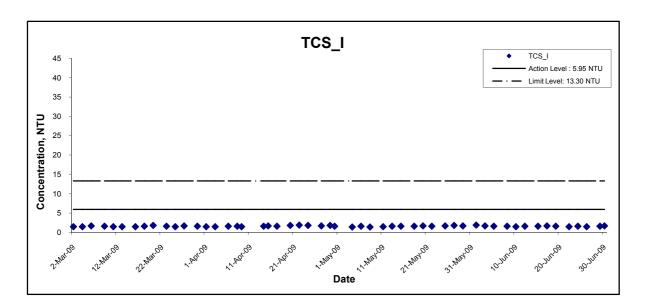
Turbidity

Title Contract No. HY/2003/19
Improvement to Tung Chung Road between Lung Tseng Tau and Cheung Sha

Graphical Presentation of Water Quality
Monitoring Results

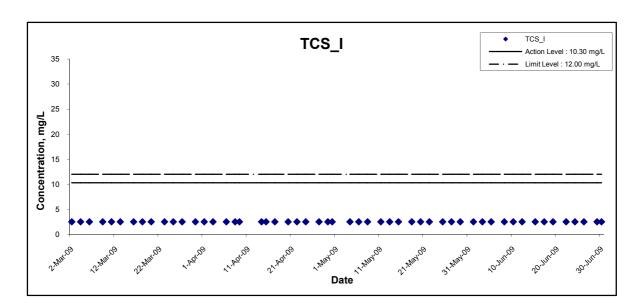
Suspended Solids

Graphical Presentation of Water Quality
