Contract No. HY/2003/19

**Improvement to Tung Chung Road
between Lung Tseng Tau and Cheung Sha**

**Quarterly EM&A Report
(Version 2.0)**

May 2008 to July 2008

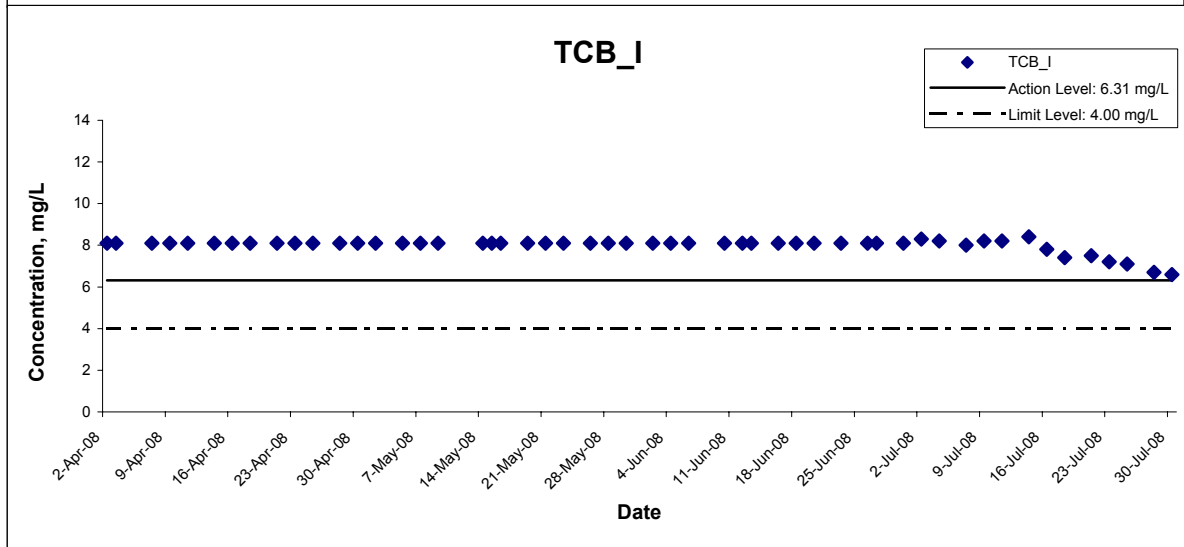
Dissolved Oxygen

Title Contract No. HY/2003/19 Improvement to Tung Chung Road between Lung Tseng Tau and Cheung Sha Graphical Presentation of Water Quality Monitoring Results	Scale N.T.S	Project No. MA6030	CINOTECH
	Date Jul 08	Appendix F

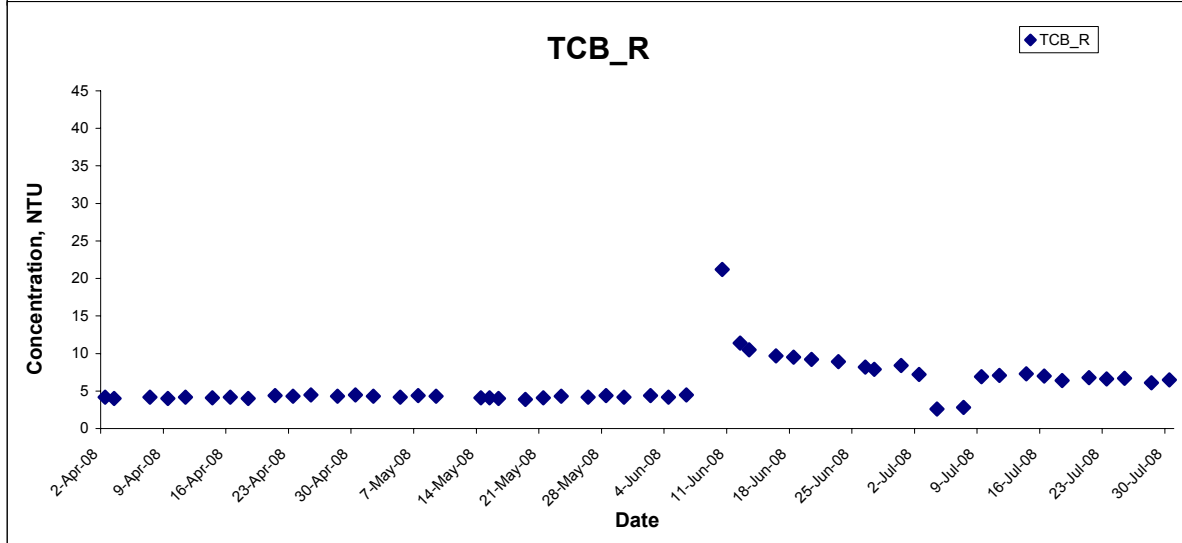
Turbidity

Title Contract No. HY/2003/19 Improvement to Tung Chung Road between Lung Tseng Tau and Cheung Sha Graphical Presentation of Water Quality Monitoring Results	Scale N.T.S	Project No. MA6030	CINOTECH
	Date Jul 08	Appendix F

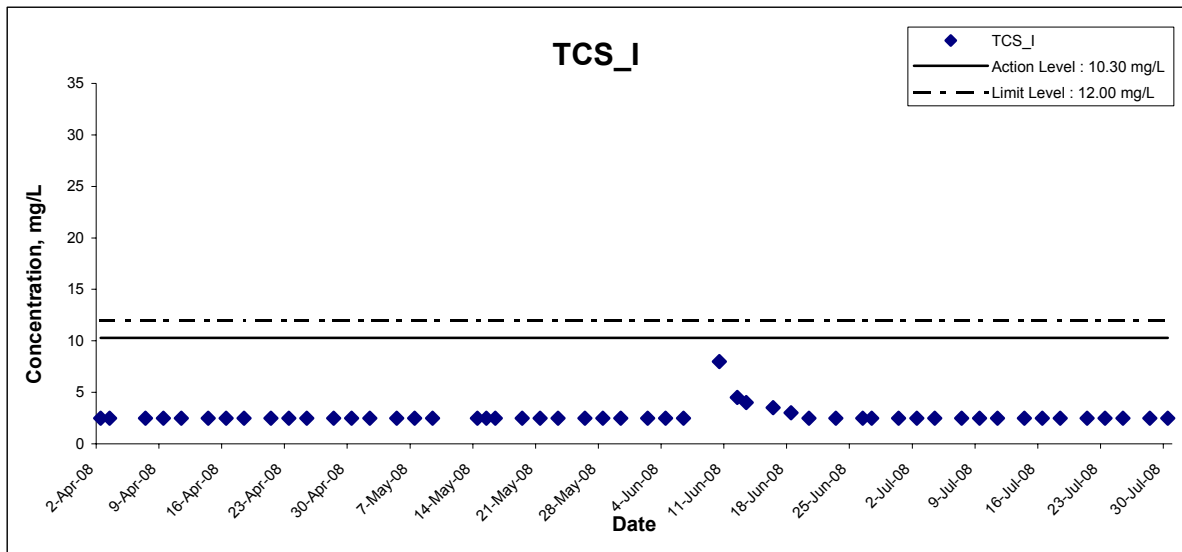
Suspended Solids

Title Contract No. HY/2003/19 Improvement to Tung Chung Road between Lung Tseng Tau and Cheung Sha Graphical Presentation of Water Quality Monitoring Results	Scale	N.T.S	Project No. MA6030	CINOTECH
	Date	Jul 08	Appendix
