**Contract No. HY/2003/19**

**Improvement to Tung Chung Road  
between Lung Tseng Tau and Cheung Sha**

**Quarterly EM&A Report  
(Version 2.0)**

August 2008 to October 2008

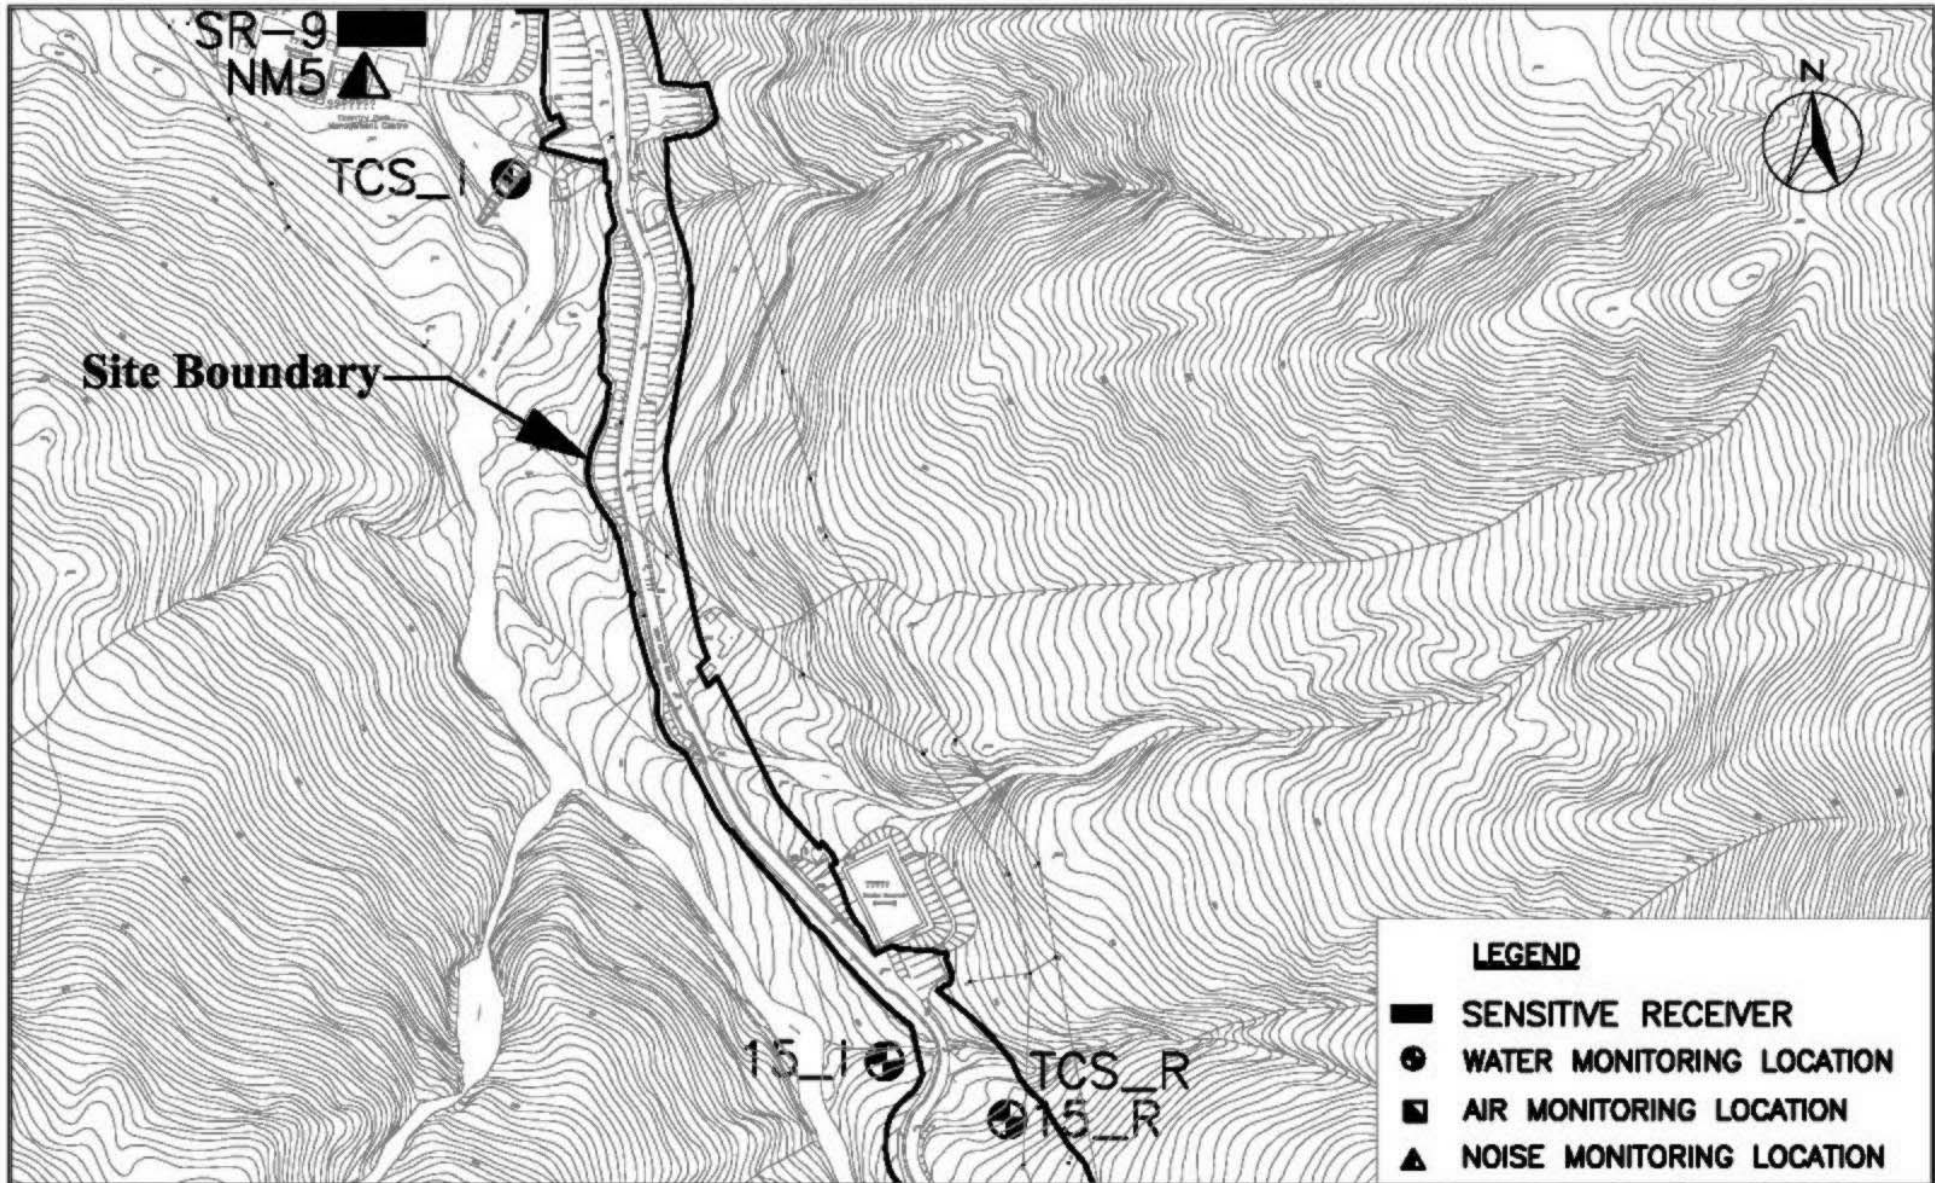
**MONITORING LOCATIONS  
(SHEET 3 OF 7)**

- SENSITIVE RECEIVER
- WATER MONITORING LOCATION
- AIR MONITORING LOCATION
- ▲ NOISE MONITORING LOCATION

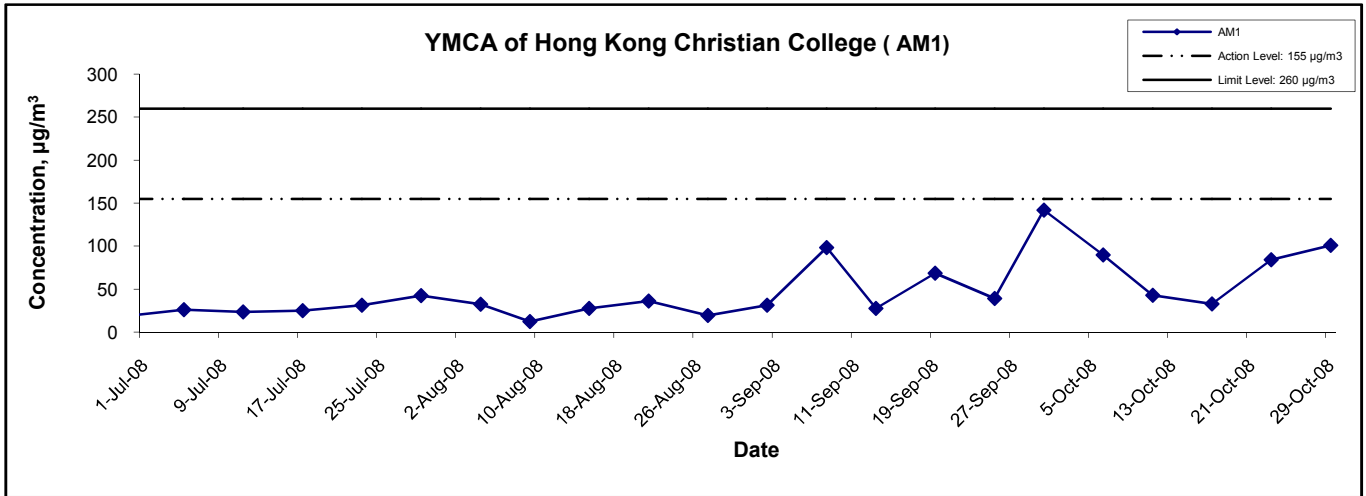
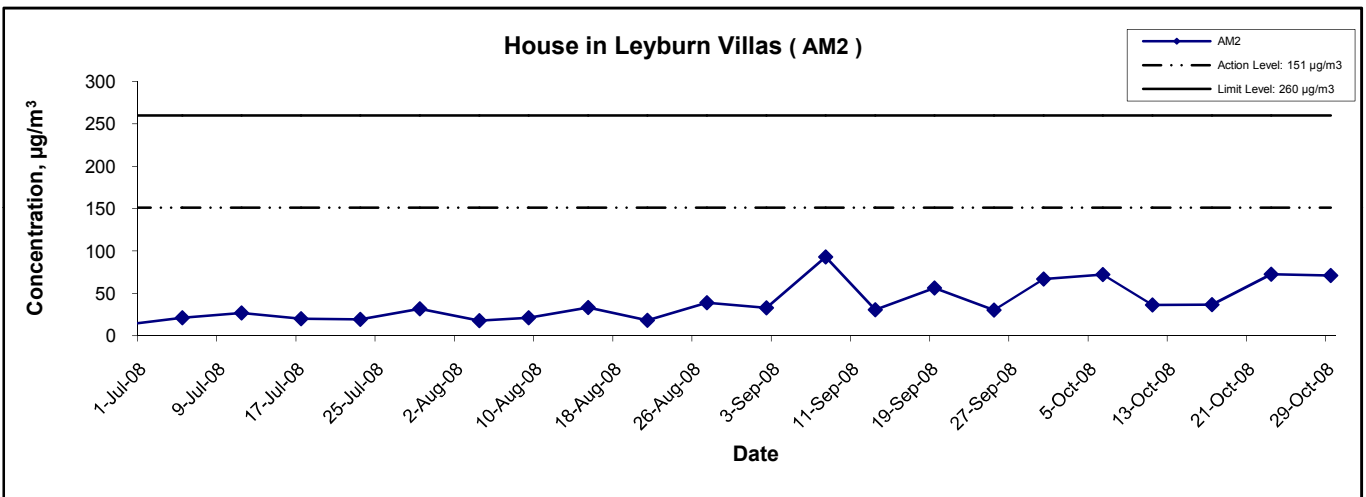
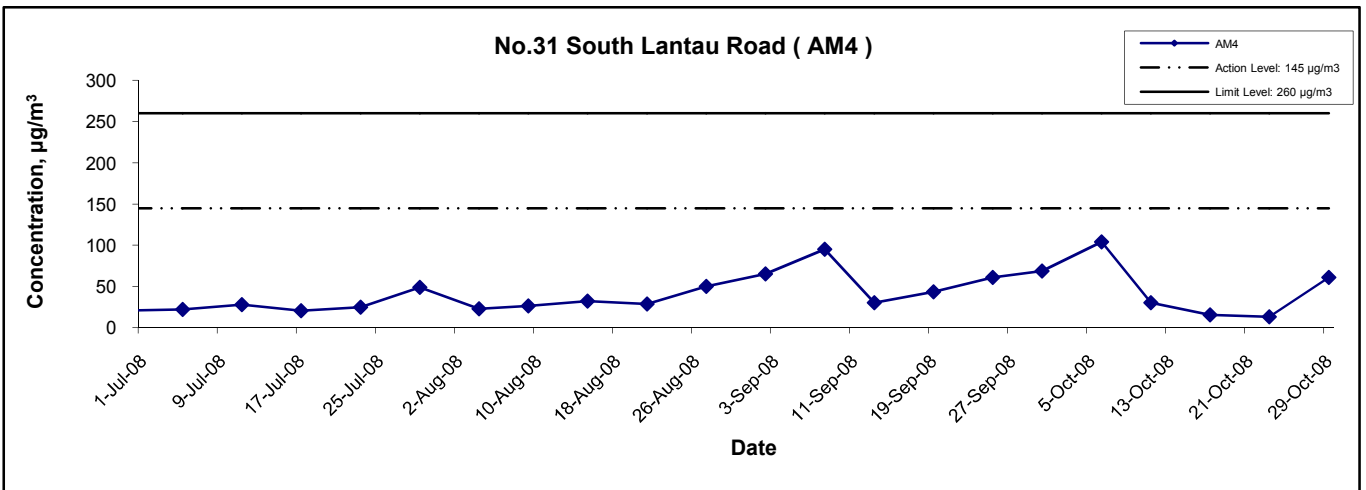
## 24-hour TSP Levels

Title Contract No. HY/2003/19 Improvement to Tung Chung Road between Lung Tseng Tau and Cheung Sha  Graphical Presentation of 24-hour TSP Monitoring Results	Scale N.T.S	Project No. MA6030	
	Date Oct 08	Appendix D

Type of Monitoring	Parameter	Frequency	Location	Measurement Conditions
Air Quality	1 hour TSP <sup>(1)</sup>	Three times / 6 days	<ul style="list-style-type: none"> <li>• AM1 (YMCA of Hong Kong Christian College)</li> <li>• AM2 (D 68 Leyburn Villas)</li> <li>• AM3 (Butterfly Crest)<sup>(2)</sup></li> <li>• AM4 (No. 31 South Lantau Road)</li> <li>• AM5 (YWCA)<sup>(3)</sup></li> </ul>	<ul style="list-style-type: none"> <li>• AM1 – Rooftop</li> <li>• AM2 – House</li> <li>• AM3 – House</li> <li>• AM4 – House</li> <li>• AM5 – To be confirmed</li> </ul>
	24 hour TSP	Once / 6 days

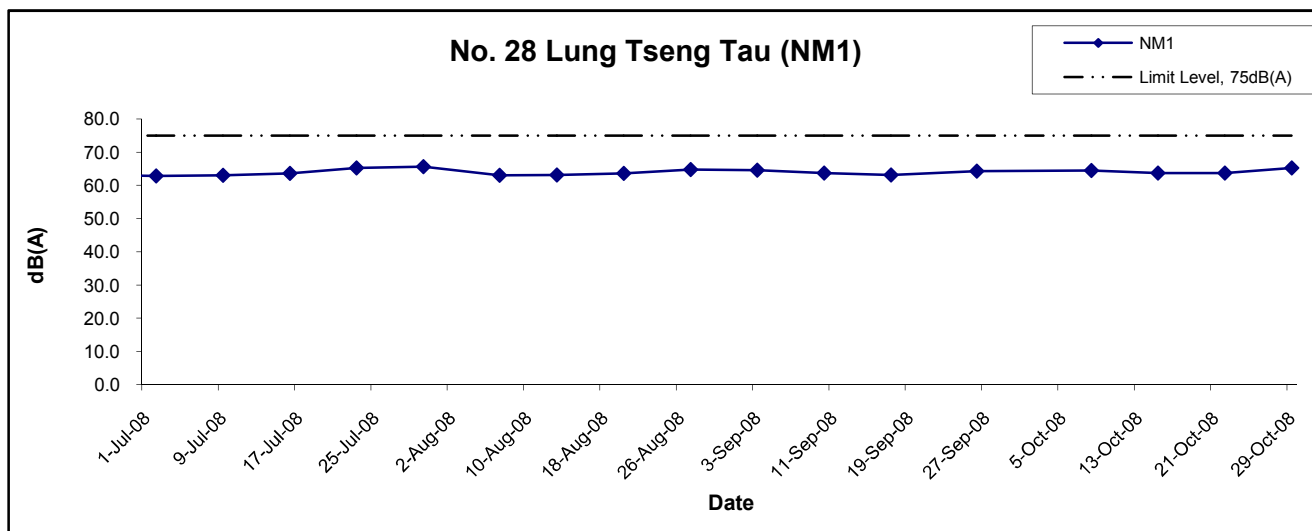
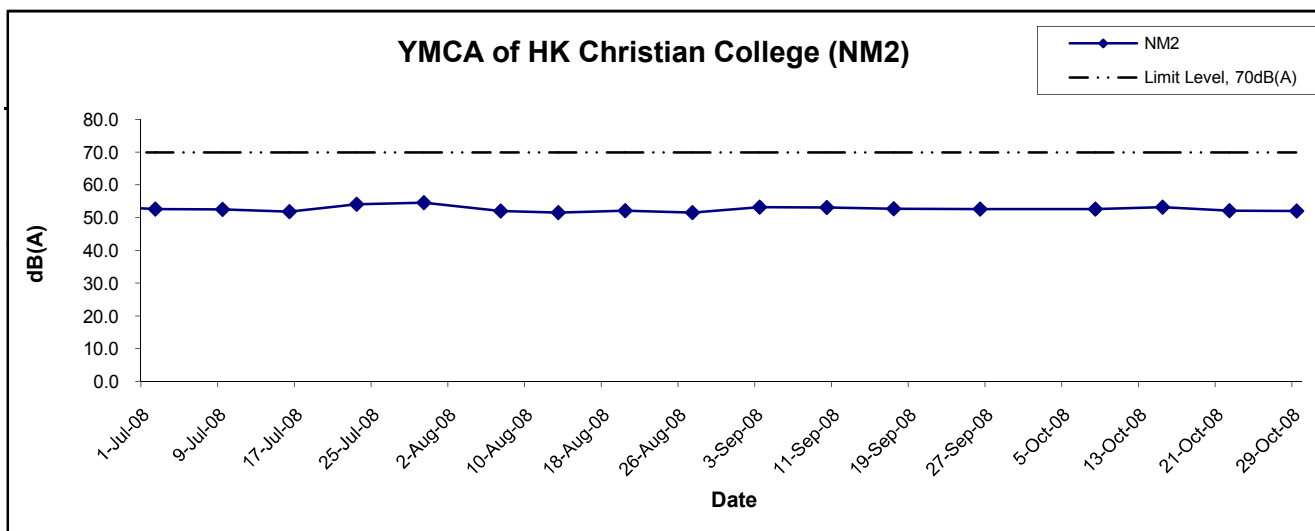
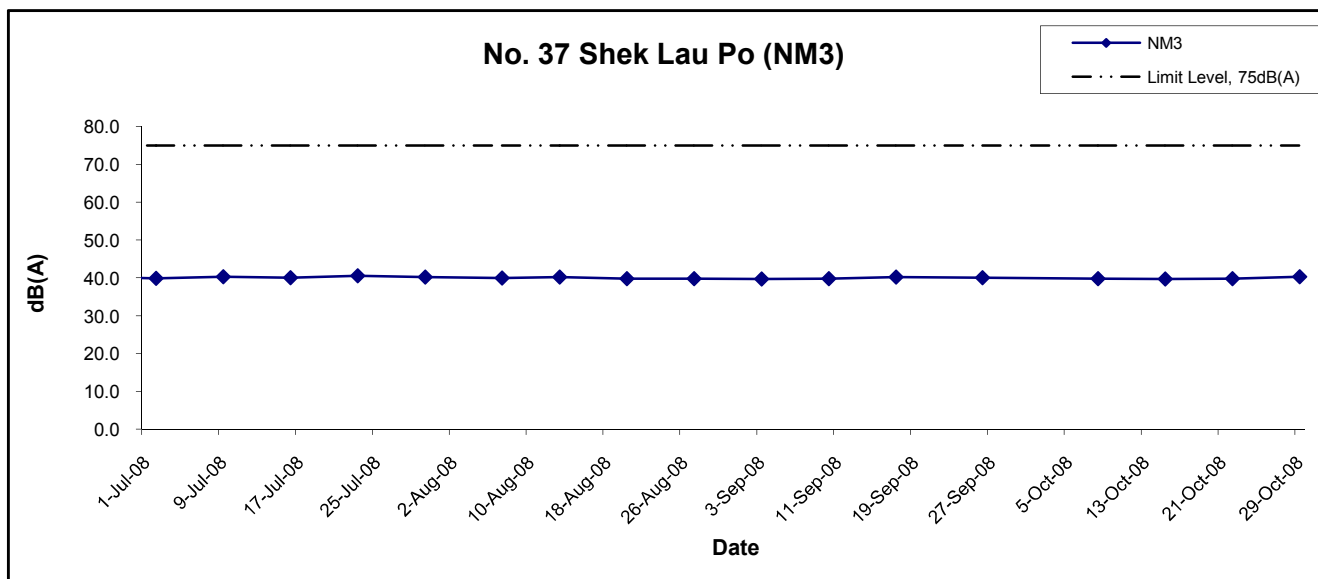
## Noise Levels

Title Contract No. HY/2003/19 Improvement to Tung Chung Road between Lung Tseng Tau and Cheung Sha  Graphical Presentation of Construction Noise Monitoring Results	Scale N.T.S	Project No. MA6030	
	Date Oct 08	Appendix E

Type of Monitoring	Parameter	Frequency	Location	Measurement Conditions
Noise	$L_{eq}$ , $L_{90}$ & $L_{10}$ at 30 minute intervals during (0700 to 1900 on normal weekdays)	Once per week	<ul style="list-style-type: none"> <li>• NM1 (No. 28 Lung Tseng Tau)</li> <li>• NM2 (YMCA of Hong Kong Christian College)</li> <li>• NM3 (No. 37 Shek Lau Po)</li> <li>• NM4 (No. 1 Shek Mun Kap)</li> <li>• NM5 (Tung Chung Au Country Parks Management Centre)</li> <li>• NM6 (D75 Leyburn Villa)</li> <li>• NM7 (House in Butterfly Crest House 22) <sup>(2)</sup></li> <li>• NM8 (No. 31 South Lantau Road)</li> </ul>	<ul style="list-style-type: none"> <li>• NM1 - Facade measurement</li> <li>• NM2 - Facade measurement</li> <li>• NM3 - Facade measurement</li> <li>• NM4 - Facade measurement</li> <li>• NM5 - Facade measurement</li> <li>• NM6 - Facade measurement</li> <li>• NM7 - Facade measurement</li> <li>• NM8 - Facade measurement</li> </ul>

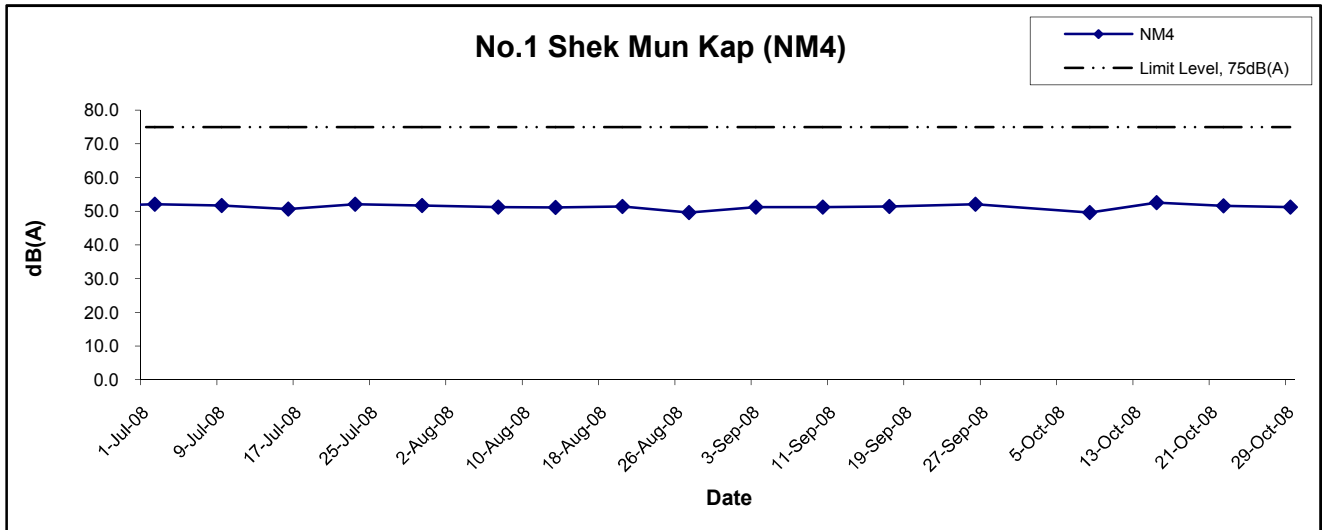
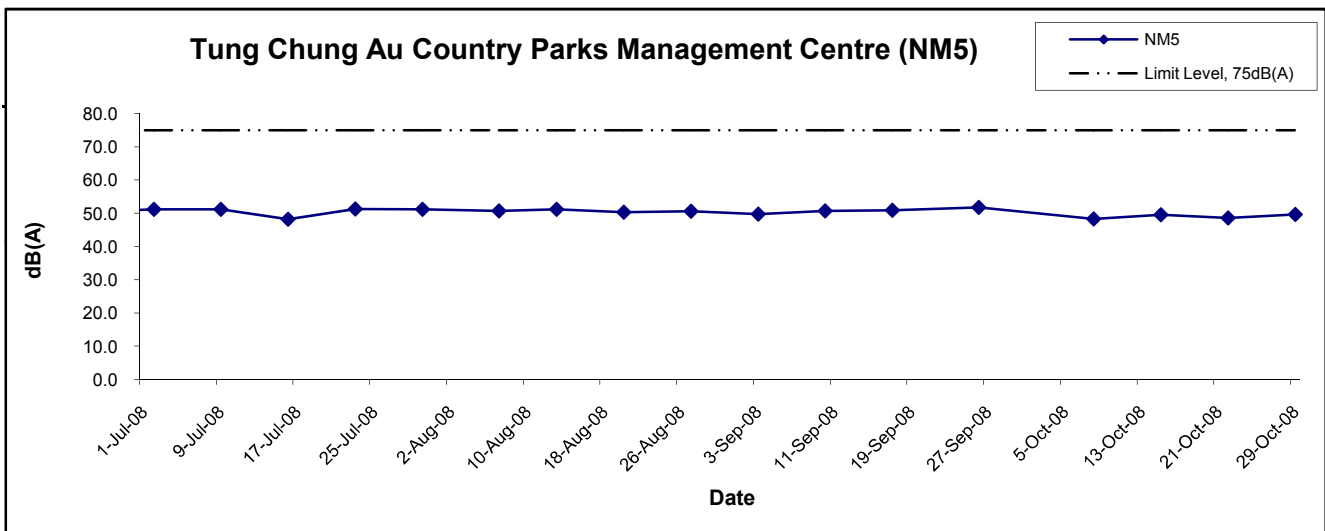
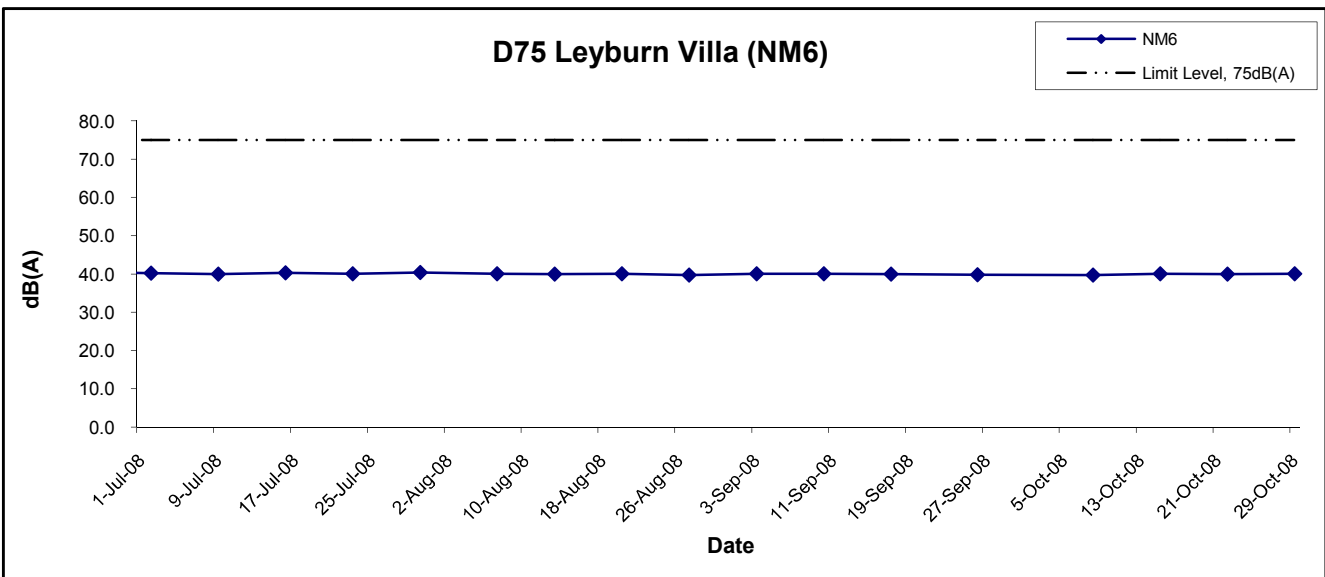
## Noise Levels

Title Contract No. HY/2003/19 Improvement to Tung Chung Road between Lung Tseng Tau and Cheung Sha  Graphical Presentation of Construction Noise Monitoring Results	Scale N.T.S	Project No. MA6030	
	Date Oct 08	Appendix E

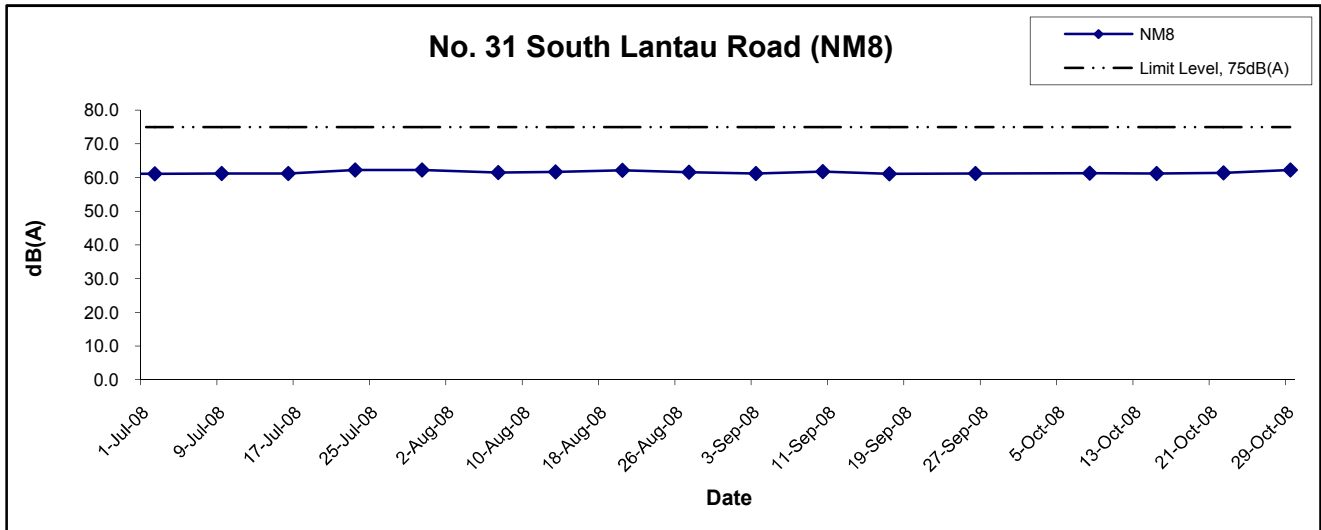
## Noise Levels

Title Contract No. HY/2003/19 Improvement to Tung Chung Road between Lung Tseng Tau and Cheung Sha  Graphical Presentation of Construction Noise Monitoring Results	Scale N.T.S	Project No. MA6030	
	Date Oct 08	Appendix E

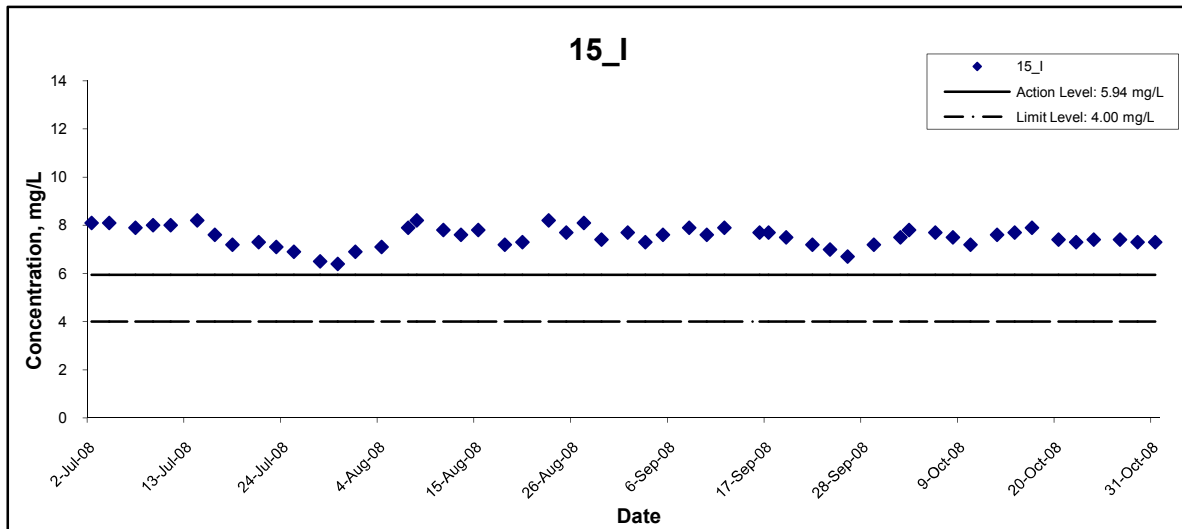
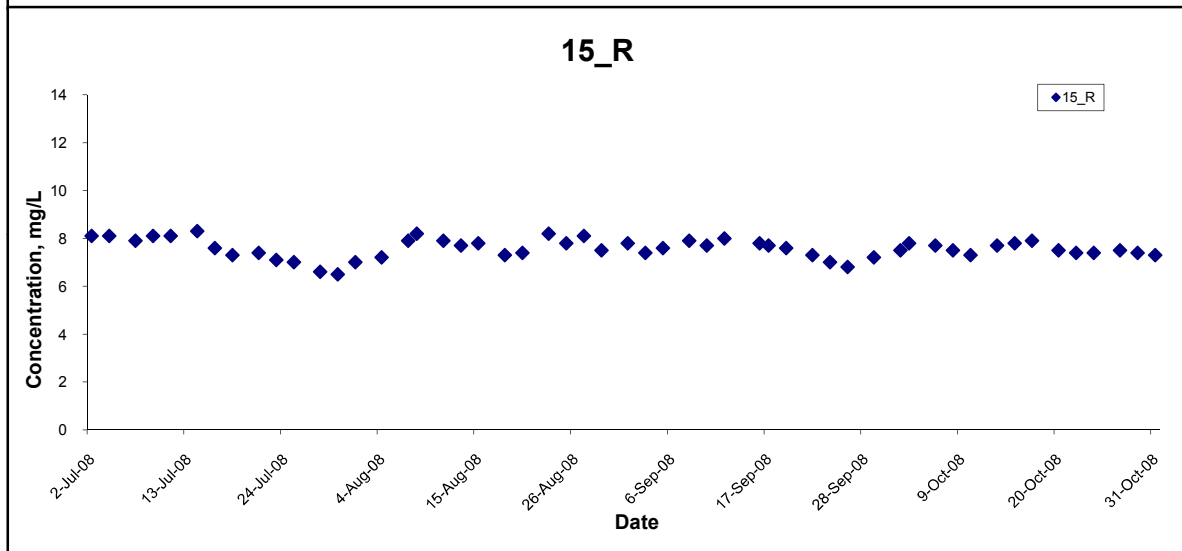
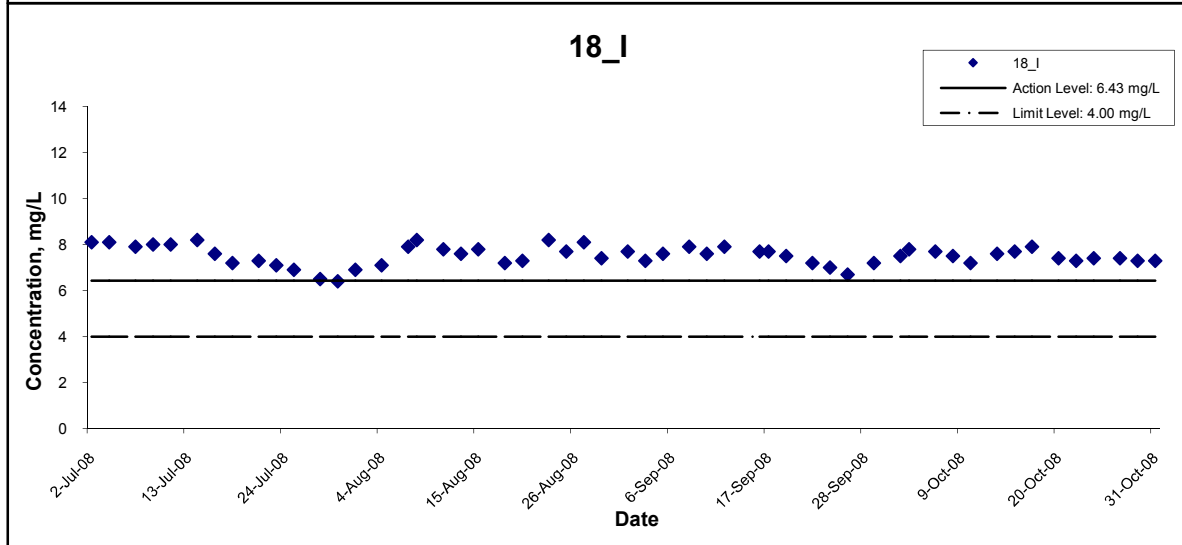
## Dissolved Oxygen

Title Contract No. HY/2003/19 Improvement to Tung Chung Road between Lung Tseng Tau and Cheung Sha  Graphical Presentation of Water Quality Monitoring Results	Scale N.T.S	Project No. MA6030	
	Date Oct 08	Appendix F

Type of Monitoring	Parameter	Frequency	Location	Measurement Conditions
Water Quality	<ul style="list-style-type: none"> <li>• Temperature (oC)</li> <li>• pH (pH unit)</li> <li>• Turbidity (NTU)</li> <li>• Water depth (m)</li> <li>• Salinity (mg/L)</li> <li>• Dissolved oxygen (DO) (mg/L and % of saturation)</li> <li>• Suspended solids (SS) (mg/L)</li> </ul>	Three times per week	<ul style="list-style-type: none"> <li>• 15_I (811781E, 813298N)</li> <li>• 15_R (811853E, 813289N)</li> <li>• 18_I (811836E, 813138)</li> <li>• 18_R (811889E, 813107N)</li> <li>• 19_I (811858E, 812987N)</li> <li>• 19_R (811920E, 812927N)</li> <li>• 21_I (811873E, 812723N)</li> <li>• 21_R (811994E, 812695N)</li> <li>• 23_I (811894E, 812658N)</li> <li>• 23_R1 (811980E, 812589N)</li> <li>• 23_R2 (812079E, 812386N)</li> <li>• 25_I (812324E, 812017N)</li> <li>• 25_R (812353E, 812052N)</li> <li>• 26_I (812456E, 811895N)</li> <li>• 26_R (812525E, 811980N)</li> <li>• 27_I (812604E, 811747N)</li> <li>• 27_R (812658E, 811770N)</li> <li>• 32_I (812988E, 811327N)</li> <li>• 32_R (812980E, 811410N)</li> <li>• 35_I (813218E, 811218N)</li> <li>• 35_R (813231E, 811275N)</li> <li>• 40_I (813690E, 811211N)</li> <li>• 40_R (813686E, 811311N)</li> <li>• CSS_I (812447E, 811165N)</li> <li>• TCS_I (811601E, 813716N)</li> <li>• TCB_I (810787E, 815706N)</li> <li>• TCB_R (810679E, 816038N)</li> </ul>	<ul style="list-style-type: none"> <li>• Sub-surface</li> </ul>

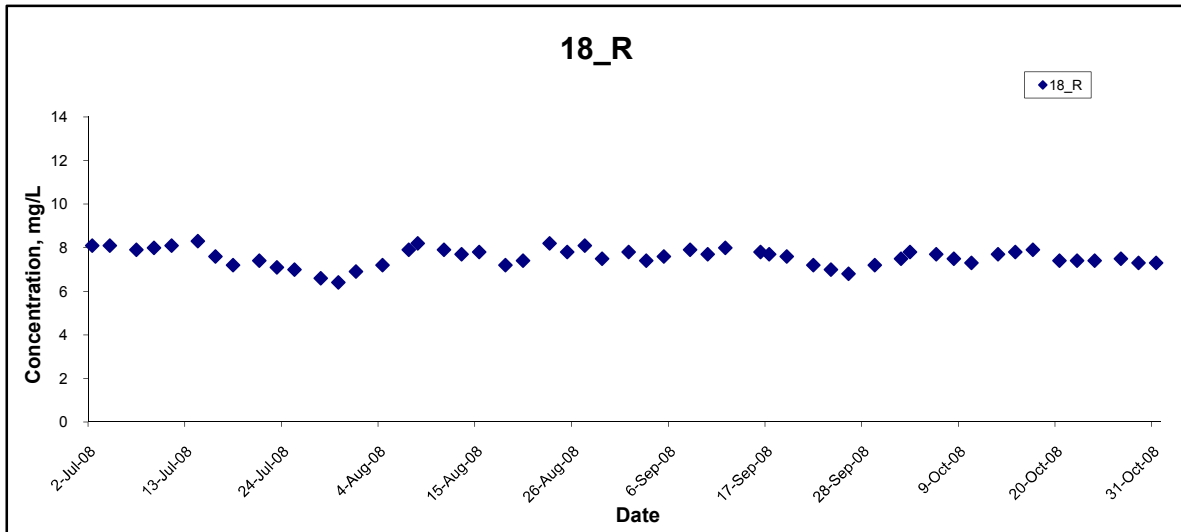
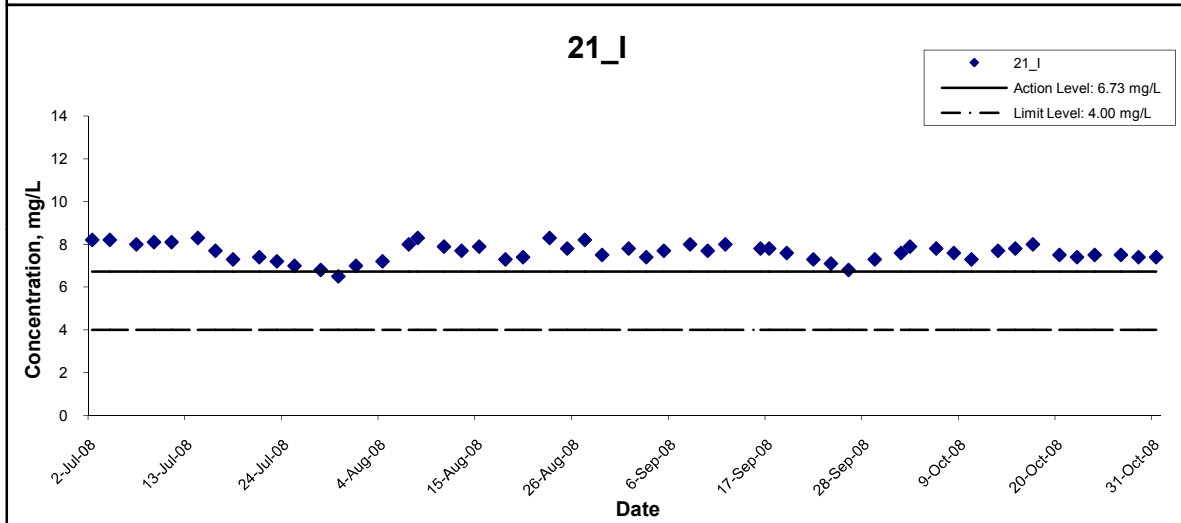
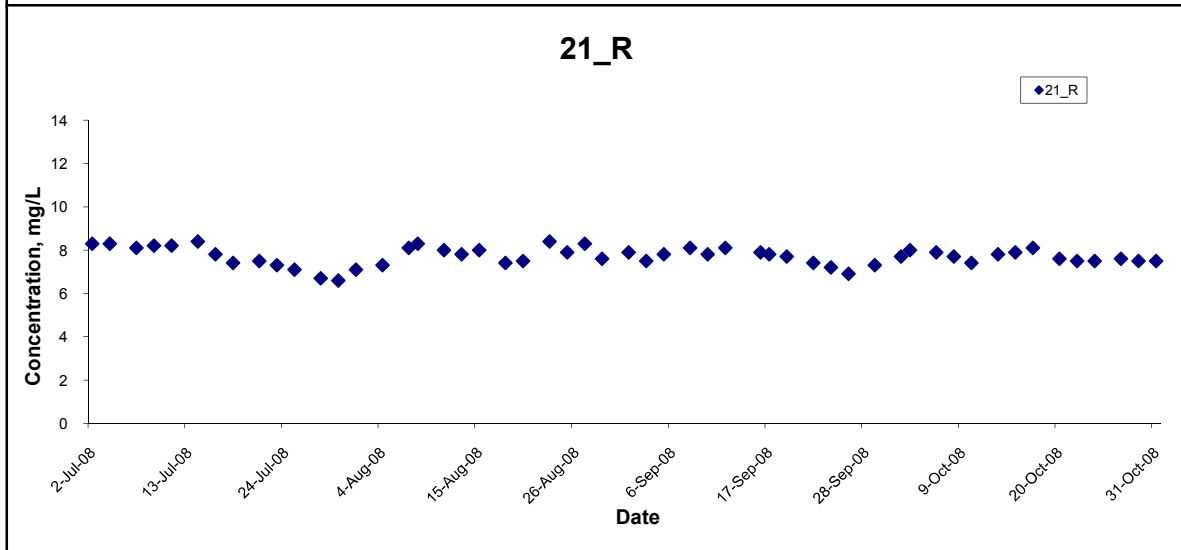
## Dissolved Oxygen

Title Contract No. HY/2003/19 Improvement to Tung Chung Road between Lung Tseng Tau and Cheung Sha Graphical Presentation of Water Quality Monitoring Results	Scale N.T.S	Project No. MA6030	CINOTECH
	Date Oct 08	Appendix F

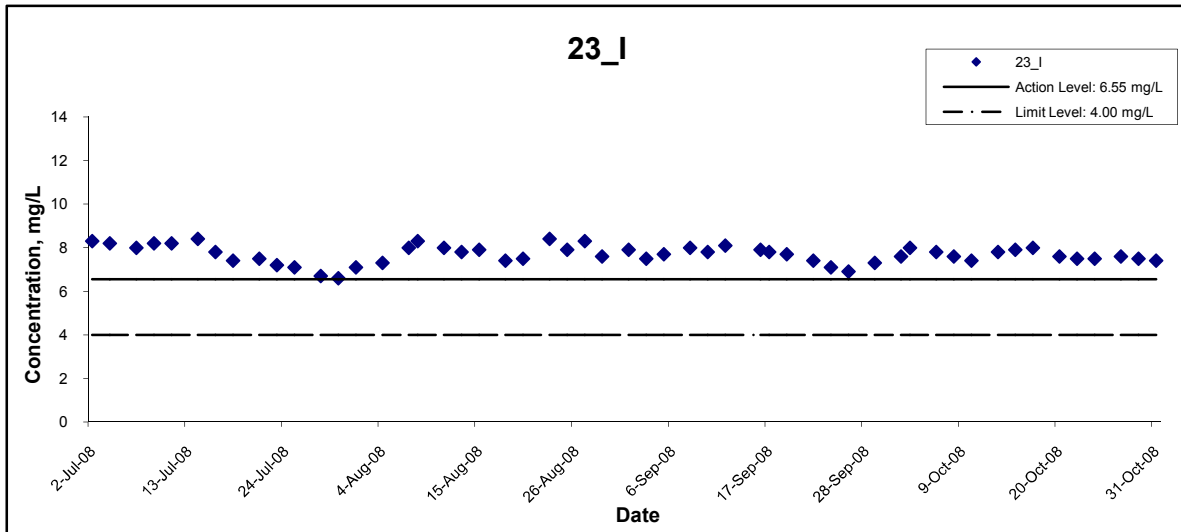
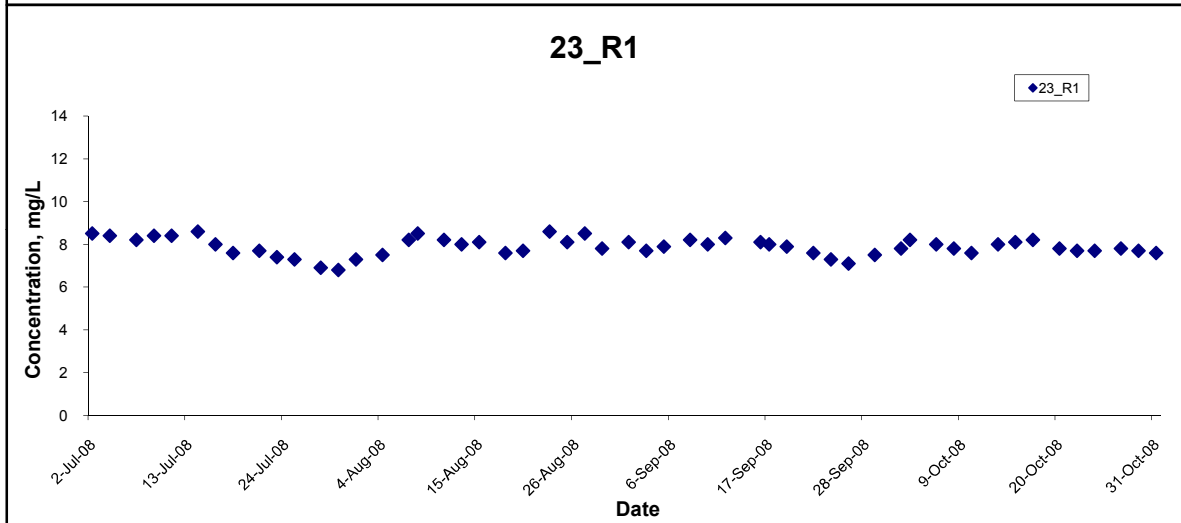
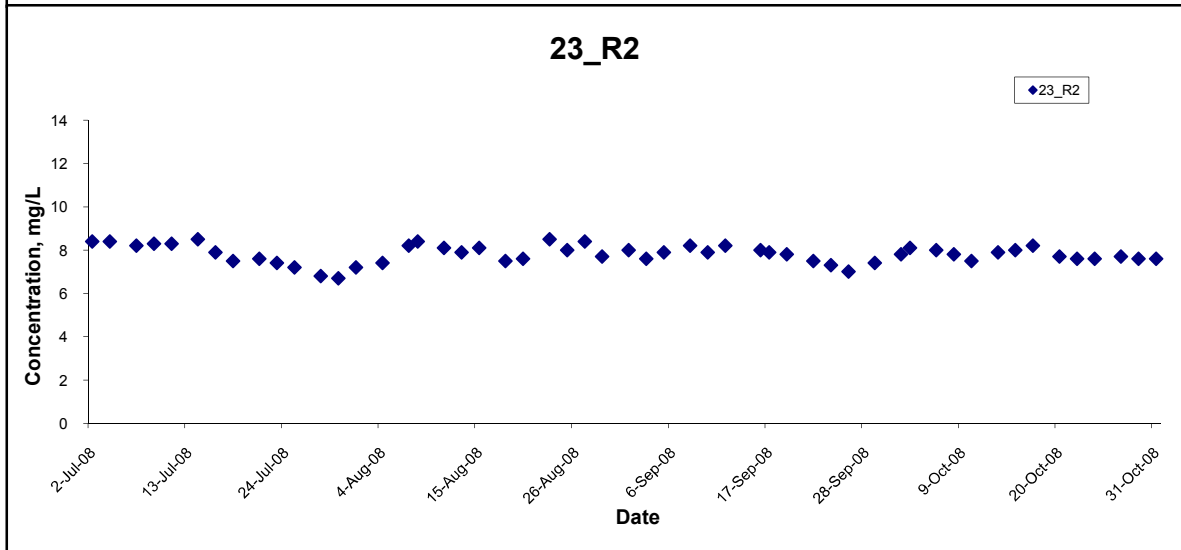
## Dissolved Oxygen

Title Contract No. HY/2003/19 Improvement to Tung Chung Road between Lung Tseng Tau and Cheung Sha  Graphical Presentation of Water Quality Monitoring Results	Scale N.T.S	Project No. MA6030	CINOTECH
	Date Oct 08	Appendix F

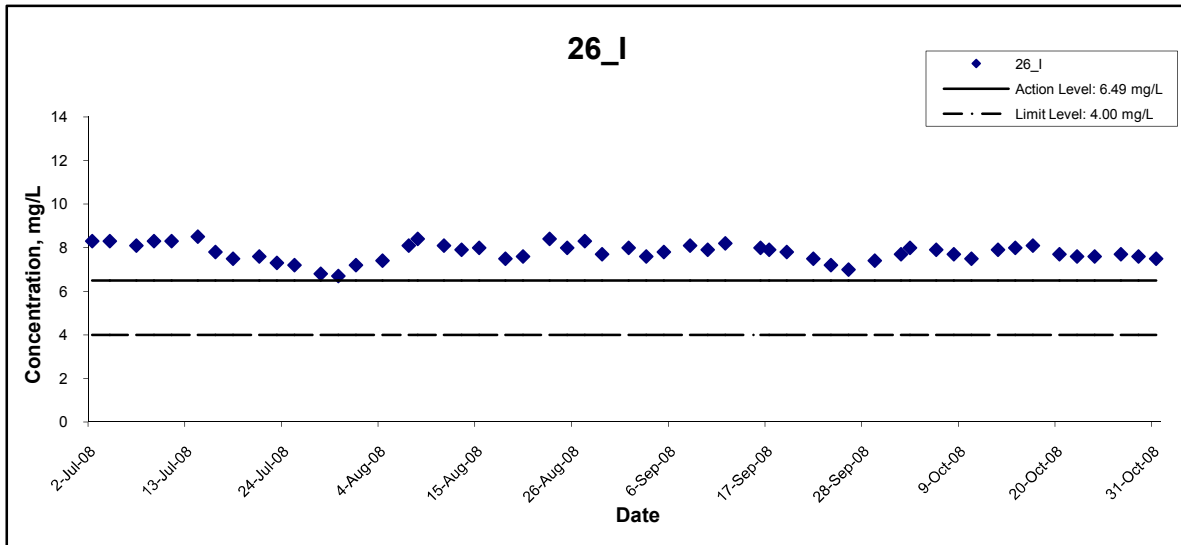
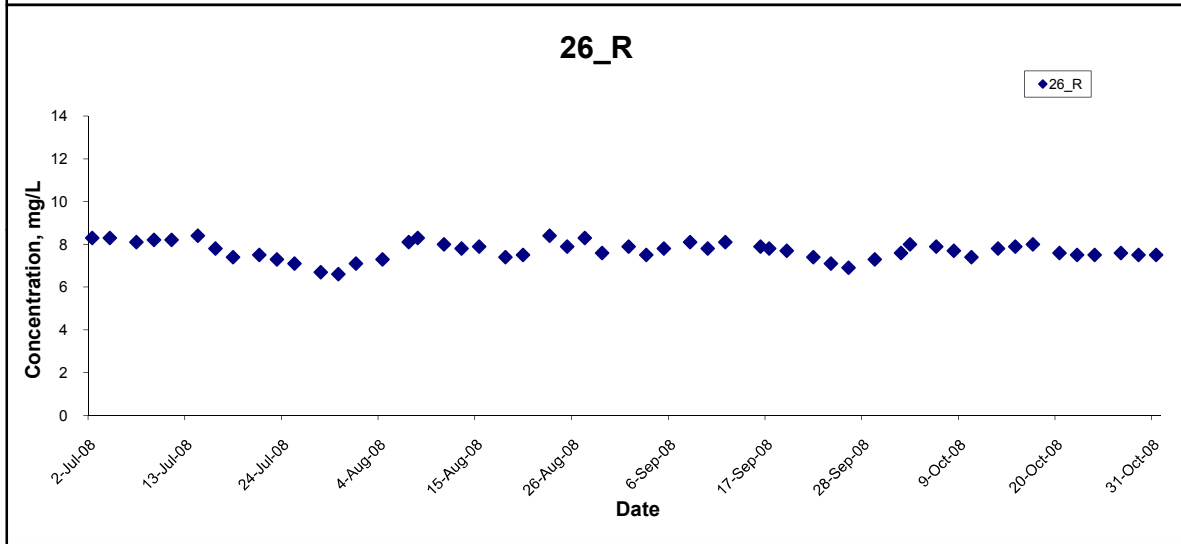
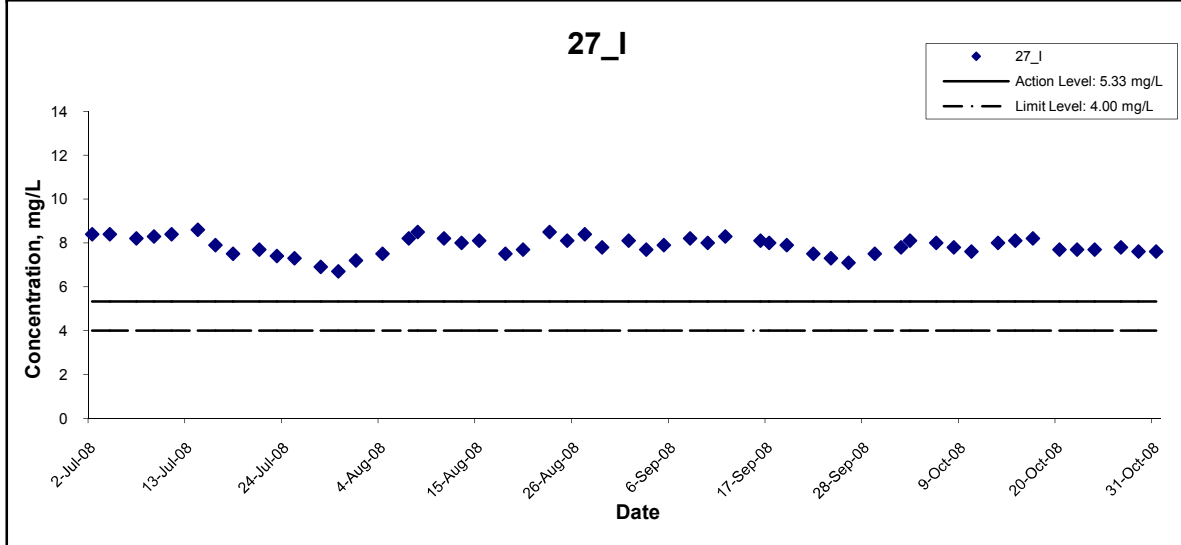
## Dissolved Oxygen

Title Contract No. HY/2003/19 Improvement to Tung Chung Road between Lung Tseng Tau and Cheung Sha  Graphical Presentation of Water Quality Monitoring Results	Scale N.T.S	Project No. MA6030	CINOTECH
	Date Oct 08	Appendix F

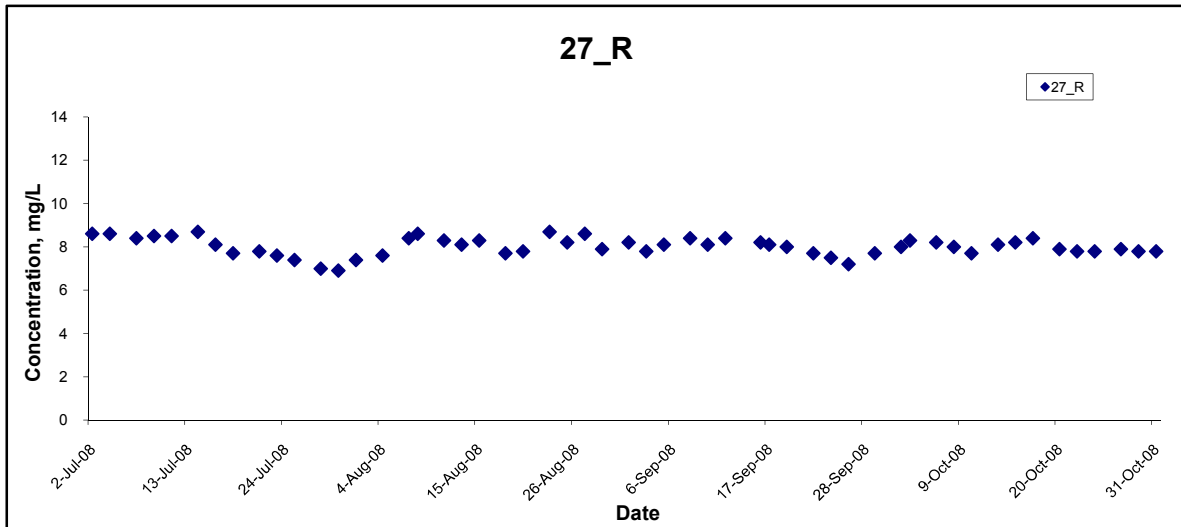
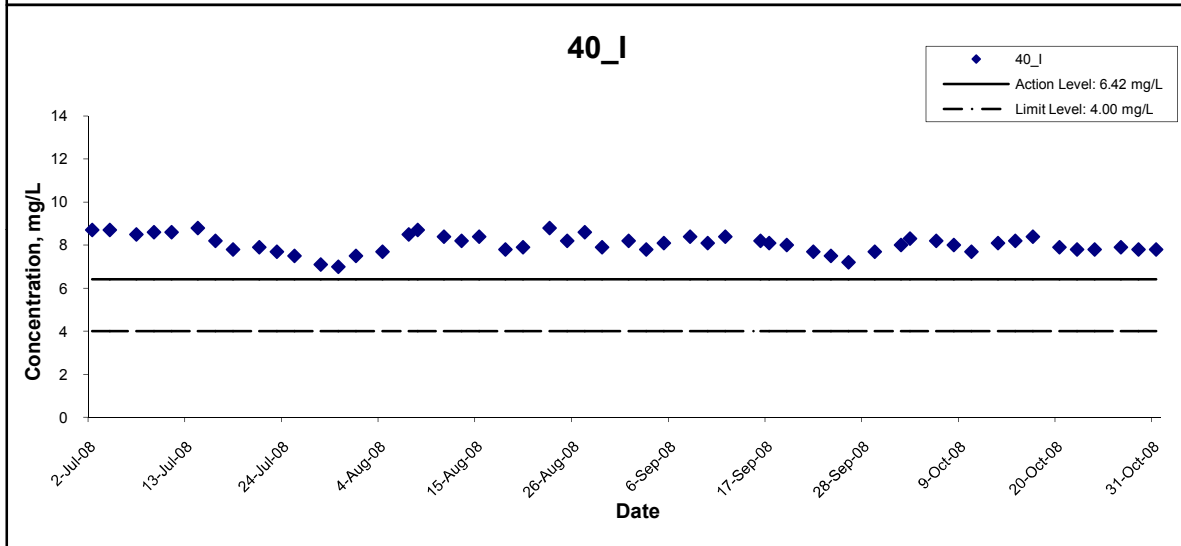
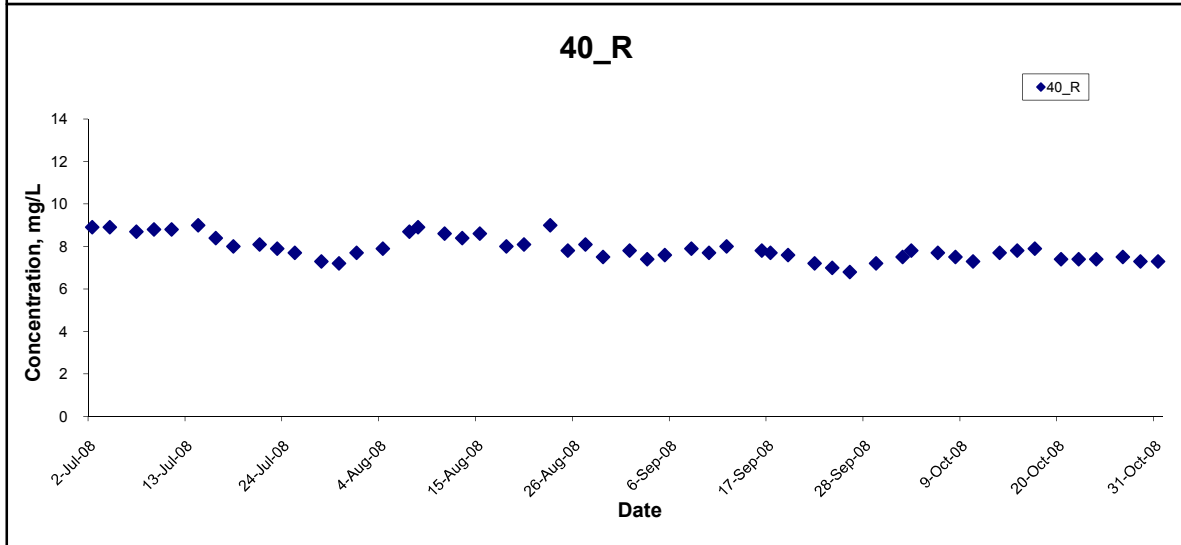
## Dissolved Oxygen

Title Contract No. HY/2003/19 Improvement to Tung Chung Road between Lung Tseng Tau and Cheung Sha  Graphical Presentation of Water Quality Monitoring Results	Scale N.T.S	Project No. MA6030	CINOTECH
	Date Oct 08	Appendix F

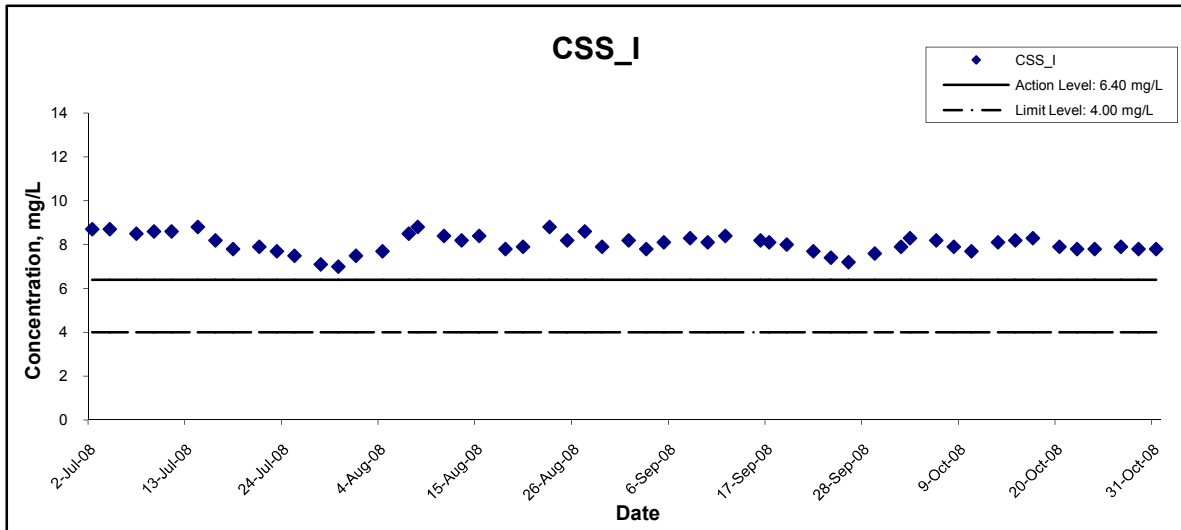
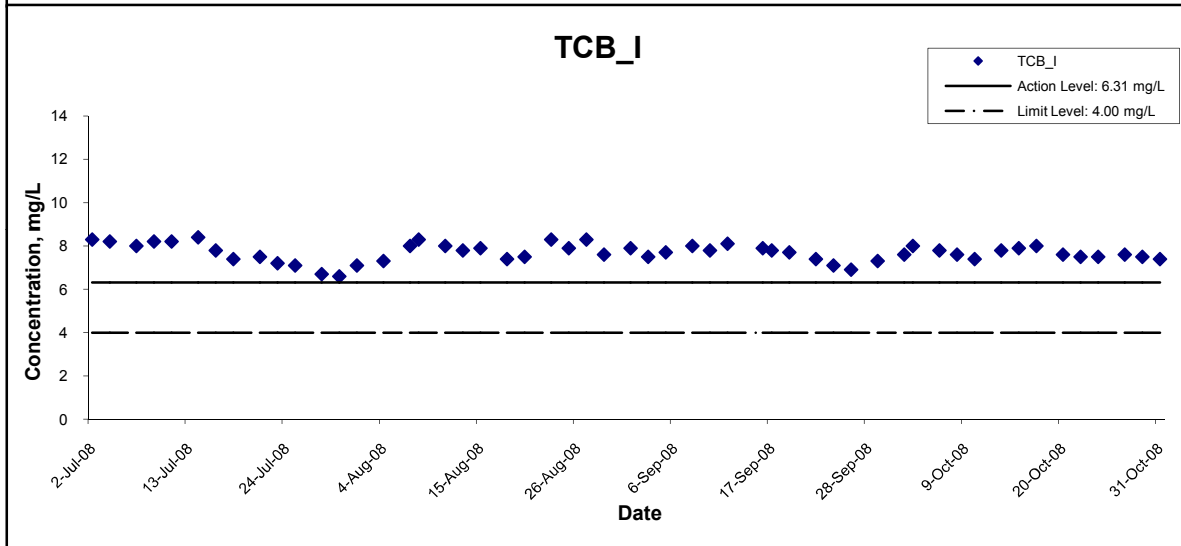
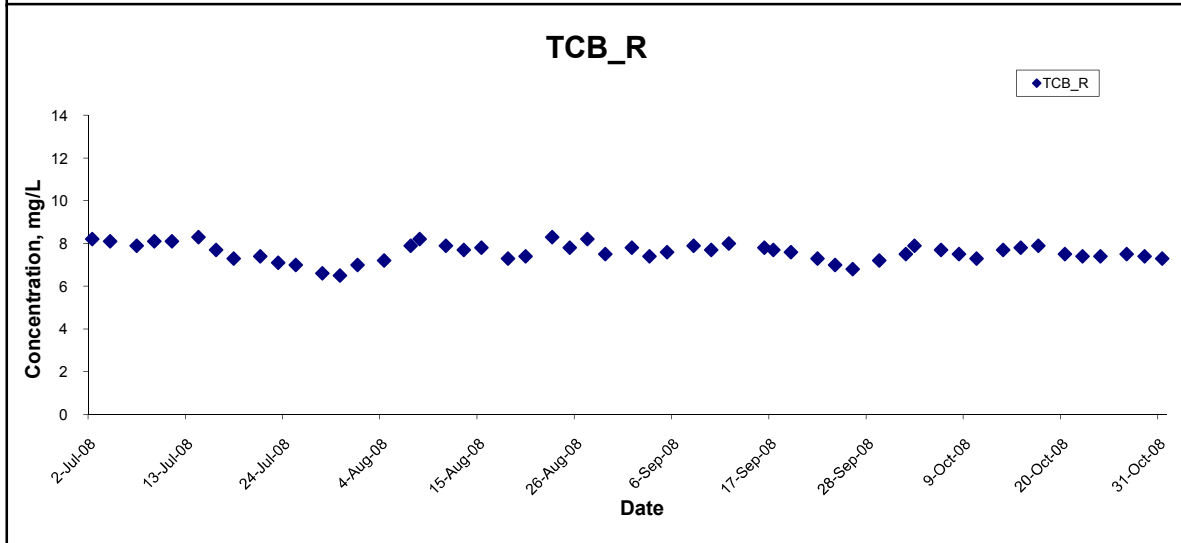
## Dissolved Oxygen

Title Contract No. HY/2003/19 Improvement to Tung Chung Road between Lung Tseng Tau and Cheung Sha Graphical Presentation of Water Quality Monitoring Results	Scale N.T.S	Project No. MA6030	
	Date Oct 08	Appendix F

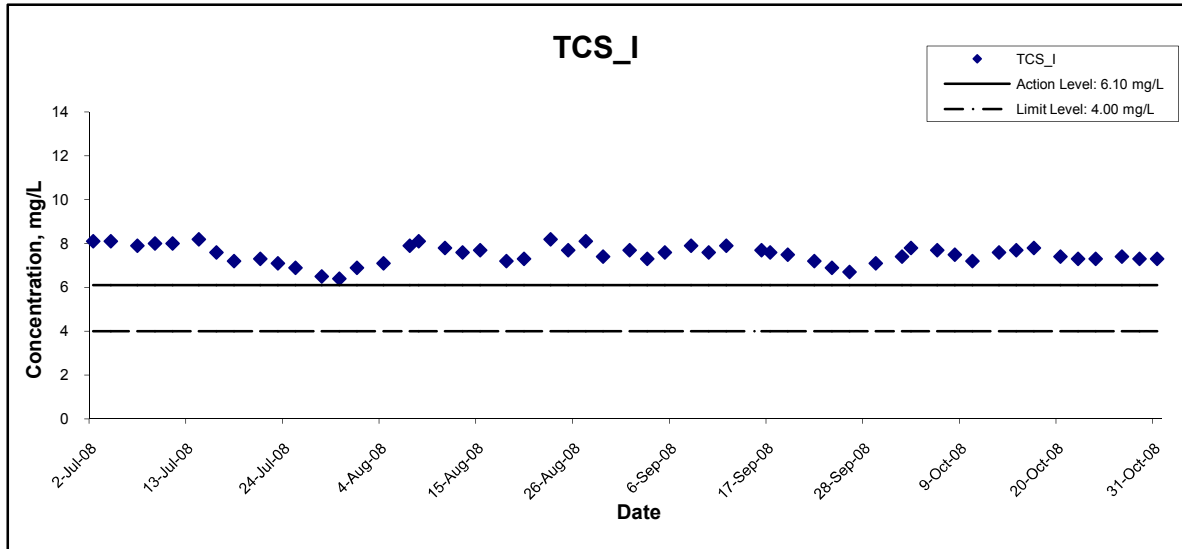
## Dissolved Oxygen

Title Contract No. HY/2003/19 Improvement to Tung Chung Road between Lung Tseng Tau and Cheung Sha  Graphical Presentation of Water Quality Monitoring Results	Scale N.T.S	Project No. MA6030	CINOTECH
	Date Oct 08	Appendix F
