**Contract No. HY/2003/19**

**Improvement to Tung Chung Road  
between Lung Tseng Tau and Cheung Sha**

**Quarterly EM&A Report  
(Version 2.0)**

August 2008 to October 2008

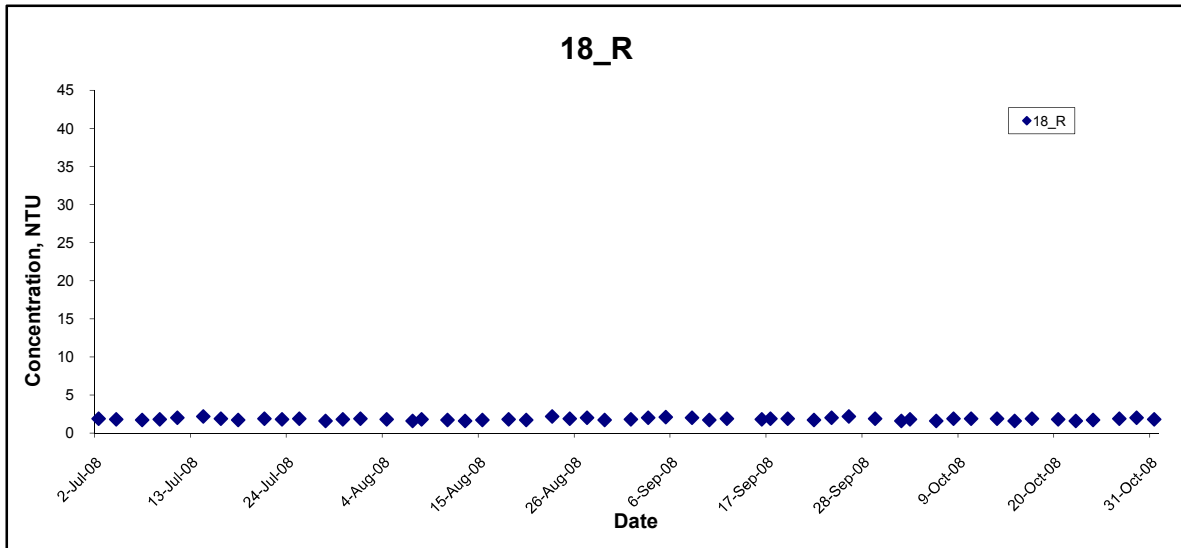
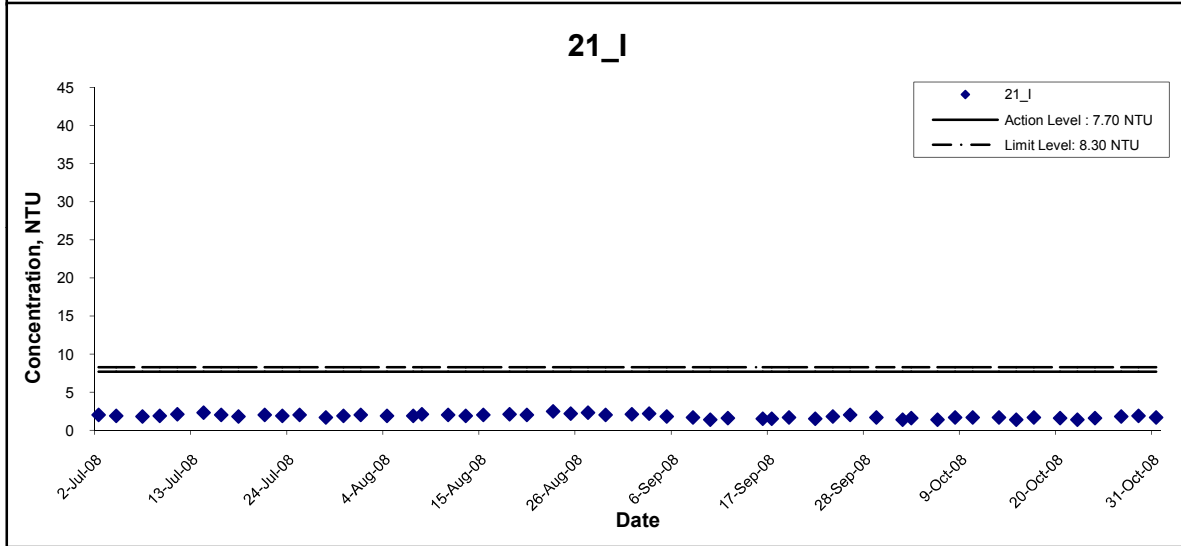
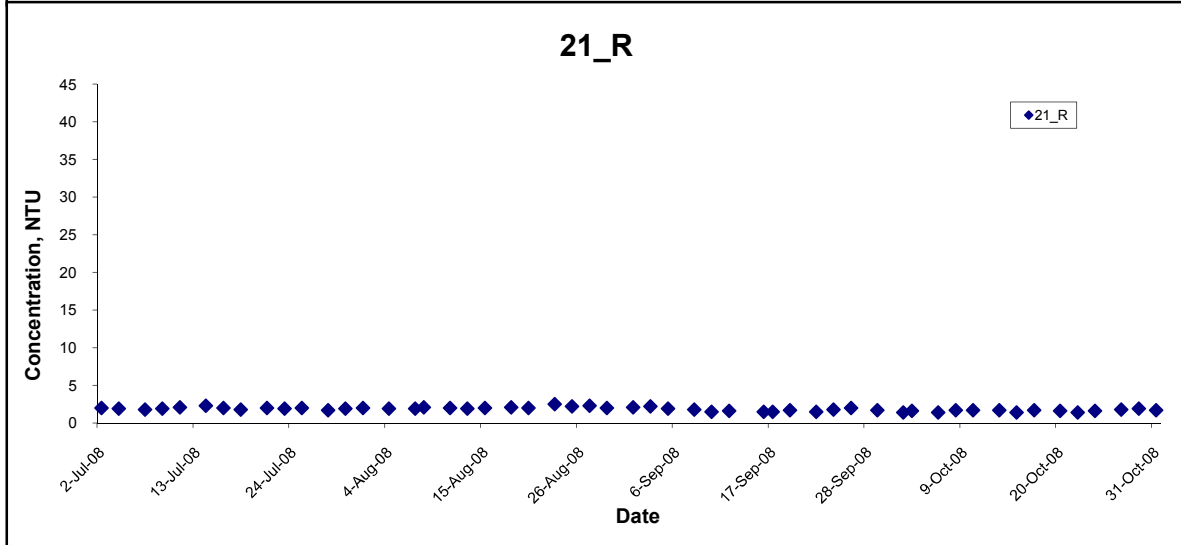
Title Contract No. HY/2003/19 Improvement to Tung Chung Road between Lung Tseng Tau and Cheung Sha Graphical Presentation of Water Quality Monitoring Results	Scale N.T.S	Project No. MA6030	CINOTECH
	Date Oct 08	Appendix F

## Turbidity

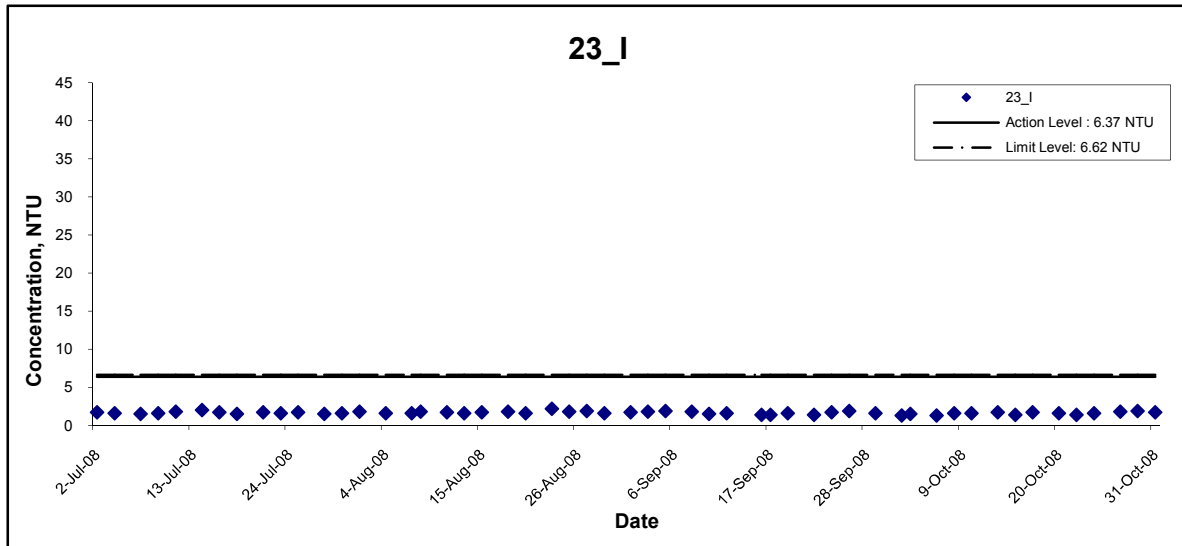
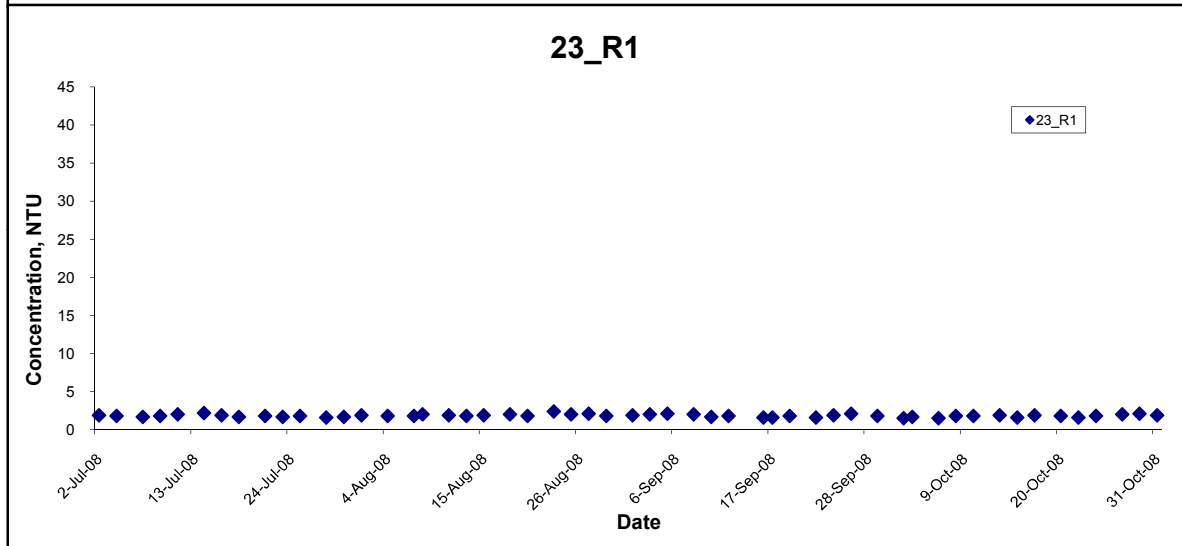
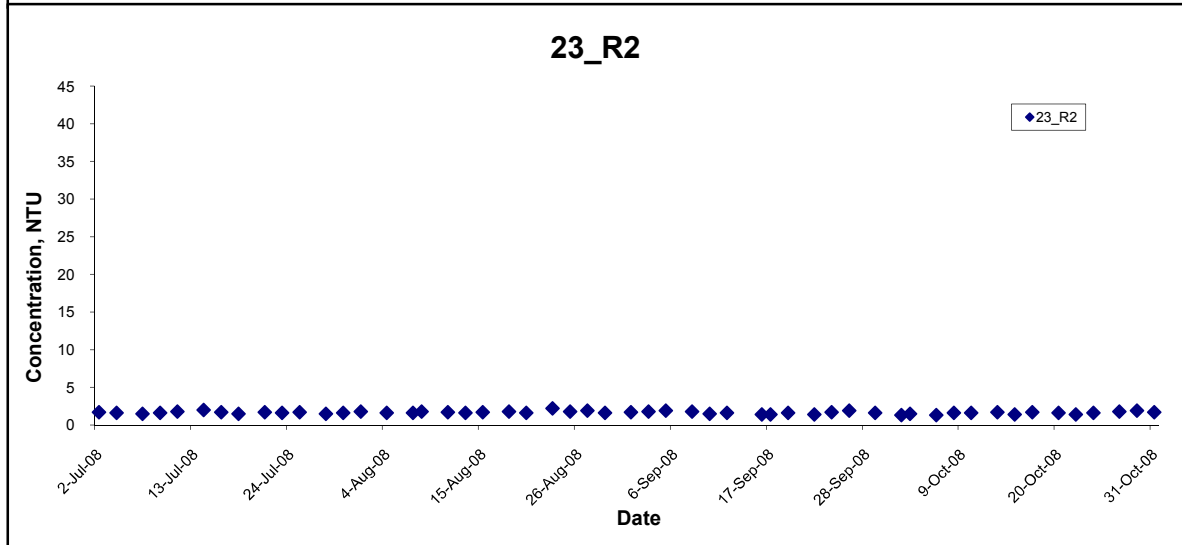
Title Contract No. HY/2003/19 Improvement to Tung Chung Road between Lung Tseng Tau and Cheung Sha Graphical Presentation of Water Quality Monitoring Results	Scale N.T.S	Project No. MA6030	
	Date Oct 08	Appendix F

## Turbidity

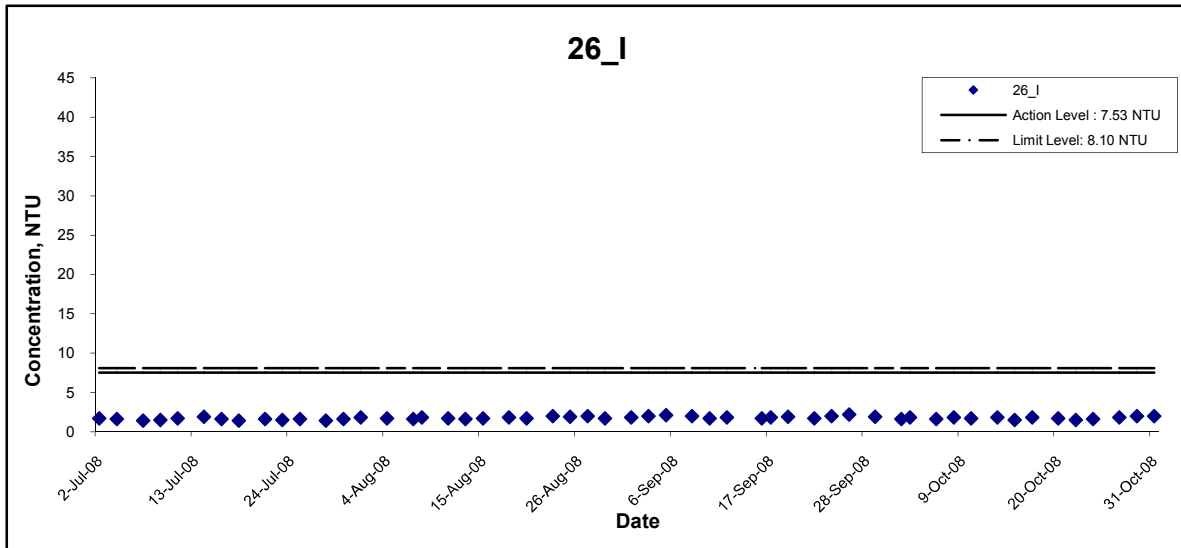
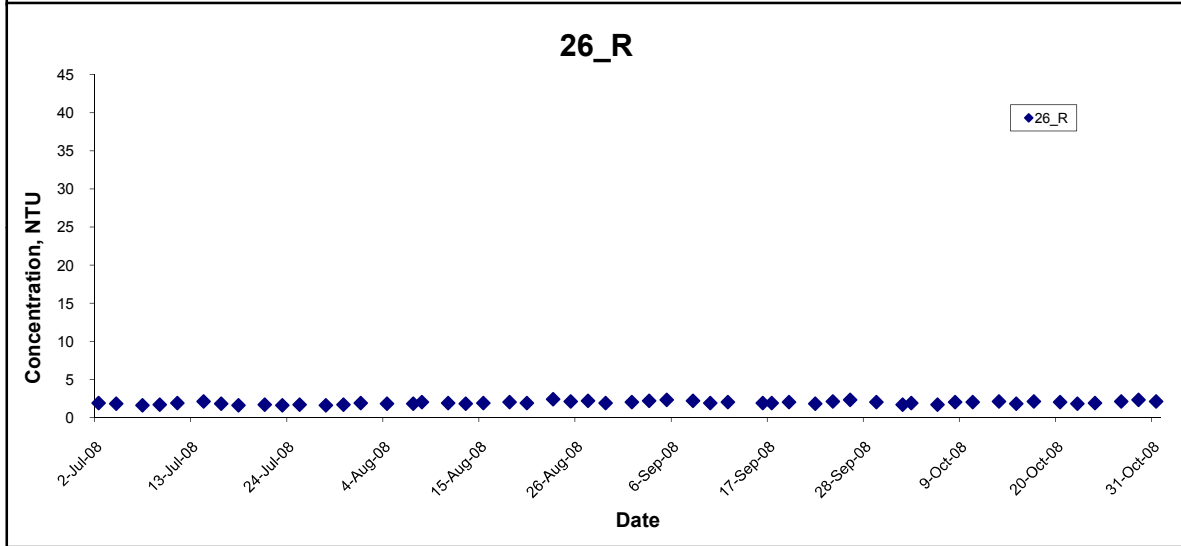
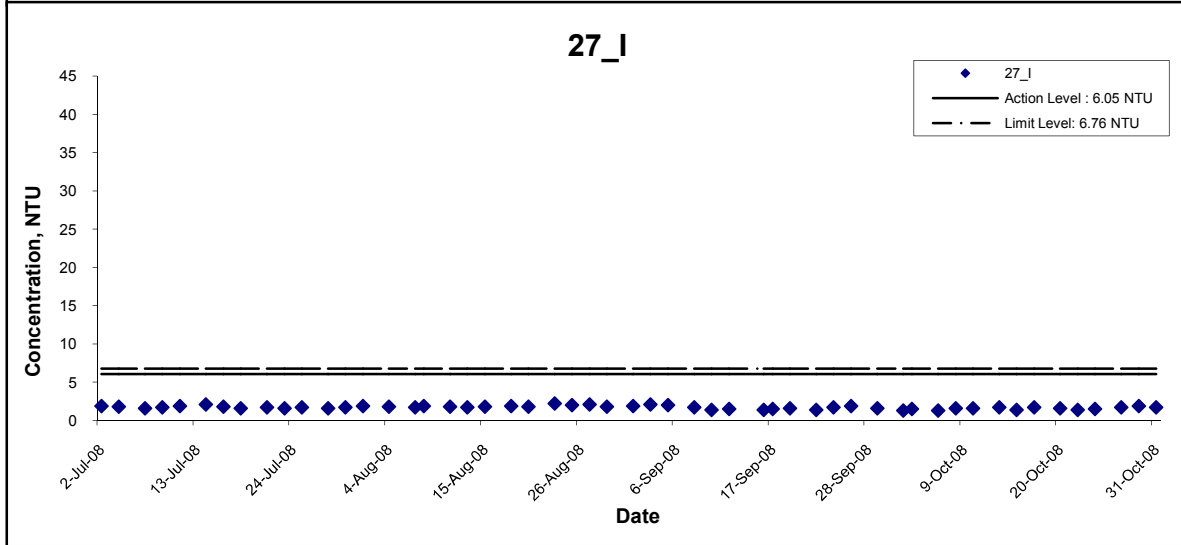
Title Contract No. HY/2003/19 Improvement to Tung Chung Road between Lung Tseng Tau and Cheung Sha Graphical Presentation of Water Quality Monitoring Results	Scale N.T.S	Project No. MA6030	
	Date Oct 08	Appendix F

## Turbidity

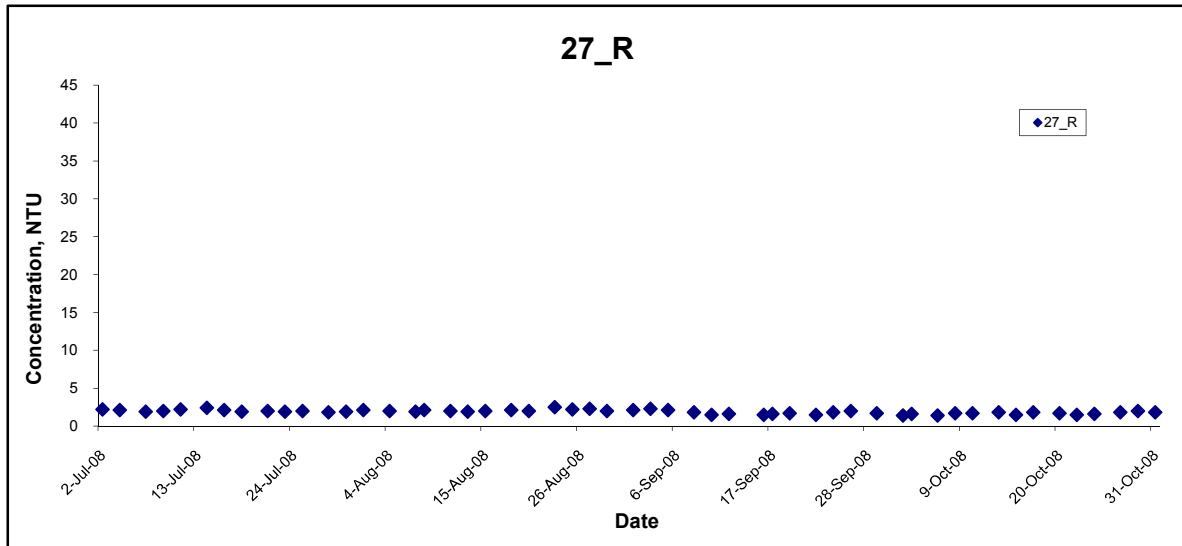
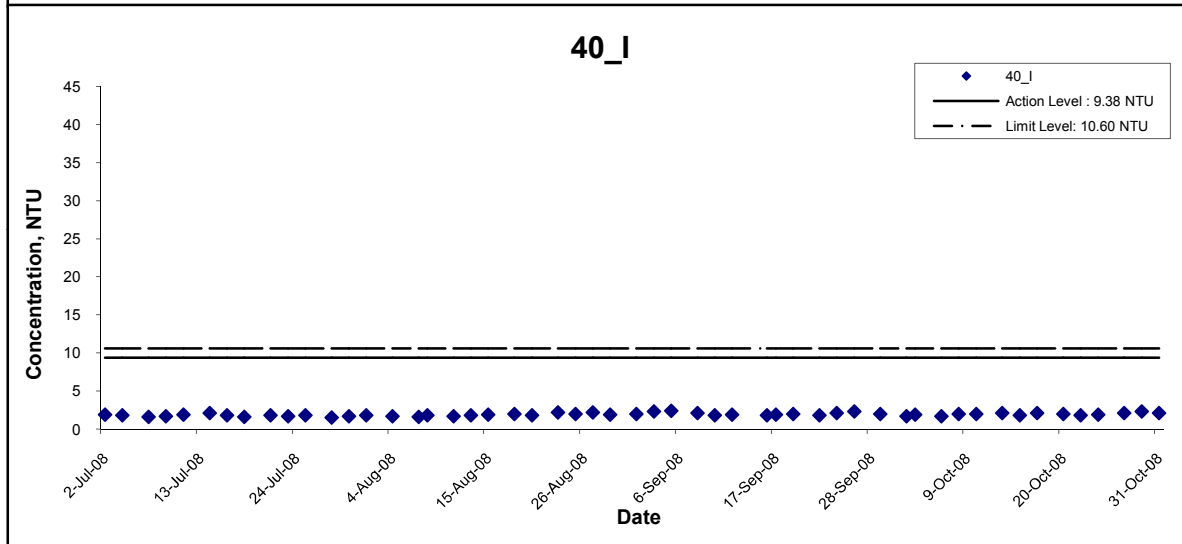
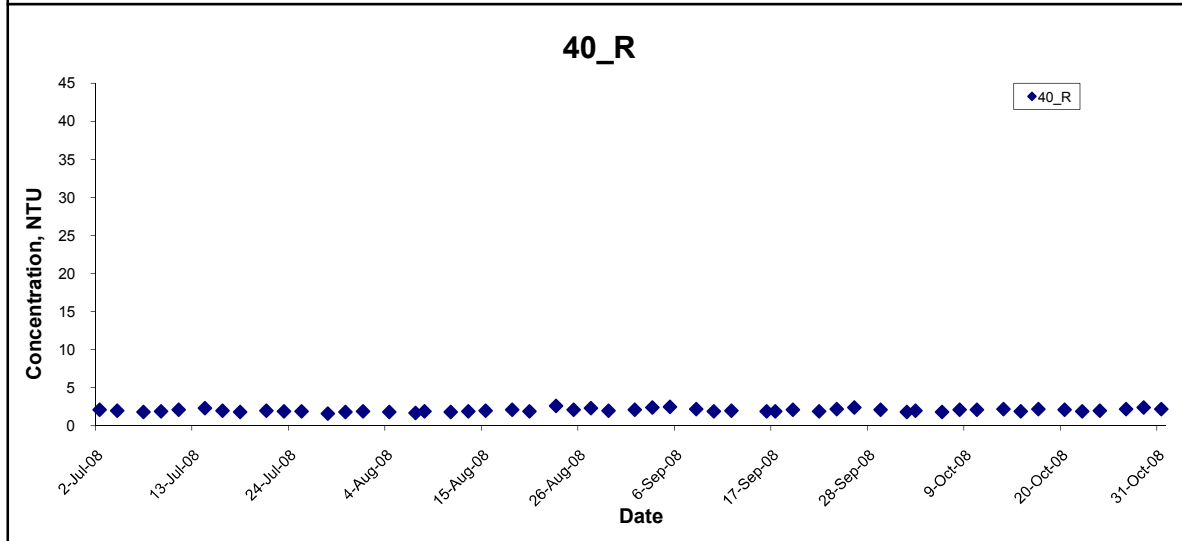
Title Contract No. HY/2003/19 Improvement to Tung Chung Road between Lung Tseng Tau and Cheung Sha Graphical Presentation of Water Quality Monitoring Results	Scale N.T.S	Project No. MA6030	CINOTECH
	Date Oct 08	Appendix F

## Turbidity

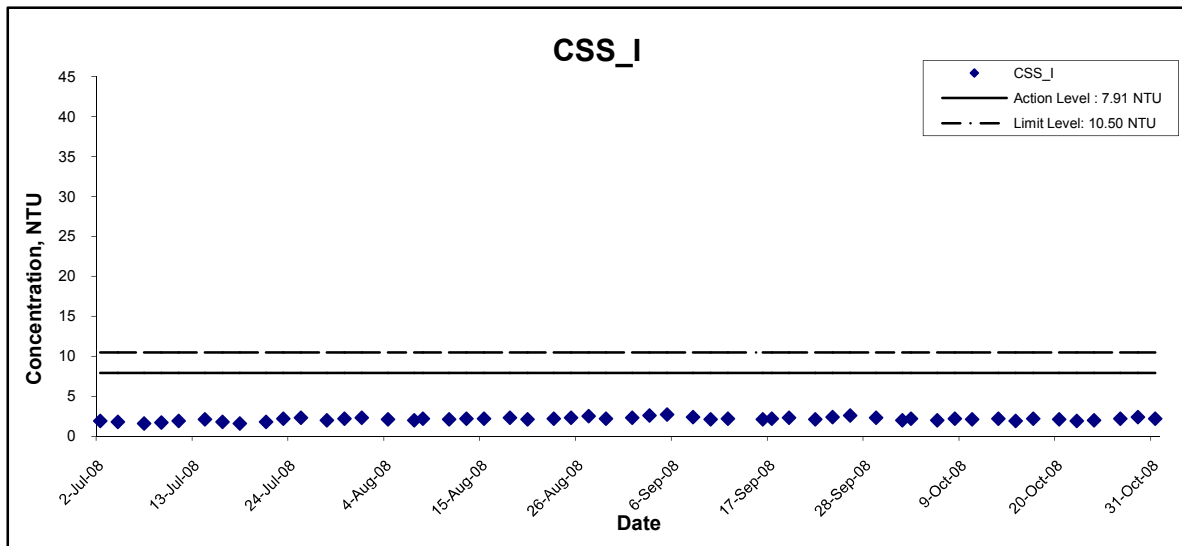
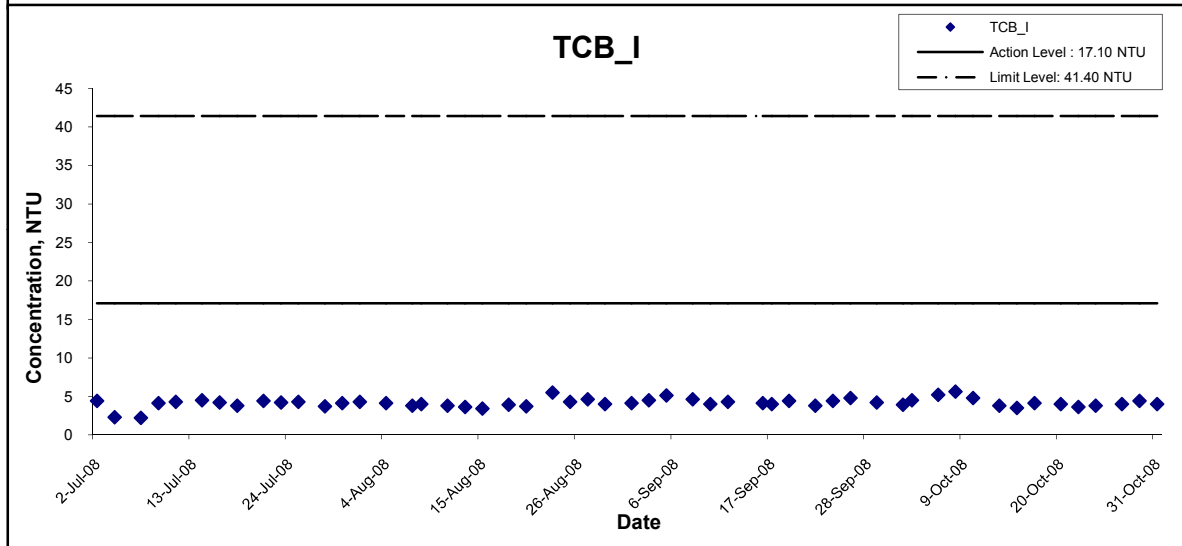
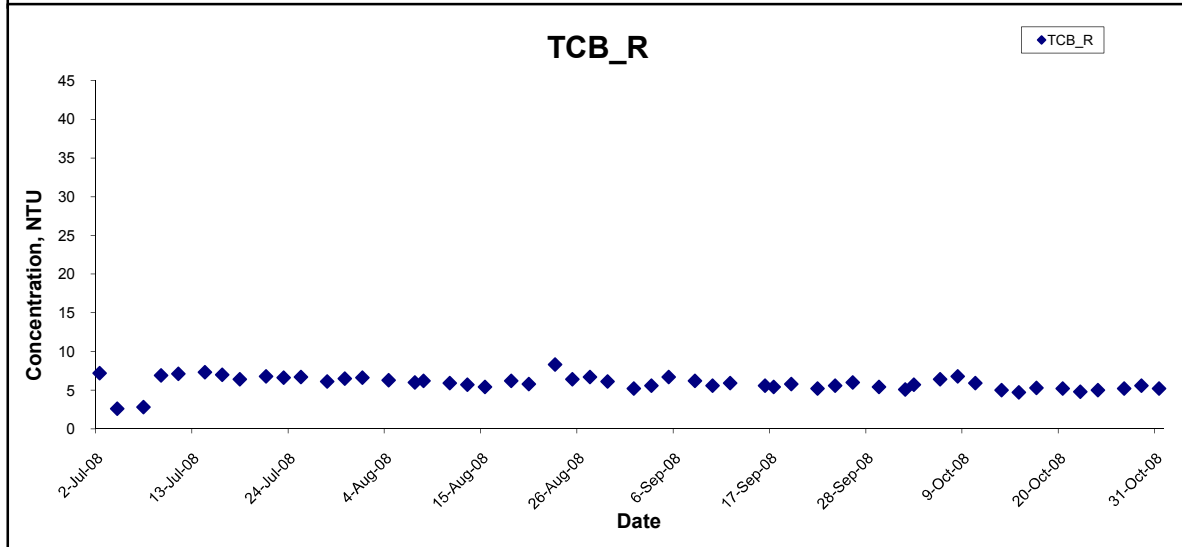
Title Contract No. HY/2003/19 Improvement to Tung Chung Road between Lung Tseng Tau and Cheung Sha  Graphical Presentation of Water Quality Monitoring Results	Scale N.T.S	Project No. MA6030	
	Date Oct 08	Appendix F

## Turbidity

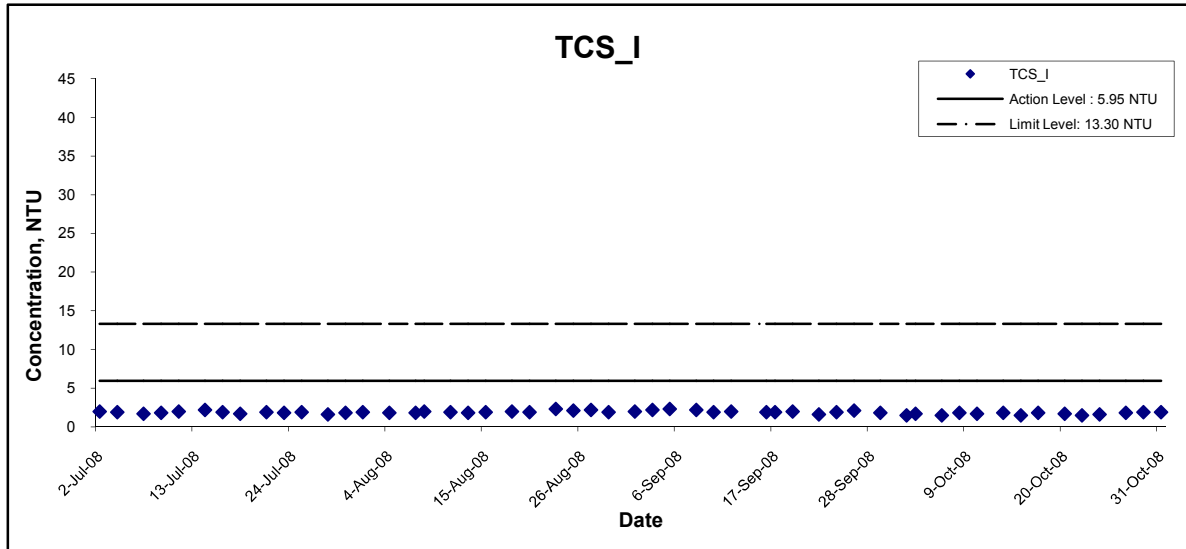
Title Contract No. HY/2003/19 Improvement to Tung Chung Road between Lung Tseng Tau and Cheung Sha  Graphical Presentation of Water Quality Monitoring Results	Scale N.T.S	Project No. MA6030	
	Date Oct 08	Appendix F

## Turbidity

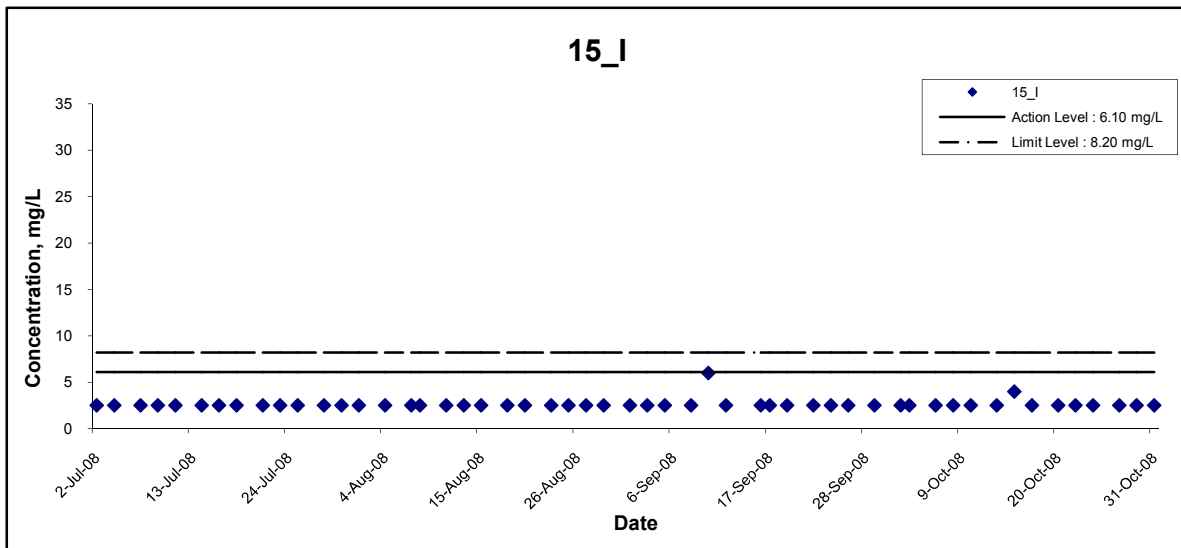
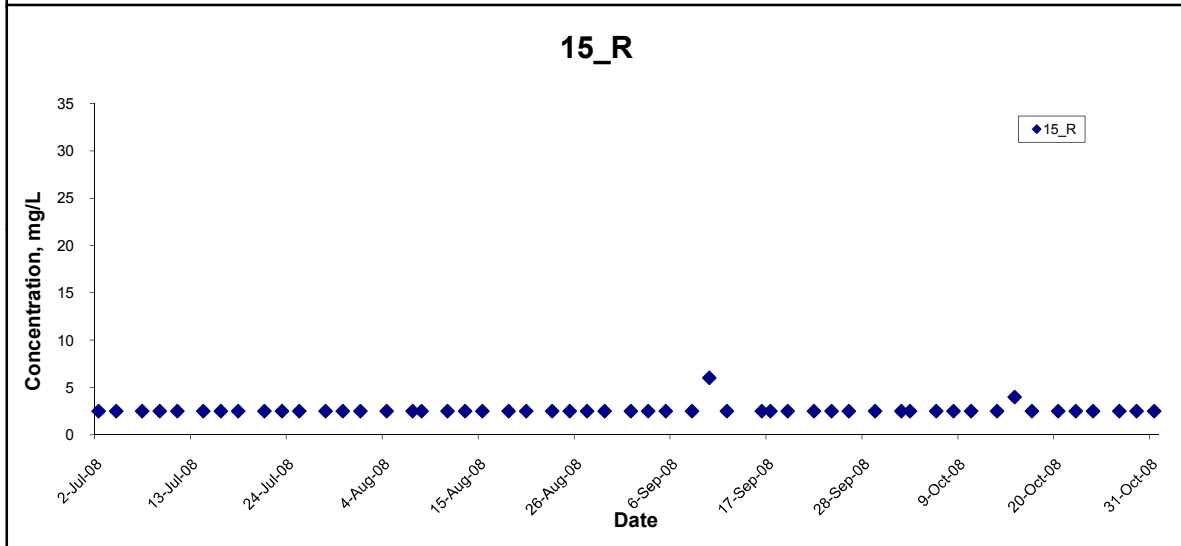
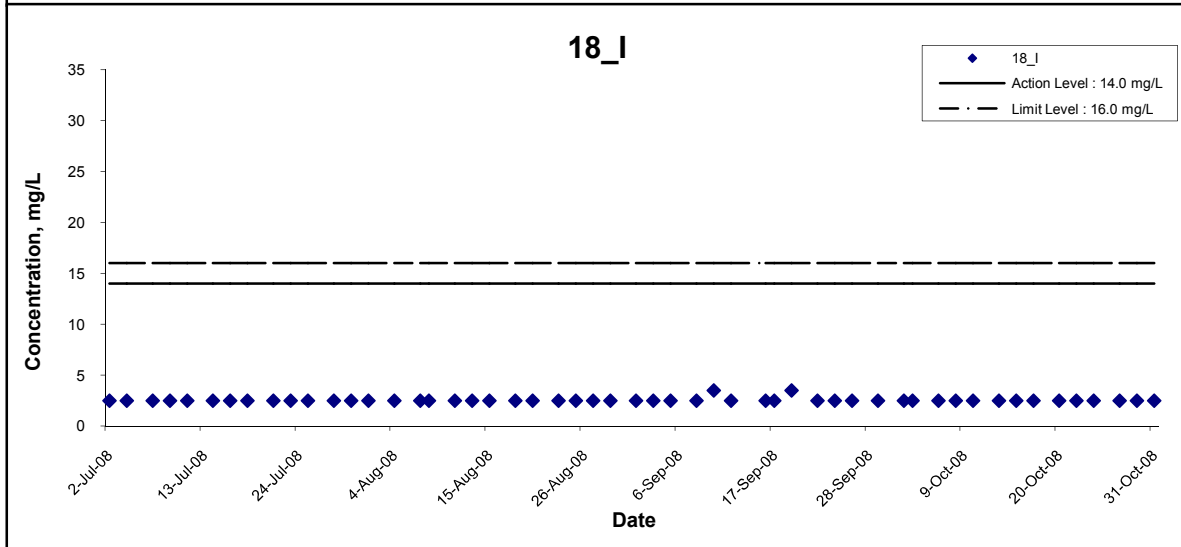
Title Contract No. HY/2003/19 Improvement to Tung Chung Road between Lung Tseng Tau and Cheung Sha  Graphical Presentation of Water Quality Monitoring Results	Scale N.T.S	Project No. MA6030	
	Date Oct 08	Appendix F

## Suspended Solids

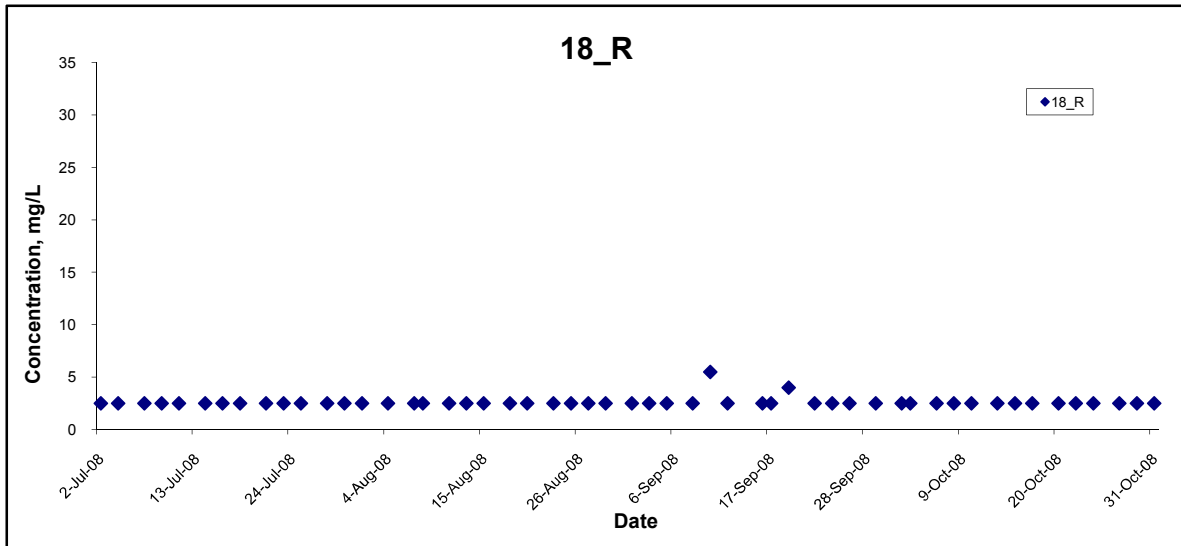
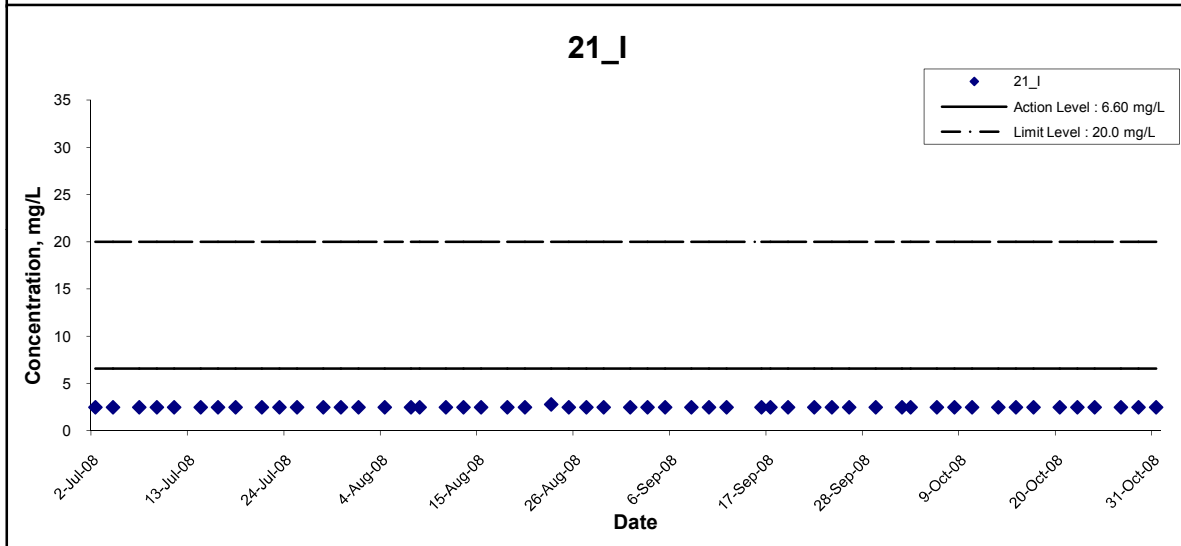
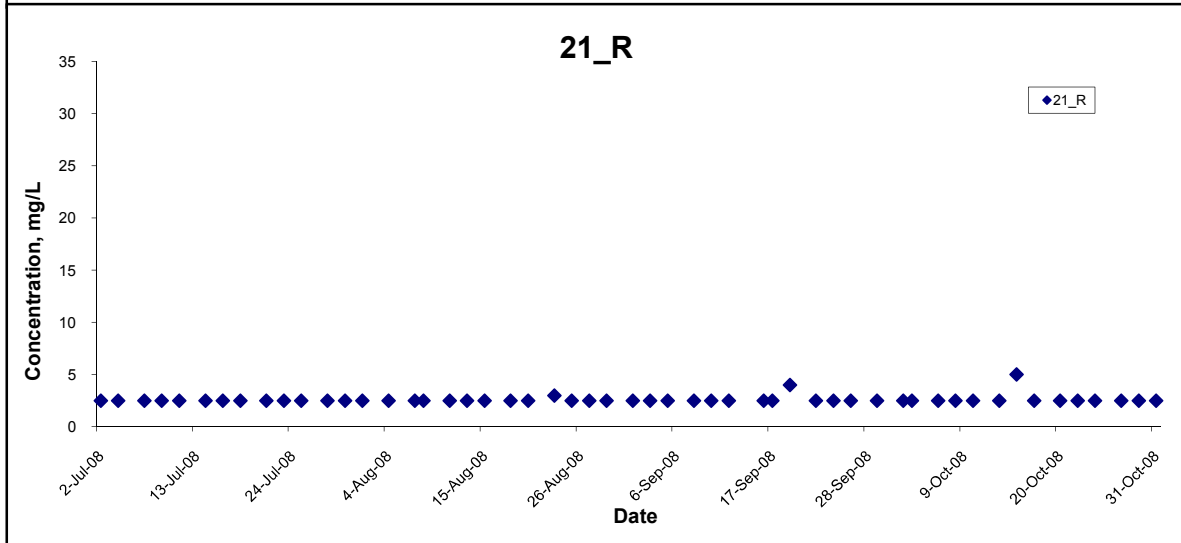
Title Contract No. HY/2003/19 Improvement to Tung Chung Road between Lung Tseng Tau and Cheung Sha  Graphical Presentation of Water Quality Monitoring Results	Scale N.T.S	Project No. MA6030	
	Date Oct 08	Appendix F

## Suspended Solids

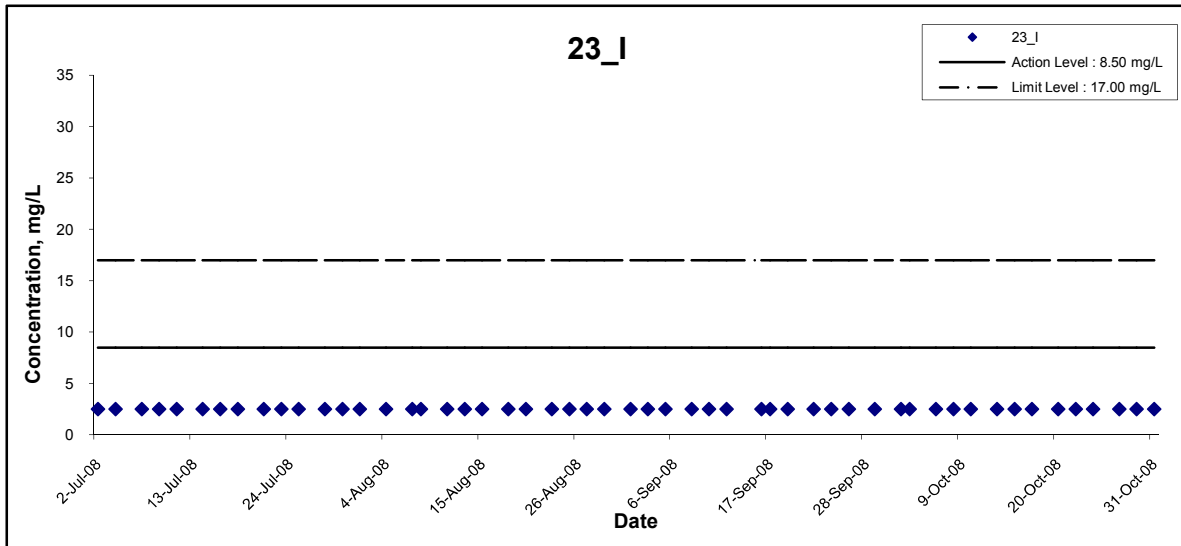
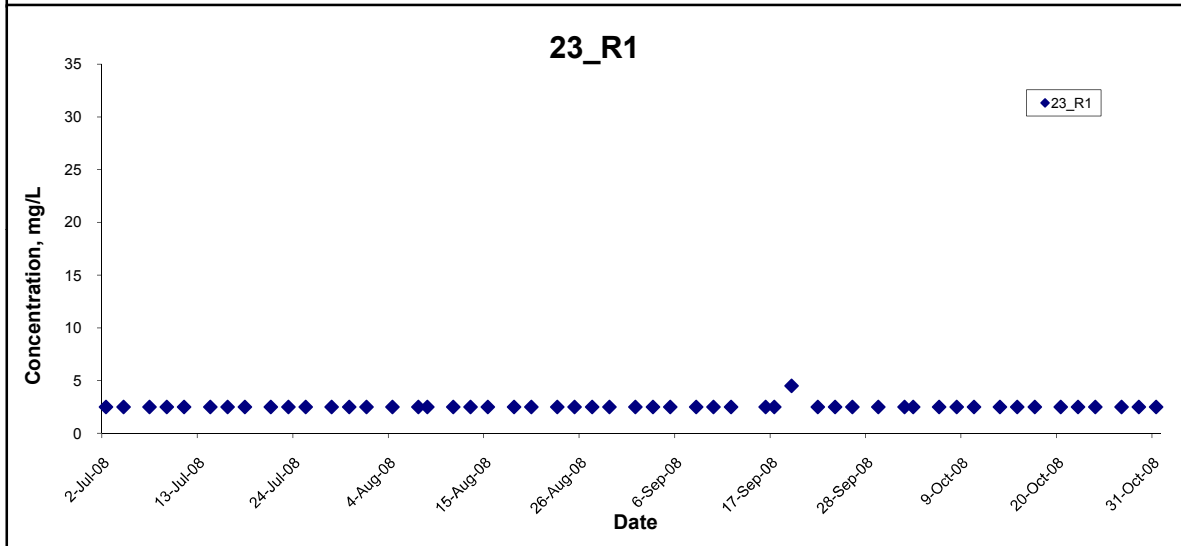
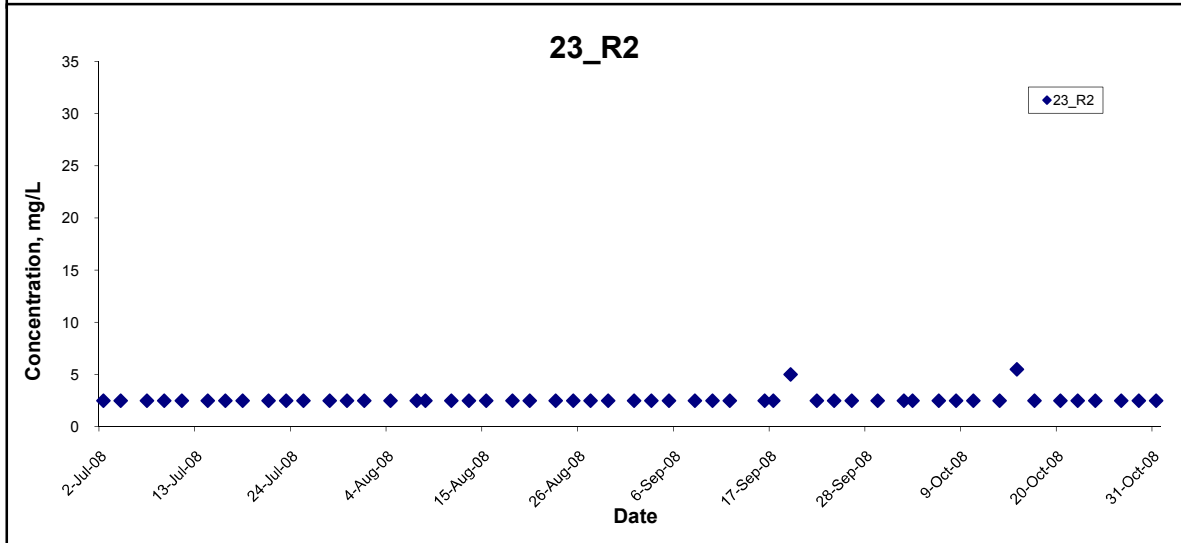
Title Contract No. HY/2003/19 Improvement to Tung Chung Road between Lung Tseng Tau and Cheung Sha Graphical Presentation of Water Quality Monitoring Results	Scale N.T.S	Project No. MA6030	CINOTECH
	Date Oct 08	Appendix F

## Suspended Solids

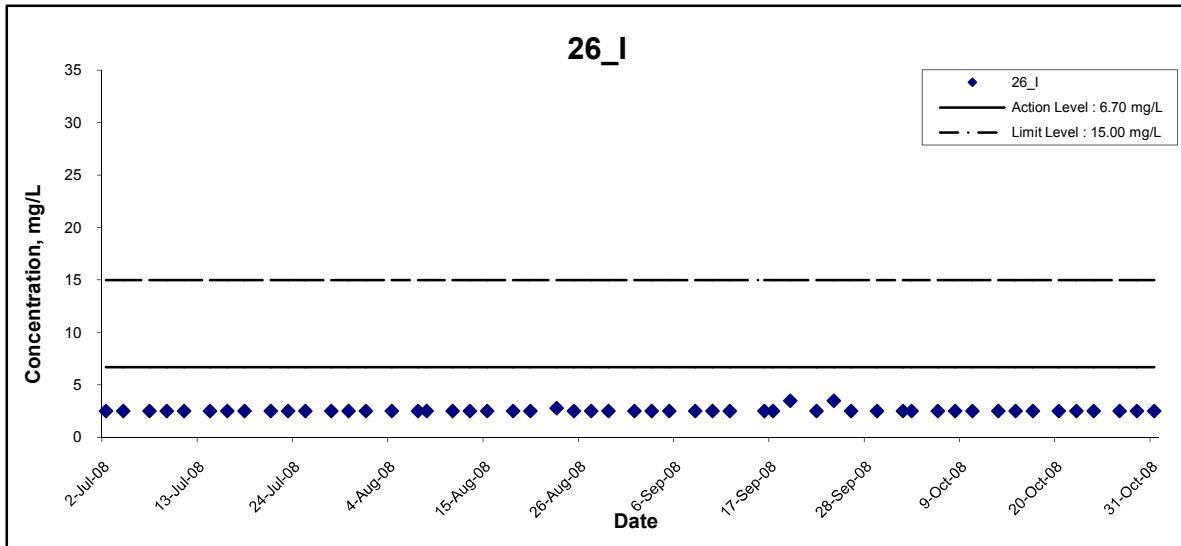
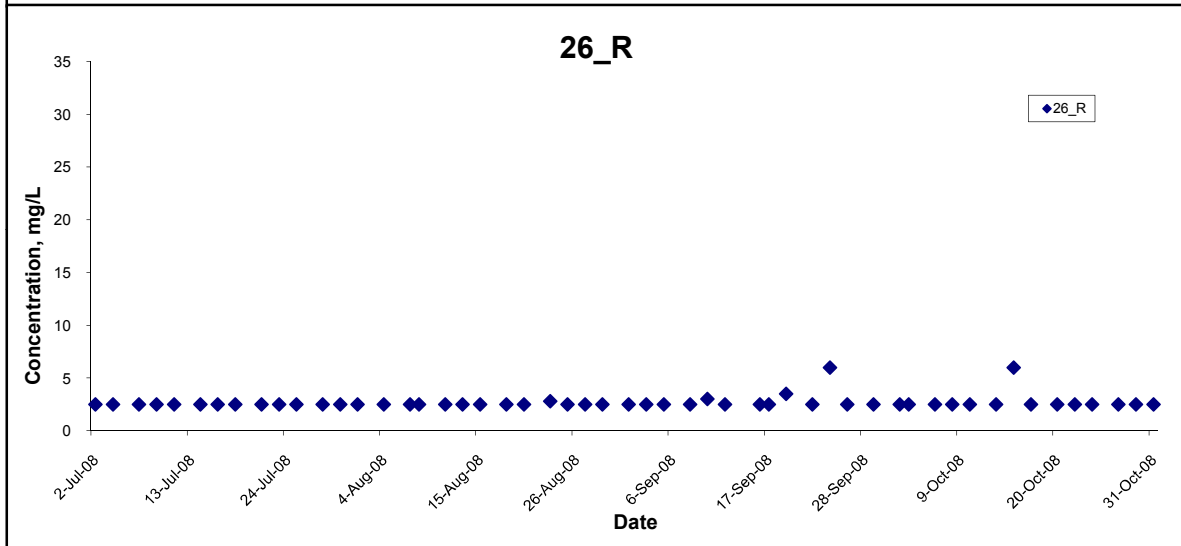
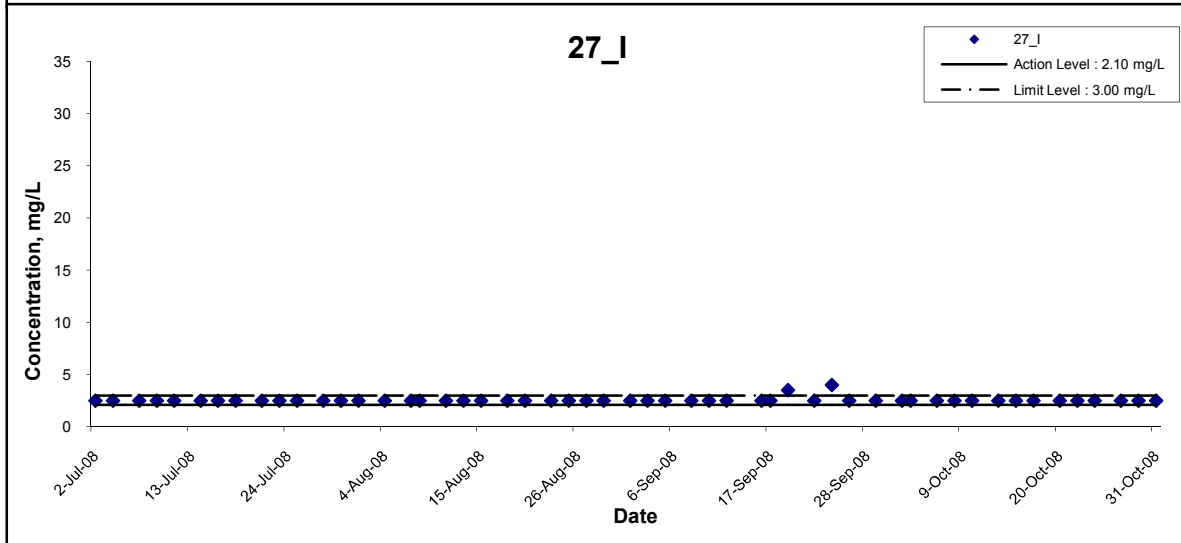
Title Contract No. HY/2003/19 Improvement to Tung Chung Road between Lung Tseng Tau and Cheung Sha Graphical Presentation of Water Quality Monitoring Results	Scale N.T.S	Project No. MA6030	
	Date Oct 08	Appendix F

## Suspended Solids

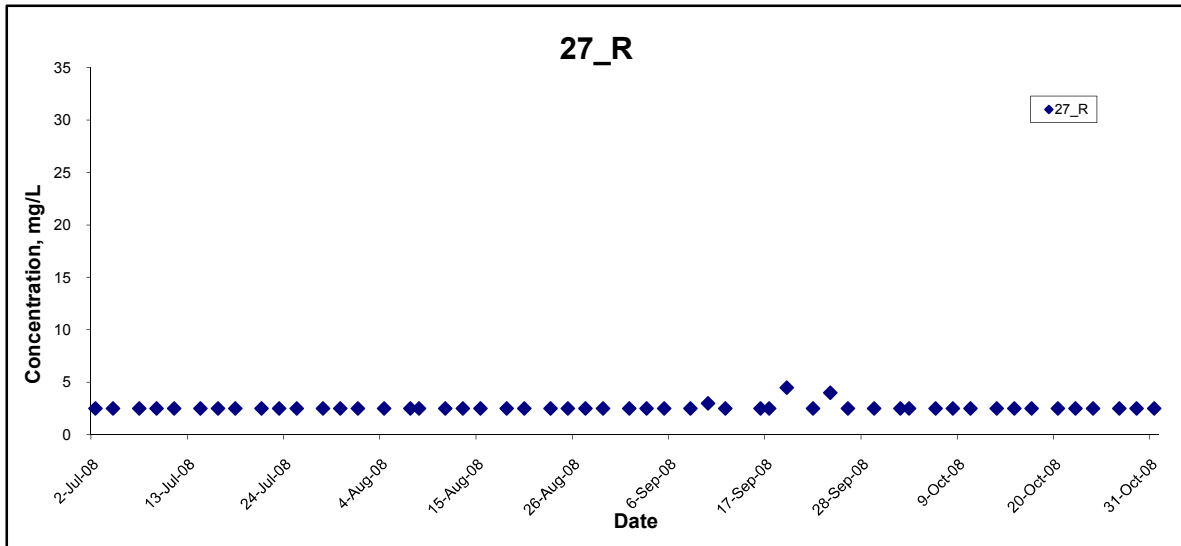
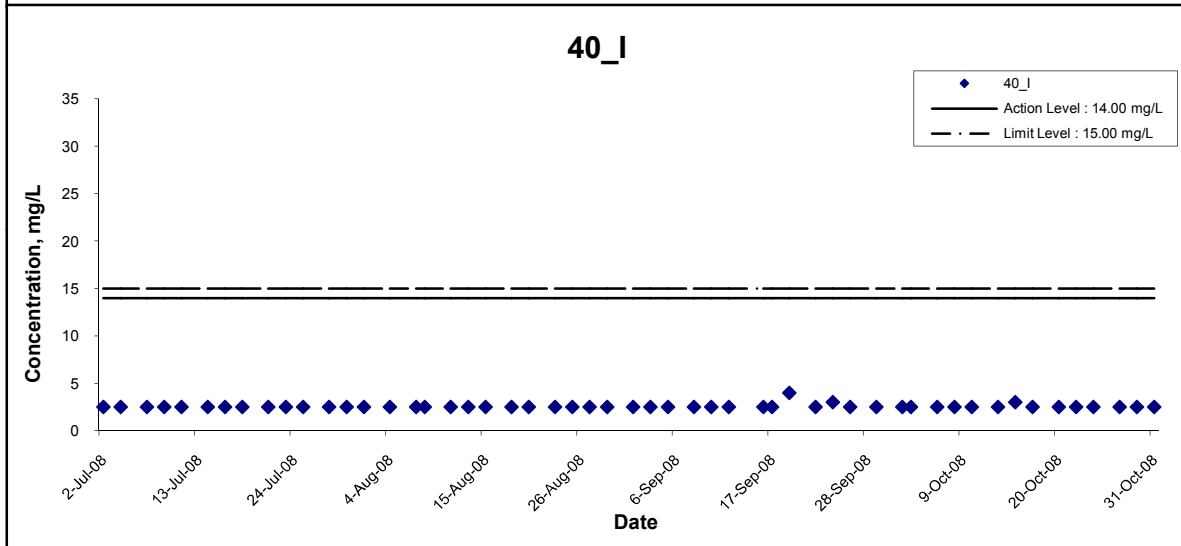
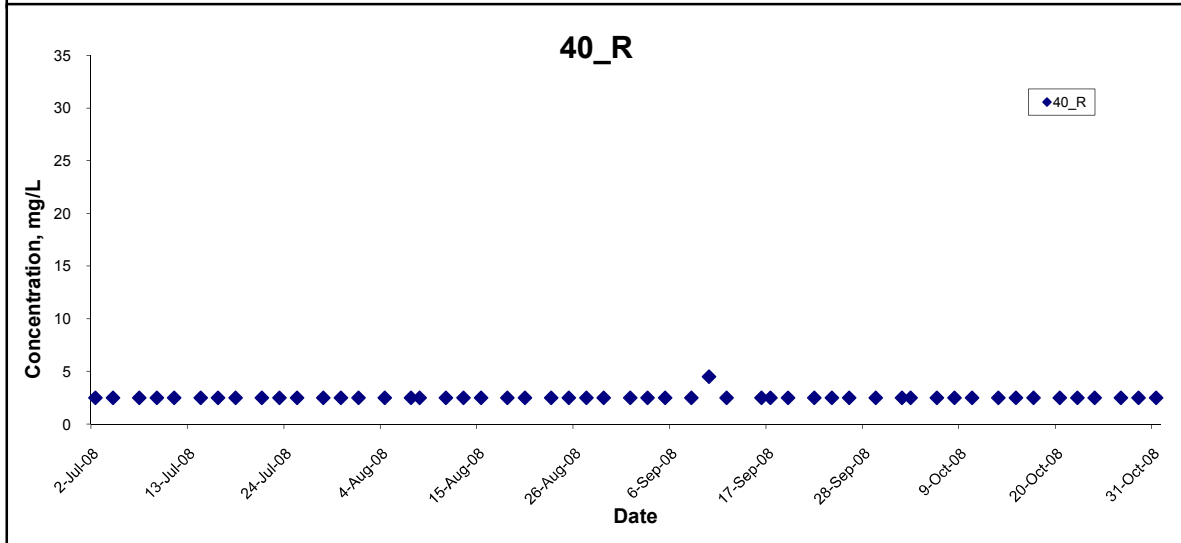
Title Contract No. HY/2003/19 Improvement to Tung Chung Road between Lung Tseng Tau and Cheung Sha Graphical Presentation of Water Quality Monitoring Results	Scale	N.T.S	Project No.	MA6030
	Date	Oct 08	Appendix	F

## Suspended Solids

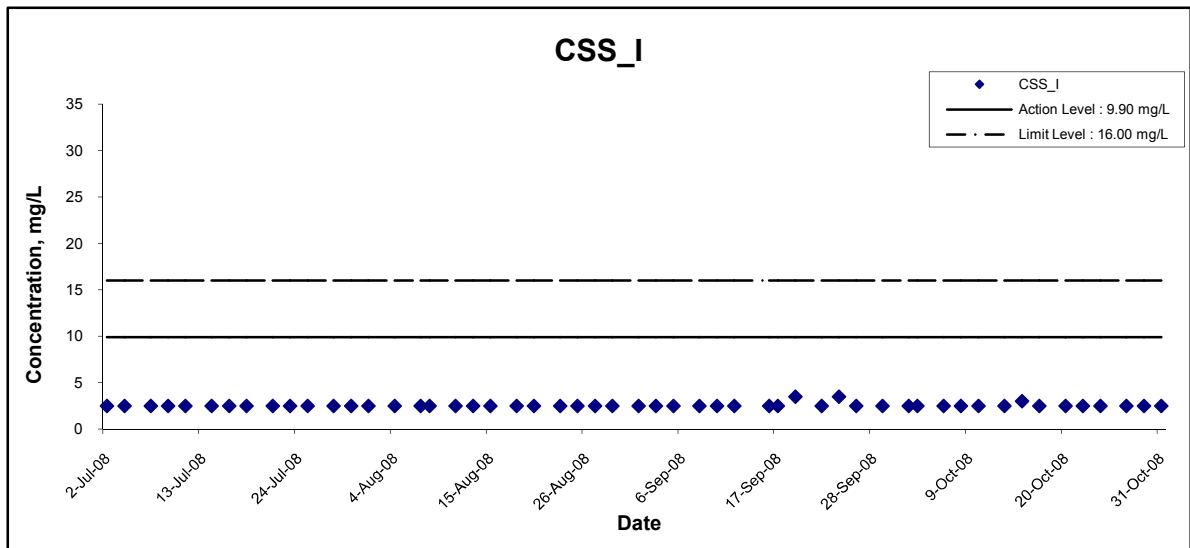
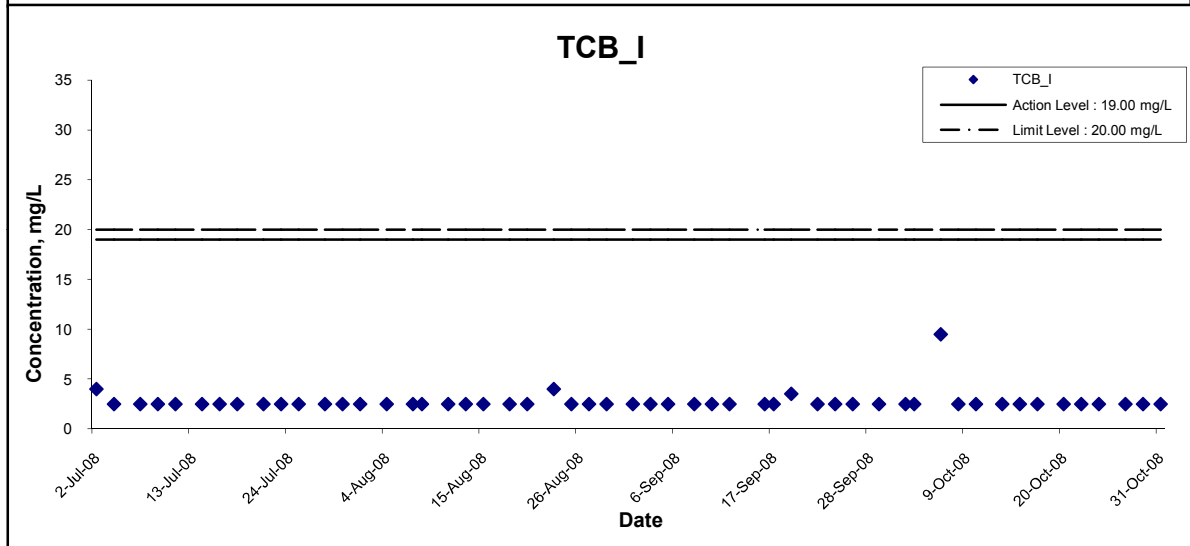
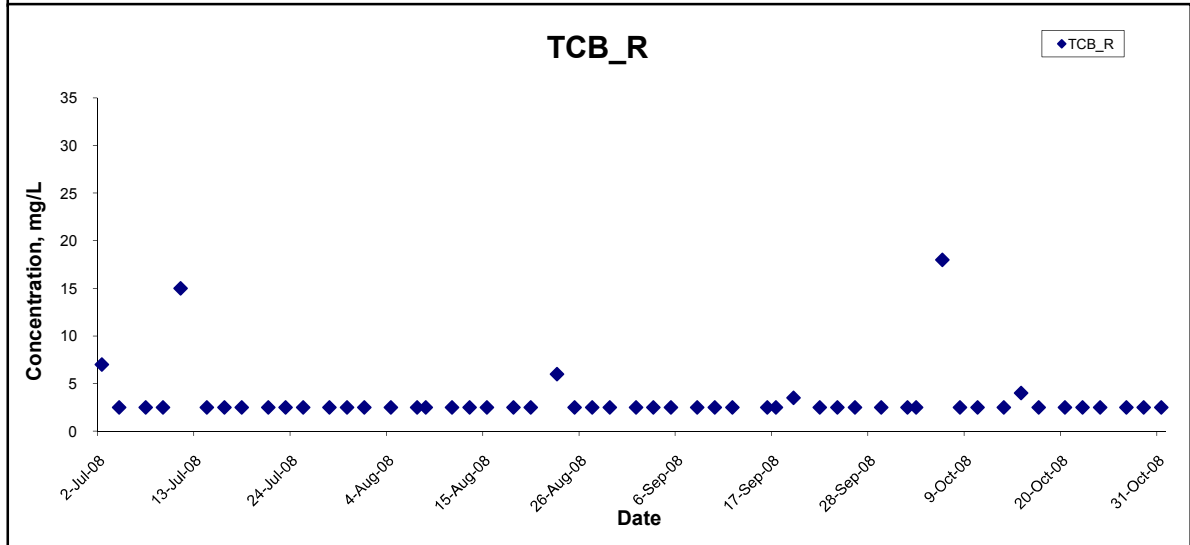
Title Contract No. HY/2003/19 Improvement to Tung Chung Road between Lung Tseng Tau and Cheung Sha Graphical Presentation of Water Quality Monitoring Results	Scale N.T.S	Project No. MA6030	
	Date Oct 08	Appendix F

## Suspended Solids
