**Contract No. HY/2003/19**

**Improvement to Tung Chung Road  
between Lung Tseng Tau and Cheung Sha**

**Quarterly EM&A Report  
(Version 2.0)**

August 2008 to October 2008

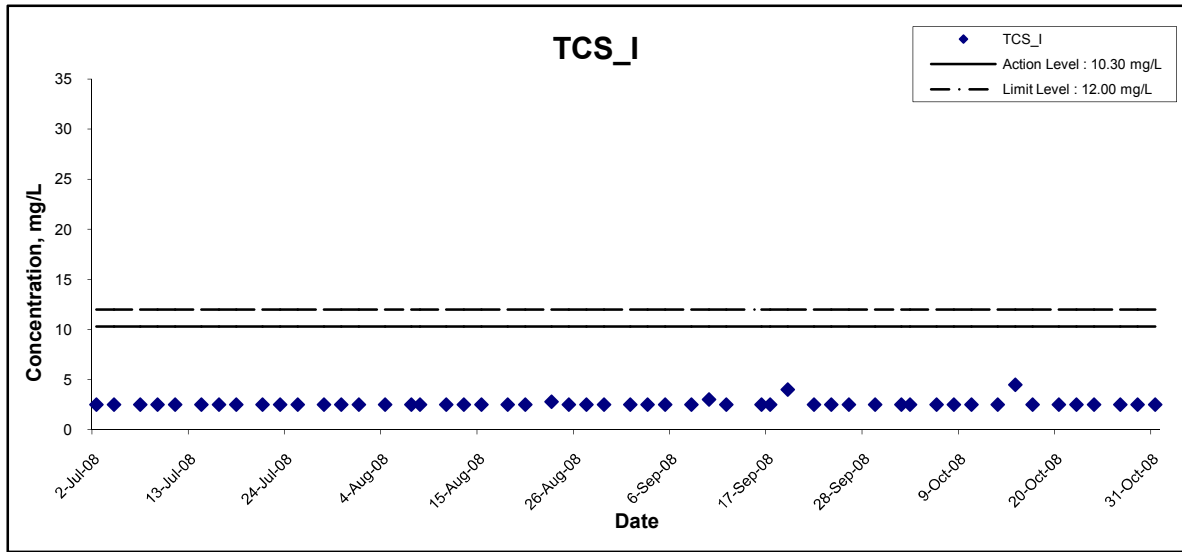
Title Contract No. HY/2003/19 Improvement to Tung Chung Road between Lung Tseng Tau and Cheung Sha Graphical Presentation of Water Quality Monitoring Results	Scale N.T.S	Project No. MA6030	
	Date Oct 08	Appendix F

## Suspended Solids
