**Contract No. HY/2003/19**

**Improvement to Tung Chung Road  
between Lung Tseng Tau and Cheung Sha**

**Quarterly EM&A Report  
(Version 2.0)**

May 2009 to July 2009

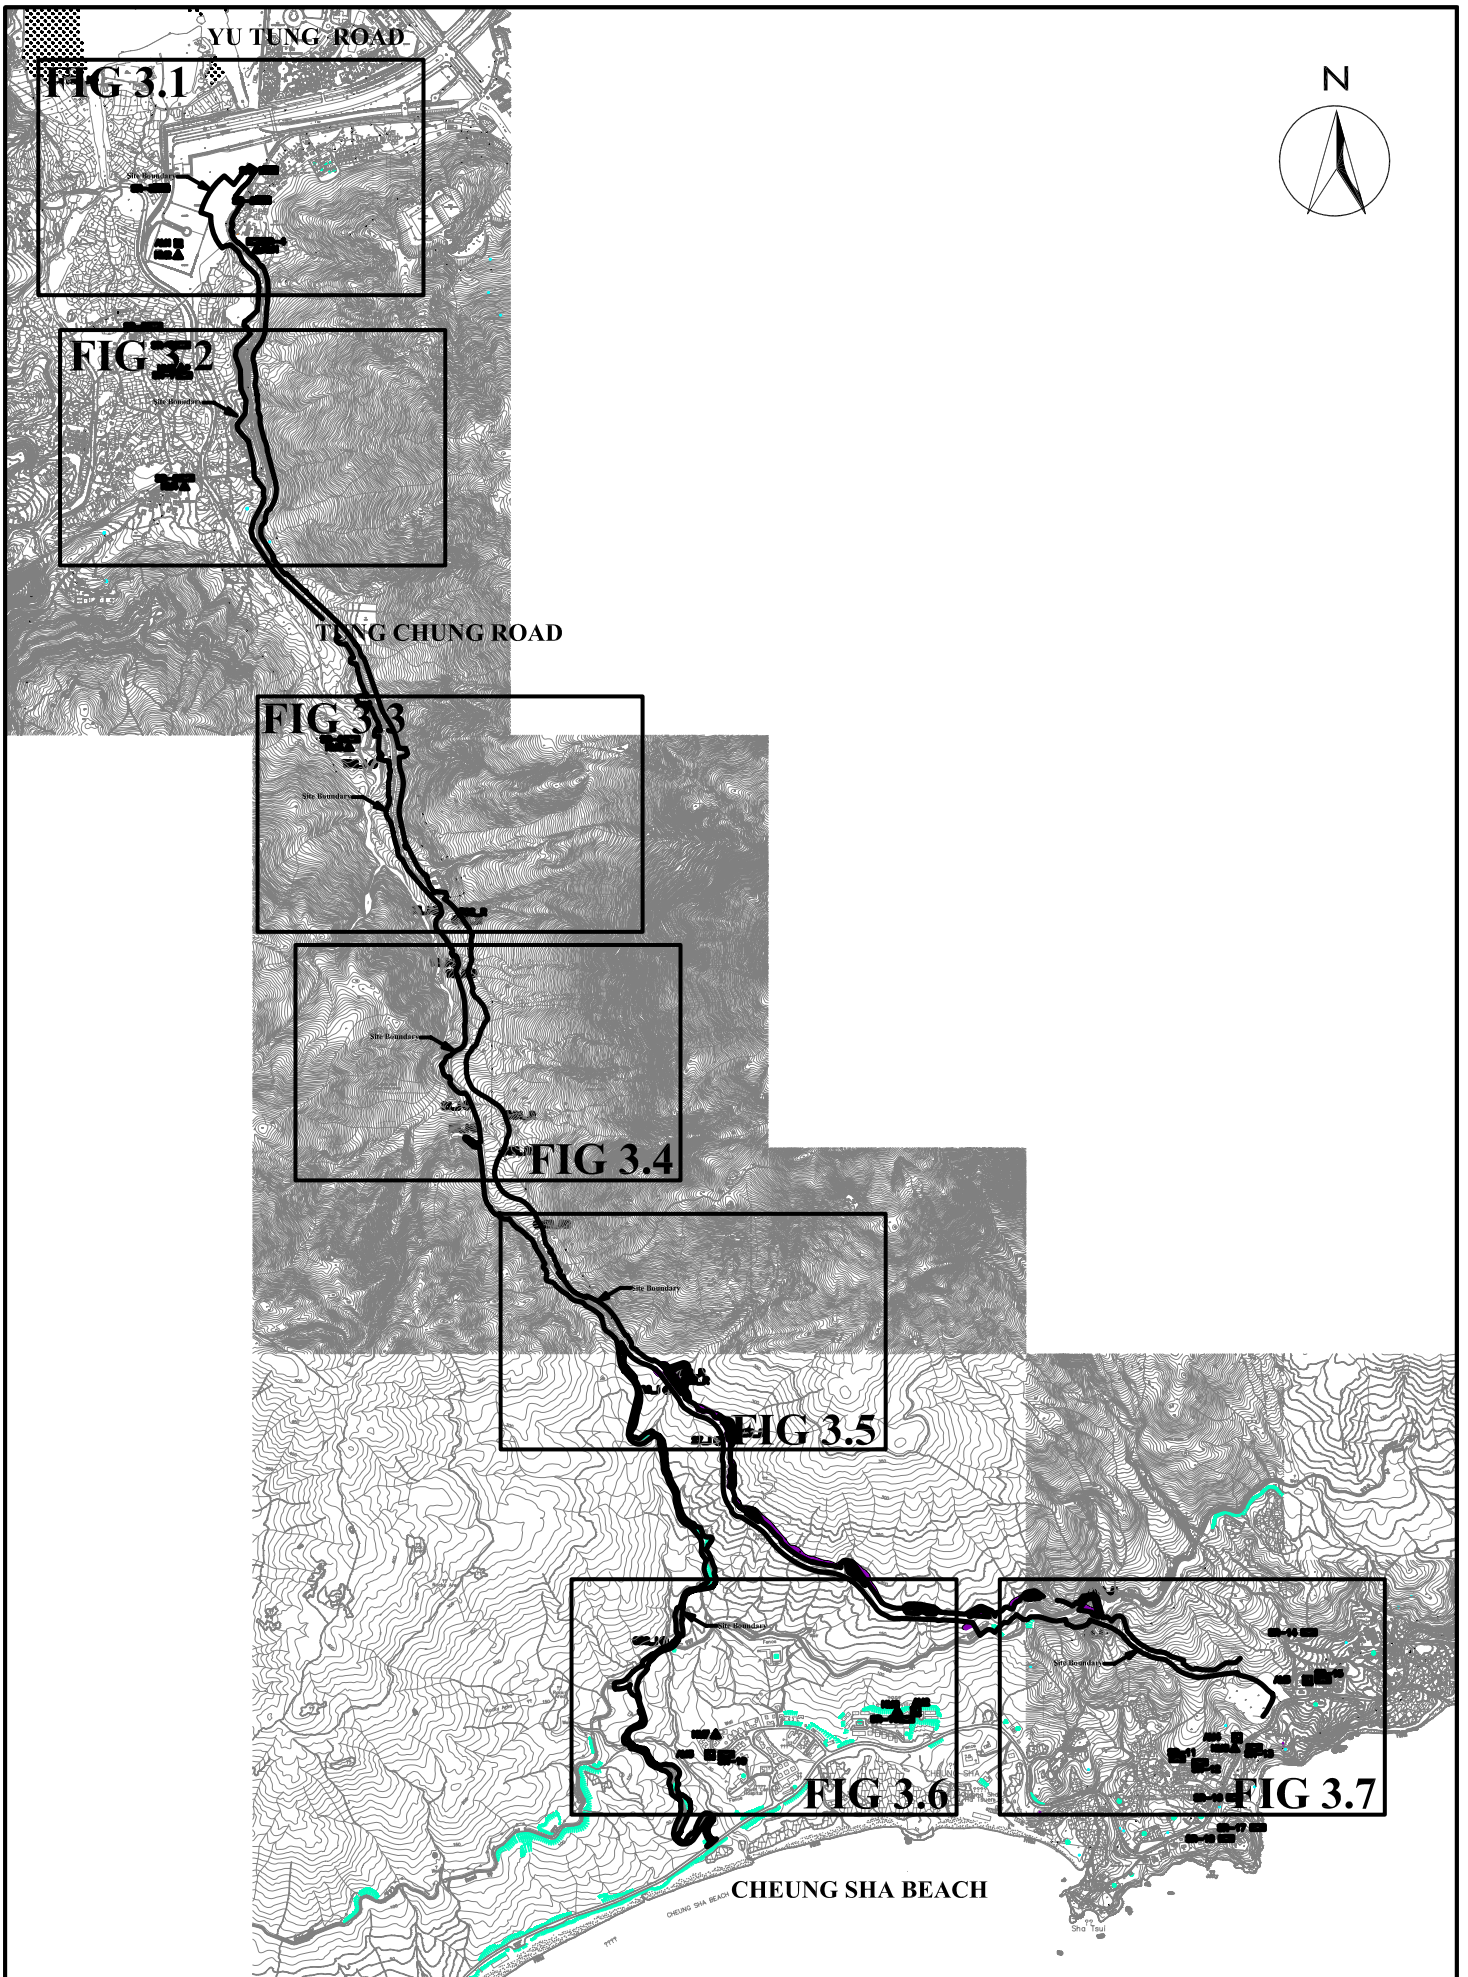
<p><b>CINOTECH</b> Cinotech Consultants Limited</p>	<p><b>IMPROVEMENT TO TUNG CHUNG ROAD BETWEEN LUNG TSENG TAU AND CHEUNG SHA</b></p> <p><b>SITE LOCATION PLAN</b></p>	SCALE	N.T.S.	DATE	OCT 2006
		CHECK	JY	DRAWN	VL
		JOB No.	MA6030	DRAWING No.	FIG 1

- 1.1 The Project “Improvement to Tung Chung Road between Lung Tseng Tau and Cheung Sha” involves the widening and realignment of Tung Chung Road between Lung Tseng Tau in North Lantau and Cheung Sha in South Lantau. The layout plan of the Project is shown in Figure 1.

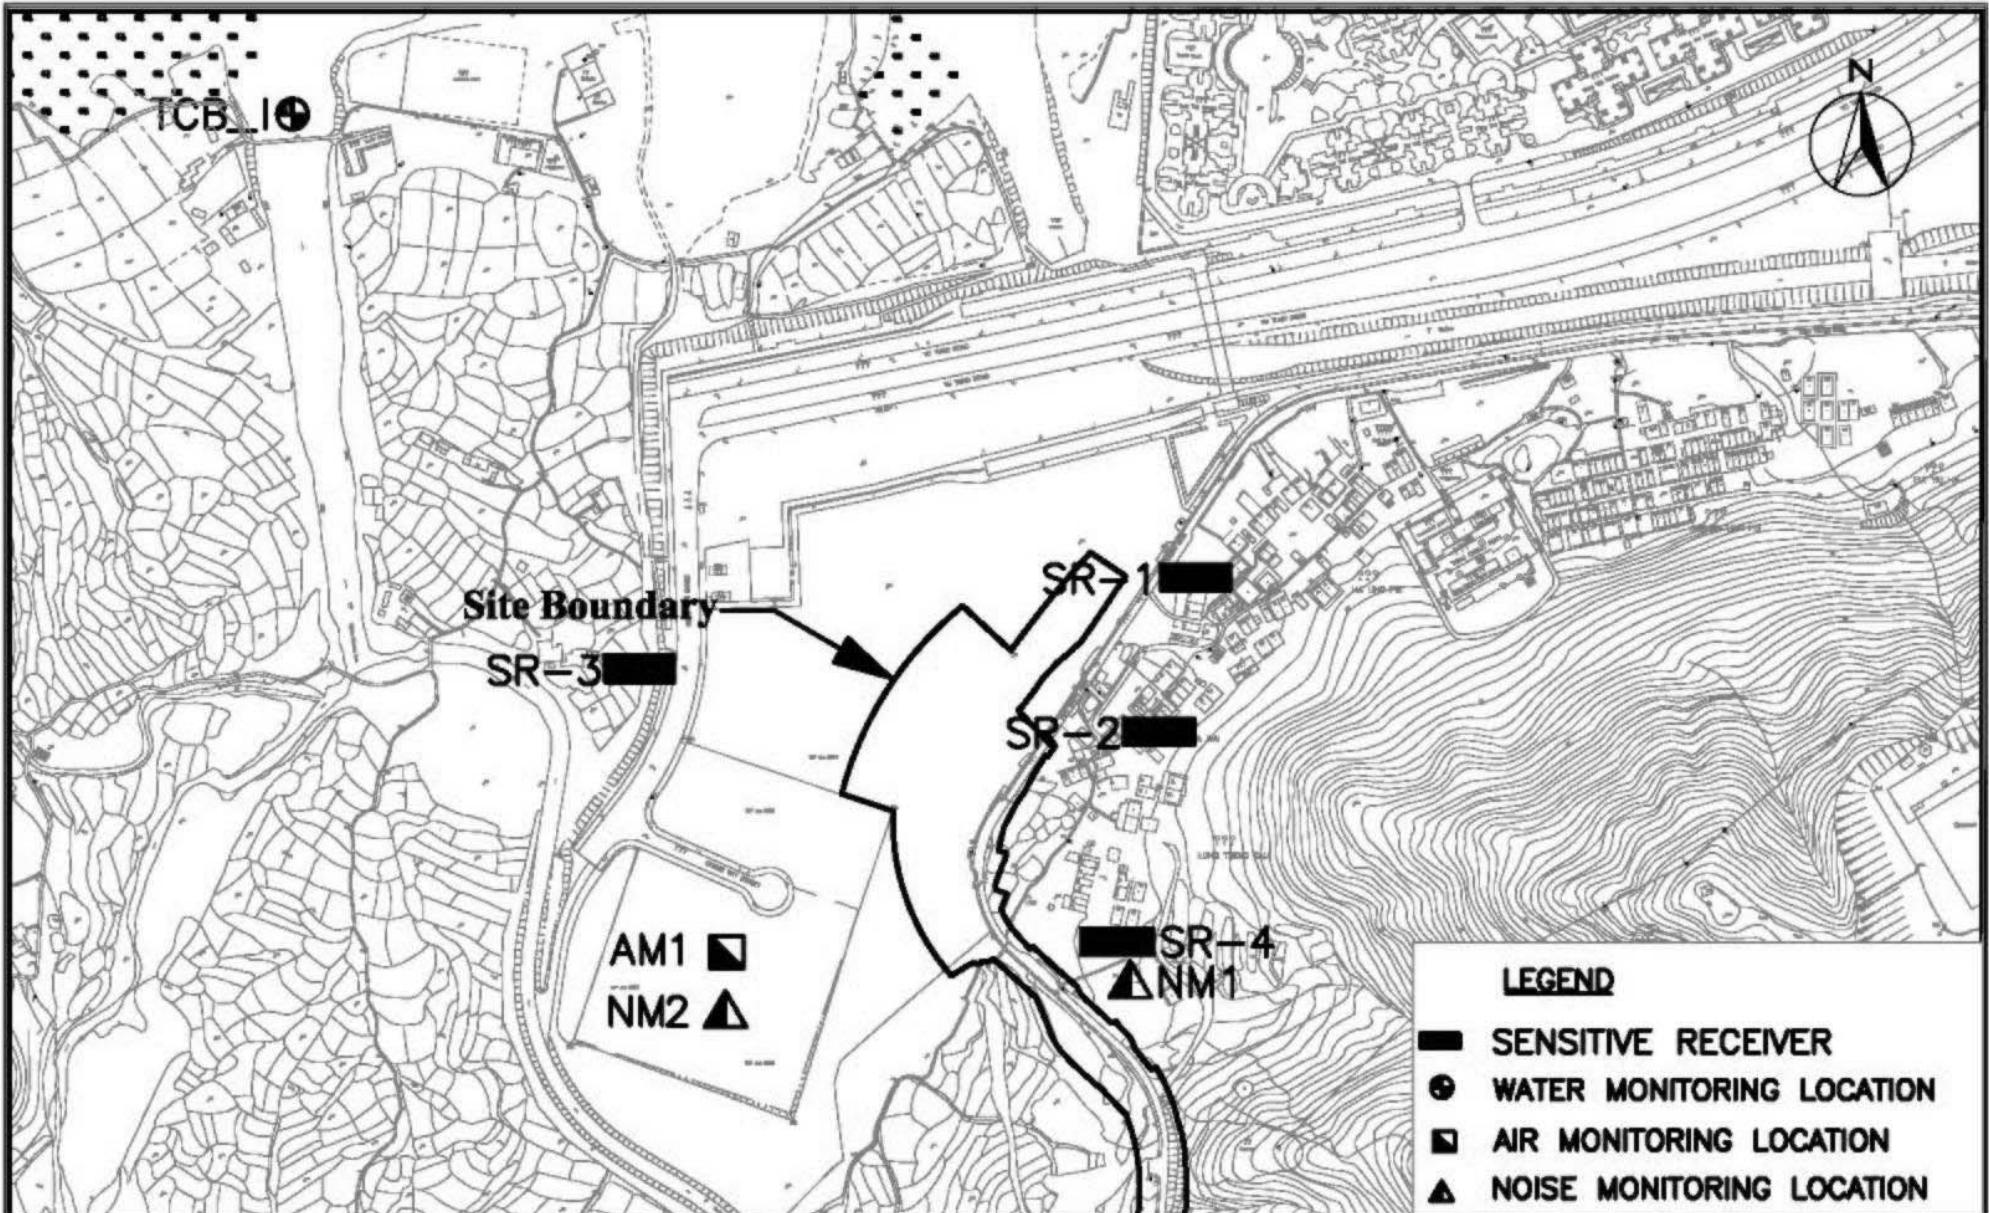
**MONITORING LOCATIONS**  
(SHEET 1 OF 7)

LEGEND	
	SENSITIVE RECEIVER
	WATER MONITORING LOCATION
	AIR MONITORING LOCATION
	NOISE MONITORING LOCATION

Figure 1	Layout Plan of the Project
Figure 2	Organization Chart
Figure 3	Monitoring Locations (7 sheets total)

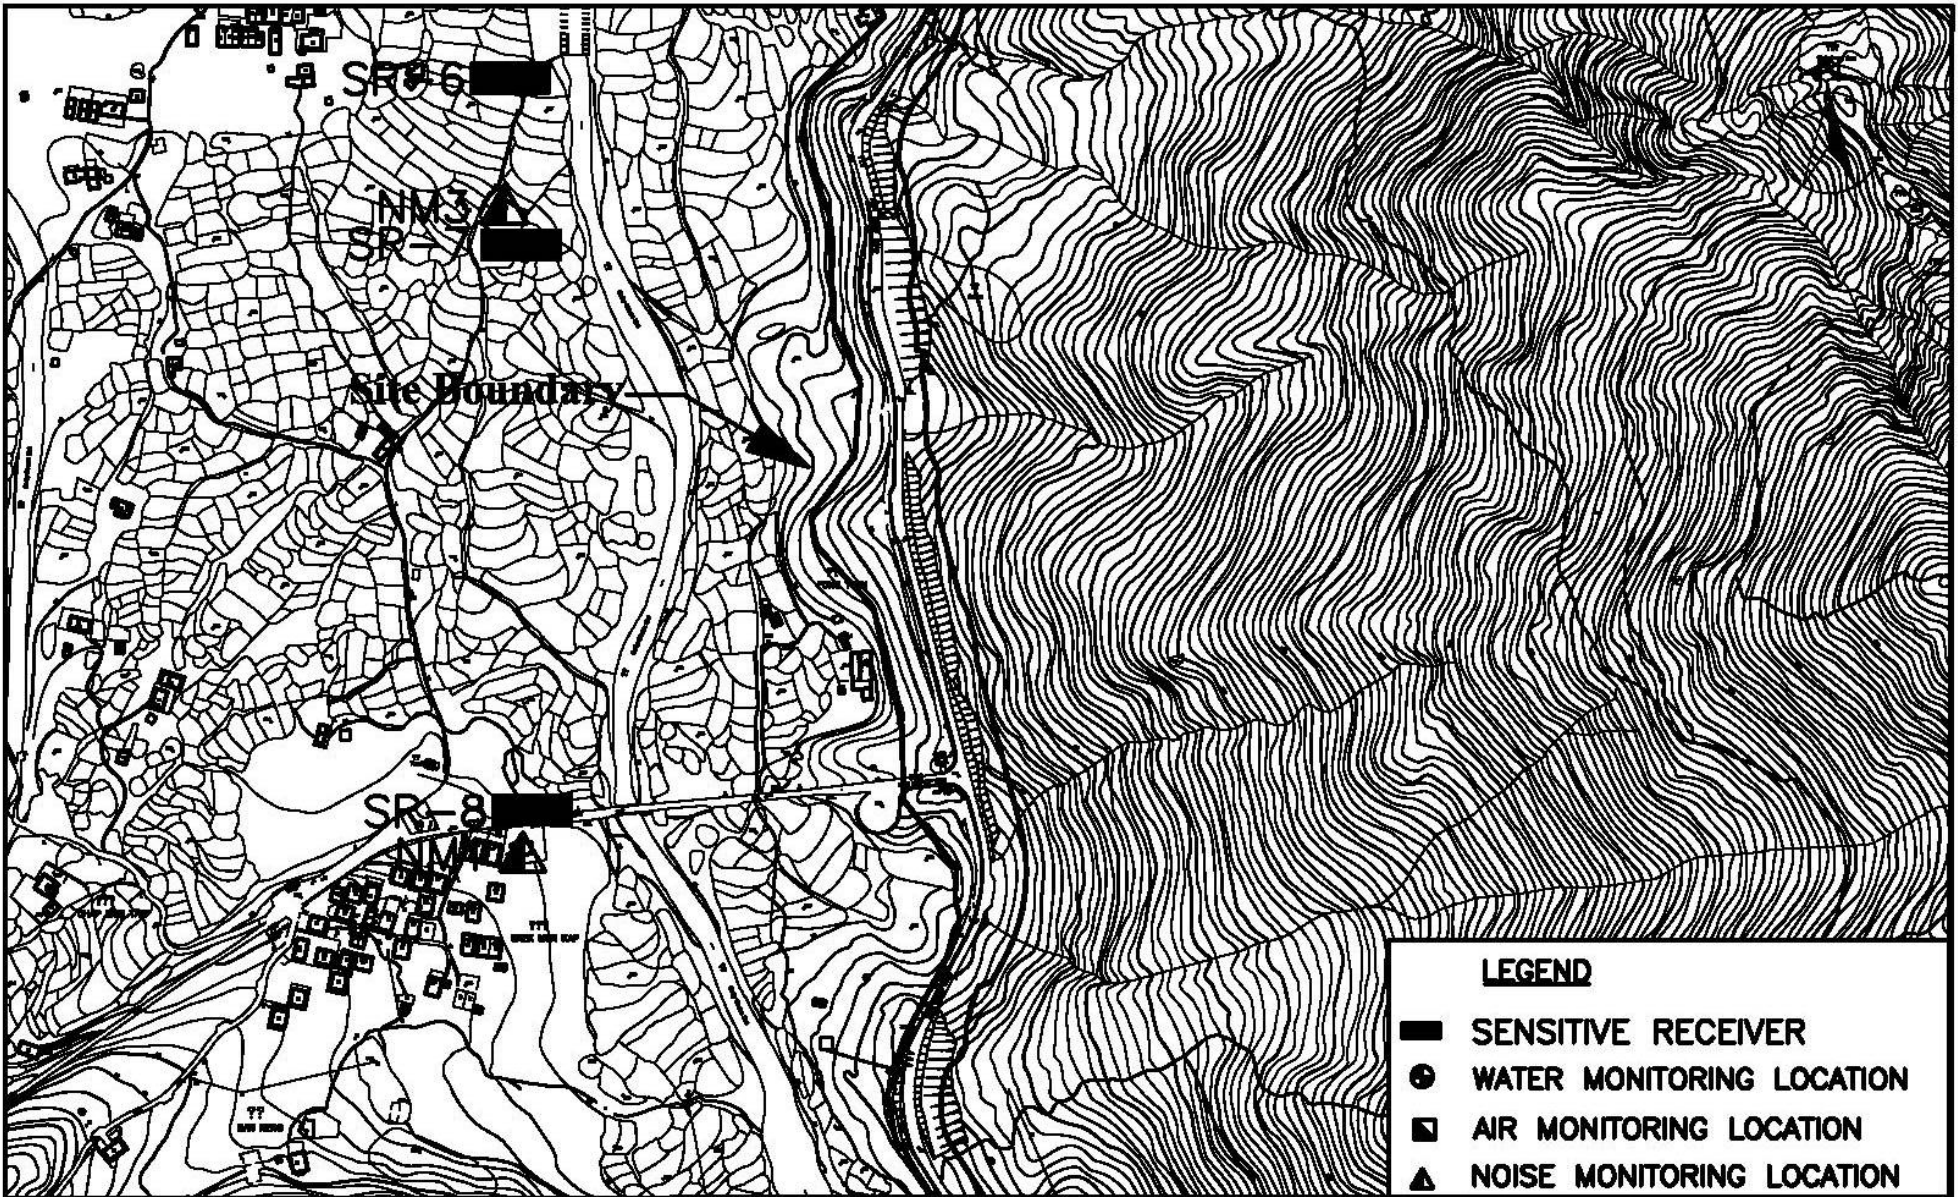
**MONITORING LOCATIONS  
(SHEET 2 OF 7)**

SCALE	A4 1:4000	DATE	OCT 2006
CHECK	JY	DRAWN	VL
JOB No.	MA6030	DRAWING No.	FIG 3.2
		REV	1

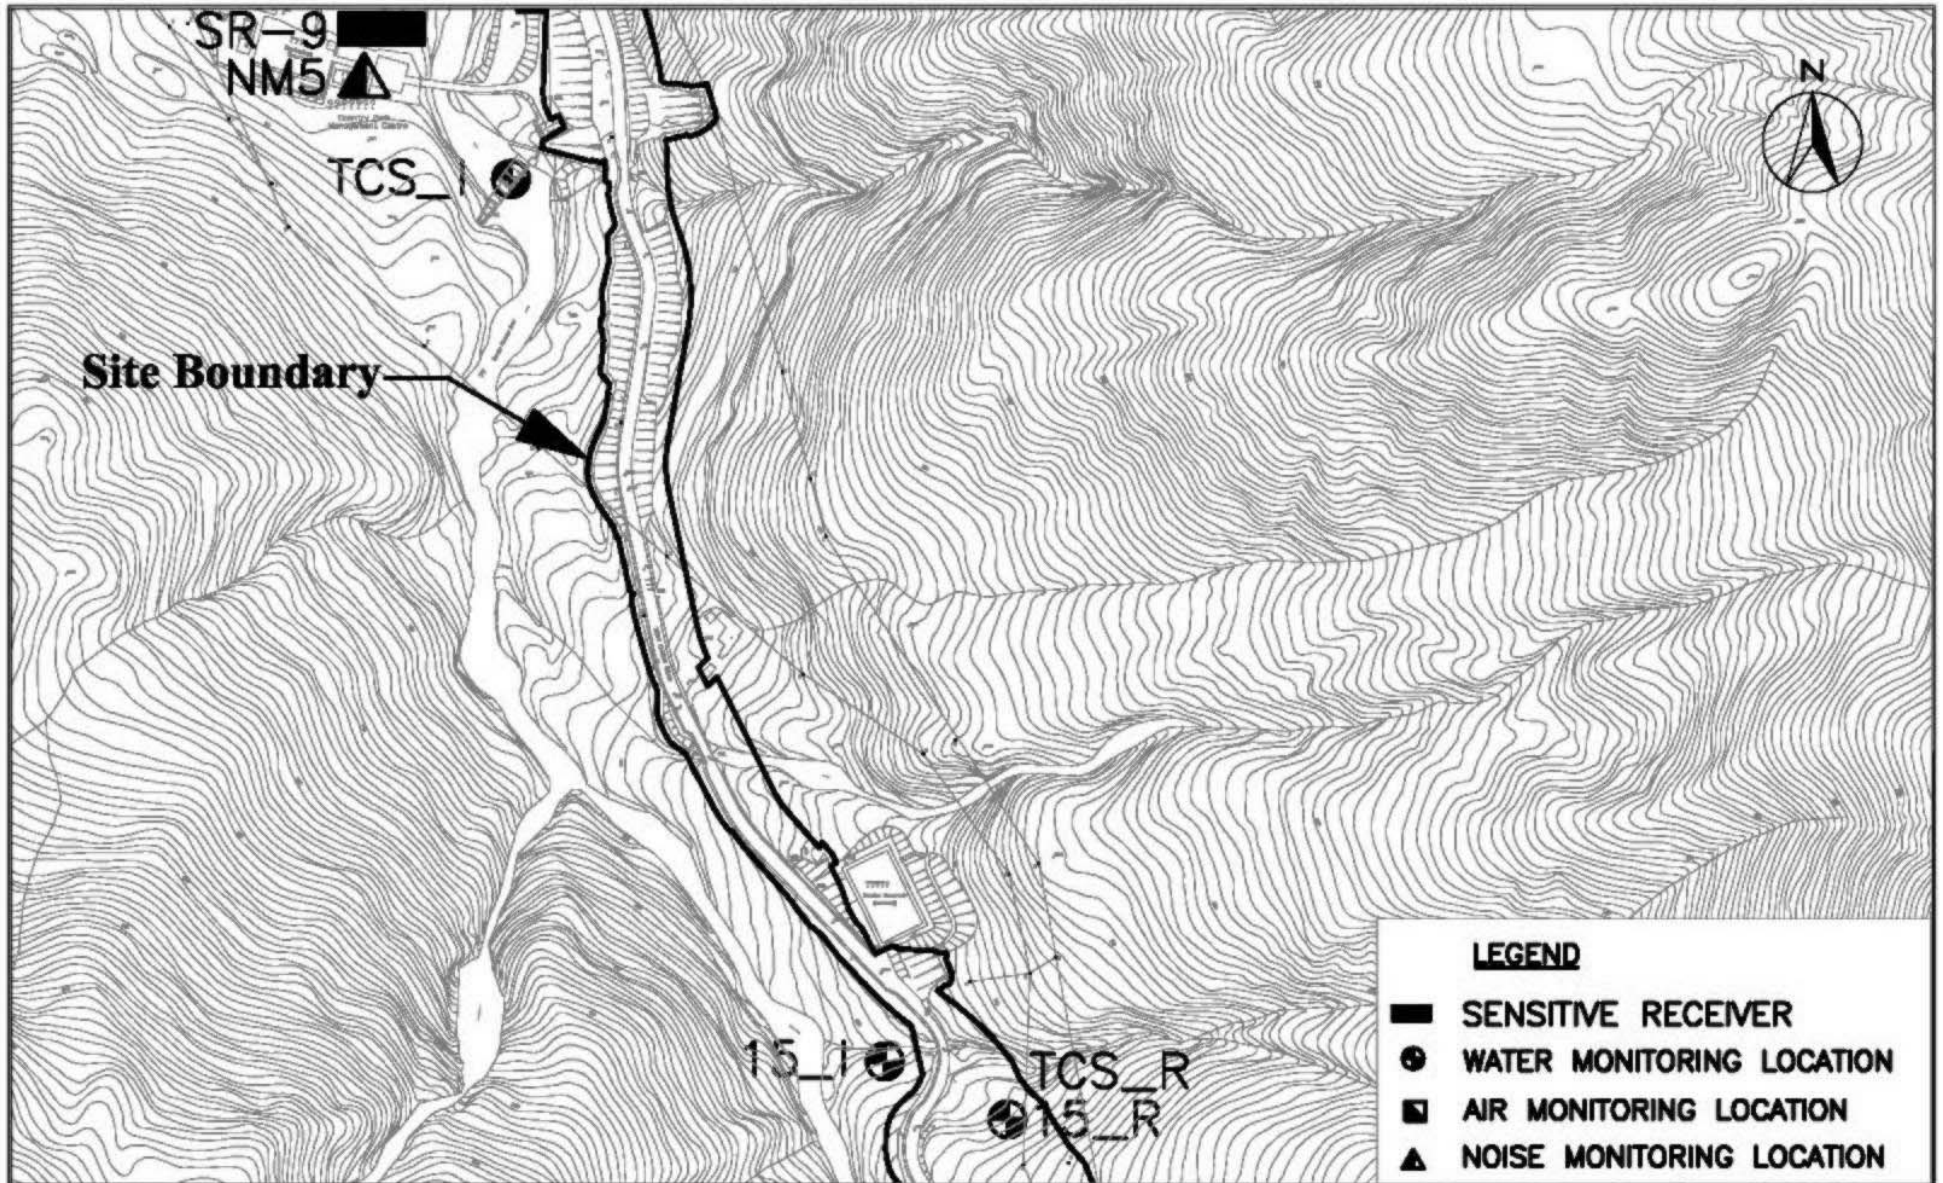
- SENSITIVE RECEIVER
- WATER MONITORING LOCATION
- AIR MONITORING LOCATION
- ▲ NOISE MONITORING LOCATION

Cinotech Consultants Limited	IMPROVEMENT TO TUNG CHUNG ROAD BETWEEN LUNG TSENG TAU AND CHEUNG SHA		SCALE	A4 1:4000	DATE	OCT 2006
	<b>MONITORING LOCATIONS</b> (SHEET 3 OF 7)		CHECK	JY	DRAWN	VL
			JOB No.	MA6030	DRAWING No.	FIG 3.3

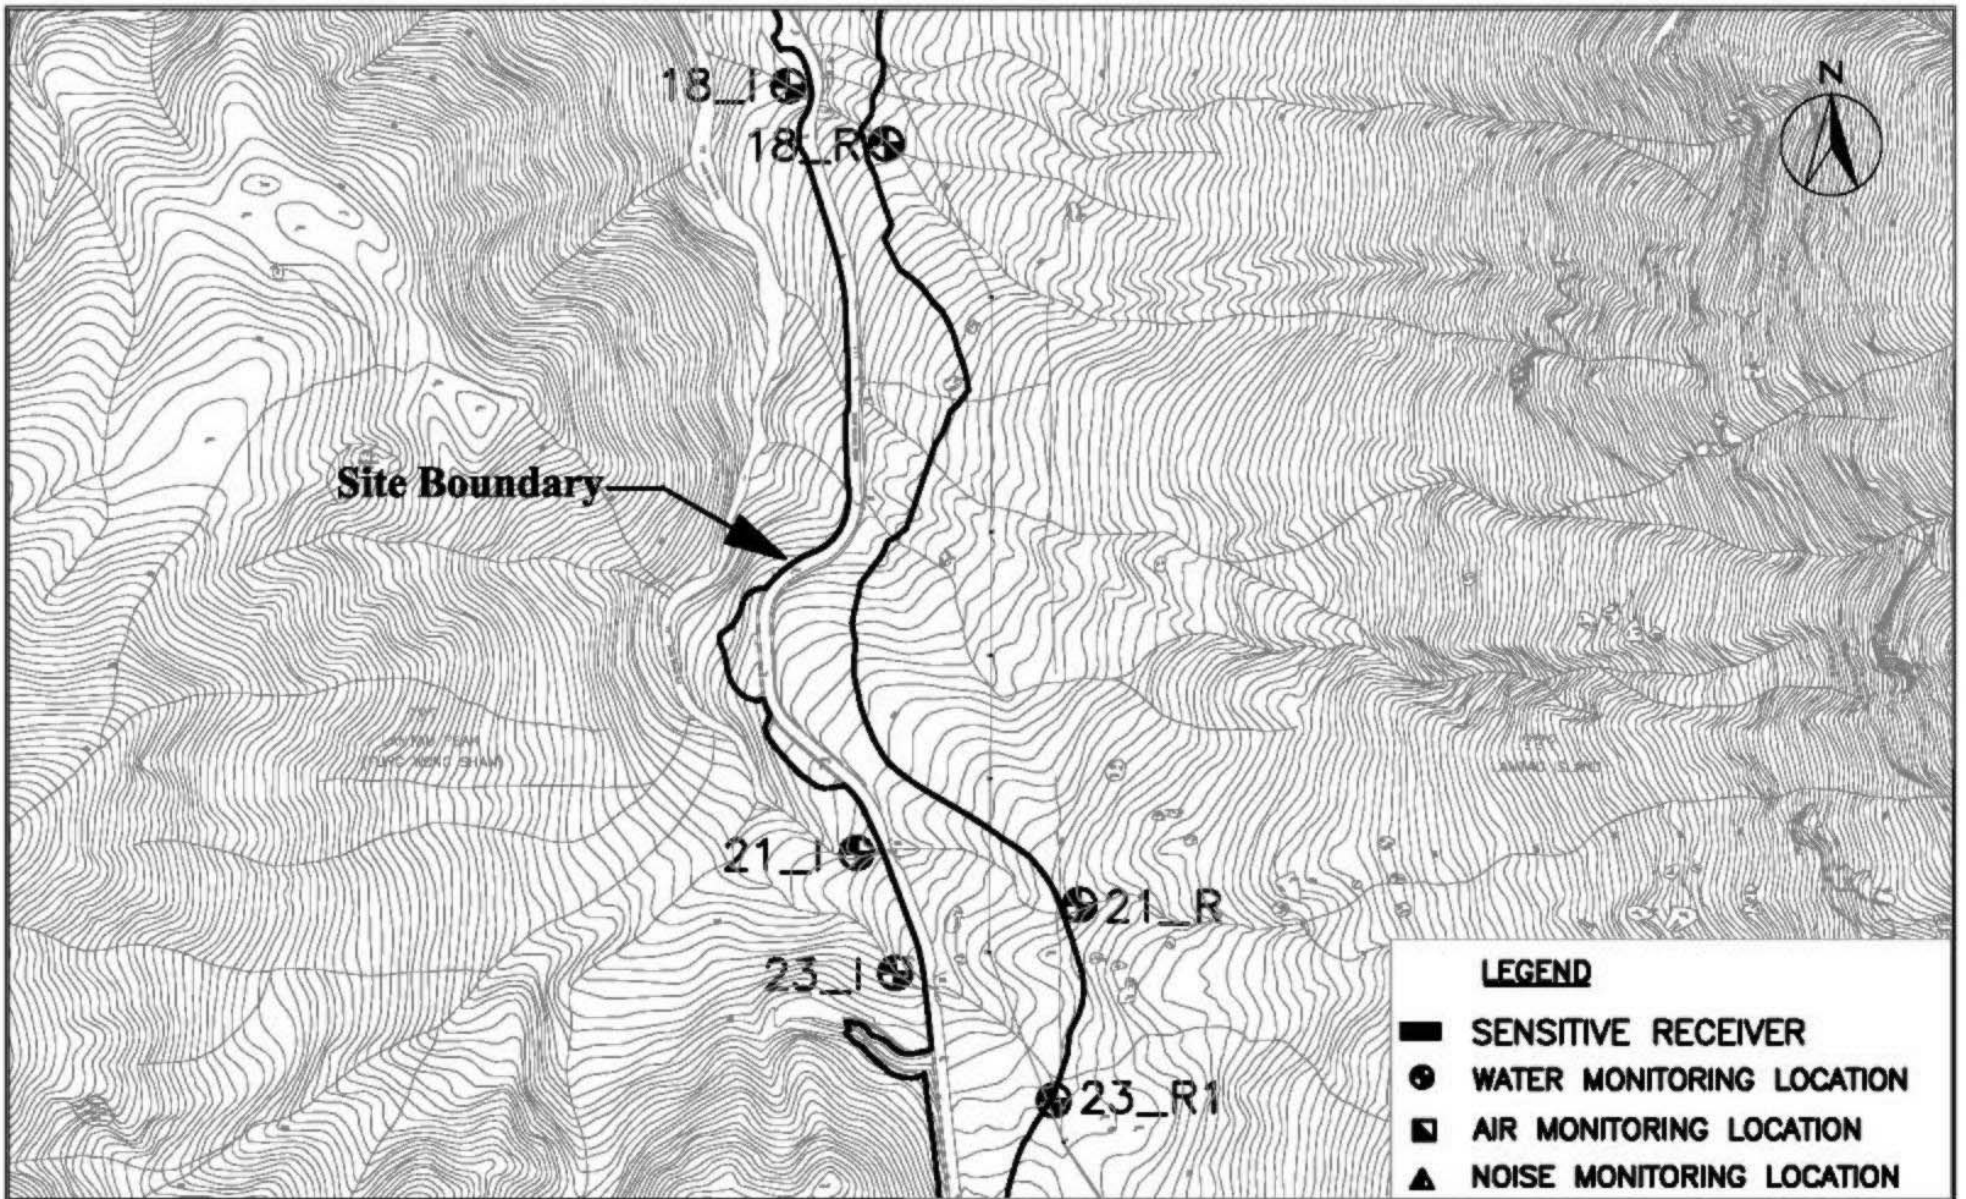
**MONITORING LOCATIONS  
(SHEET 4 OF 7)**

- SENSITIVE RECEIVER
- WATER MONITORING LOCATION
- AIR MONITORING LOCATION
- ▲ NOISE MONITORING LOCATION

SCALE	A4 1:4000	DATE	OCT 2006
CHECK	JY	DRAWN	VL
JOB No.	MA6030	DRAWING No.	FIG 3.4
		REV	1

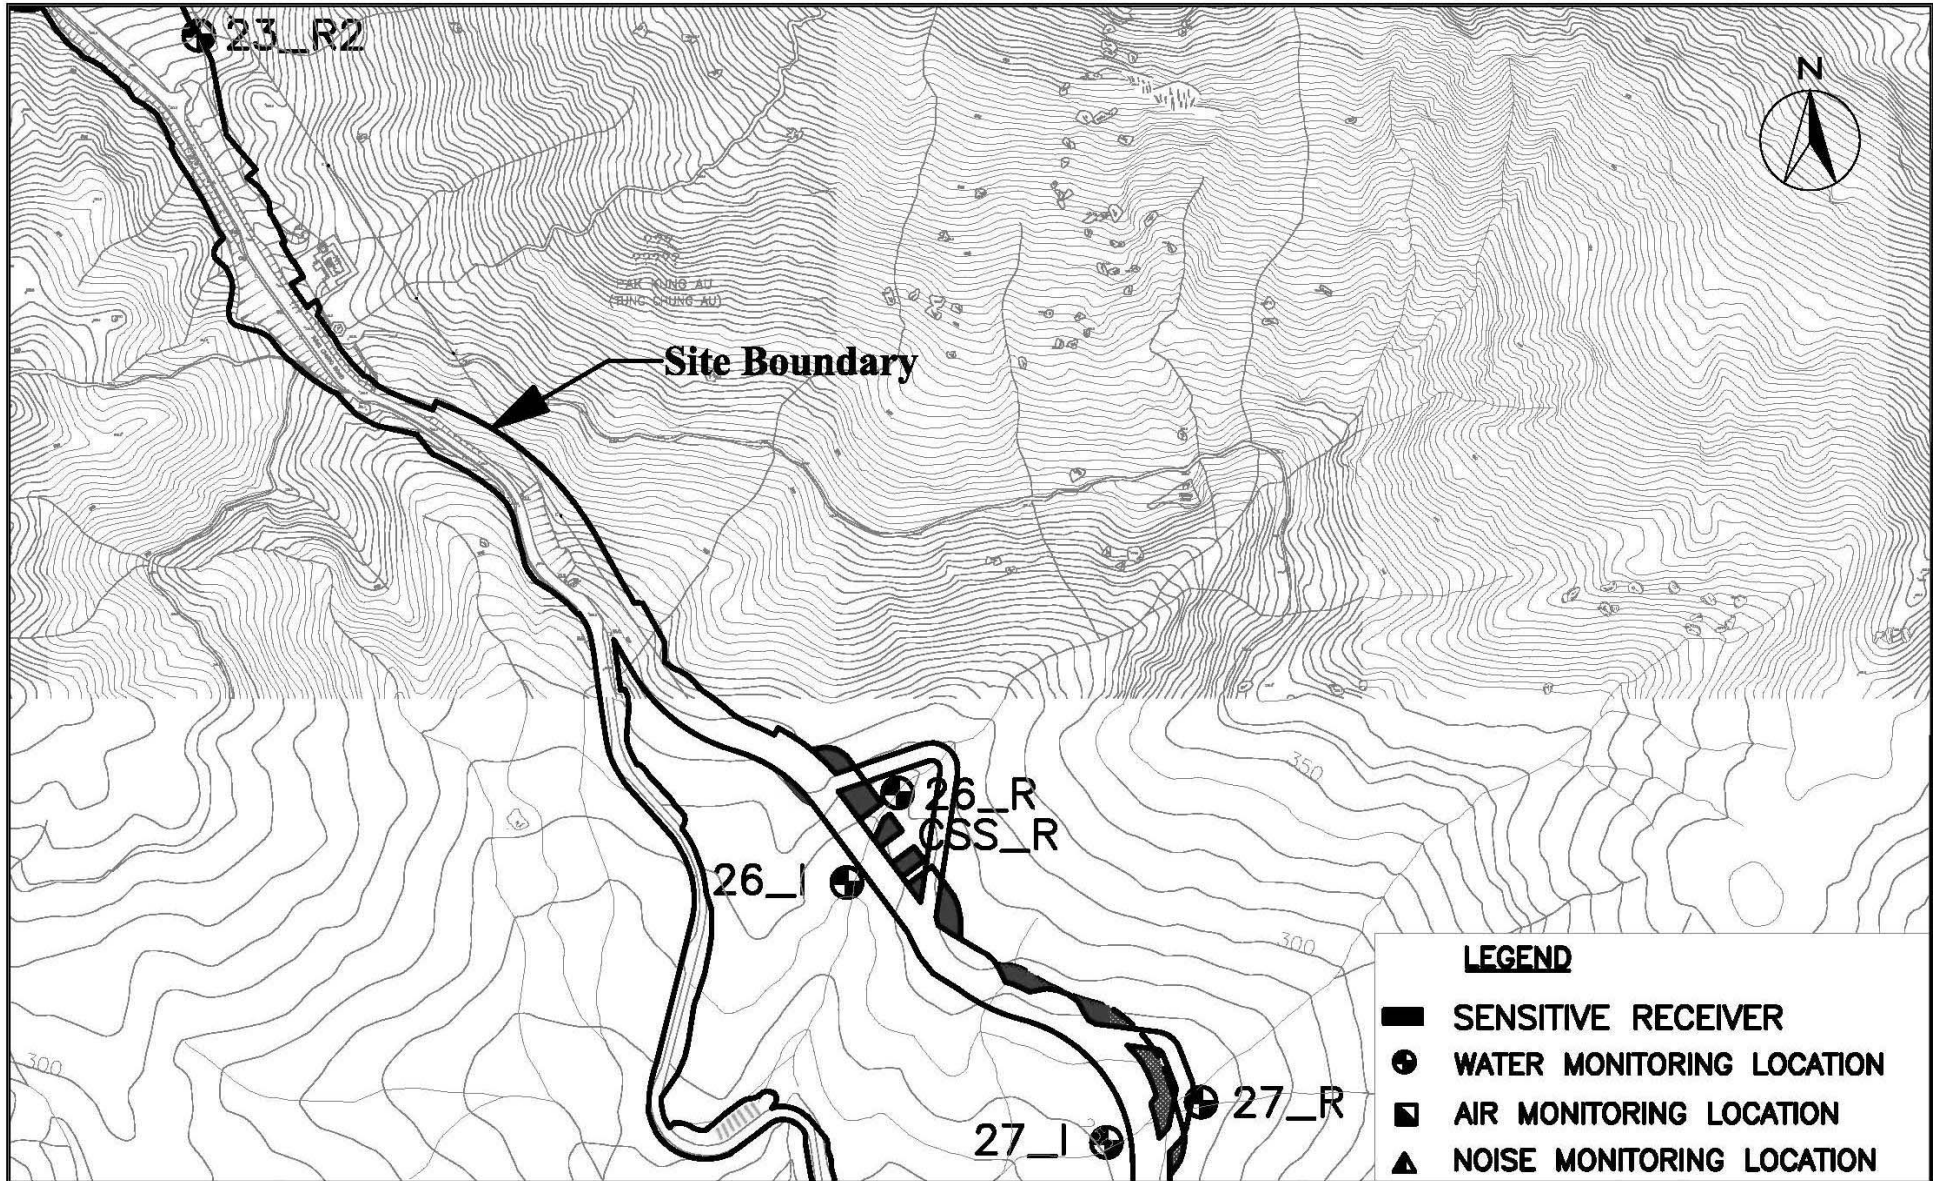
**MONITORING LOCATIONS  
(SHEET 5 OF 7)**

SCALE	A4 1:4000	DATE	OCT 2006
CHECK	JY	DRAWN	VL
JOB No.	MA6030	DRAWING No.	FIG 3.5
		REV	1

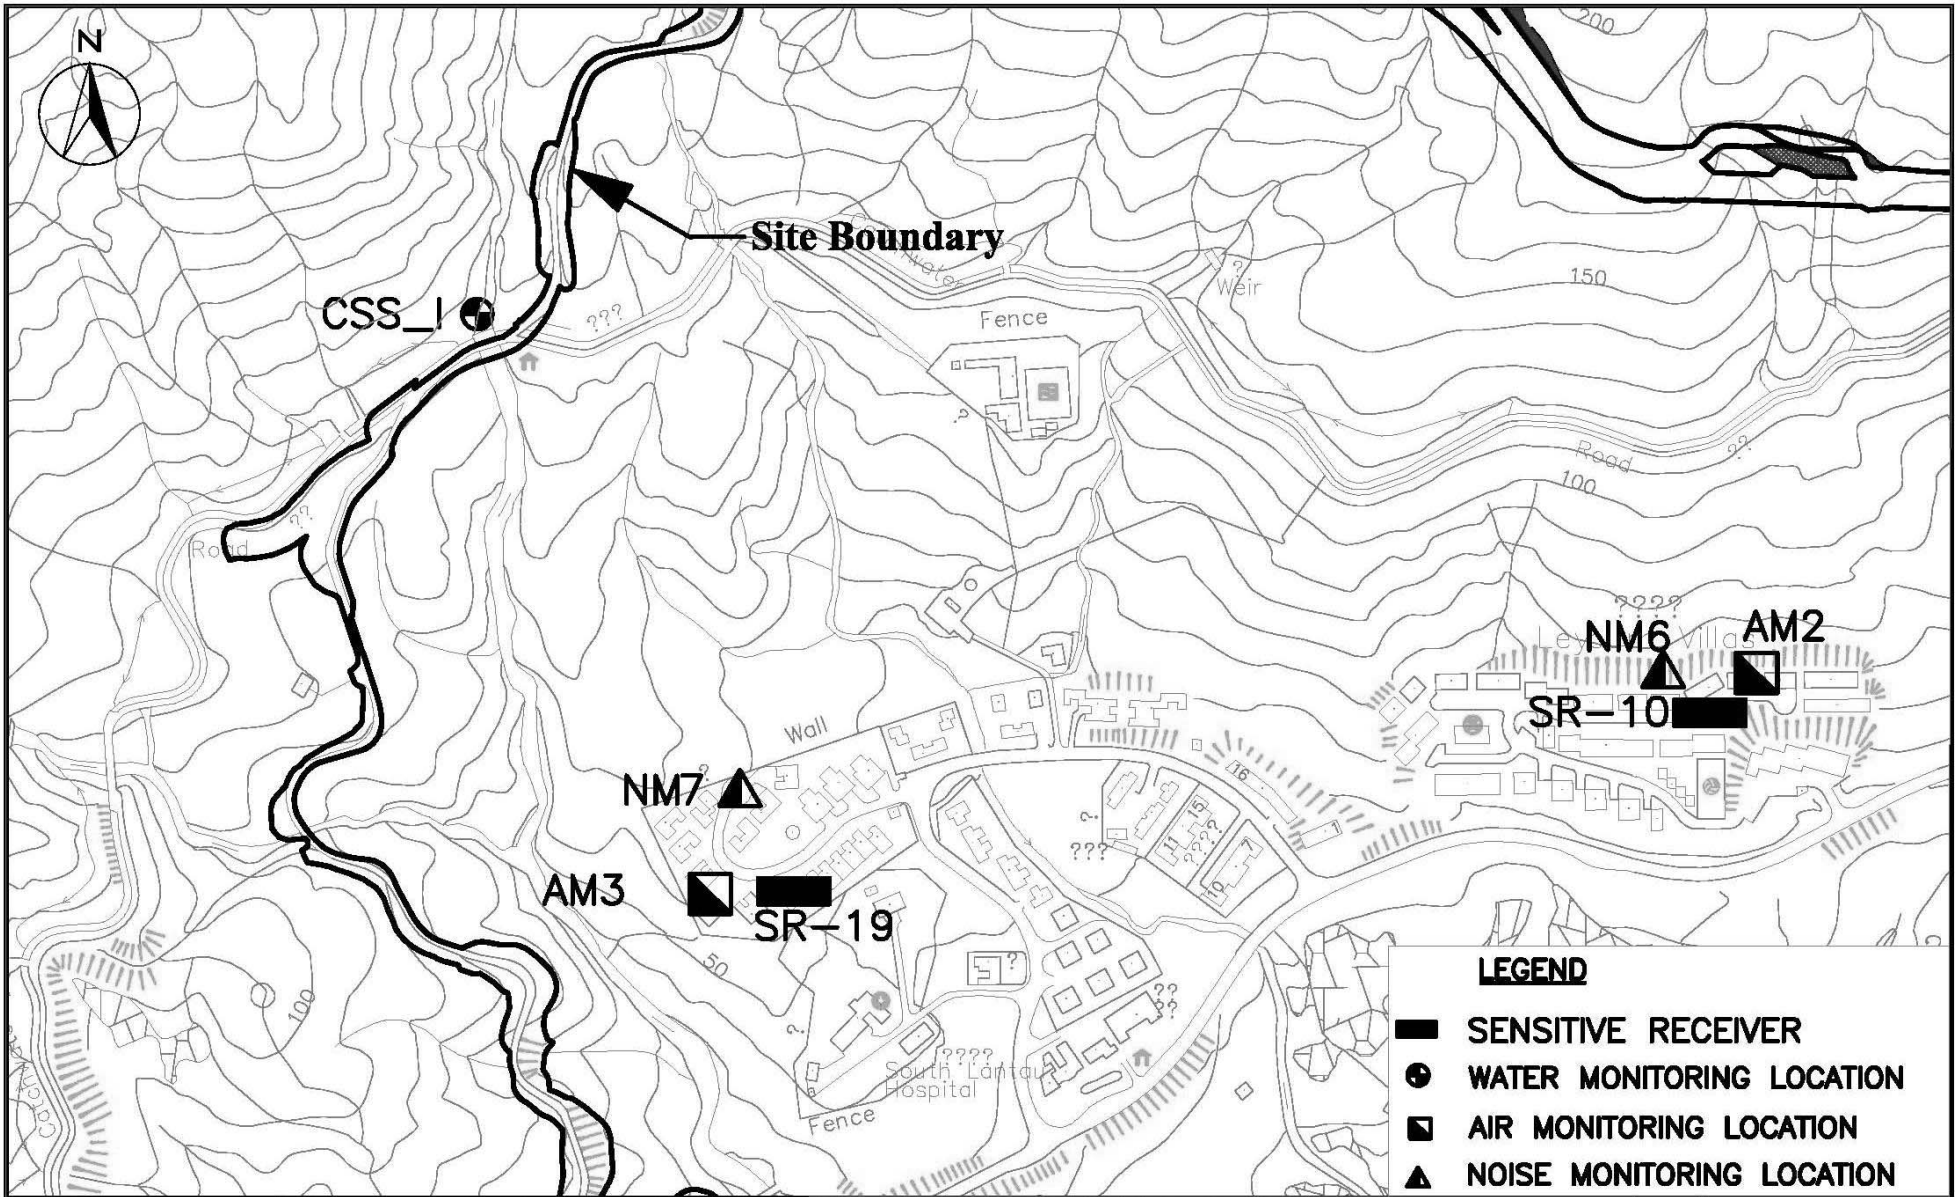
**MONITORING LOCATIONS**  
(SHEET 6 OF 7)

- SENSITIVE RECEIVER
- WATER MONITORING LOCATION
- AIR MONITORING LOCATION
- NOISE MONITORING LOCATION

SCALE	A4 1:4000	DATE	OCT 2006
CHECK	JY	DRAWN	VL
JOB No.	MA6030	DRAWING No.	FIG 3.6
		REV	1

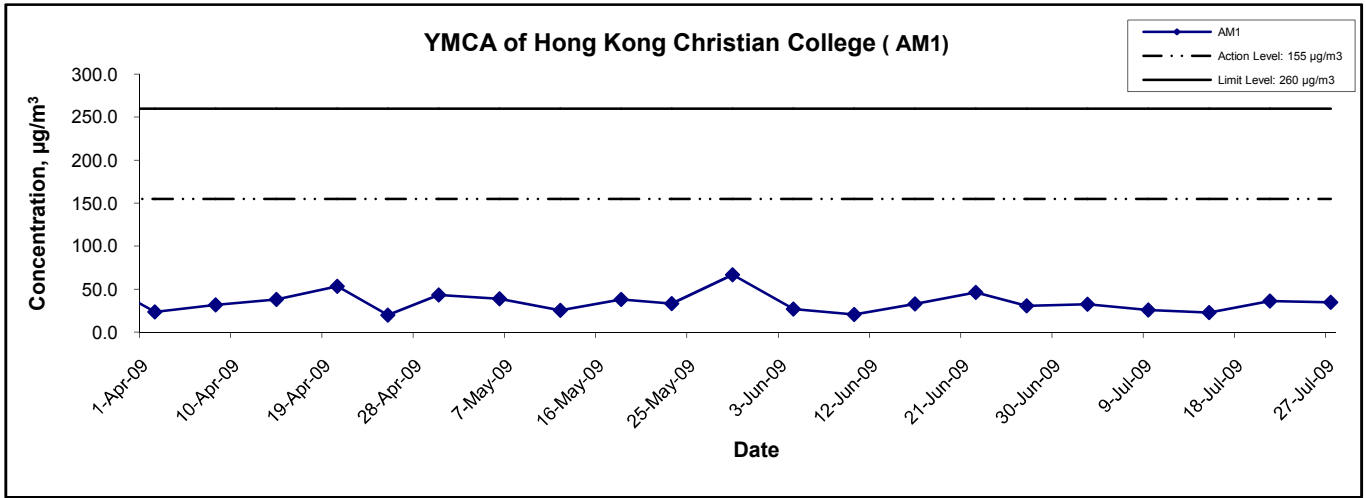
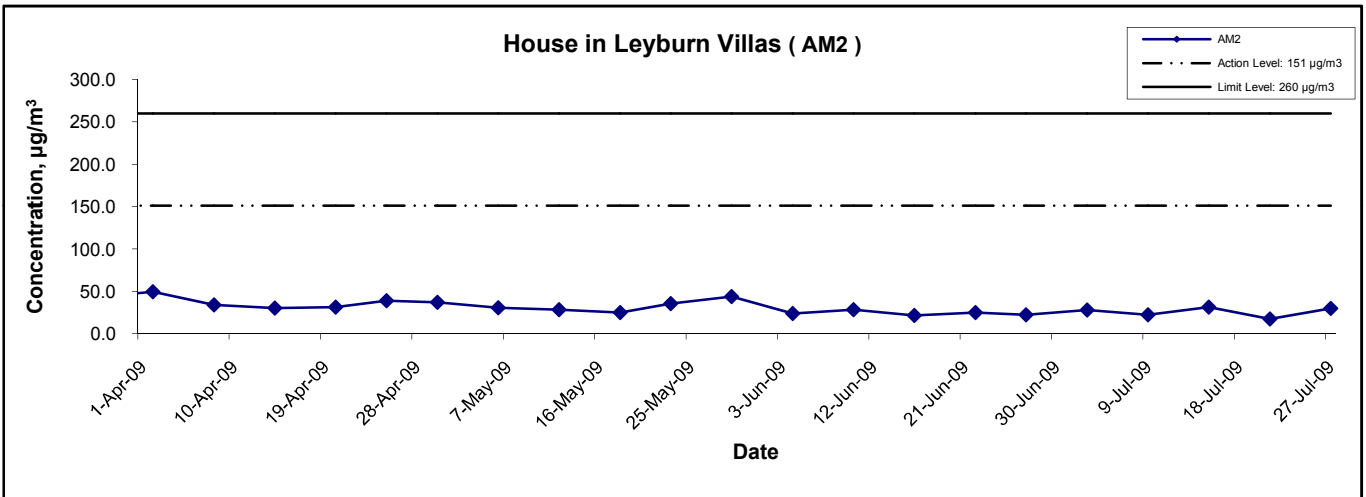
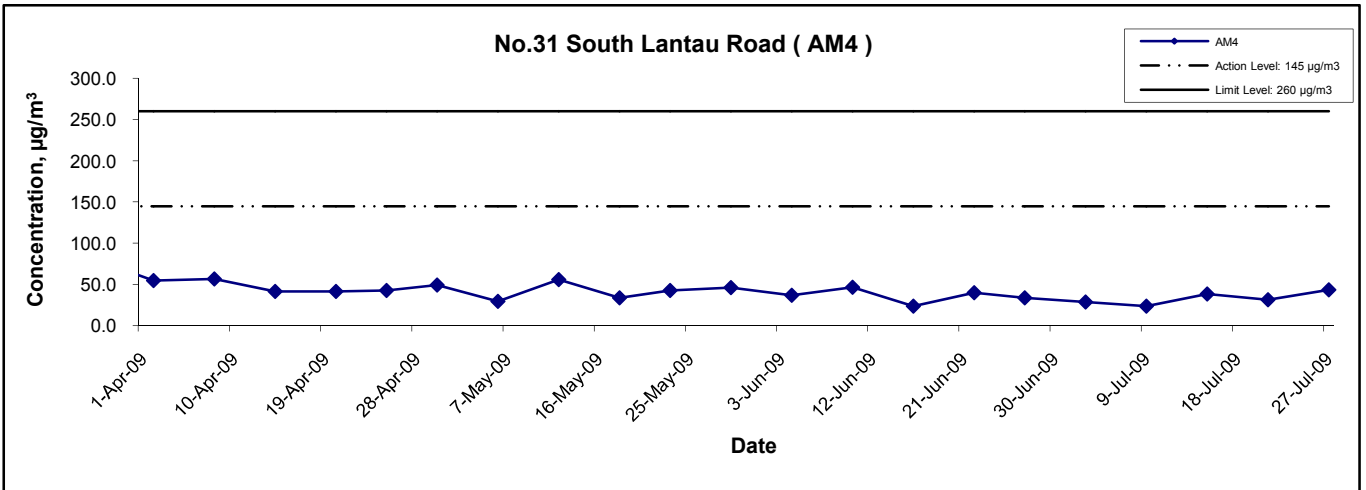
## 24-hour TSP Levels

**Title**  
 Contract No. HY/2003/19  
 Improvement to Tung Chung Road between Lung Tseng Tau and Cheung Sha  
 Graphical Presentation of 24-hour TSP Monitoring Results

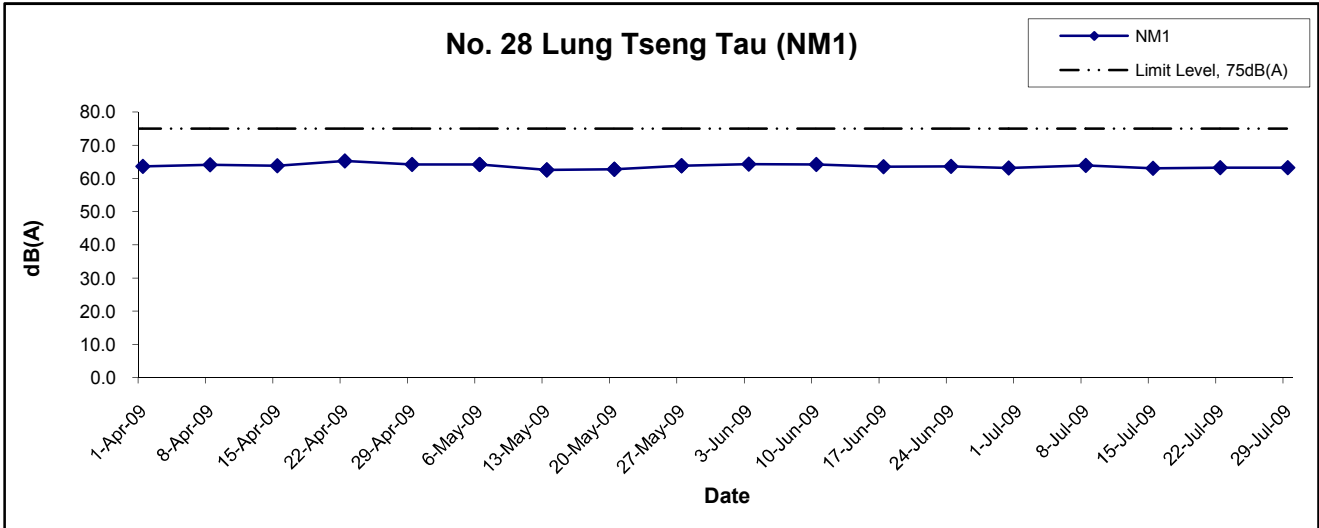
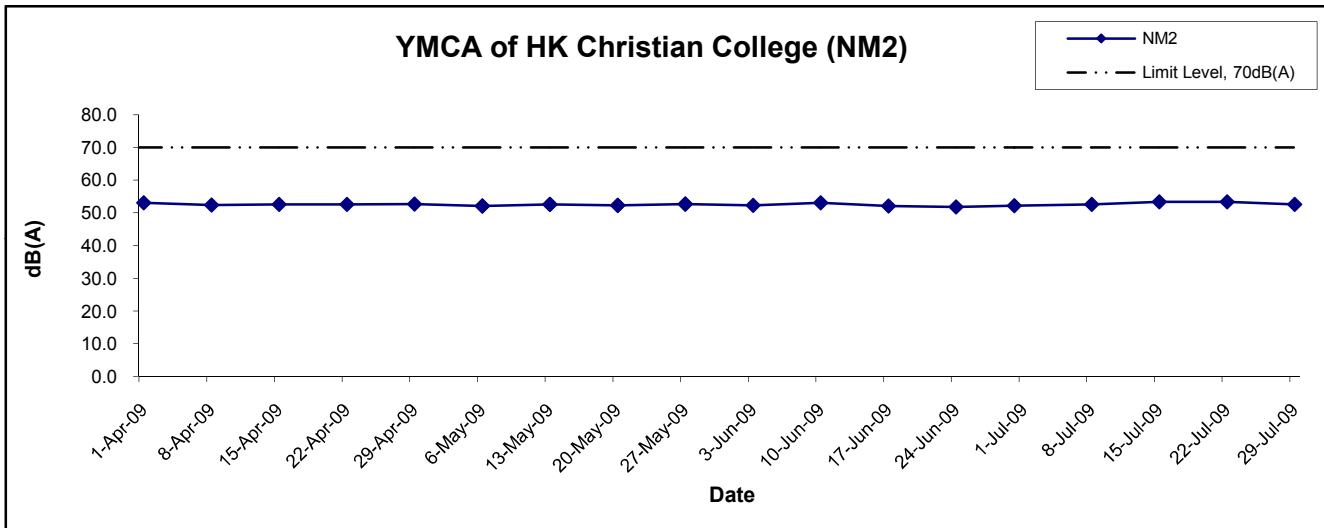
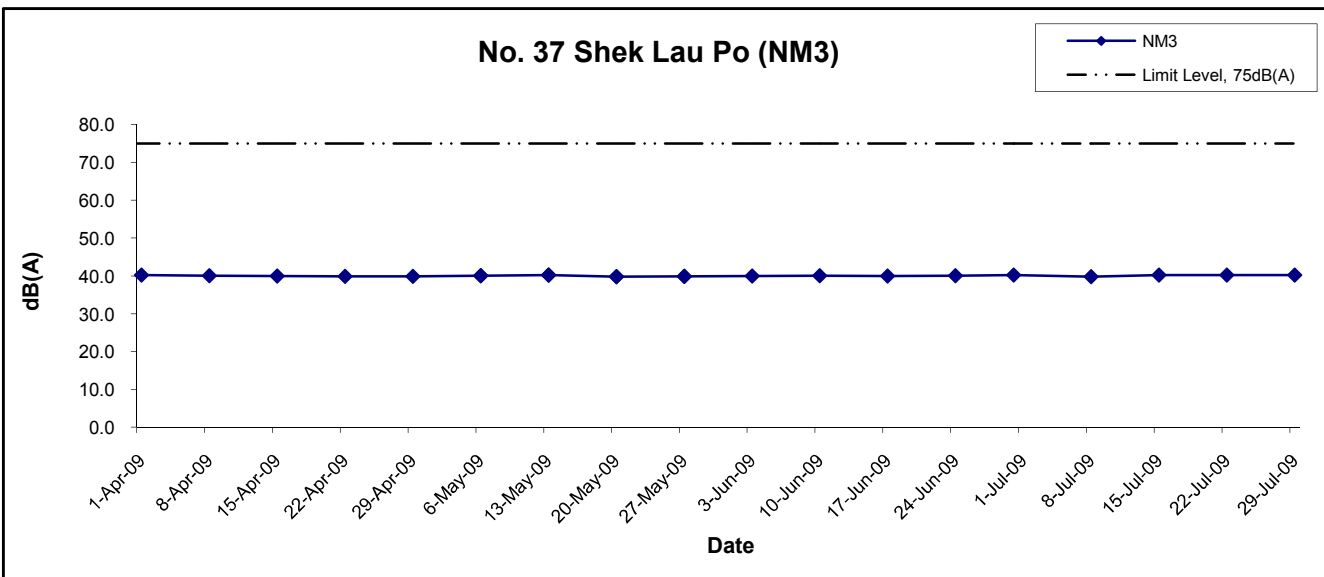
## Noise Levels

Title Contract No. HY/2003/19 Improvement to Tung Chung Road between Lung Tseng Tau and Cheung Sha  Graphical Presentation of Construction Noise Monitoring Results	Scale N.T.S	Project No. MA6030	
	Date Jul 09	Appendix E

Type of Monitoring	Parameter	Frequency	Location	Measurement Conditions
Noise	$L_{eq}$ , $L_{90}$ & $L_{10}$ at 30 minute intervals during (0700 to 1900 on normal weekdays)	Once per week	<ul style="list-style-type: none"> <li>• NM1 (No. 28 Lung Tseng Tau)</li> <li>• NM2 (YMCA of Hong Kong Christian College)</li> <li>• NM3 (No. 37 Shek Lau Po)</li> <li>• NM4 (No. 1 Shek Mun Kap)</li> <li>• NM5 (Tung Chung Au Country Parks Management Centre)</li> <li>• NM6 (D75 Leyburn Villa)</li> <li>• NM7 (House in Butterfly Crest House 22) <sup>(2)</sup></li> <li>• NM8 (No. 31 South Lantau Road)</li> </ul>	<ul style="list-style-type: none"> <li>• NM1 - Facade measurement</li> <li>• NM2 - Facade measurement</li> <li>• NM3 - Facade measurement</li> <li>• NM4 - Facade measurement</li> <li>• NM5 - Facade measurement</li> <li>• NM6 - Facade measurement</li> <li>• NM7 - Facade measurement</li> <li>• NM8 - Facade measurement</li> </ul>
