**Contract No. HY/2003/19**

**Improvement to Tung Chung Road  
between Lung Tseng Tau and Cheung Sha**

**Quarterly EM&A Report  
(Version 2.0)**

May 2009 to July 2009

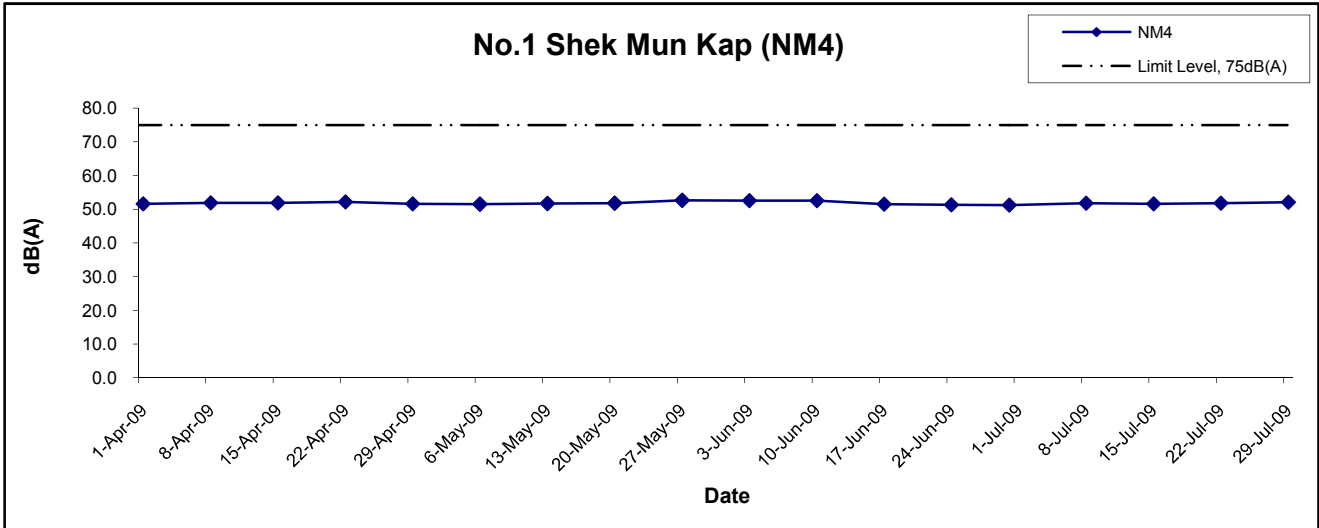
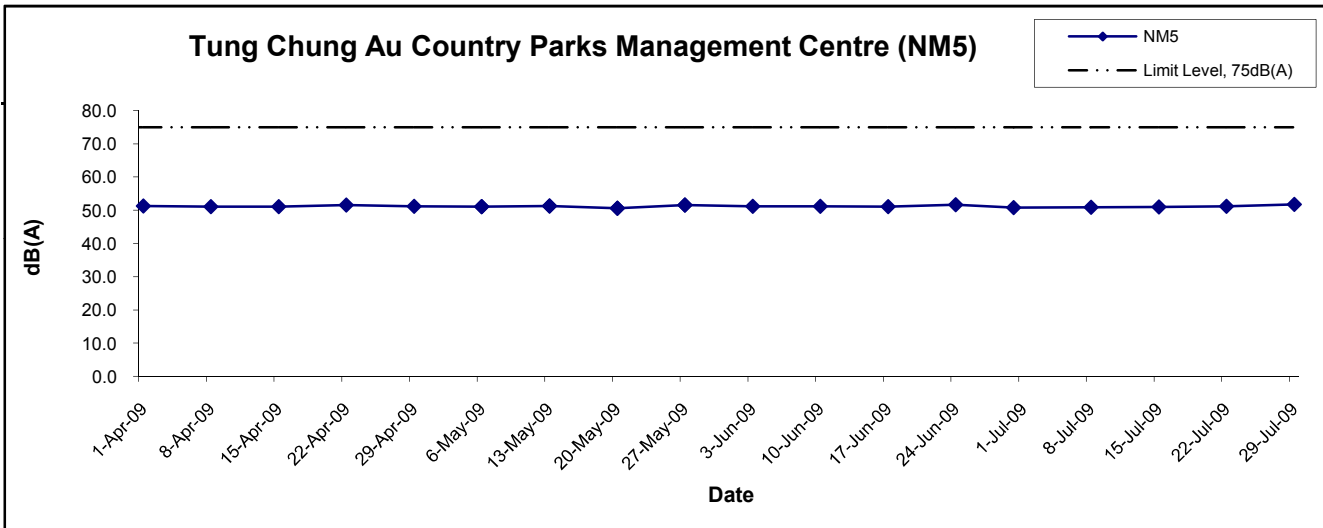
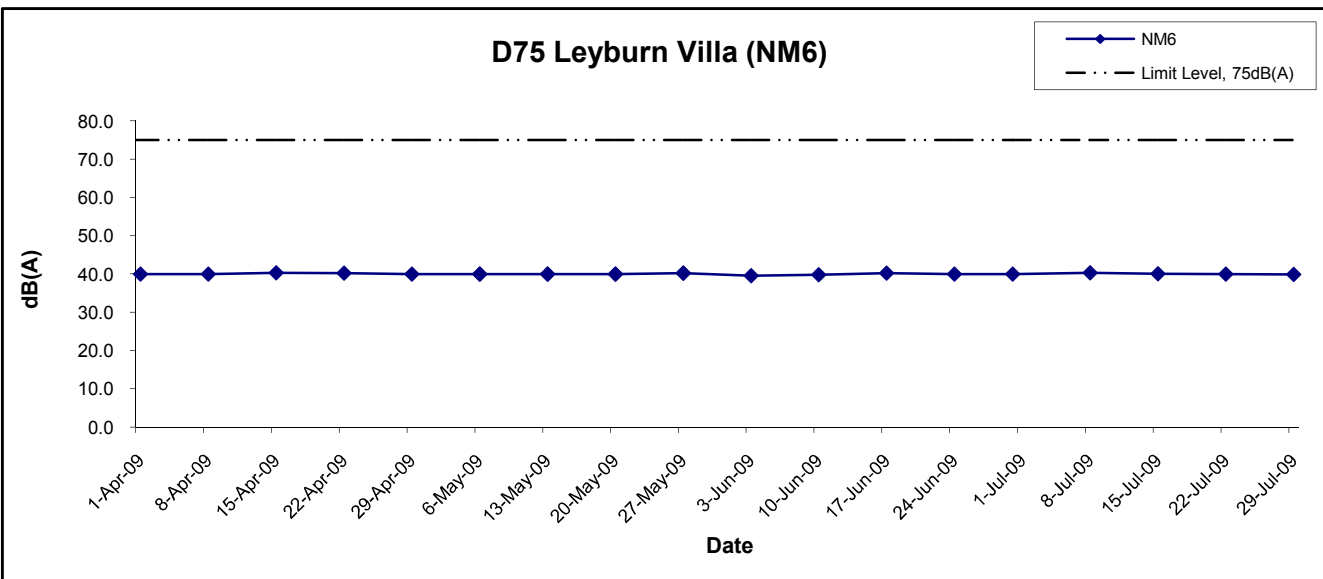
## Noise Levels

Title Contract No. HY/2003/19 Improvement to Tung Chung Road between Lung Tseng Tau and Cheung Sha  Graphical Presentation of Construction Noise Monitoring Results	Scale N.T.S	Project No. MA6030	
	Date Jul 09	Appendix E

Type of Monitoring	Parameter	Frequency	Location	Measurement Conditions
Noise	$L_{eq}$ , $L_{90}$ & $L_{10}$ at 30 minute intervals during (0700 to 1900 on normal weekdays)	Once per week	<ul style="list-style-type: none"> <li>• NM1 (No. 28 Lung Tseng Tau)</li> <li>• NM2 (YMCA of Hong Kong Christian College)</li> <li>• NM3 (No. 37 Shek Lau Po)</li> <li>• NM4 (No. 1 Shek Mun Kap)</li> <li>• NM5 (Tung Chung Au Country Parks Management Centre)</li> <li>• NM6 (D75 Leyburn Villa)</li> <li>• NM7 (House in Butterfly Crest House 22) <sup>(2)</sup></li> <li>• NM8 (No. 31 South Lantau Road)</li> </ul>	<ul style="list-style-type: none"> <li>• NM1 - Facade measurement</li> <li>• NM2 - Facade measurement</li> <li>• NM3 - Facade measurement</li> <li>• NM4 - Facade measurement</li> <li>• NM5 - Facade measurement</li> <li>• NM6 - Facade measurement</li> <li>• NM7 - Facade measurement</li> <li>• NM8 - Facade measurement</li> </ul>

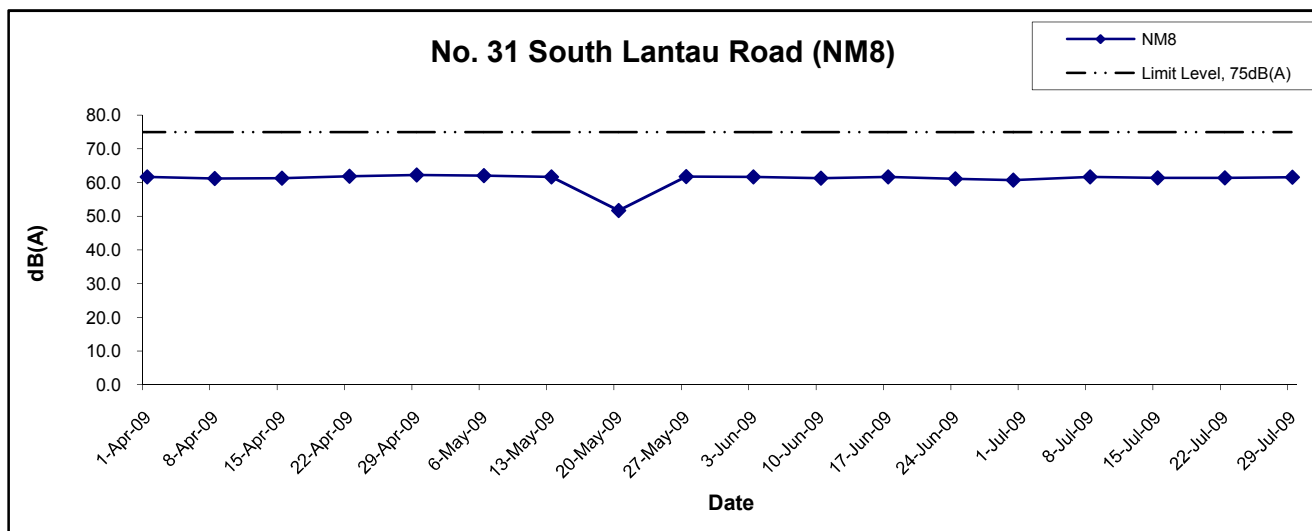
## Noise Levels

Title Contract No. HY/2003/19 Improvement to Tung Chung Road between Lung Tseng Tau and Cheung Sha  Graphical Presentation of Construction Noise Monitoring Results	Scale N.T.S	Project No. MA6030	
	Date Jul 09	Appendix E

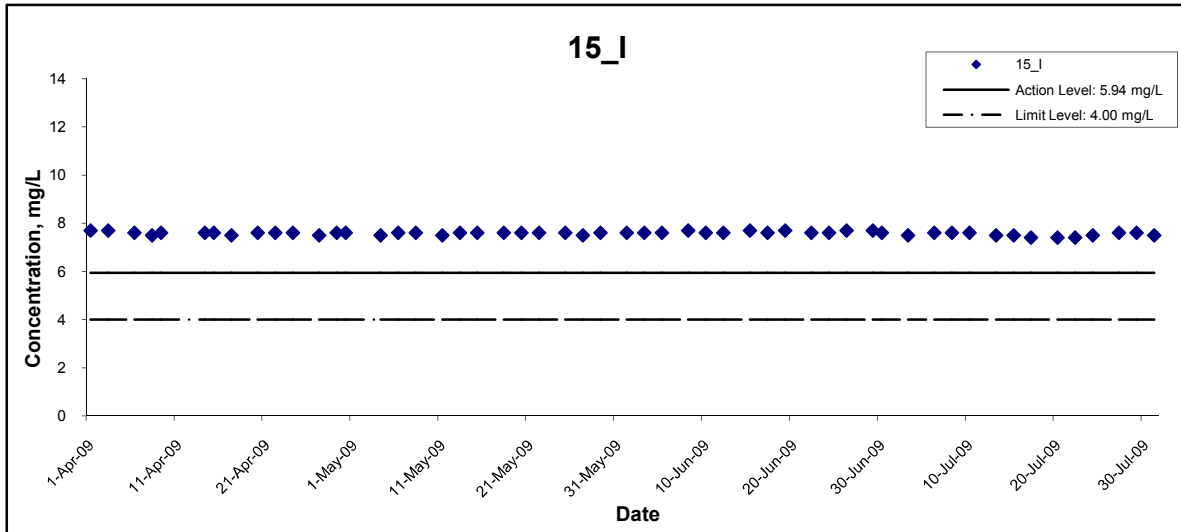
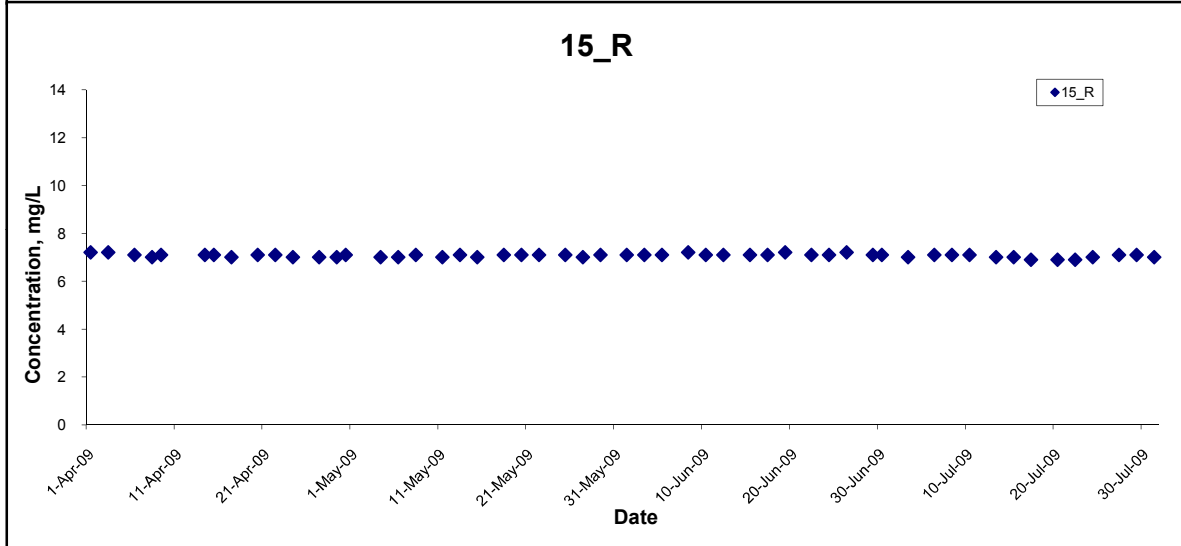
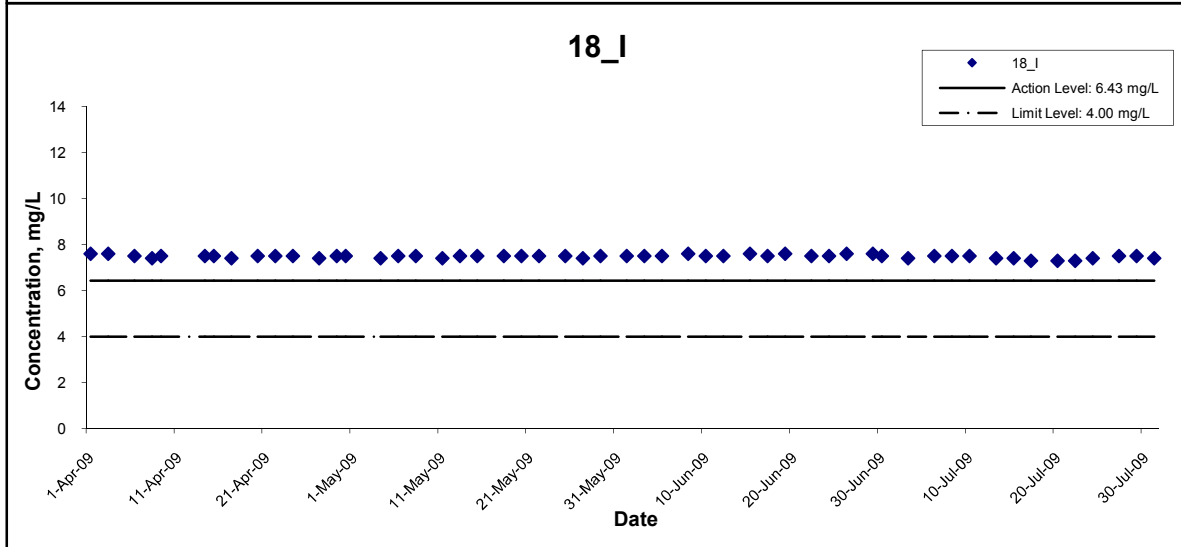
## Dissolved Oxygen

Title Contract No. HY/2003/19 Improvement to Tung Chung Road between Lung Tseng Tau and Cheung Sha  Graphical Presentation of Water Quality Monitoring Results	Scale N.T.S	Project No. MA6030	
	Date Jul 09	Appendix F

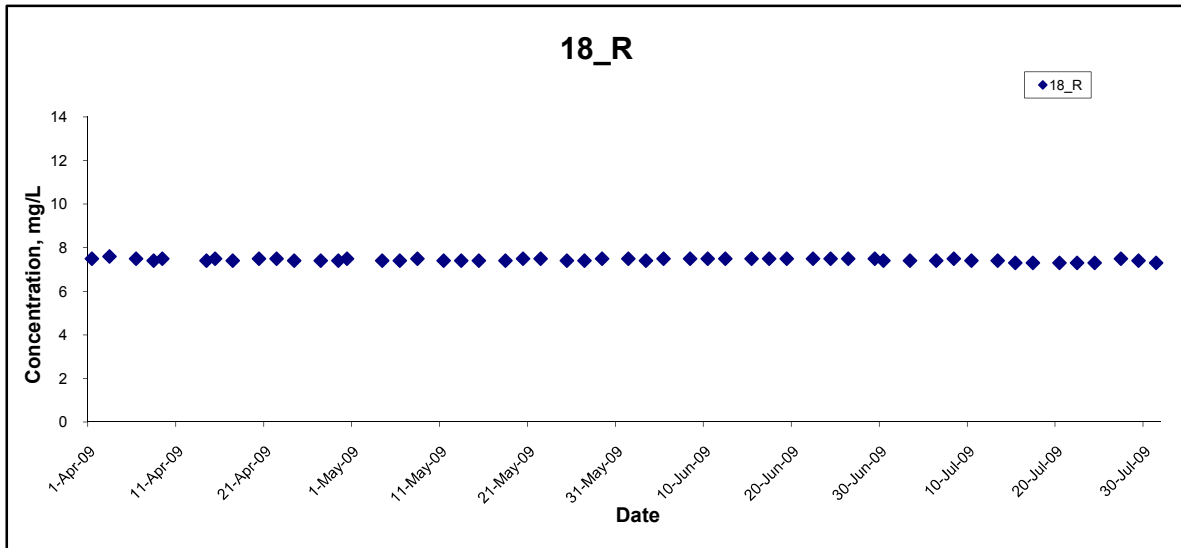
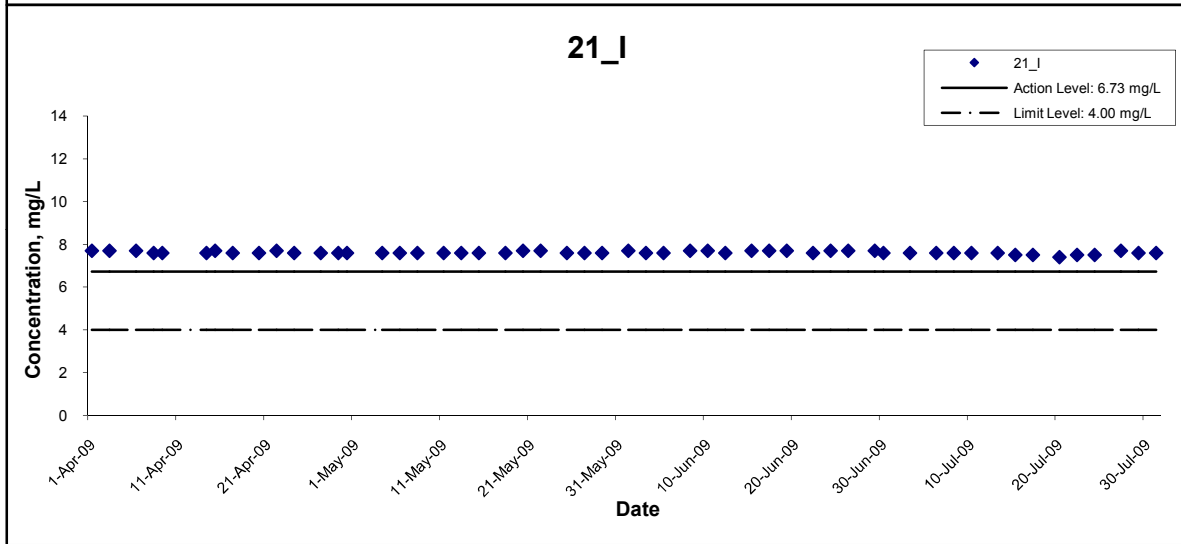
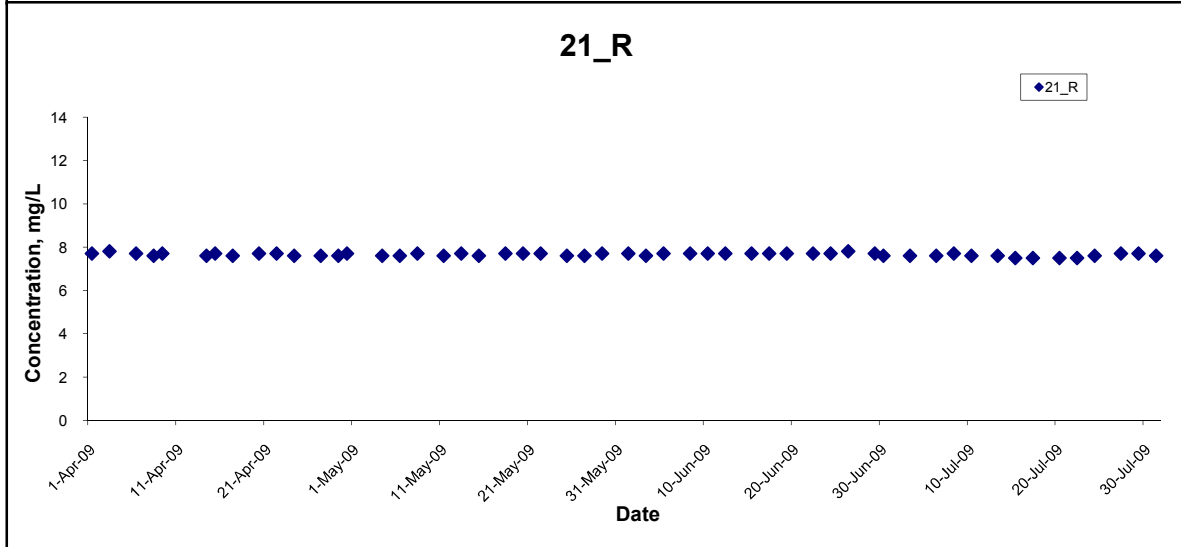
## Dissolved Oxygen

Title Contract No. HY/2003/19 Improvement to Tung Chung Road between Lung Tseng Tau and Cheung Sha Graphical Presentation of Water Quality Monitoring Results	Scale N.T.S	Project No. MA6030	CINOTECH
	Date Jul 09	Appendix F

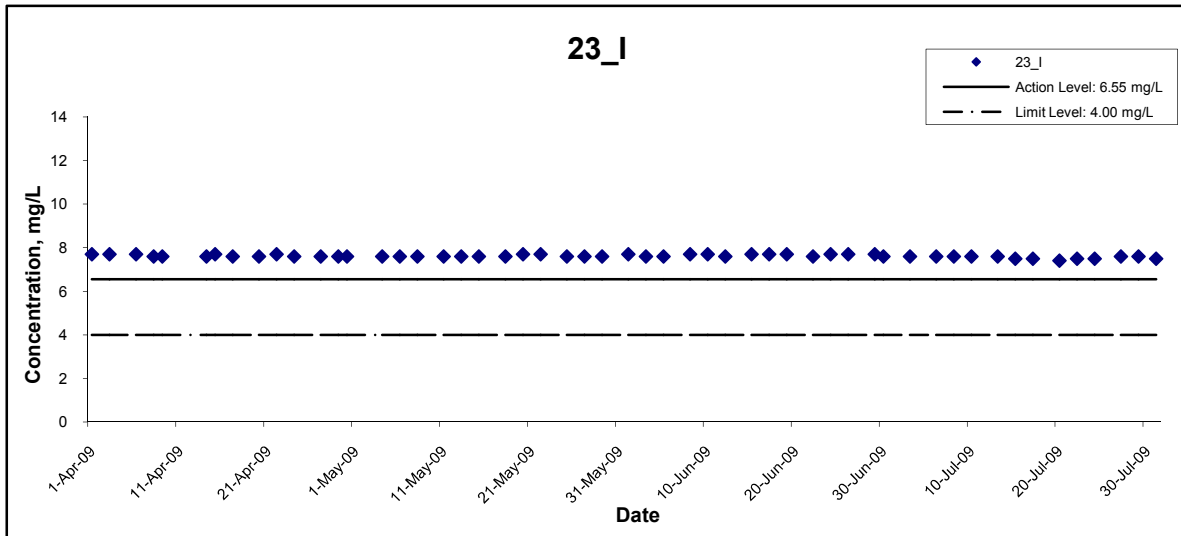
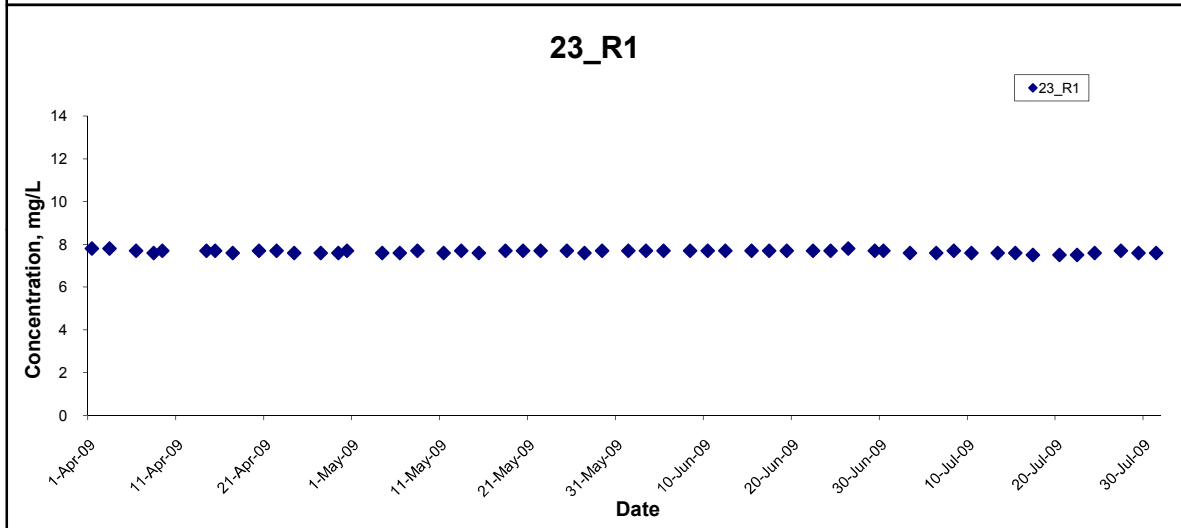
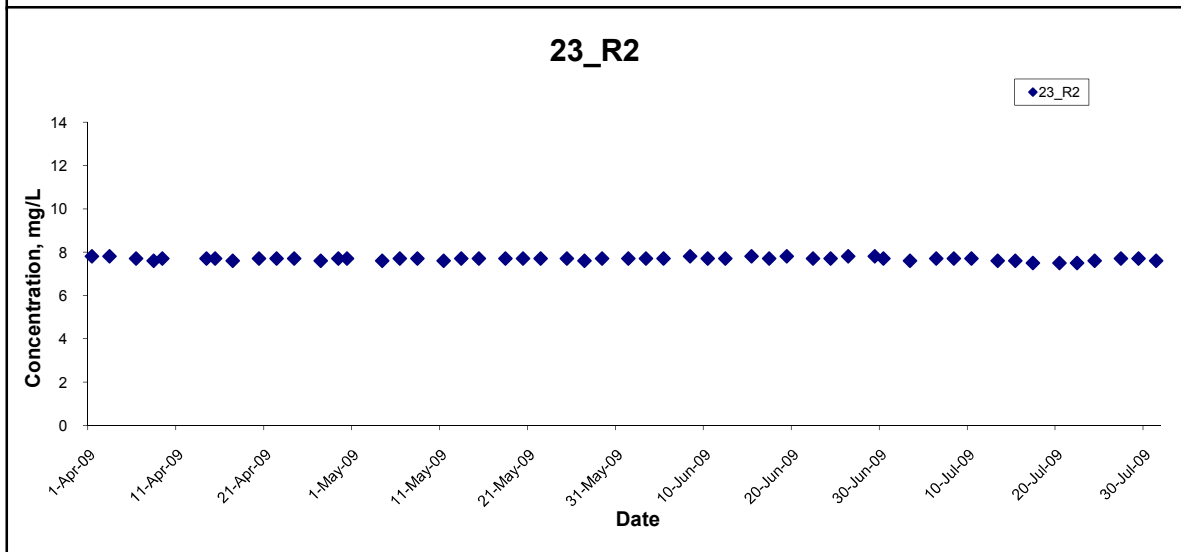
## Dissolved Oxygen

Title Contract No. HY/2003/19 Improvement to Tung Chung Road between Lung Tseng Tau and Cheung Sha Graphical Presentation of Water Quality Monitoring Results	Scale N.T.S	Project No. MA6030	CINOTECH
	Date Jul 09	Appendix F

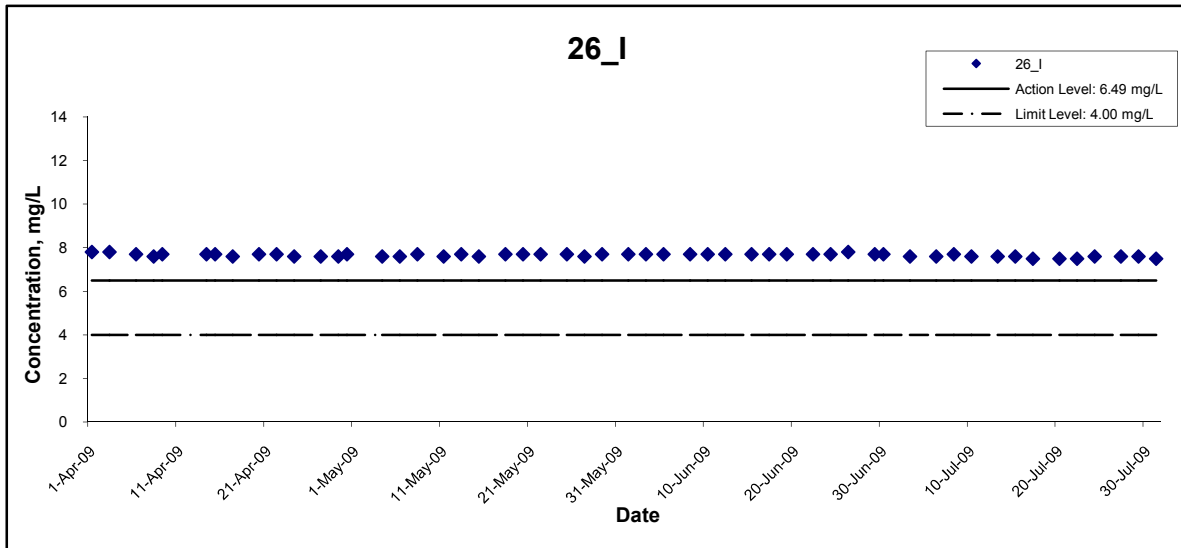
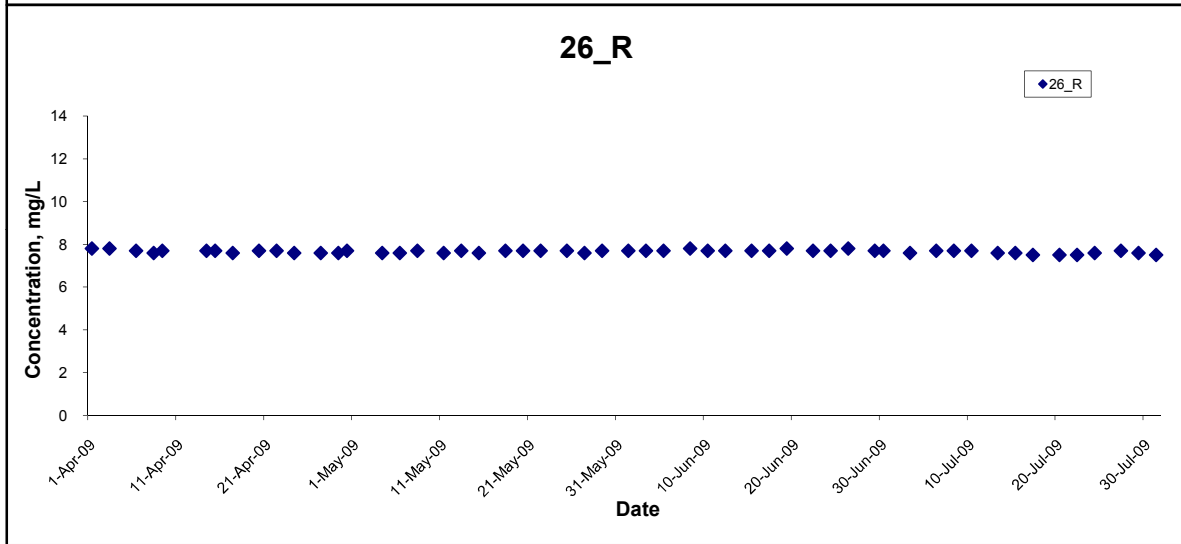
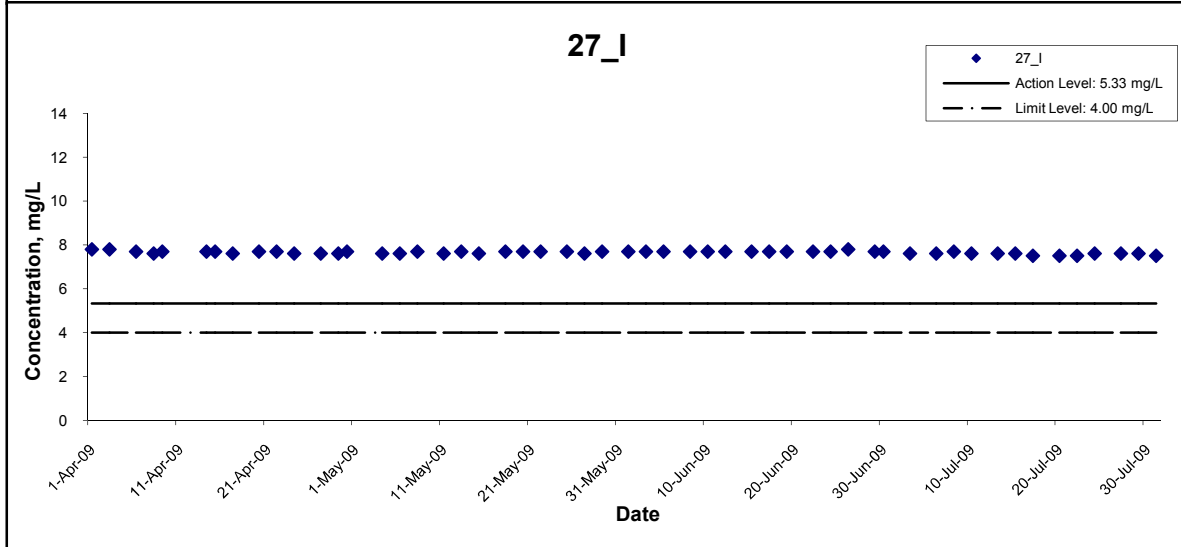
## Dissolved Oxygen

Title Contract No. HY/2003/19 Improvement to Tung Chung Road between Lung Tseng Tau and Cheung Sha Graphical Presentation of Water Quality Monitoring Results	Scale N.T.S	Project No. MA6030	CINOTECH
	Date Jul 09	Appendix F

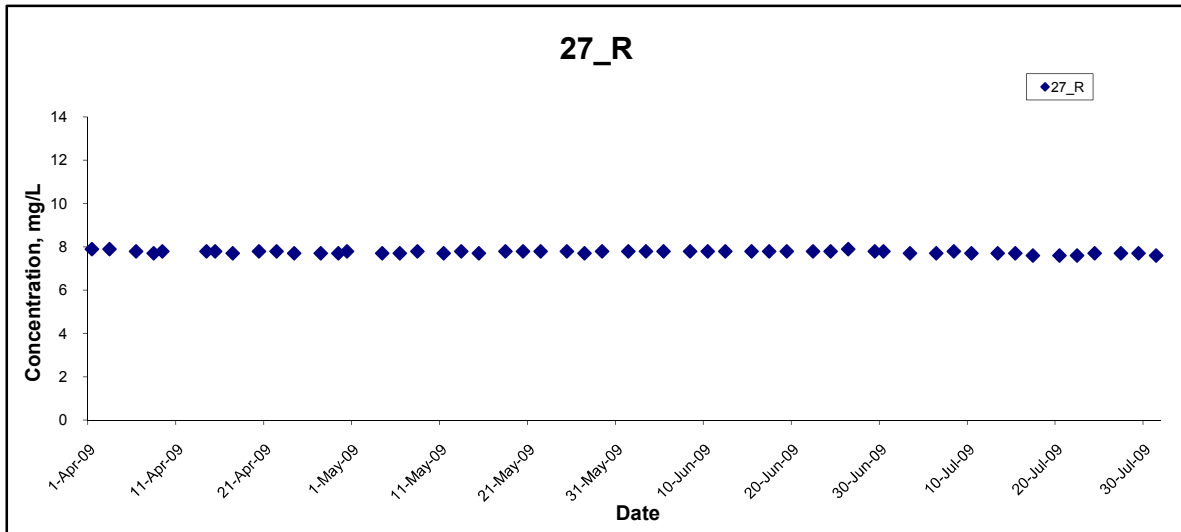
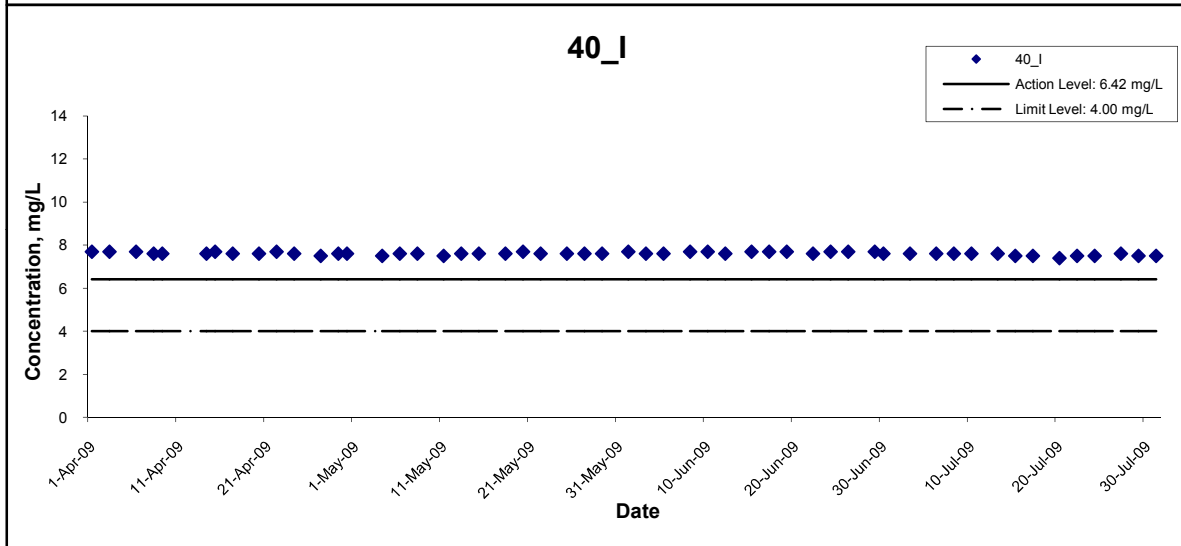
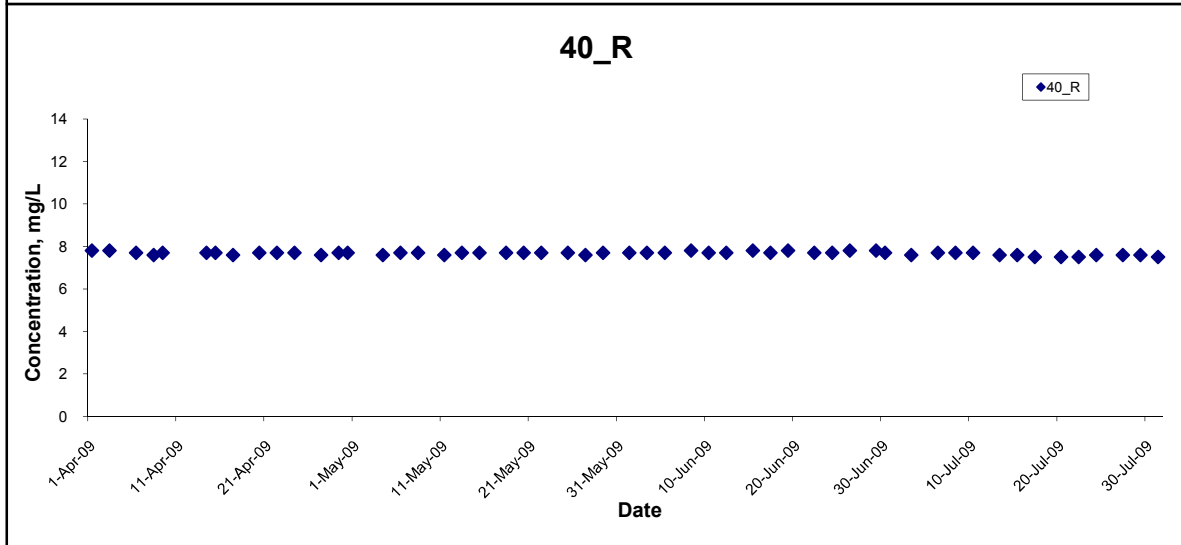
## Dissolved Oxygen

Title Contract No. HY/2003/19 Improvement to Tung Chung Road between Lung Tseng Tau and Cheung Sha Graphical Presentation of Water Quality Monitoring Results	Scale N.T.S	Project No. MA6030	CINOTECH
	Date Jul 09	Appendix F

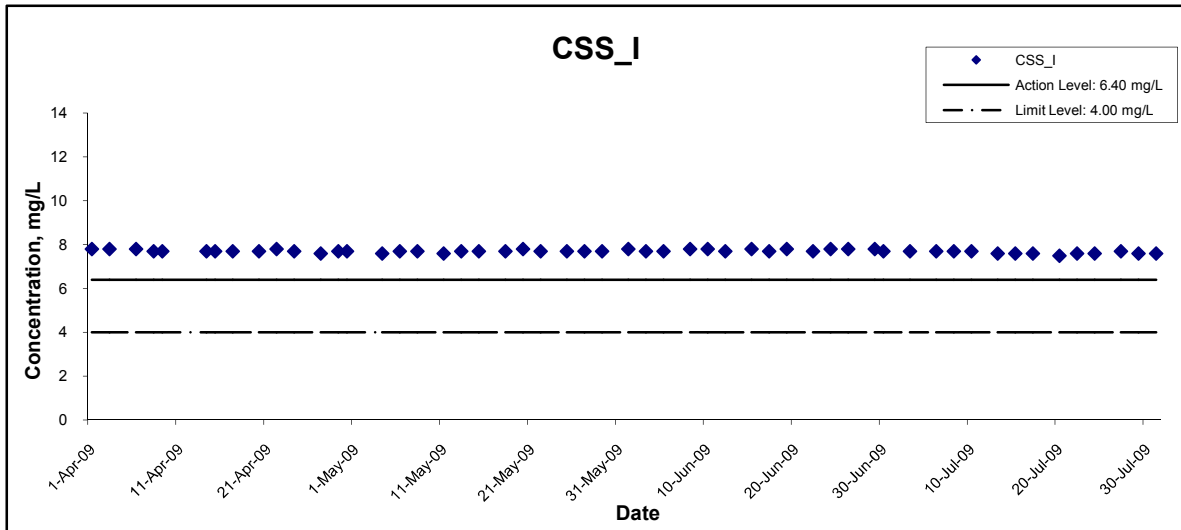
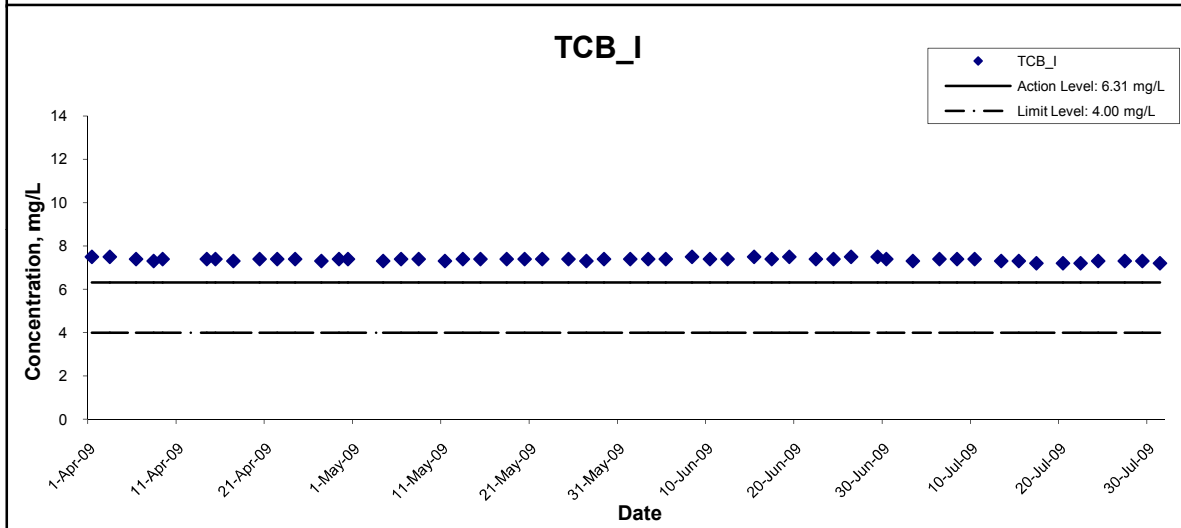
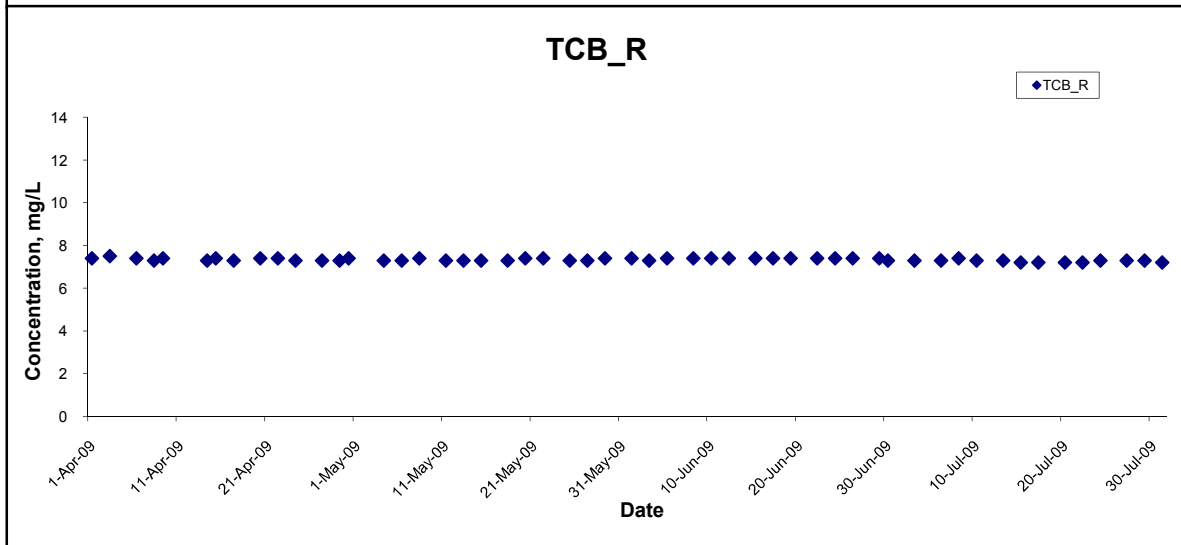
## Dissolved Oxygen

Title Contract No. HY/2003/19 Improvement to Tung Chung Road between Lung Tseng Tau and Cheung Sha  Graphical Presentation of Water Quality Monitoring Results	Scale N.T.S	Project No. MA6030	CINOTECH
	Date Jul 09	Appendix F

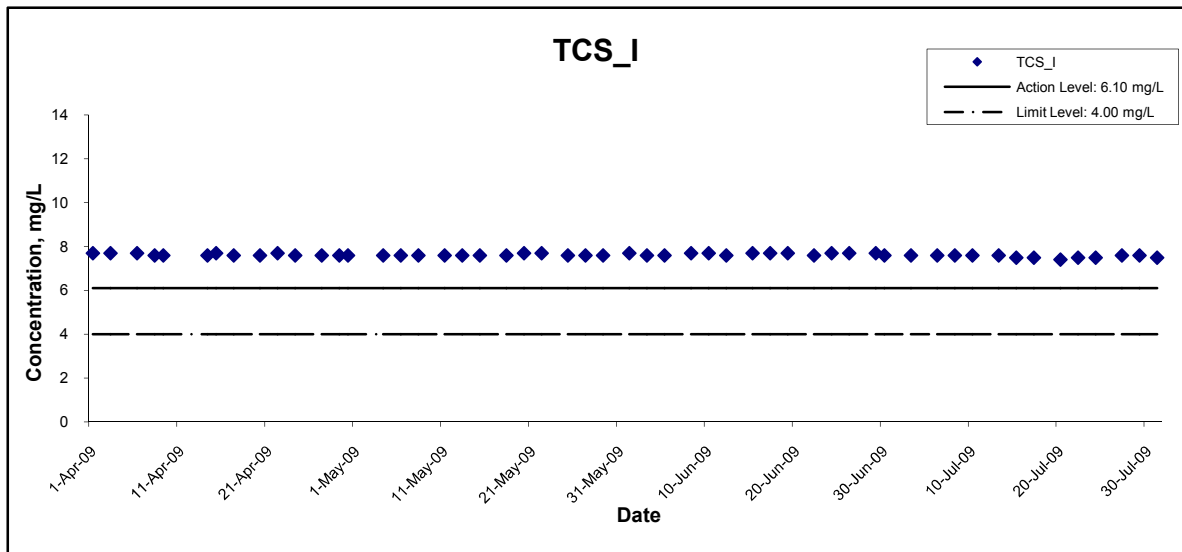
## Dissolved Oxygen

Title Contract No. HY/2003/19 Improvement to Tung Chung Road between Lung Tseng Tau and Cheung Sha Graphical Presentation of Water Quality Monitoring Results	Scale N.T.S	Project No. MA6030	<b>CINOTECH</b>
	Date Jul 09	Appendix F

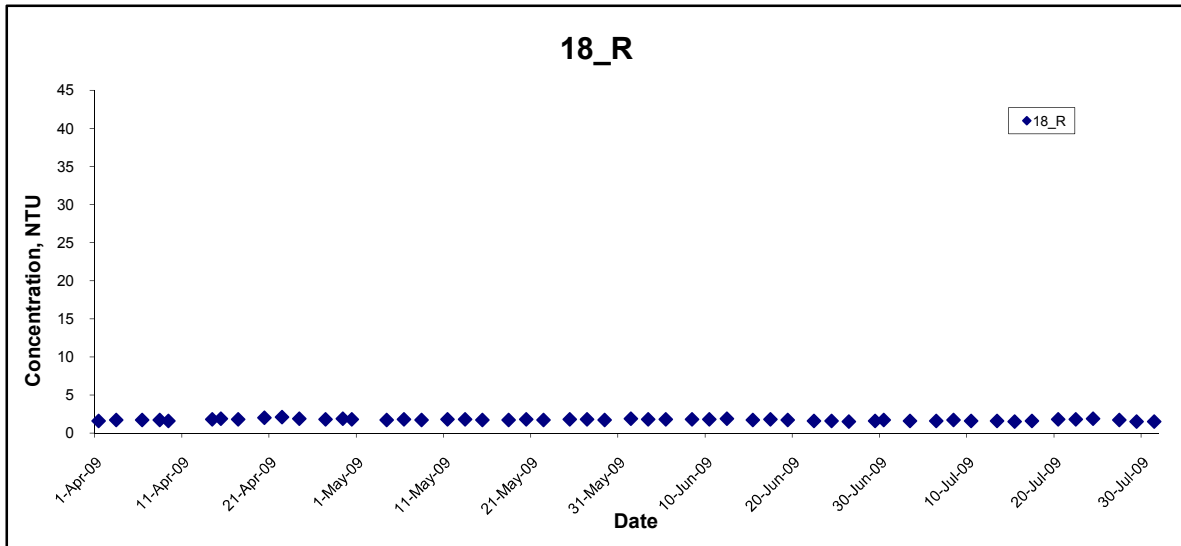
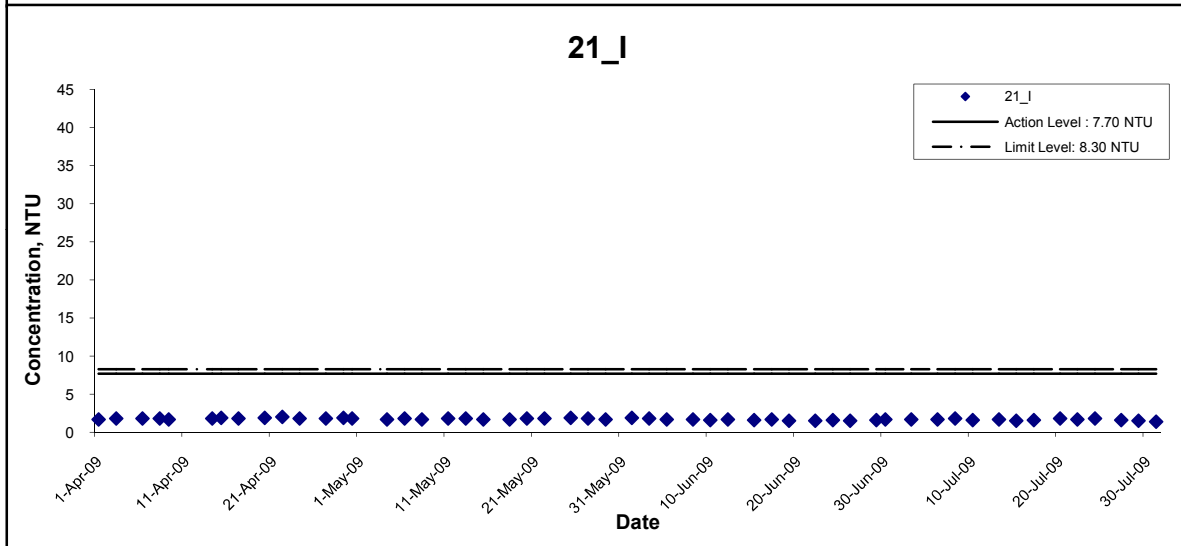
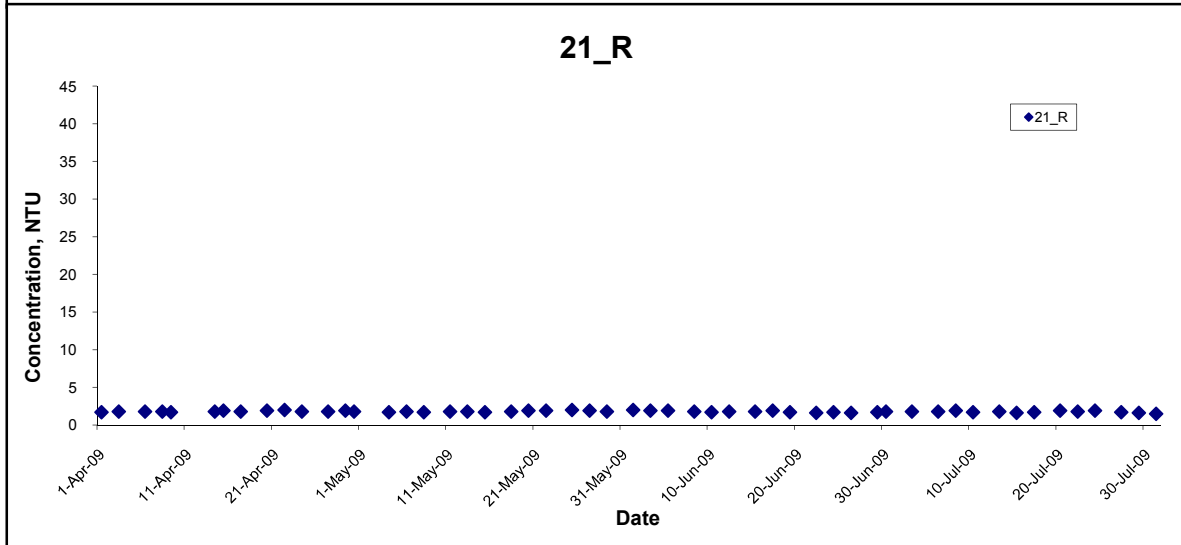
Title Contract No. HY/2003/19 Improvement to Tung Chung Road between Lung Tseng Tau and Cheung Sha Graphical Presentation of Water Quality Monitoring Results	Scale N.T.S	Project No. MA6030	
	Date Jul 09	Appendix F

## Turbidity

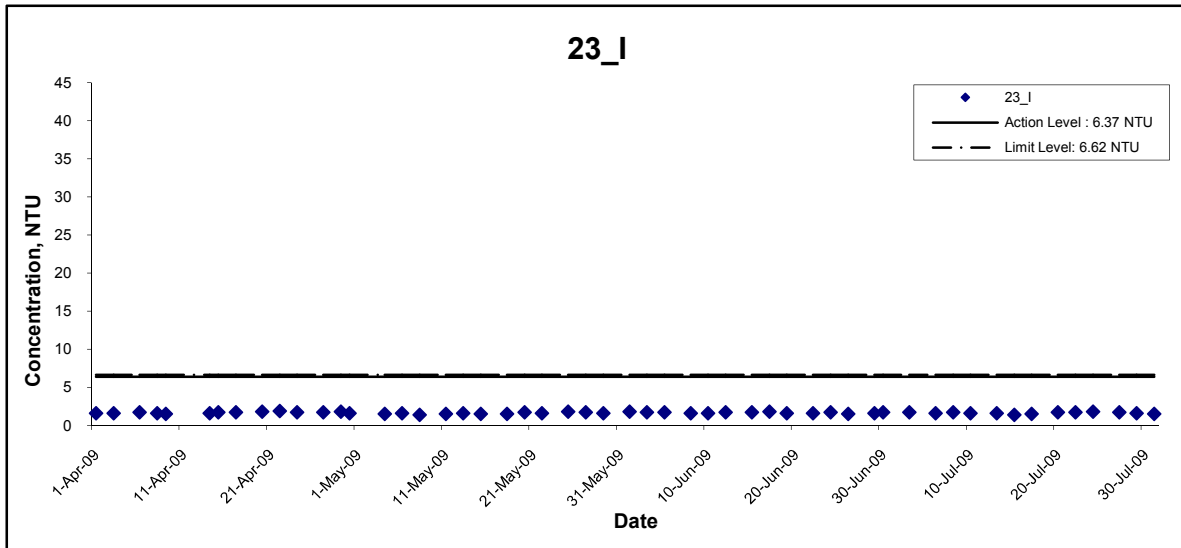
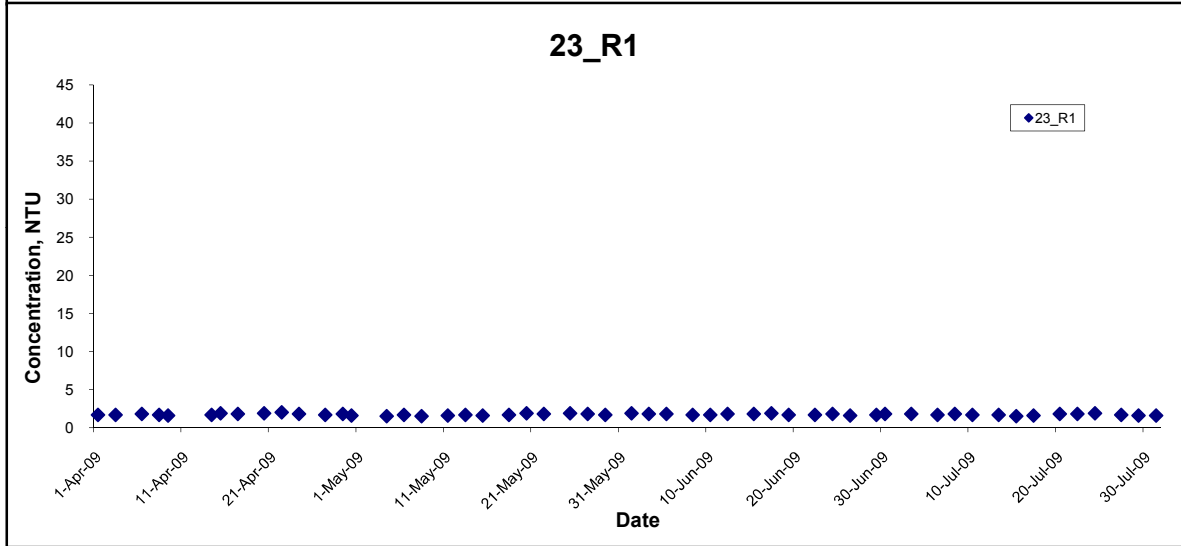
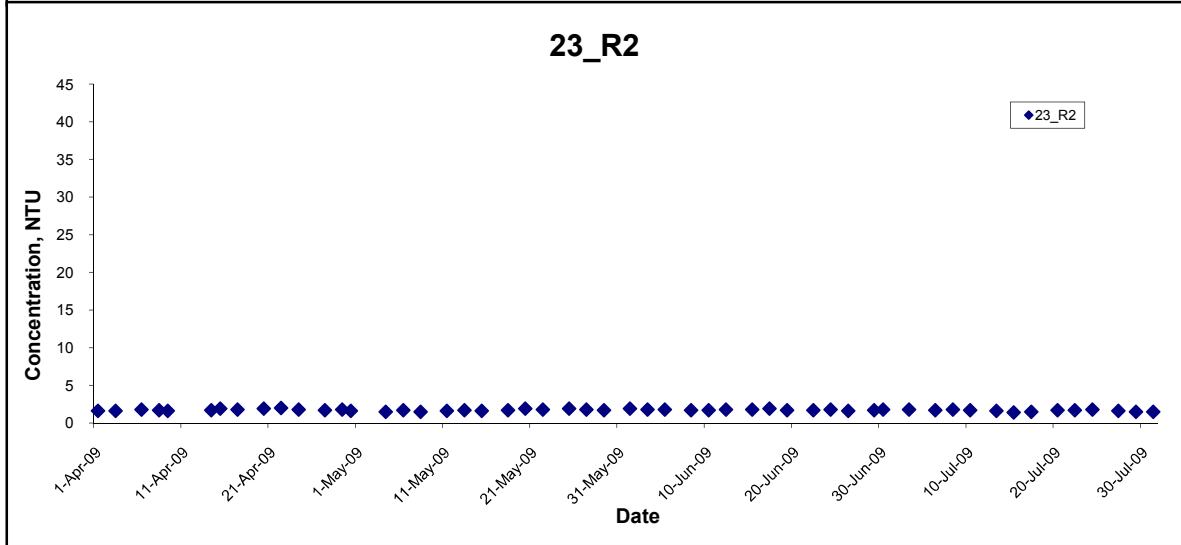
Title Contract No. HY/2003/19 Improvement to Tung Chung Road between Lung Tseng Tau and Cheung Sha Graphical Presentation of Water Quality Monitoring Results	Scale N.T.S	Project No. MA6030	CINOTECH
	Date Jul 09	Appendix F

## Turbidity

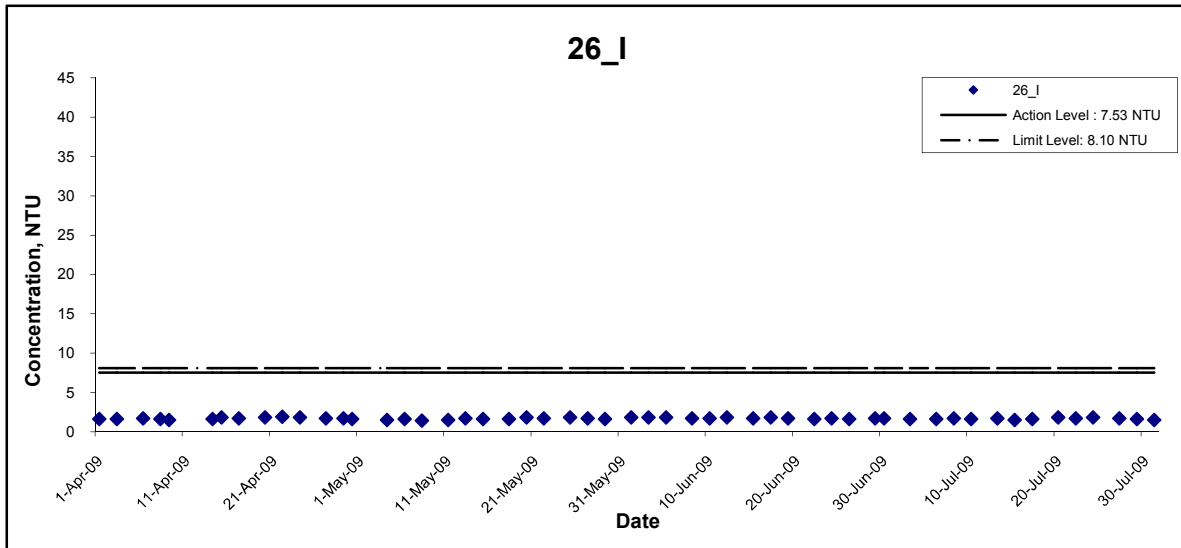
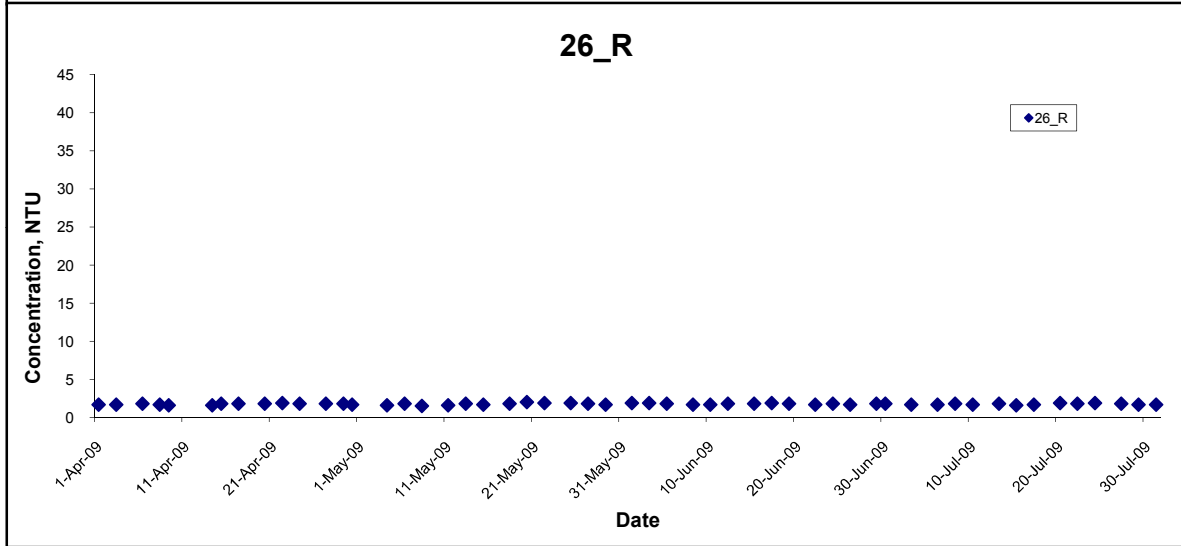
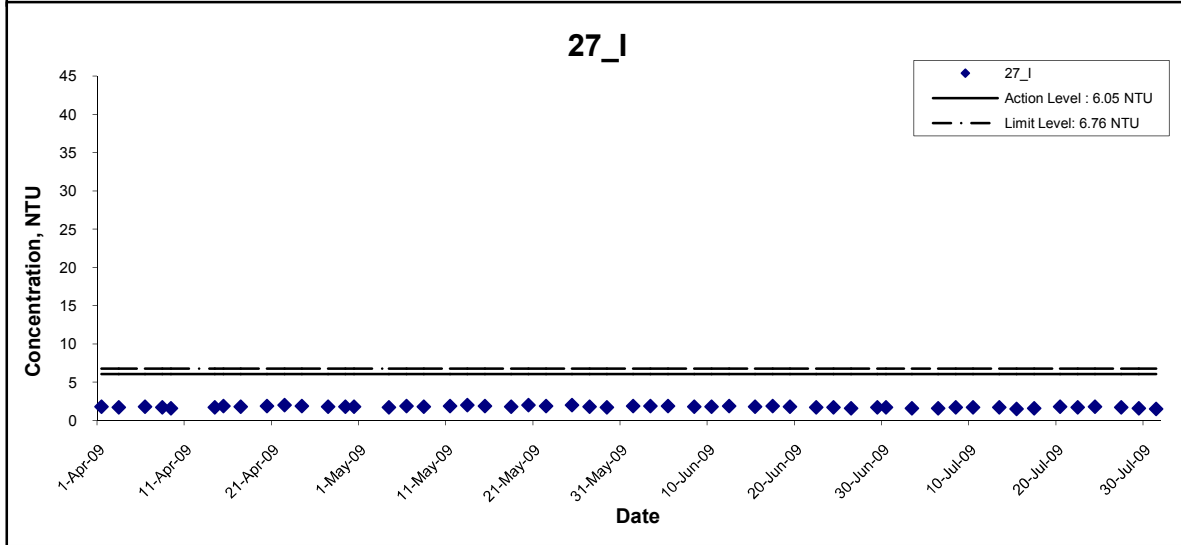
Title Contract No. HY/2003/19 Improvement to Tung Chung Road between Lung Tseng Tau and Cheung Sha Graphical Presentation of Water Quality Monitoring Results	Scale N.T.S	Project No. MA6030	CINOTECH
	Date Jul 09	Appendix F

## Turbidity
