**Contract No. HY/2003/19**

**Improvement to Tung Chung Road  
between Lung Tseng Tau and Cheung Sha**

**Quarterly EM&A Report  
(Version 2.0)**

May 2009 to July 2009

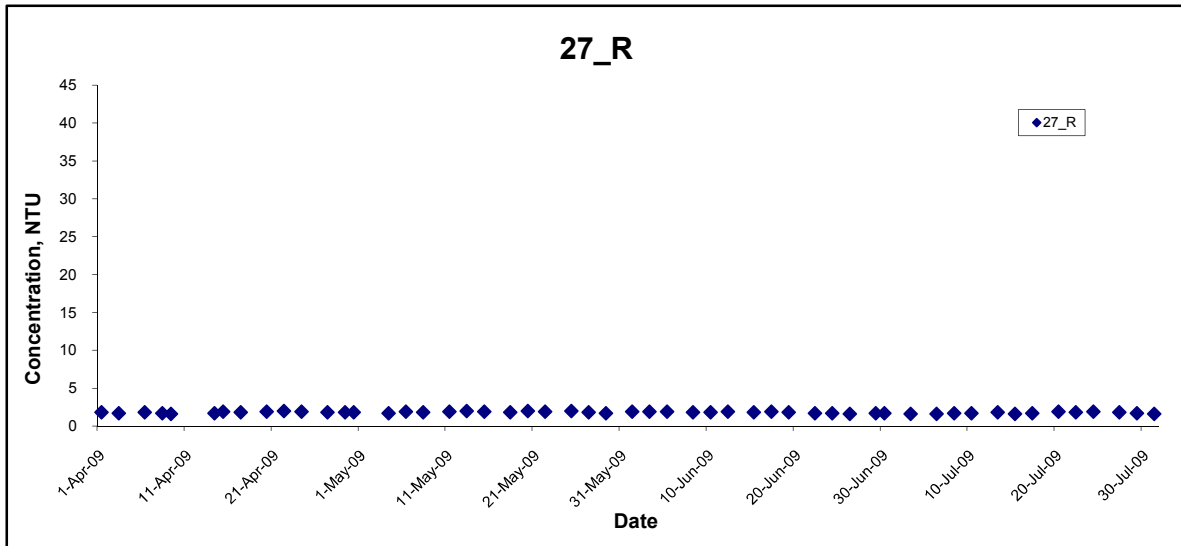
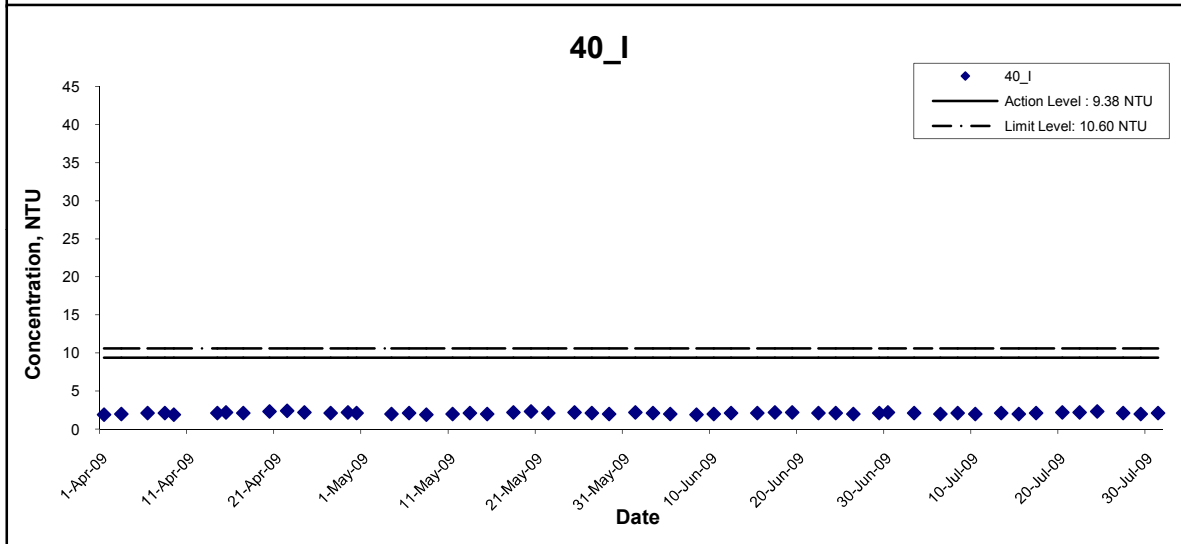
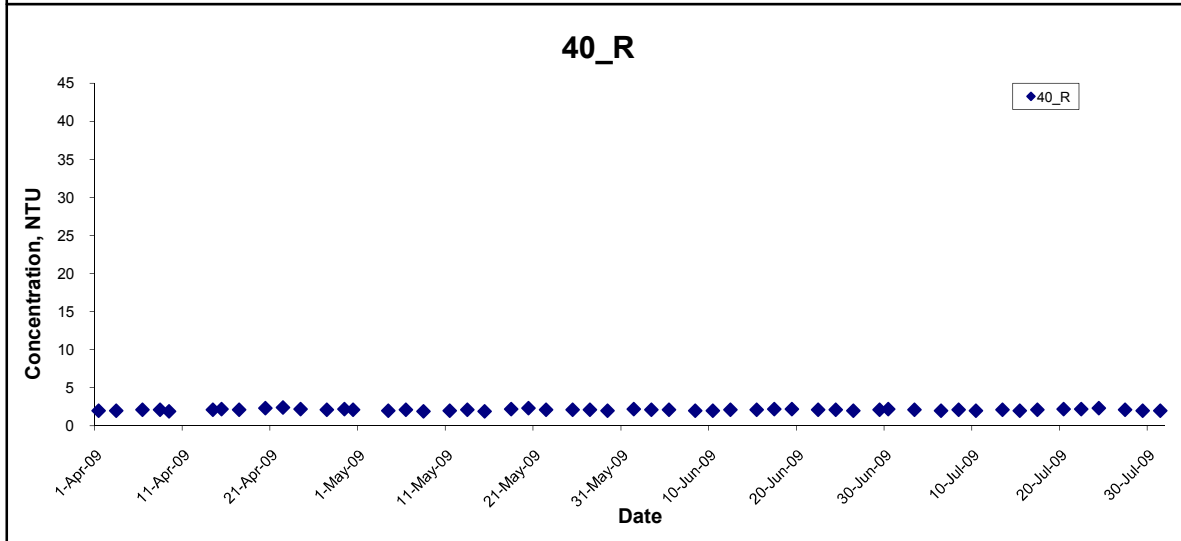
Title Contract No. HY/2003/19 Improvement to Tung Chung Road between Lung Tseng Tau and Cheung Sha Graphical Presentation of Water Quality Monitoring Results	Scale	N.T.S	Project No.	MA6030
	Date	Jul 09	Appendix	F

## Turbidity

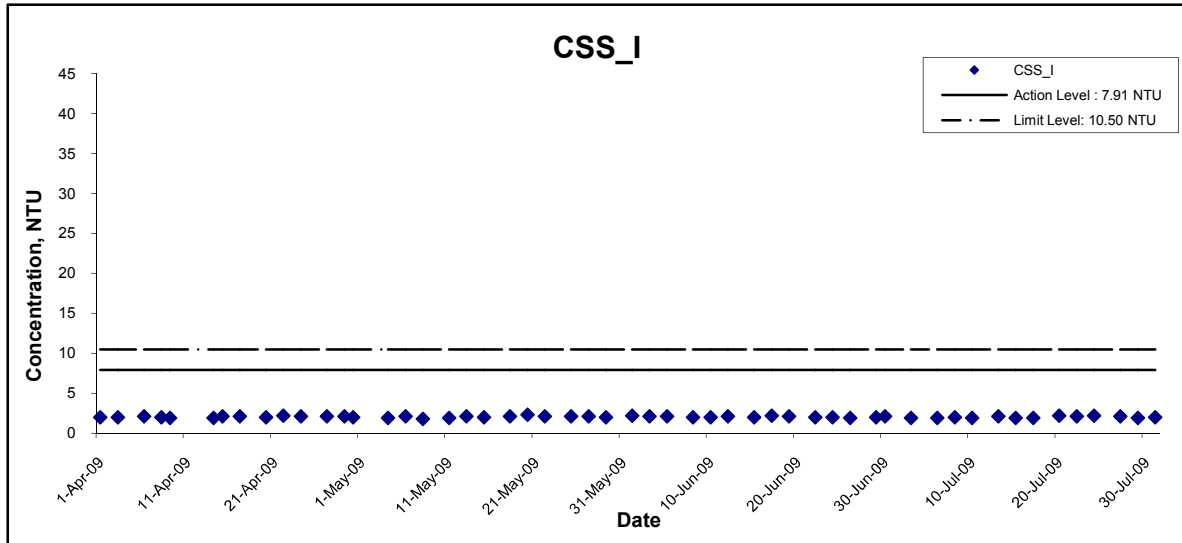
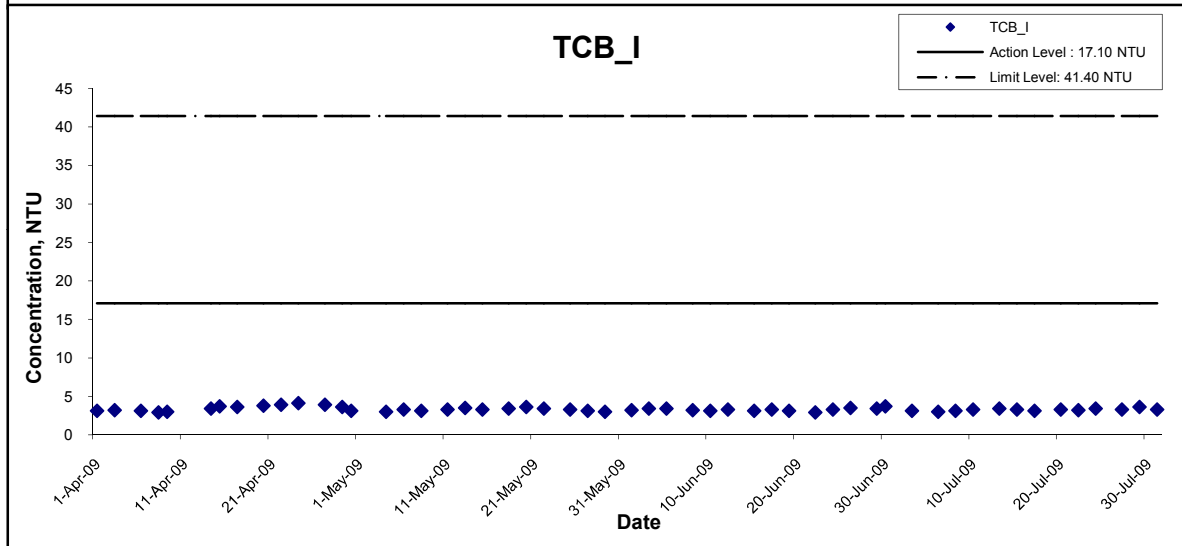
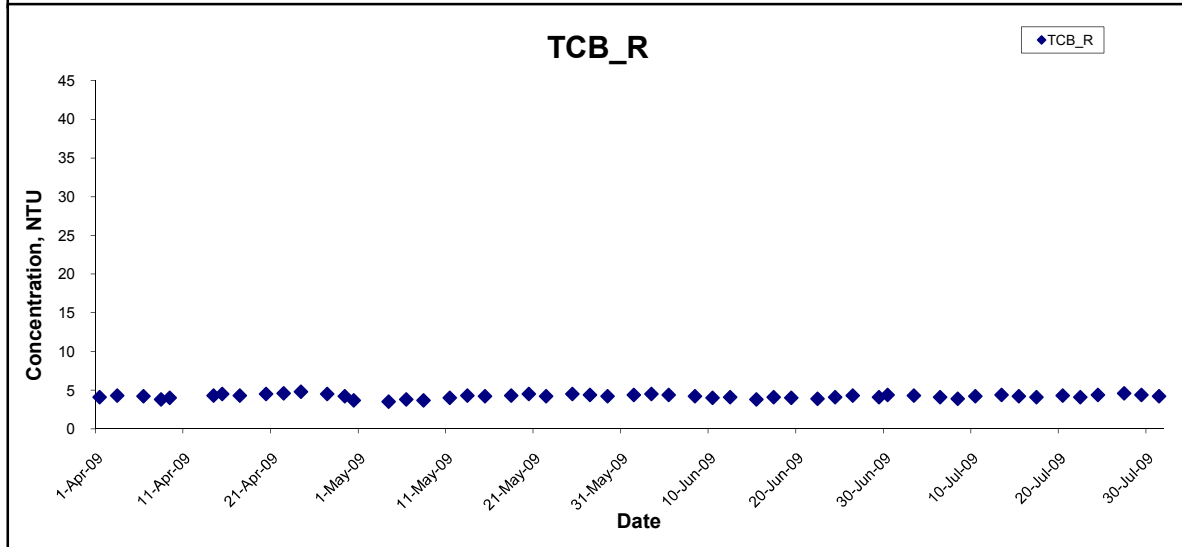
Title Contract No. HY/2003/19 Improvement to Tung Chung Road between Lung Tseng Tau and Cheung Sha Graphical Presentation of Water Quality Monitoring Results	Scale N.T.S	Project No. MA6030	CINOTECH
	Date Jul 09	Appendix F

## Turbidity

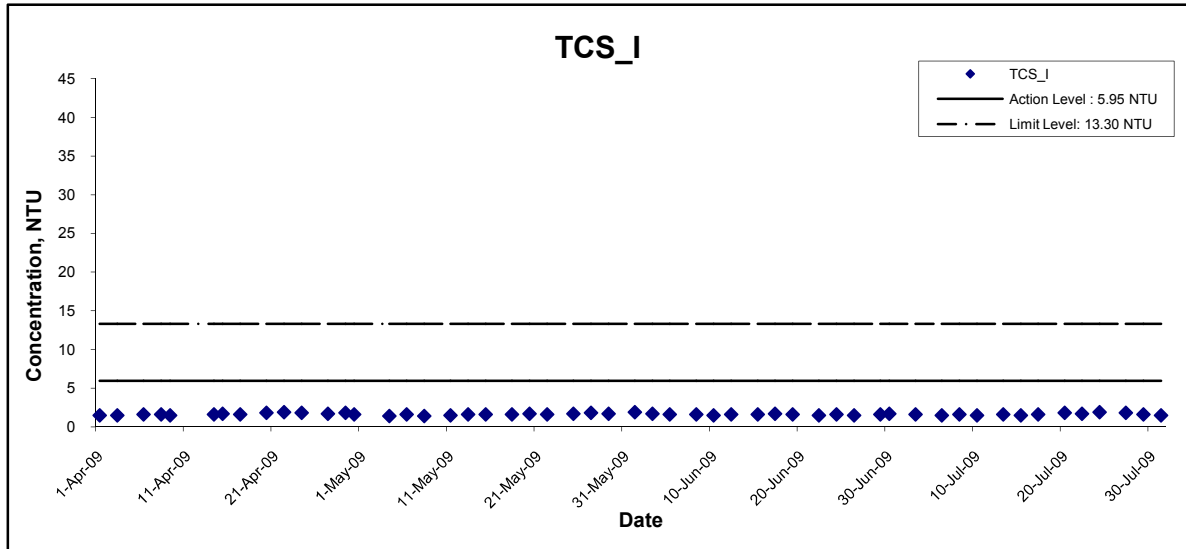
Title Contract No. HY/2003/19 Improvement to Tung Chung Road between Lung Tseng Tau and Cheung Sha  Graphical Presentation of Water Quality Monitoring Results	Scale N.T.S	Project No. MA6030	
	Date Jul 09	Appendix F

## Turbidity

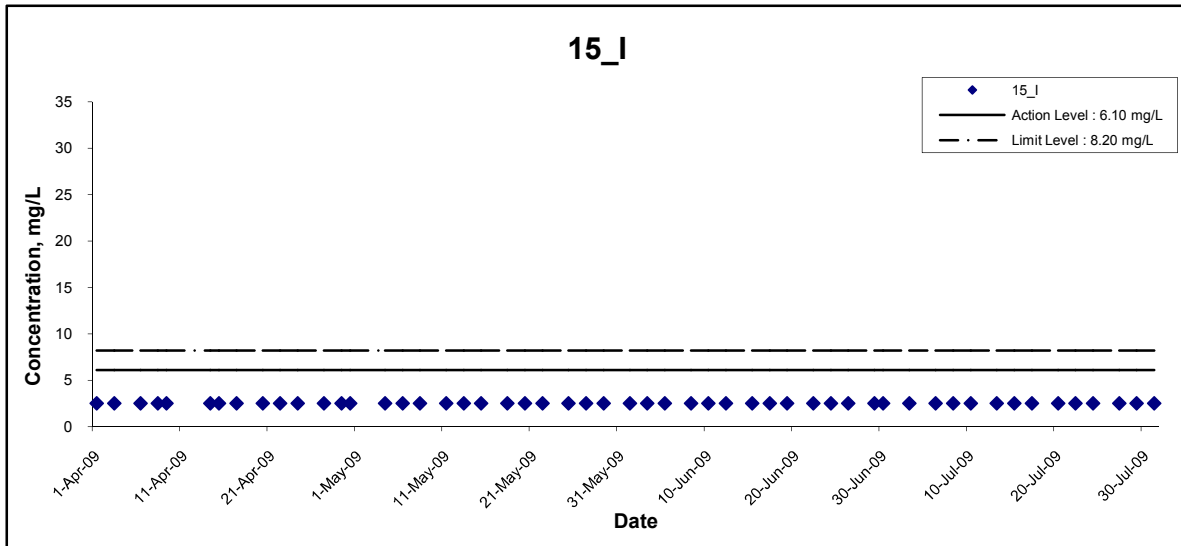
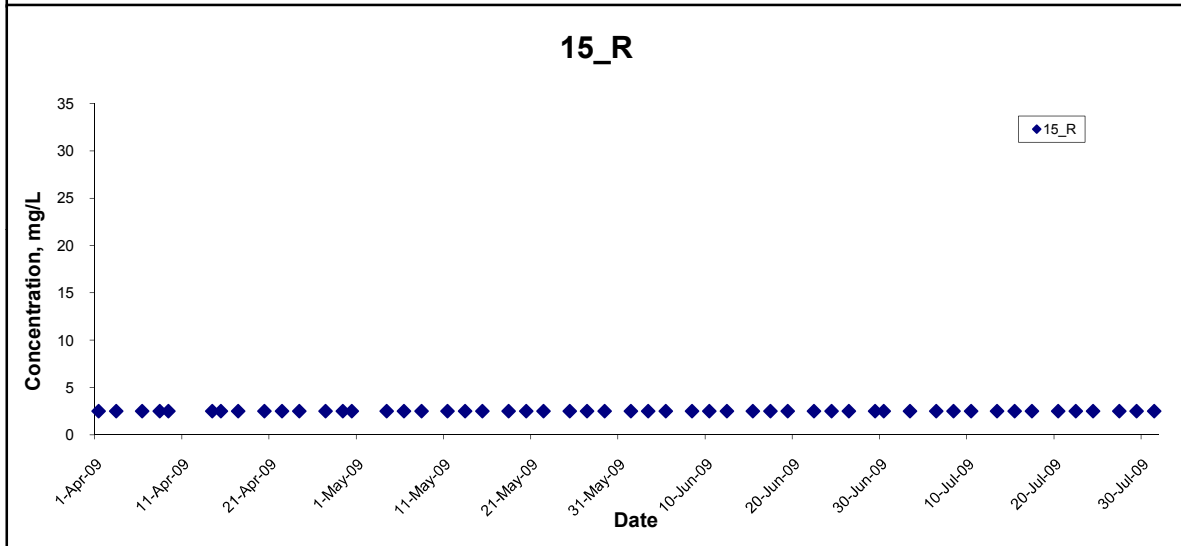
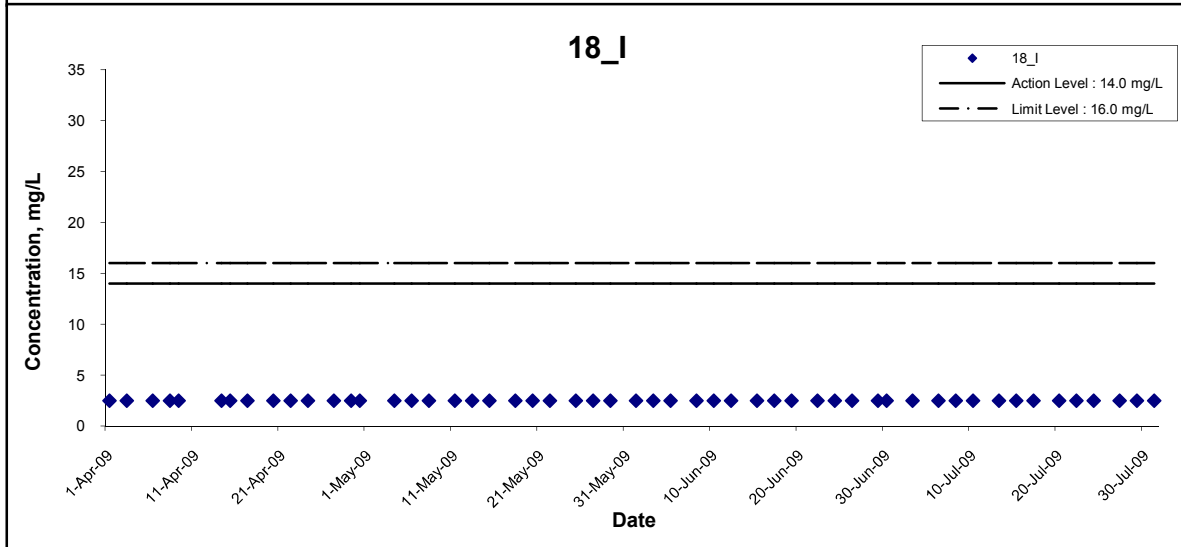
Title Contract No. HY/2003/19 Improvement to Tung Chung Road between Lung Tseng Tau and Cheung Sha  Graphical Presentation of Water Quality Monitoring Results	Scale N.T.S	Project No. MA6030	
	Date Jul 09	Appendix F

## Suspended Solids

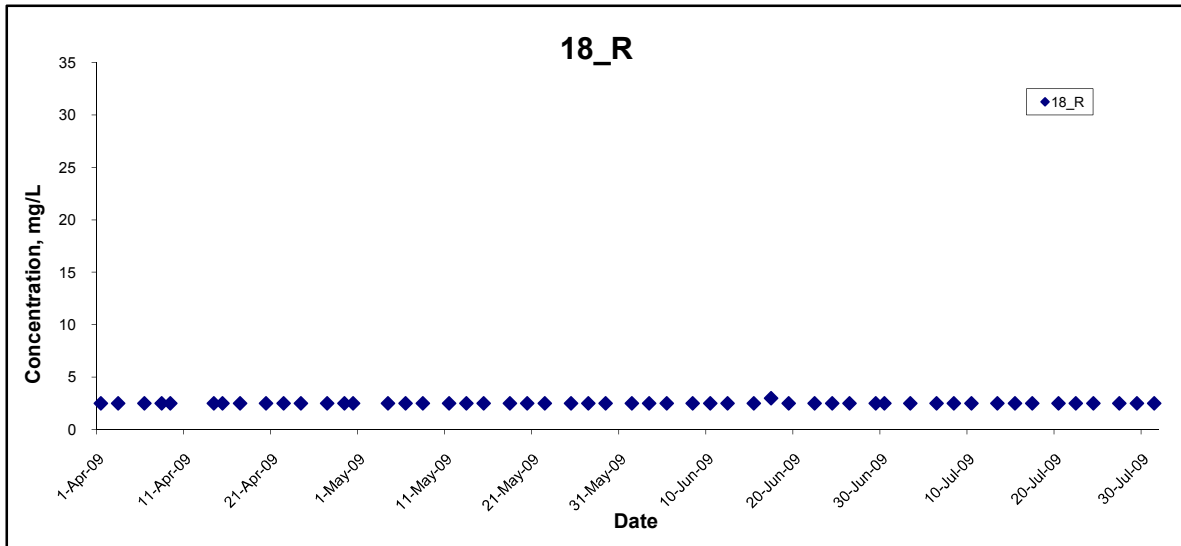
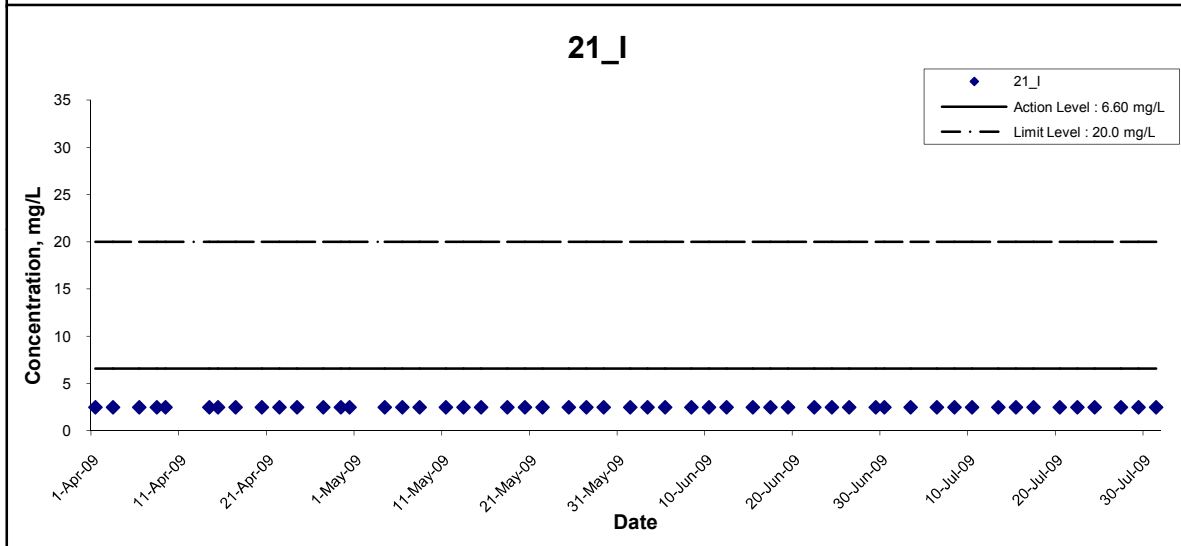
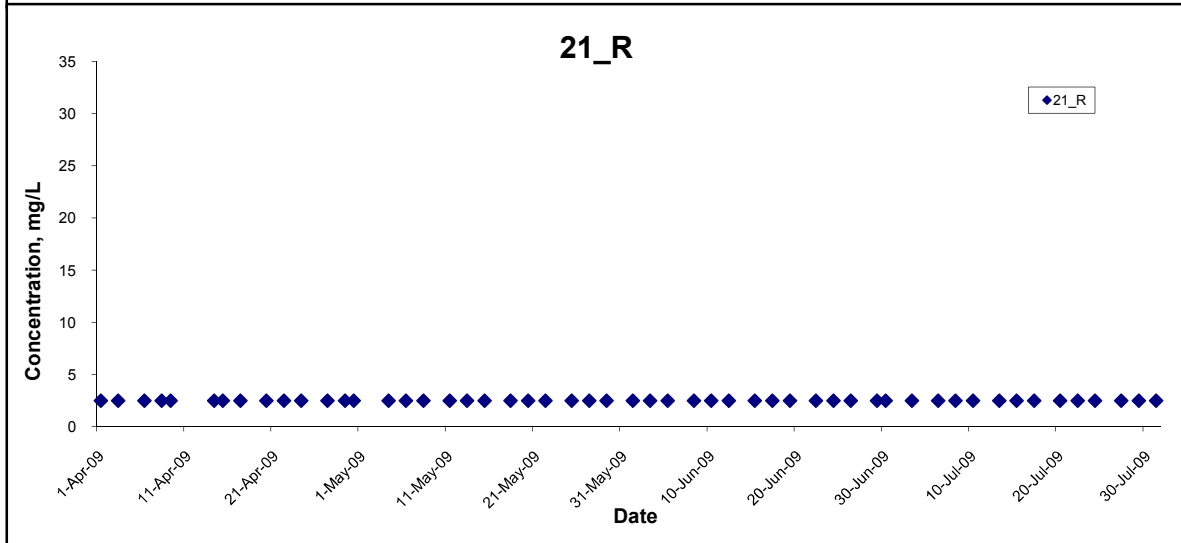
Title Contract No. HY/2003/19 Improvement to Tung Chung Road between Lung Tseng Tau and Cheung Sha Graphical Presentation of Water Quality Monitoring Results	Scale N.T.S	Project No. MA6030	CINOTECH
	Date Jul 09	Appendix F

## Suspended Solids

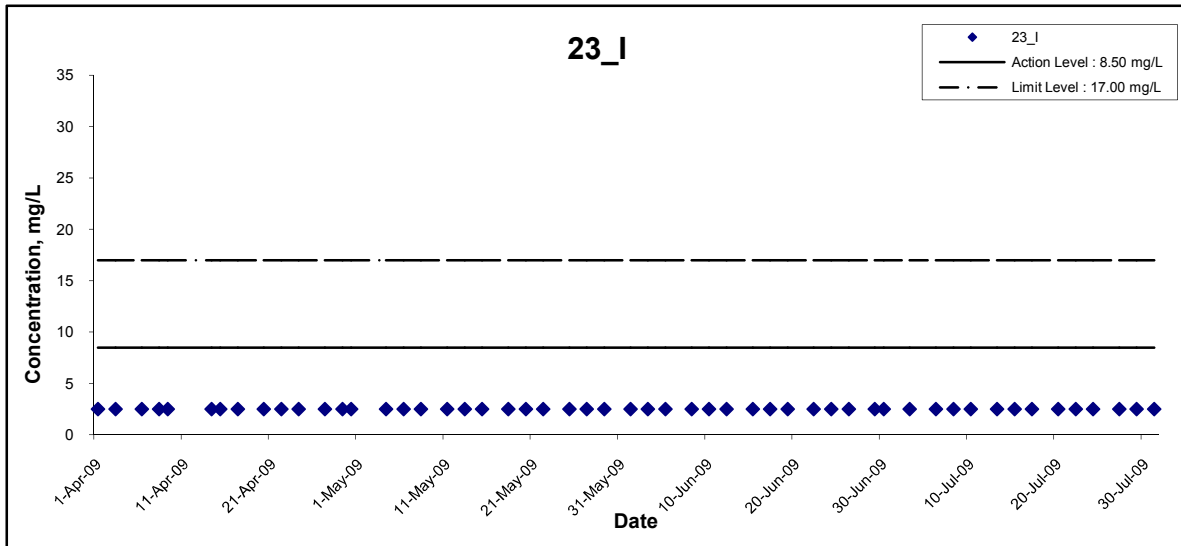
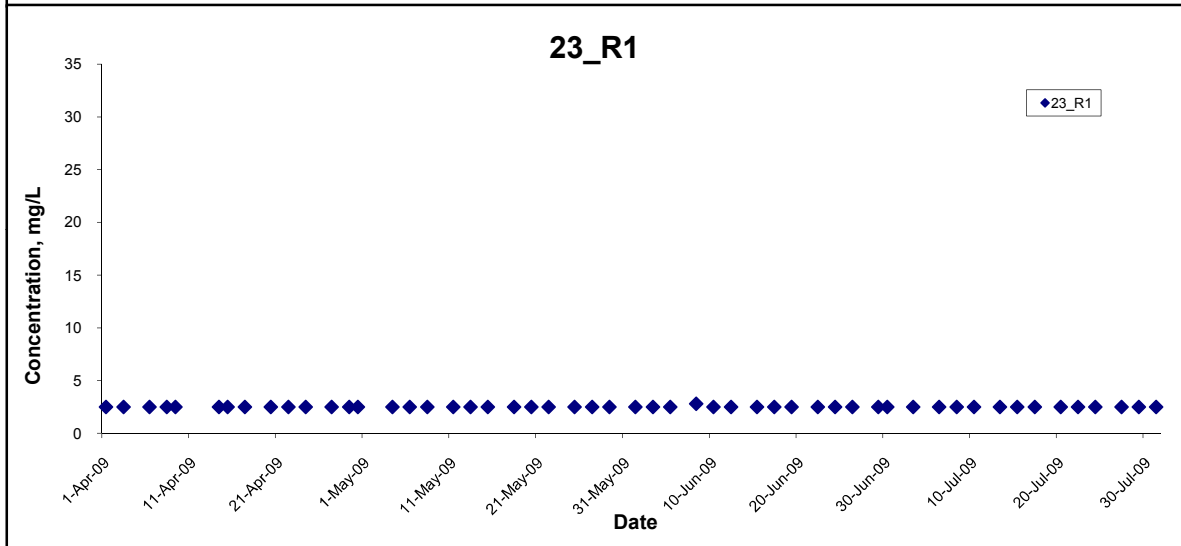
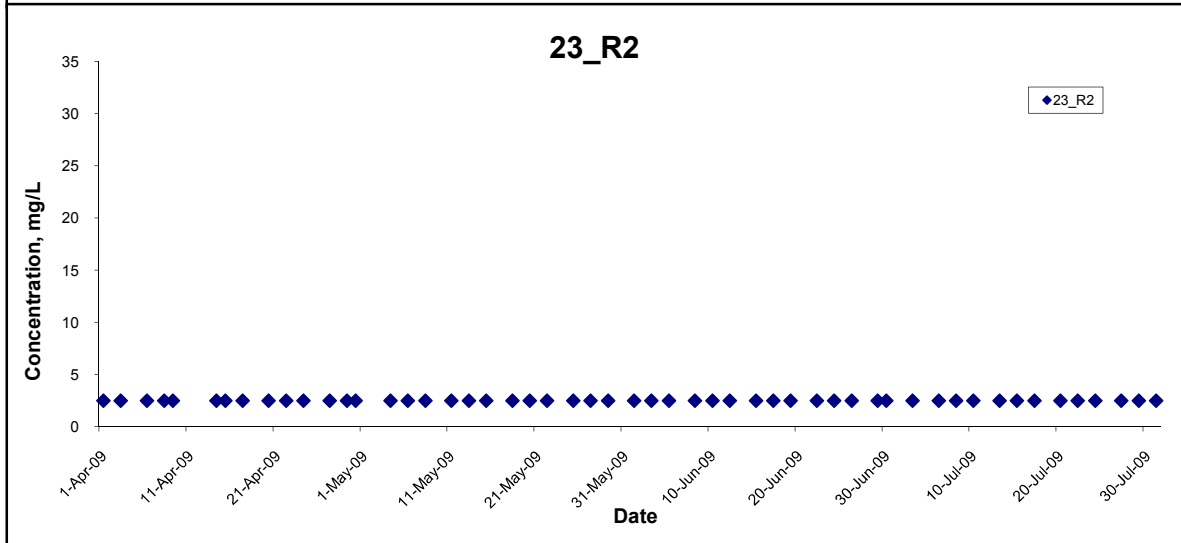
Title Contract No. HY/2003/19 Improvement to Tung Chung Road between Lung Tseng Tau and Cheung Sha Graphical Presentation of Water Quality Monitoring Results	Scale N.T.S	Project No. MA6030	CINOTECH
	Date Jul 09	Appendix F

## Suspended Solids

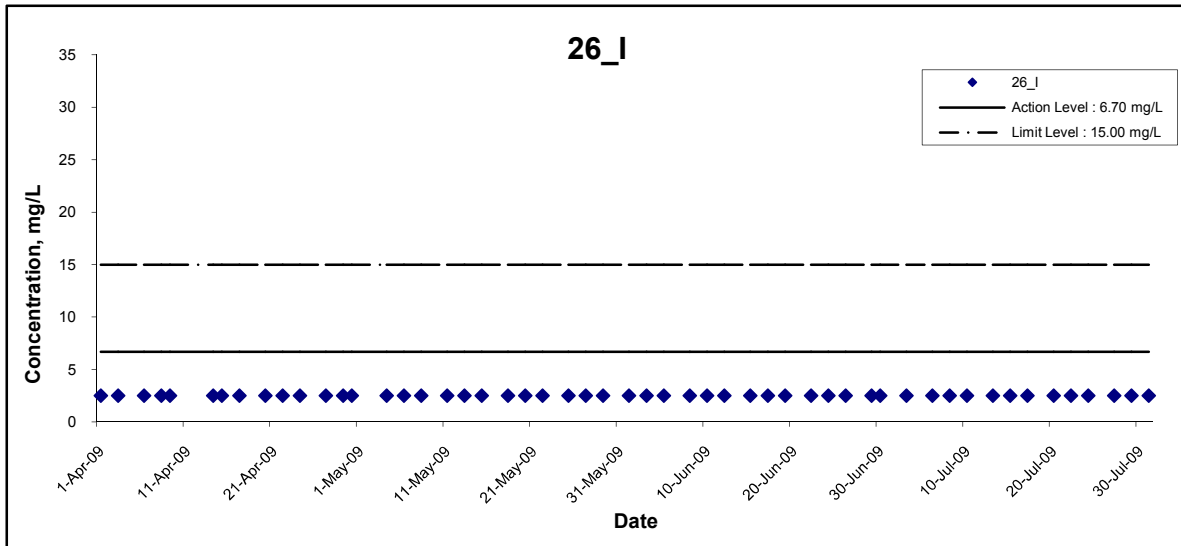
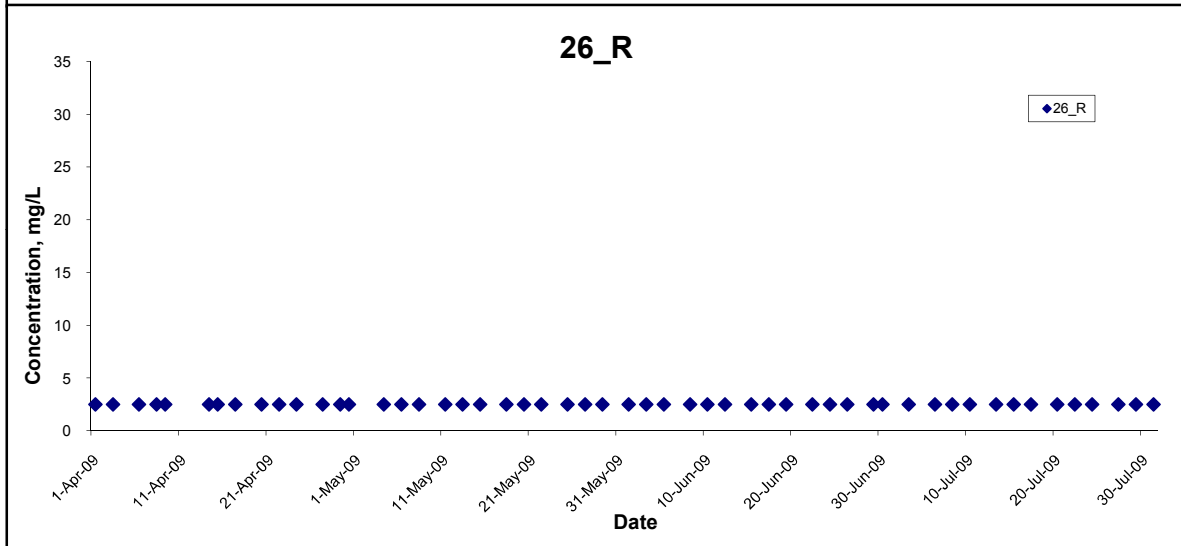
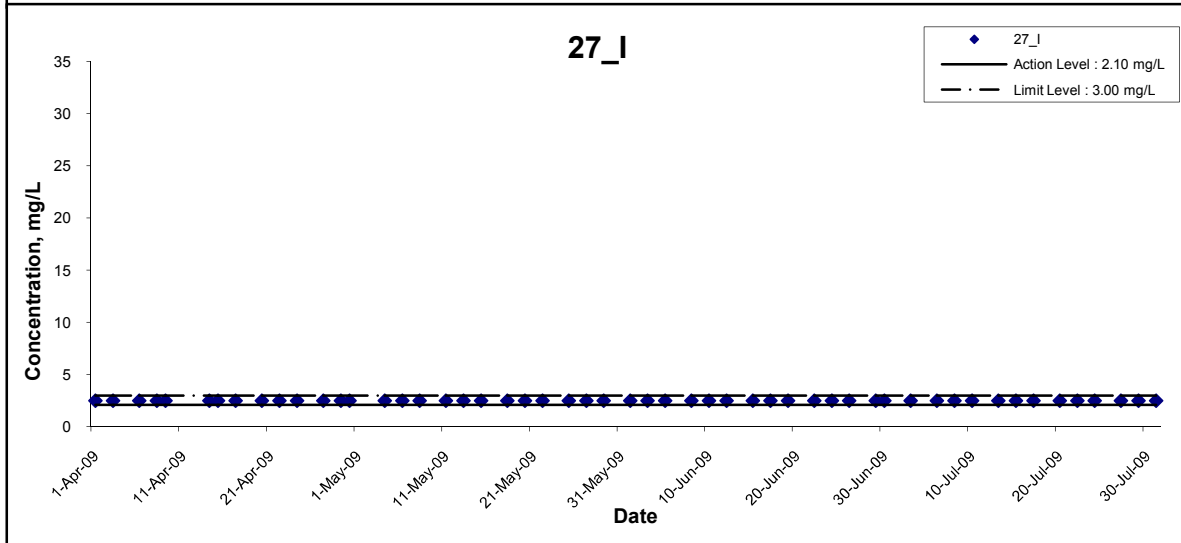
Title Contract No. HY/2003/19 Improvement to Tung Chung Road between Lung Tseng Tau and Cheung Sha Graphical Presentation of Water Quality Monitoring Results	Scale N.T.S	Project No. MA6030	CINOTECH
	Date Jul 09	Appendix F

## Suspended Solids

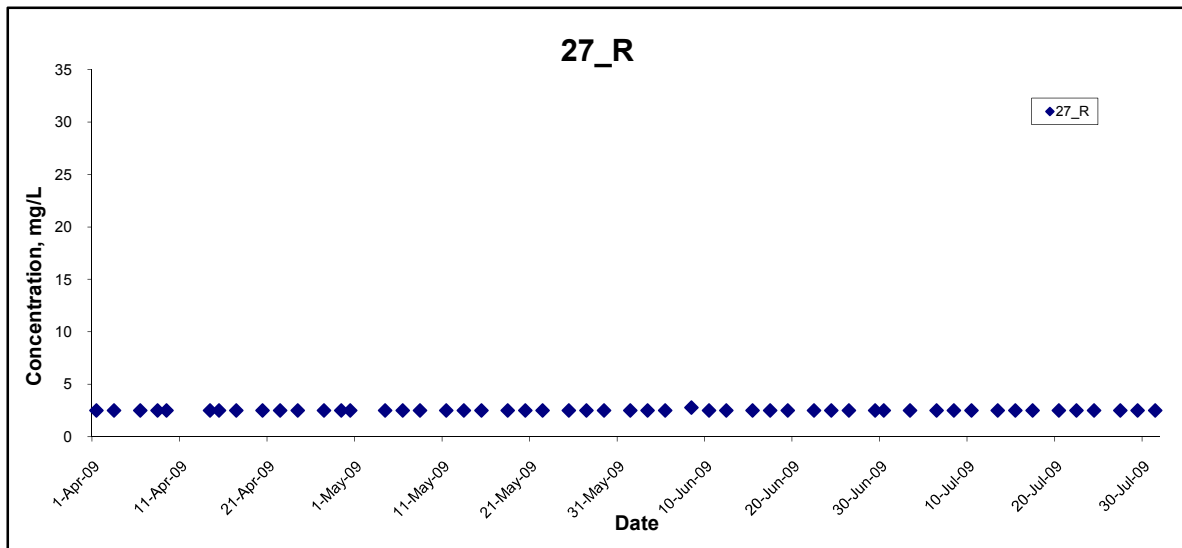
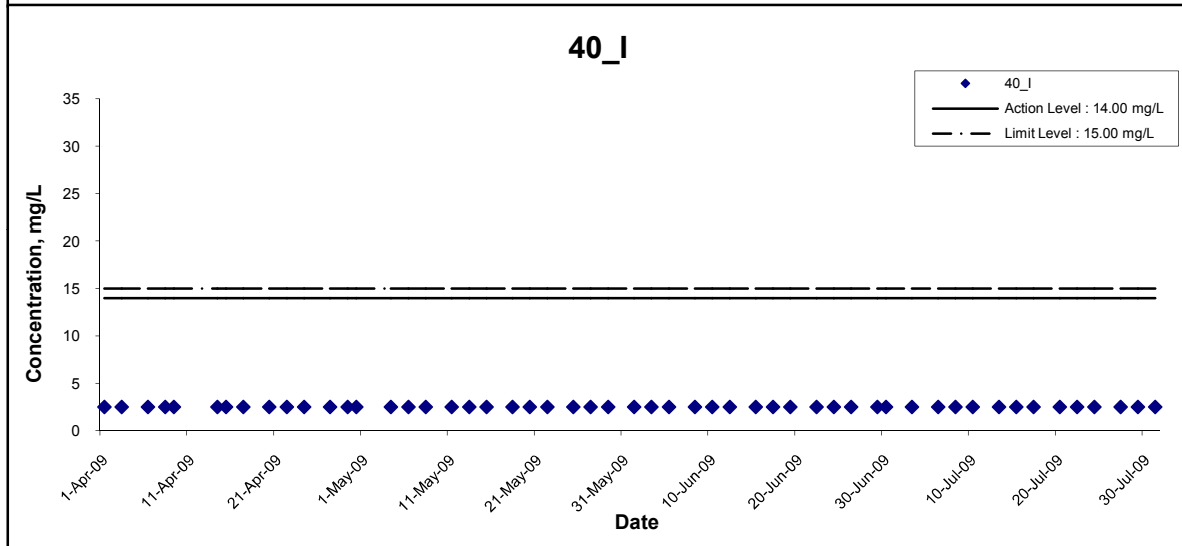
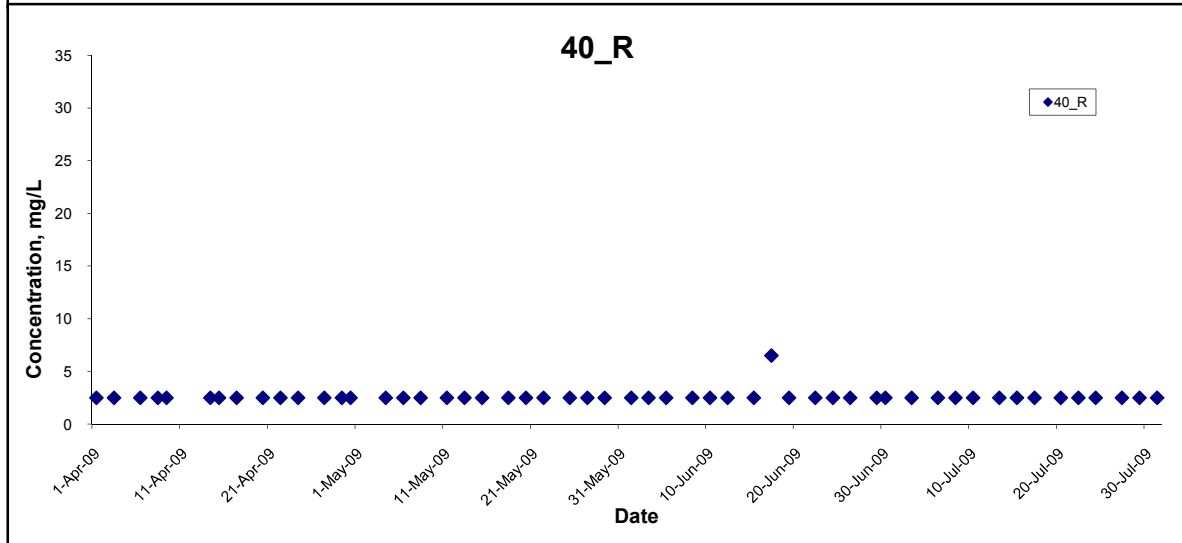
Title Contract No. HY/2003/19 Improvement to Tung Chung Road between Lung Tseng Tau and Cheung Sha Graphical Presentation of Water Quality Monitoring Results	Scale N.T.S	Project No. MA6030	CINOTECH
	Date Jul 09	Appendix F

## Suspended Solids

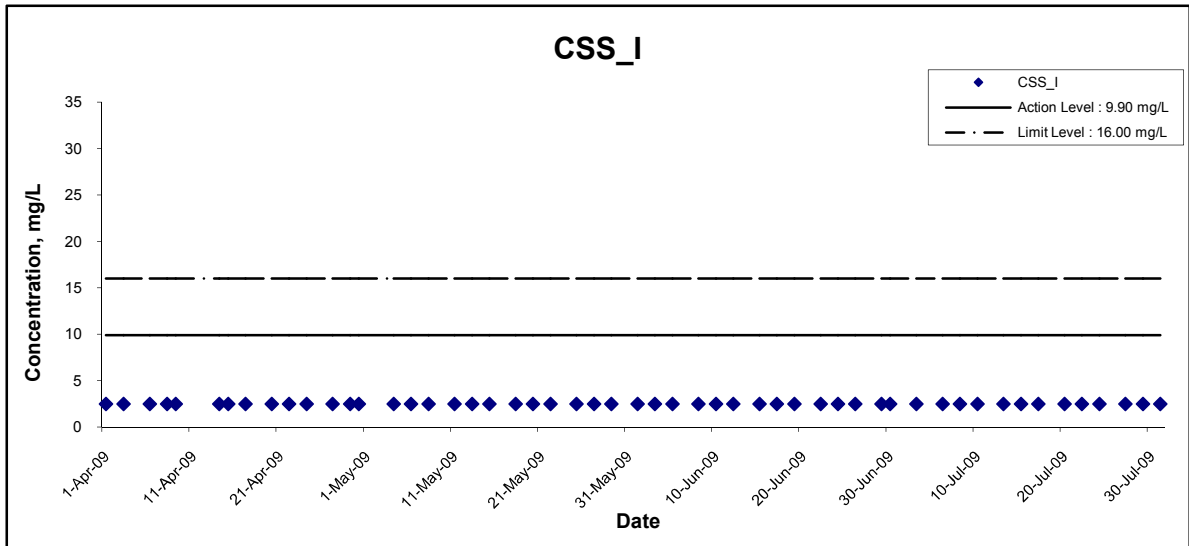
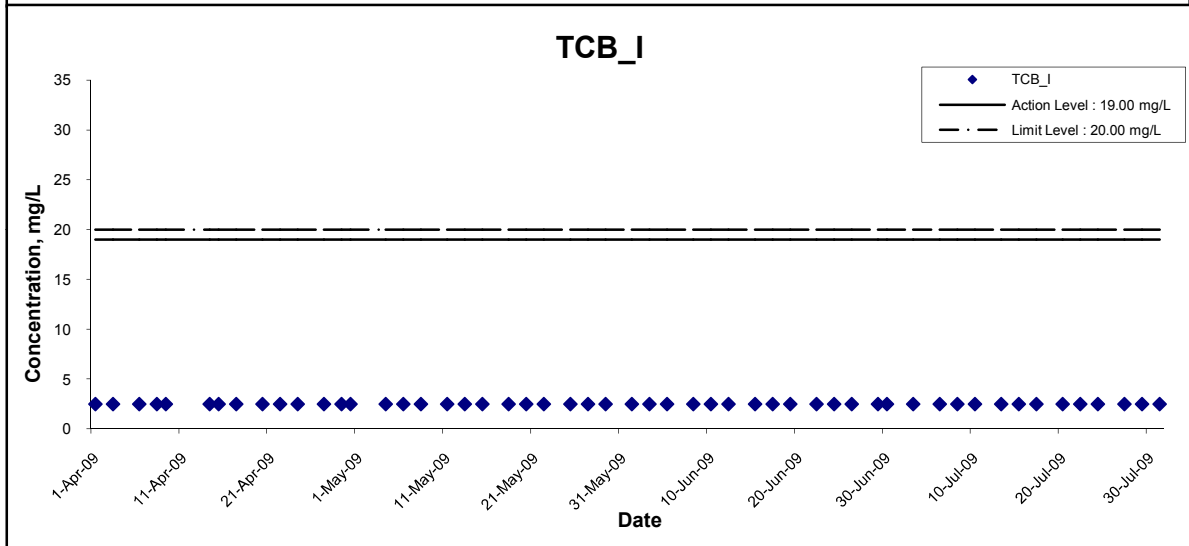
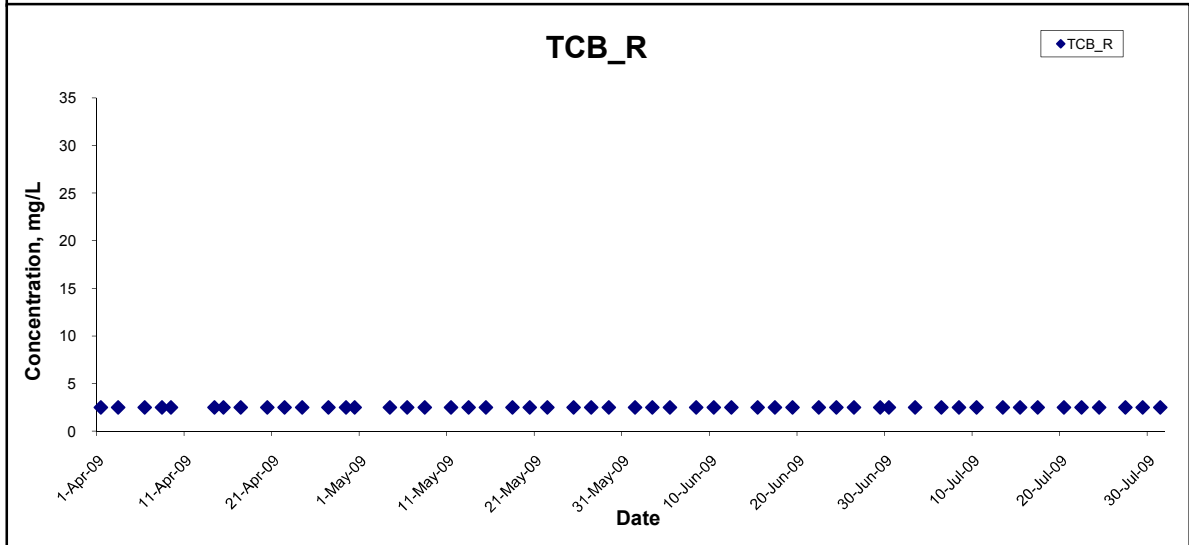
Title Contract No. HY/2003/19 Improvement to Tung Chung Road between Lung Tseng Tau and Cheung Sha  Graphical Presentation of Water Quality Monitoring Results	Scale N.T.S	Project No. MA6030	CINOTECH
	Date Jul 09	Appendix F

## Suspended Solids

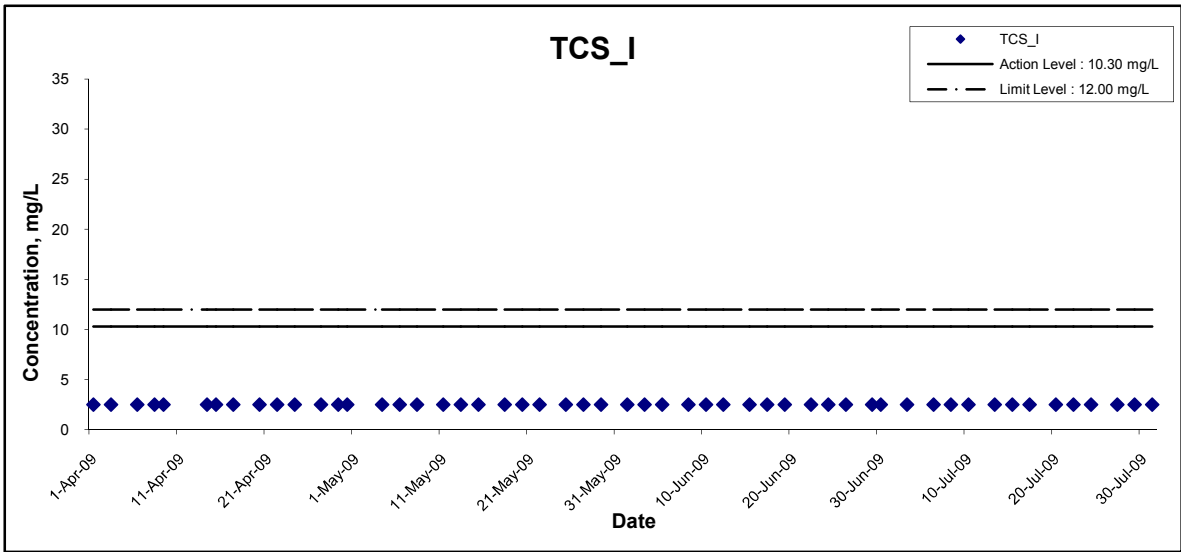
Title Contract No. HY/2003/19 Improvement to Tung Chung Road between Lung Tseng Tau and Cheung Sha Graphical Presentation of Water Quality Monitoring Results	Scale	N.T.S	Project No.	MA6030
	Date	Jul 09	Appendix	F

### Suspended Solids
