Contract No. : DC/2007/06
**River Improvement Works in Upper Lam Tsuen, She
Shan River and Upper Tai Po River**

ENVIRONMENTAL MONITORING AND AUDIT

MONTHLY EM&A REPORT of

UPPER TAI PO RIVER

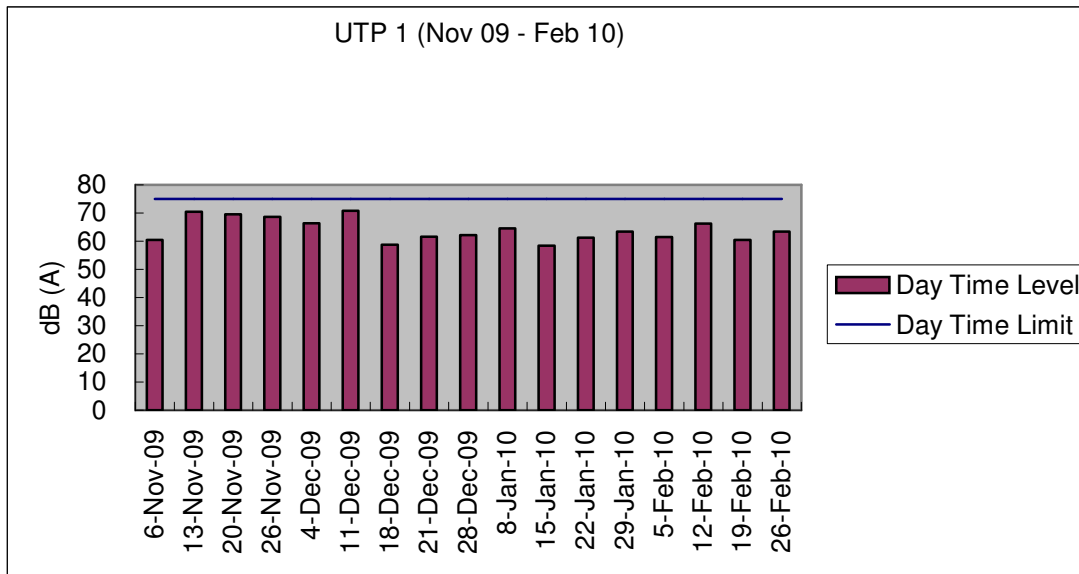
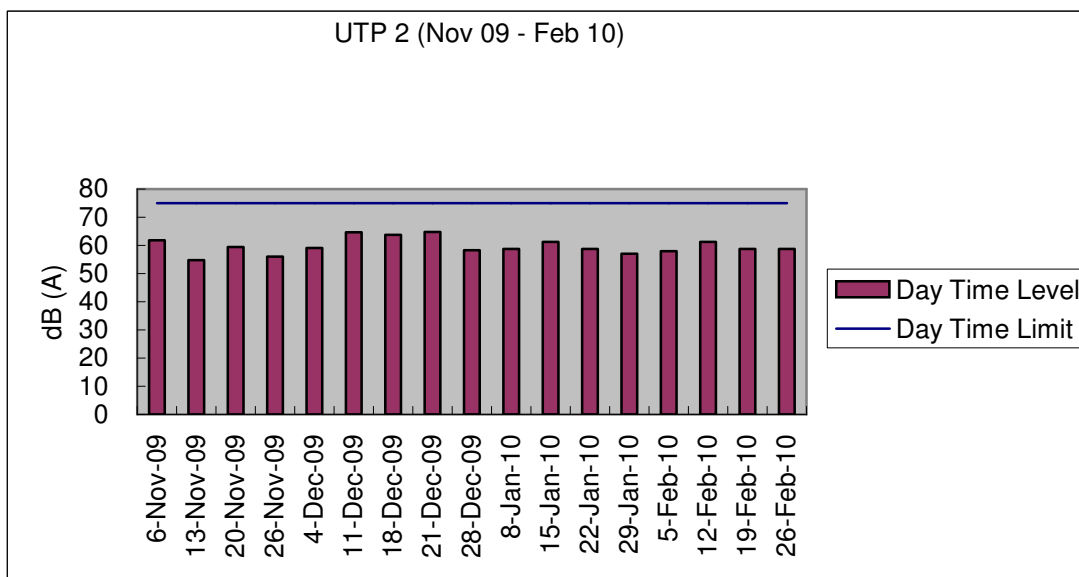
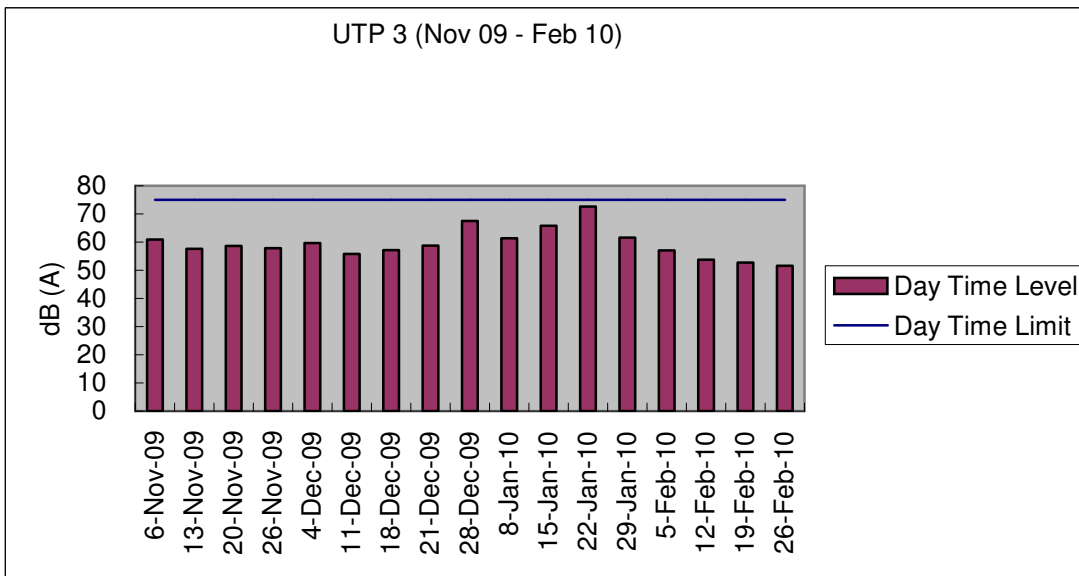
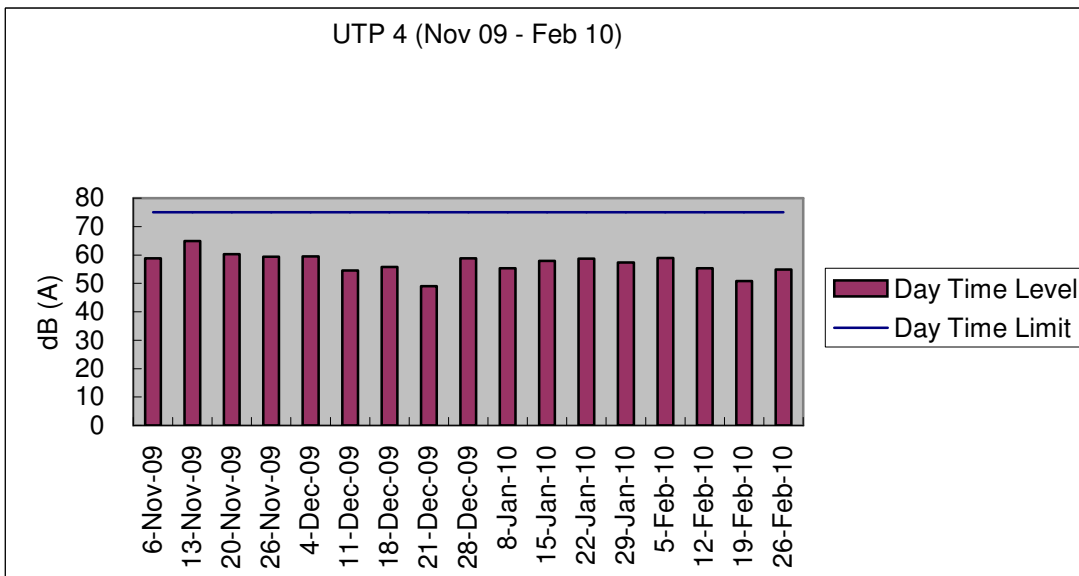
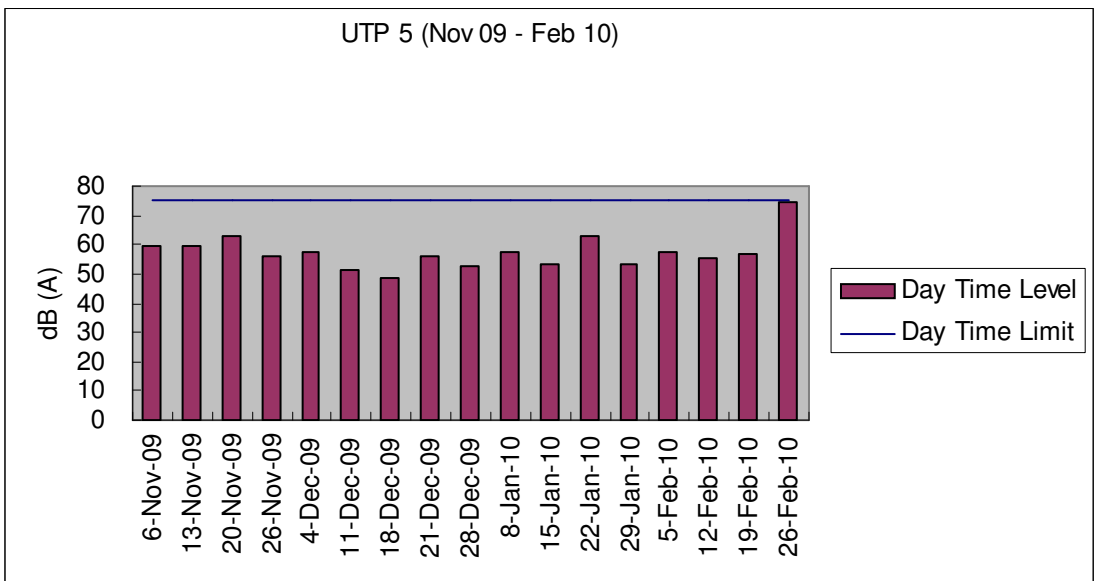
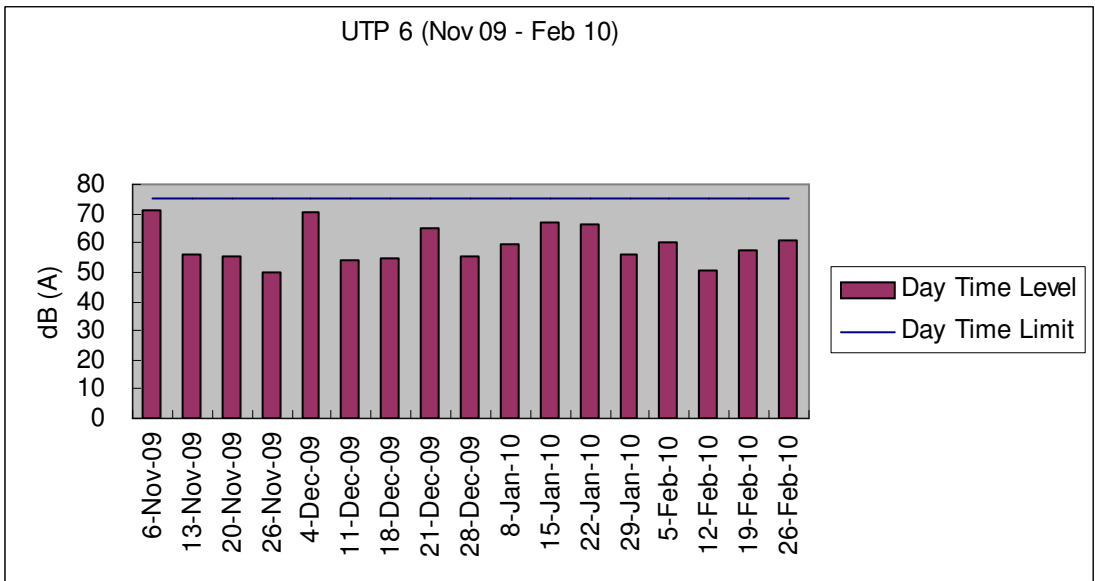
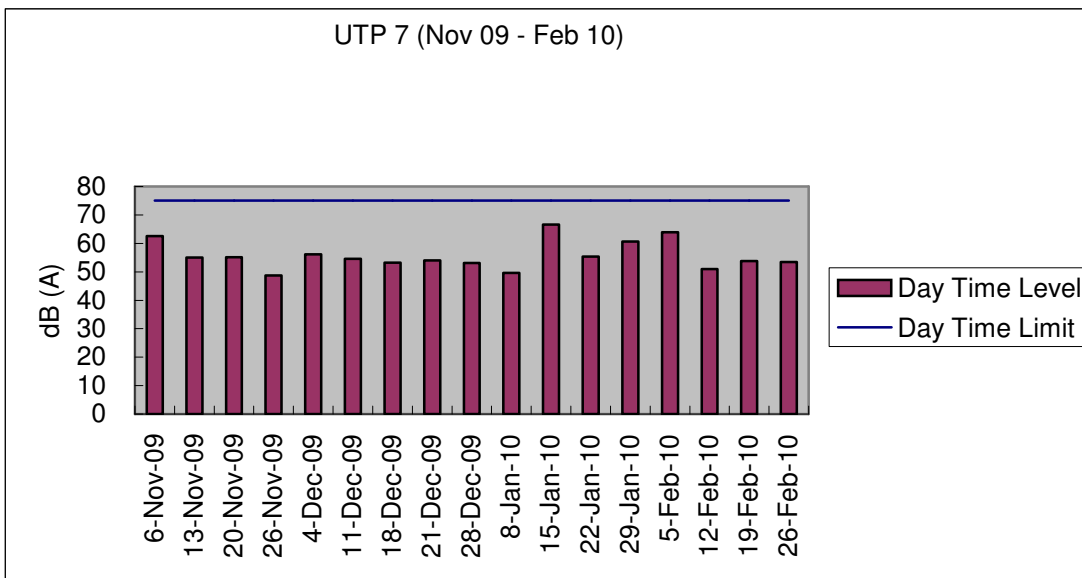
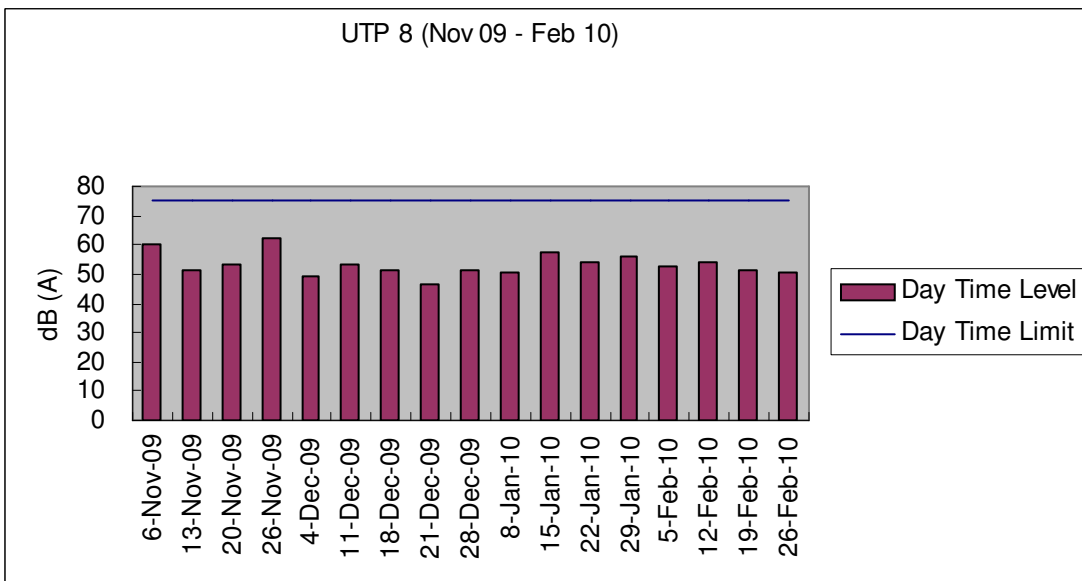
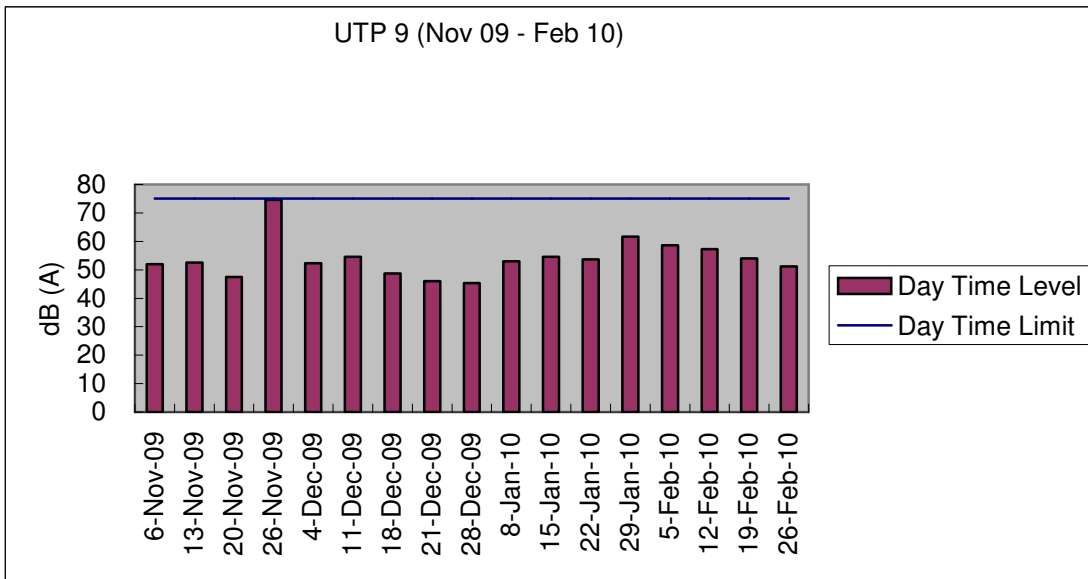
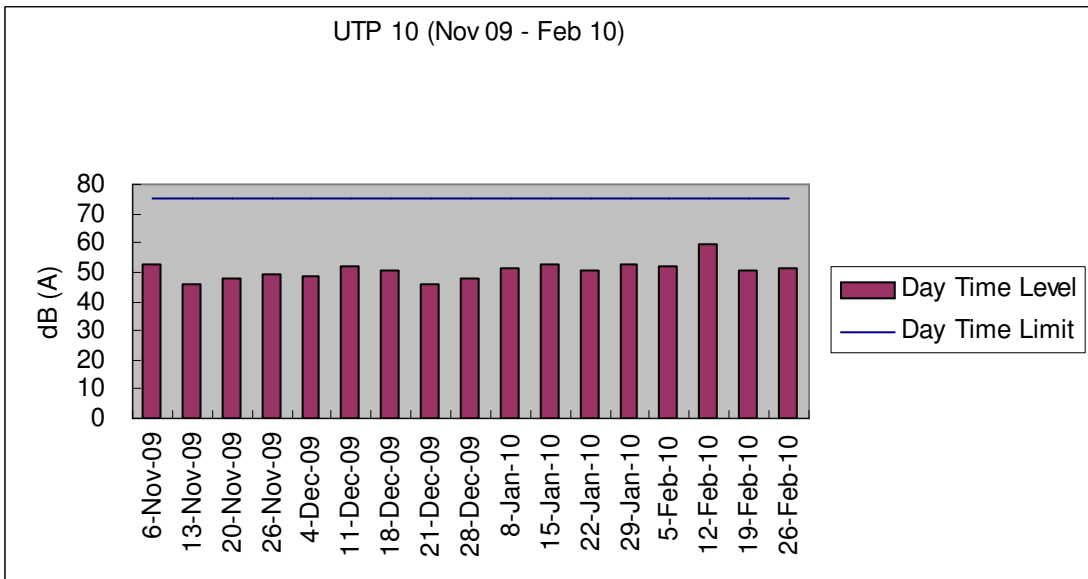
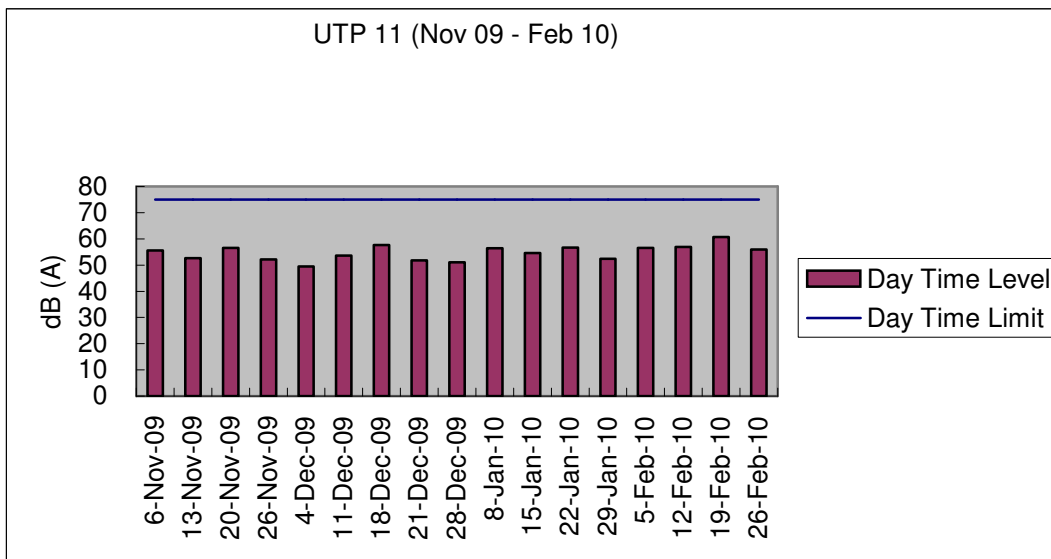
Graphical plot for noise measurements

The followings were the graphical plots for the 11 monitoring locations. Each plot showed the date of measurement taken, day time limit of 75 dB(A) as well as the measured daytime level for each location. The graphs contain the data recorded from November 2009 to February 2010.

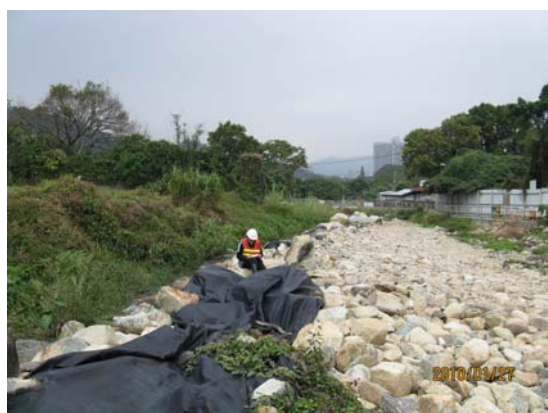
Photo 1: General view of the works area

- Field ecological monitoring was undertaken on 27th January 2010;
- Stream habitat at most sections of Upper Tai Po River (Photo 1) was changed due to drainage works; and

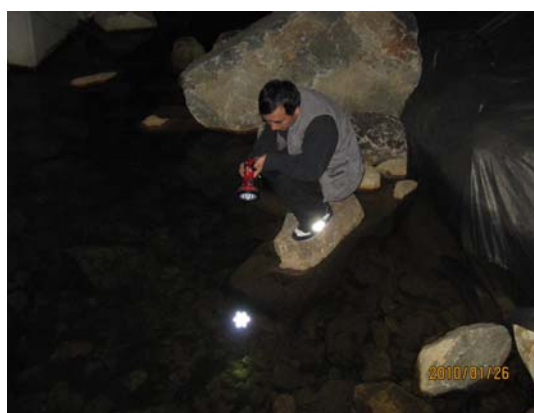
Photo 2: Night survey

Fish community including target species (Three-lined Chinese Stream Catfish and Predaceous Chub) and Hong Kong Newt population at the specified river channel was monitored by live trapping, hand nets and direct observation methods. Active searching at night (photo 2) for *Pseudobagrus trilineatus* has also been carried out. Sampling was conducted at two proposed sampling locations, i.e. upper and lower sections of the river and covered major type of stream habitats, e.g. stream pool and riffle. The number of the captured or observed fish was estimated and recorded. Nomenclature and protection status of the species followed those documented in the AFCD website (www.hkbiddiversity.net) and Virginia et al (2004).

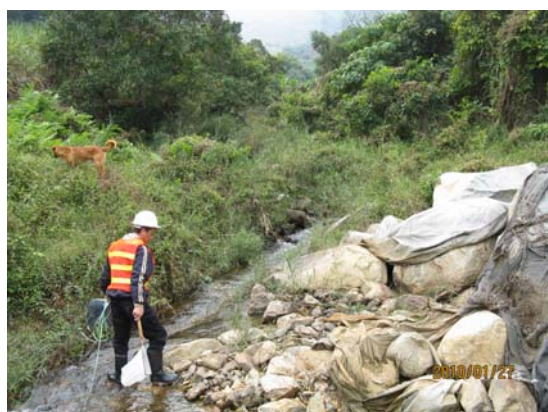
Photo 3: Stream benthos sampling

Macro-invertebrates in the likely affected streams was surveyed. Two sampling sites within the affected stream sites was designed to collect necessary macroinvertebrate fauna for ecological impact monitoring information. Three replicates was taken at each sampling point and pool together for further sample process. Kick sampling (photo 3) and hand netting was the main survey methodologies for stream organisms. Dissection microscope, digital camera was used to aid identification and enumeration. Numerical abundance, species identity was recorded. Nomenclature and protection status of the species will follow those documented in the AFCD website (www.hkbiddiversity.net) and other literatures such as Dudgeon (1999)

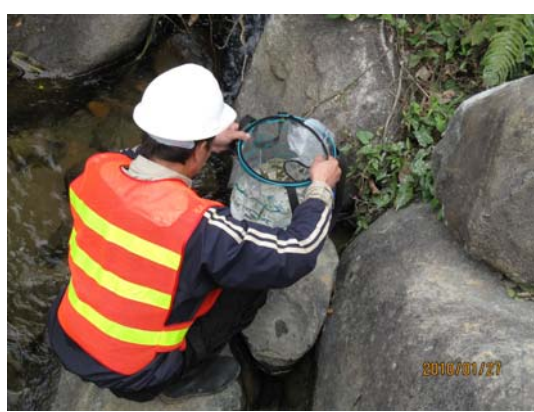
Photo 4: Releasing captured fish at upper stream outside the construction area.
