Contract No. : DC/2007/06
**River Improvement Works in Upper Lam Tsuen, She
Shan River and Upper Tai Po River**

ENVIRONMENTAL MONITORING AND AUDIT

MONTHLY EM&A REPORT of

UPPER TAI PO RIVER

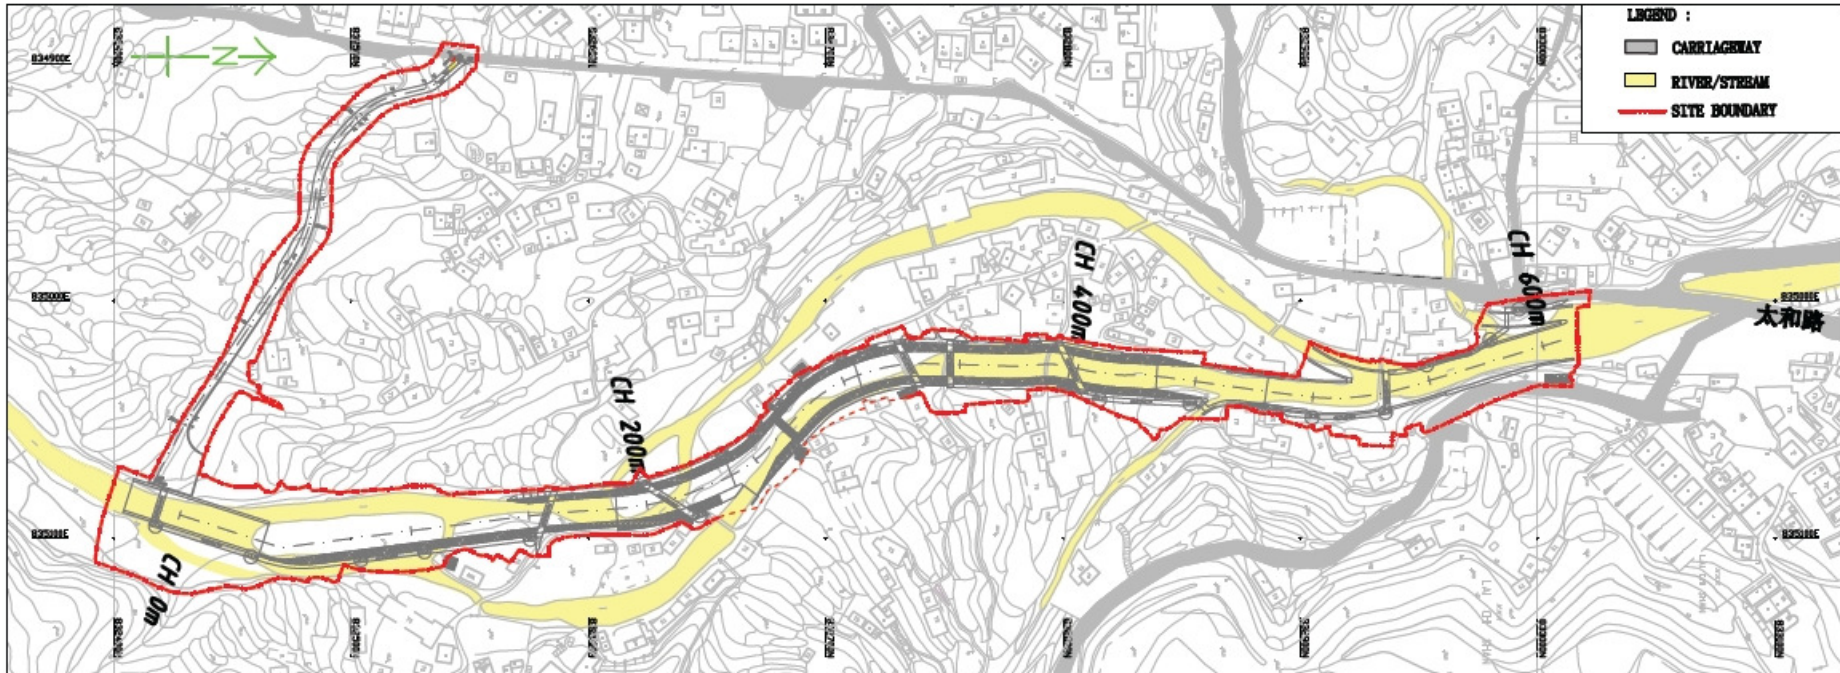
Fig 2.1 Layout of construction area

- (1) Site clearance and preparation works
- (2) Construction of the maintenance access which involves the construction of retaining walls
- (3) River channel construction and excavation, involving the excavation works, construction of retaining walls and gabion walls
- (4) Re-provisioning of footbridges
- (5) Construction of footpaths
- (6) Landscaping works

The location of the project site – Upper Tai Po River starting from Ta Tit Yan of Yai Mo Shan, the Upper Tai Po River flows from southeast to northeast alongside Wilson Trail, turning northward before joining the Lam Tsuen River and then runs towards Tai Po Market. To the east of the river, there are active and abandoned cultivated lands. While the village settlements are mainly located on the west and northeast side of the river bank, where the San Uk Ka and Lai Chi Shan establishment also lie. The Project site is indicated in **Figure 2.1**.

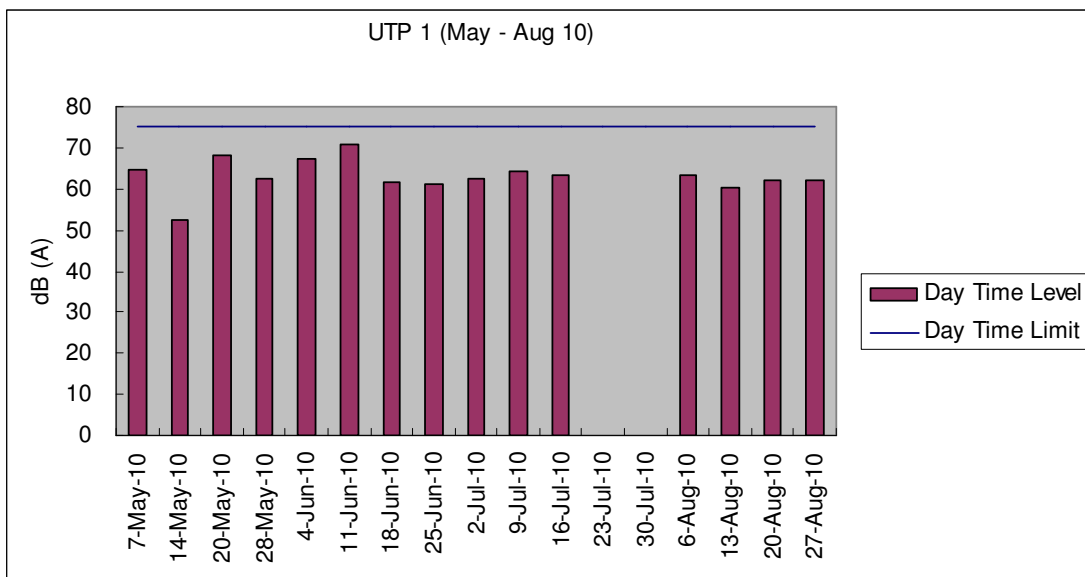
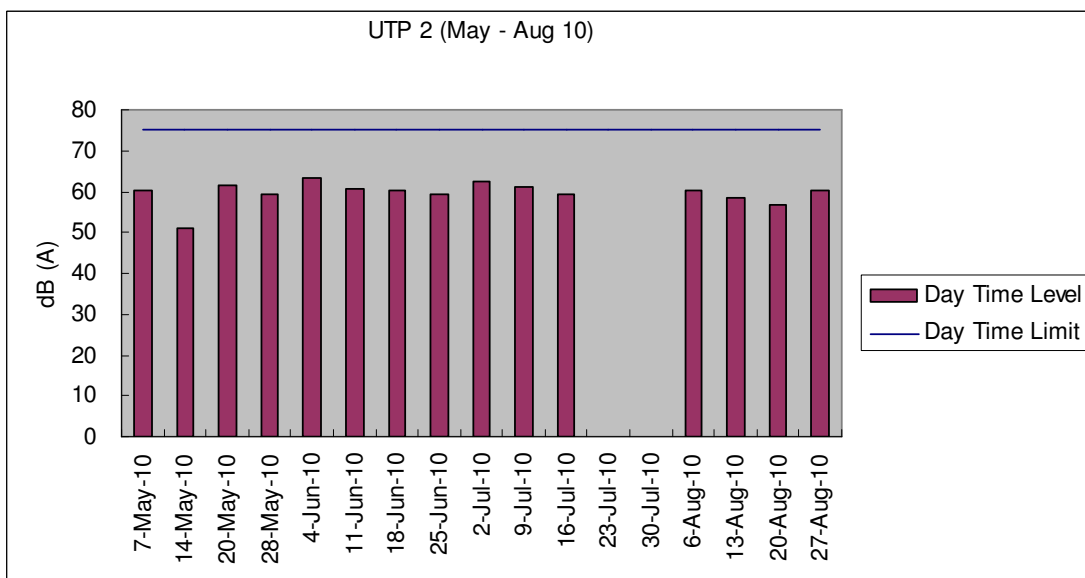
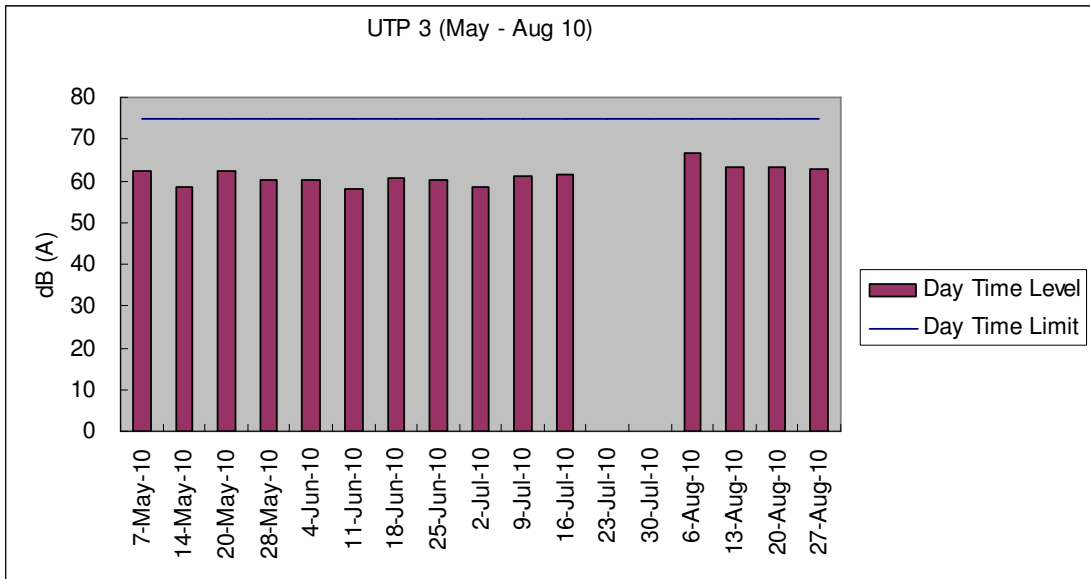
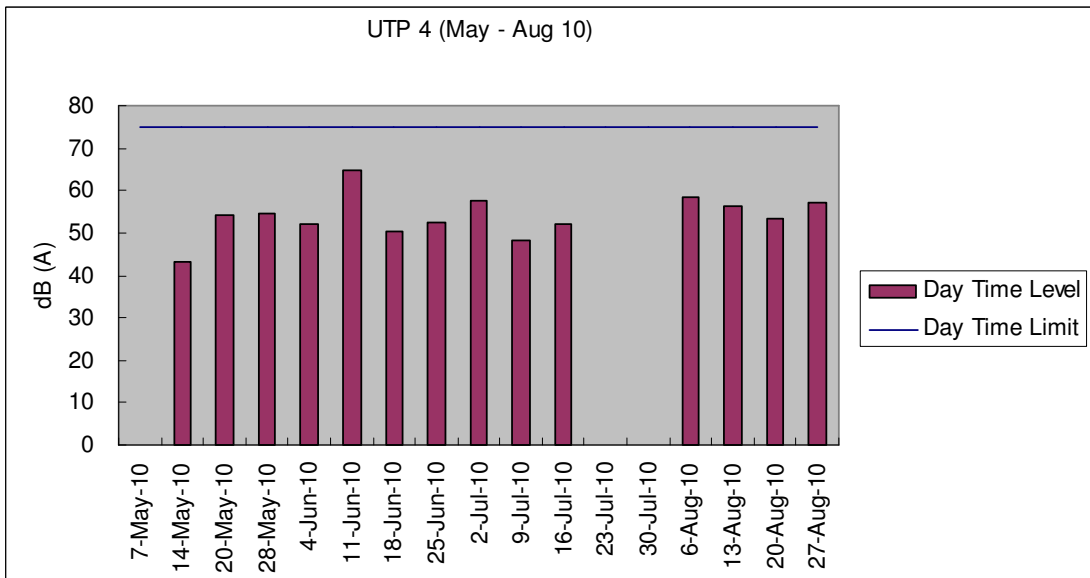
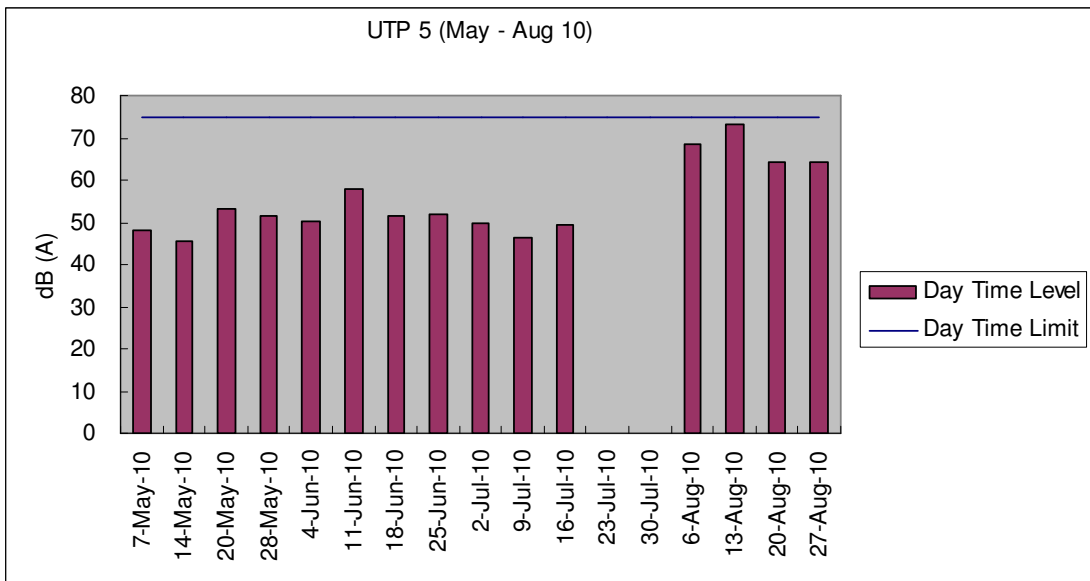
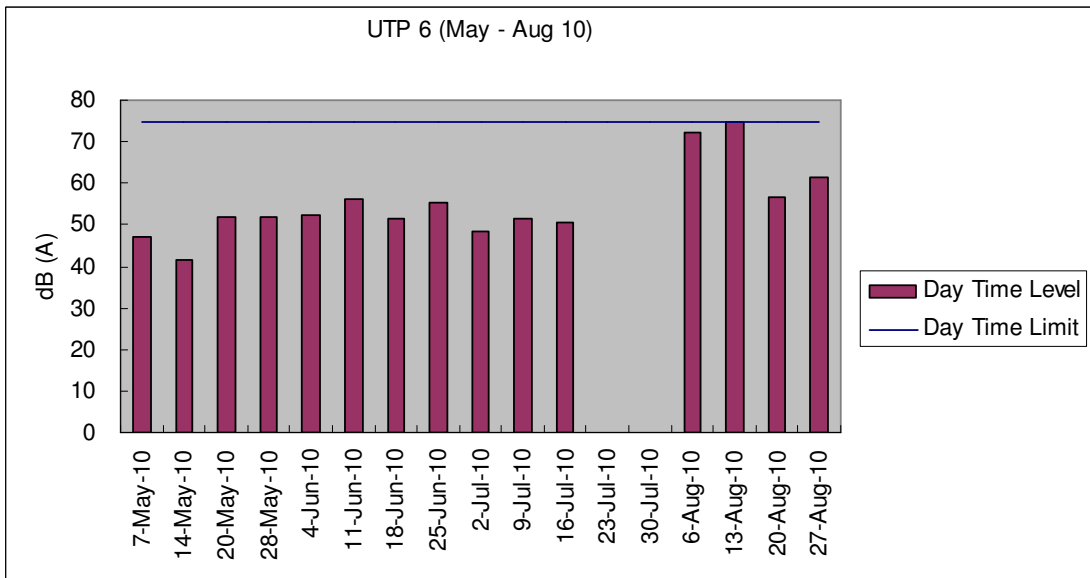
The followings were the graphical plots for the 11 monitoring locations. Each plot showed the date of measurement taken, day time limit of 75 dB(A) as well as the measured daytime level for each location. The graphs contain the data recorded from May 2010 to August 2010.

Noise monitoring at monitoring stations UTP4, 7, 9, 10 and 11 on 7th May 2010 were cancelled due to the rainy weather, while noise monitoring originally proposed to be carried out 23rd and 30th July 2010 were cancelled due to the effect of flooding incident at UTPR.
