Contract No. : DC/2007/06
**River Improvement Works in Upper Lam Tsuen,
She Shan River and Upper Tai Po River**

ENVIRONMENTAL MONITORING AND AUDIT

MONTHLY EM&A REPORT of

UPPER TAI PO RIVER

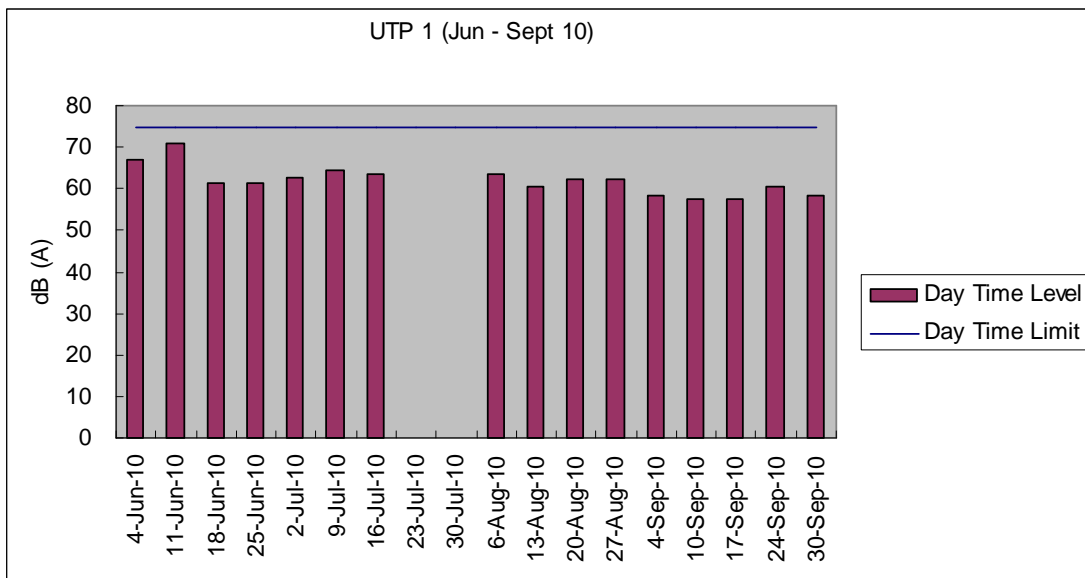
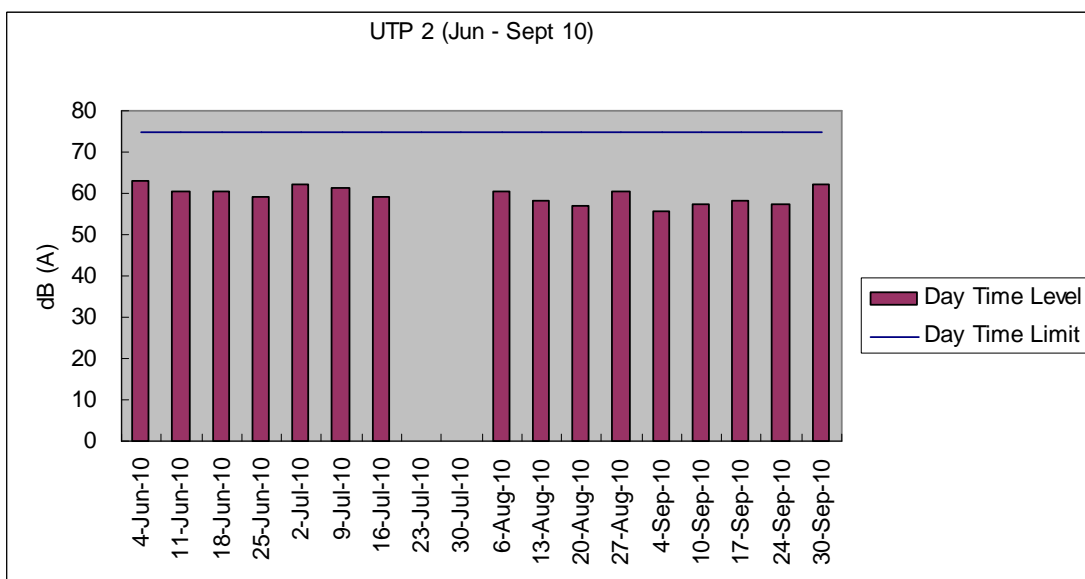
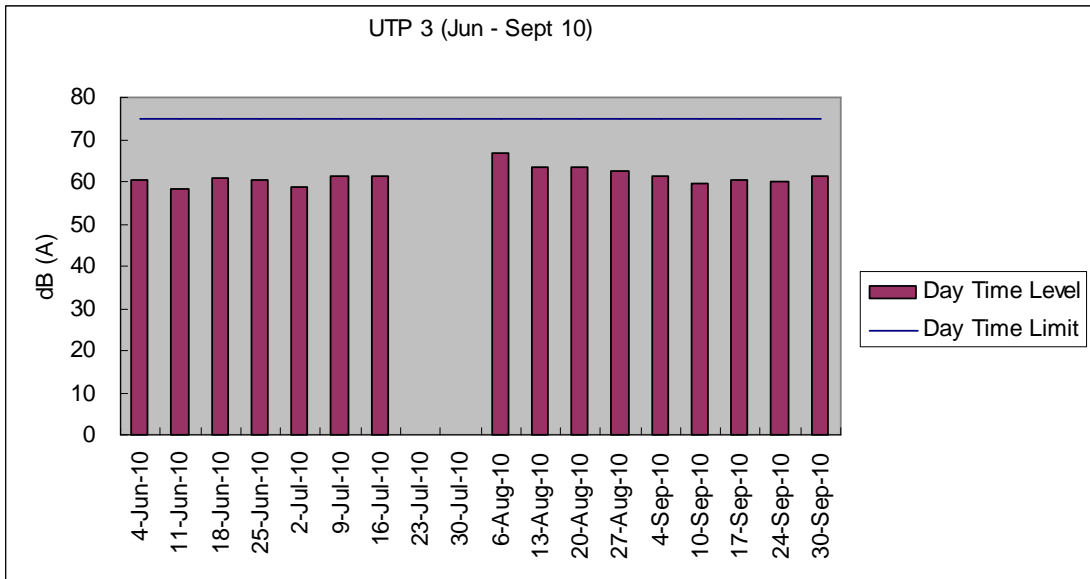
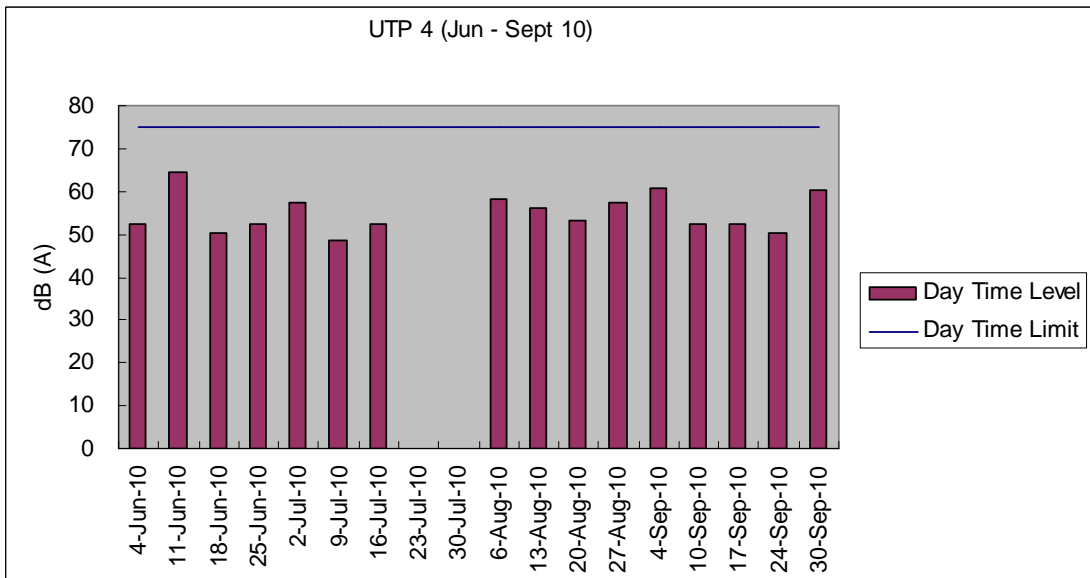
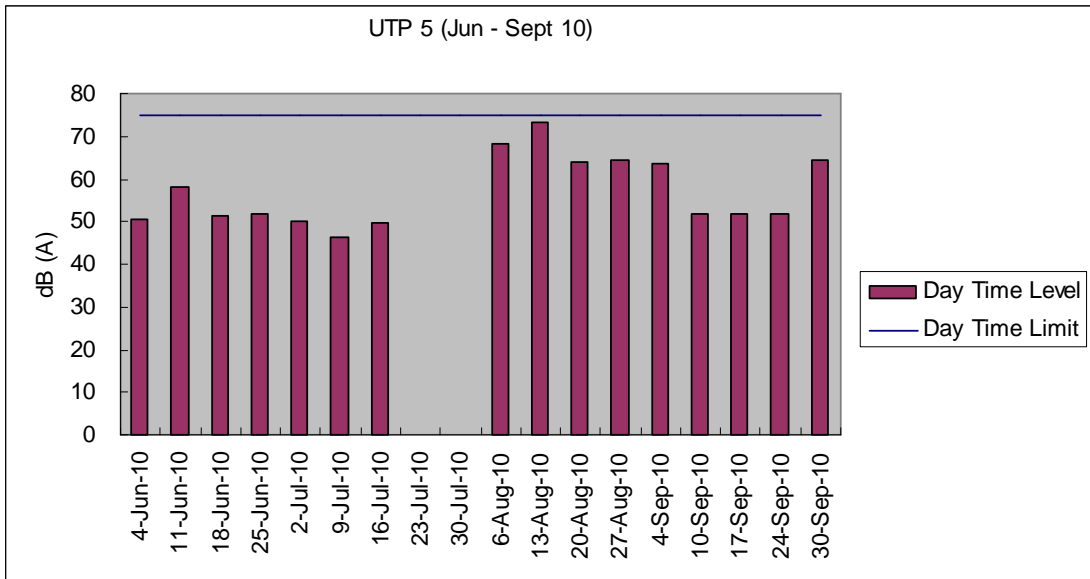
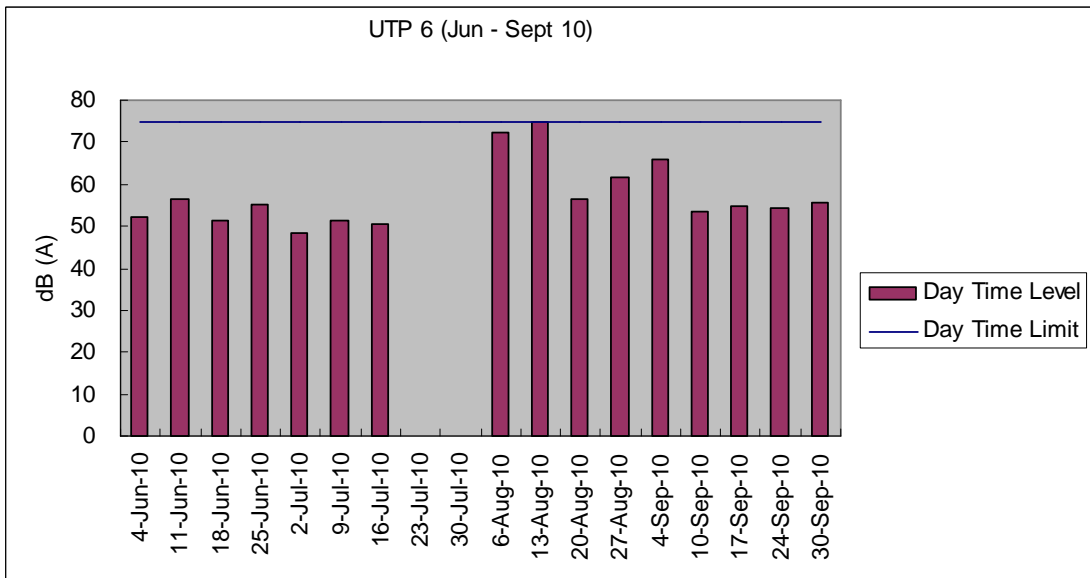
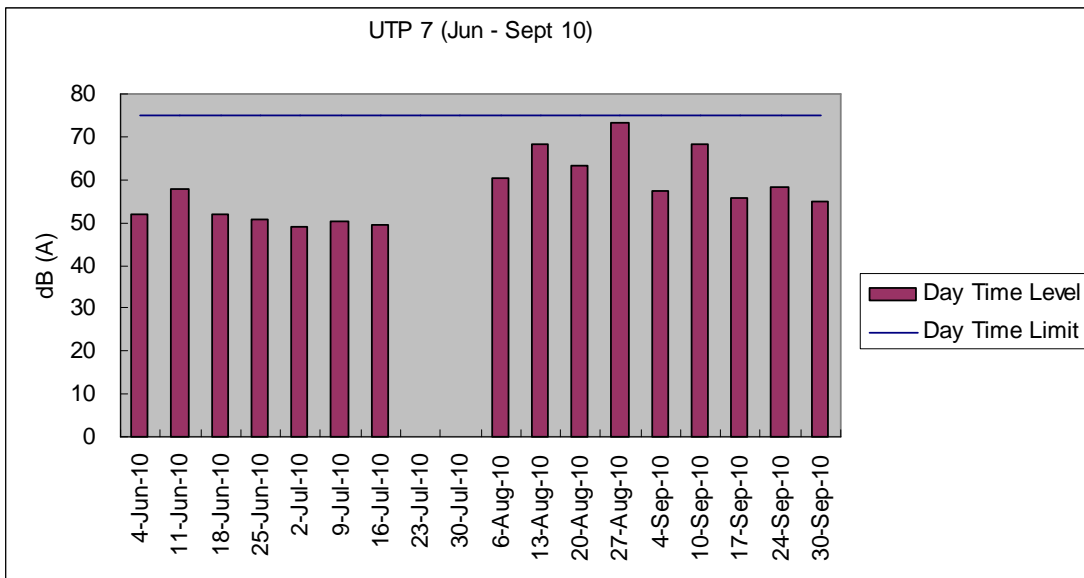
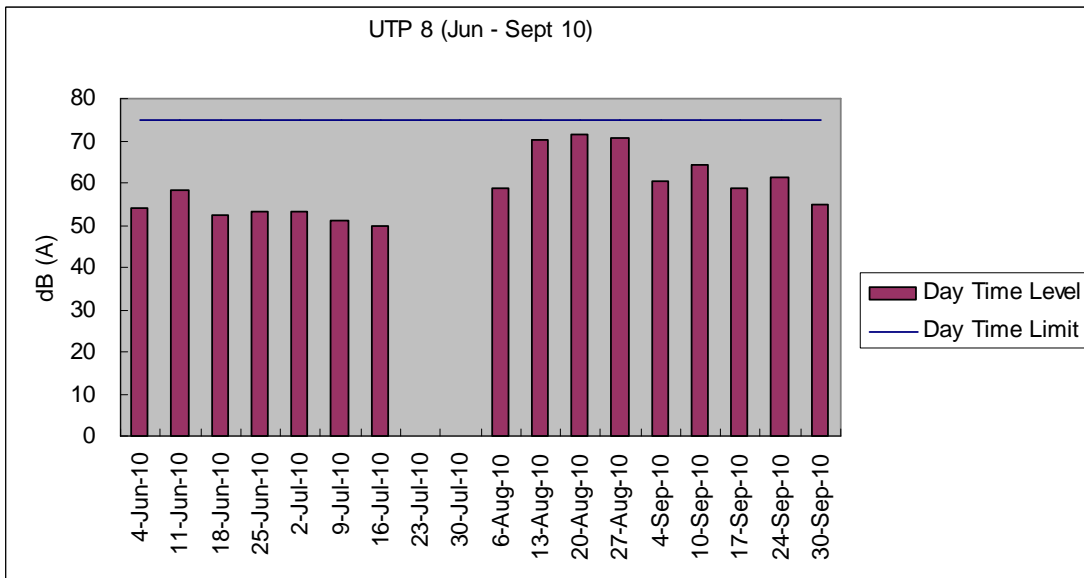
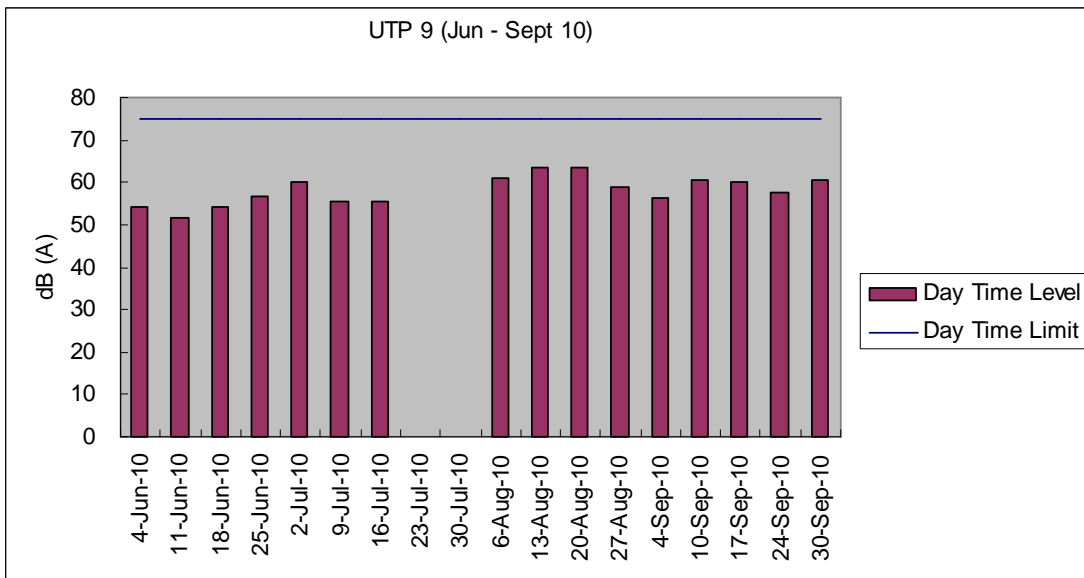
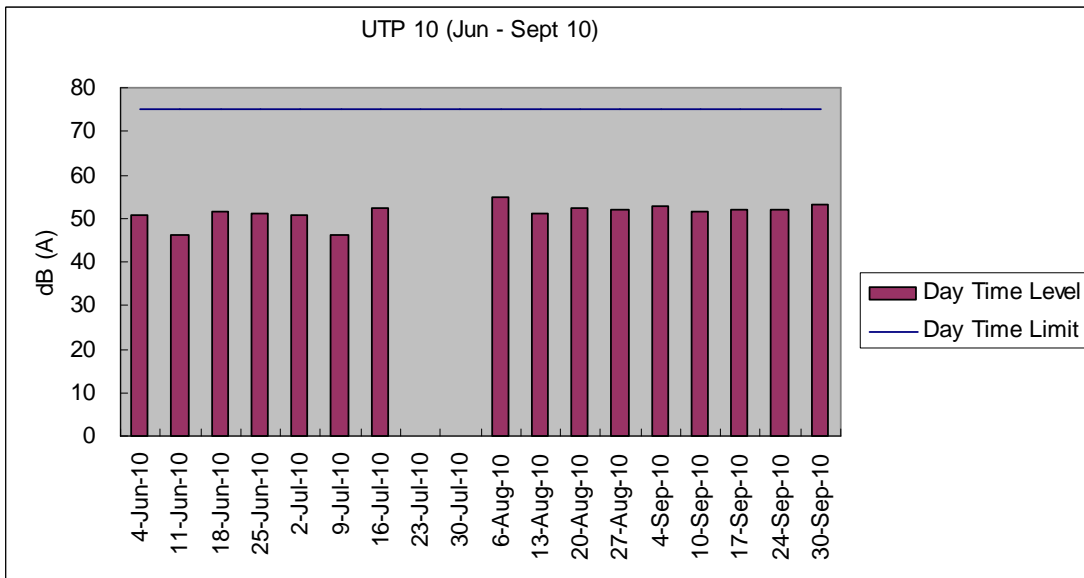
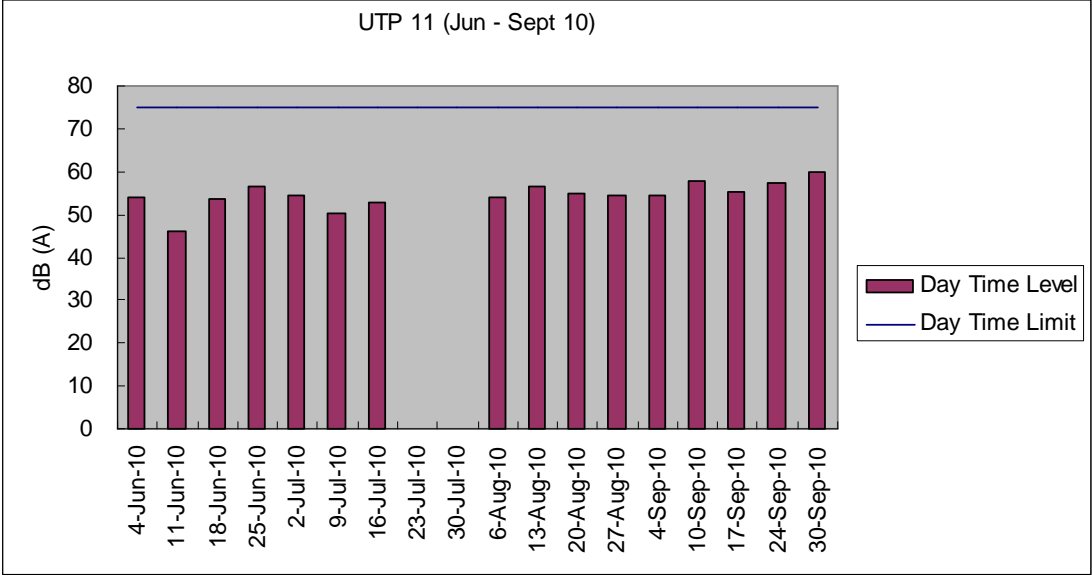
The followings were the graphical plots for the 11 monitoring locations. Each plot showed the date of measurement taken, day time limit of 75 dB(A) as well as the measured daytime level for each location. The graphs contain the data recorded from June 2010 to September 2010.

Noise monitoring originally proposed to be carried out 23rd and 30th July 2010 were cancelled due to the effect of flooding incident at UTPR.
