Contract No. : DC/2007/06
**River Improvement Works in Upper Lam Tsuen,
She Shan River and Upper Tai Po River**

ENVIRONMENTAL MONITORING AND AUDIT

MONTHLY EM&A REPORT of

UPPER TAI PO RIVER

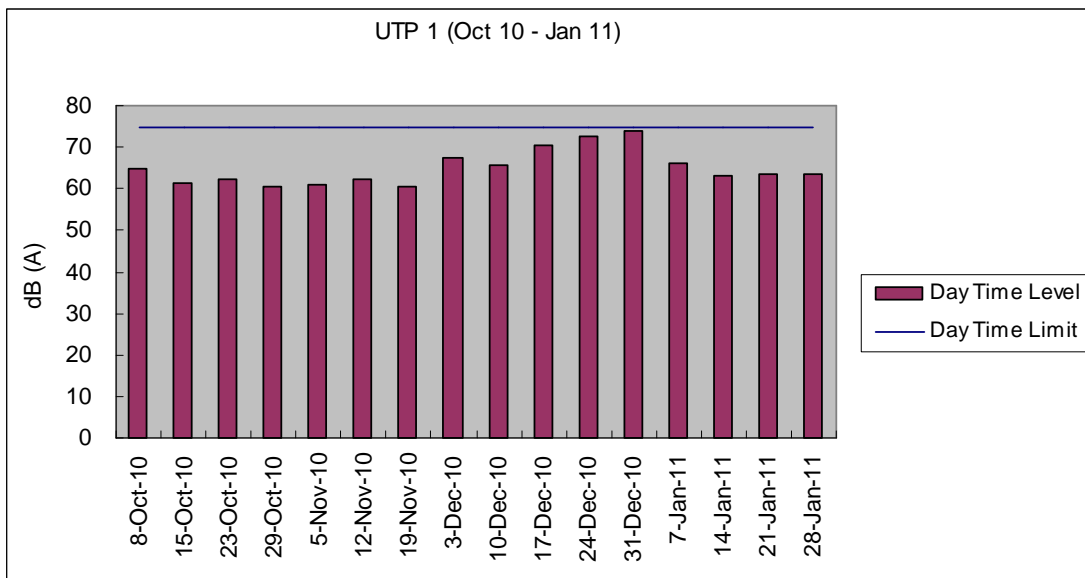
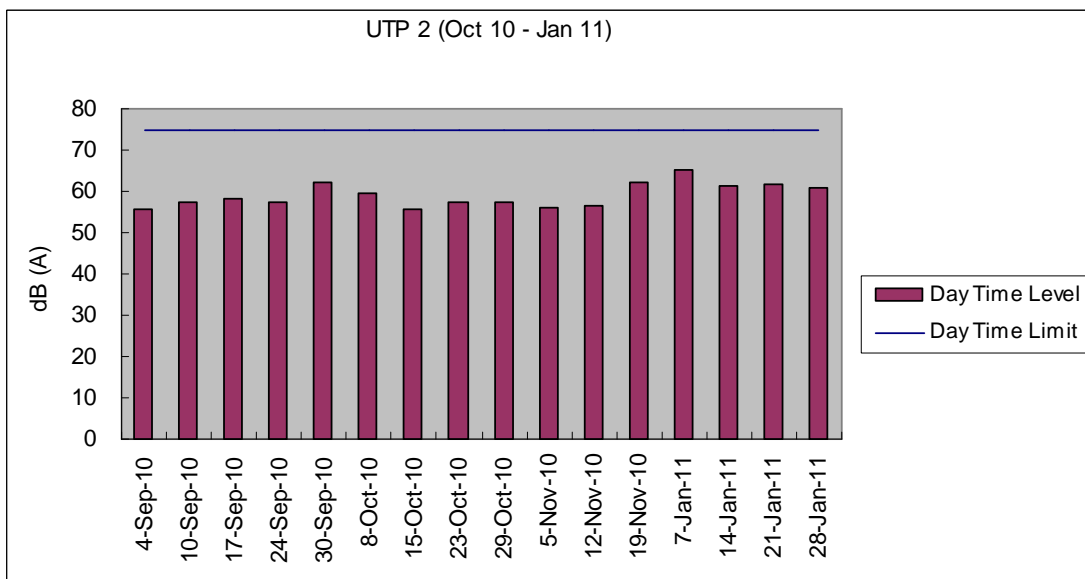
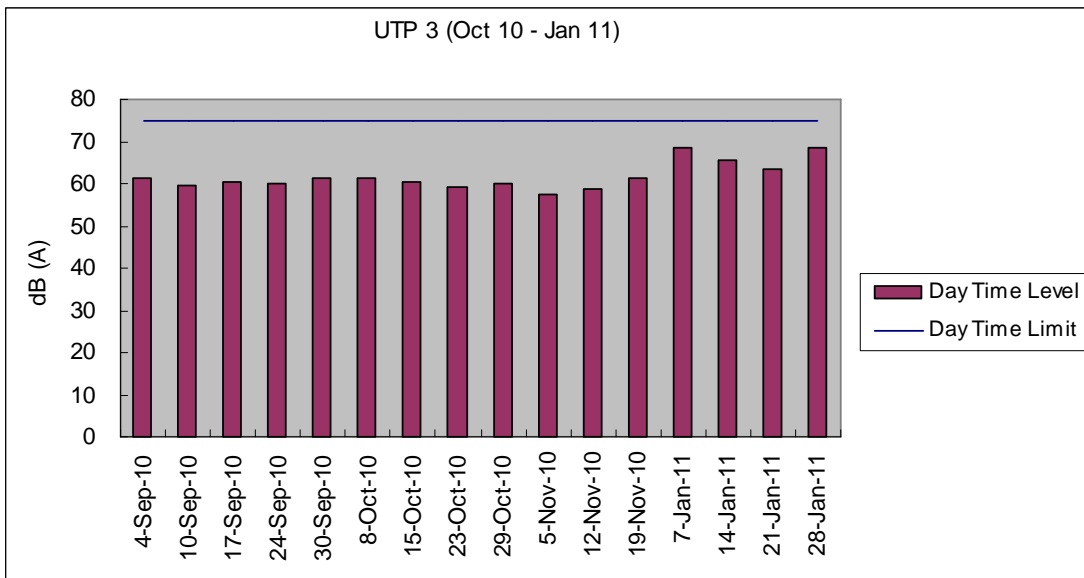
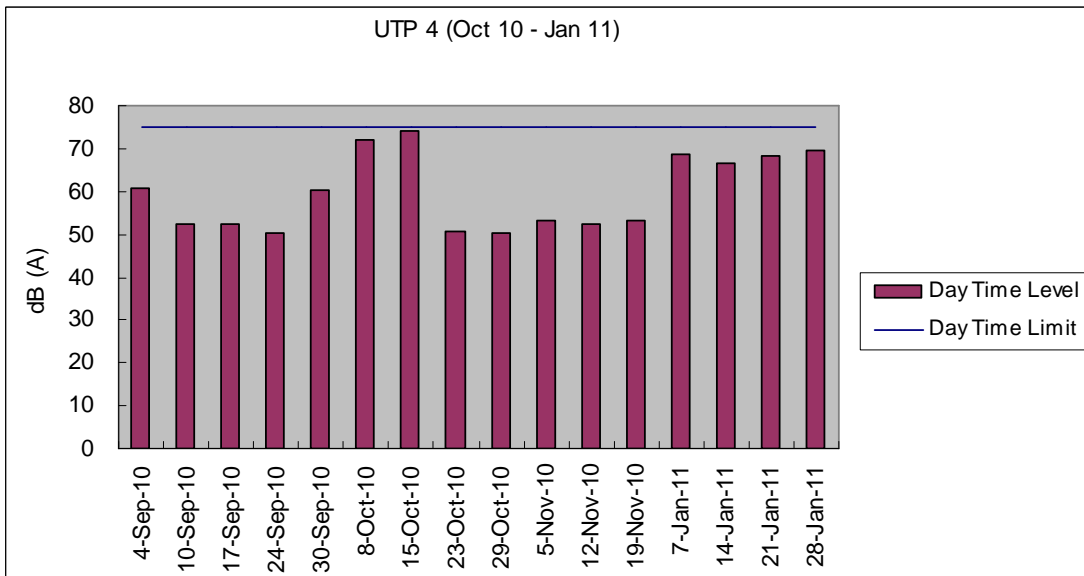
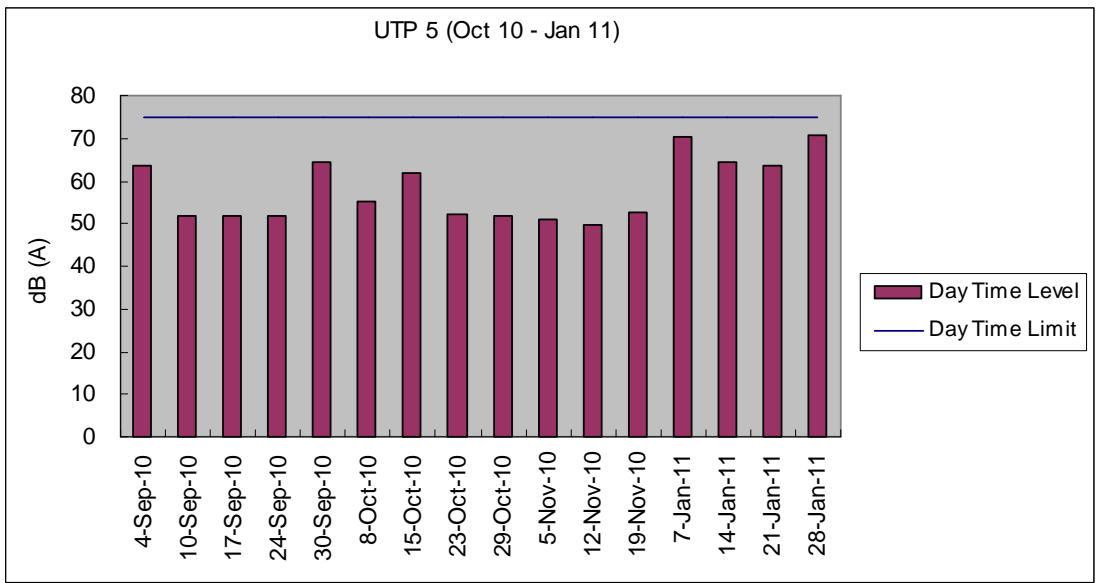
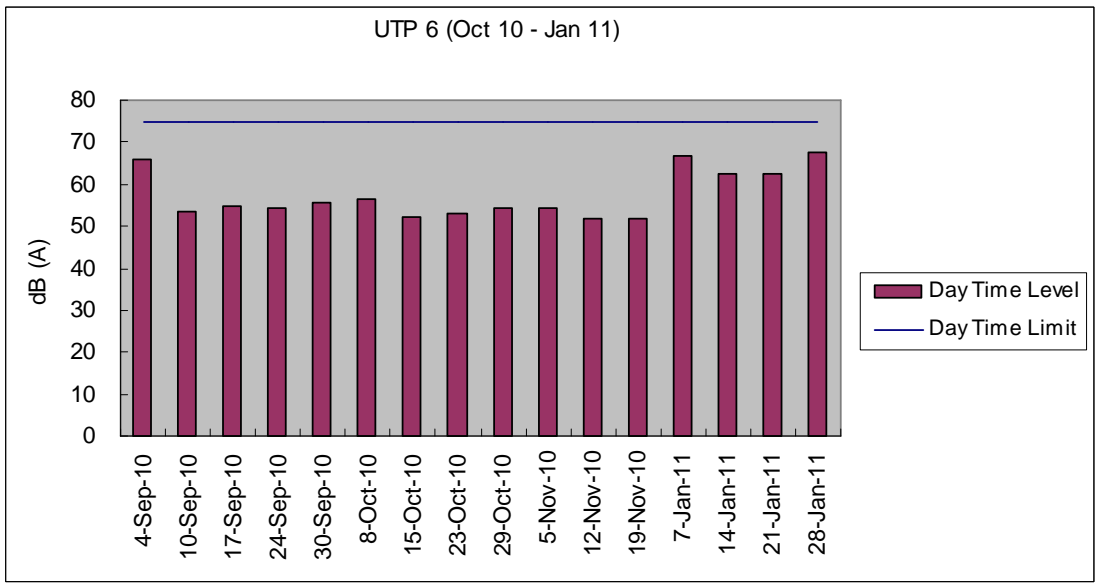
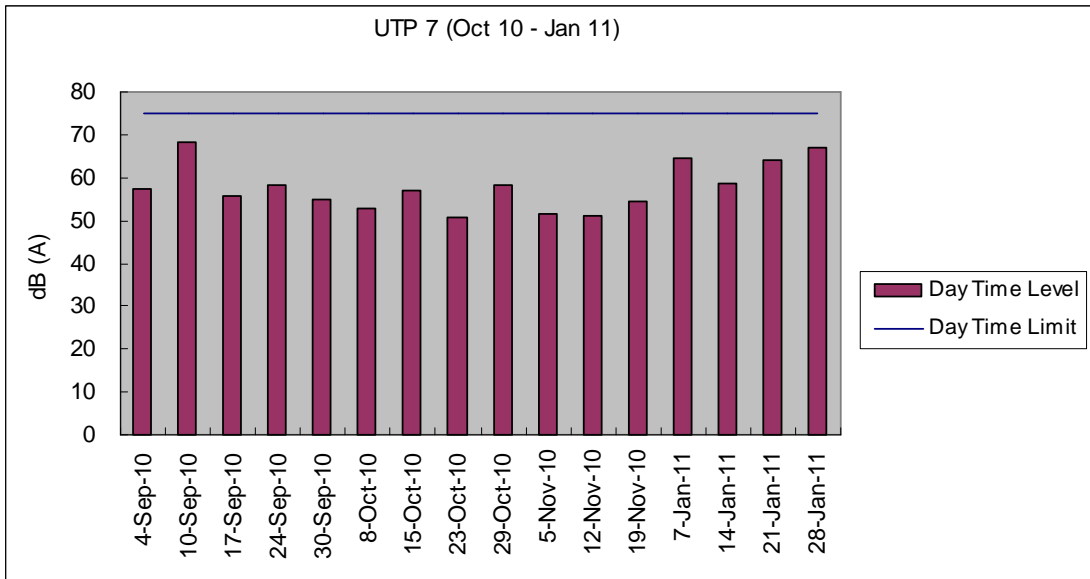
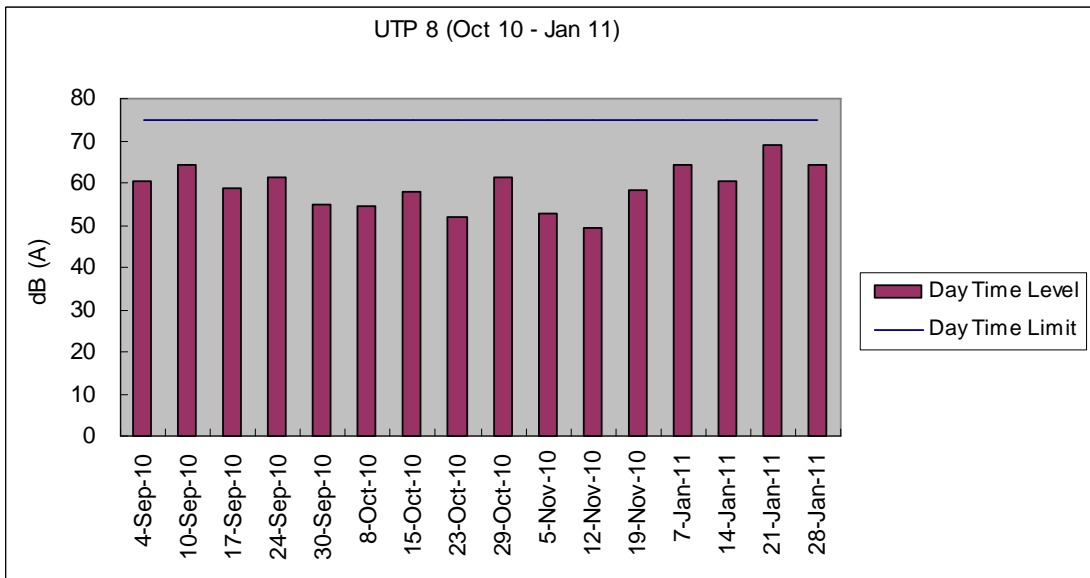
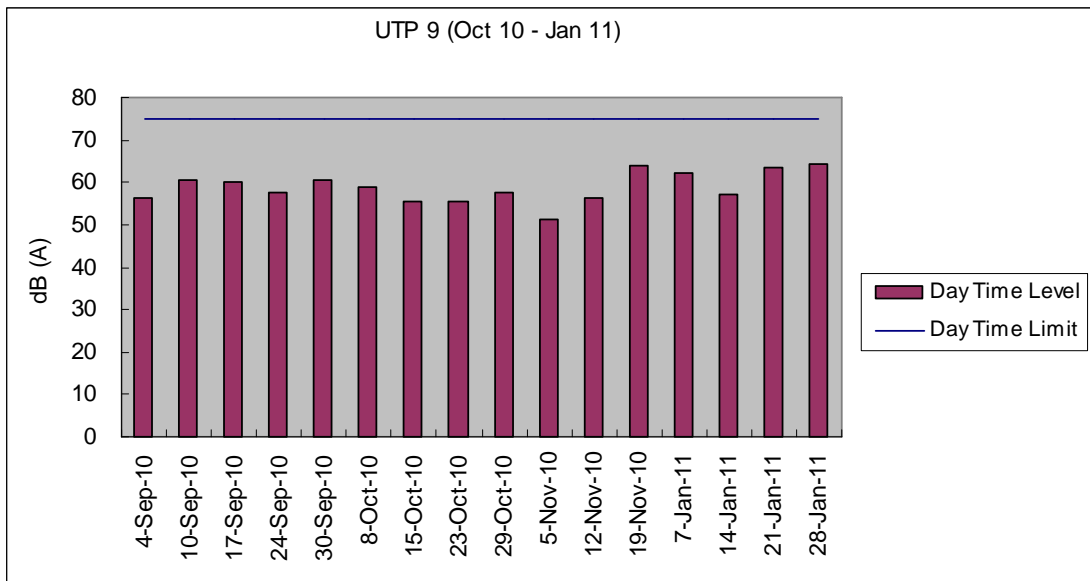
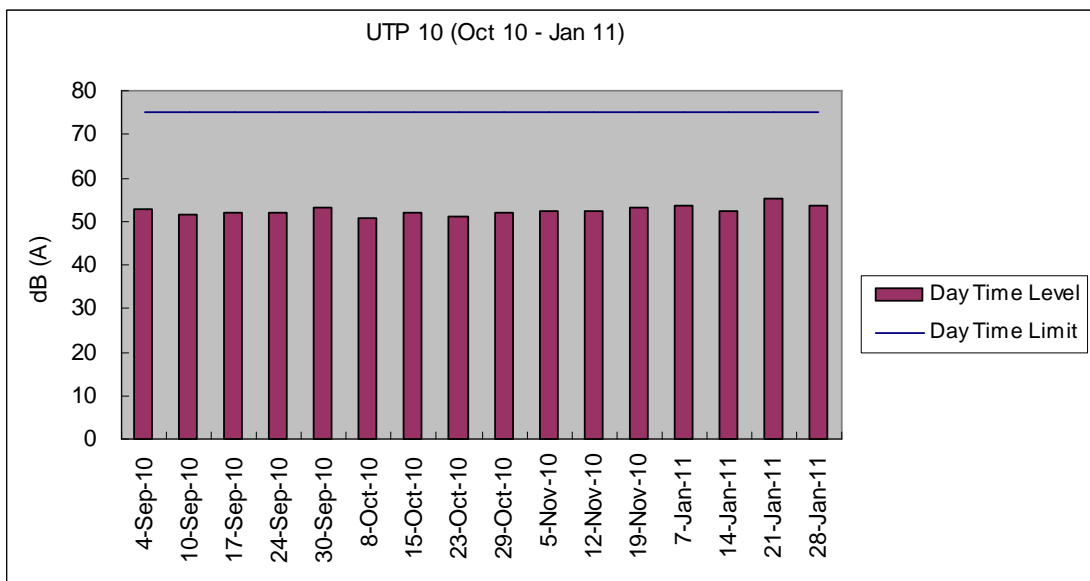
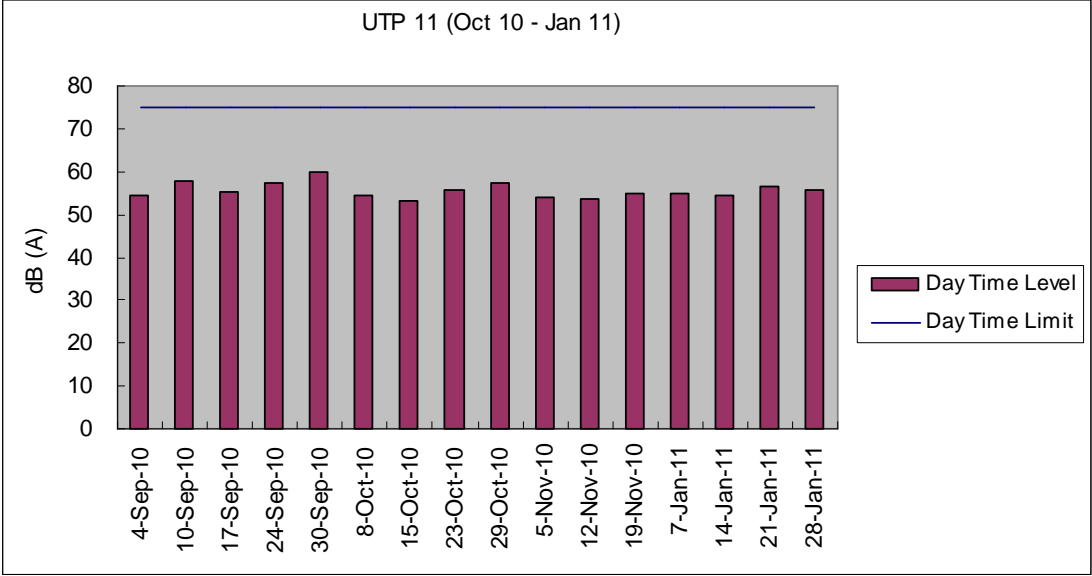
The followings were the graphical plots for the 11 monitoring locations. Each plot showed the date of measurement taken, day time limit of 75 dB(A) as well as the measured daytime level for each location. The graphs contain the data recorded from October 2010 to January 2011.

Noise monitoring originally proposed to be carried out 26th November 2010 was cancelled due to security and safety reason.
