Contract No. DC/2007/10 Design and Construction of Hong Kong West Drainage Tunnel

Quarterly EM&A Report (version 1.0)

January to March 2010

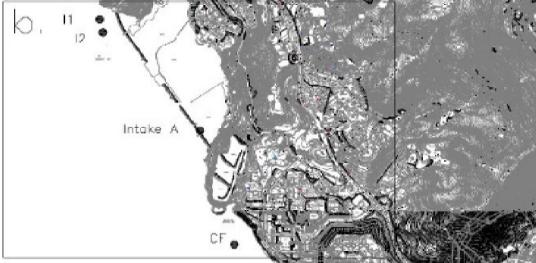
Scale		project	
	N.T.S	No.	MA8001
Date		Figure	
	Jul-08		4

Dalut Na	Co-ordinates		
Point No.	Easting	Westing	
CE	830026	814956	
11	831088	813654	
IS.	831105	813582	
CF	831778	812420	
Intake A	831603	813044	
Intake B	830606	814583

Contract No. DC/2007/10
Design and Construction of Hong Kong West Drainage Tunnel
Locations of Water Quality Monitoring Stations

Type of Monitoring	Parameter	Frequency	Location	Measurement Conditions
Water Quality	 Temperature (oC) pH (pH unit) Turbidity (NTU) Water depth (m) Salinity (mg/L) Dissolved oxygen (DO) (mg/L and % of saturation) Suspended solids (SS) (mg/L) 	Three times per week	 CE (830026E, 814956N) CF (831778E, 812420N) I1 (831088E, 813654N) I2 (831105E, 813582N) Intake A (831603E, 813044N) Intake B (830606E, 814583N) 	3 water depths except CF, omit mid-depth sampling.

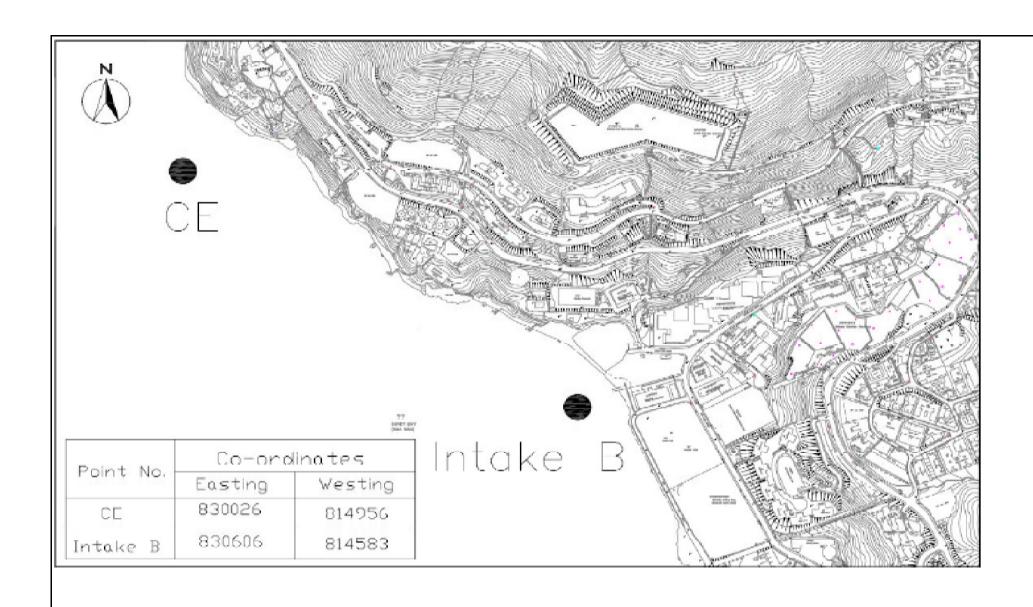
Scale	NTO	project No.	MA8001
Date		Figure	
	Jul-08		4a

Title Contract No. DC/2007/10

Design and Construction of Hong Kong West Drainage Tunnel

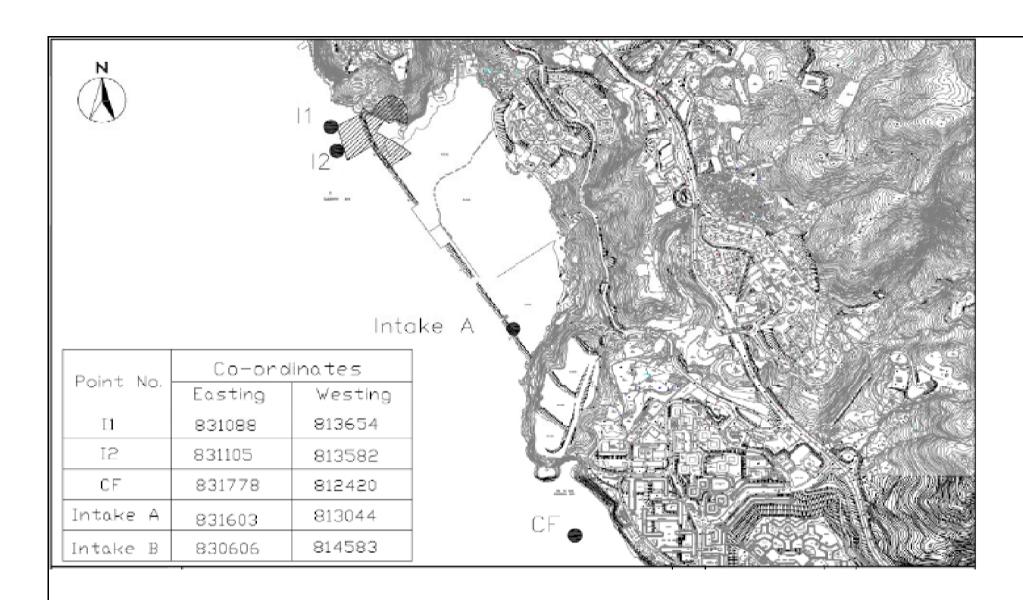
Scale	N.T.S	project No.	MA8001	
Date		Figure		
	Jul-08		4b

Contract No. DC/2007/10
Design and Construction of Hong Kong West Drainage Tunnel
Locations of Water Quality Monitoring Stations

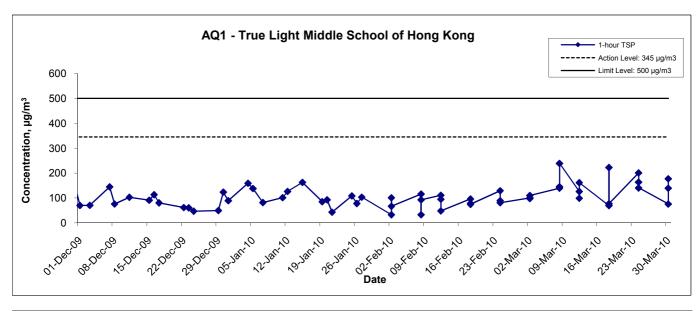
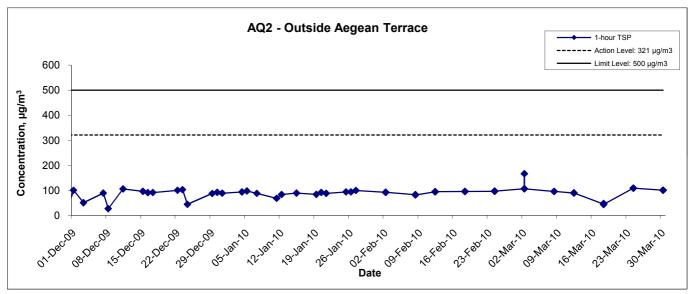
1-hr TSP Concentration Levels

Title	Contract No. DC/2007/10 Design and Construction of Hong Kong West Drainage Tunnel	Scale		Project No.	MA8001	CINOTE
	Graphical Presentation of 1-hour TSP Monitoring Results	Date	Mar 10	Appendi	x D	CINOIS

Type of Monitoring	Parameter	Frequency	Location	Measurement Conditions
	1 hour TSP	Three times / 6 days	 AQ1 (True Light Middle School of Hong Kong) AQ2 (Outside Aegean Terrace) 	AQ1 – Canopy AQ2 – Roadside
Air Quality	24 hour TSP	Once / 6 days	 AQ1 (True Light Middle School of Hong Kong) AQ3 (Outside Site Office at Western Portal) 	AQ3 – Roadside

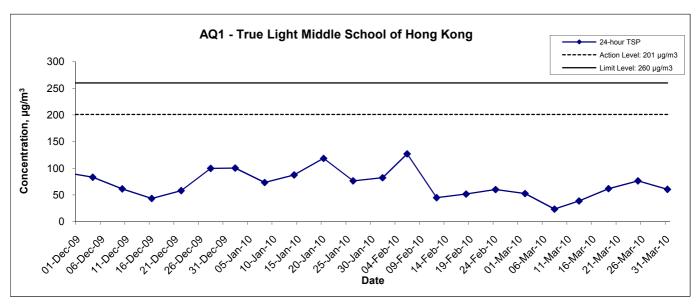
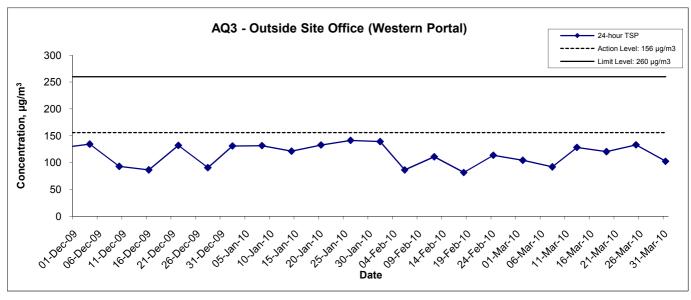
24-hr TSP Concentration Levels

Title	Contract No. DC/2007/10
	Design and Construction of Hong Kong West Drainage Tunnel
	Graphical Presentation of 24-hour TSP Monitoring Results

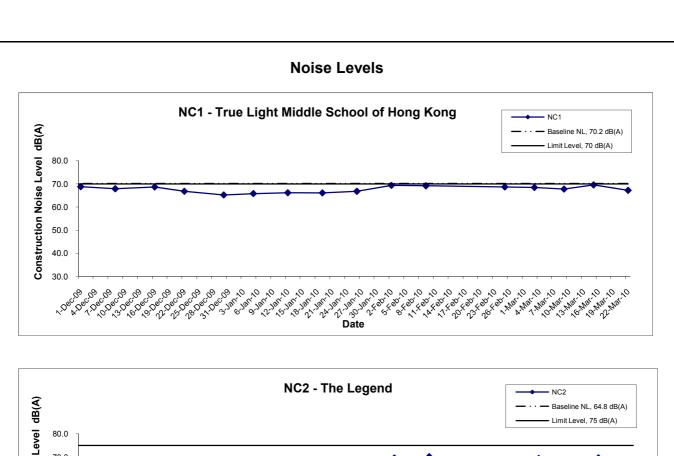
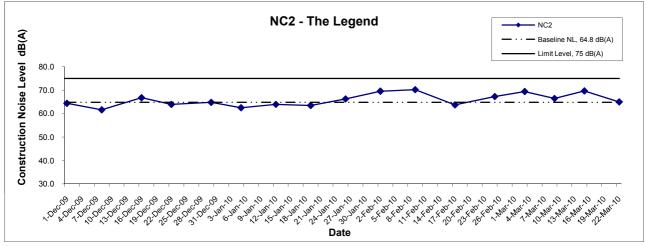
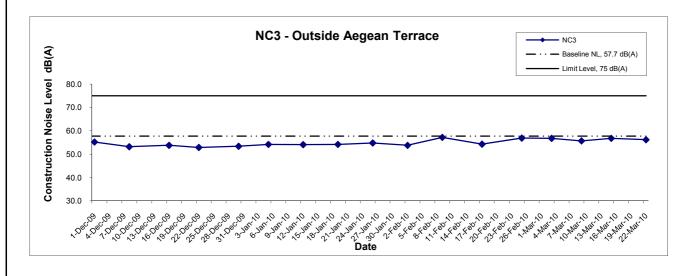
Title Contract No. DC/2007/10
Design and Construction of Hong Kong West Drainage Tunnel
Graphical Presentation of Construction Noise Monitoring
Results

Type of Monitoring	Parameter	Frequency	Location Measurement Conditions
	L_{eq} , L_{90} & L_{10} at 30 minute intervals during (0700 to 1900 on normal weekdays) L_{eq} , L_{90} & L_{10} at 5 minute intervals during	Once per week Once per week	 NC1 (True Light Middle School of Hong Kong) NC1 - Facade measurement NC1a (Outside True Light Middle School of Hong Kong (the nearest measurement
	(1900 to 2300) ⁽¹⁾	(include 3 consecutive 5-min measurements)	of staff accommodation) – for restricted hours (reference only) • NC2 - Facade measurement
	L_{eq}, L_{90} & L_{10} at 5 minute intervals during $(2300 \ to \ 0700 \ of \ next \ day)^{(1)}$	Once per week (include 3 consecutive 5-min measurements)	 NC2 (The Legend) NC3 - Facade NC3 (Outside Aegean Terrace) NC7 (Buddist Li Ka Shing Care NC7 - Facade
Airborne Noise	$L_{\rm eq}, L_{\rm 90}$ & $L_{\rm 10}$ at 5 minute intervals during (0700 to 2300 on holidays) ⁽¹⁾	Once per week (include 3 consecutive 5-min measurements)	 & Attention Home for the Elderly) NC8 (Marymount Secondary School) NC9 (117 Blue Pool Road) NC11 (Honey Court) NC12 (Ying Wa Girl's School) NC13 (Peaksville Court) NC14 (Hong Kong Japanese School) NC15 (Hong Kong Academy) NC16 (Raimondi College) NC14 (Hong Kong Home assurement measurement NC14 - Facade

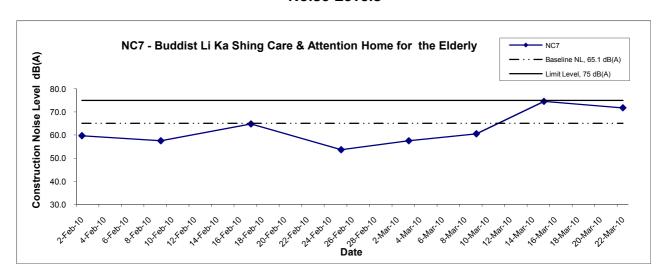
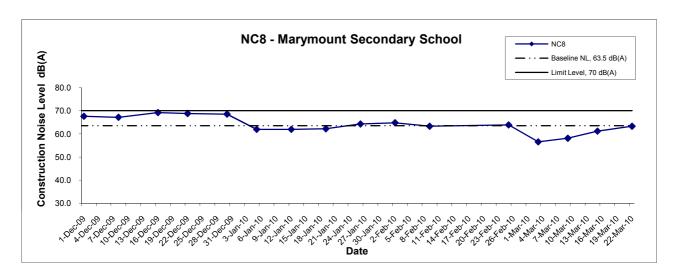
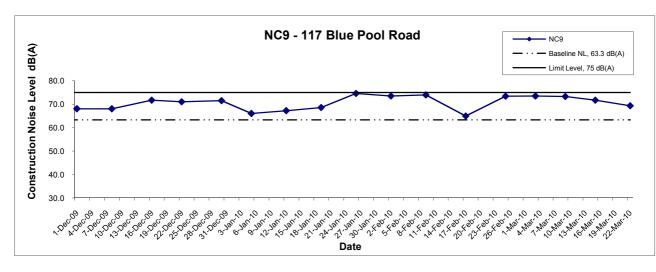
Noise Levels

Title Contract No. DC/2007/10
Design and Construction of Hong Kong West Drainage Tunnel
Graphical Presentation of Construction Noise Monitoring
Results

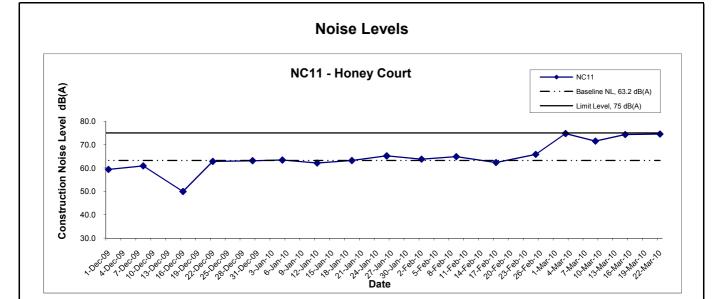
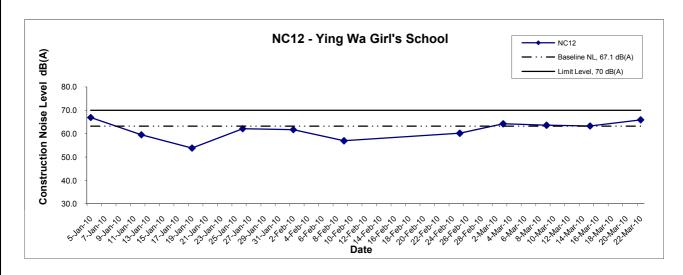
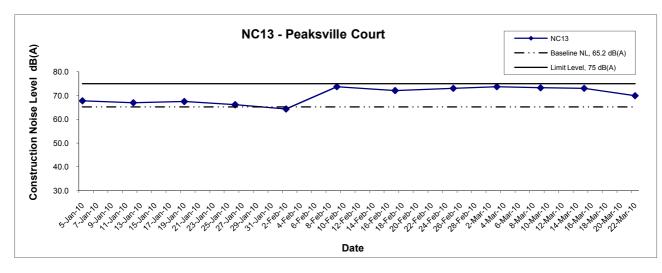
Title Contract No. DC/2007/10
Design and Construction of Hong Kong West Drainage Tunnel
Graphical Presentation of Construction Noise Monitoring
Results

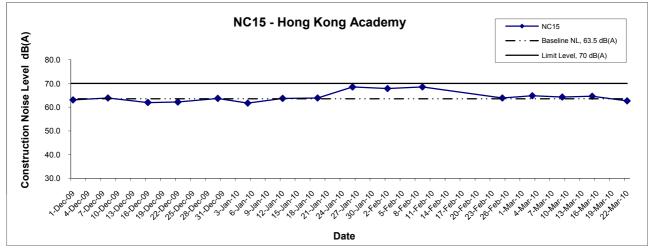
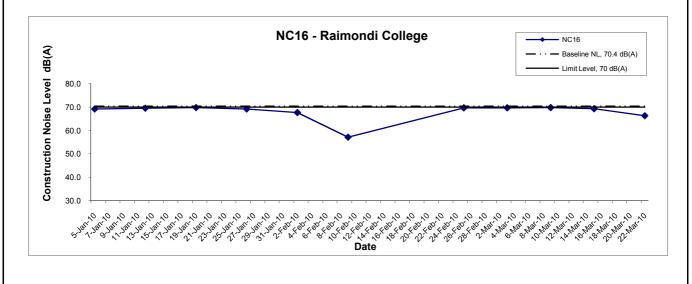
Title Contract No. DC/2007/10
Design and Construction of Hong Kong West Drainage Tunnel
Graphical Presentation of Construction Noise Monitoring
Results

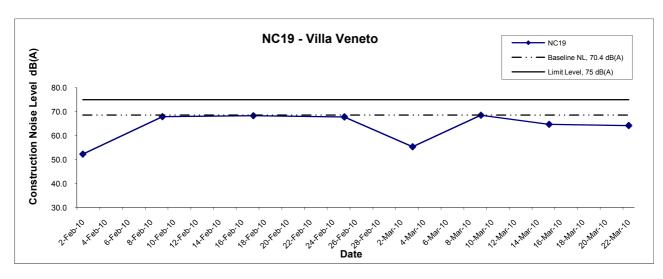
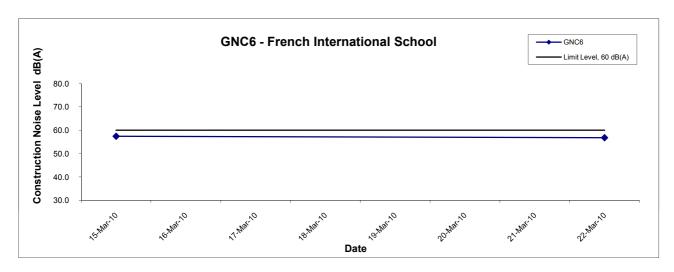
Noise Levels

Contract No. DC/2007/10
Design and Construction of Hong Kong West Drainage Tunnel
Graphical Presentation of Construction Noise Monitoring Results

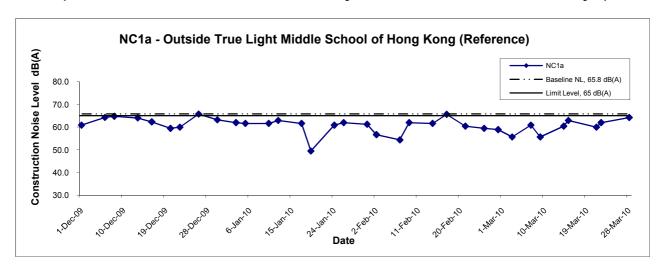
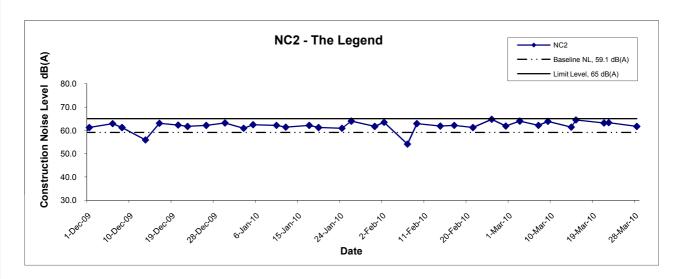
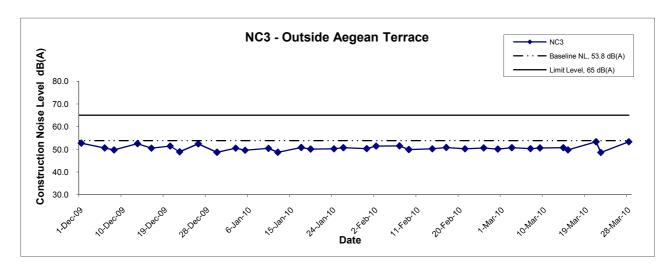
Noise Levels (Restricted Hours - 07:00 - 23:00 holidays & 19:00 - 23:00 on all other days)

Title	Contract No. DC/2007/10 Design and Construction of Hong Kong West Drainage Tunnel	Scale	N.T.S	Project No. MA8001	CINICITCOL
	Graphical Presentation of Construction Noise Monitoring Results	Date	Mar 10	Appendix E	CINOIECU

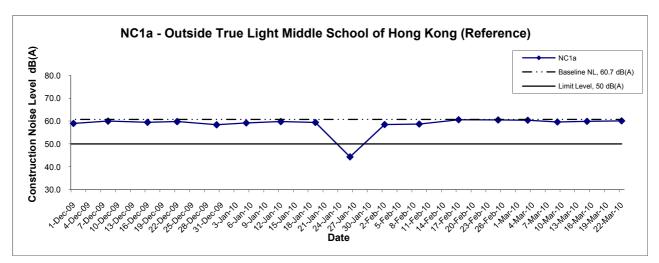
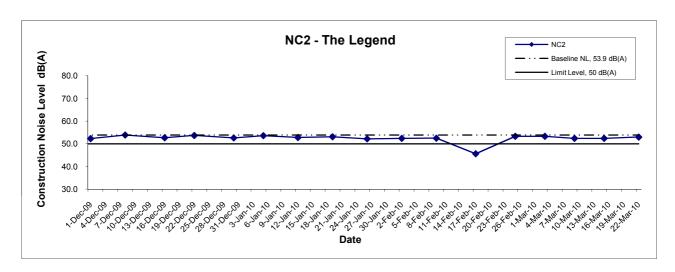
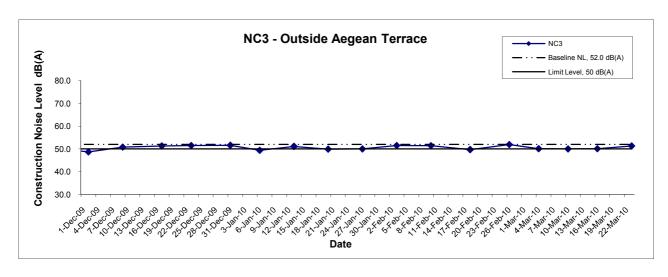
Noise Levels (Restricted Hours - 23:00 to 07:00 on all days)

Title Contract No. DC/2007/10
Design and Construction of Hong Kong West Drainage Tunnel
Graphical Presentation of Construction Noise Monitoring
Results
