# Contract No. DC/2007/10 Design and Construction of Hong Kong West Drainage Tunnel

Quarterly EM&A Report

April to June 2011 (version 2.0)

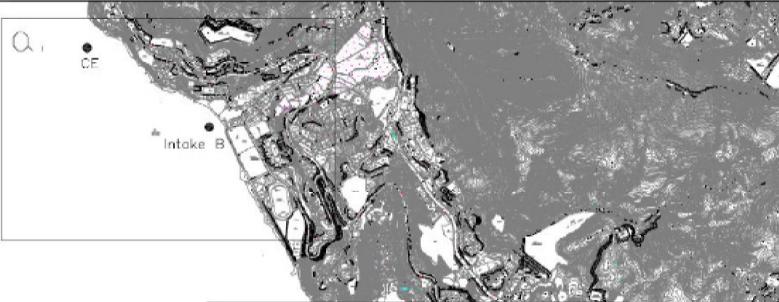
Scale		Project	
	N.T.S	No.	MA8001
Date		Figure	
	Jun-08		4.1

Paint No	Co-ordinates			
FOIRT NO.	Easting	Westing		
CE	830026	814956		
I1	831088	813654		
15	831105	813582		
CF	831778	812420		
Intake A	831603	813044		
Intake B	830606	814583

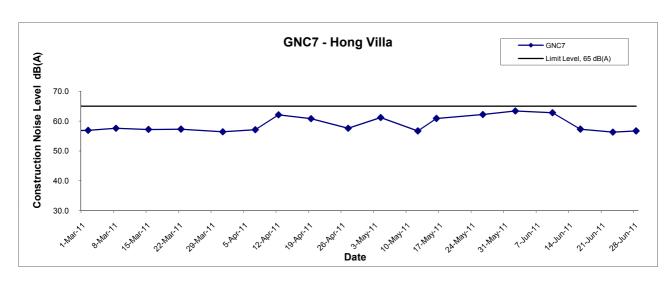
#### **Noise Levels**

Contract No. DC/2007/10 Design and Construction of Hong Kong West Drainage Tunnel
Graphical Presentation of Construction Noise Monitoring Results
