Contract No. DC/2007/10 Design and Construction of Hong Kong West Drainage Tunnel

Quarterly EM&A Report

July to September 2011 (version 3.0)

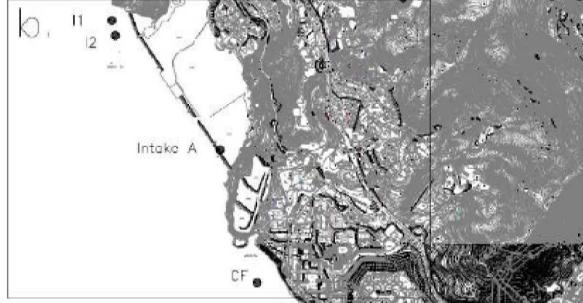
Scale		Project	
	N.T.S	No.	MA8001
Date		Figure	
	Jun-08		4.1

Dalask Na	Co-ordinates			
Point No.	Easting	Westing		
CE	830026	814956		
I1	831088	813654		
IS	831105	813582		
CF	831778	812420		
Intake A	831603	813044		
Intake B	830606	814583

Type of Monitoring	Parameter	Frequency	Location	Measurement Conditions
Water Quality	 Temperature (oC) pH (pH unit) Turbidity (NTU) Water depth (m) Salinity (mg/L) Dissolved oxygen (DO) (mg/L and % of saturation) Suspended solids (SS) (mg/L) 	Three times per week	 CE (830026E, 814956N) CF (831778E, 812420N) I1 (831088E, 813654N) I2 (831105E, 813582N) Intake A (831603E, 813044N) Intake B (830606E, 814583N) 	3 water depths except CF, omit mid-depth sampling.

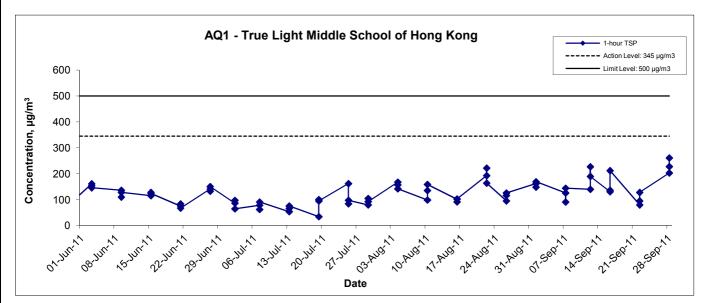
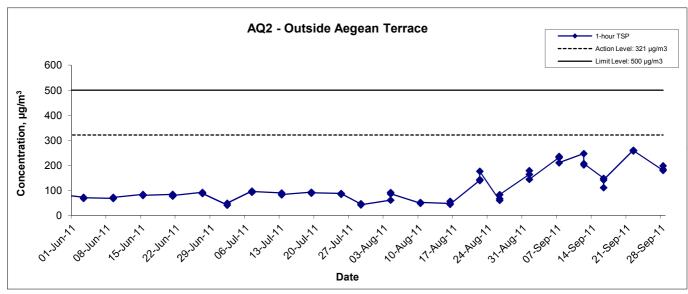
Title	Contract No. DC/2007/10
	Design and Construction of Hong Kong West Drainage Tunnel
	Graphical Presentation of 1-hour TSP Monitoring Results

1-hr TSP Concentration Levels

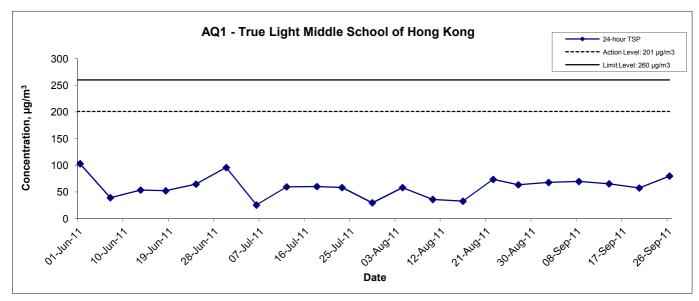
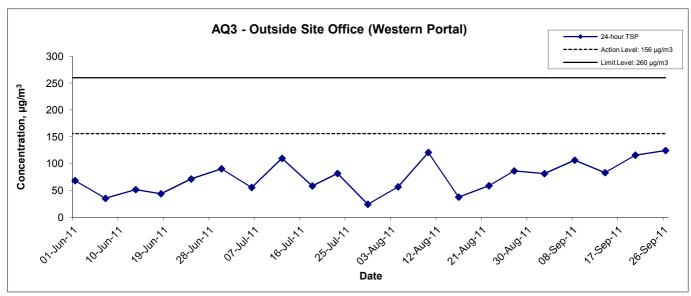
Title	Contract No. DC/2007/10
	Design and Construction of Hong Kong West Drainage Tunnel
	Graphical Presentation of 24-hour TSP Monitoring Results

24-hr TSP Concentration Levels

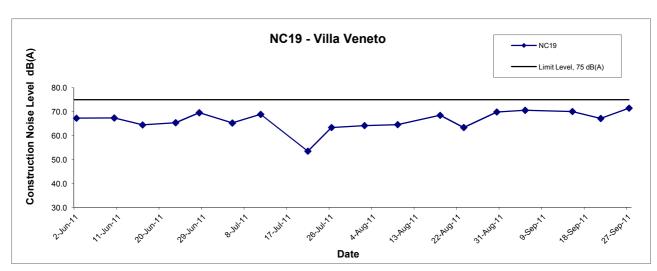
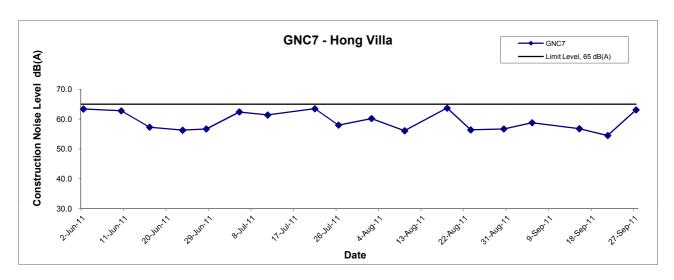
Noise Levels

Title	Contract No. DC/2007/10 Design and Construction of Hong Kong West Drainage Tunnel
	Graphical Presentation of Construction Noise Monitoring Results

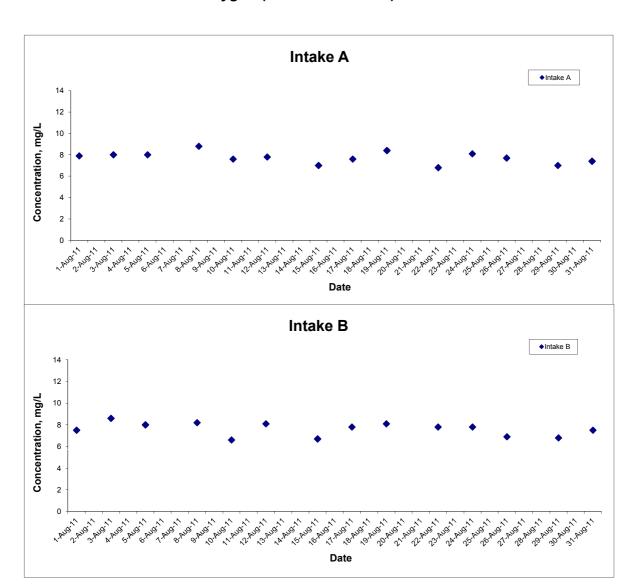
Dissolved Oxygen (Surface & Middle) at Mid-Ebb Tide

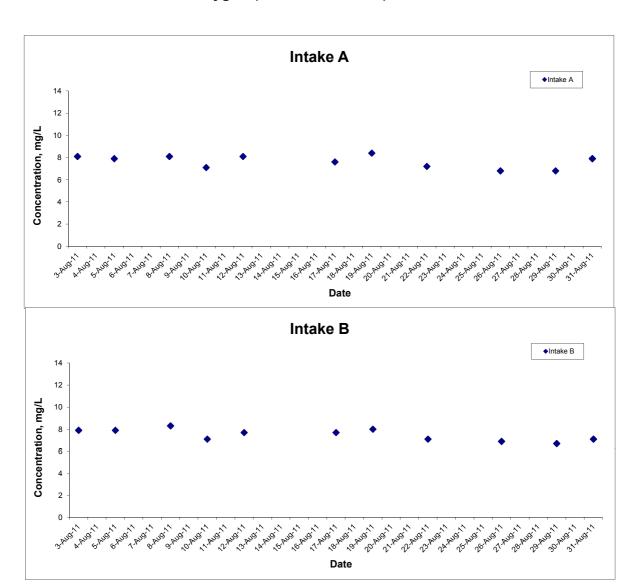
Dissolved Oxygen (Surface & Middle) at Mid-Flood Tide

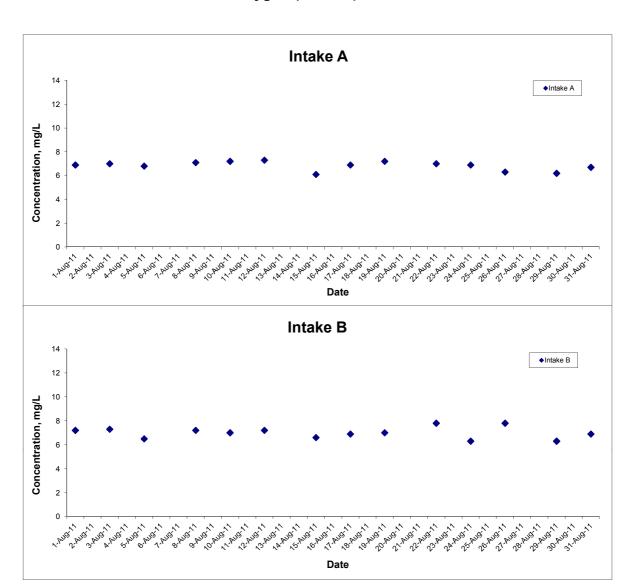
Dissolved Oxygen (Bottom) at Mid-Ebb Tide

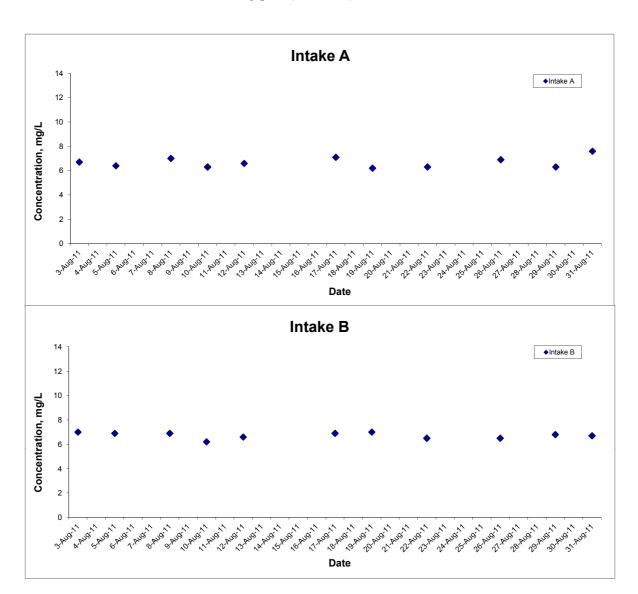
Dissolved Oxygen (Bottom) at Mid-Flood Tide

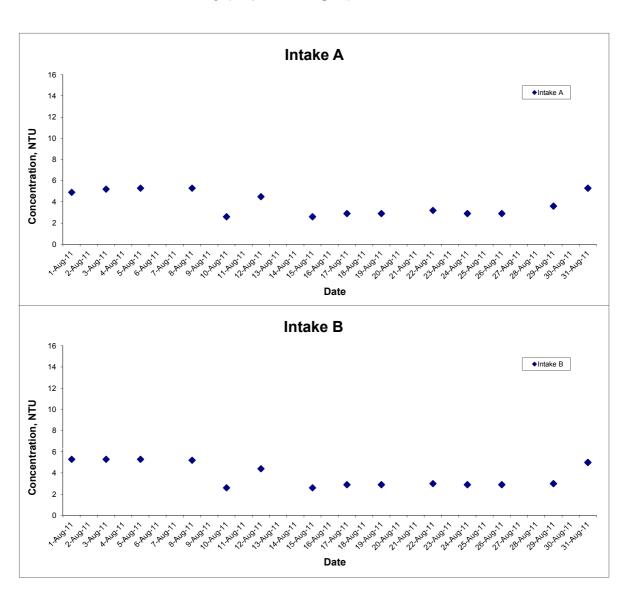
Turbidity (Depth-averaged) at Mid-Ebb Tide

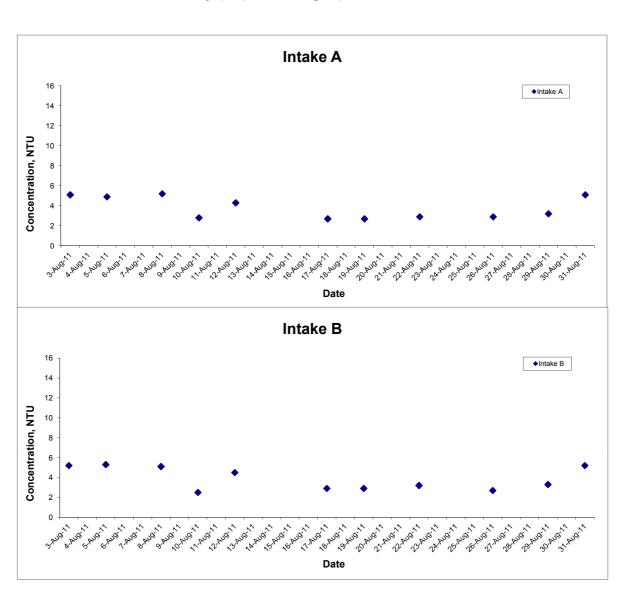
Turbidity (Depth-averaged) at Mid-Flood Tide

Title	Contract No. DC/2007/10 Design and Construction of Hong Kong West Drainage Tunnel
	Graphical Presentation of Water Quality Monitoring Results

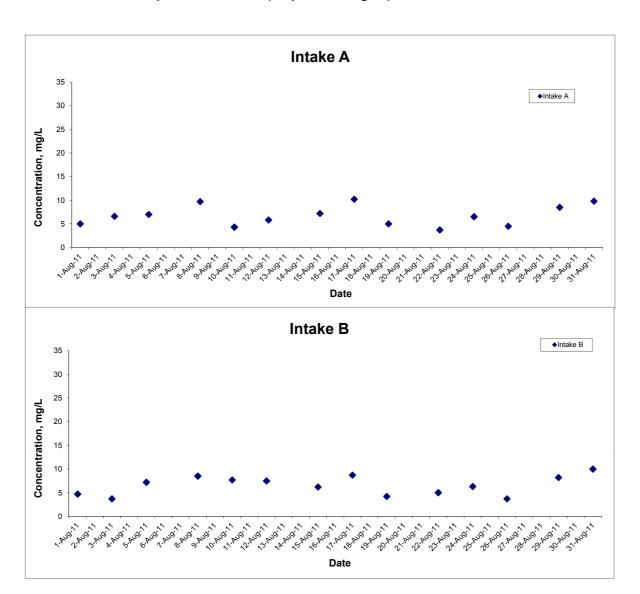
Suspended Solids (Depth-averaged) at Mid-Ebb Tide

Title Contract No. DC/2007/10 Design and Construction of Hong Kong West Drainage Tunnel	Scale		Project No. M	A800 ²
Graphical Presentation of Water Quality	Date		Appendix	
Monitoring Results		Aug 11		L

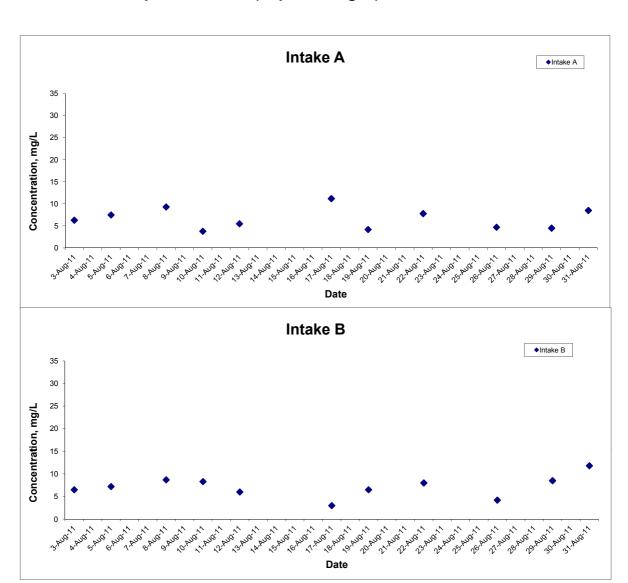
Suspended Solids (Depth-averaged) at Mid-Flood Tide
