**Development of a Biodiesel Plant at
Tseung Kwan O Industrial Estate**

**Monthly Environmental Monitoring and
Audit Report for
July 2023**

Monthly Environmental Monitoring and Audit Report No. 88 (July 2023)

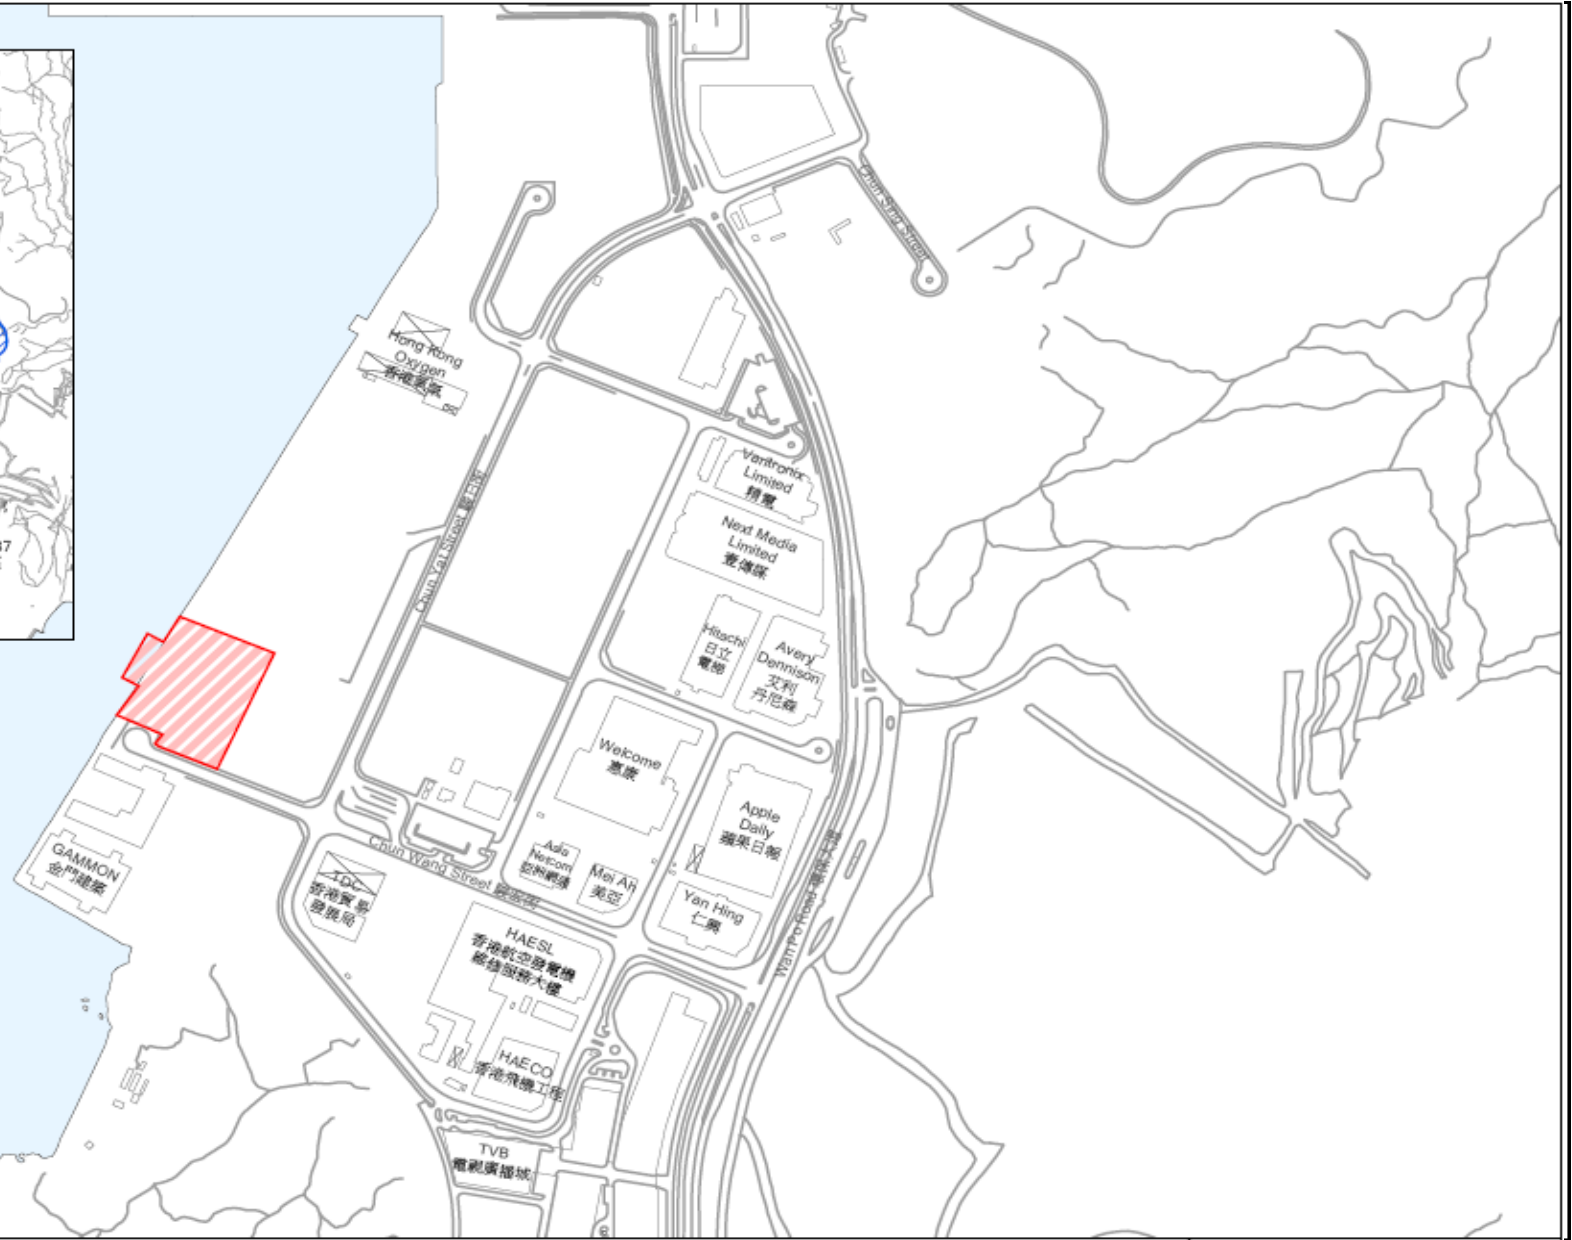
Location Plan

Title Development of a Biodiesel Plant at Tseung Kwan O Industrial Estate
