HZMB Hong Kong Link Road, HZMB Hong Kong Boundary Crossing Facilities,

Contract No. HY/2010/02 - HZMB HKBCF - Reclamation Works Annual EM&A Review Report for March 2013 to February 2014

HONG KONG - ZHUHAI - MACAO BRIDGE
HONG KONG BOUNDARY CROSSING FACILITIES
- RECLAMATION WORKS
Project No.: 60249820 Date: APR 2012

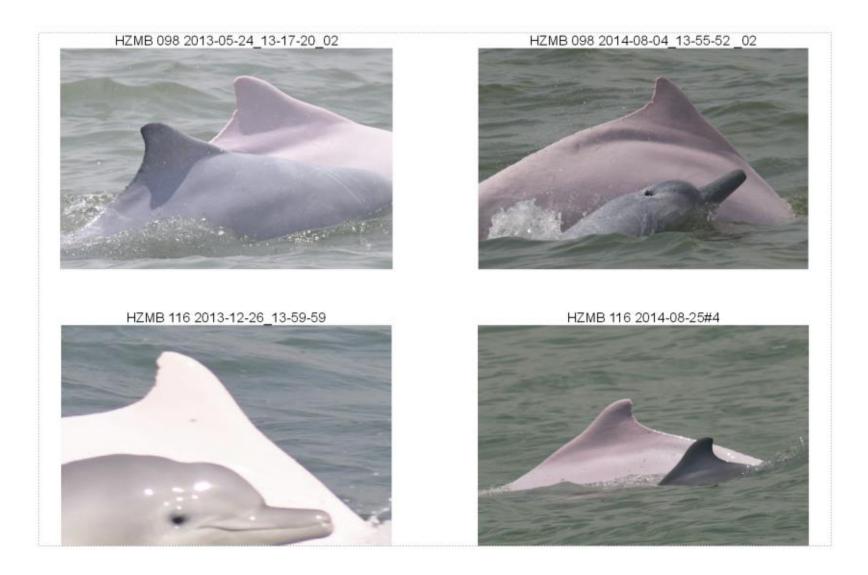
Figure 9. Calves of females identified in the HZMB Catalogue seen during the year March 2012 and February 2014. Images of first and last sighting to indicate current longevity.

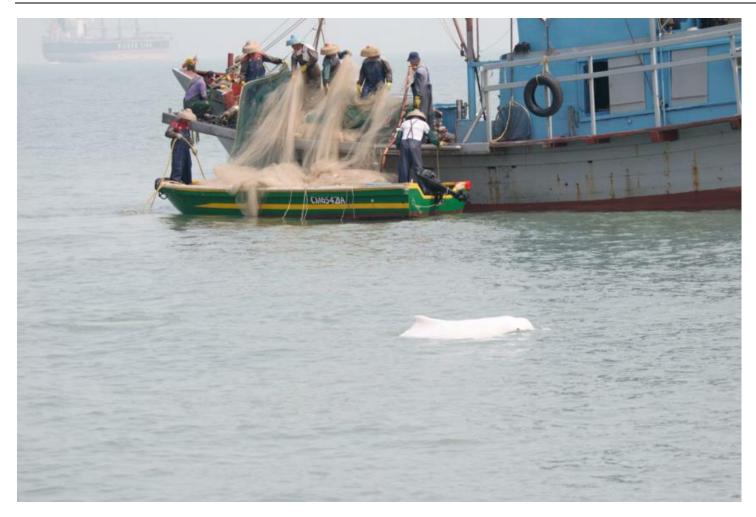
Figure 13. Chinese white dolphins (Sousa chinensis) are often reported feeding in association with purse seine fishing boats

- 3.4.10.1 Four distinctive behavioural categories were defined; "associated with fishing trawler", "feeding", "travelling" and "surface active". Three other categories were also defined; "multiple" (more than one behaviour was observed at one time), "other" and "unknown". During the spring (March May 2013) and winter (December 2013 February 2014), dolphins were most often engaged in travelling activities (Figure 10 of Appendix H). An increase in travelling activities is noted in Dec 2013-Feb 2014 when compared to Dec 2012-Feb 2013. During the summer and autumn months (June November 2013) foraging activities (both feeding and associated with fishing vessels) was the predominant activity (Figure 11 of Appendix H). This was also the case in June to November 2012 (Figure 12 of Appendix H). Although a ban is in place on commercial trawling, a style of purse seine fishing has become more common in Hong Kong waters and dolphins are often associated with this type of fishing when it occurs in the habitat (Figure 13 of Appendix H).
