## **10.0 LANDSCAPE AND VISUAL**

10.1.1 The landscape and visual impact assessment has the broad objectives to outline the baseline conditions, identify sensitive receivers, assess impacts and recommend suitable mitigation measures during construction and operation of the proposed sewerage network.

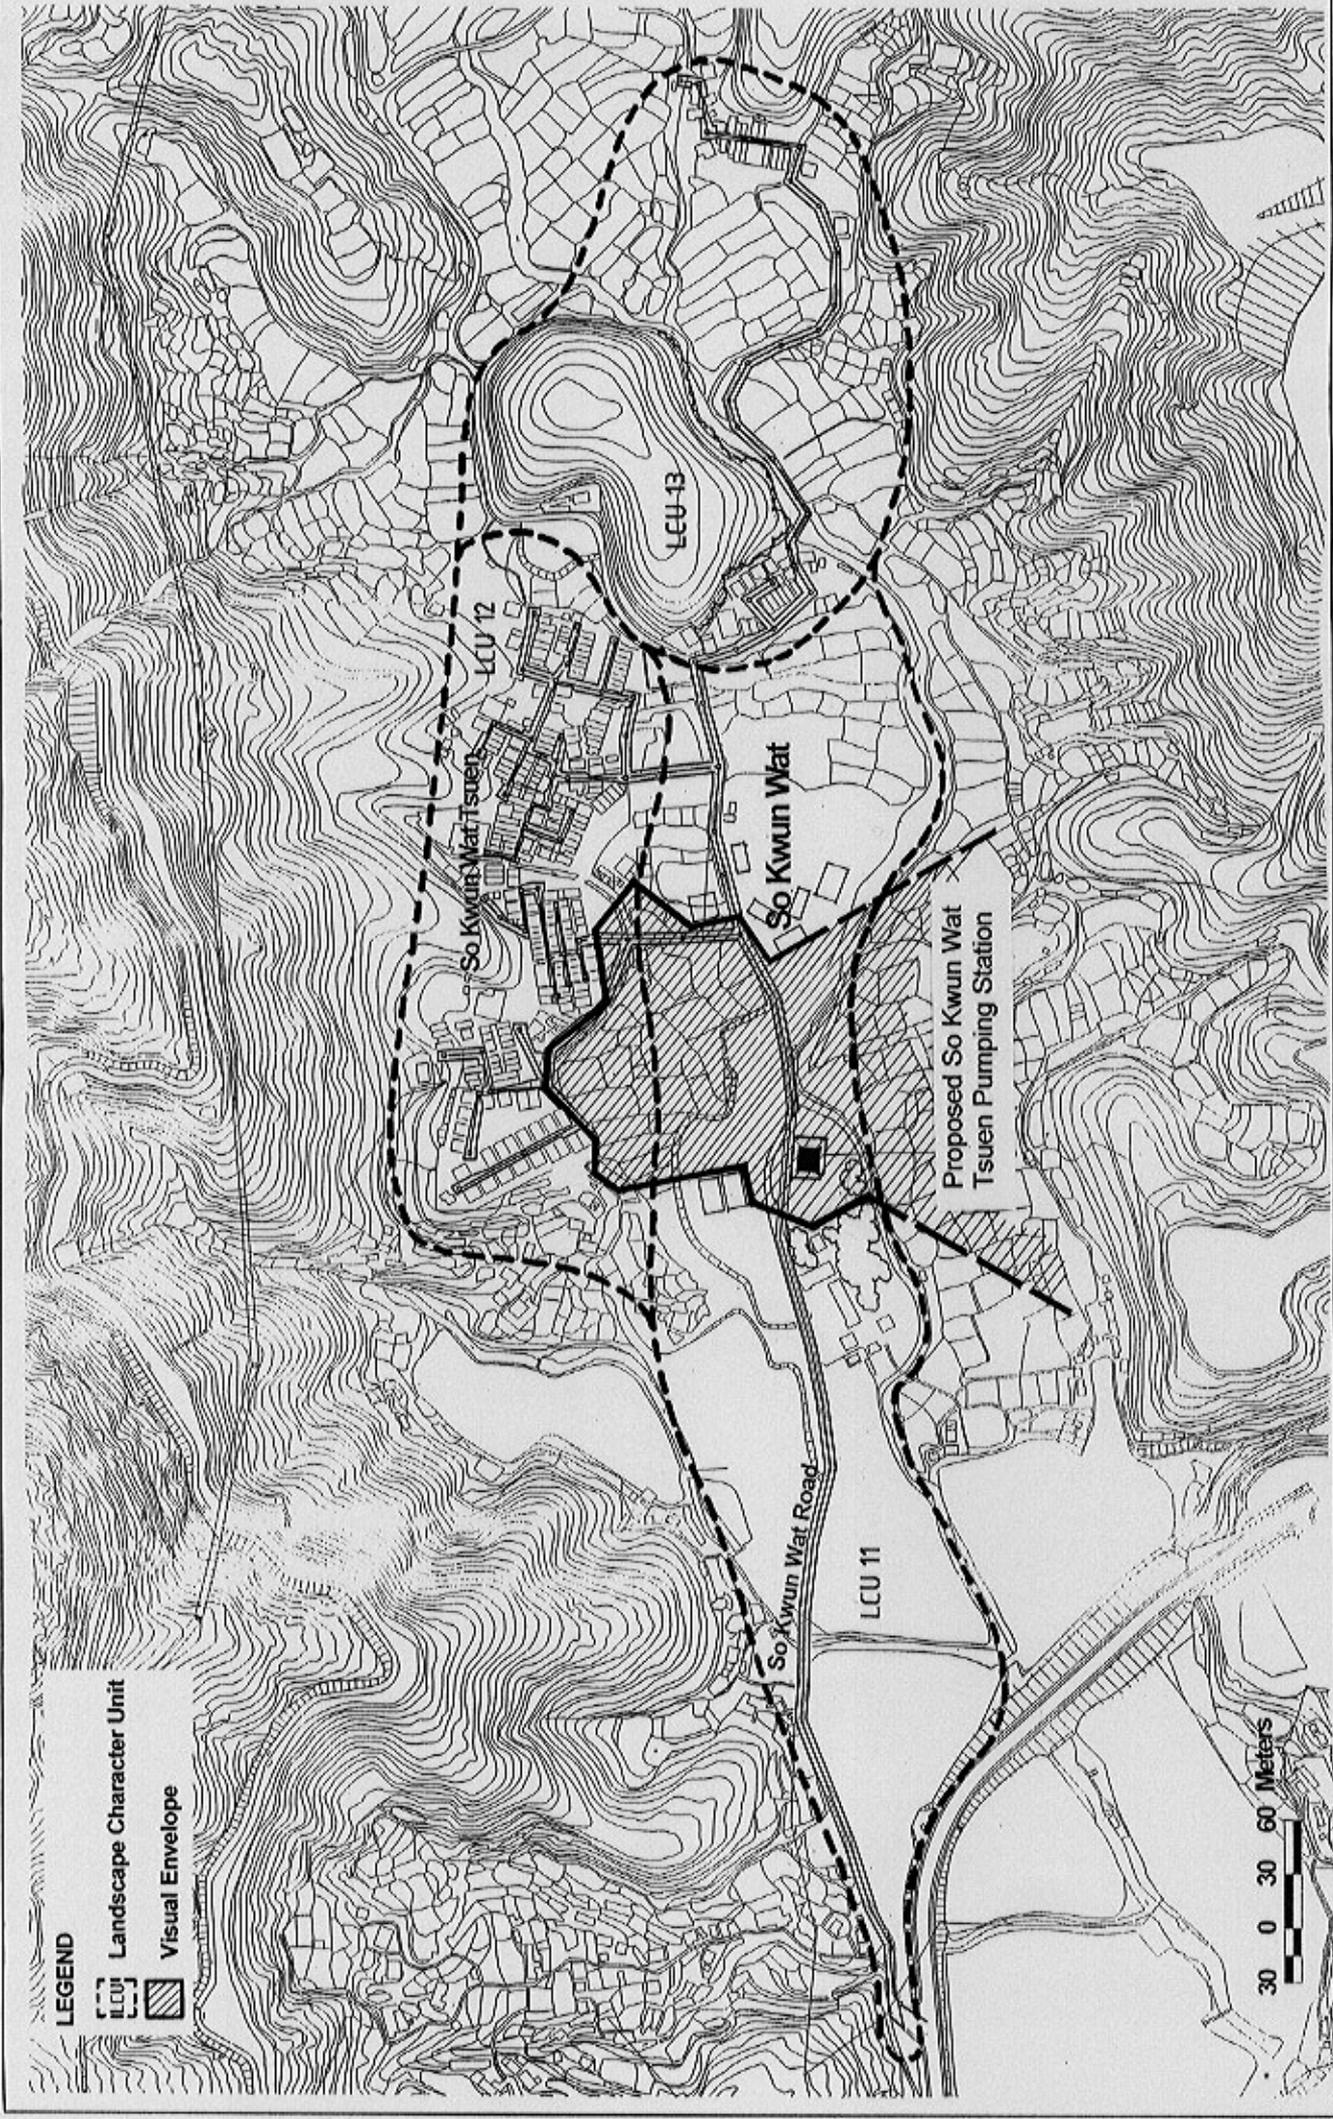
**Landscape and Visual Impact Assessment  
Survey Plan (Sheet 3 of 3)**

Landscape Character Unit
-

Visual Envelope

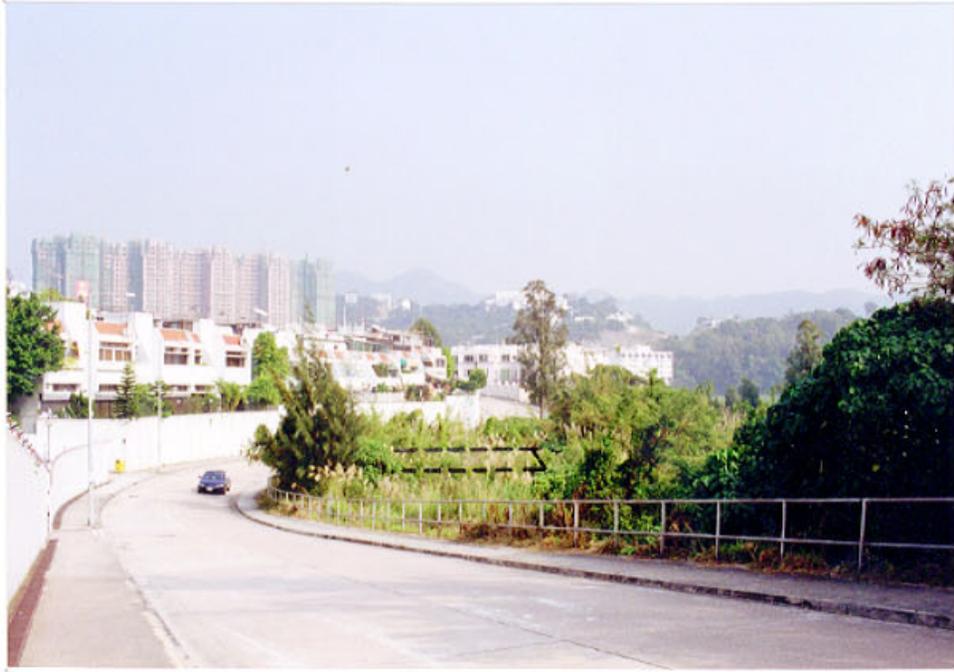
Photograph A LANDSCAPE AND VISUAL CONTEXT

LCU 1: VIEWS FROM EAST AND WEST ENDS OF LOK CHUI STREET  
ILLUSTRATING VISUAL CONTRAST AND LEVEL DIFFERENCE  
BETWEEN VILLAS AND VEGETATED PUMPING STATION SITE

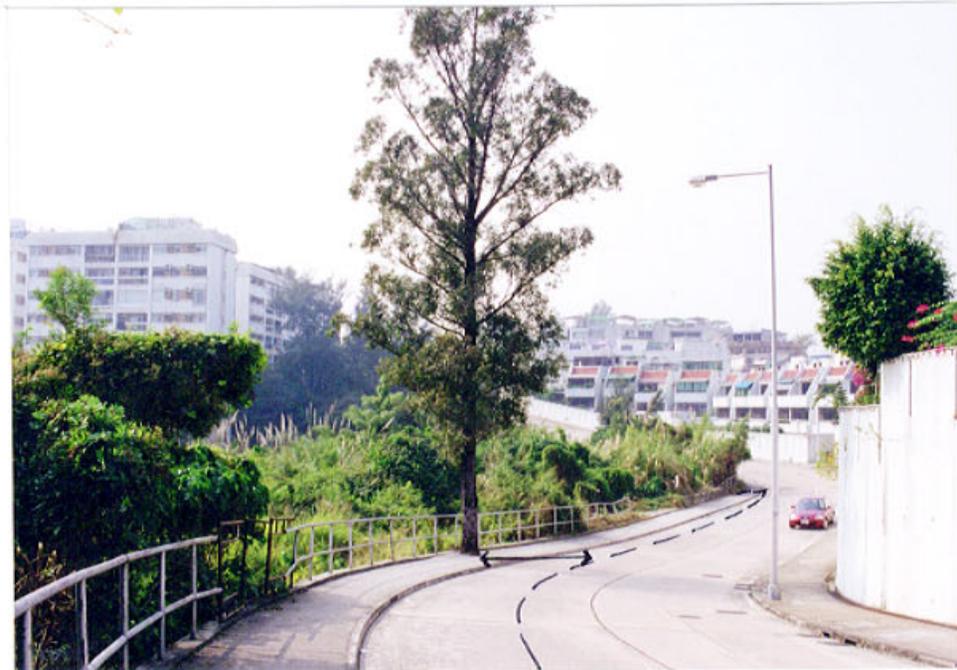
Photograph B RECOMMENDED REALIGNMENT OF SEWER INTO STREET  
TO AVOID DAMAGING ROOTBALL OF MATURE ROADSIDE TREE

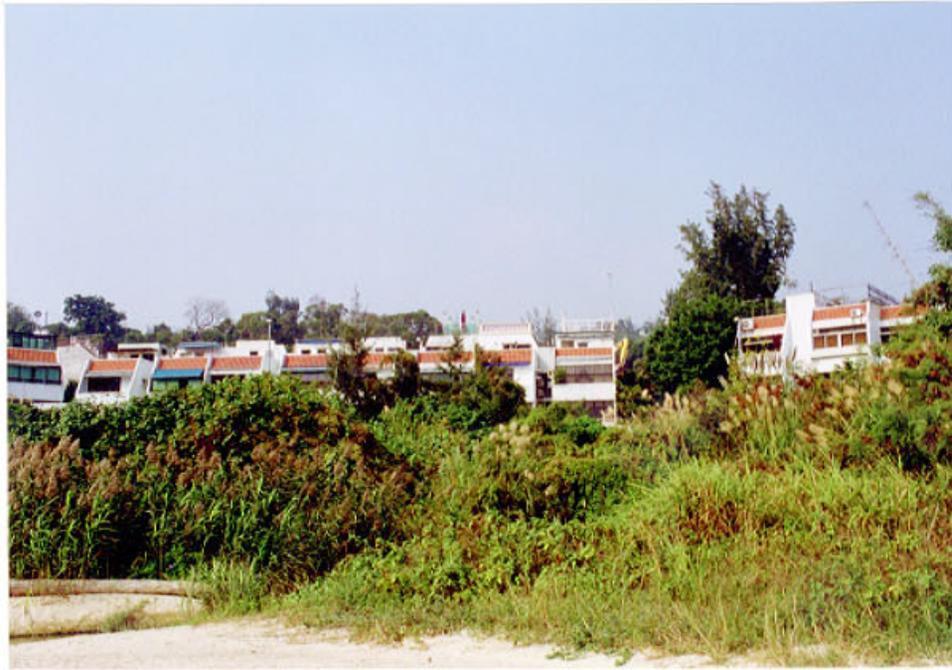
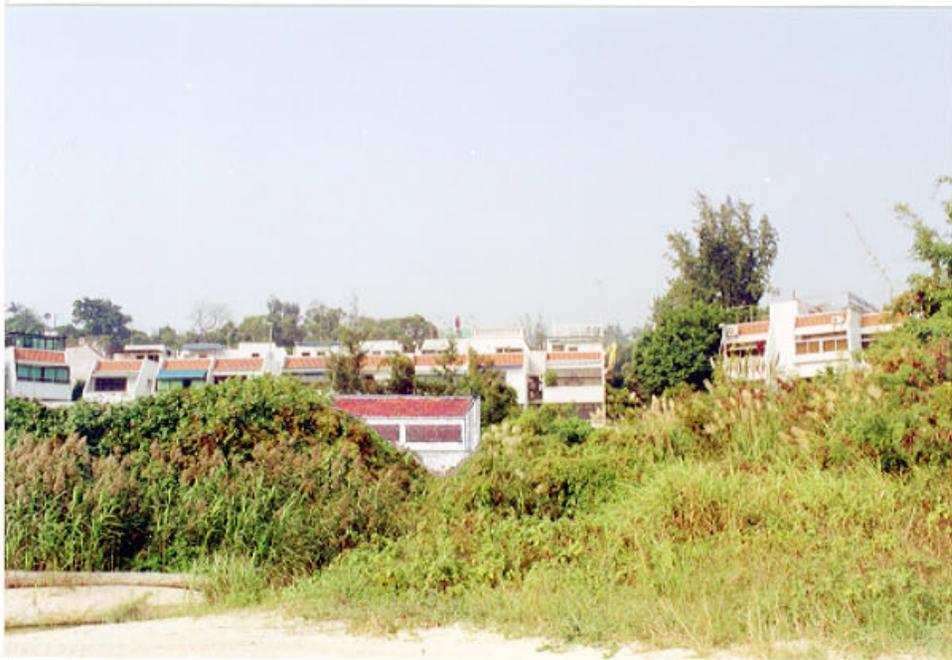
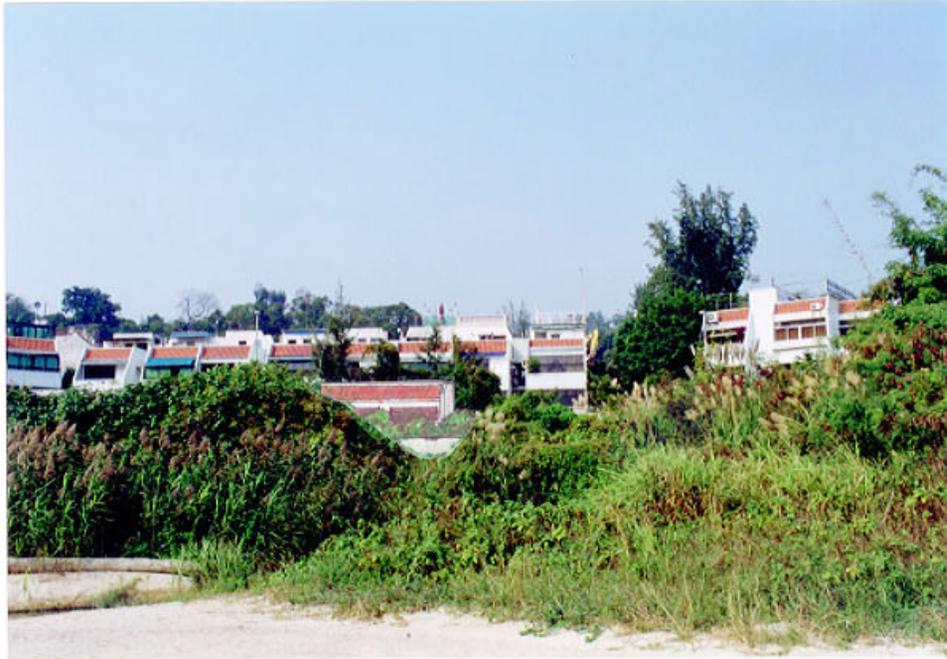
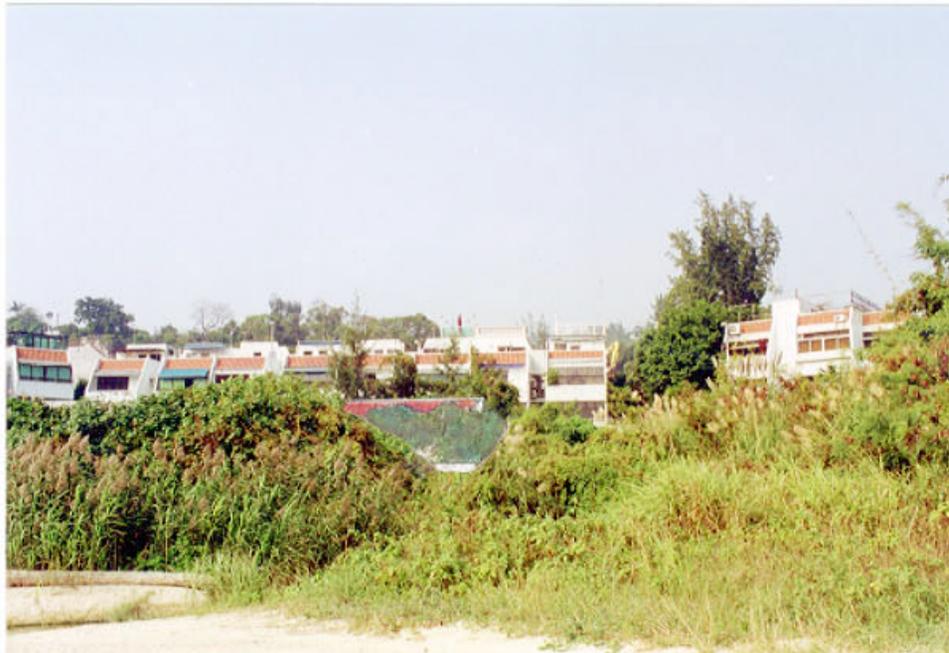
**BEFORE AND AFTER VIEWS OF LOK CHUI STREET  
PUMPING STATION VIEWED FROM BEACH**

**VIEW WITHOUT LANDSCAPE MITIGATION**

**VIEW WITH LANDSCAPE MITIGATION AT COMPLETION**

**MODERN VILLA ARCHITECTURE AND BOUNDARY PLANTING  
PROPOSED TO BLEND STRUCTURE WITH SURROUNDINGS**

**VIEW AFTER 10 YEARS OPERATION**

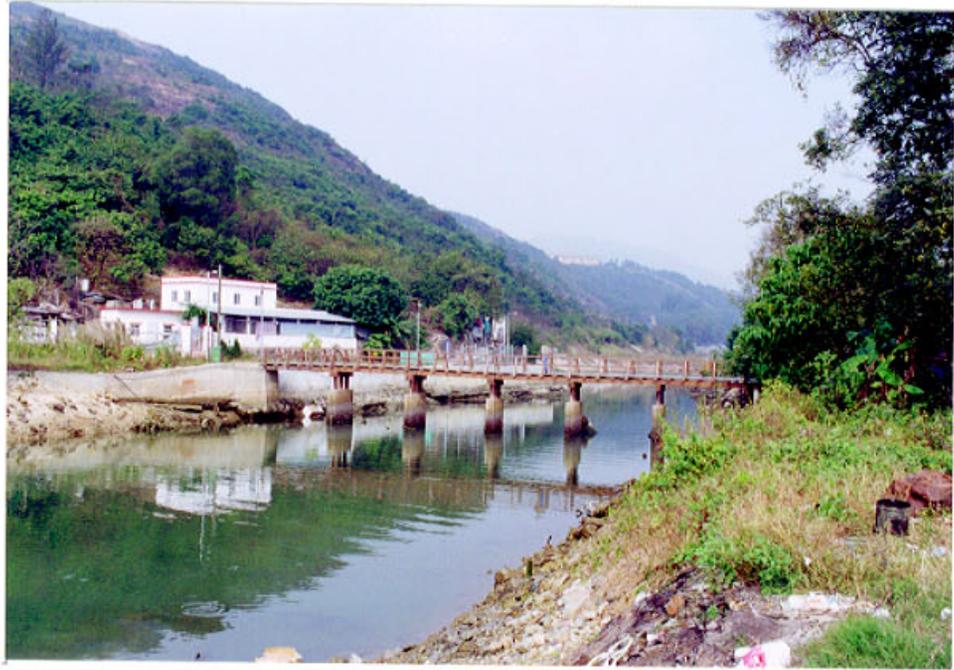
**BEFORE AND AFTER VIEW OF PIPEBRIDGE**

**FOOTBRIDGE IN BACKGROUND TO BE REPROVISIONED BY OTHERS AS CONCRETE STRUCTURE. PIPEBRIDGE TO BE GENERALLY SIMILAR, SIMPLE DESIGN WITH COMPATIBLE COLOUR SCHEME AND HANDRAIL DETAILING. SECURITY GATES AT EACH END TO AVOID 'BOX' PROFILE AND ADOPT MORE ELEGANT FORM AS SHOWN.**

10.9.1 The sewer alignment from Tai Lam Chung Tsuen Pumping Station to Tai Lam Valley Pumping Station follows the existing road alignment and crosses the river via a pipebridge. The landscape character of the riverside is influenced mainly by concrete channel structures and bank reinforcement works and has lost much of its former natural appearance. The existing footbridge adjacent to the pipebridge alignment (refer Drawing 10.2) is currently being replaced under the RPIS Minor Rural Improvement Works Package 1 & 2, Project TM-068. To minimise the cumulative impacts the two bridges will be of simple and consistent design. Drawing 10.7 illustrates the before and after photograph / photomontage.

10.9.5 In order to help blend the pipebridge into the surroundings a low key, simple design using neutral colours is proposed to match the style of the proposed adjacent replacement footbridge. Any good excavated topsoil should be stored carefully on site and used to complete grass reinstatement on the riverbank or screen planting in the nearby pumping station compound.

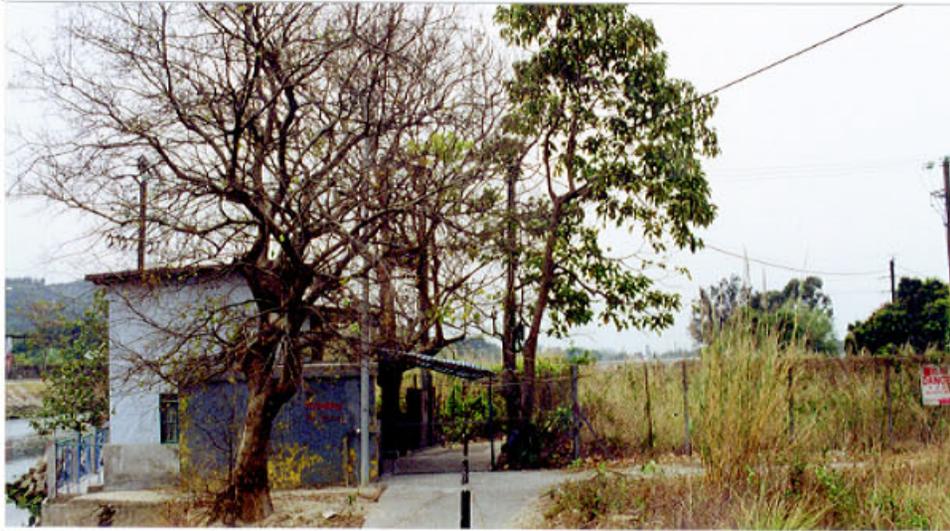
Photograph A CARE REQUIRED TO ENSURE SEWER ALIGNMENT  
AVOIDS MATURE TREES

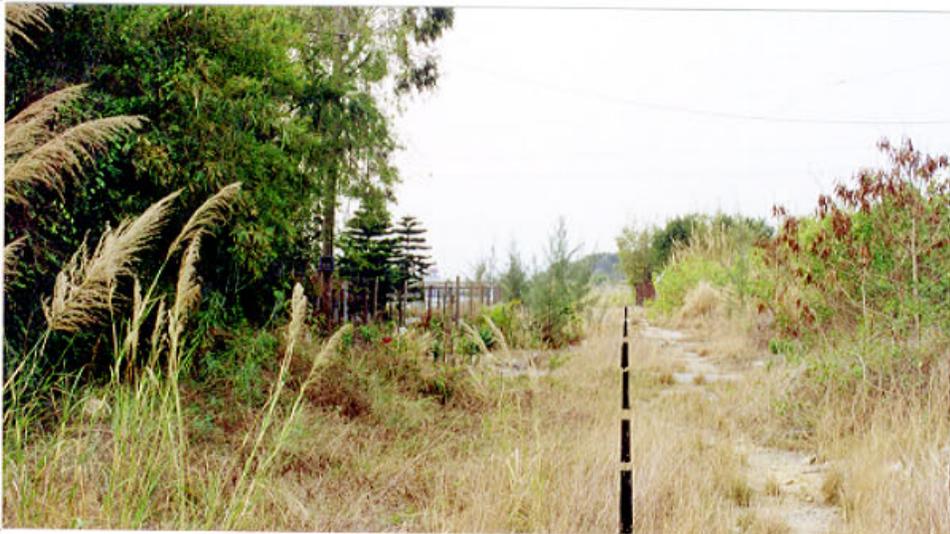
Photograph B LCU 3: AREA OF RECLAMATION PREVIOUSLY  
DISTURBED FOR WSD PIPELINE

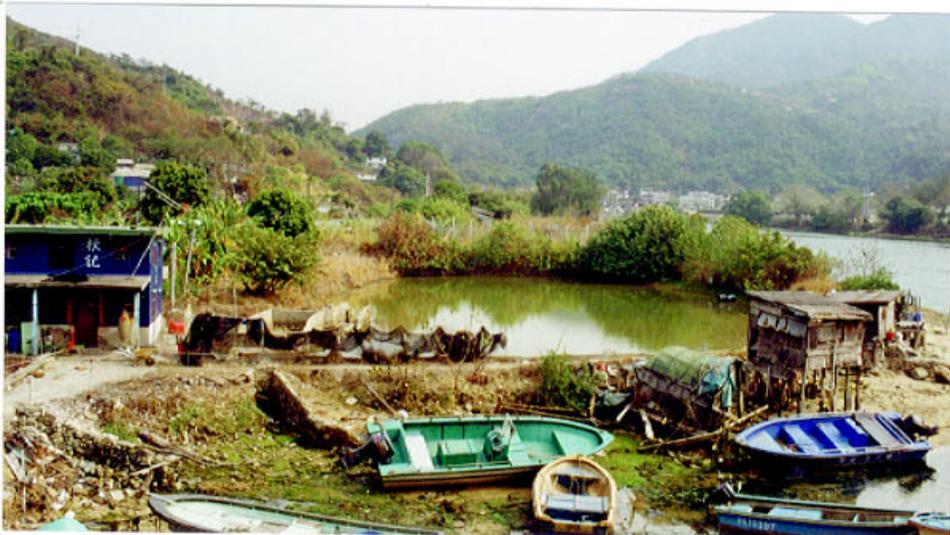
Photograph C LCU 4: POND AND RIVERBANK

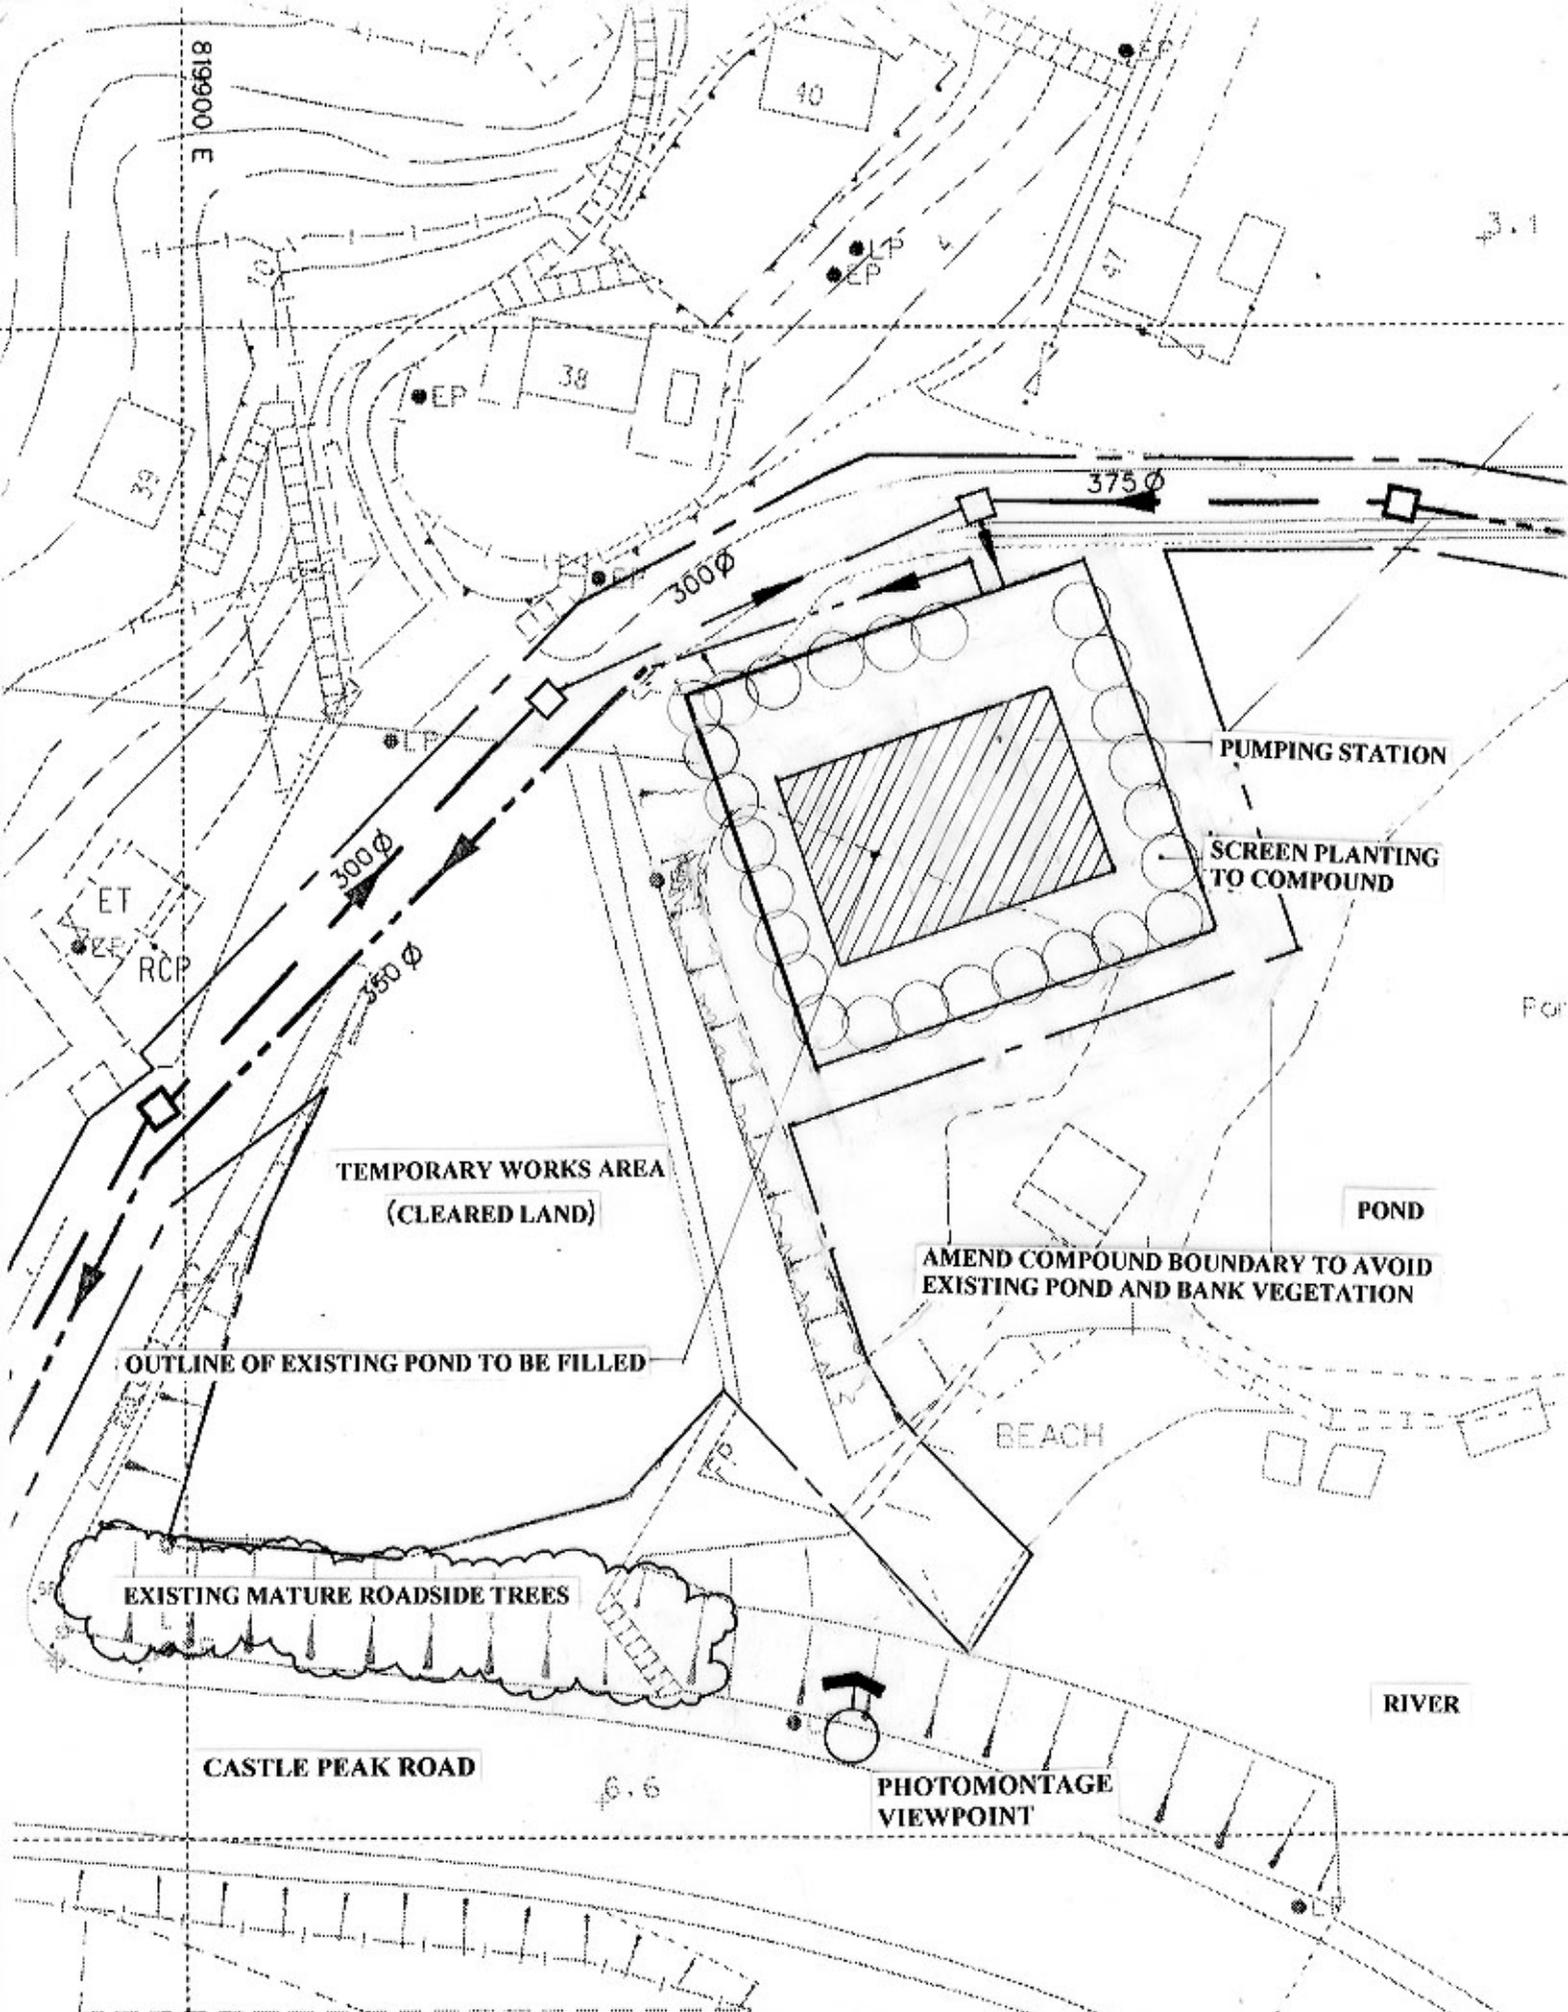
**Drawing 10.9**

**AREA 2: TAILAM VALLEY PUMPING STATION** SCALE 1:500

- 10.9.11 The proposed location for the Tai Lam Valley pumping station, as shown in Drawing 10.2, is partly on a derelict site, used for storage and lorry parking. The most significant landscape features in the vicinity of the pumping station site are the adjacent brackish fish pond with thicket vegetation on the banks, as shown in Photograph C on Drawing 10.8 and Drawing 10.10, as well as the short belt of mature trees bordering Castle Peak Road, shown in Drawing 10.9. The remainder of the surrounding area is dominated by lengths of unattractive chain link fences in various states of repair, including the chain link and barbed wire enclosure to WSD's recently constructed water mains. A small number of village houses are located on the lower hillside to the north overlooking the site.

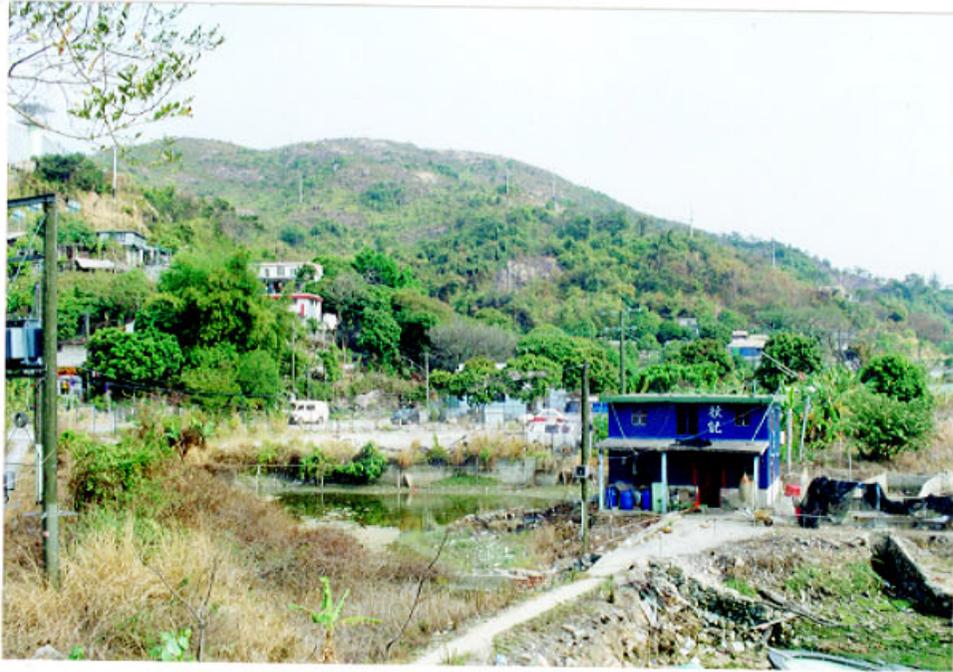
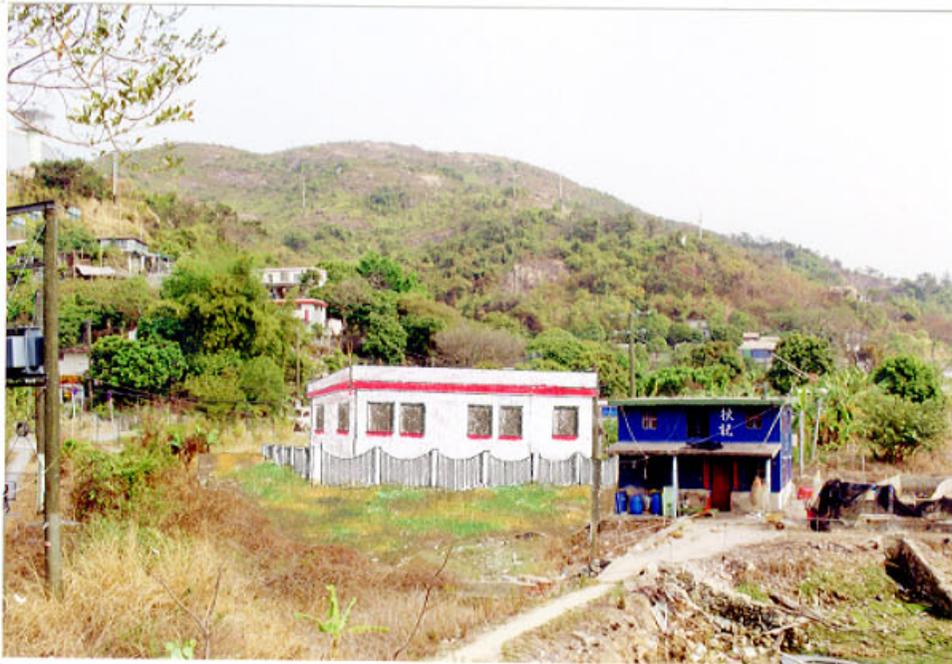
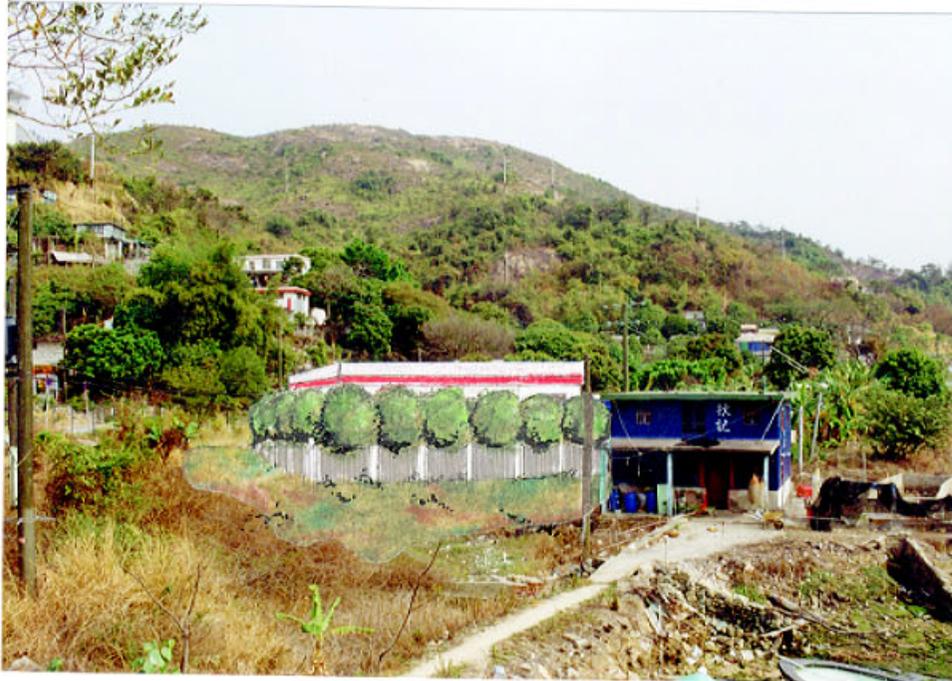
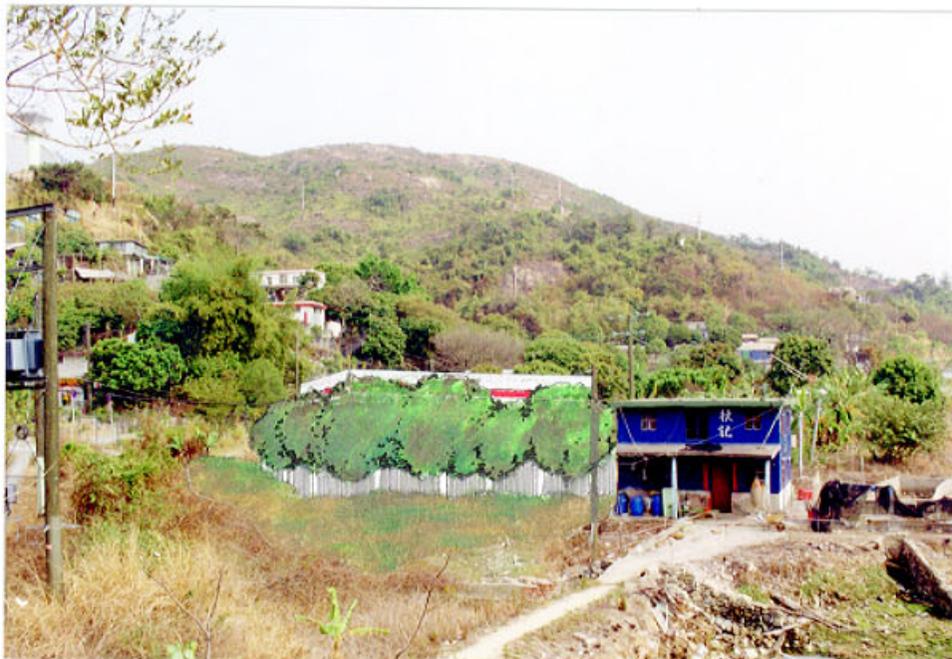
BEFORE AND AFTER VIEW OF TAI LAM VALLEY  
PUMPING STATION VIEWED FROM CASTLE PEAK ROAD

VIEW WITHOUT LANDSCAPE MITIGATION

VIEW WITH LANDSCAPE MITIGATION AT COMPLETION

MODERN VILLAGE HOUSE ARCHITECTURE AND BOUNDARY PLANTING  
PROPOSED TO BLEND STRUCTURE WITH SURROUNDINGS

VIEW AFTER 10 YEARS OPERATION

10.9.13 Upon completion the temporary works area will be fully reinstated and will not cause any landscape or visual impacts. The pumping station will be a permanent change to the surroundings and intrusion into the views from a small number of village houses.

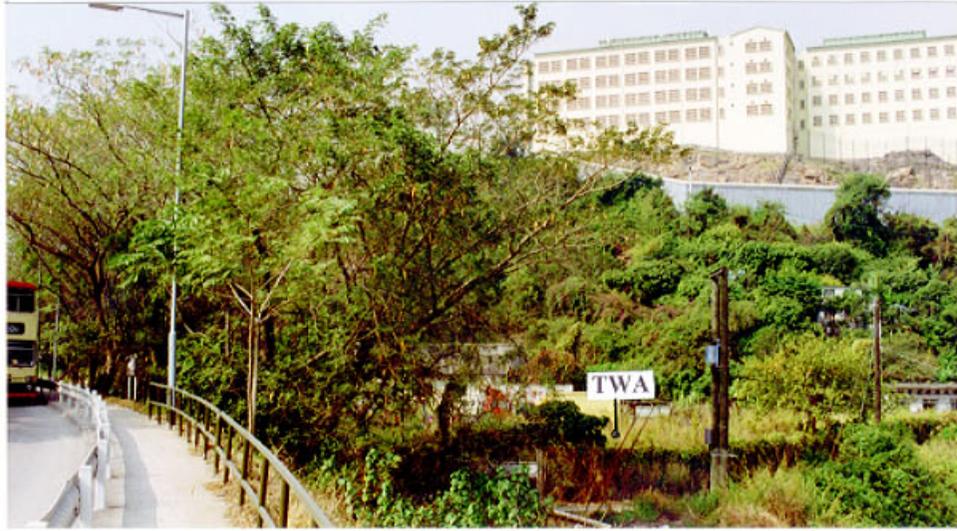
Photograph A LCU 4: ROADSIDE TREES PARTLY SCREEN PUMPING STATION AND TEMPORARY WORKS AREA

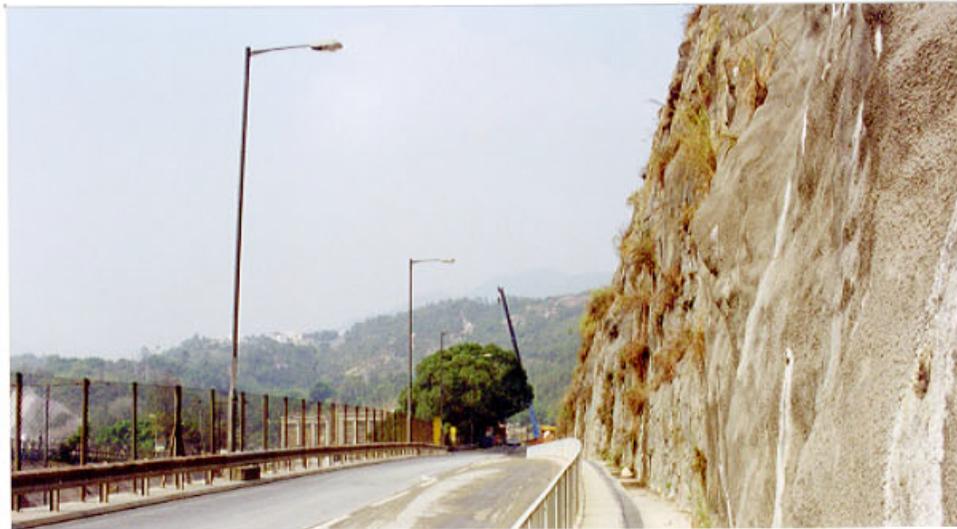
Photograph B LCU 5: SEWERS ALIGNED UNDER ROADS / FOOTPATHS ADJACENT TO ROCKFACE

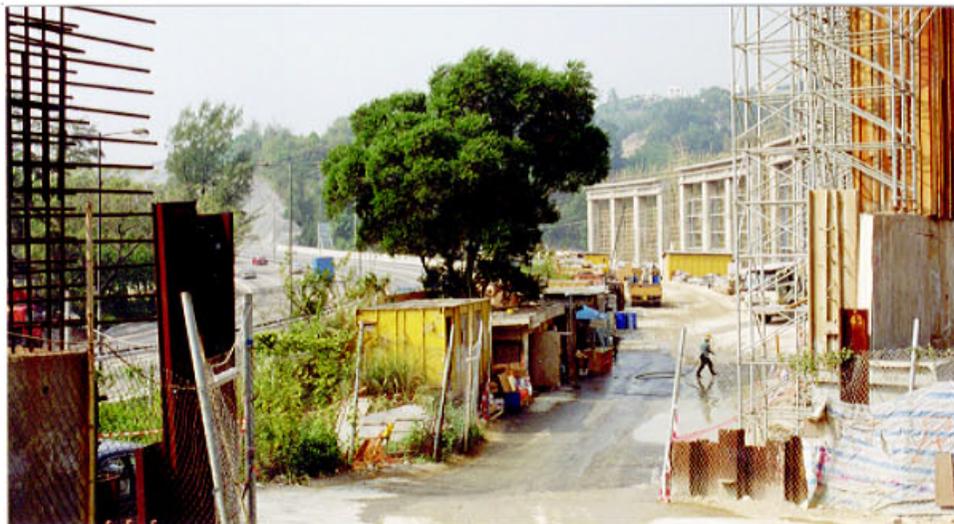
Photograph C LCU 6: SEWERS ALIGNED UNDER ROADS / FOOTPATHS ADJACENT TO NEW RESIDENTIAL DEVELOPMENT

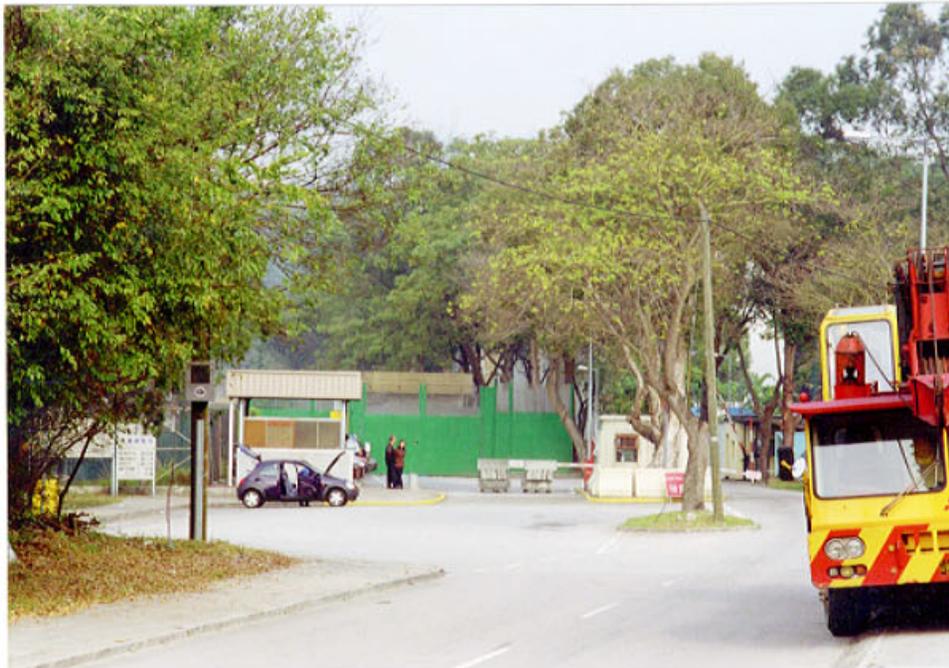
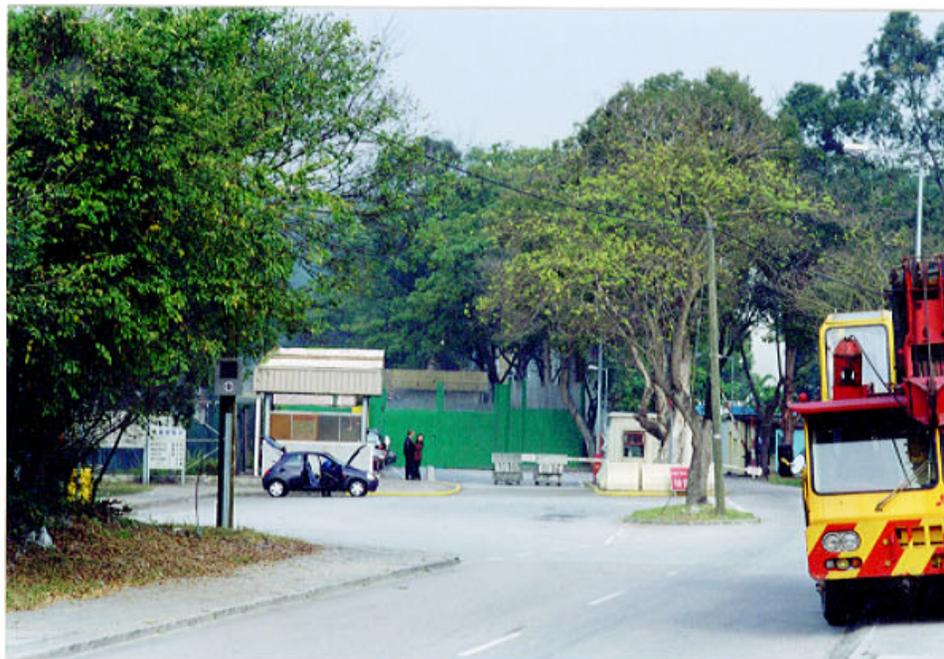
BEFORE AND AFTER VIEW OF TAI LAM CORRECTIONAL INSTITUTION  
PUMPING STATION VIEW FROM ROADSIDE.

SIMPLE STRUCTURE AND LIGHT COLOURING TO  
BLEND STRUCTURE WITH SURROUNDING BUILDINGS

NOTE: No tree planting proposed due to screening effect of existing  
Compound. Same view for years 1 and 10 of operation

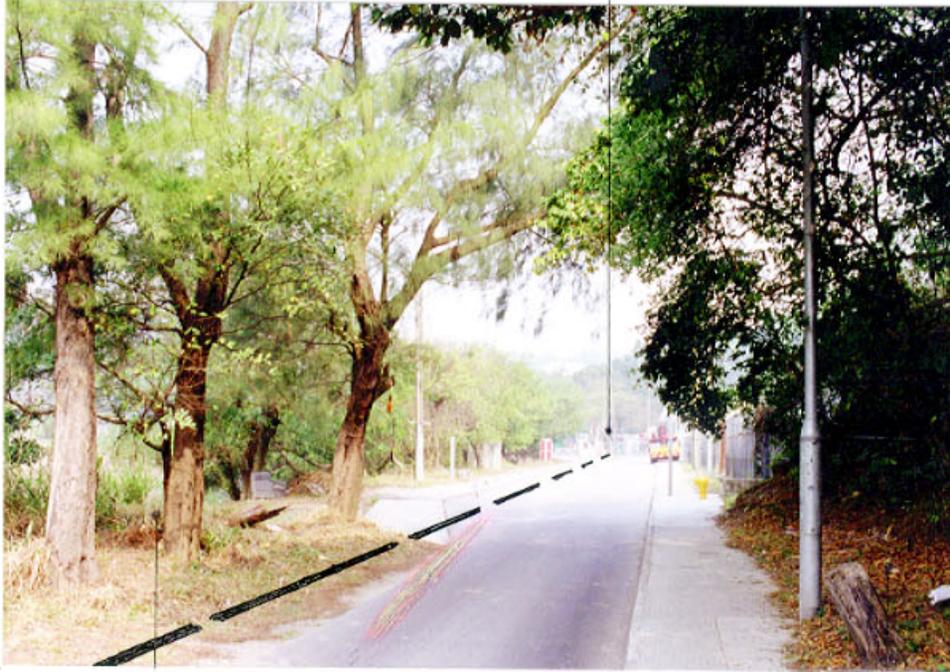
LANDSCAPE AND VISUAL CONTEXT OF TAI LAM  
CHUNG ROAD

ROADSIDE TREES AT NARROW PORTION OF ROAD,  
WITHIN SEWER WORKS AREA, TO BE FELLED.  
WOODLAND OPPOSITE TO BE RETAINED

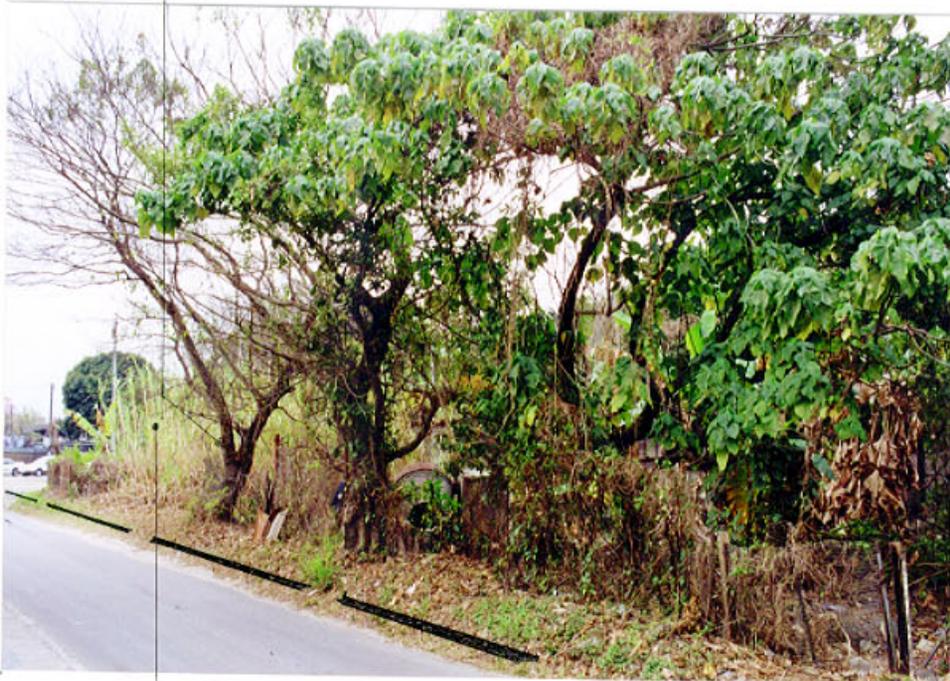
LOCATION OF TAI LAM CHUNG TSUEN  
PUMPING STATION

3 NOS. CASUARINA EQUISETIFOLIA  
2 NOS. CELTIS SINENSIS  
1 NO. MACARANGA TANARIUS  
LIKELY FELLED TO  
ACCOMMODATE PIPE ALIGNMENT

two *Celtis sinensis* and one *Macaranga tanarius*, as shown in the photographs in Drawing 10.14. The trees are common species of fair to poor condition and are not considered suitable for transplanting. In addition to the trees, approximately 280m<sup>2</sup> of understorey grass and scrub would be cleared during the construction works which could be reinstated as a grass verge upon completion. The pumping station will require clearance of approximately 750m<sup>2</sup> of mainly bare ground and grass cover and a small group of approximately ten banana, papaya and longnan trees as shown in Drawing 10.15 and the photographs in Drawing 10.16. None of the trees is rare or of sufficiently good amenity value to justify transplanting.

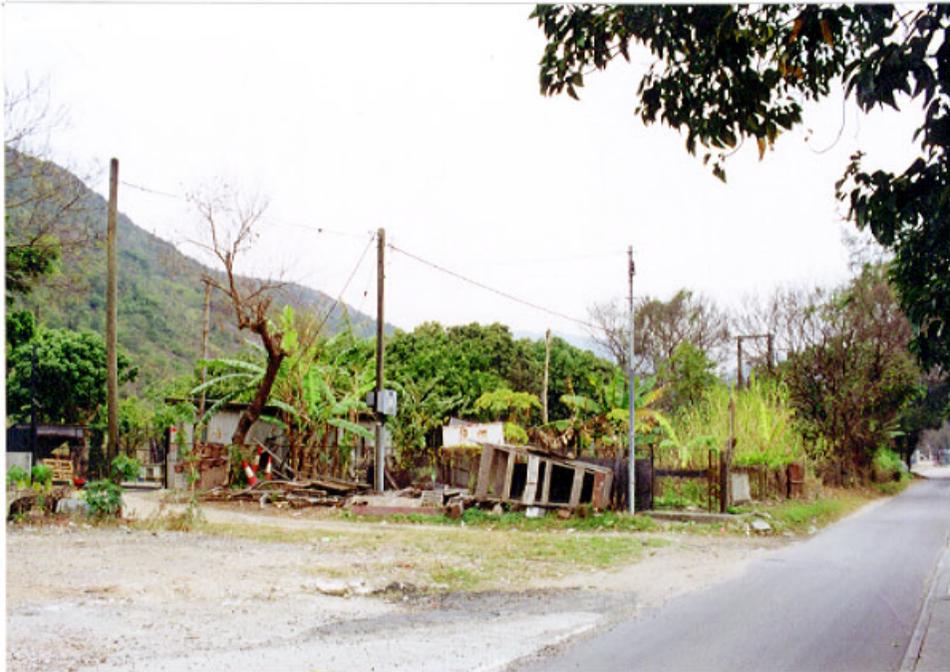
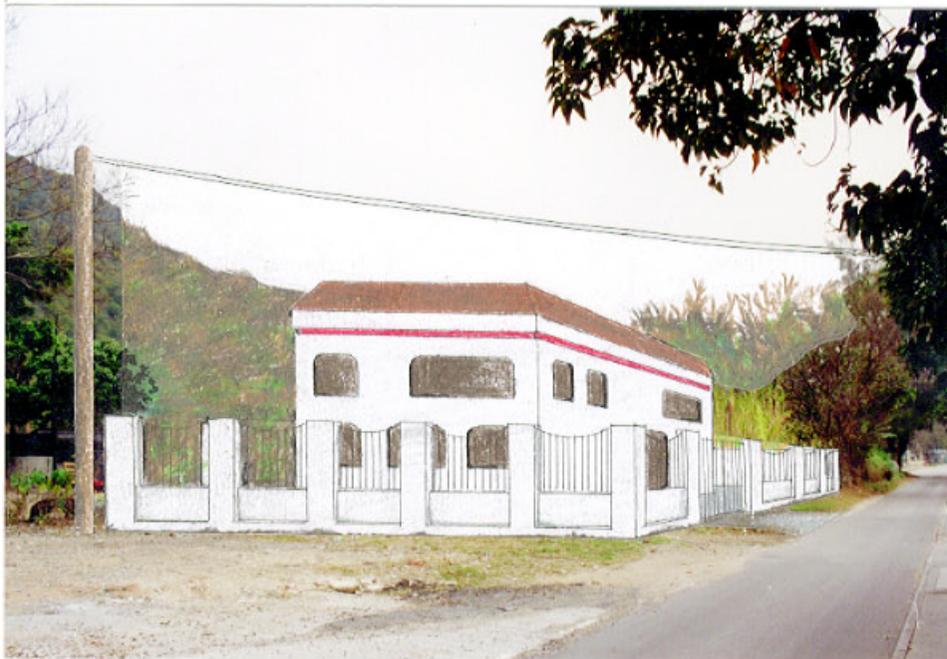
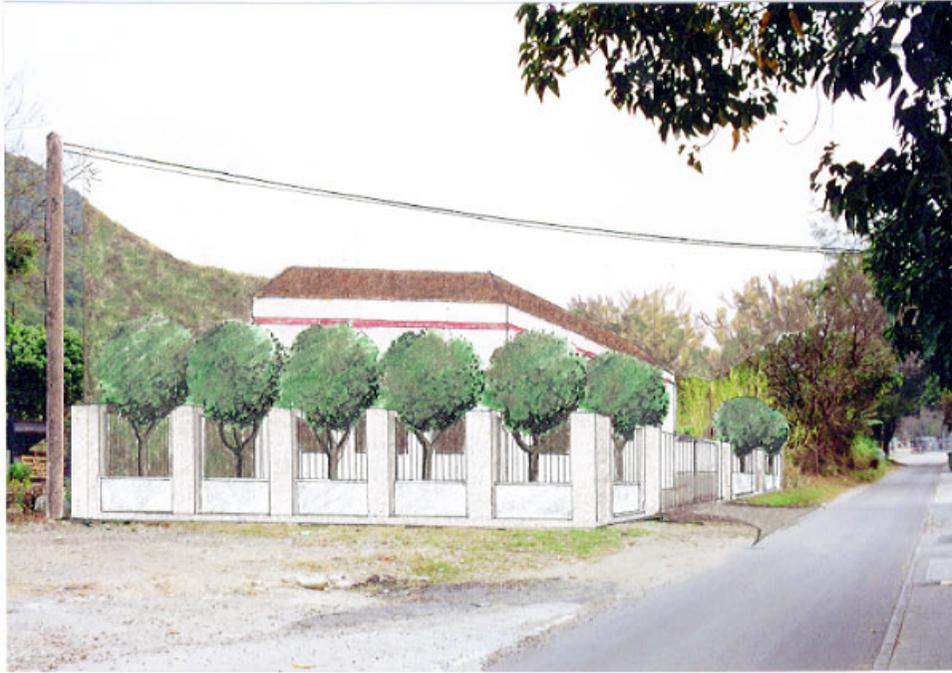
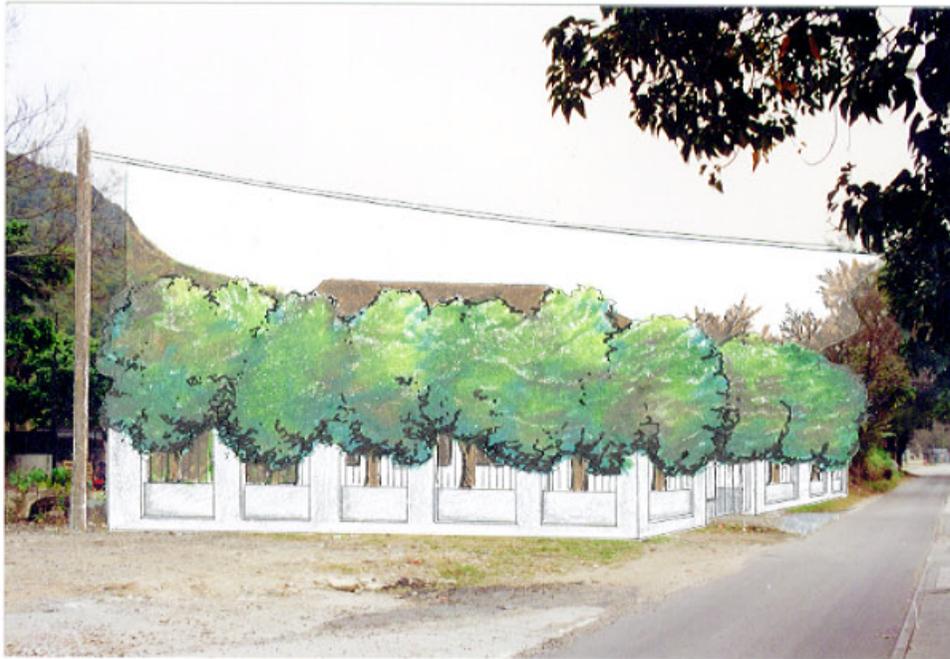
**BEFORE AND AFTER VIEW OF TAI LAM CHUNG TSUEN  
PUMPING STATION VIEWED FROM ROADSIDE**

**VIEW WITHOUT LANDSCAPE MITIGATION**

**VIEW WITH LANDSCAPE MITIGATION AT COMPLETION**

**MODERN VILLAGE HOUSE ARCHITECTURE AND BOUNDARY PLANTING  
PROPOSED TO BLEND STRUCTURE WITH SURROUNDINGS**

**VIEW AFTER 10 YEARS OPERATION**
