## **10.0 LANDSCAPE AND VISUAL**

10.1.1 The landscape and visual impact assessment has the broad objectives to outline the baseline conditions, identify sensitive receivers, assess impacts and recommend suitable mitigation measures during construction and operation of the proposed sewerage network.

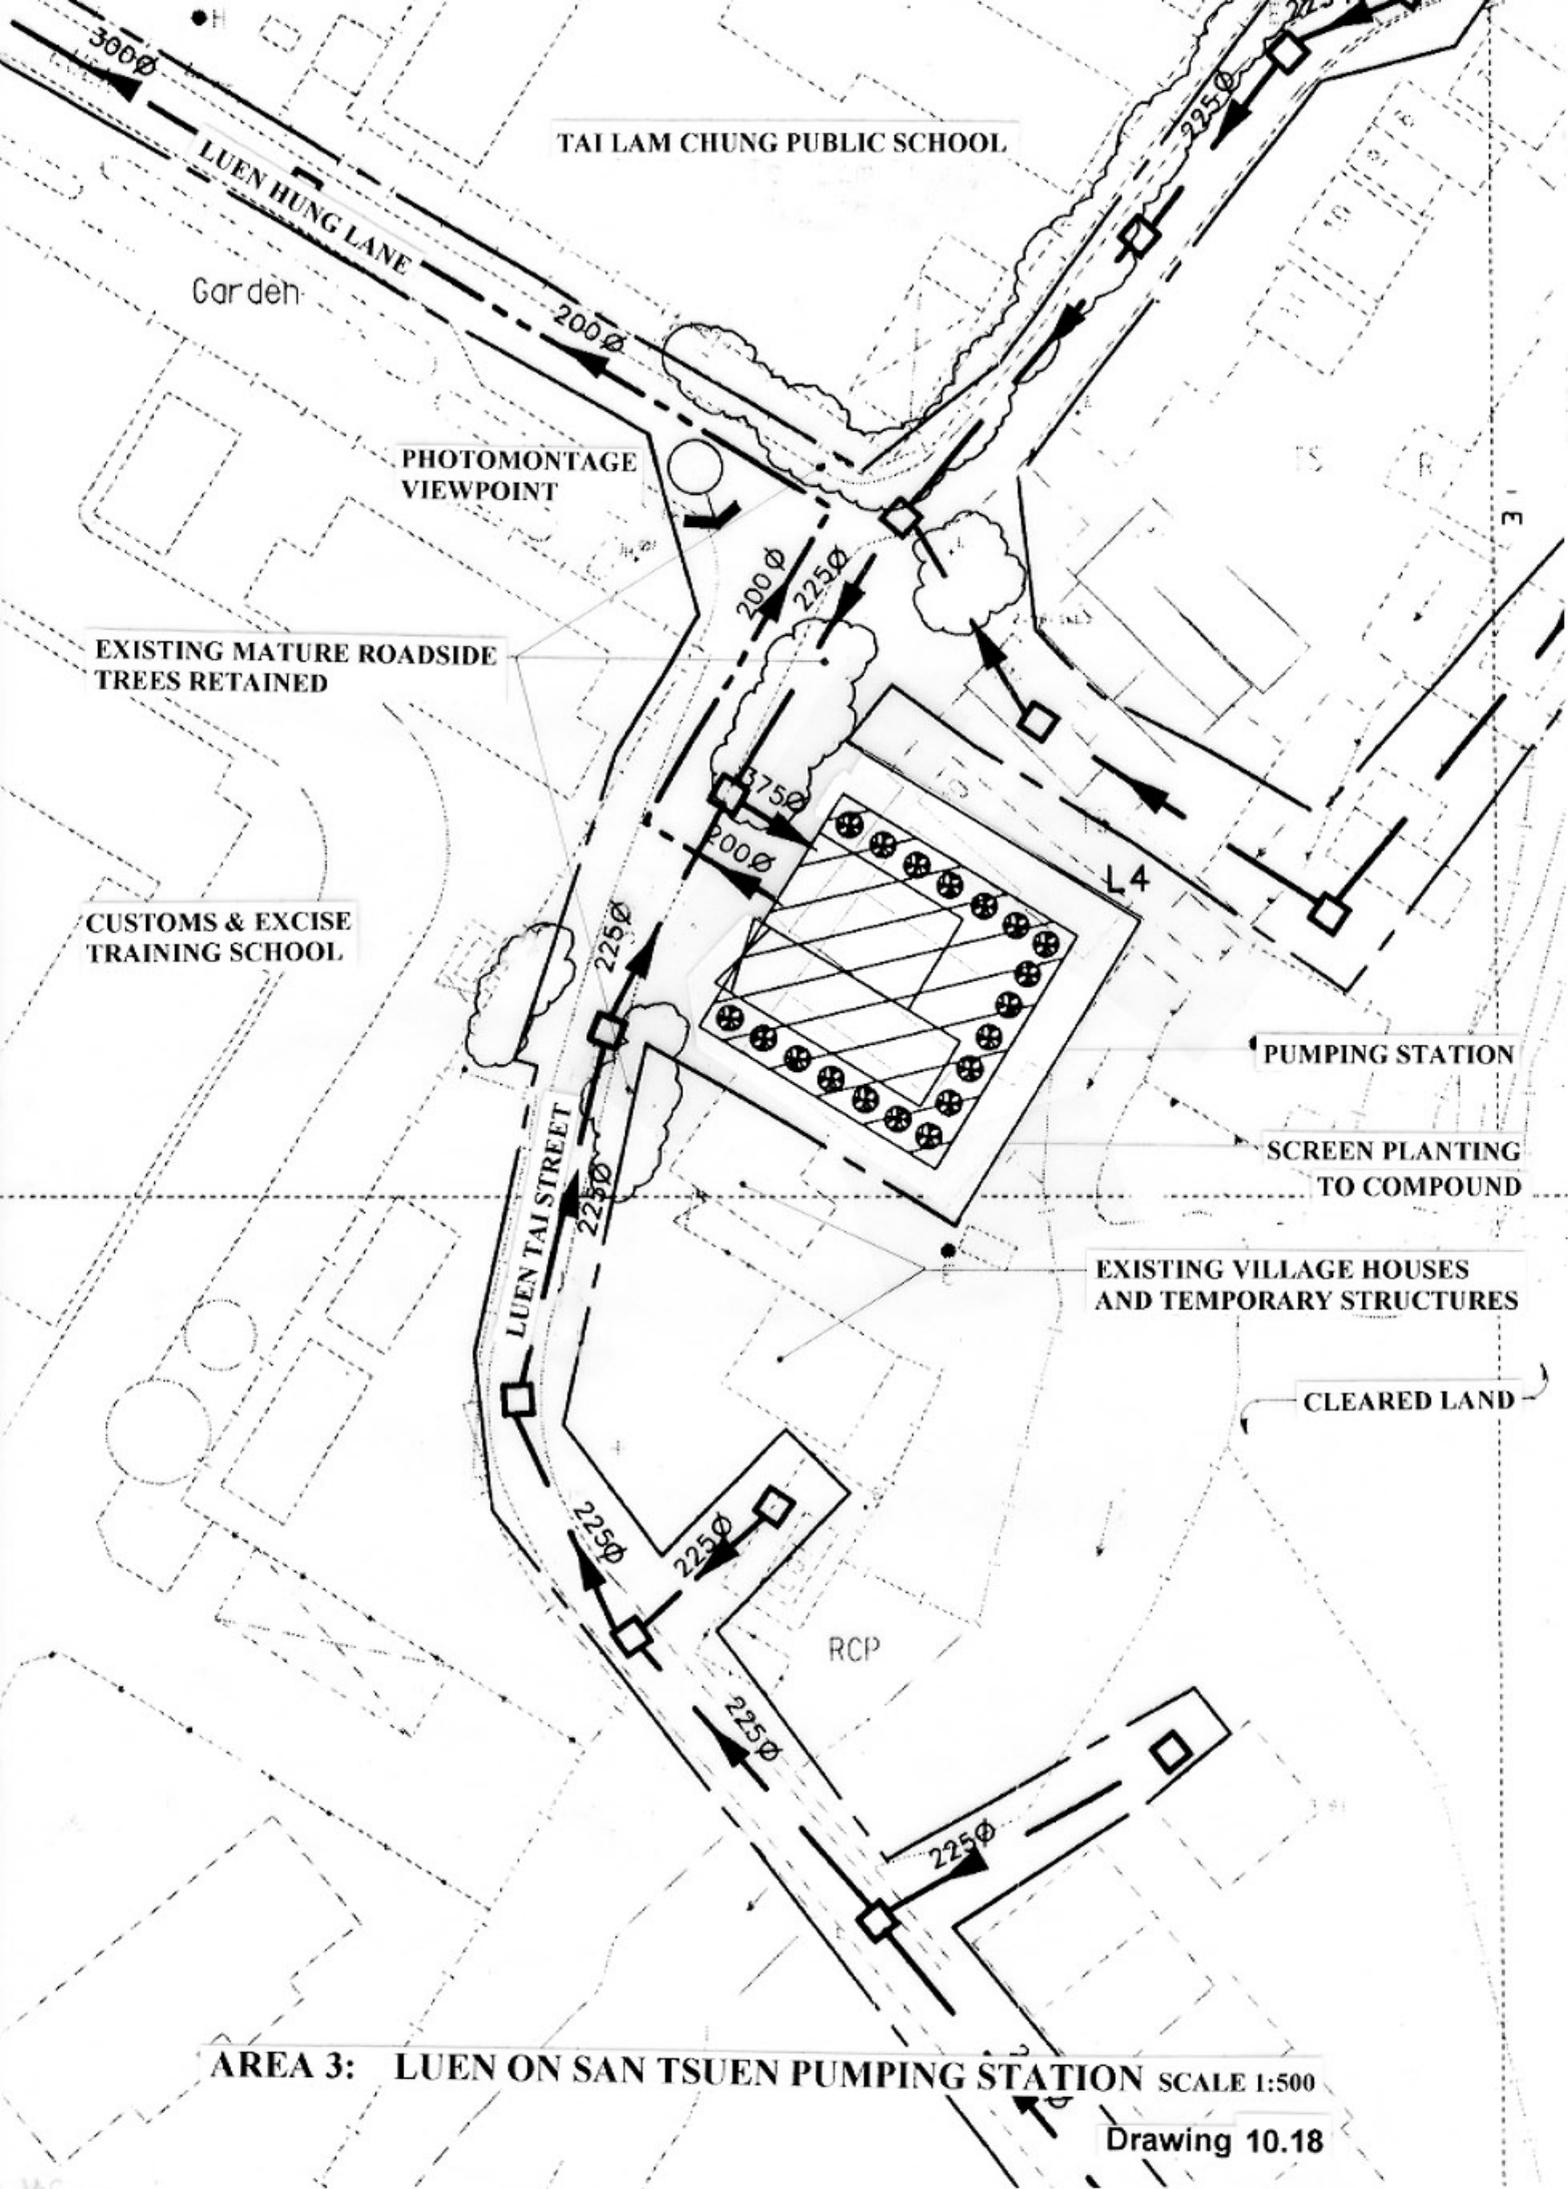
Drawing 10.18

AREA 3: LUEN ON SAN TSUEN PUMPING STATION SCALE 1:500

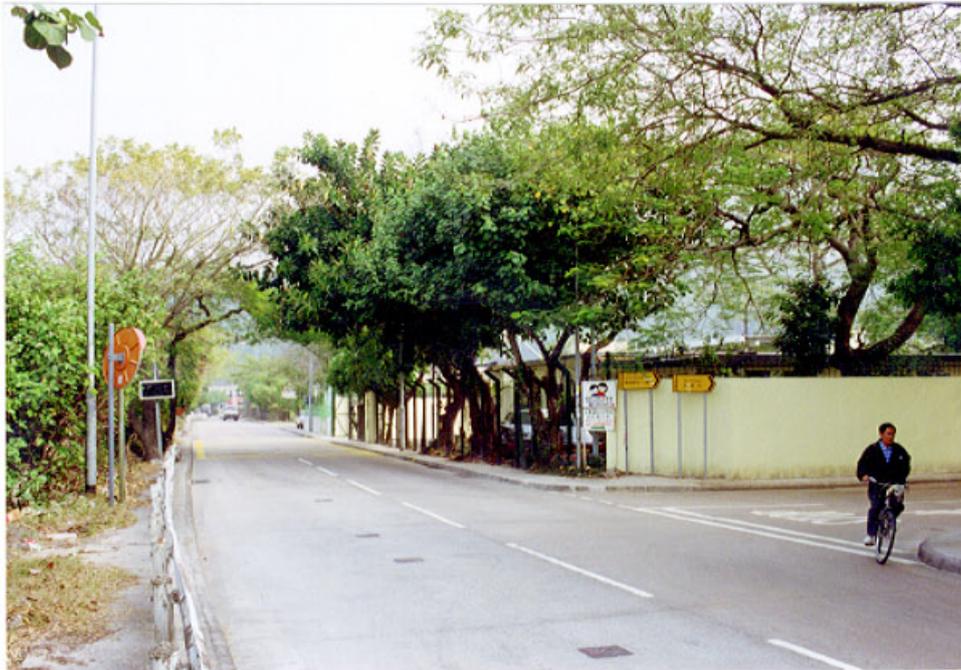
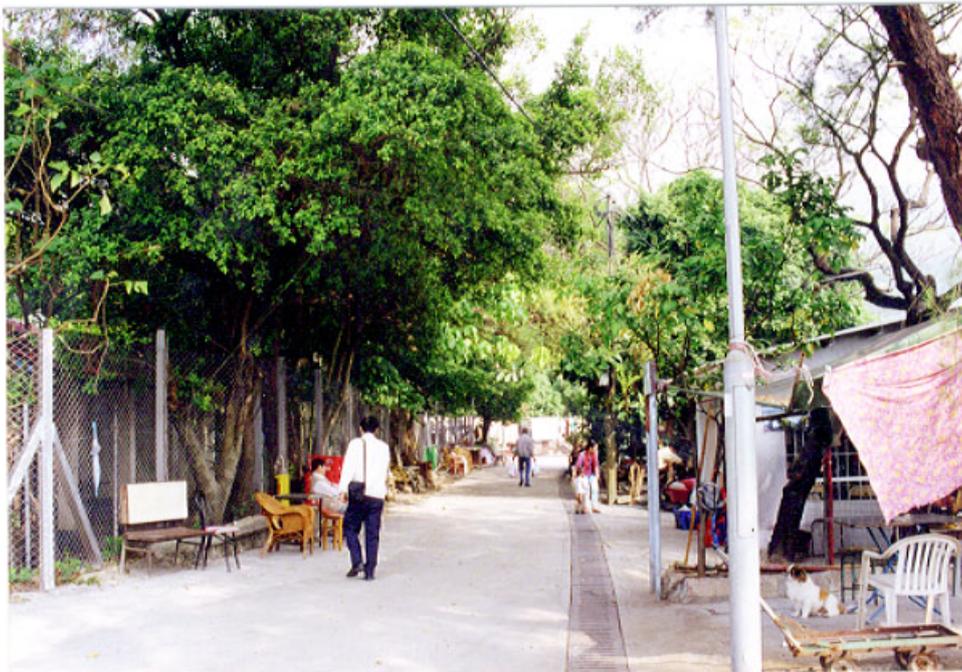
LANDSCAPE AND VISUAL CONTEXT  
TYPICAL VIEWS WITHIN LUEN ON SAN VILLAGE.  
MATURE ROADSIDE TREES NOT AFFECTED BY  
ALIGNMENT OF SEWERS UNDER ROADS

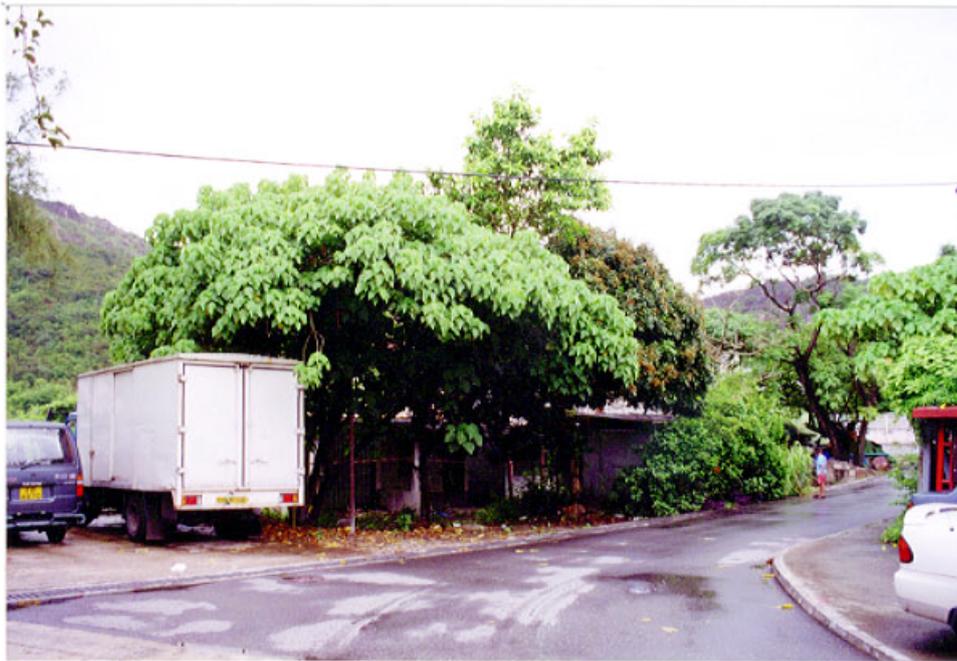
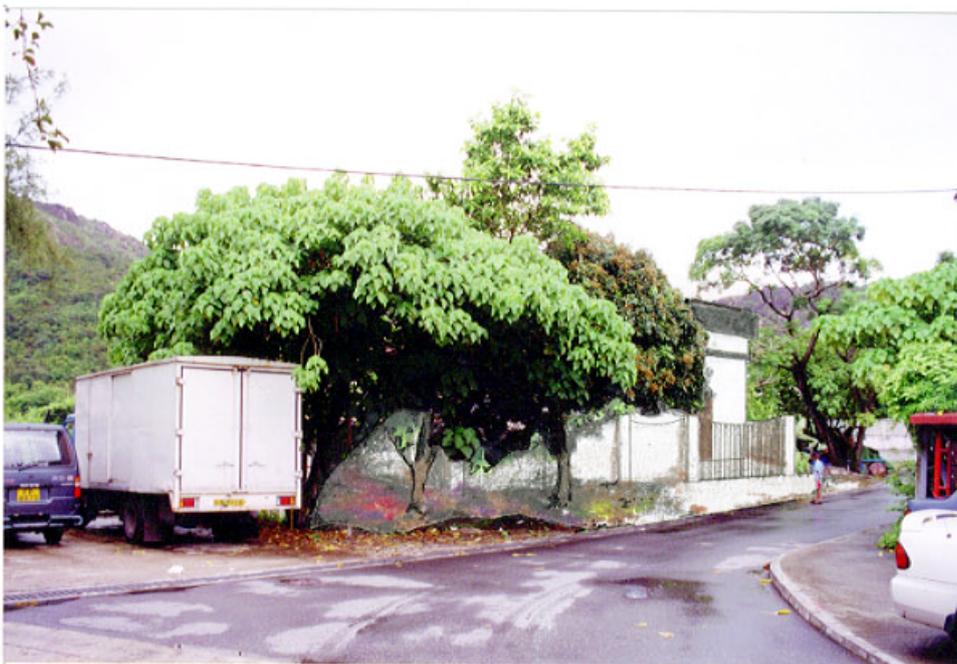
**BEFORE AND AFTER VIEWS OF LUEN ON SAN TSUEN  
PUMPING STATION VIEWED FROM ROADSIDE**

**VILLAGE HOUSE ARCHITECTURE WITH BOUNDARY PLANTING  
PROPOSED TO BLEND STRUCTURE WITH SURROUNDINGS.**

**NOTE:** Existing roadside trees provide effective screen during construction and operation. Same view for years 1 and 10 of operation.

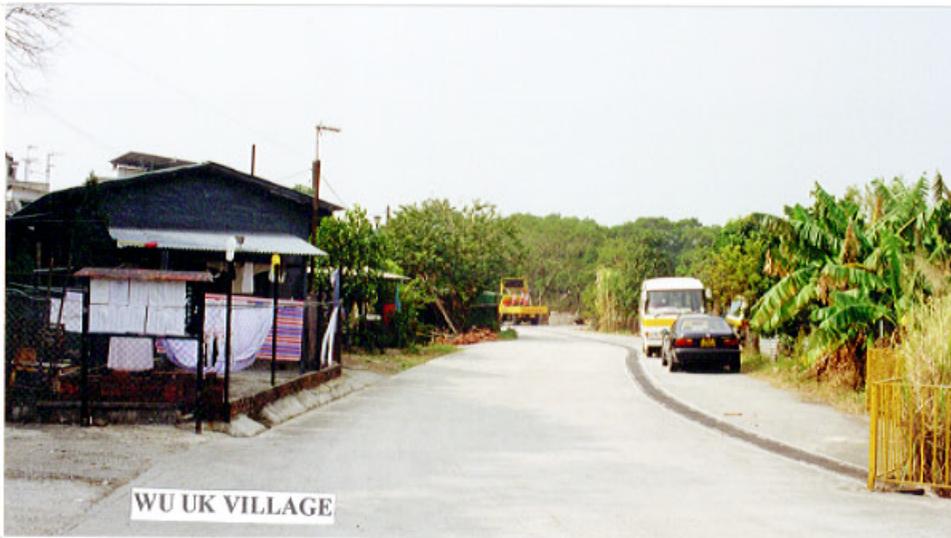
WU UK VILLAGE

LANDSCAPE AND VISUAL CONTEXT  
TYPICAL VIEWS WITHIN WU UK AND WONG UK VILLAGES  
WHERE SEWERS ALIGNED MAINLY UNDER STREETS. CARE  
REQUIRED TO AVOID MATURE TREES DURING CONSTRUCTION

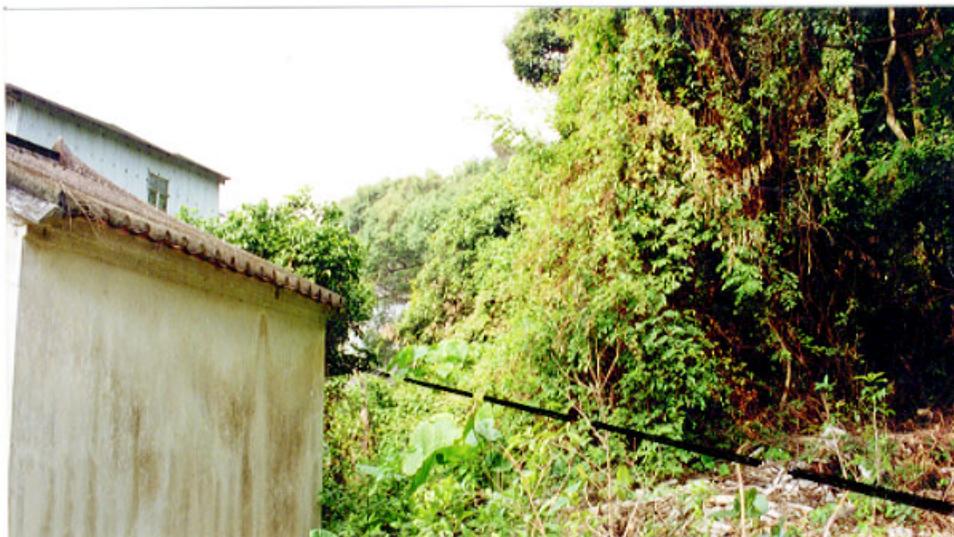
ORIGINAL SEWER ALIGNMENT BEHIND WONG UK VILLAGE  
RELOCATED INTO PARALLEL VILLAGE LANE AS  
RECOMMENDED TO AVOID TREE FELLING (REFER DWG. 10.2)

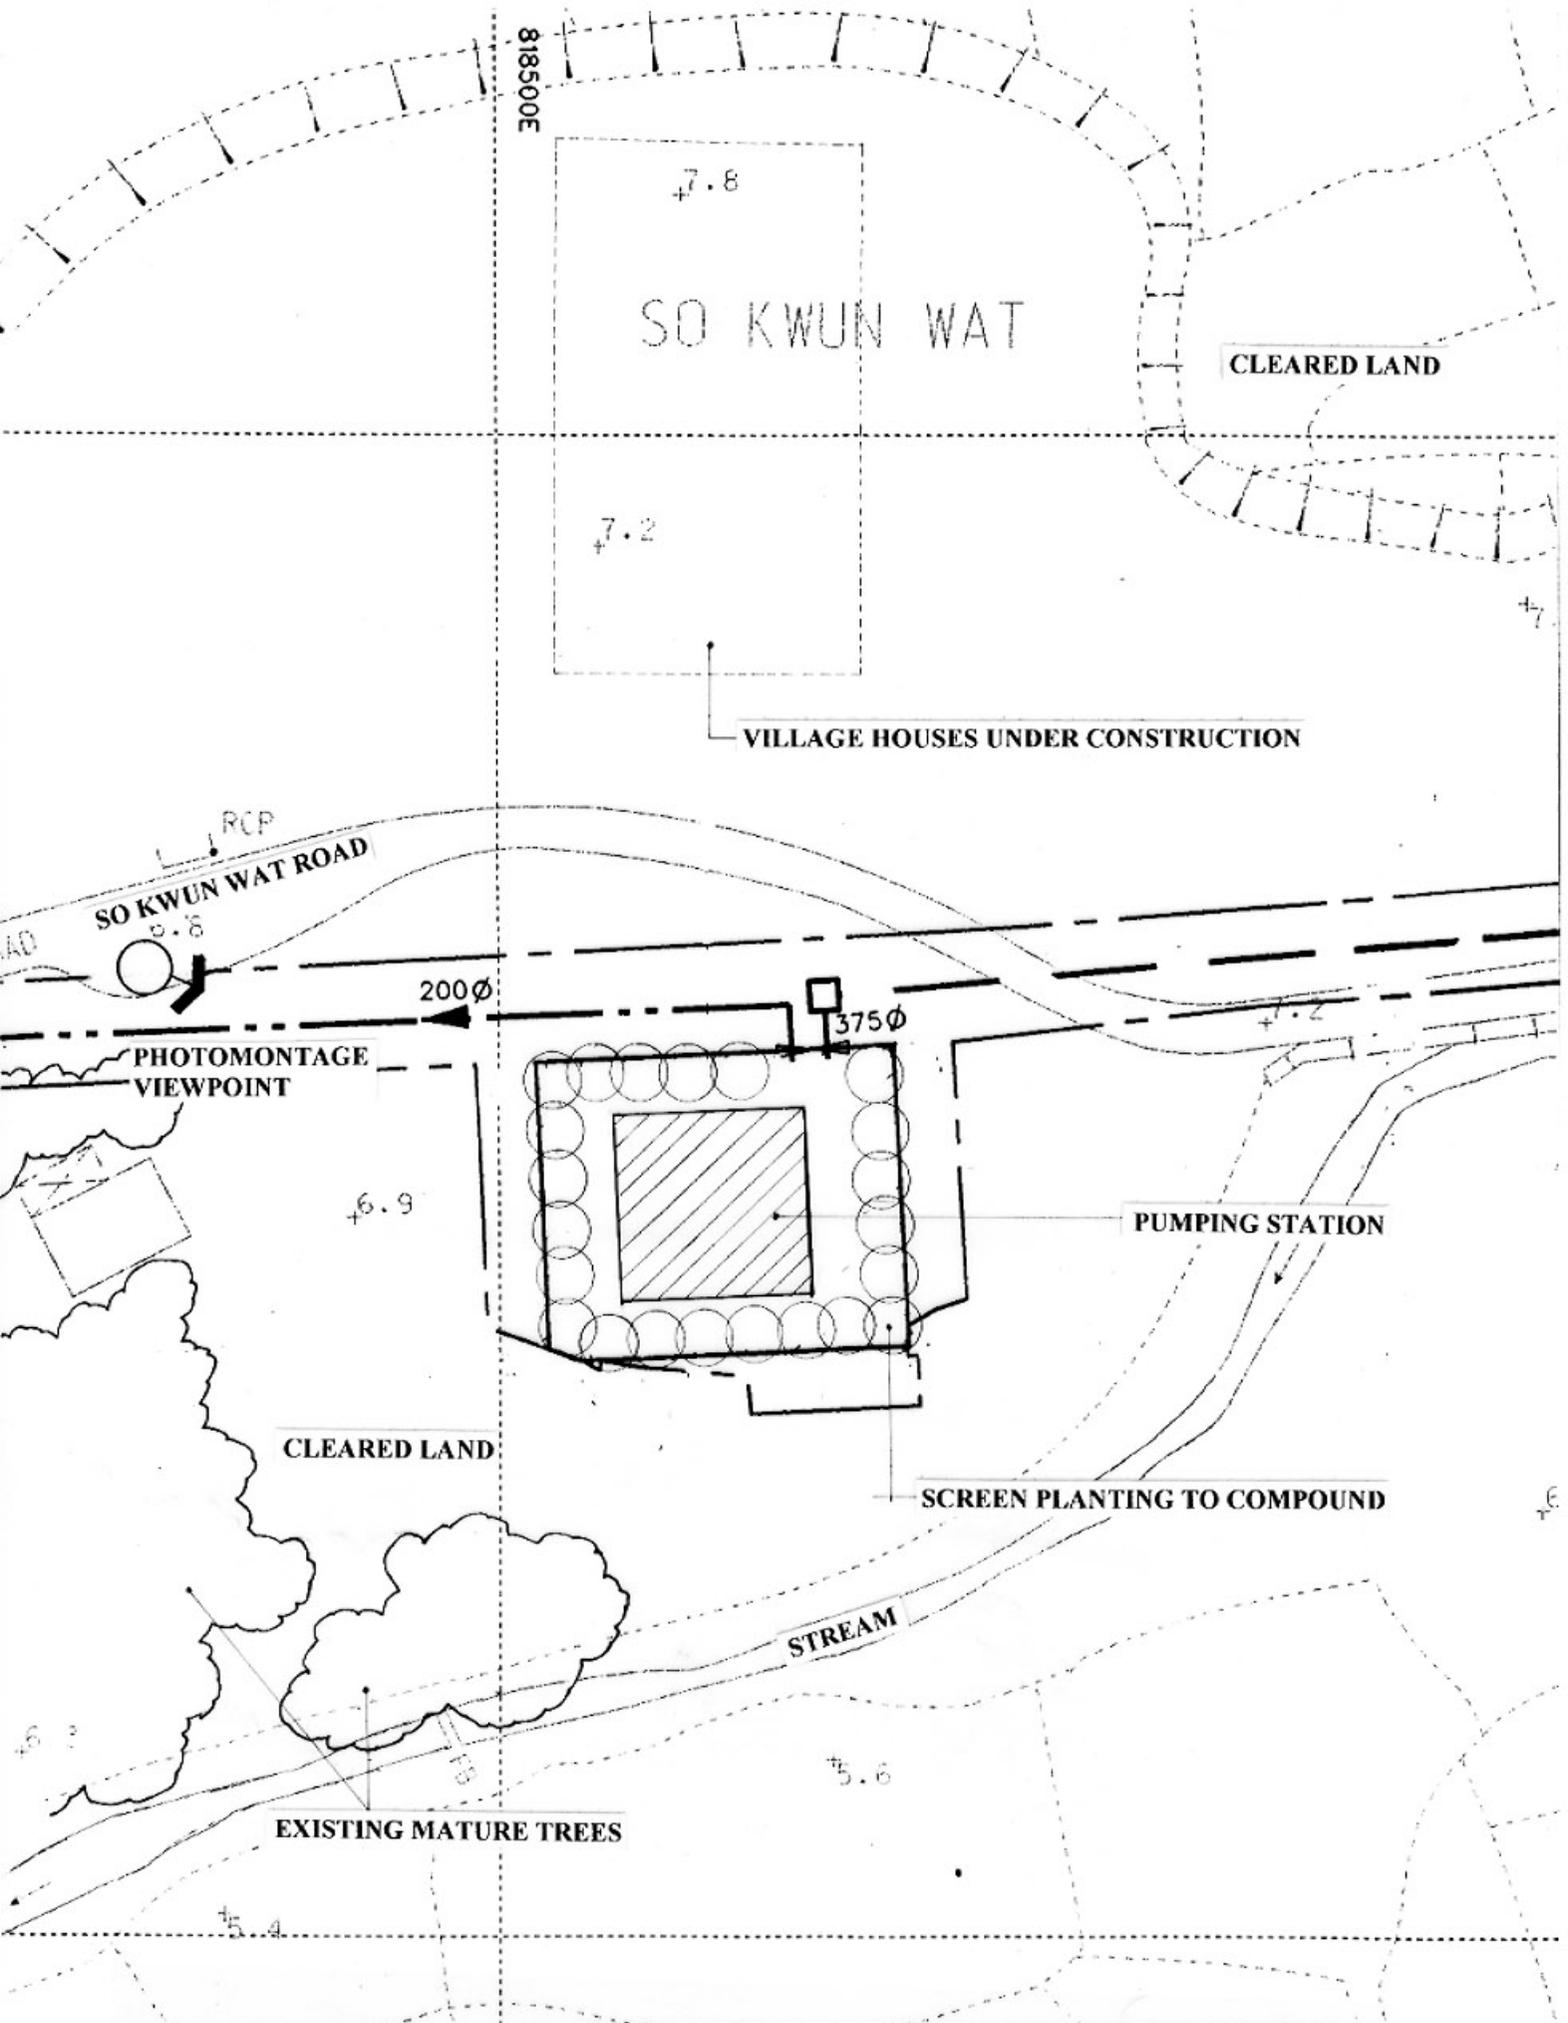
Drawing 10.22

AREA 4 : SO KWUN WAT TSUEN PUMPING STATION SCALE 1:500

10.11.6 In the absence of any natural screening to help mitigate the visual impacts, it is recommended that boundary tree and shrub planting is provided to the pumping station. Any good excavated topsoil should be stored on site and used to complete the screen planting. Furthermore, the building and perimeter wall/railing should be designed to reflect the general appearance of the nearby village houses as described for other pumping stations above and illustrated in the before and after photograph / photomontage in Drawing 10.23 and 10.23A, as well as the landscape / visual character photographs in Drawing 10.24.

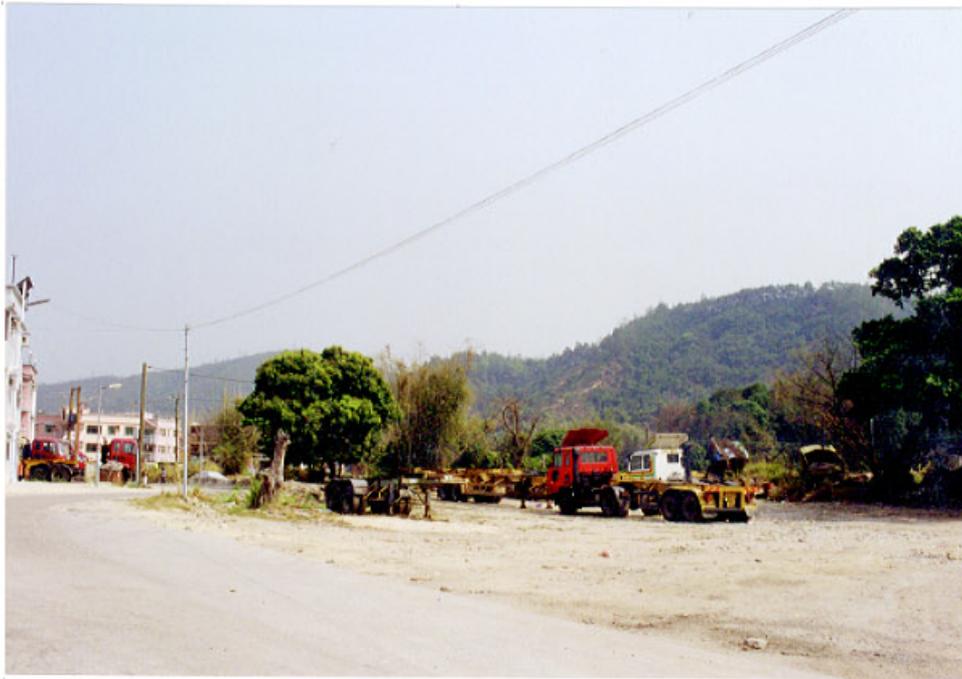
**BEFORE AND AFTER VIEWS OF SO KWUN WAT  
PUMPING STATION VIEWED FROM ROADSIDE**

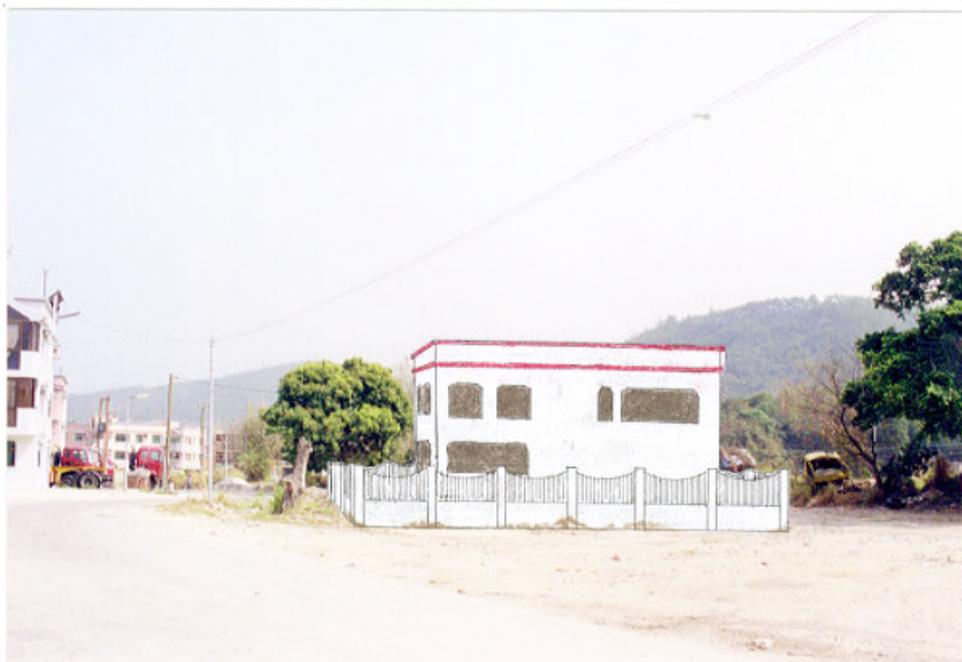
**VIEW WITHOUT LANDSCAPE MITIGATION**

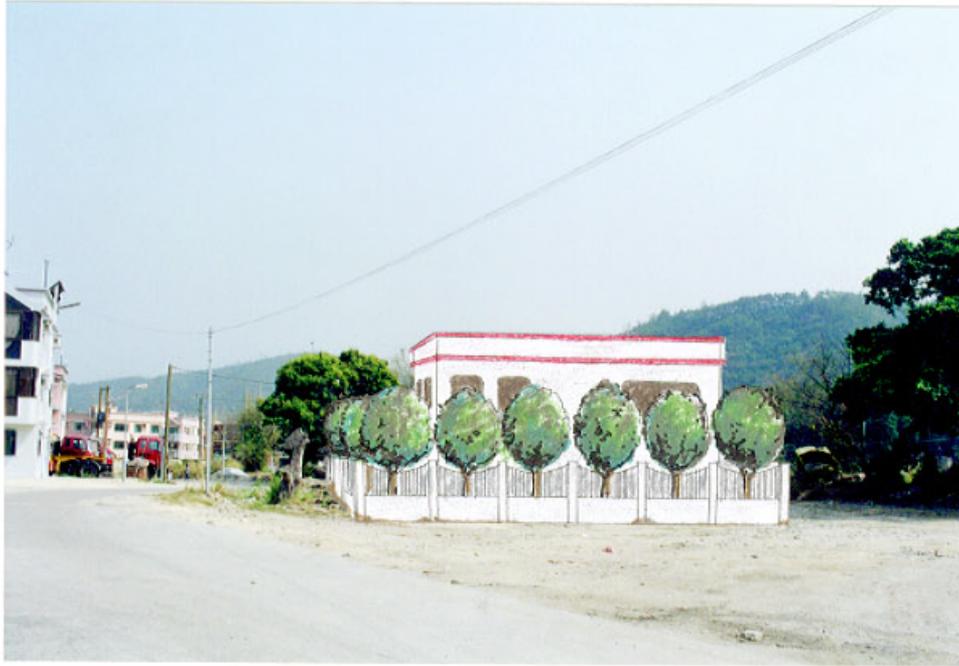
VIEW WITH LANDSCAPE MITIGATION AT COMPLETION

MODERN VILLAGE HOUSE ARCHITECTURE AND BOUNDARY PLANTING  
PROPOSED TO BLEND STRUCTURE WITH SURROUNDINGS

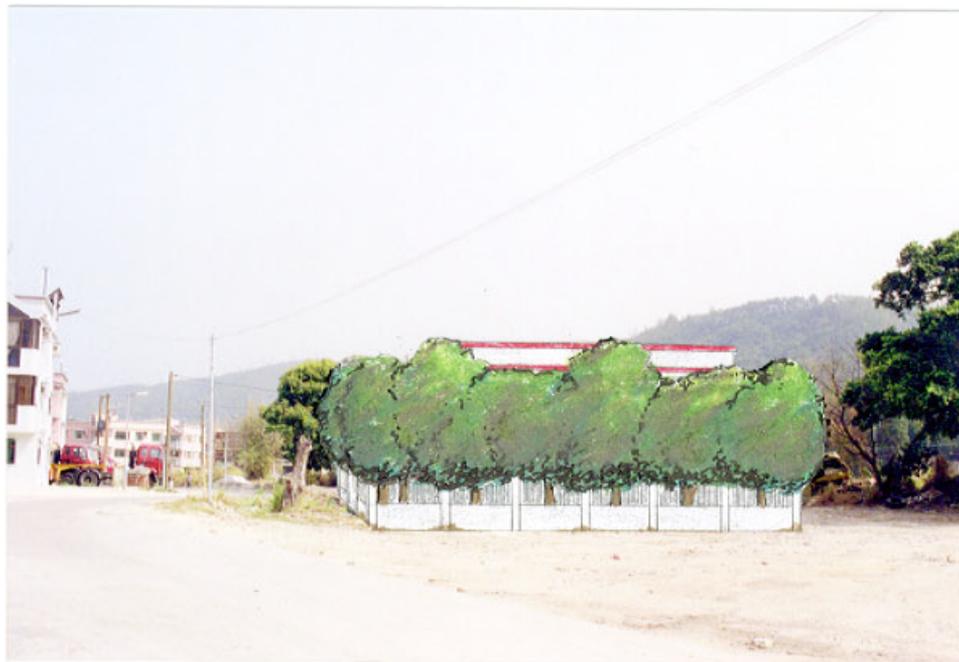
VIEW AFTER 10 YEARS OPERATION

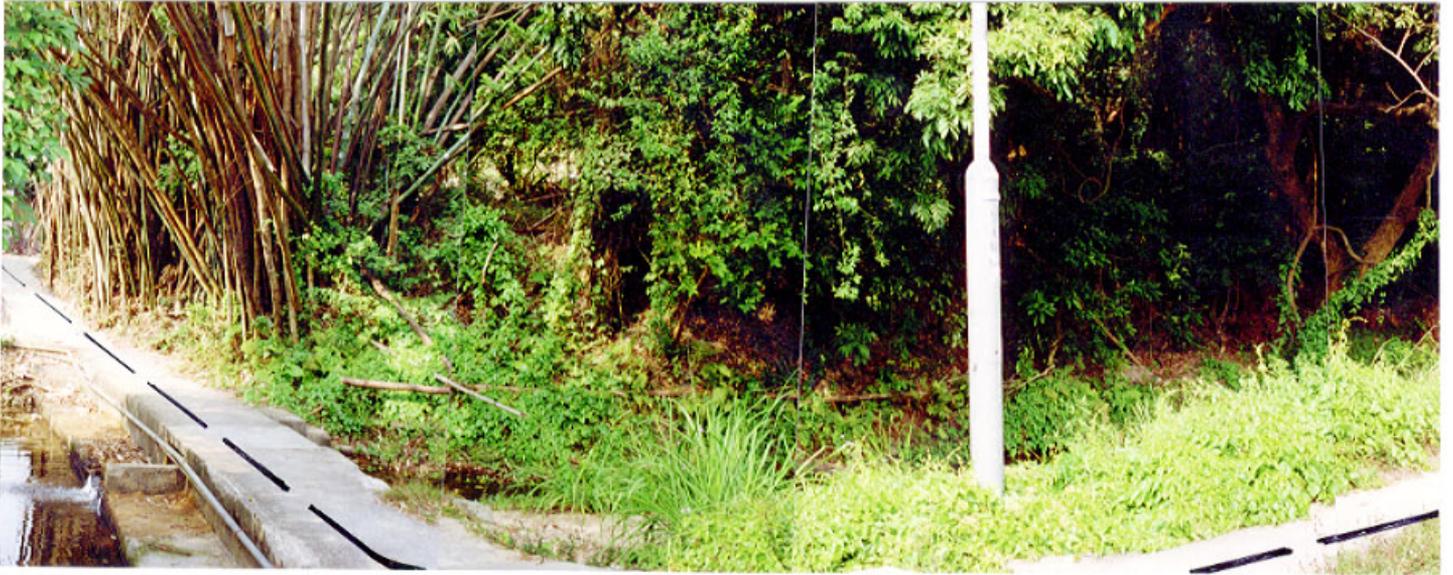
Photograph A **ADOPTED REALIGNMENT OF SEWER TO AVOID WOODLAND FRINGE AND FOLLOW EXISTING CONCRETE TRACK (REFER DWG. 10.3)**

- 10.11.12 The pipe laying will follow the existing concrete tracks crossing the grassland/arable areas. However, the tracks are narrow and trenching works will result in the temporary loss of adjacent vegetation; approximately 2,500m<sup>2</sup> of abandoned farmland/grassland/ruderal and 670m<sup>2</sup> of arable land. However, no trees would have to be felled but sewer trenching within the narrow, winding lanes of the older villages should be carefully supervised during construction to ensure, where practicable, the root systems of existing mature trees are not damaged (see Photograph B of Drawing 10.25). The works will only be seen for a short period mainly by pedestrians entering or leaving the village.

LCU 13	Temporary disturbance of village footpaths for pipe laying	Low	Low	Medium	Realign portion of pipeline out of woodland fringe and bamboo grove to follow concrete track to avoid tree felling. Stockpile topsoil where route crosses field paths and regrass upon completion. Care during pipe laying through village to avoid damage to trees.	Slight / moderate adverse	Slight / moderate adverse

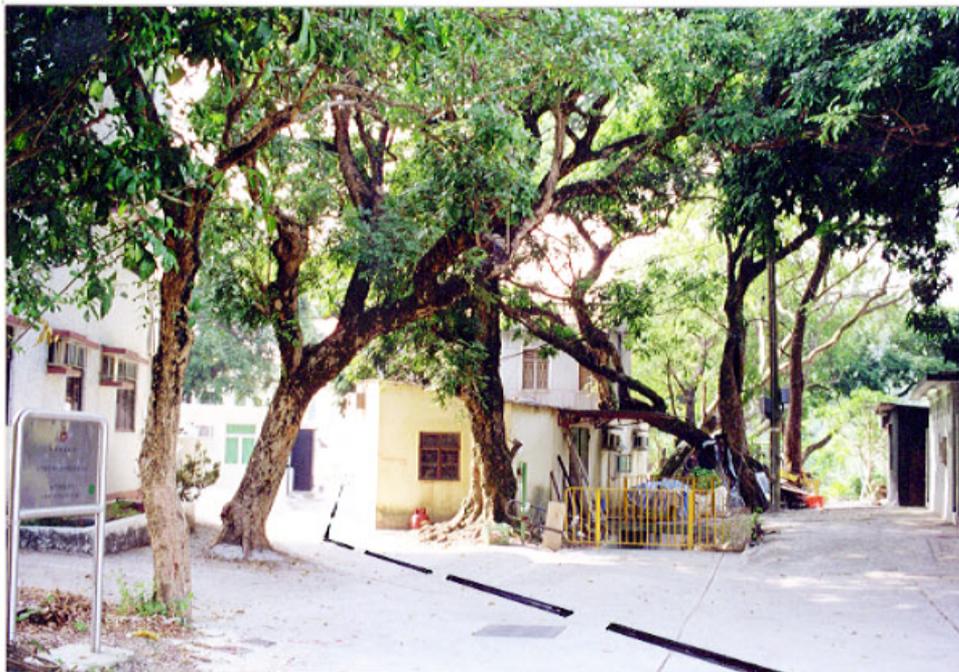
Photograph B **CARE REQUIRED WITHIN VILLAGE TO ENSURE SEWER AVOIDS MATURE TREES IN NARROW LANES**

- 10.11.15 Excavated top soils should be retained and stockpiled close to the pipe trench and replaced upon completion of the works to permit regrassing and plant recolonisation. Sewer trenching within the narrow lanes should be carefully supervised during construction to ensure, where practicable, the root systems of existing mature trees are not damaged.
