1	INTRODUCTON	1
1.1	BACKGROUND	1
1.2	SCOPE OF HAZARD TO LIFE ASSESSMENT	2
1.3	HAZARD TO LIFE ASSESSMENT OBJECTIVES AND RISK CRITERIA	3
1.4	STRUCTURE OF THE APPENDIX 10	5
2	PROJECT DESCRIPTION AND BASIS FOR THE ASSESSMENT	7

*1.1**BACKGROUND*

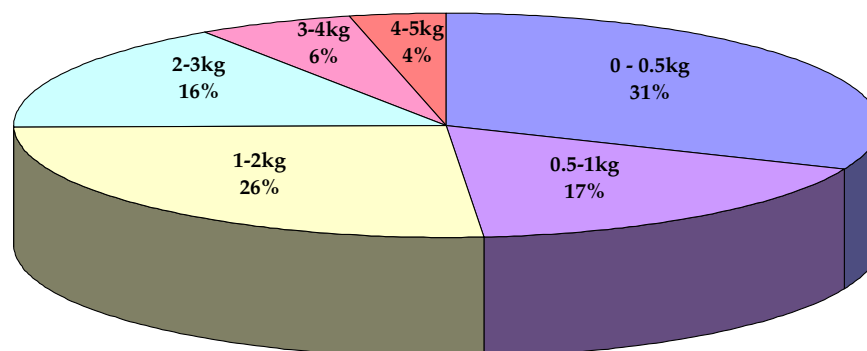
Figure 2.2 *Distribution of Design MIC for the WIL Alignment*

The distribution of design MIC for the WIL alignment is shown in *Figure 2.2*. It can be seen that more than 70% of the design MIC is less than 2 kg.

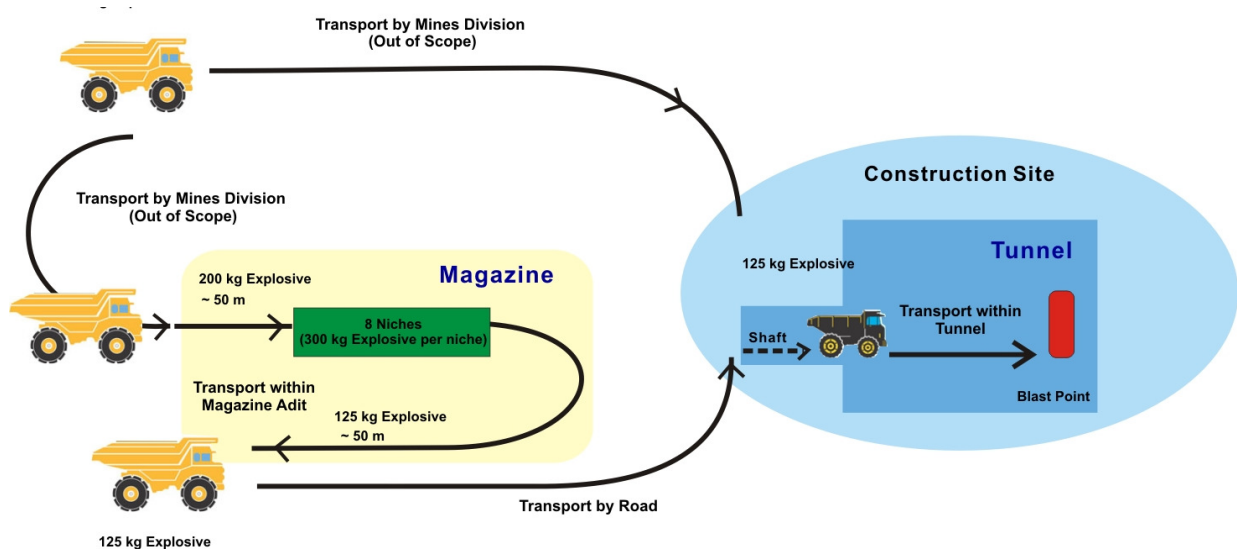
Figure 2.4 *Transport Strategy for the Explosives*

The transport strategy for the explosives is shown in *Figure 2.4*.

Explosives and detonators will be transported separately from the underground magazine to the designated access shafts / blasting sites by the contractors' licensed delivery vehicles under the escort of armed security guards. Deliveries of explosives will take place during non-peak traffic hours where possible.

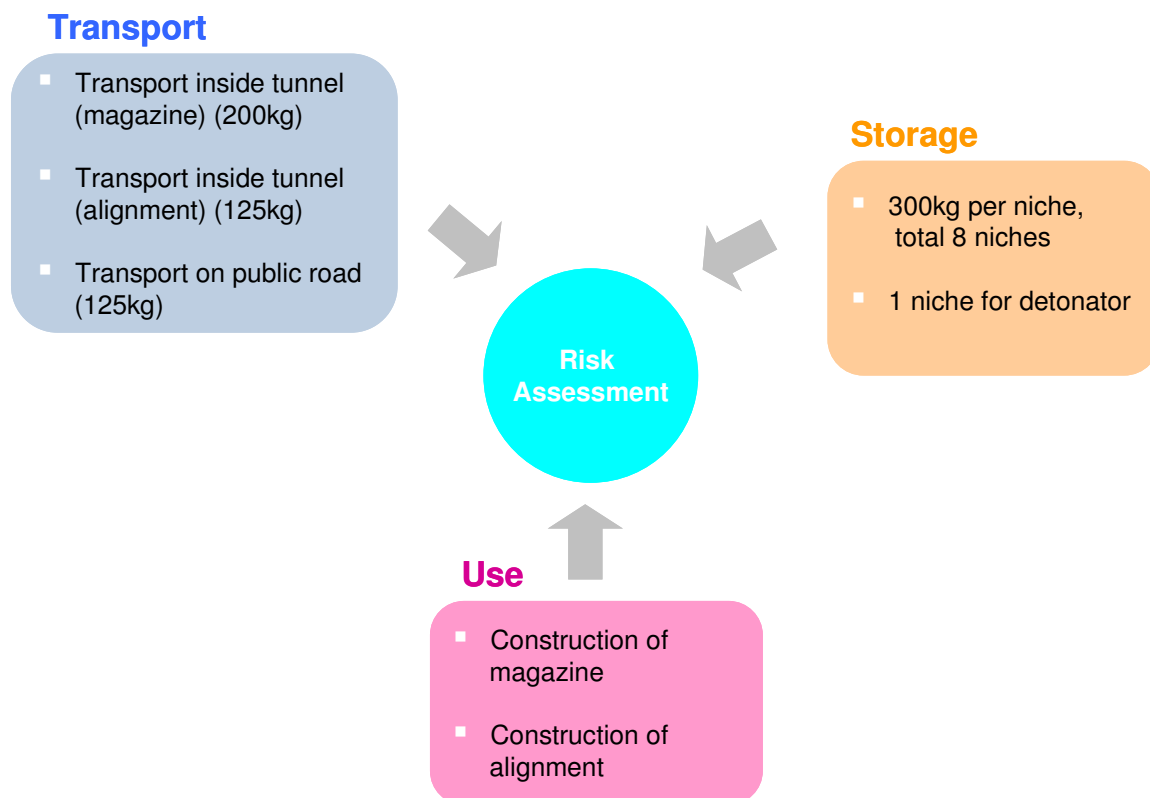
Figure 3.1 *Three Components of the Risk Assessment*

The overall methodology for the Hazard to Life Assessment addresses the risk associated with the storage, transport and use of explosives for the WIL construction (see *Figure 3.1*).

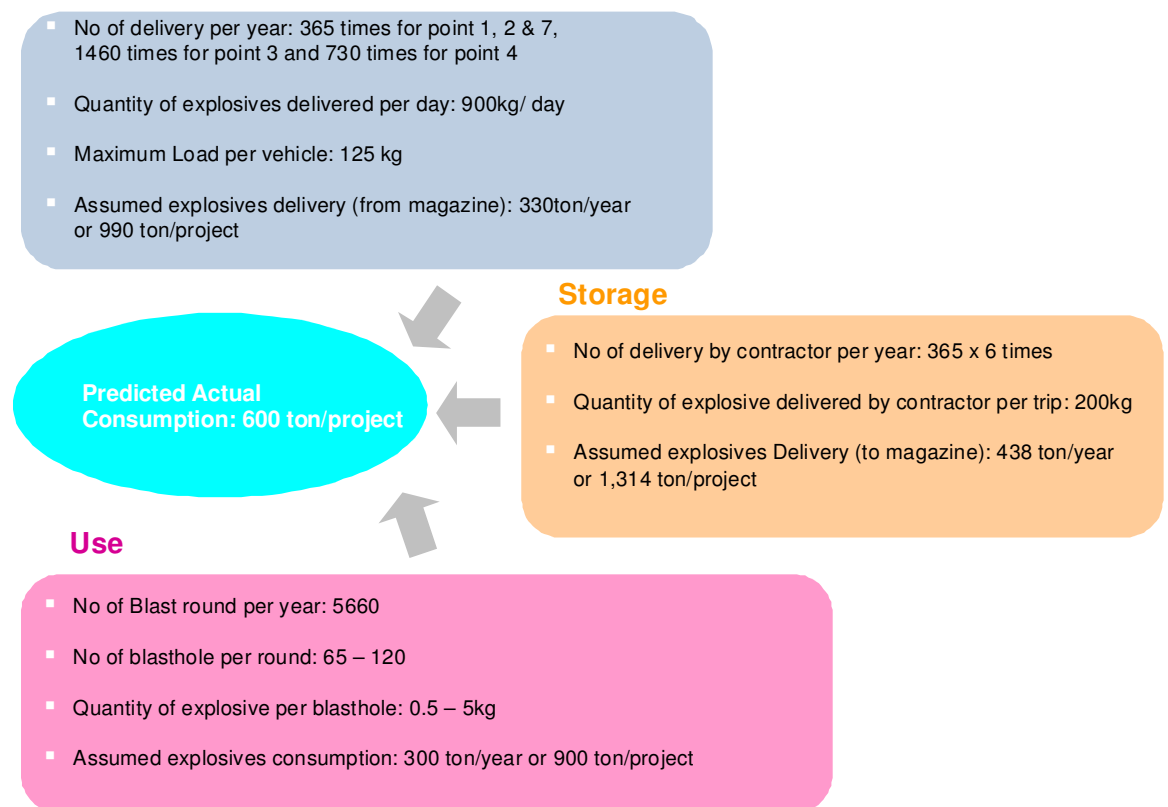
Figure 3.3 *Consumption of Explosives for the WIL*

Notes: The quantities assumed for use, transport, storage for the QRA are higher than the predicted actual consumptions, to account for the peak consumption in a year for conservative purpose

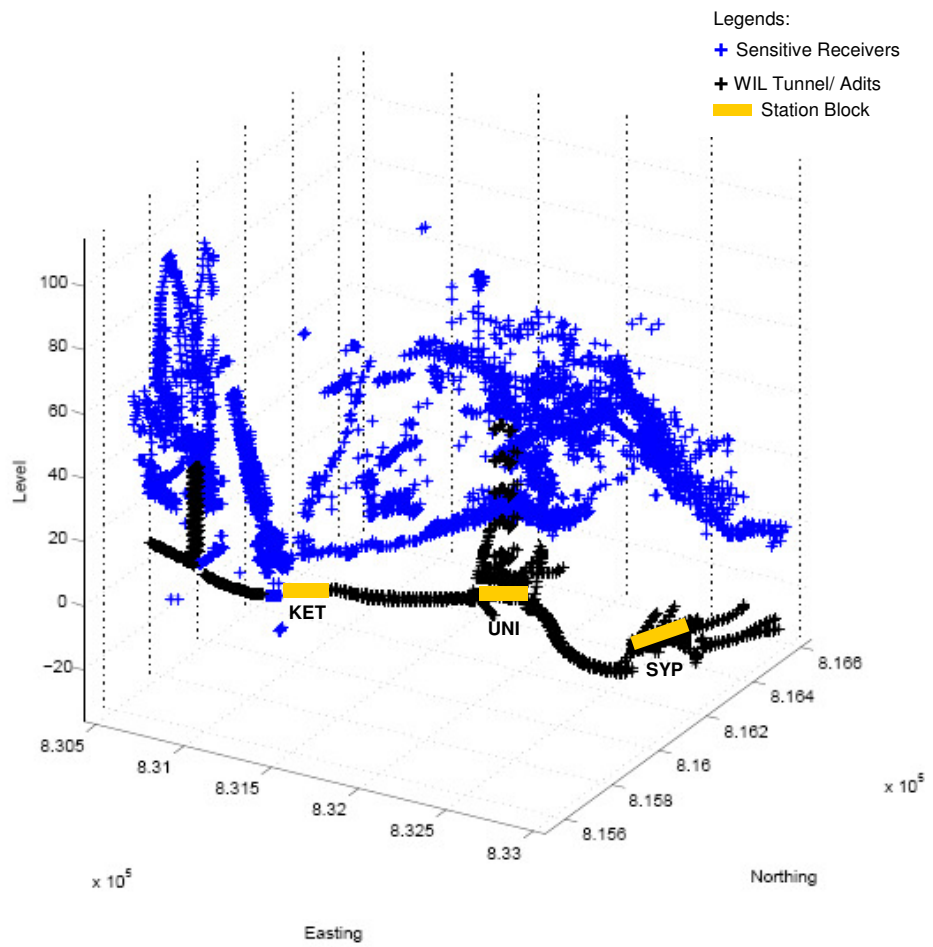
Figure 4.2 *Blasting Chainage and Sensitive Receivers Considered for the Construction of WIL Alignment (Side Review)*

Figure 4.2 provides a three-dimensional view of the blasting chainage and sensitive receivers for the WIL alignment considered in the study. Those features considered as sensitive receivers are described in *Section 4.3.1*.

The latitude and longitude (ie ‘Northing’ and ‘Easting’) of every point shown in *Figure 4.2* are based on the ‘Hong Kong 1980 Grid’ coordinate system in Hong Kong. The plot of ‘Northing’ (y-axis) and ‘Easting’ (x-axis) is shown as the horizontal plane in this figure. The level of a point refers to the elevation of the relative receiver with respect to the Principal Datum (the unit is mPD), and is shown as z-axis in this figure.

In order to consider the dynamic characteristic of the blasting work, a 3-dimensional review was carried out to assess the nearest features to the blasting site. The graphical representation is shown in *Figure 4.2* and *Figure 4.3* for the WIL alignment and magazine store respectively.

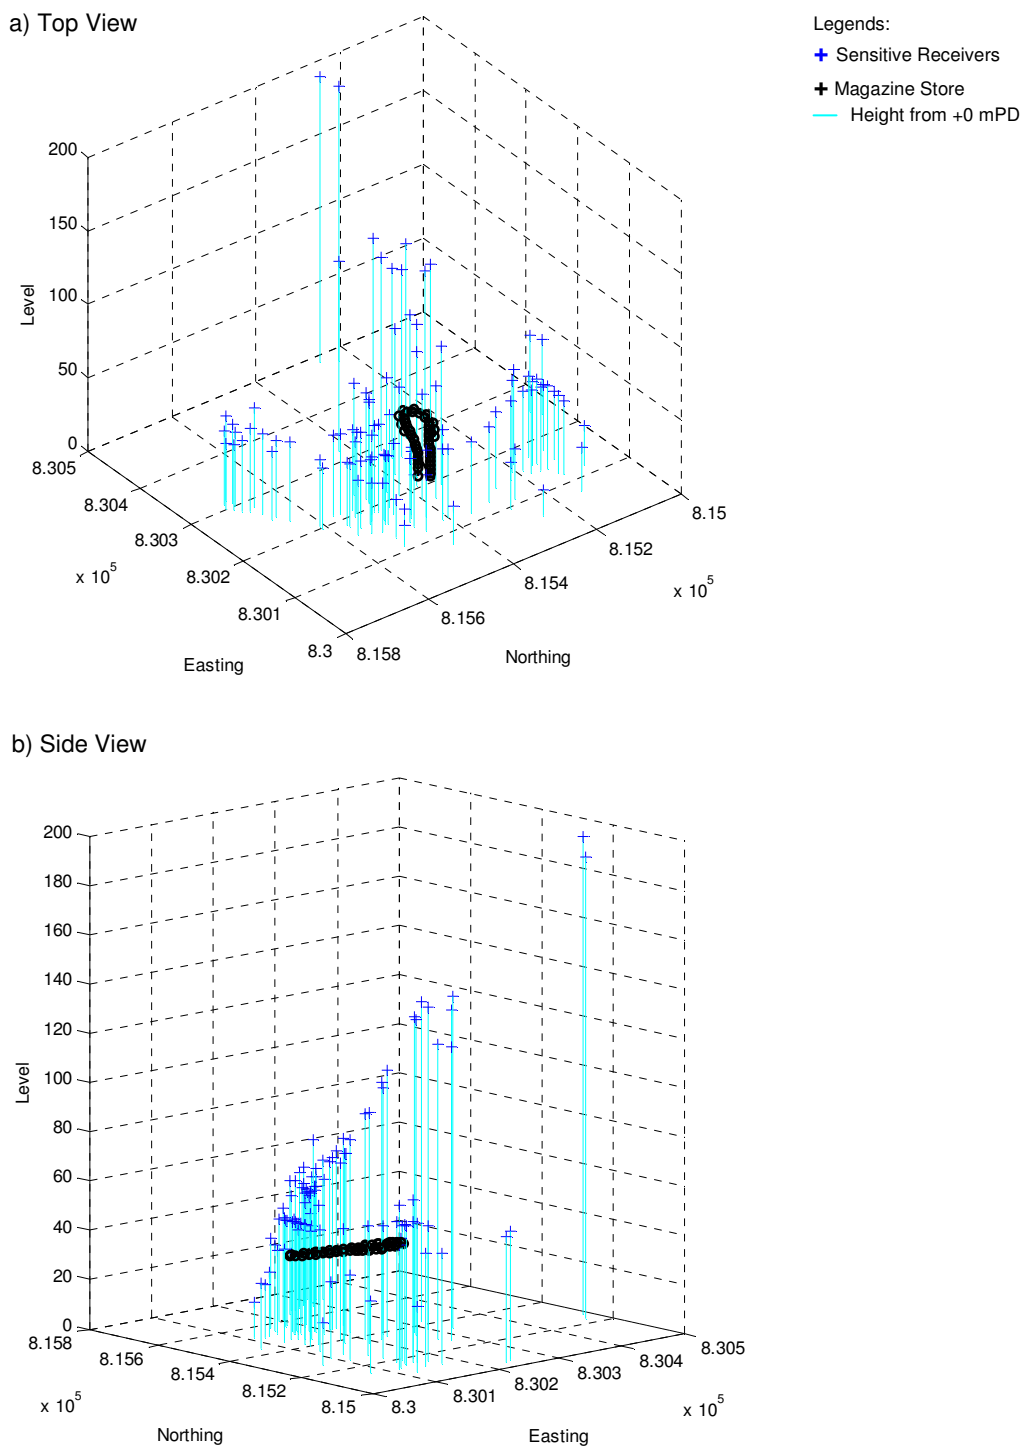
Figure 4.3 *Blasting Chainage and Sensitive Receivers Considered for the Construction of the Magazine (Top View and Side View)*

Similarly, three-dimensional view of the blasting chainage and sensitive receivers for the magazine store considered in the study is shown in *Figure 4.3*.

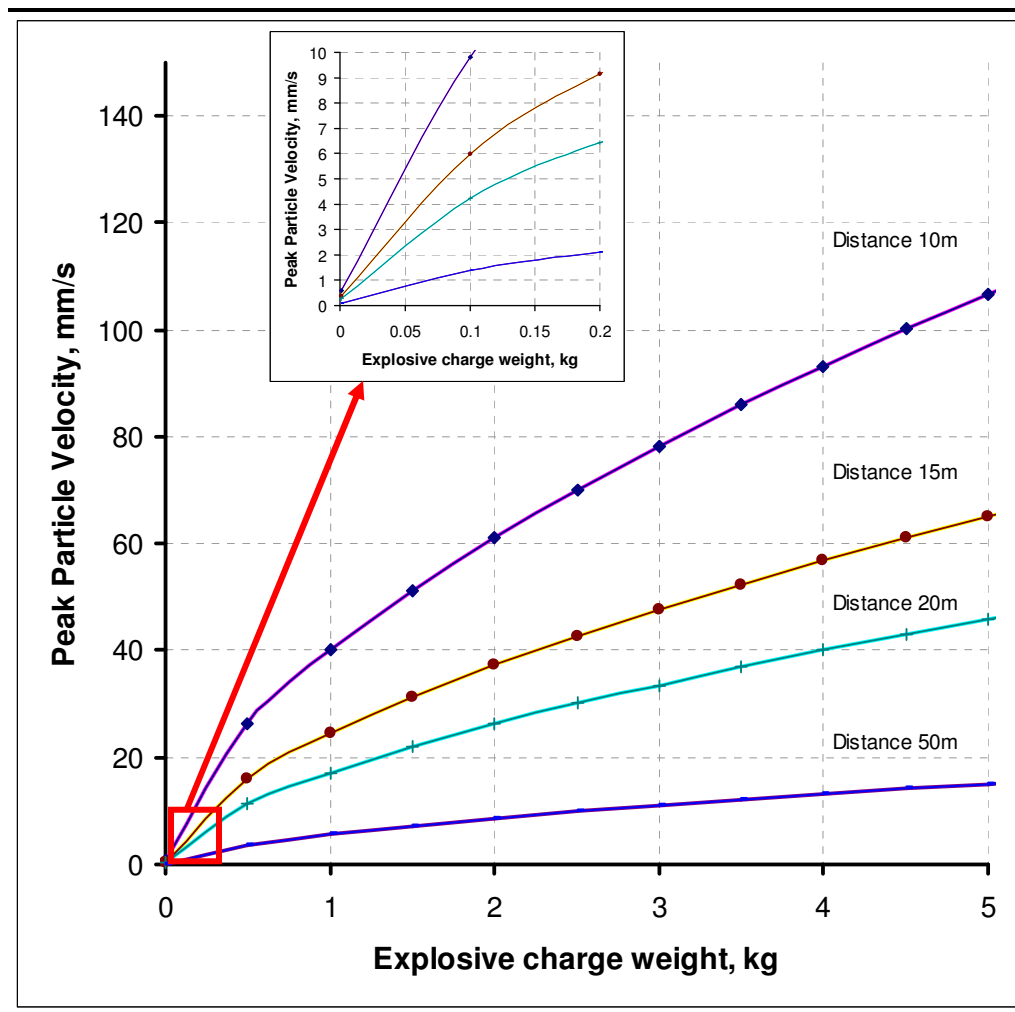
Figure 5.1 Variation of PPV at Different Charge Weight

As shown in *Figure 5.1*, a feature of a lower acceptable PPV level may become the controlling sensitive receiver for a particular tunnel section even if it may not be the nearest feature. It is therefore worth noting that along the WIL alignment, there is a lot of historical buildings or other critical sensitive receivers, such as temples and monument, which have a very low maximum allowance vibration limit (~5mm/s) for the purpose of building preservation. When these features become the controlling sensitive receivers for the design of certain tunnel sections, the design MIC will be low and thus the vibration level susceptible by other feature (such as buildings and slopes) will reduce. This can be considered as an inherent safe feature for the blasting design.

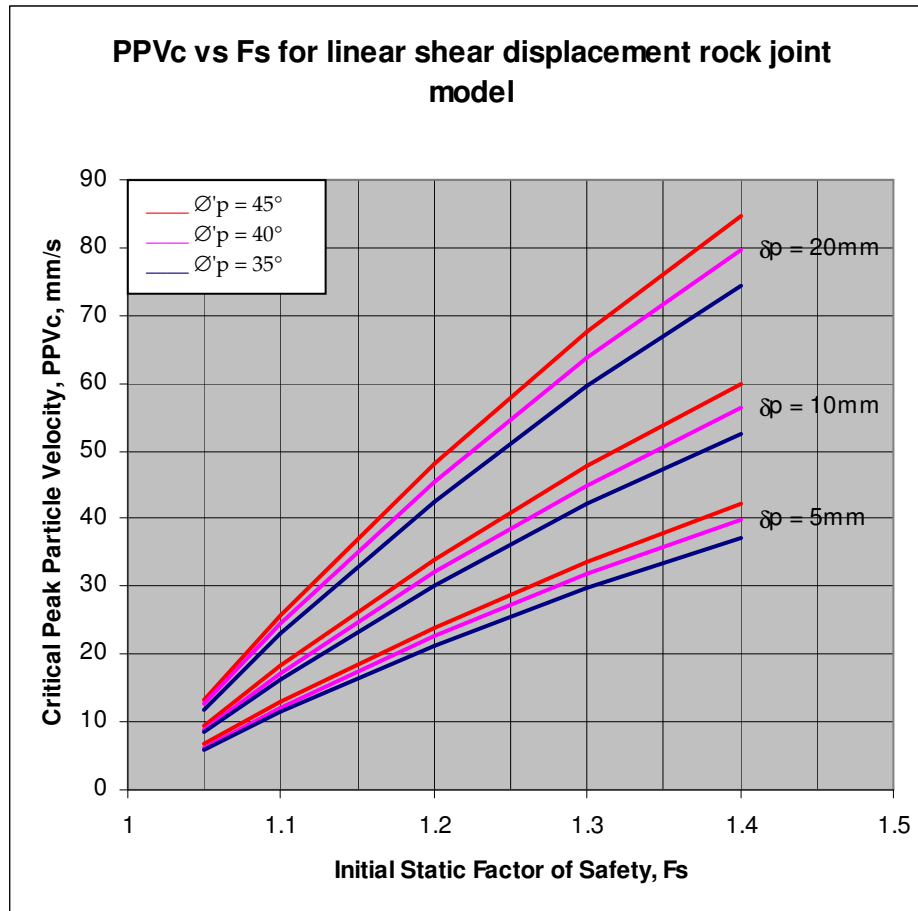
Figure 7.1 Critical Peak Particle Velocity vs Initial Static Factor of Safety

GEO Report 15 [12] publishes a graphical representation of the Critical Peak Particle Velocity, PPV_c, and the initial static factor of safety for varying joint displacements at peak stress. This is reproduced in the *Figure 7.1* below.

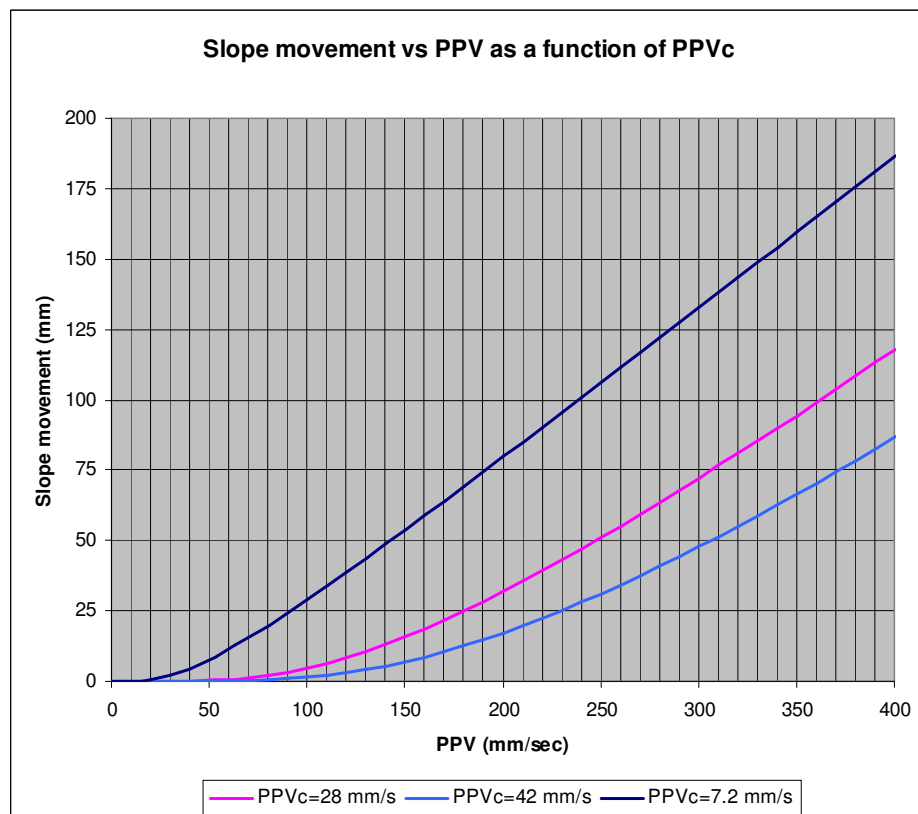
Figure 7.2 Slope Movement for the Slopes Nearest to Magazine

the peak particle velocity (PPV) required to cause slope movement can be plotted for each critical peak particle velocity value. This is illustrated in the *Figure 7.2* below for the critical peak particle velocities estimated for the slopes 11-SW-A-C292/3, and the retaining wall 11-SW-A-R782 which will be impacted by the detonation of explosives within the magazine (see *Section 7.3.1*) for illustration.

The peak particle velocity that could possibly arise from an initiation within each magazine chamber has been evaluated for the nearby slopes and occupied buildings. The results are tabulated below. The slope movement is read from the respective PPVc curve for the concerned slope/ retaining wall in Figure 7.2 based on the calculated PPV value.

Based upon *Figure 7.2*, the peak particle velocity that results in a 0.01% chance (i.e. 20 mm slope movement) of slope failure is 165 mm/s, 211 mm/s, and 81

- (1) Refer to Section 7.2.6 and Figure 7.2 for the relationship between slope displacement and slope failure probability
- (2) Not evaluated since explosion at entrance portal do not lead to any consequence, ie less than 0.01% chance of failure of R782

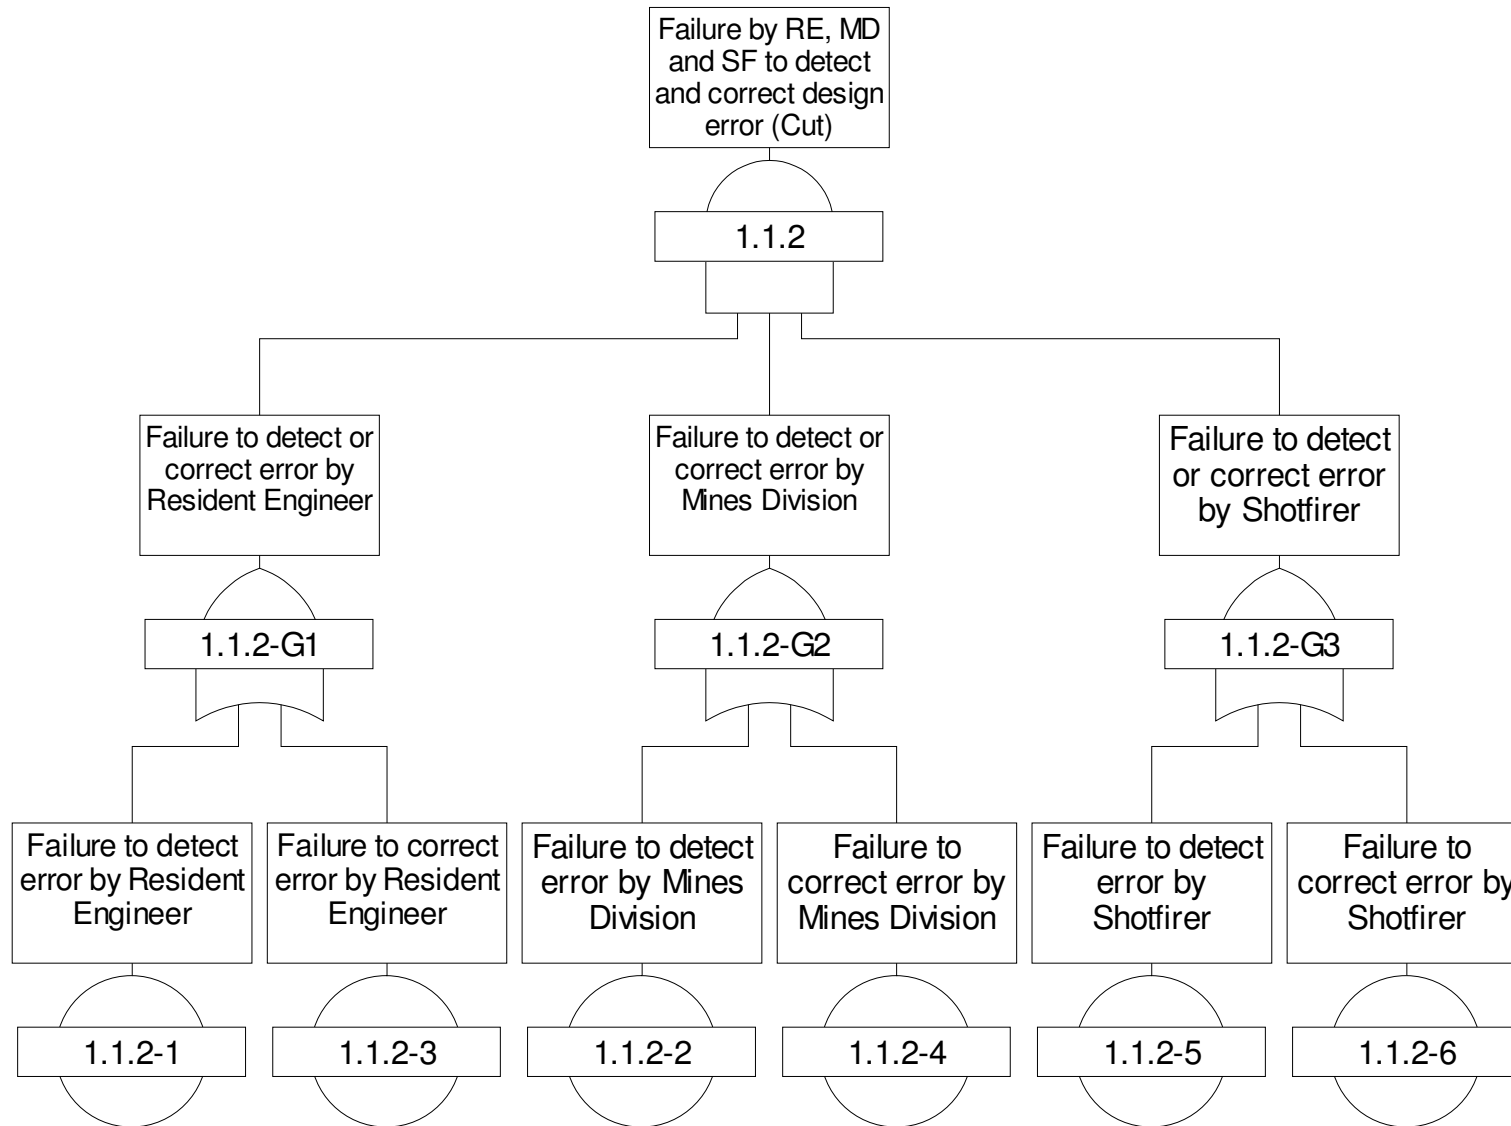
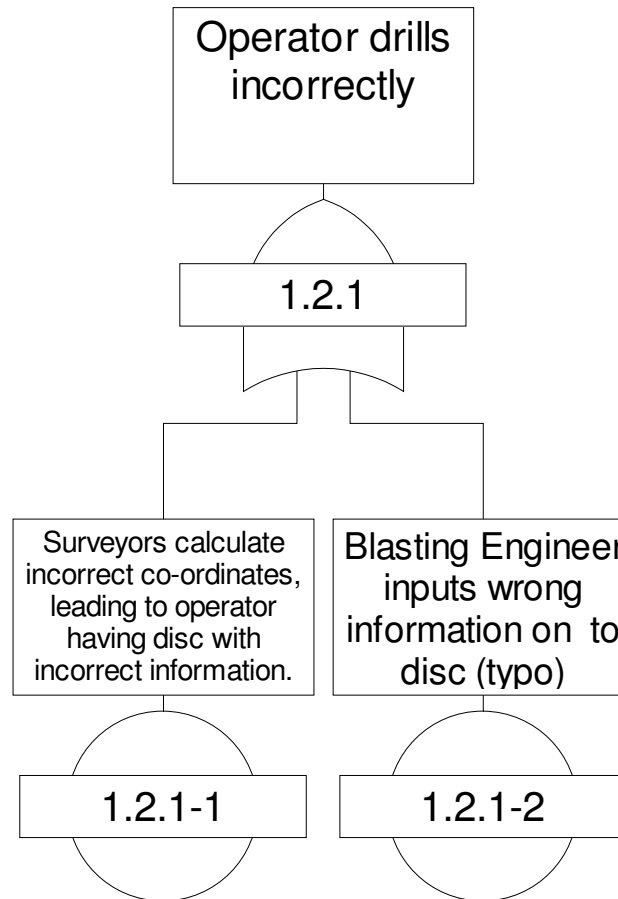
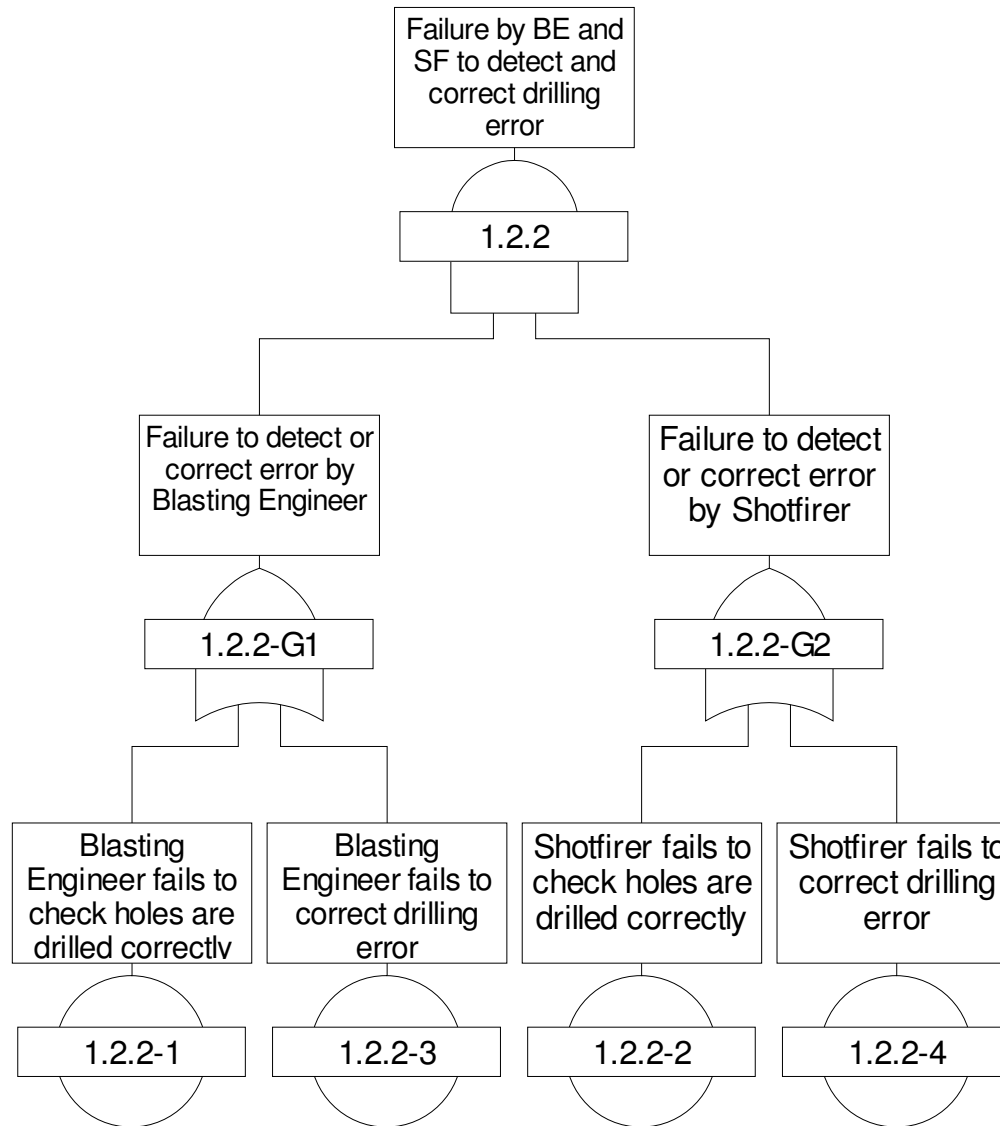
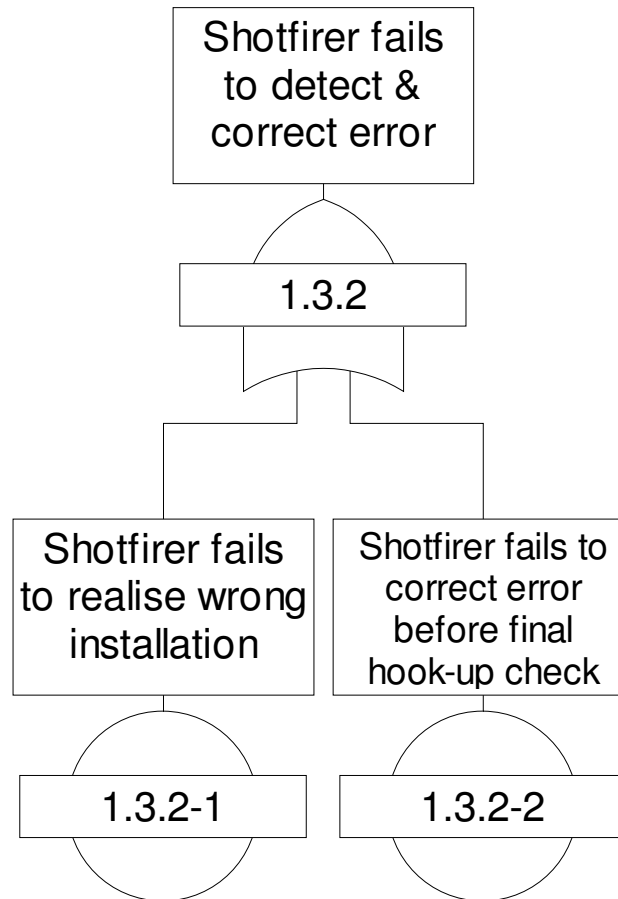
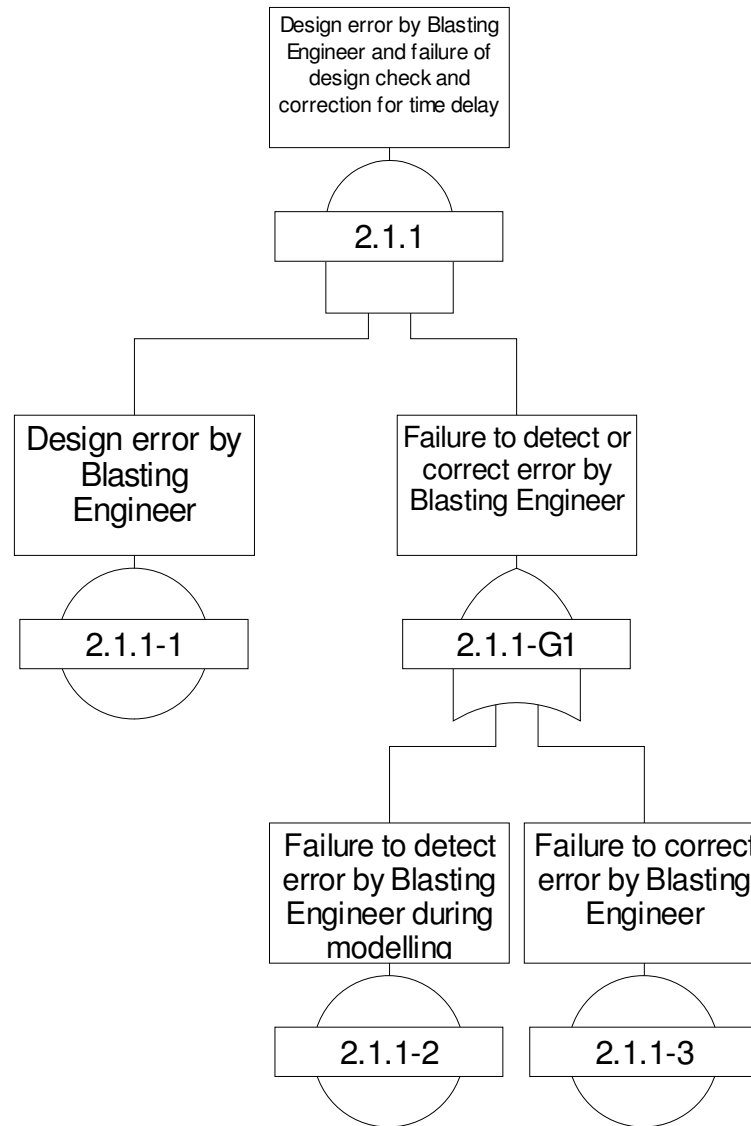
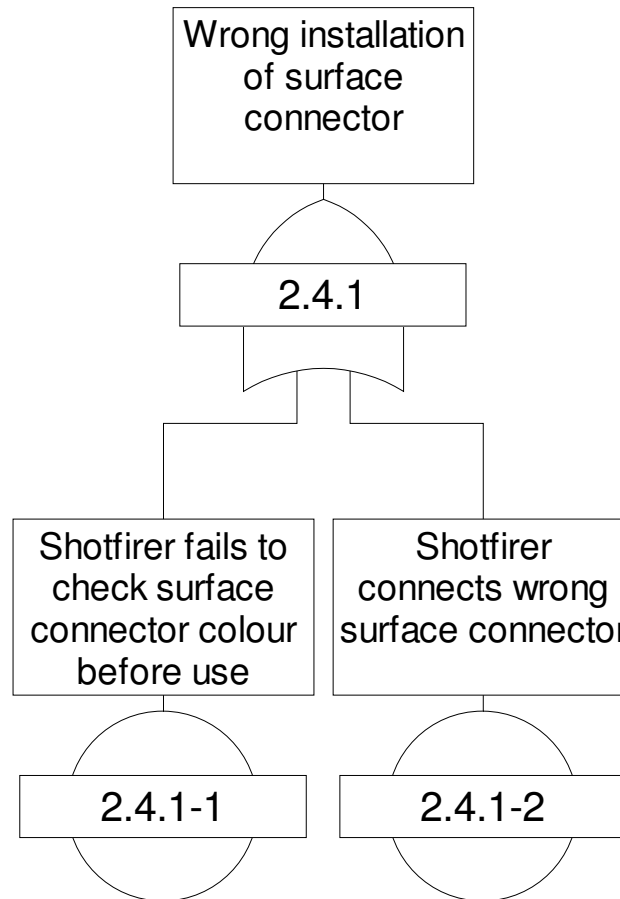
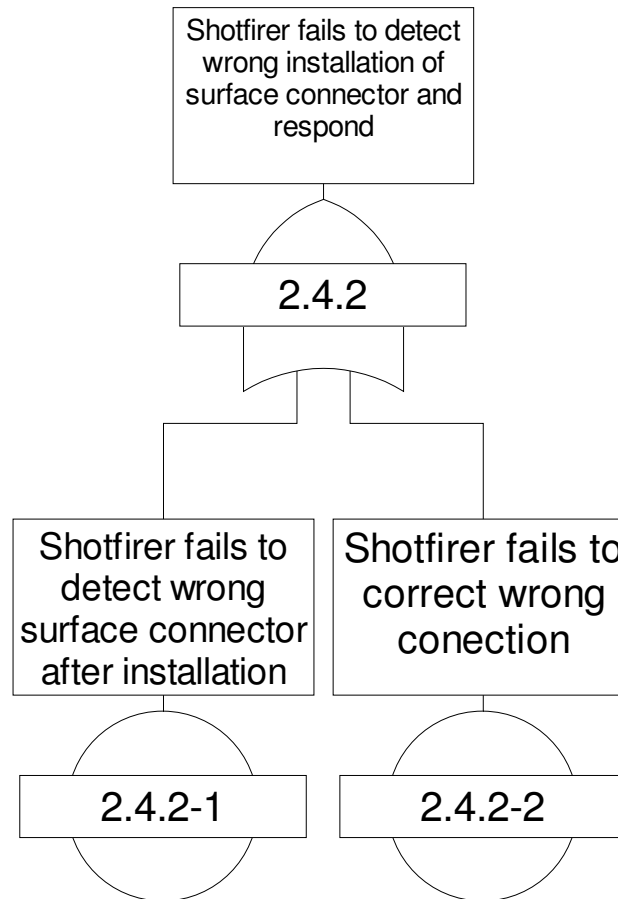
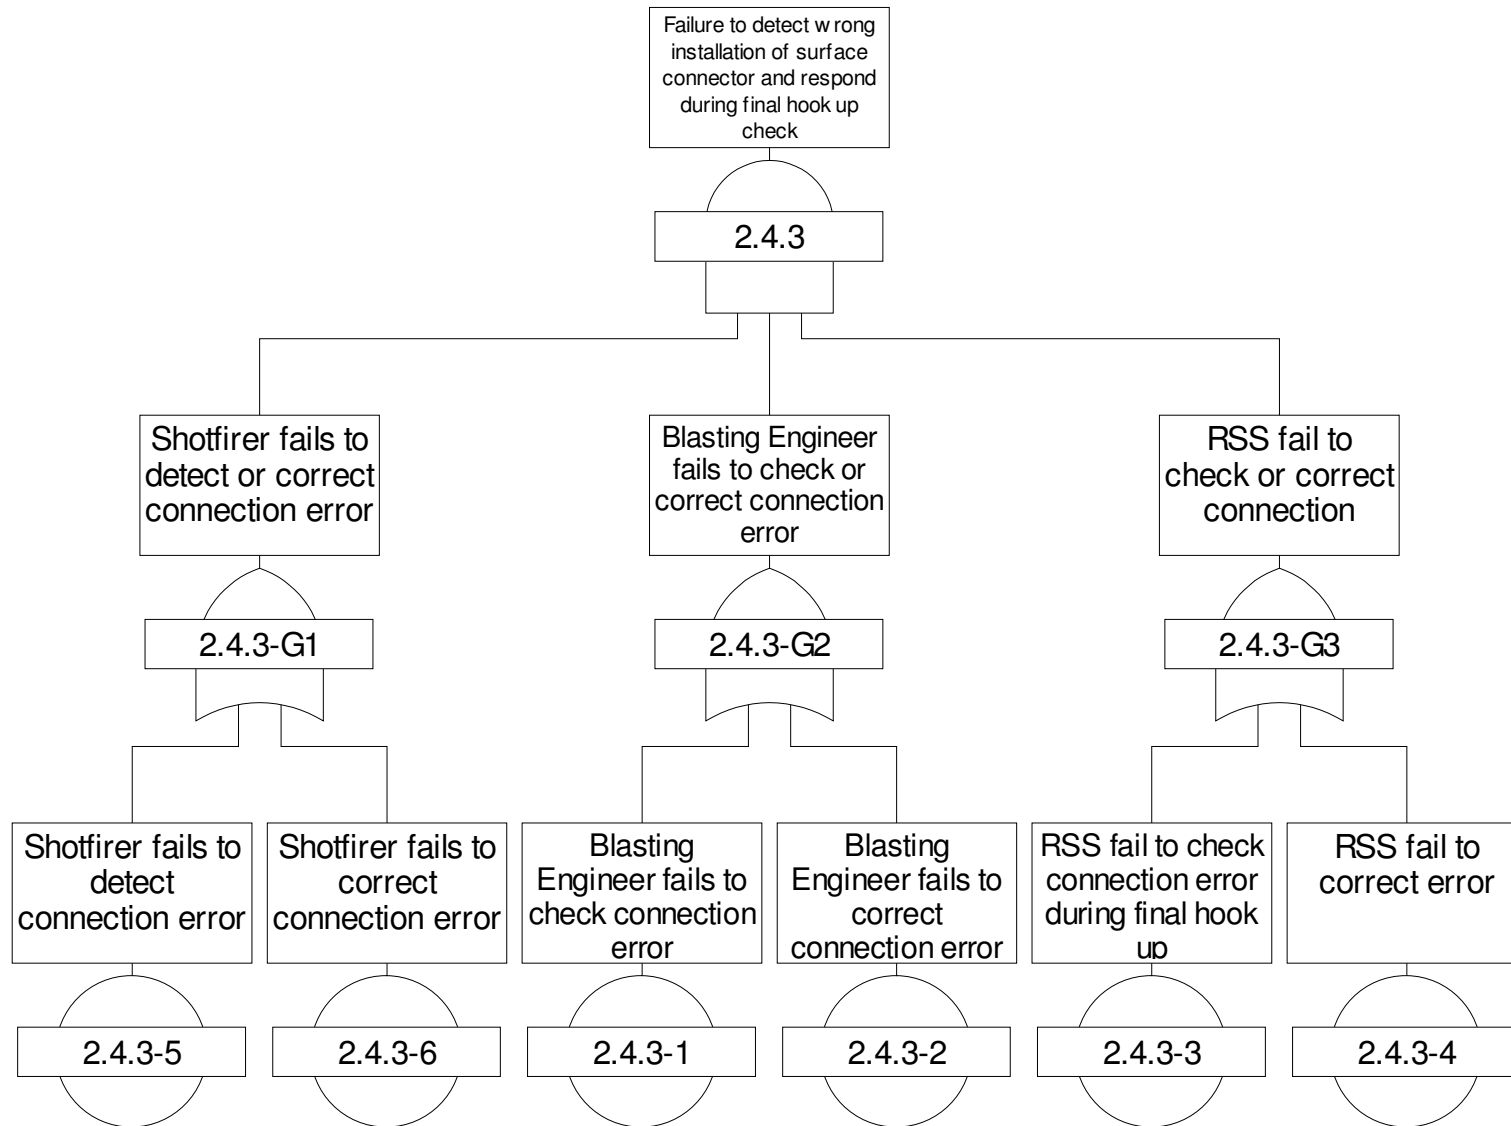
Fault Tree Models for Human Reliability Assessment

Fault Tree Analysis examines the logical relationship between the circumstances, failures events, and human/management errors which must occur in order for these specified undesired events to occur.

Attachment F1 presents the fault tree of human error leading to cut failure. MS Excel spreadsheet was used to calculate the overall probabilities for events.
