擴建馬鞍山海水配水庫 -  
建設馬鞍山三號海水配水庫

工程項目簡介

(二零零七年九月)

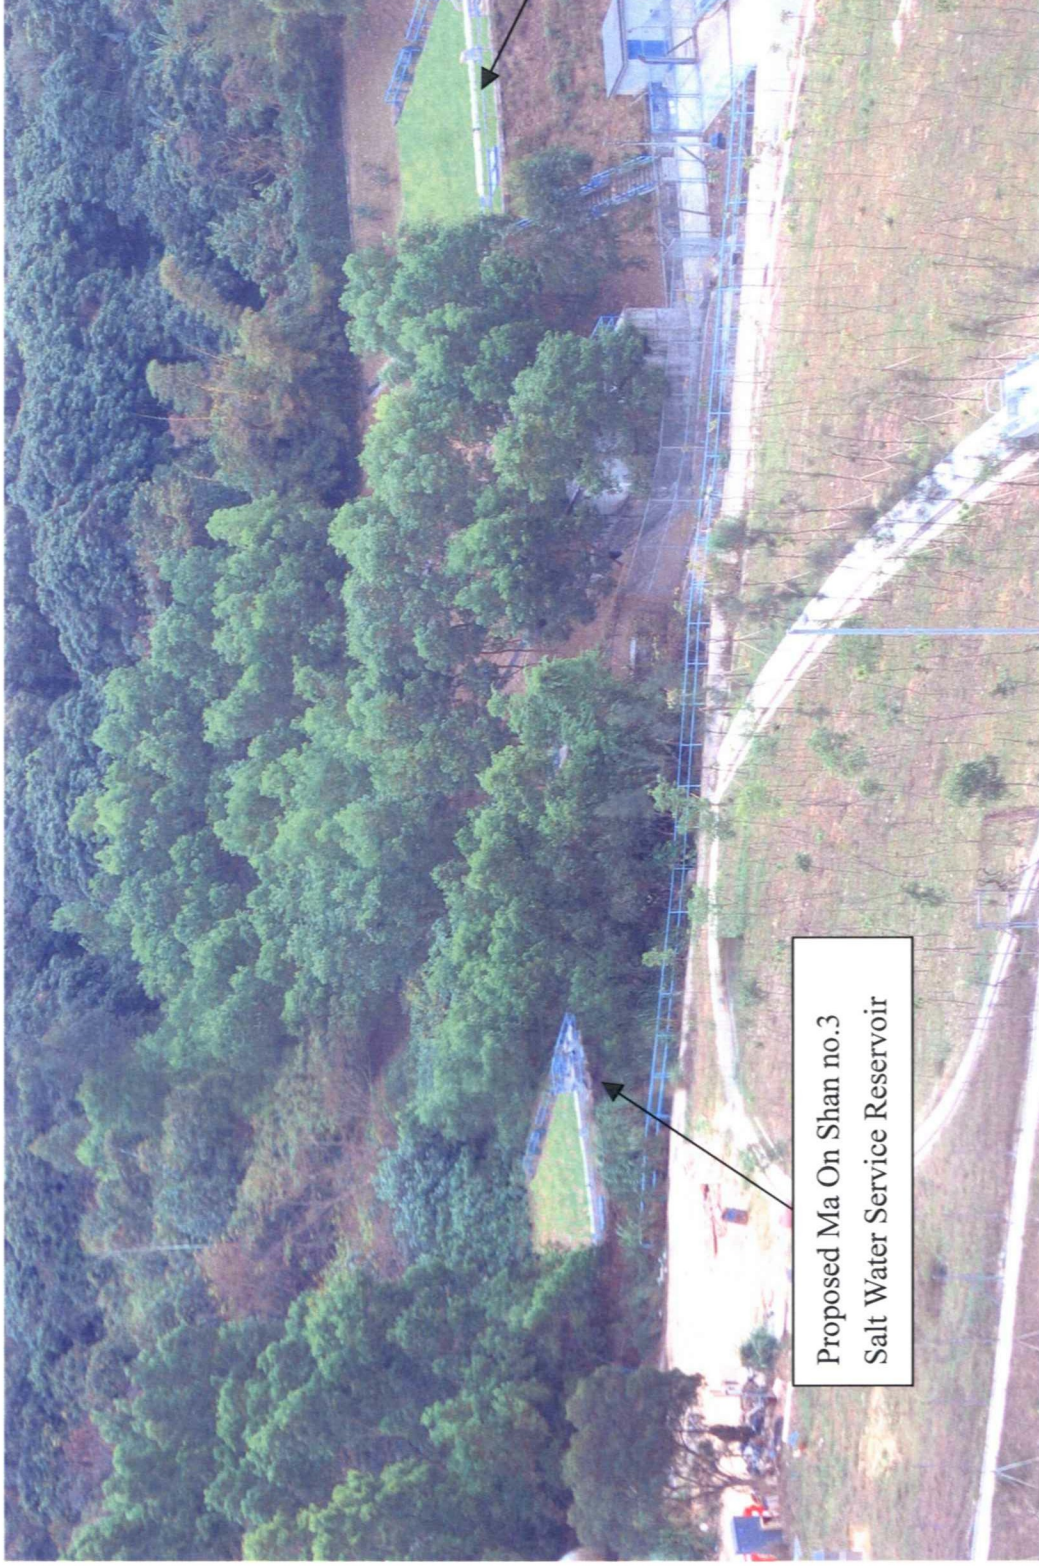
**圖二 工程項目的構想圖**

**Perspective of the Ma On Shan no.3  
Salt Water Service Reservoir**

Existing Ma On Shan  
& Ma On Shan no.2  
Salt Water Service  
Reservoir

Proposed Ma On Shan no.3  
Salt Water Service Reservoir

工程項目地點在馬鞍山海水配水庫水務署永久政府撥地範圍內。根據城市規劃委員會馬鞍山分區計劃大綱圖編號 S/MOS/13，本場地置於“政府、機構或社區”地帶。工程項目亦位於馬鞍山郊野公園範圍內及在其邊緣。工程項目的位置圖見圖一。圖二展示工程項目的構想圖。
