Contract No. : EP/SP/52/06
Development of an EcoPark in Tuen Mun Area 38

ENVIRONMENTAL MONITORING AND AUDIT

MONTHLY EM&A REPORT for

OCTOBER 2006

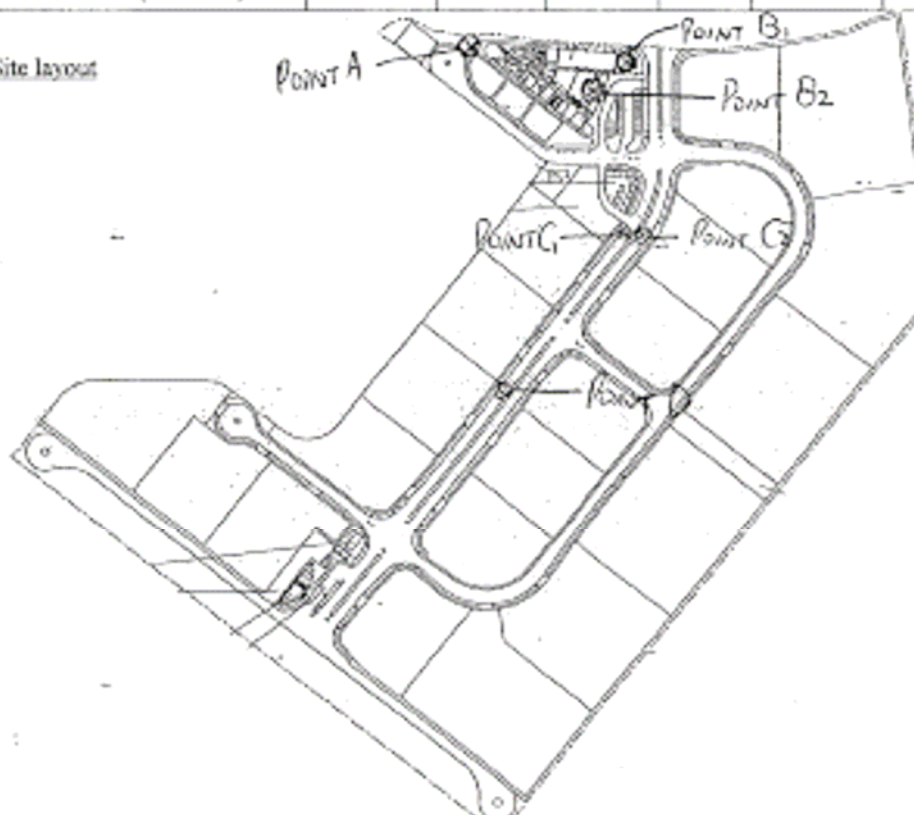
Site layout

Location 位置	Time 時間 (hrs)	Result 結果				
		CH ₄ (%)	CO ₂ (%)	O ₂ (%)	Bal. Gas (%)	Baro. Pressure (mmHg)
Point A	10:25	0	0	19.8	80	30.06
Point B1	10:35	0	0	19.6	80.3	30.06
Point B2 (Railroffer retention tank)	10:30	0	0	19.6	80.1	30.06
Point C1 (FMH041)	10:40	0	0	19.5	80.5	30.06
Point C2 (FMH040)	10:43	0	0	19.4	80.6	30.06
Point D	10:50	0	0	19.3	80.7	30.06
Point C1 (FMH041)						
Point C2 (FMH040)
