Contract No. : EP/SP/52/06
Development of an EcoPark in Tuen Mun Area 38

ENVIRONMENTAL MONITORING AND AUDIT

MONTHLY EM&A REPORT for

NOVEMBER 2006

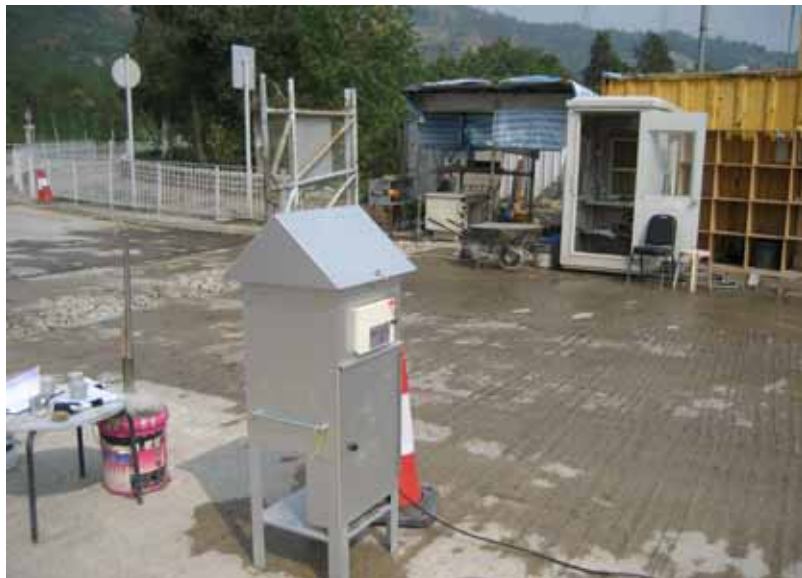
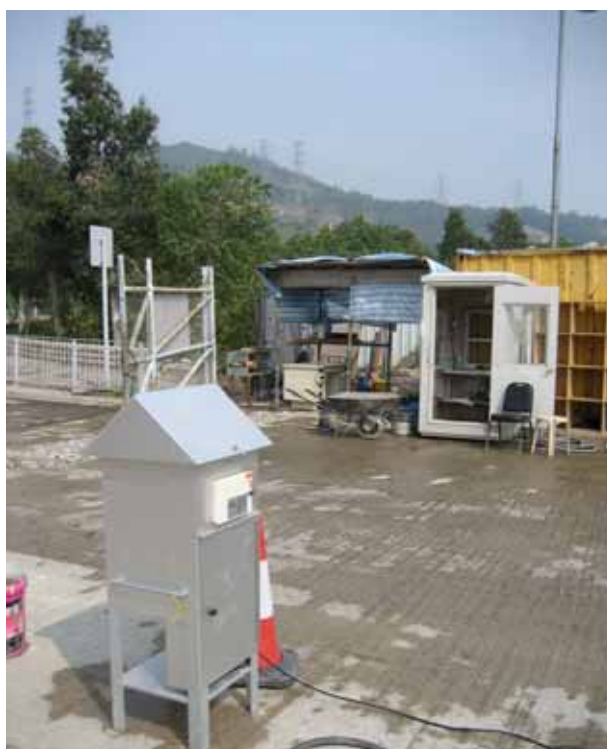
The Location Plan of High Volume Air Sampler

Photos of High Volume Air Sampler

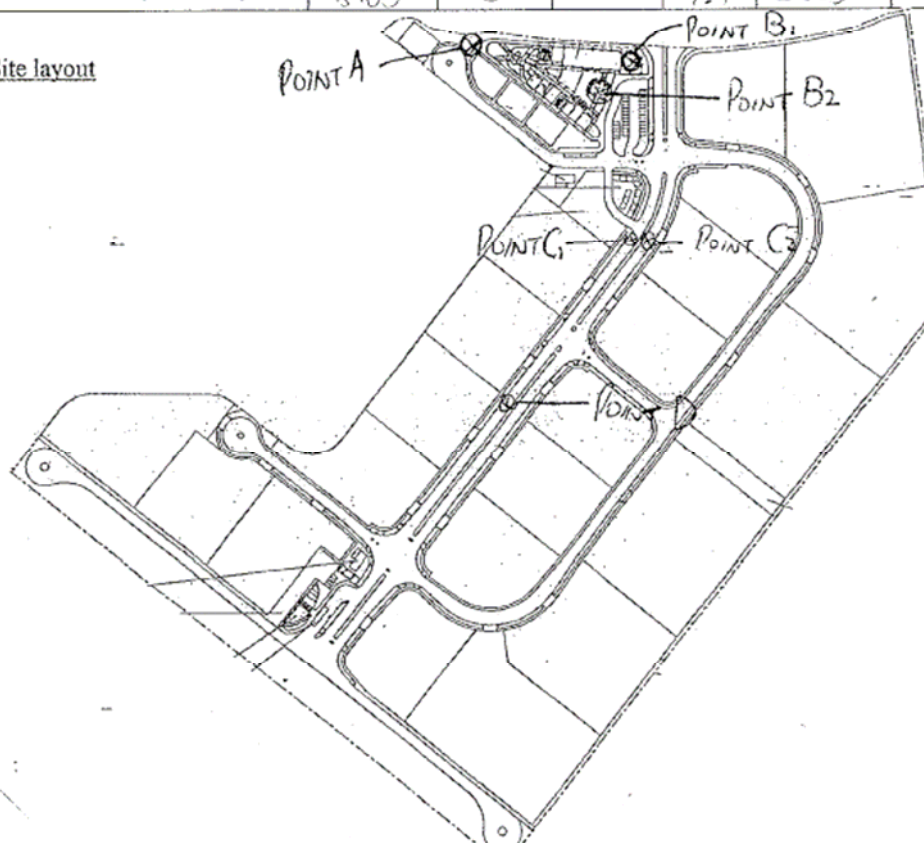
Site layout

Detector: 測試器	Model 型號: GEM 2000	Last calibration 上次檢測: 01 October 2006				
	S/N 編號: GM-08793	Next calibration 下次檢測: 01 April 2007				
Date of Monitor 監測日期: 01-11-2006		Performed by: MLC				
Location 位置	Time 時間 (hrs)	Result 結果				
		CH ₄ (%)	CO ₂ (%)	O ₂ (%)	Bal. Gas (%)	Baro. Pressure ("Hg)
Point A	9:50	0	0	19.9	79.9	29.91
Point B1	9:55	0	0	19.7	80.1	29.91
Point B2 (Rainwater retention tank)	9:52	0	0	19.9	80.1	29.91
Point C1 (FMH041)	10:08	0	0	19.7	80.4	29.91
Point C2 (FMH040)	10:02	0	0	19.6	80.3	29.91
Point D	10:12	0	0	19.5	80.4	29.91
Point C1 (FMH041)	8:00	0	0	19.8	80.3	29.91
Point C2 (FMH040)	8:05	0	0	19.7	80.5	29.91

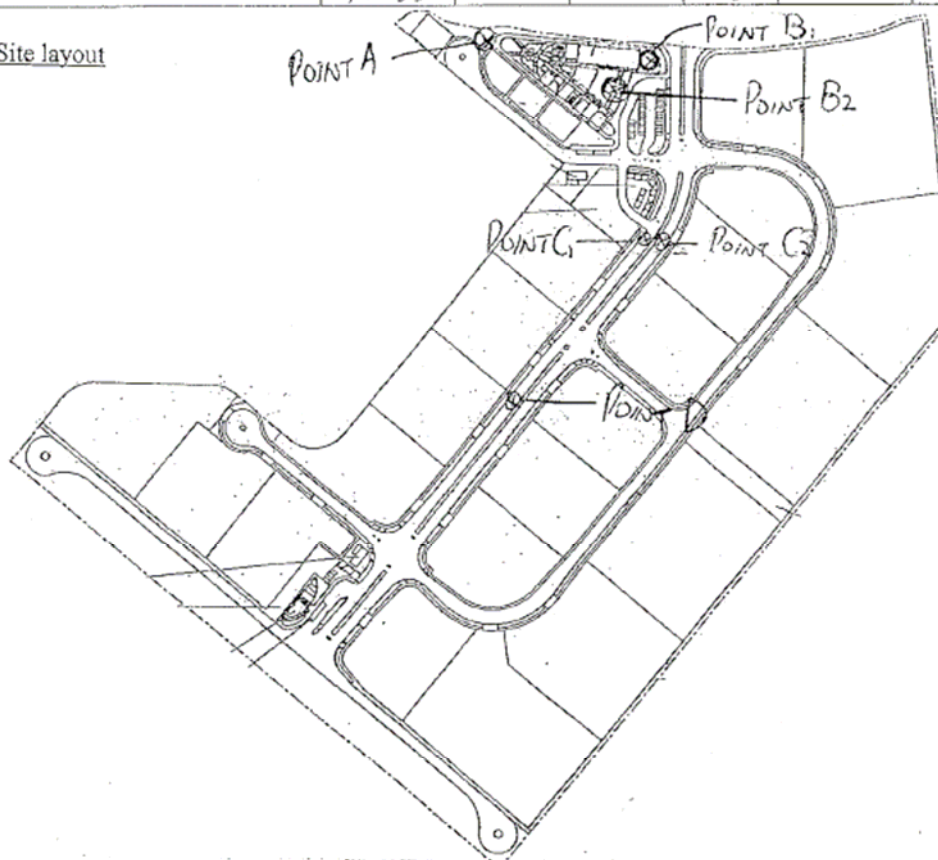
Site layout

Detector : 測試器	Model 型號 : S/N 編號 :	GEM 2000 GM-08793	Last calibration 上次檢測: Next calibration 下次檢測:	01 October 2006 01 April 2007			
Date of Monitor 監測日期 : 08 NOV 2006			Performed by: <i>ALC</i>				
Location 位置		Time 時間 (hrs)	Result 結果				
			CH ₄ (%)	CO ₂ (%)	O ₂ (%)	Bal. Gas (%)	Baro. Pressure ("Hg)
Point A		10:25	0	0	20.0	80.0	30.08
Point B1		10:30	0	0	19.8	79.9	30.08
Point B2 (Rainwater retention tank)		10:35	0	0	19.9	80.1	30.08
Point C1 (FMH041)		10:41	0	0	19.6	80.3	30.08
Point C2 (FMH040)		10:43	0	0	19.6	80.3	30.08
Point D		10:55	0	0	19.5	80.5	30.08

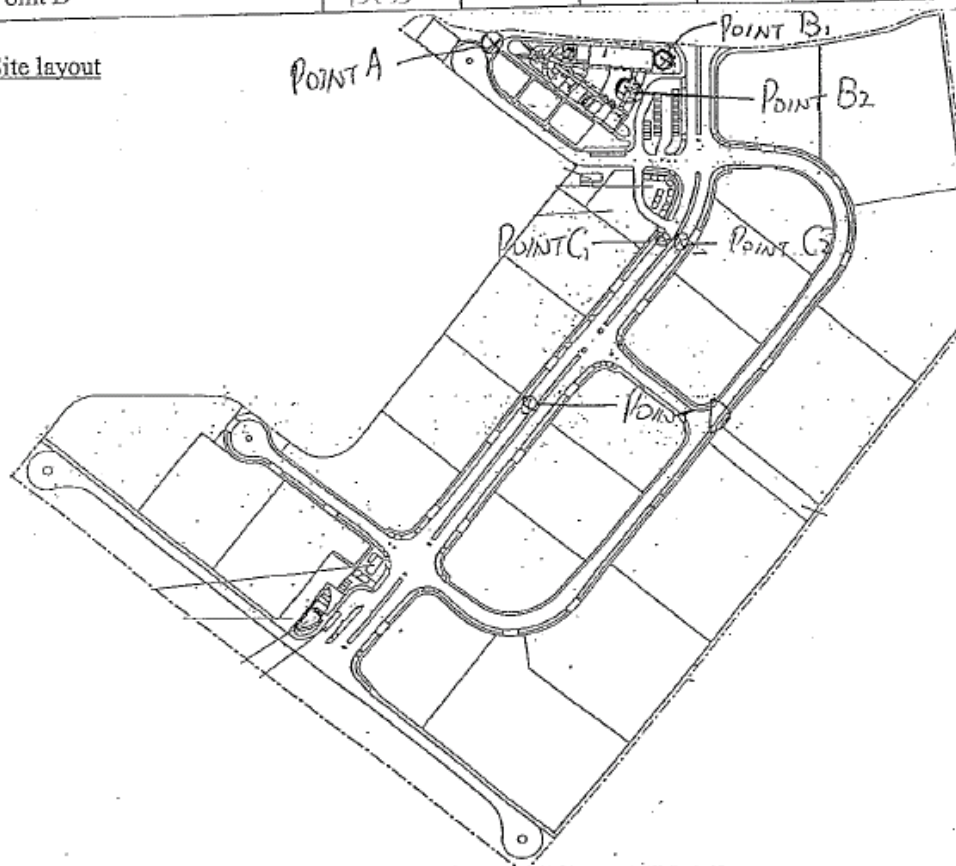
Site layout

Location 位置	Time 時間 (hrs)	Result 結果				
		CH ₄ (%)	CO ₂ (%)	O ₂ (%)	Bal. Gas (%)	Baro. Pressure (“Hg)
Point A	15:47	0	0	20.1	79.8	29.98
Point B1	15:42	0	0	19.9	80.0	29.98
Point B2 (Rainwater retention tank)	15:44	0	0	20.2	79.97	29.98
Point C1 (FMH041)	15:38	0	0	20.0	79.9	29.98
Point C2 (FMH040)	15:31	0	0	19.6	80.2	29.98
Point D	15:35	0	0	20.0	79.9	29.98

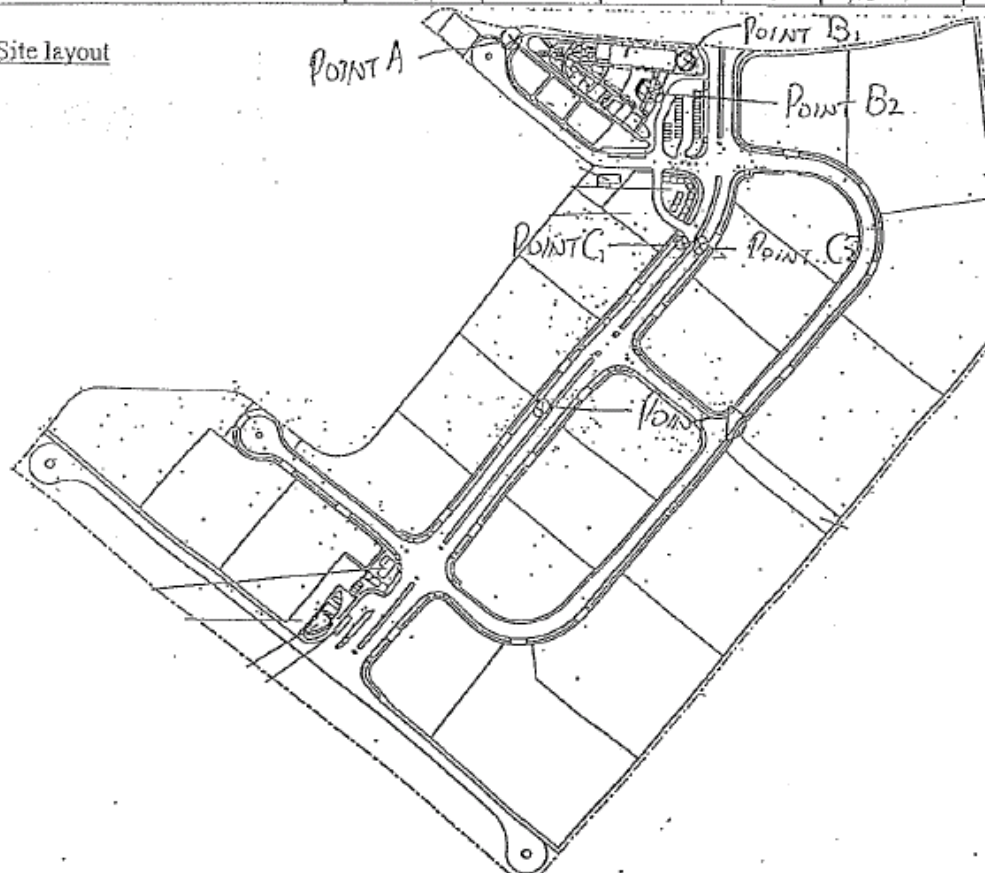
Site layout

Location 位置	Time 時間 (hrs)	Result 結果				
		CH ₄ (%)	CO ₂ (%)	O ₂ (%)	Bal. Gas (%)	Baro. Pressure (“Hg)
Point A	09:44	0	0	19.1	80.0	29.88
Point B1	09:48	0	0	19.1	80.8	29.88
Point B2 (Rainwater retention tank)	09:50	0	0	19.1	80.8	29.88
Point C1 (FMH041)	09:57	0	0	19.1	80.8	29.88
Point C2 (FMH040)	10:05	0	0	19.0	80.9	29.88
Point D	10:01	0	0	19.0	80.9	29.88

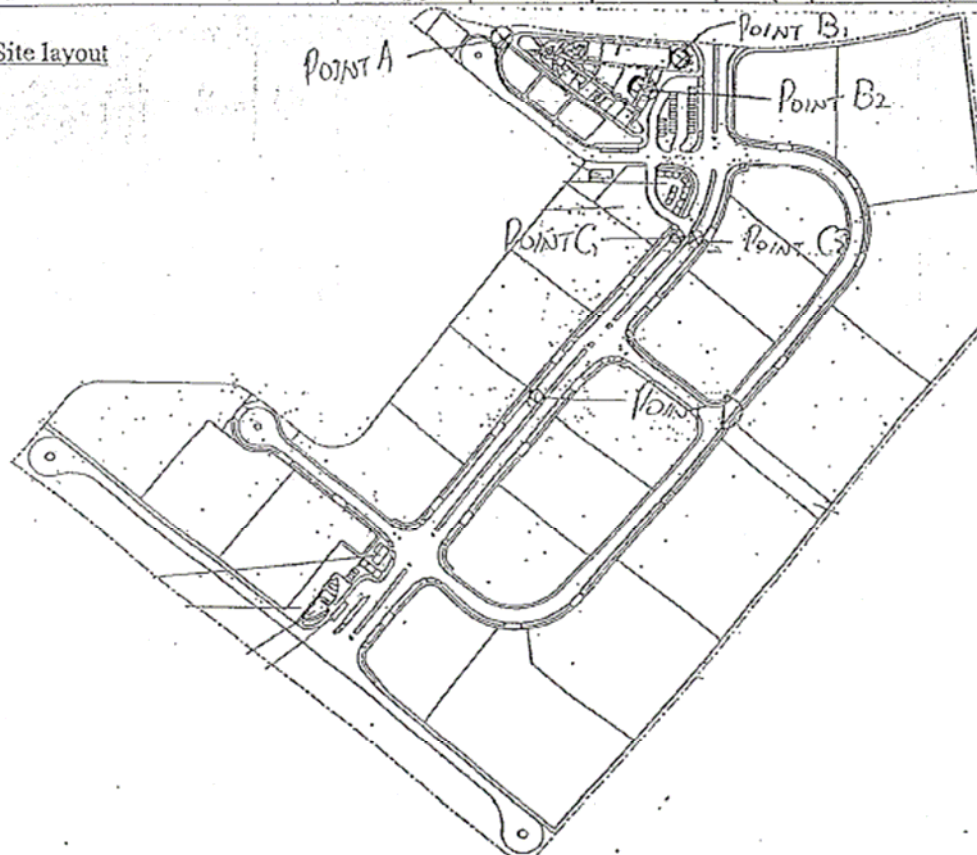
Site layout

Location 位置	Time 時間 (hrs)	Result 結果				
		CH ₄ (%)	CO ₂ (%)	O ₂ (%)	Bal. Gas (%)	Baro. Pressure ("Hg)
Point A	8:42	0	0	19.0	80.9	30.04
Point B1	8:47	0	0	19.2	80.7	30.04
Point B2 (Rainwater retention tank)	not	accessible				#
Point C1 (FMH041)	08:51	0	0	19.2	80.7	30.04
Point C2 (FMH040)	08:29	0	0	19.2	80.7	30.04
Point D	08:26	0	0	19.2	80.7	30.04
