Contract No. : EP/SP/52/06
Development of an EcoPark in Tuen Mun Area 38

ENVIRONMENTAL MONITORING AND AUDIT

MONTHLY EM&A REPORT for

FEBRUARY 2007

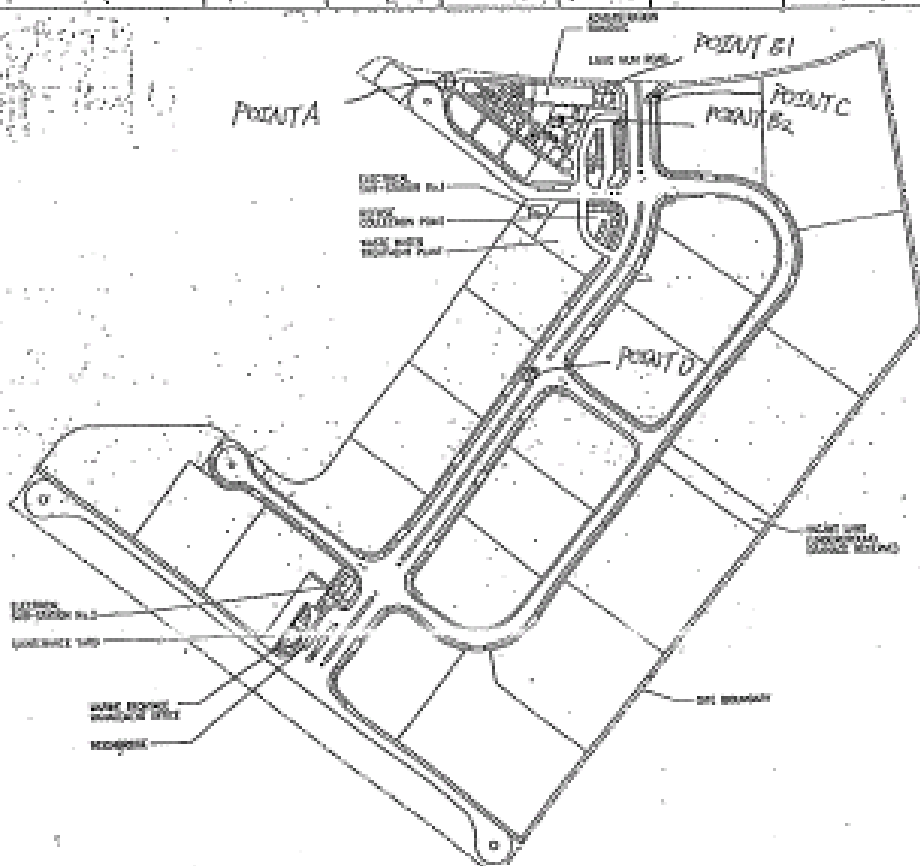
Site layout

Location 位置	Time 時間 (hrs)	Result 結果				
		CH ₄ (%)	CO ₂ (%)	O ₂ (%)	Bal. Gas (%)	Baro. Pressure (H _g)
Point A	1615	0	0	18.0	81.9	29.93
Point B1	1624	0	0	17.9	82.0	29.93
Point B2 (Rainwater retention tank)	1626	0	0	18.0	81.9	29.93
Point C1 (FMH040)	1627	0	0	17.9	82.0	29.93
Point D	1631	0	0	17.8	82.1	29.93
