Contract No. : EP/SP/52/06 Development of EcoPark in Tuen Mun Area 38

ENVIRONMENTAL MONITORING AND AUDIT MONTHLY EM&A REPORT for

May 2008

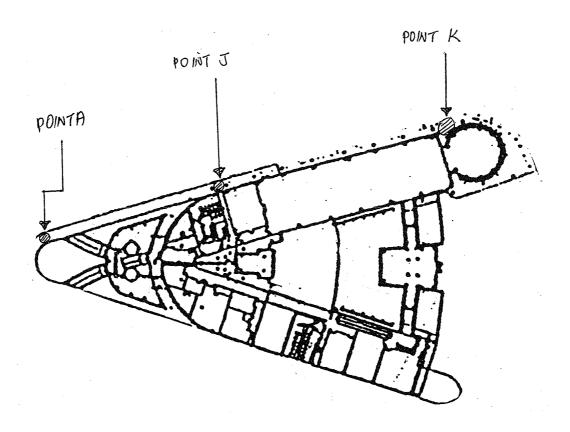
Site layout

Daily Air Monitoring 每日空氣監測記錄

Model 型號:	GEM 2000	Last calibration 上次檢測:	03 Apr. 07
測試器	S/N 編號:	GM-08793	Next calibration 下次檢測:	02 Apr. 08

Instrument for O2 measurement: GasAlert MicroClip GAMIC-4-DL2 Serial no.: S103-13348

Table 3.5 Summary of LFG Measurement for the reporting month											
Sampling											
Location	Measurement	Time	Condition	(CH ₄) %LEL	(CO ₂) %LEL						
Point A	6 May 08	1131		0	0	20.9%					
Point J	6 May 08	1133	Drizzle	0	0	20.9%					
Point K	6 May 08	1135		0	0	20.9%					
Point A	14 May 08	1509		0	0	20.9%					
Point J	14 May 08	1511	Sunny	0	0	20.9%					
Point K	14 May 08	1513		0	0	20.9%					
Point A	21 May 08	1410		0	0	20.9%					
Point J	21 May 08	1412	Sunny	0	0	20.9%					
Point K	21 May 08	1415		0	0	20.9%					
Point A	29 May 08	1510		0	0	20.9%					
Point J	29 May 08	1512	Rain	0	0	20.9%					
Point K	29 May 08	1514		0	0	20.9%

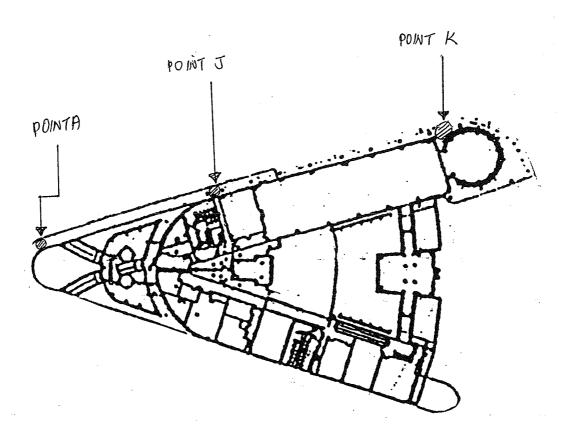
Site layout

Instrument for O2 measurement: GasAlert MicroClip GAMIC-4-DL2 Serial no.: S103-13348

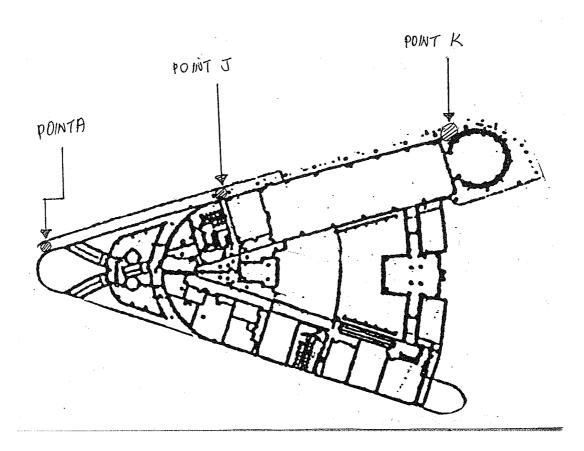
Site layout

Instrument for O2 measurement: GasAlert MicroClip GAMIC-4-DL2 Serial no.: S103-13348

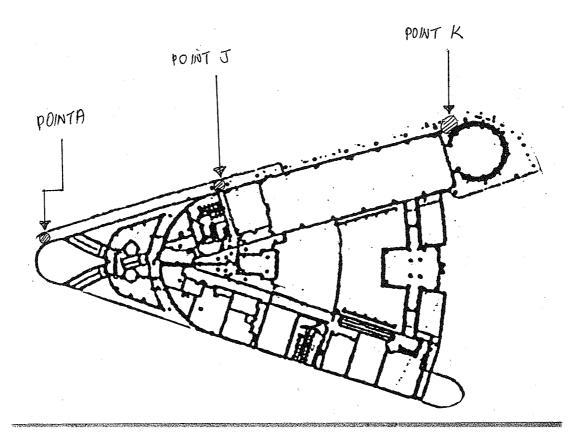
Site layout

Instrument for O2 measurement: GasAlert MicroClip GAMIC-4-DL2 Serial no.: S103-13348
