**PROVISION OF CREMATORS AT
WO HOP SHEK CREMATORIUM**

**QUARTERLY ENVIRONMENTAL
MONITORING & AUDIT REPORT
(NOVEMBER 2009 – JANUARY 2010)**

ALLIED ENVIRONMENTAL CONSULTANTS LTD.

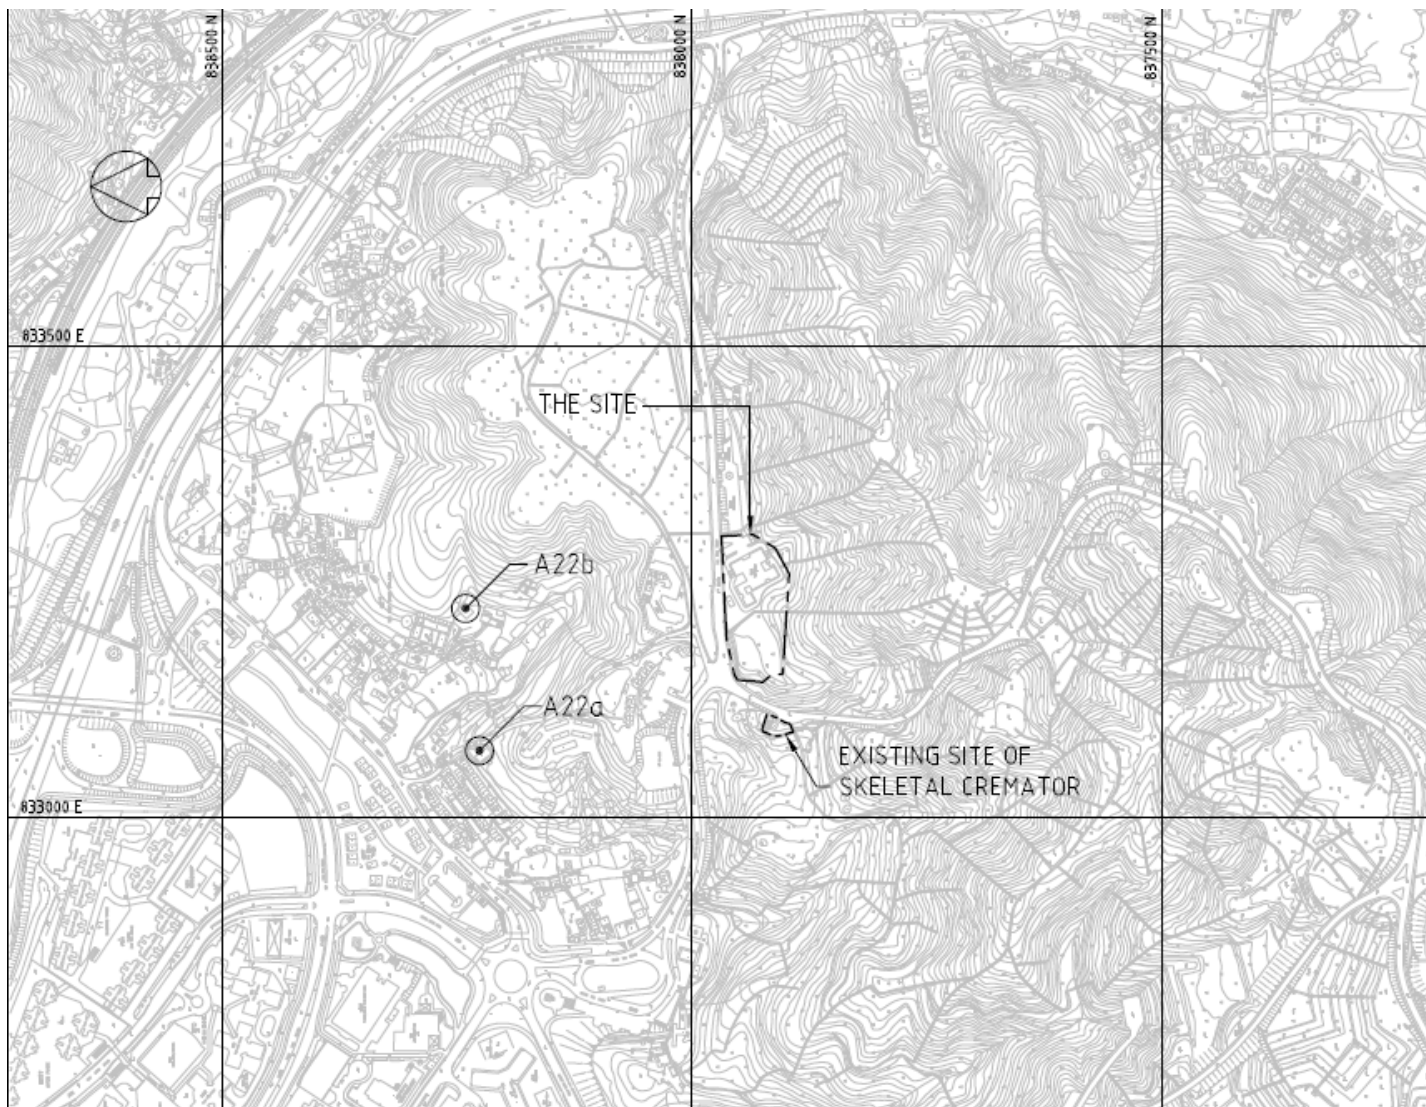
PROVISION OF CREMATORS AT WO HOP SHEK CREMATORIUM AT KIU TAU ROAD
LOCATION OF AIR QUALITY MONITORING STATION

Environmental monitoring was carried out for the Provision of Cremators at Wo Hop Shek Crematorium in the reporting period. 1-hour and 24-hour TSP air quality monitoring were conducted at (i) 83 Wo Ka Lau Road (A22a) and (ii) 51D Wo Hop Shek San Tsuen (A22b) during the period from 1st November 2009 to 31st January 2010.

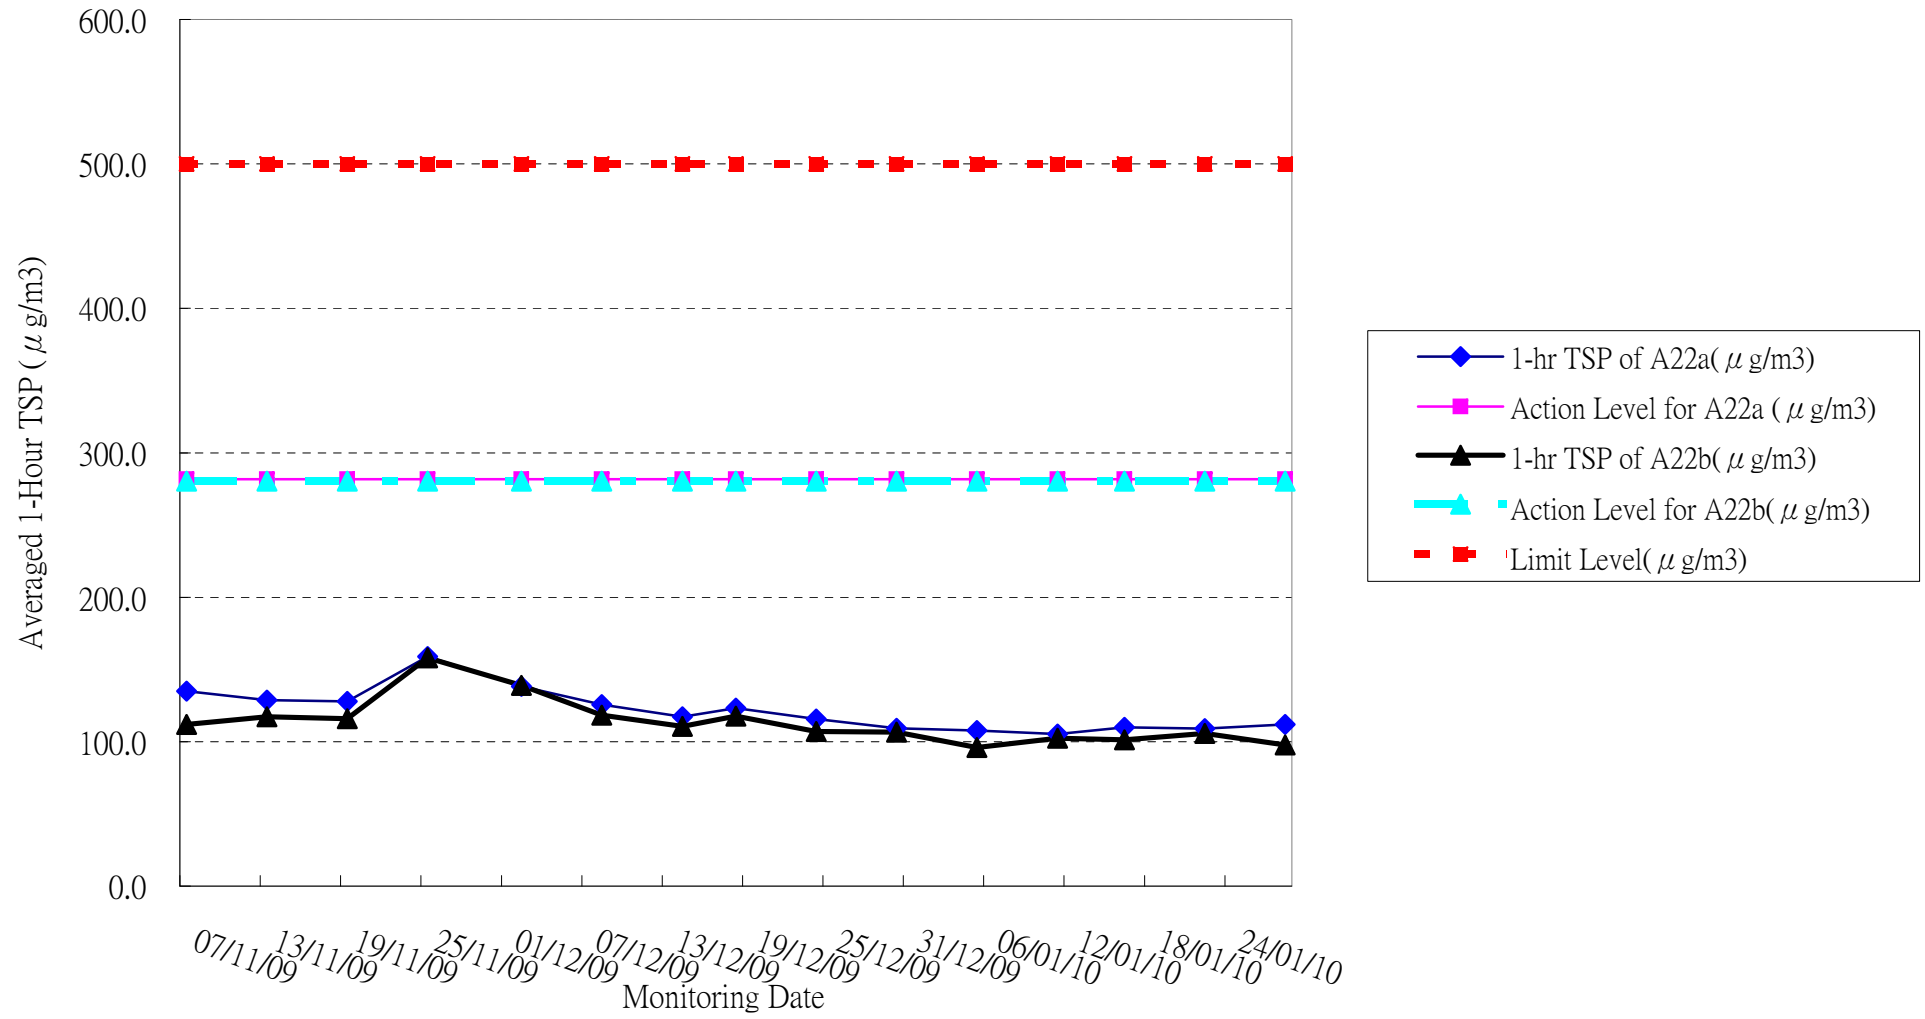
1-Hour TSP air quality monitoring data plot recorded at the designated monitoring points

Date	1-hr TSP of A22a($\mu\text{g}/\text{m}^3$)	Action Level for A22a ($\mu\text{g}/\text{m}^3$)	1-hr TSP of A22b($\mu\text{g}/\text{m}^3$)	Action Level for A22b($\mu\text{g}/\text{m}^3$)	Limit Level($\mu\text{g}/\text{m}^3$)
07/11/09	135.0	281.7	112.0	280.4	500.0
13/11/09	128.7	281.7	117.3	280.4	500.0
19/11/09	128.0	281.7	116.0	280.4	500.0
25/11/09	159.0	281.7	158.0	280.4	500.0
02/12/09	138.3	281.7	139.0	280.4	500.0
08/12/09	125.7	281.7	118.3	280.4	500.0
14/12/09	117.3	281.7	110.7	280.4	500.0
18/12/09	123.3	281.7	117.7	280.4	500.0
24/12/09	115.7	281.7	107.0	280.4	500.0
30/12/09	109.3	281.7	106.7	280.4	500.0
05/01/10	107.7	281.7	96.0	280.4	500.0
11/01/10	105.3	281.7	102.3	280.4	500.0
16/01/10	110.0	281.7	101.3	280.4	500.0
22/01/10	109.0	281.7	105.7	280.4	500.0
28/01/10	112.0	281.7	97.7	280.4	500.0

All monitoring results complied with the relevant action and limit levels. No environmental complaints and notification of summons or prosecution were received during the reporting period.

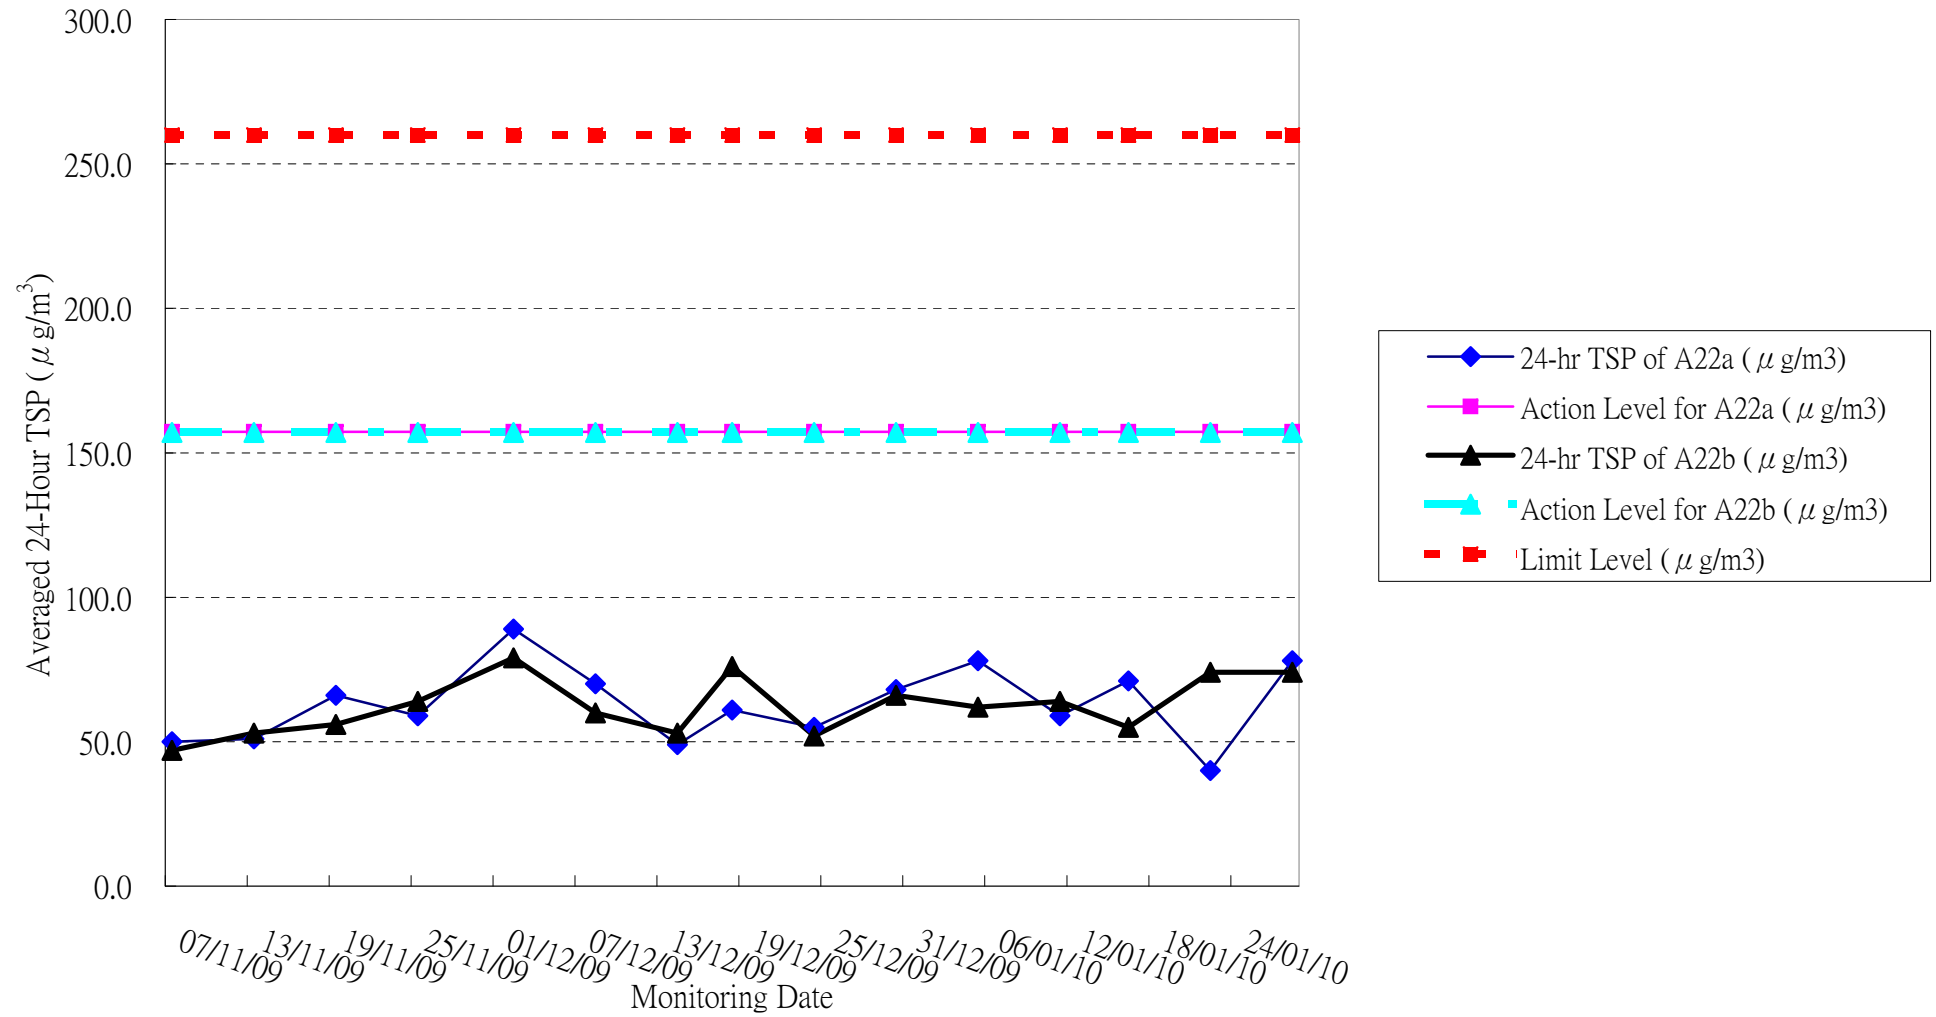
24-Hour TSP air quality monitoring data plot recorded at the designated monitoring points

Date	24-hr TSP of A22a (µg/m3)	Action Level for A22a (µg/m3)	24-hr TSP of A22b (µg/m3)	Action Level for A22b (µg/m3)	Limit Level (µg/m3)
07/11/09	50.0	157.3	47.0	157.0	260.0
13/11/09	51.0	157.3	53.0	157.0	260.0
19/11/09	66.0	157.3	56.0	157.0	260.0
25/11/09	59.0	157.3	64.0	157.0	260.0
02/12/09	89.0	157.3	79.0	157.0	260.0
08/12/09	70.0	157.3	60.0	157.0	260.0
14/12/09	49.0	157.3	53.0	157.0	260.0
18/12/09	61.0	157.3	76.0	157.0	260.0
24/12/09	55.0	157.3	52.0	157.0	260.0
30/12/09	68.0	157.3	66.0	157.0	260.0
05/01/10	78.0	157.3	62.0	157.0	260.0
11/01/10	59.0	157.3	64.0	157.0	260.0
16/01/10	71.0	157.3	55.0	157.0	260.0
22/01/10	40.0	157.3	74.0	157.0	260.0
28/01/10	78.0	157.3	74.0	157.0	260.0
