**PROVISION OF CREMATORS AT  
WO HOP SHEK CREMATORIUM**

**QUARTERLY ENVIRONMENTAL  
MONITORING & AUDIT REPORT  
(MAY 2010 – JULY 2010)**

**ALLIED ENVIRONMENTAL CONSULTANTS LTD.**

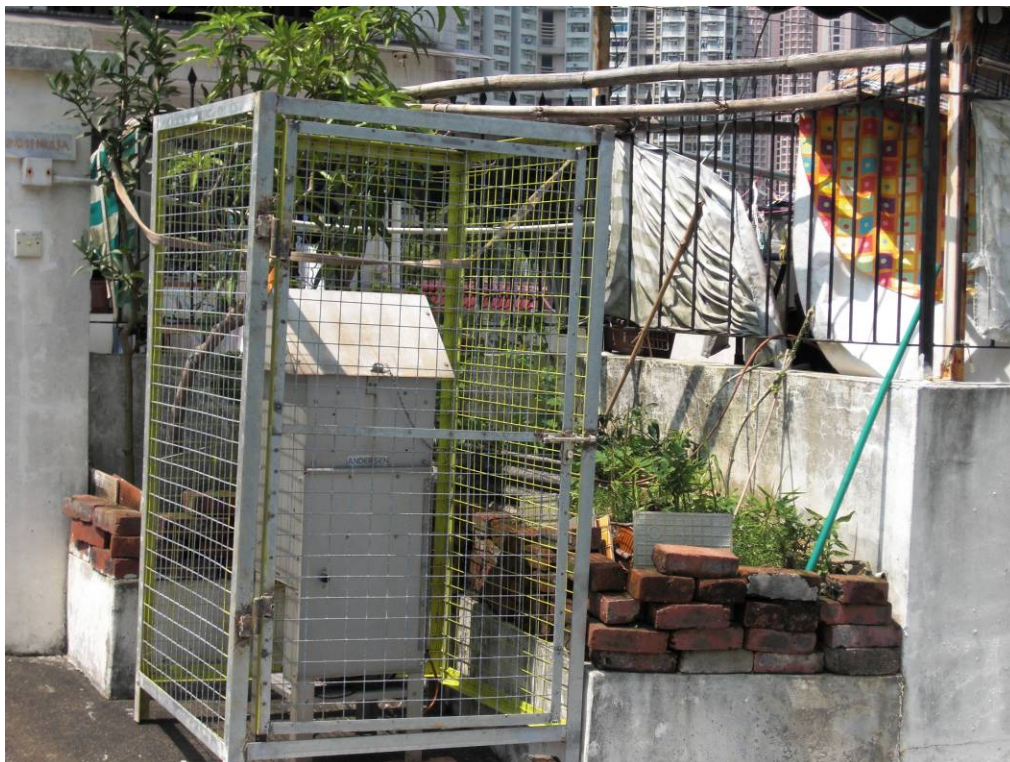
Ground floor within the front gate of 83 Wo Ka Lau Road

**PROVISION OF CREMATORS AT WO HOP SHEK CREMATORIUM AT KIU TAU ROAD**  
**PHOTOS OF AIR QUALITY MONITORING STATION**

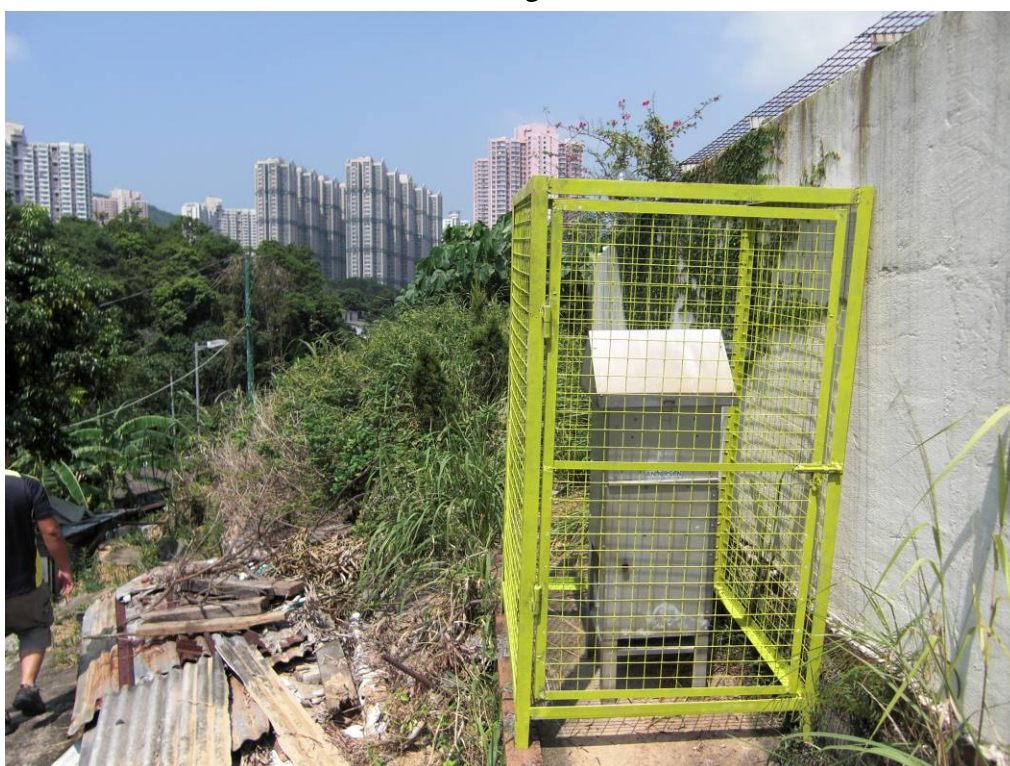
Ground floor boundary wall of house 51D of Wo Hop Shek San Tsuen

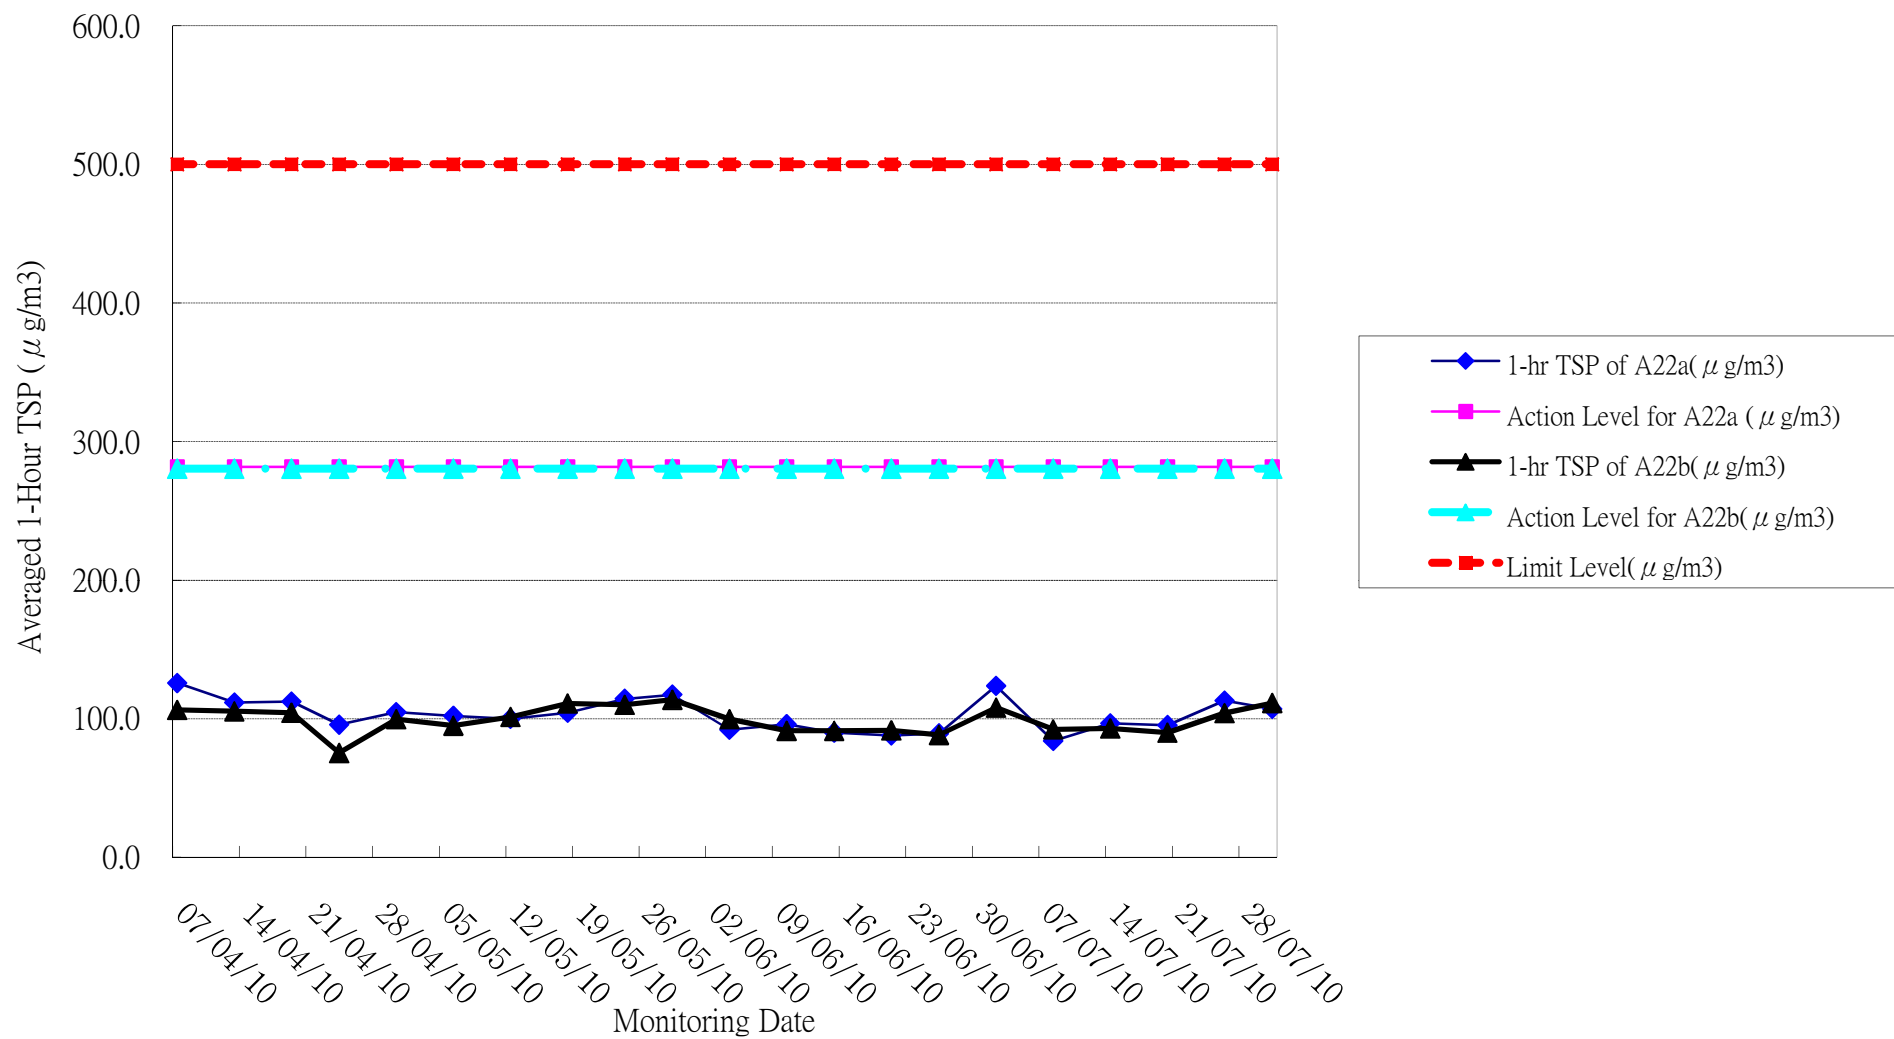
Date	1-hr TSP of A22a( $\mu\text{g}/\text{m}^3$ )	Action Level for A22a ( $\mu\text{g}/\text{m}^3$ )	1-hr TSP of A22b( $\mu\text{g}/\text{m}^3$ )	Action Level for A22b( $\mu\text{g}/\text{m}^3$ )	Limit Level( $\mu\text{g}/\text{m}^3$ )
06/05/10	102.0	281.7	95.0	280.4	500.0
12/05/10	100.0	281.7	101.3	280.4	500.0
18/05/10	104.3	281.7	111.0	280.4	500.0
24/05/10	114.3	281.7	110.0	280.4	500.0
29/05/10	117.3	281.7	113.7	280.4	500.0
04/06/10	92.0	281.7	99.7	280.4	500.0
10/06/10	96.0	281.7	91.3	280.4	500.0
15/06/10	90.0	281.7	91.3	280.4	500.0
21/06/10	87.9	281.7	91.7	280.4	500.0
26/06/10	89.3	281.7	88.3	280.4	500.0
02/07/10	123.7	281.7	108.0	280.4	500.0
08/07/10	84.0	281.7	92.3	280.4	500.0
14/07/10	96.7	281.7	93.0	280.4	500.0
20/07/10	95.3	281.7	90.0	280.4	500.0
26/07/10	113.0	281.7	104.0	280.4	500.0
31/07/10	107.0	281.7	111.3	280.4	500.0

1-Hour TSP air quality monitoring data plot recorded at the designated monitoring points

All monitoring results complied with the relevant action and limit levels. No environmental complaints and notification of summons or prosecution were received during the reporting period.

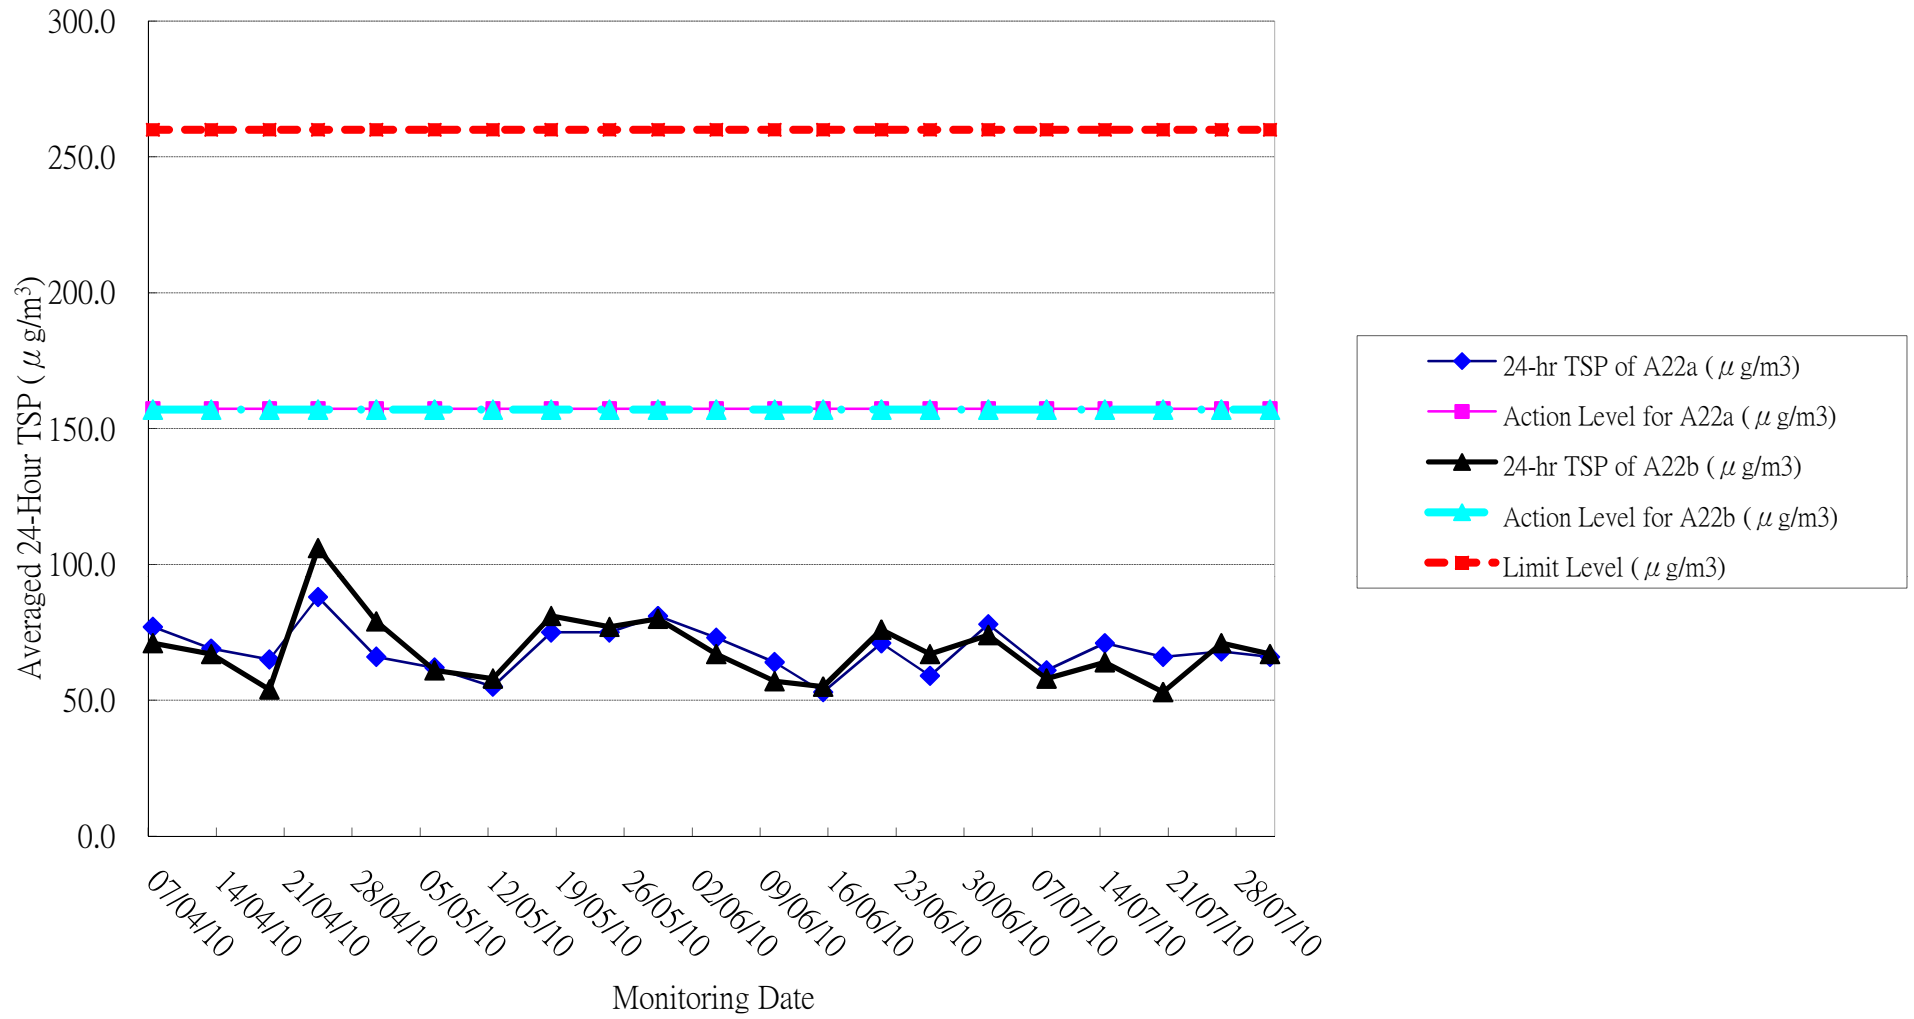
Date	24-hr TSP of A22a (µg/m3)	Action Level for A22a (µg/m3)	24-hr TSP of A22b (µg/m3)	Action Level for A22b (µg/m3)	Limit Level (µg/m3)
06/05/10	62.0	157.3	61.0	157.0	260.0
12/05/10	55.0	157.3	58.0	157.0	260.0
18/05/10	75.0	157.3	81.0	157.0	260.0
24/05/10	75.0	157.3	77.0	157.0	260.0
29/05/10	81.0	157.3	80.0	157.0	260.0
04/06/10	73.0	157.3	67.0	157.0	260.0
10/06/10	64.0	157.3	57.0	157.0	260.0
15/06/10	53.0	157.3	55.0	157.0	260.0
21/06/10	71.0	157.3	76.0	157.0	260.0
26/06/10	59.0	157.3	67.0	157.0	260.0
02/07/10	78.0	157.3	74.0	157.0	260.0
08/07/10	61.0	157.3	58.0	157.0	260.0
14/07/10	71.0	157.3	64.0	157.0	260.0
20/07/10	66.0	157.3	53.0	157.0	260.0
26/07/10	68.0	157.3	71.0	157.0	260.0
31/07/10	66.0	157.3	67.0	157.0	260.0

24-Hour TSP air quality monitoring data plot recorded at the designated monitoring points

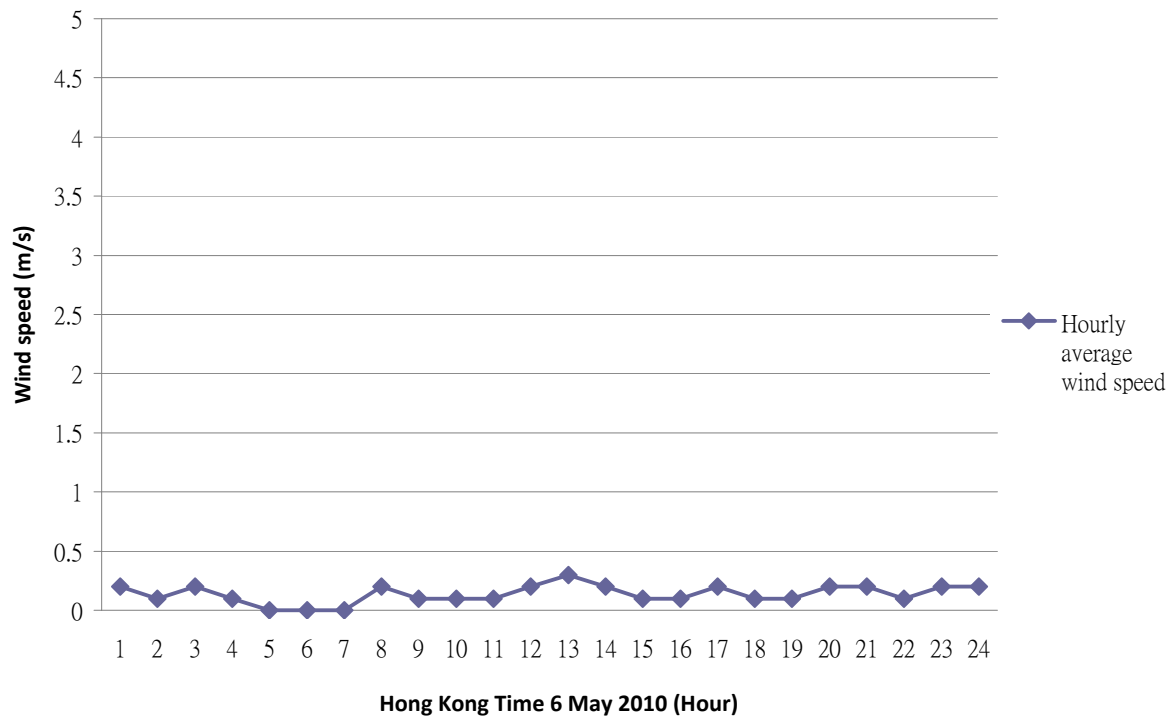
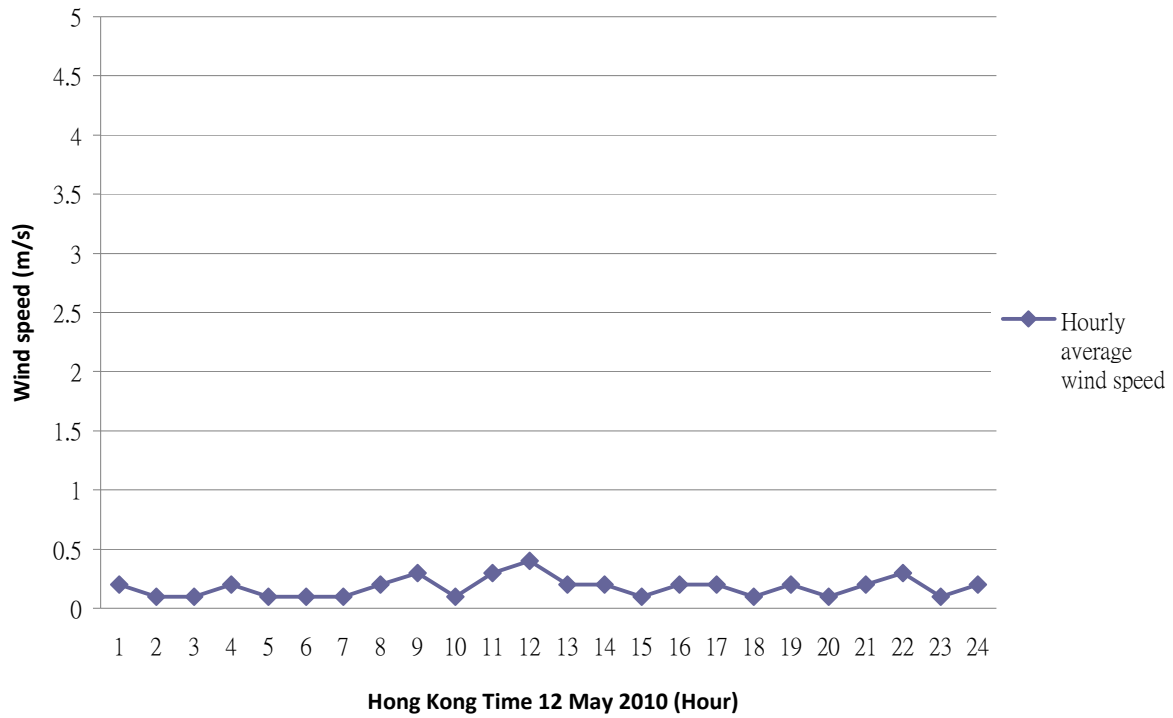
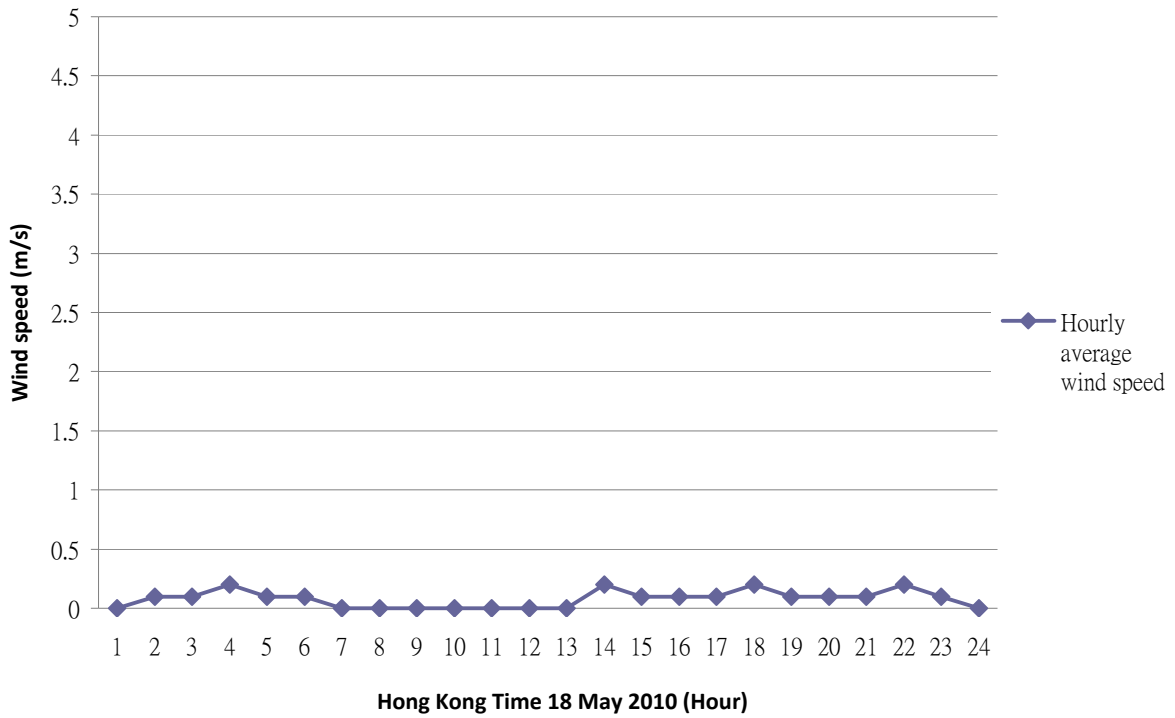
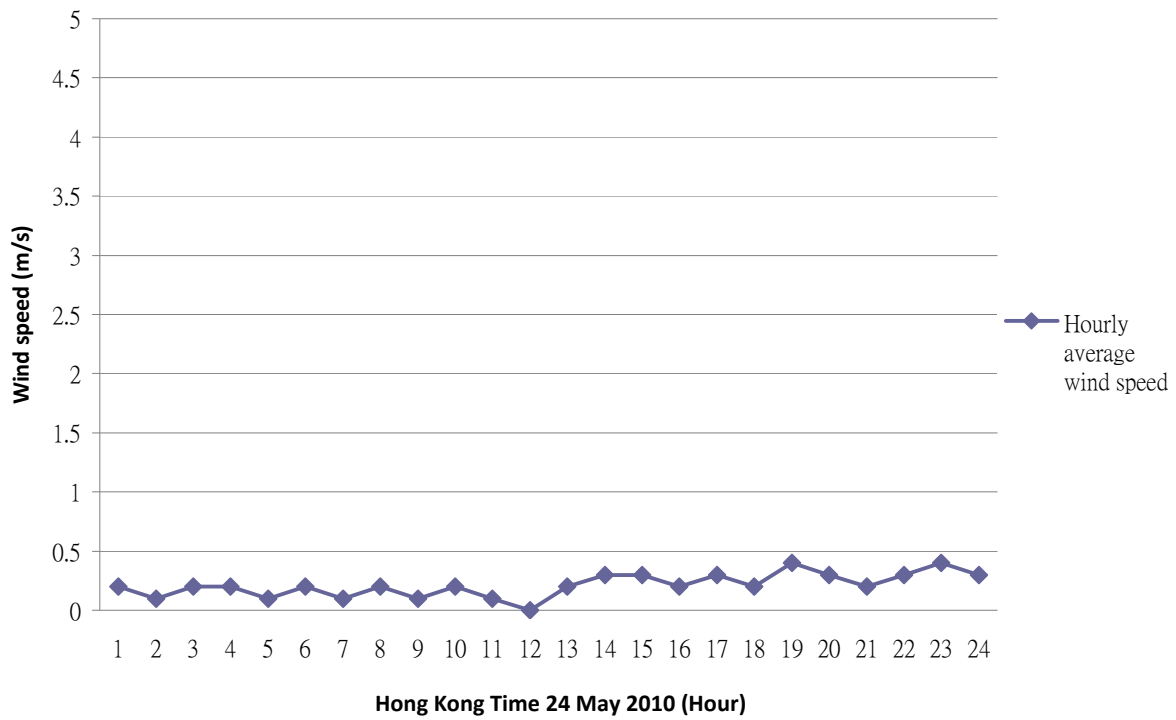
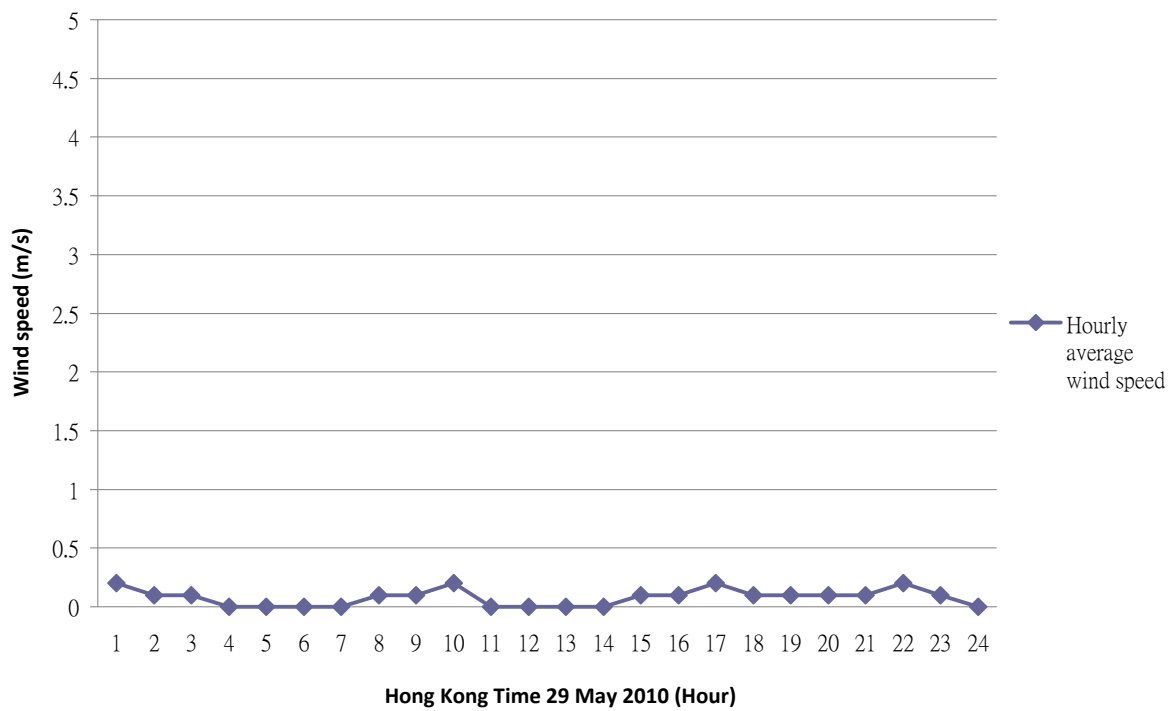
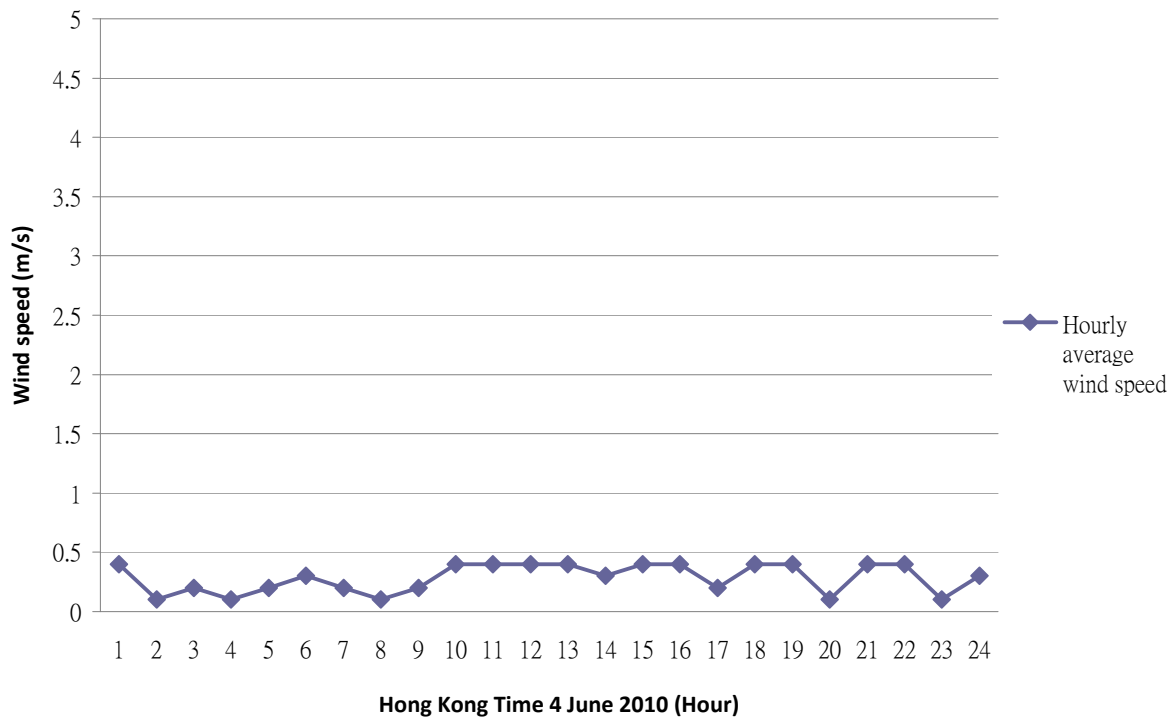
## Wind speed profile at on-site wind station

- Wind sensors were installed on masts at an elevated level 10m above ground so that they are clear of obstructions of turbulence caused by the buildings;
- The wind data were captured by a data logger and to be downloaded for processing at least once a month;
- The wind data monitoring equipment shall be re-calibrated at least once every six months; and
- Wind direction is divided into 16 sectors of 22.5 degrees each.

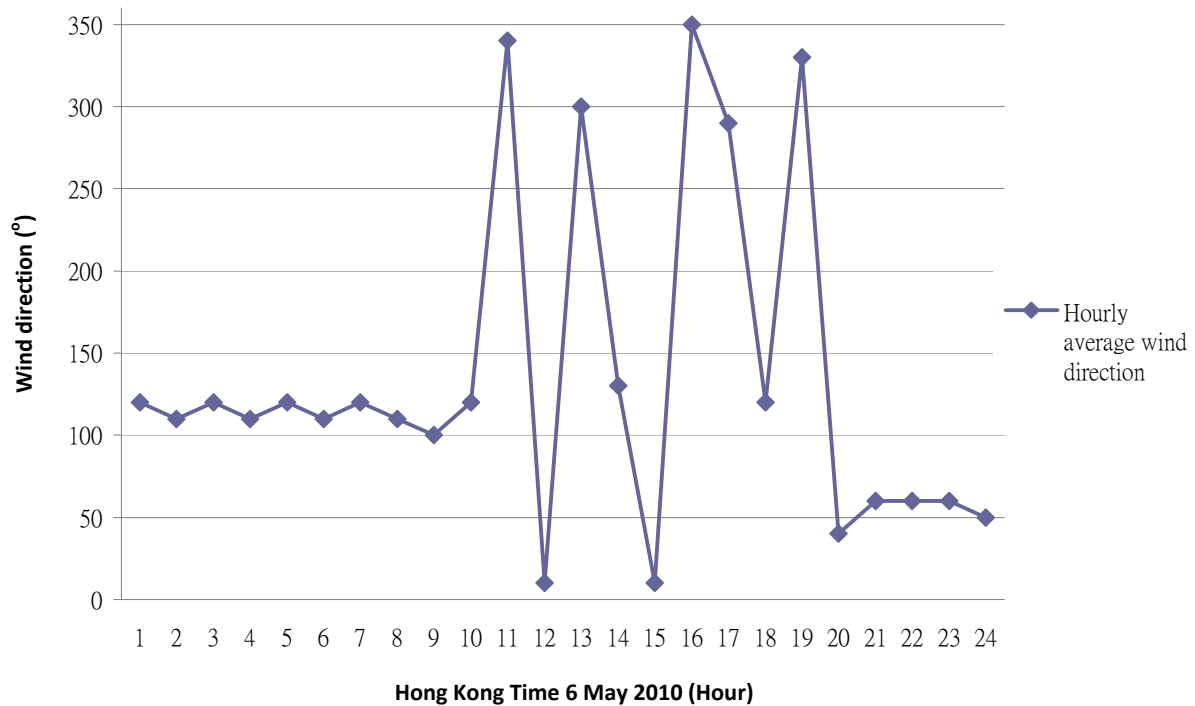
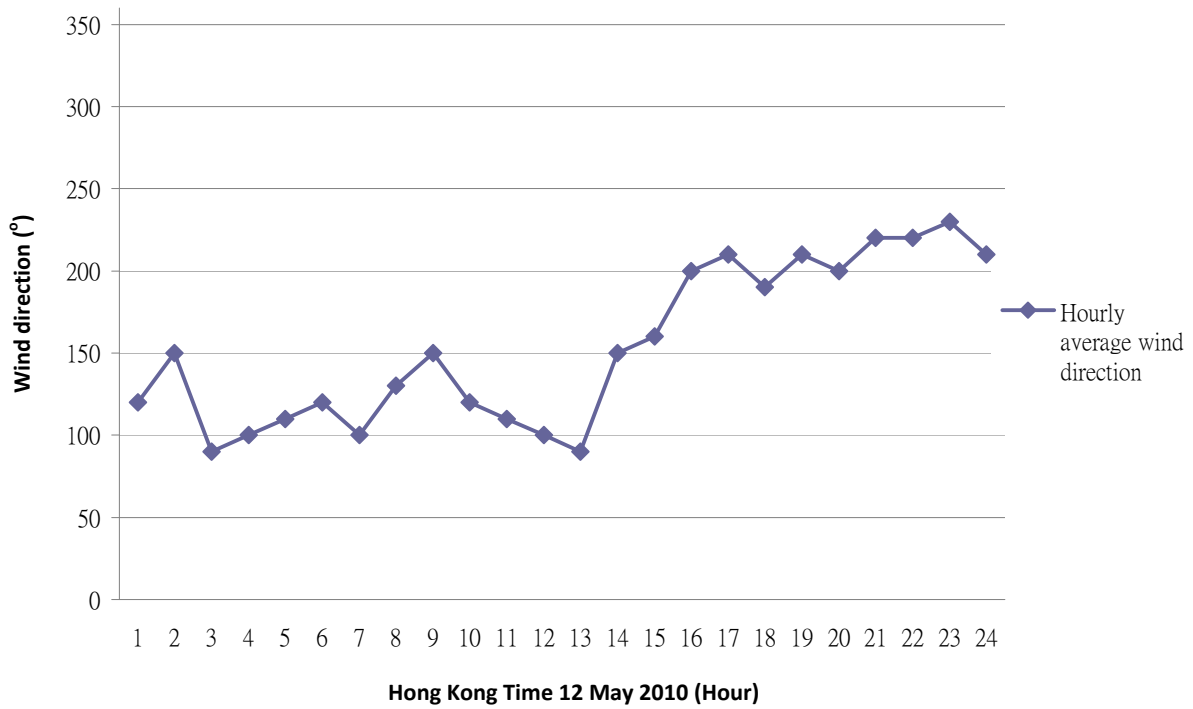
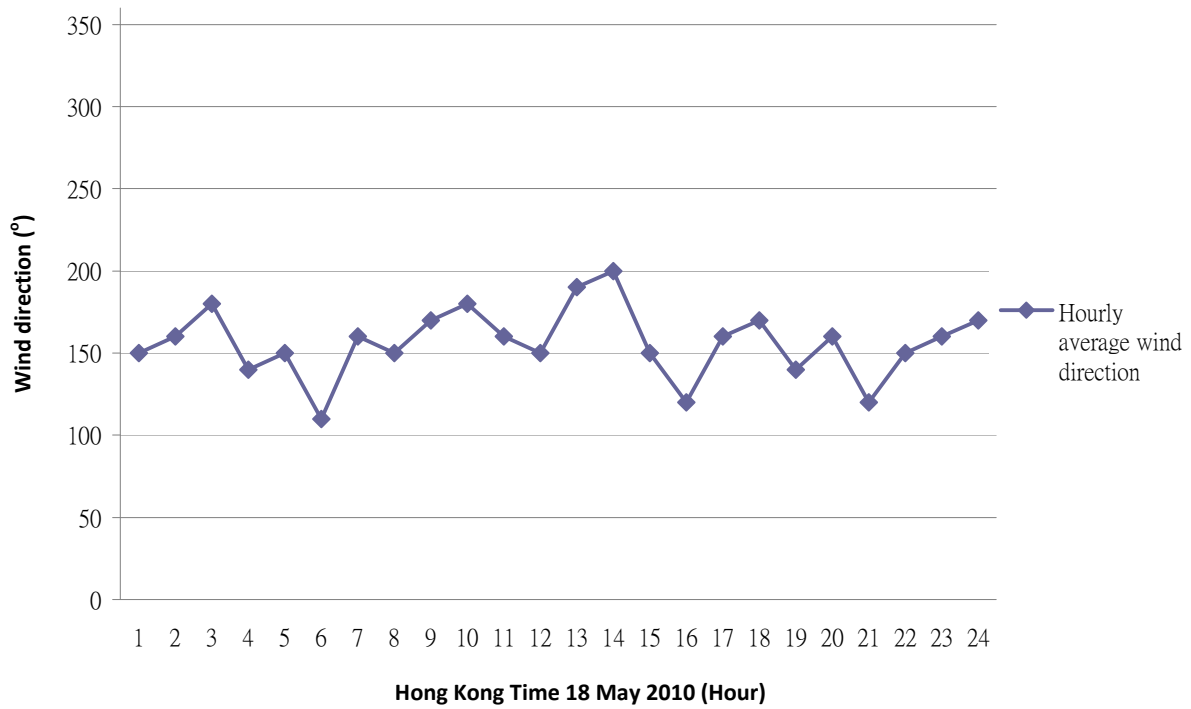
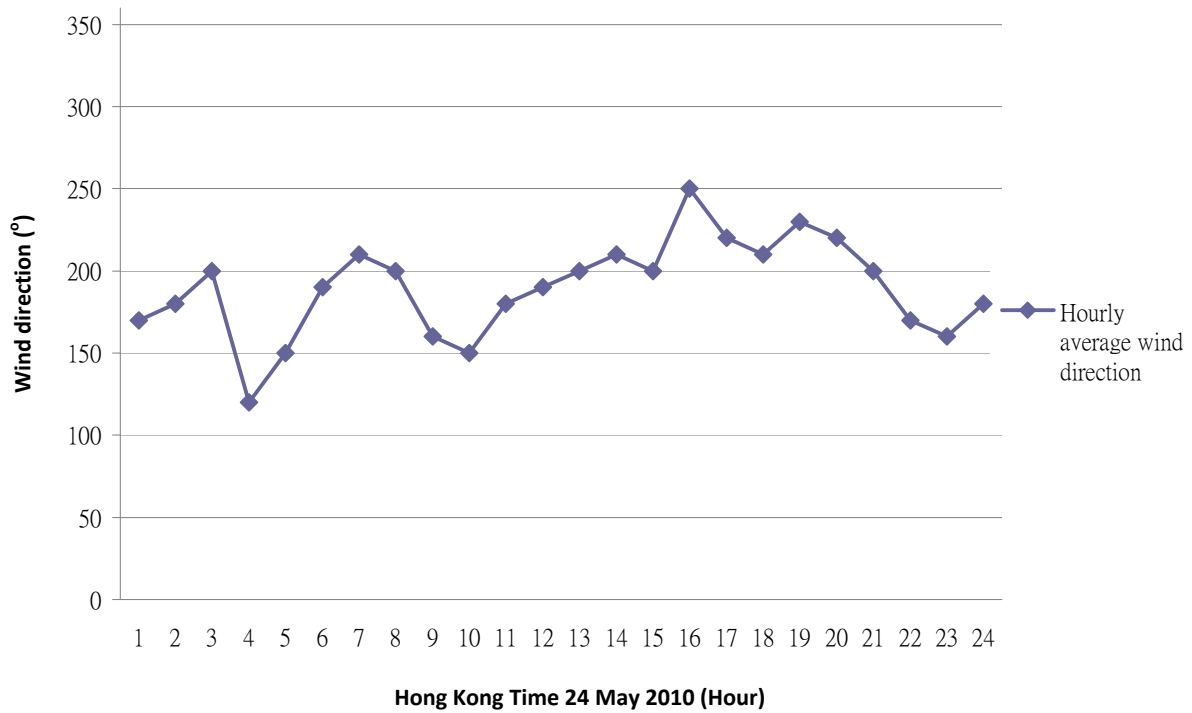
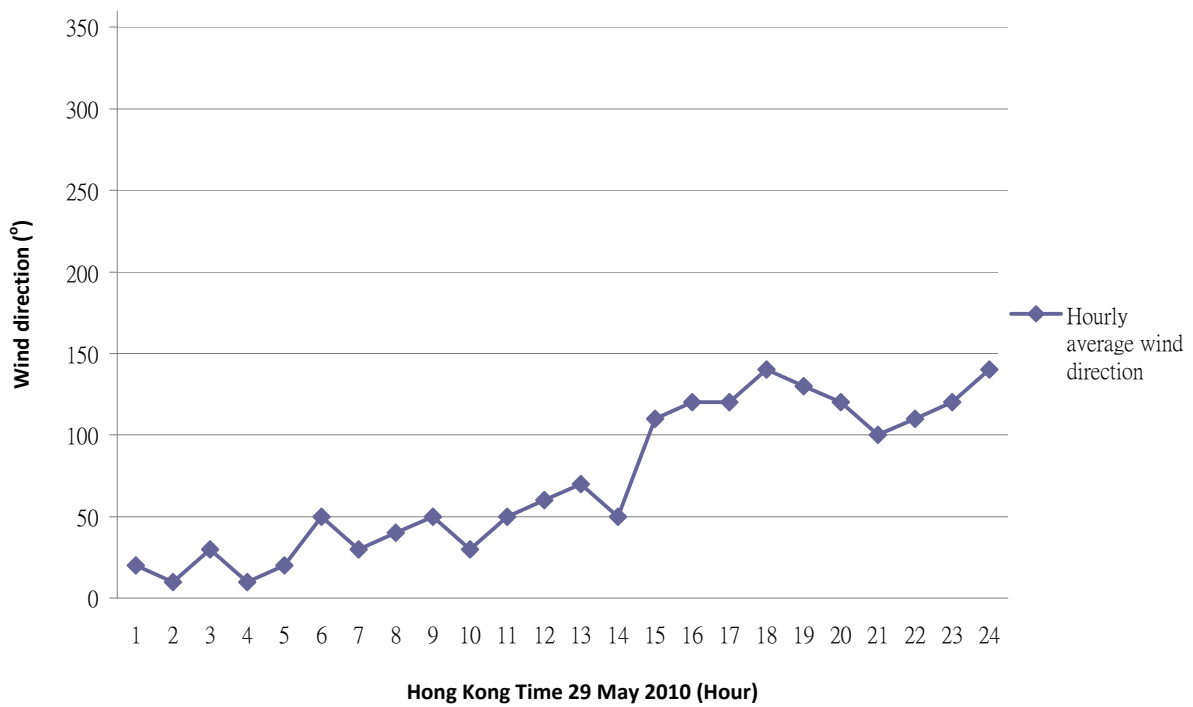
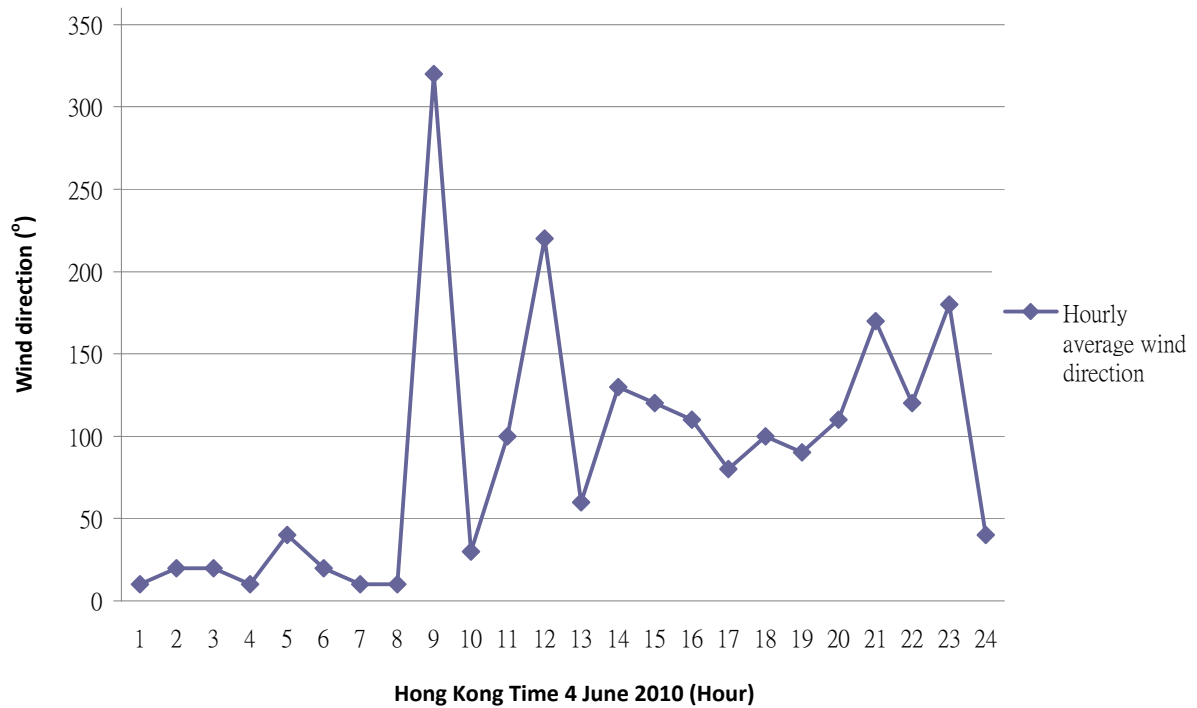
## Wind direction profile at on-site wind station
