Environmental Permit No. FEP-01/571/2019/B

Proposed Golf Course Development at Tai Po Lot No. 246 Shuen Wan

Document to be Certified: Design Plan

Date of Report: December 2025

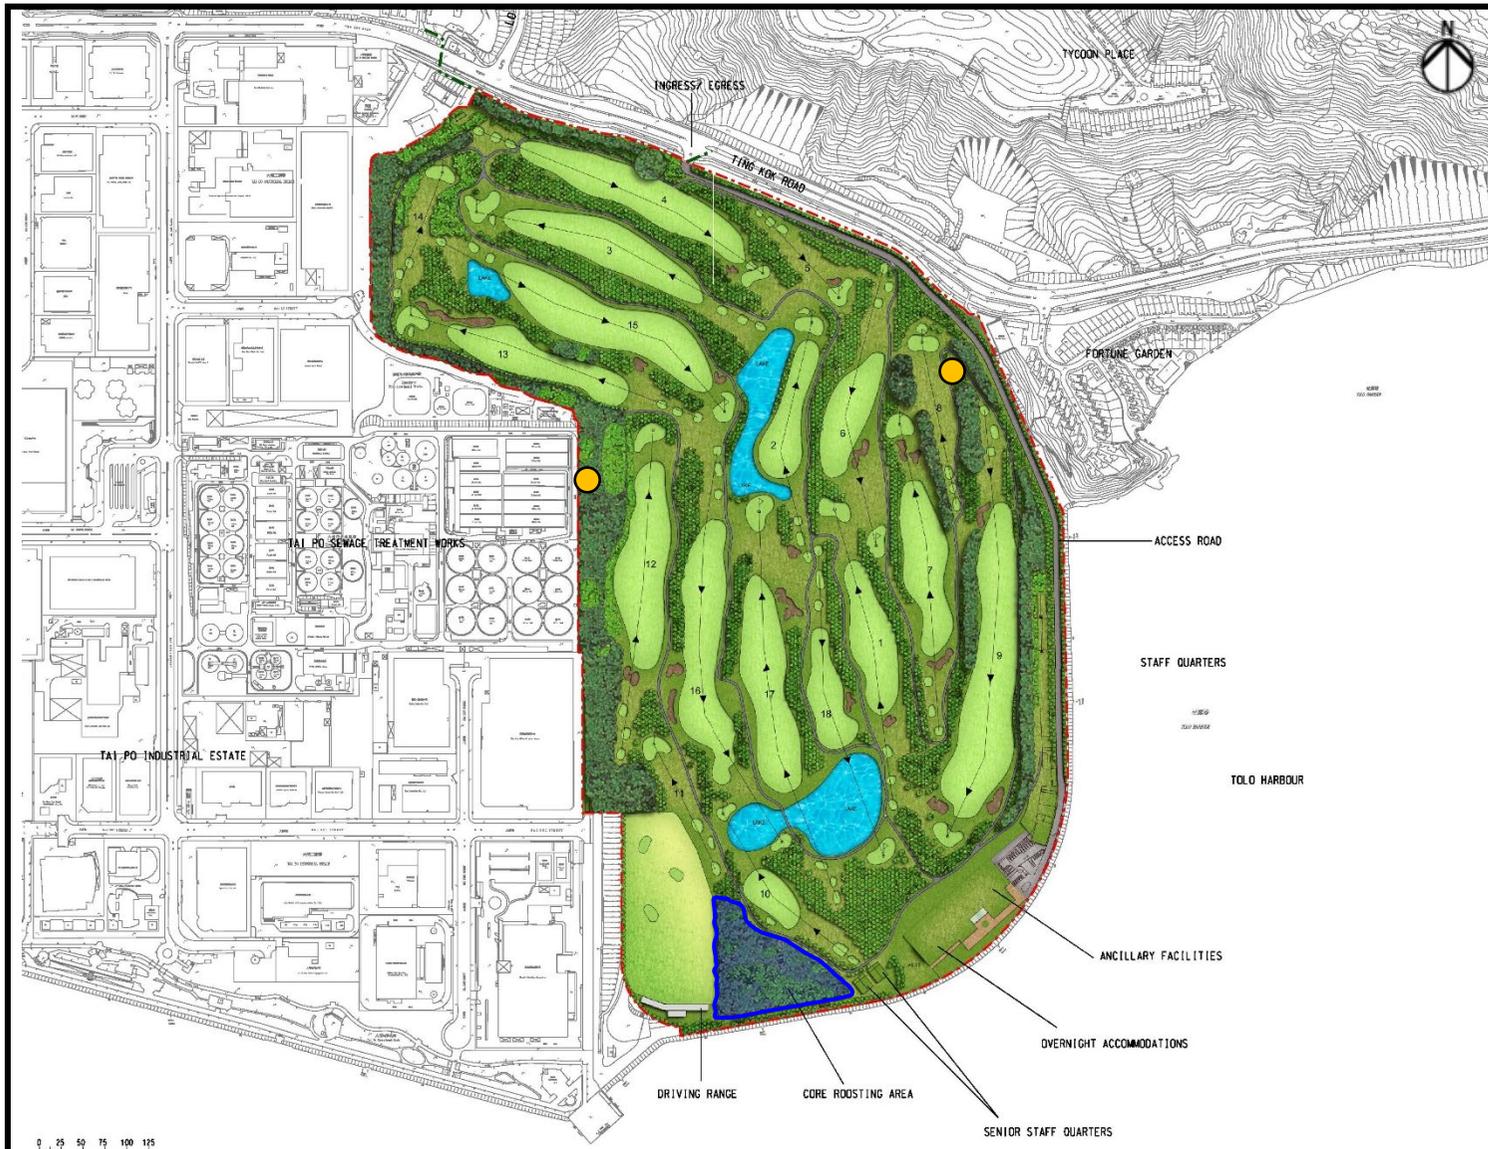
Project Title 工程項目名稱	Shuen Wan Golf Course 船灣高爾夫球場
Figure 1 圖一	Project Location and Conceptual Layout Plan 工程項目位置及概念佈局圖 [This figure was prepared based on Figure 2.1 of EIA Report (Register No.: AEIAR-221/2019)] [本圖是根據環境影響評估報告 (登記冊編號: AEIAR-221/2019) 圖 2.1 編制]

Figure 1 of FEP-01/571/2019/B
