Castle Peak Road Improvement Between Sham Tseng and Ka Loon Tsuen, Tsuen Wan West Contract No. HY/99/18

Quarterly Environmental Monitoring and Audit Summary Report November 2003 to January 2004

Quarterly Environmental Monitoring and Audit Summary Report

November 2003 to January 2004

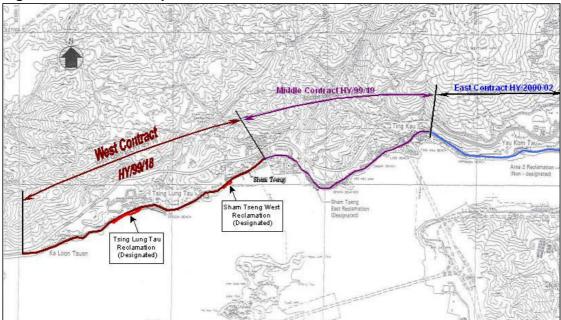
Figure 1-1 Site location plan

The Castle Peak Road improvements works consists of upgrading the existing Castle Peak Road to provide a dual two-lane carriageway of "Rural Road A" classification between Area 2, Tsuen Wan and Ka Loon Tsuen, and all associated utility, junction and pedestrian facilities. The Castle Peak Improvement project is divided into three contracts. This Environmental Monitoring and Audit (EM&A) exercise only concerns the West Contract No. HY/99/18 between Sham Tseng and Ka Loon Tsuen, Tsuen Wan. Figure 1-1 shows the site location plan.

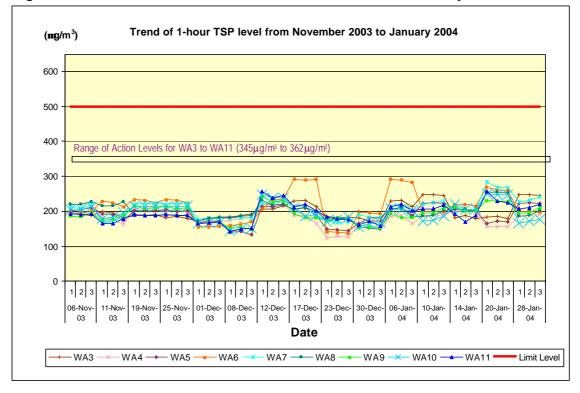
Figure 4-1 Trend of 1-hour TSP levels from November 2003 to January 2004

The trend of 1-hour TSP levels at each monitoring location are plotted and presented in Figure 4-1.

There was no exceedance on Action and Limit Levels in the reporting period.

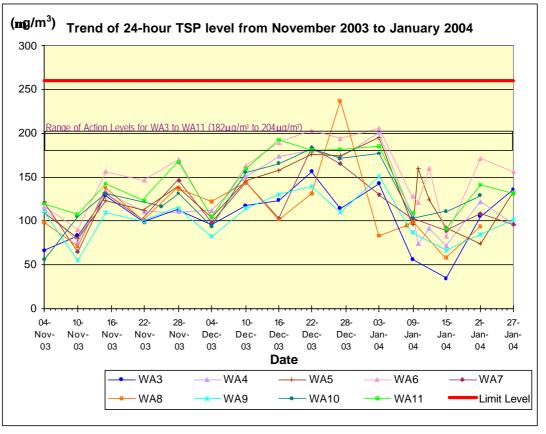
Figure 4-2 Trend of 24-hour TSP level from November 2003 to January 2004

The trend of 24-hour TSP levels at each monitoring location are plotted and presented in Figure 4-2.

These exceedances were mainly due to the poor weather condition in the territory or construction work other than the construction site. Upon the implementation of mitigation measures, no further exceedance was recorded in the subsequent air quality monitoring.

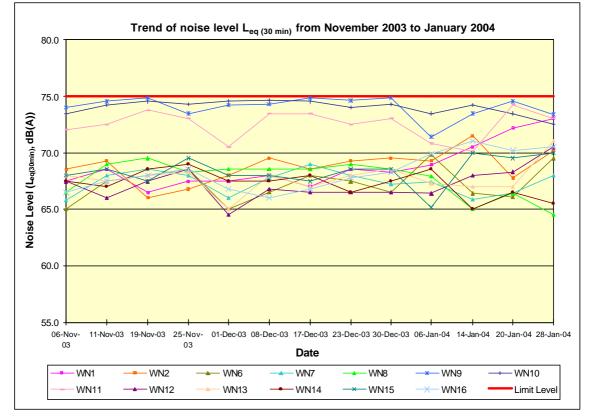
Figure 5-1 Trend of noise level from November 2003 to January 2004

The trend of the noise levels at each monitoring location are plotted and presented in Figure 5-1.

There was no exceedance on the Limit Level in the reporting period.
