**Castle Peak Road
Improvement Between
Sham Tseng and Ka
Loon Tsuen,
Tsuen Wan
West Contract No.
HY/99/18**

Monthly Environmental
Monitoring and Audit
Report
May 2004

Ove Arup & Partners Hong Kong Ltd

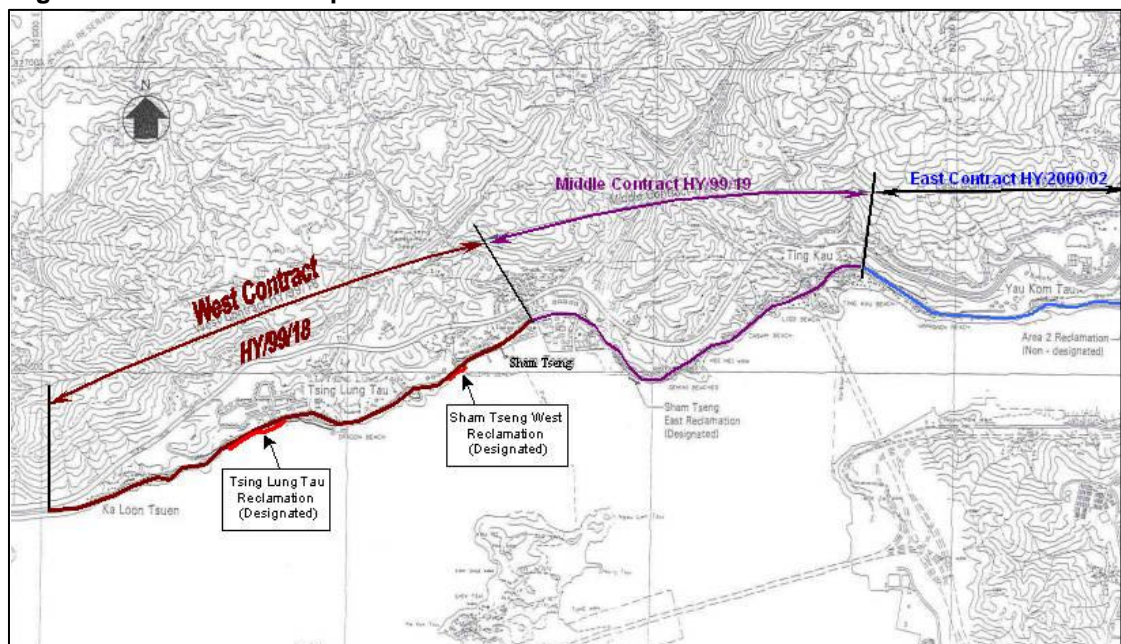
Figure 1-1 Site location plan

The Castle Peak Road improvements works consists of upgrading the existing Castle Peak Road to provide a dual two-lane carriageway of “Rural Road A” classification between Area 2, Tsuen Wan and Ka Loon Tsuen, and all associated utility, junction and pedestrian facilities. The Castle Peak Improvement project is divided into three contracts. This Environmental Monitoring and Audit (EM&A) exercise only concerns the West Contract No. HY/99/18 between Sham Tseng and Ka Loon Tsuen, Tsuen Wan. Figure 1-1 shows the site location plan and the detailed site layout plans are provided in Appendix A.

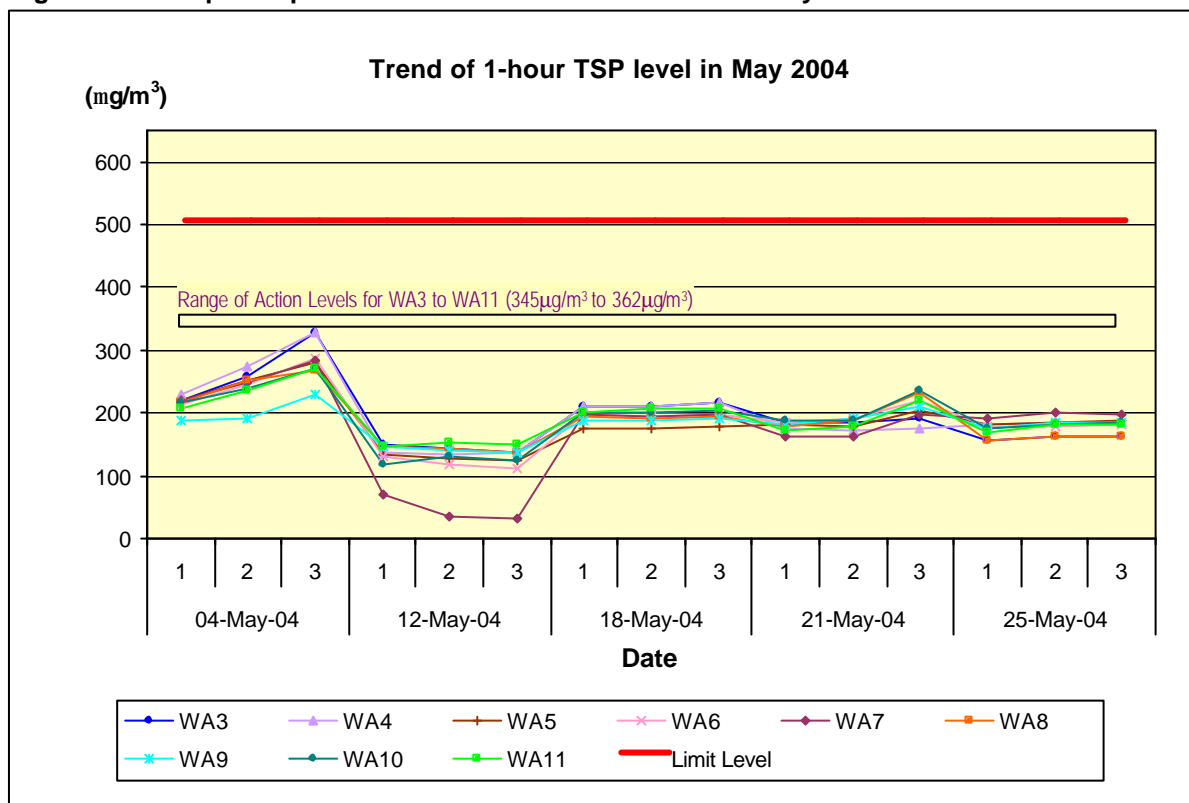
Figure 4-1 Graphical presentation of 1-hour TSP levels for May 2004

The detailed monitoring results of 1-hour TSP are given in Appendix F and the 1-hour TSP level at each monitoring location are plotted and presented in Figure 4-1.

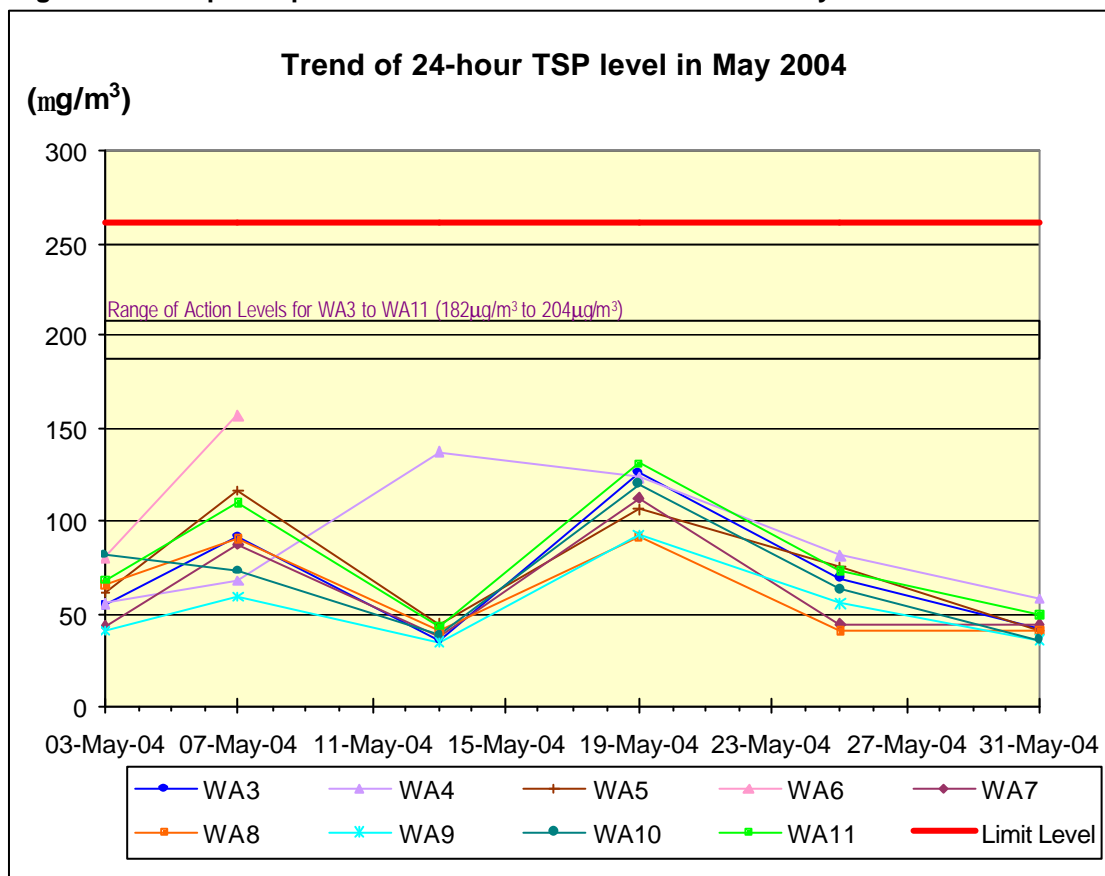
Figure 4-2 Graphical presentation of 24-hour TSP levels for May 2004

A total of 6 sets of 24-hour TSP measurement had been taken on 3, 7, 13, 19, 25 and 31 May 2004 except for WA6 which was suspended since 13 May 2004 due to the malfunction of the HVS.

The detailed monitoring results of 24-hour TSP are given in Appendix H and the 24-hour TSP level at each monitoring location are plotted and presented in Figure 4-2.

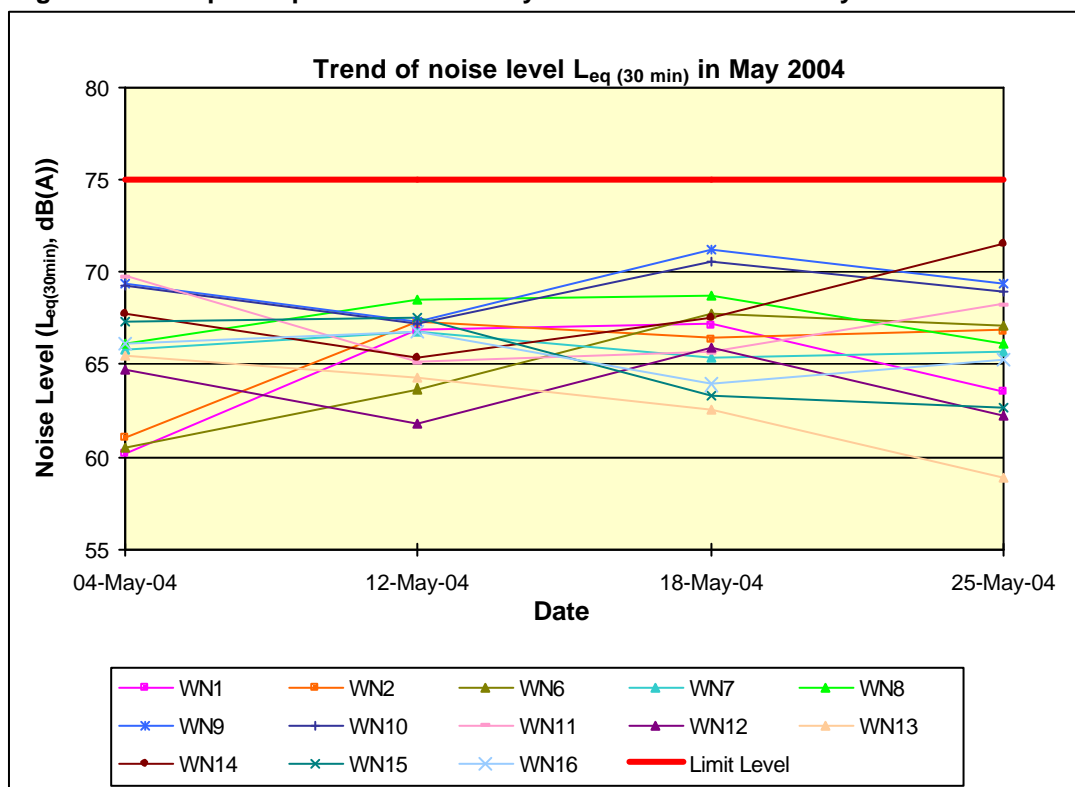
Figure 5-1 Graphical presentation of daytime noise levels for May 2004

The noise levels at each monitoring location are plotted and presented in Figure 5-1.
